## Volkswagen e-Golf BEV 136pk E-dition Winter Multimedia, Jul-20, 73,294 km

Memo

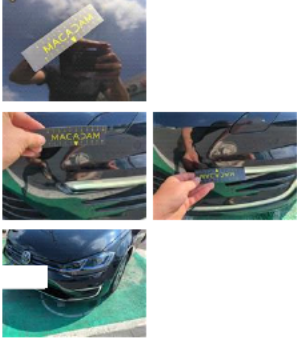
| Incident | Component | Observations |
|---|---|---|
| 6 | Front bumper | various damage (see photo) |
