Expertise

Protocol number: 46625516  
Order No. / Reference: 26674320  
Inspection date: 21 Jul 2026

Manufacturer: Ford

Model: Transit 350 L3H2 Lkw VA MH Trail

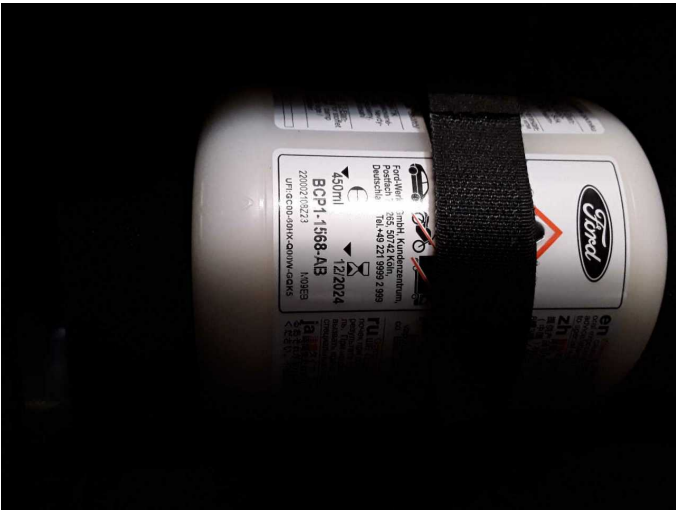
| No. | Component group | Description |
|---|---|---|
| 1 | Equipment | Tirefit filler - Expired - Replace |

Damage 1: Equipment: Tirefit filler - Expired - Replace

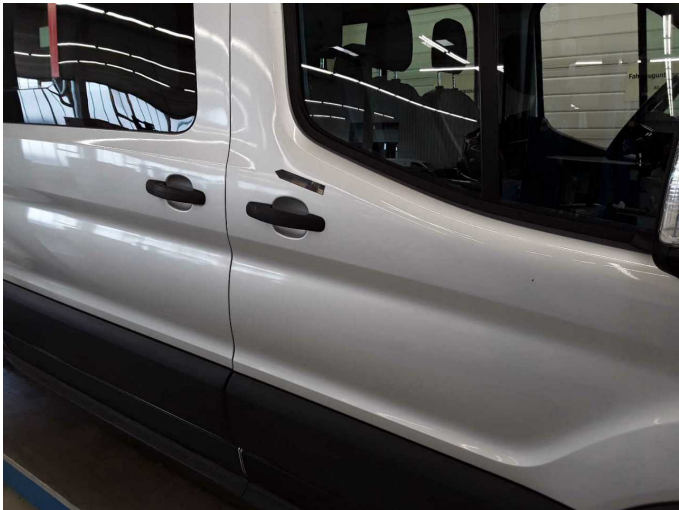
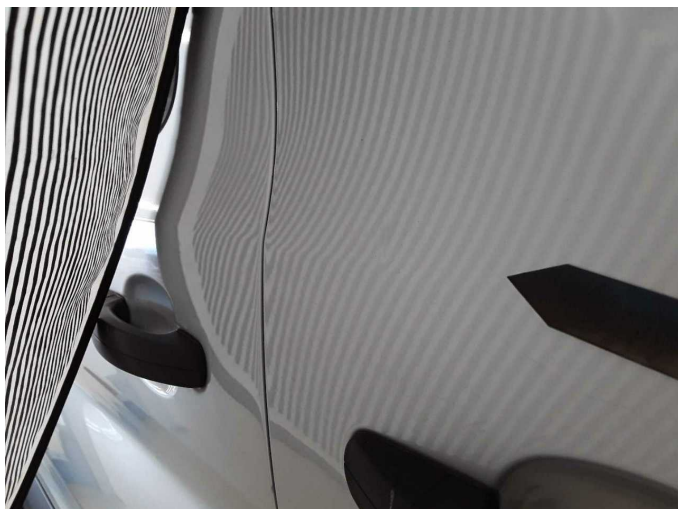
| No. | Component group | Description |
|---|---|---|
| 2 | Door - front right side | Door - dent(s) - Smart repair |

Damage 2: Door - front right side: Door - dent(s) - Smart repair

**Damage 2:** Door - front right side: Door - dent(s) - Smart repair

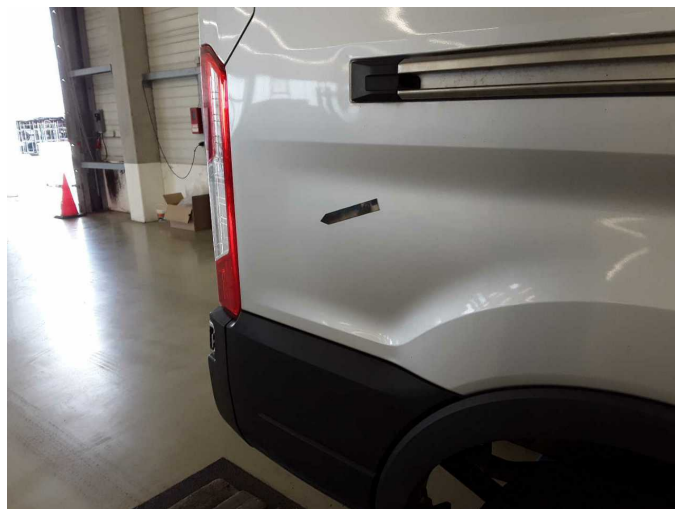
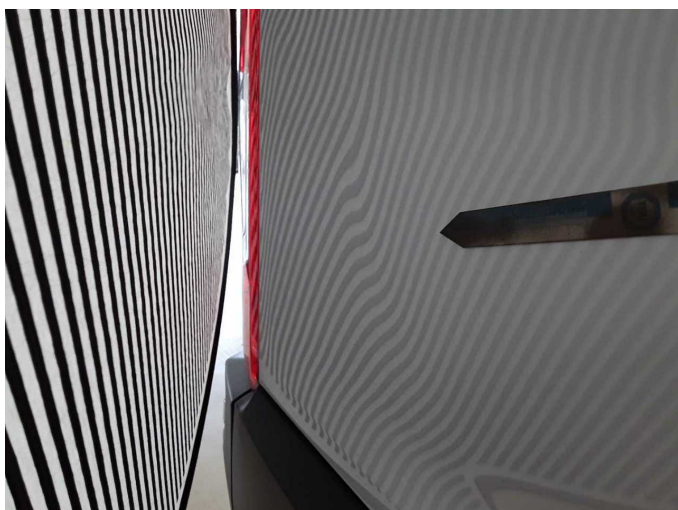
| No. | Component group | Description |
|---|---|---|
| 3 | Side panel - rear right side | Side panel - dent(s) - Smart repair |

**Damage 3:** Side panel - rear right side: Side panel - dent(s) - Smart repair

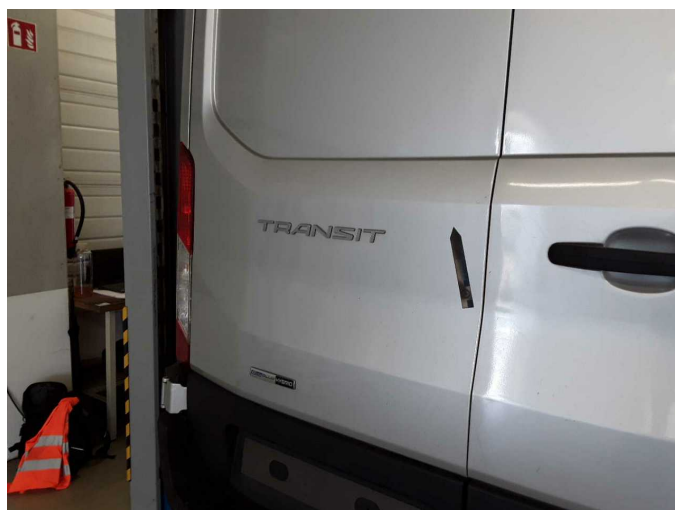
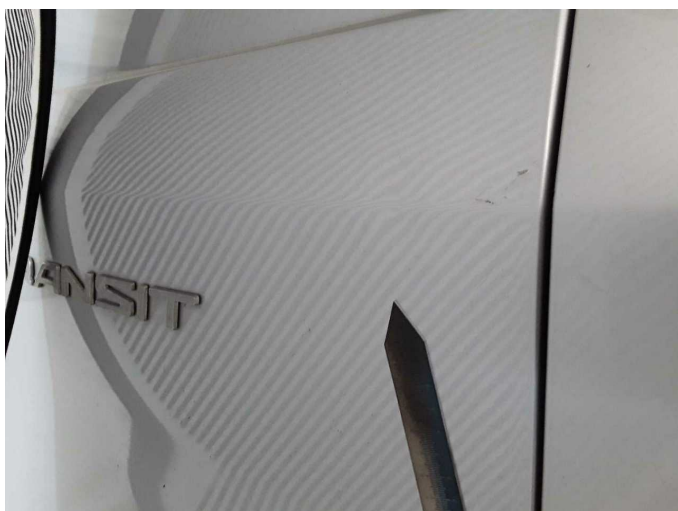
| No. | Component group | Description |
|---|---|---|
| 4 | Boot lid / rear door | Rear door - left side - dent(s) - Smart repair |

**Damage 4:** Boot lid / rear door: Rear door - left side - dent(s) - Smart repair

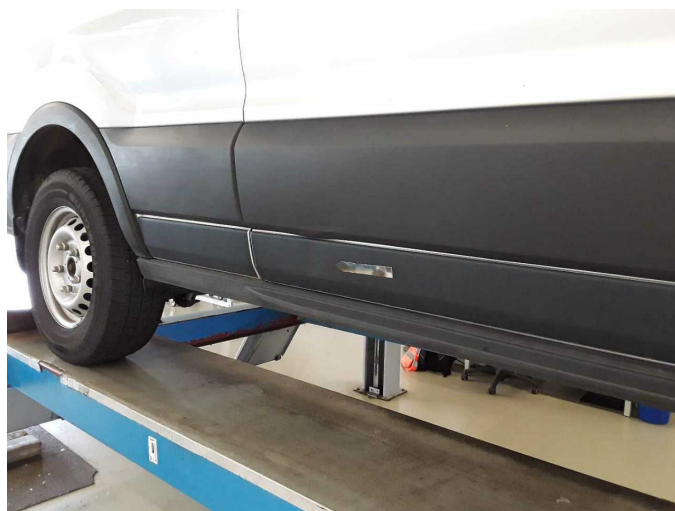
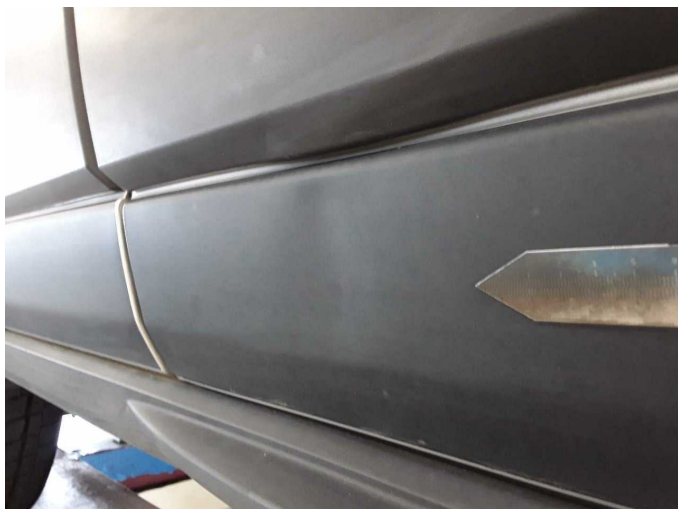
| No. | Component group | Description |
|---|---|---|
| 5 | Sliding door, right | Sliding door with glass panel - dent(s) - Smart repair |

**Damage 5:** Sliding door, right: Sliding door with glass panel - dent(s) - Smart repair

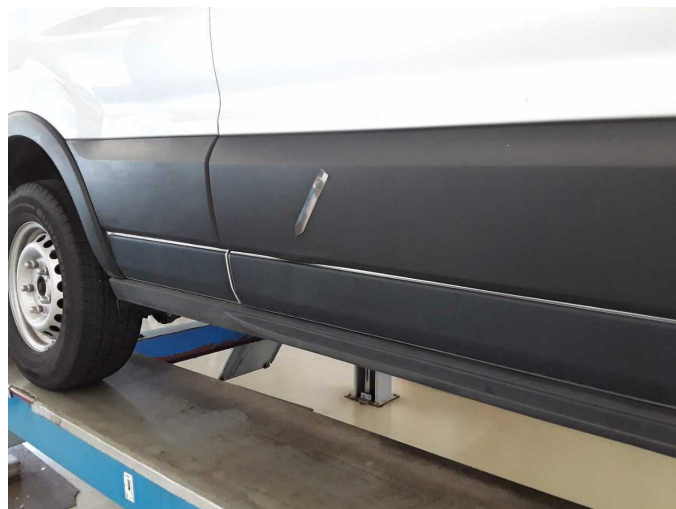
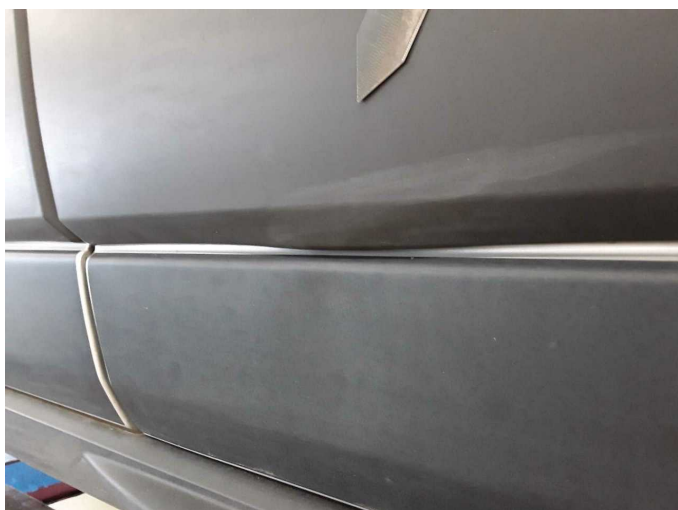
| No. | Component group | Description |
|---|---|---|
| 6 | Sliding door, right | Protection strip - Deformed - Replace |

**Damage 6:** Sliding door, right: Protection strip - Deformed - Replace

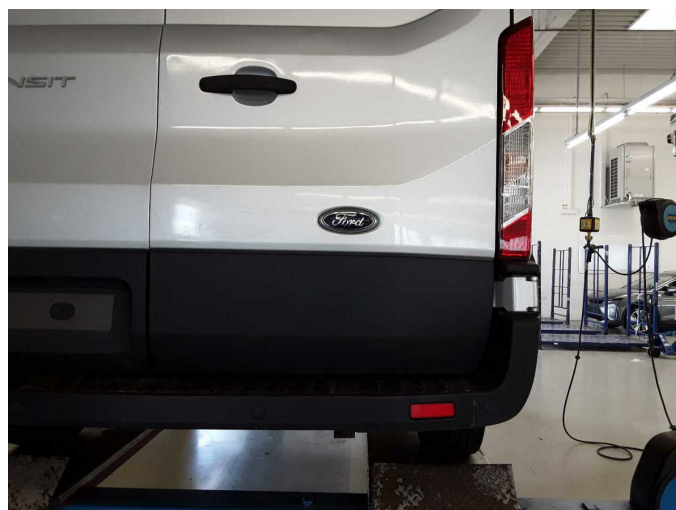
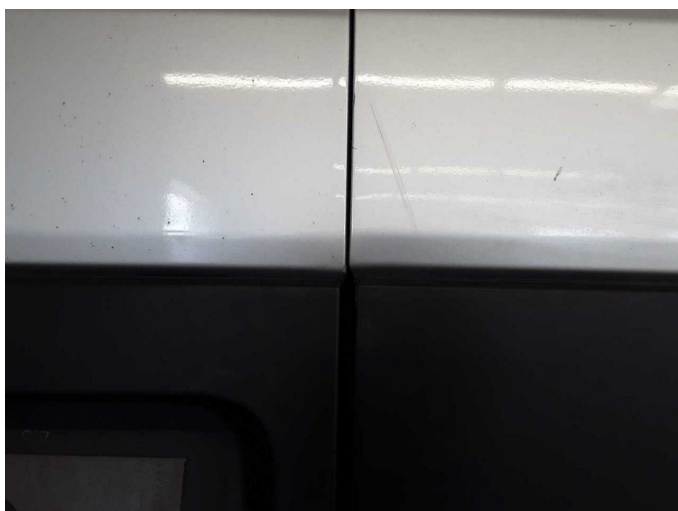
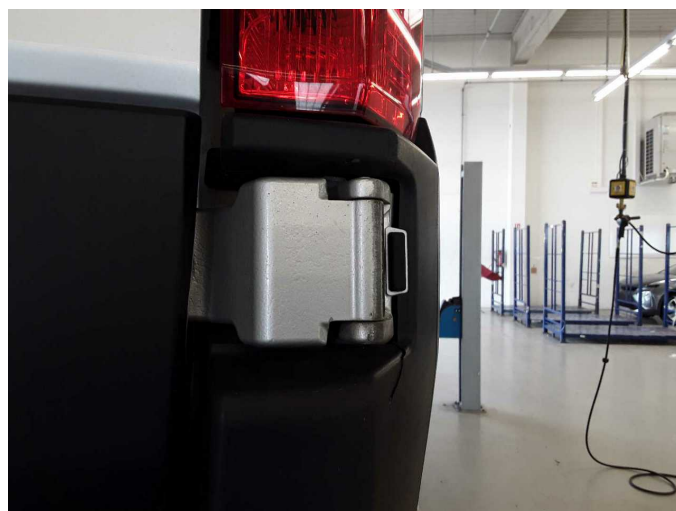
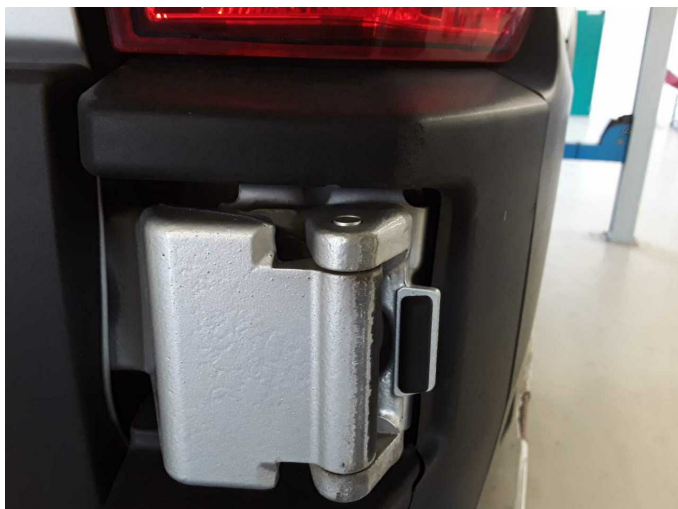
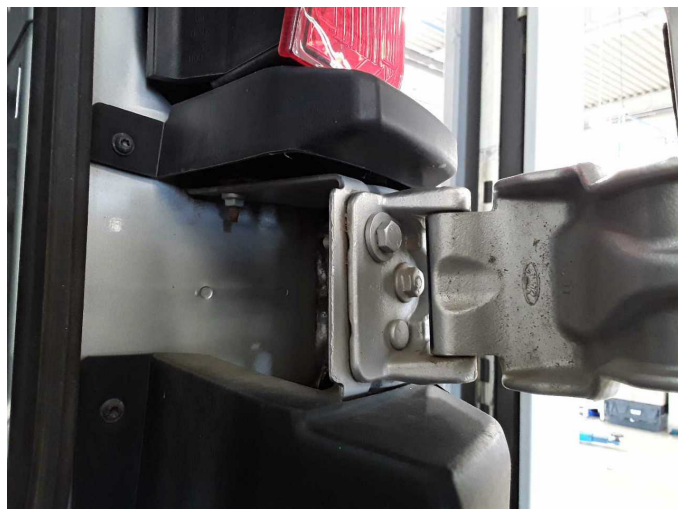
| No. | Component group | Description |
|---|---|---|
| 8 | Boot lid / rear door | Hinge (rechts unten) - Malposition - Set / adjust |

**Damage 8:** Boot lid / rear door: Hinge (rechts unten) - Malposition - Set / adjust

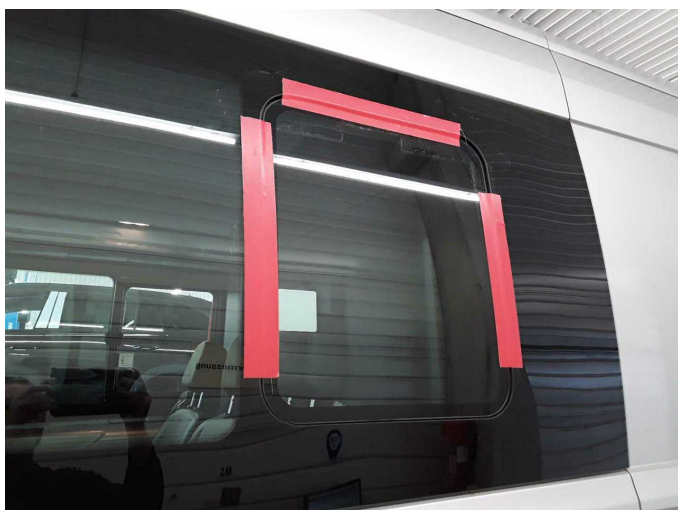
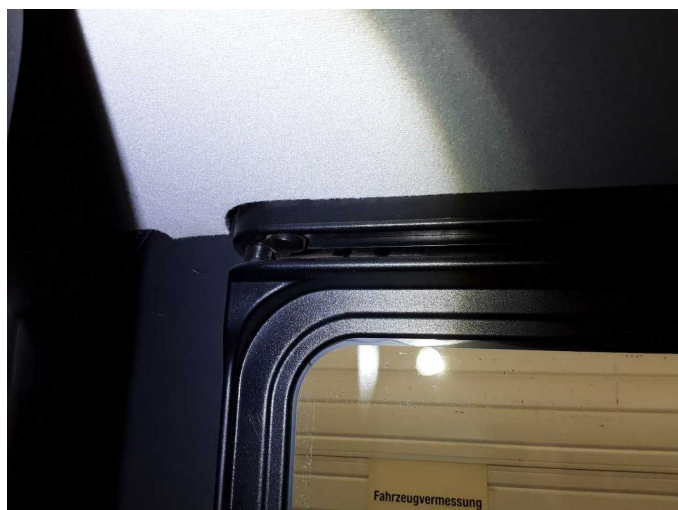
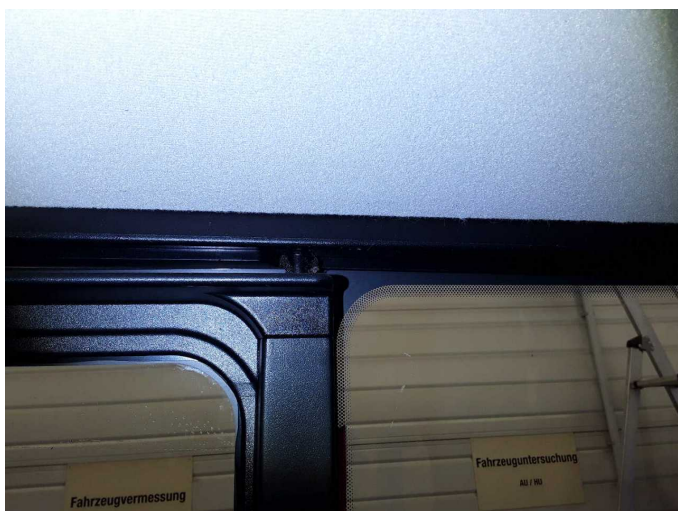
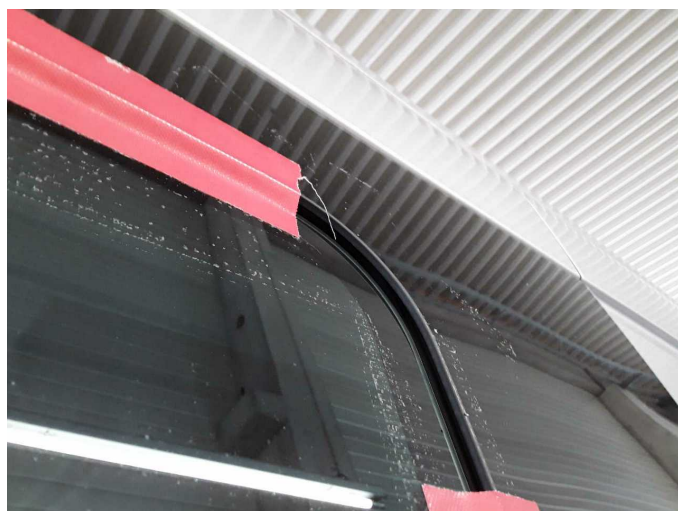
| No. | Component group | Description |
|---|---|---|
| 9 | Vehicle glazing | Side window - rear left side (Schiebefenster, Zusatzkosten können entstehen) - Loose - Repair |

**Damage 9:** Vehicle glazing: Side window - rear left side (Schiebefenster, Zusatzkosten können entstehen) - Loose - Repair

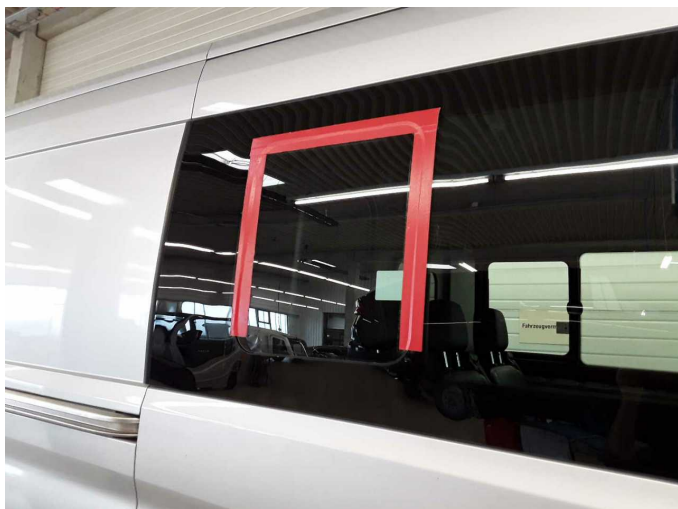
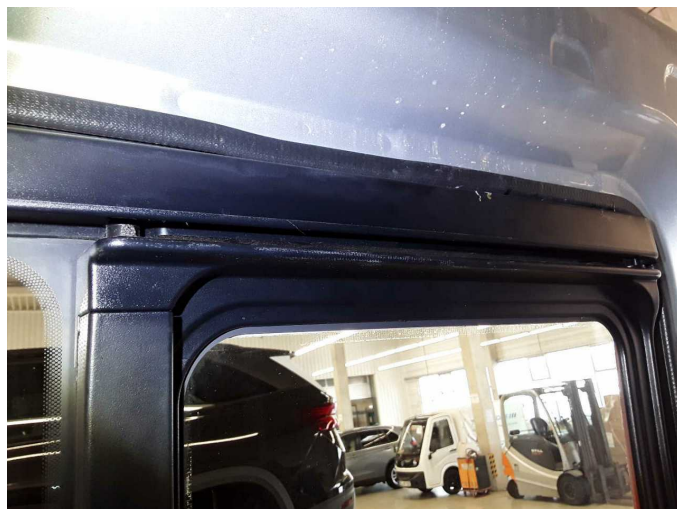
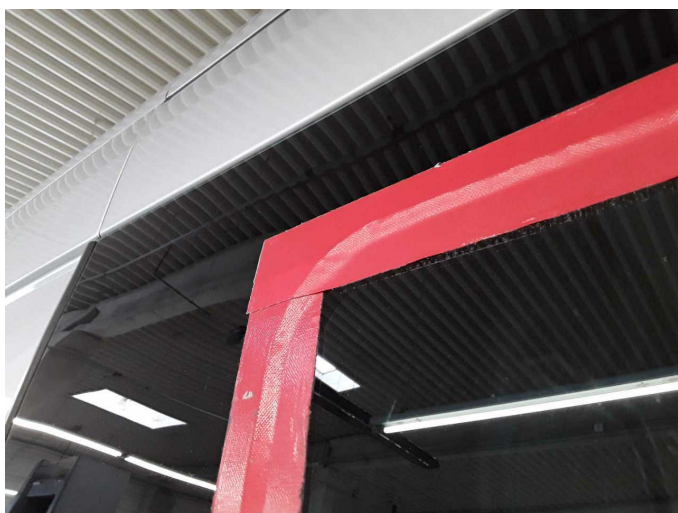
| No. | Component group | Description |
|---|---|---|
| 10 | Vehicle glazing | Side window - rear right side (Schiebefenster, Zusatzkosten können entstehen) - Loose - Repair |

**Damage 10:** Vehicle glazing: Side window - rear right side  
(Schiebefenster, Zusatzkosten können entstehen) - Loose - Repair

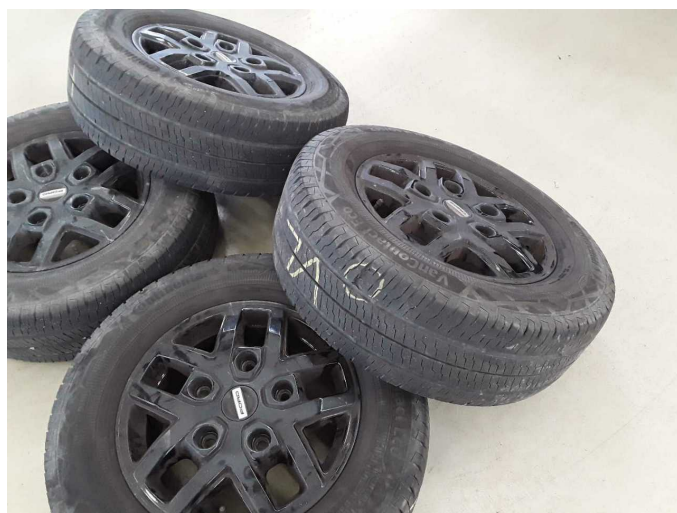
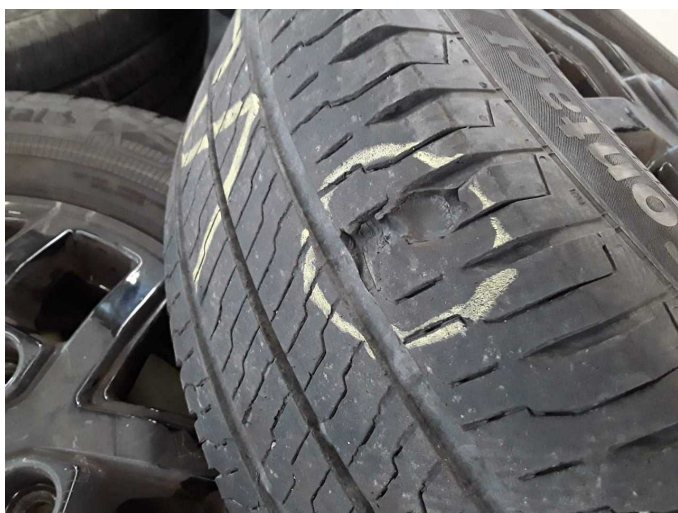
| No. | Component group | Description |
|---|---|---|
| 11 | 2nd wheel set | 1 tyre - Broken / torn - Replace |

**Damage 11:** 2nd wheel set: 1 tyre - Broken / torn - Replace

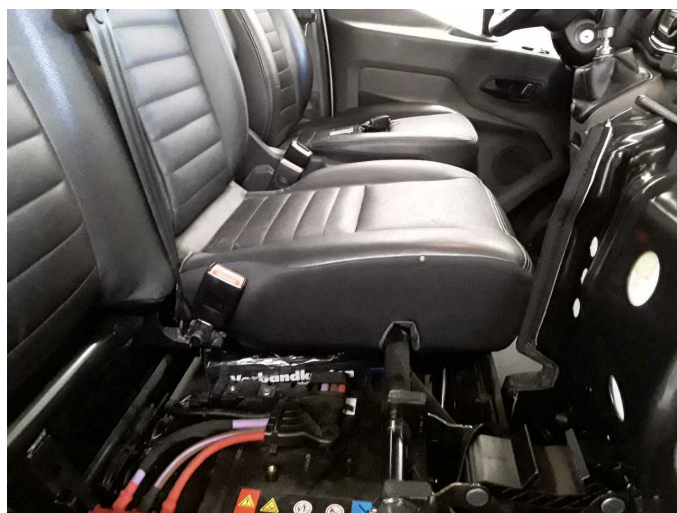
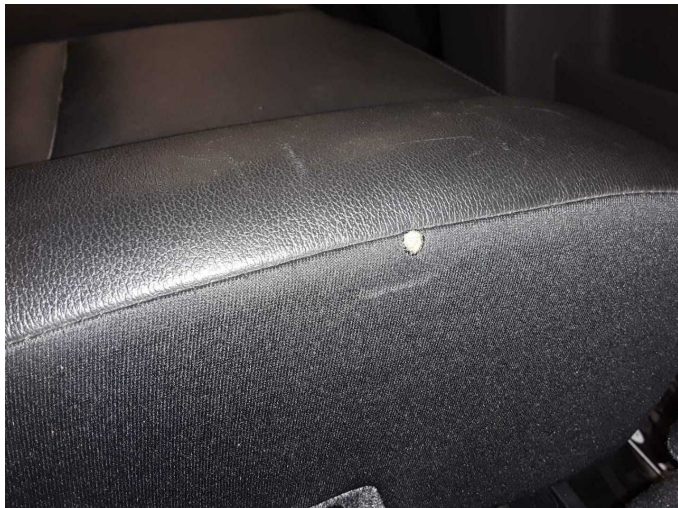
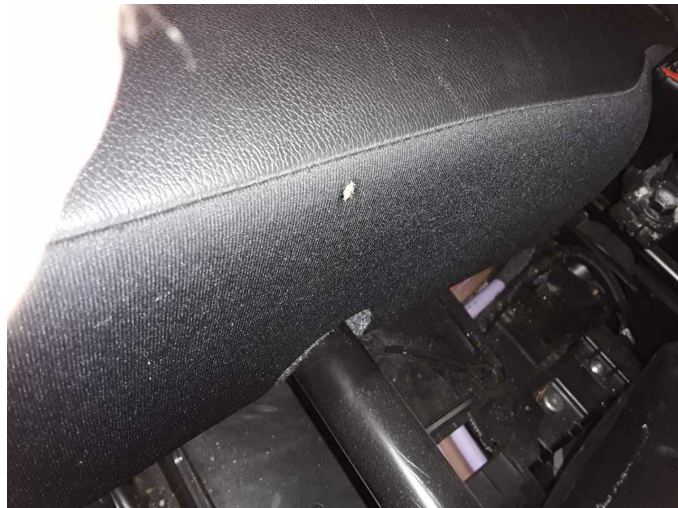
| No. | Component group | Description |
|---|---|---|
| 12 | Seat - front | Seat cover -2 seater - right side - Burn hole (cigarettes) - Smart repair |

**Damage 12:** Seat - front: Seat cover -2 seater - right side - Burn hole  
(cigarettes) - Smart repair

**Damage 12:** Seat - front: Seat cover -2 seater - right side - Burn hole (cigarettes) - Smart repair

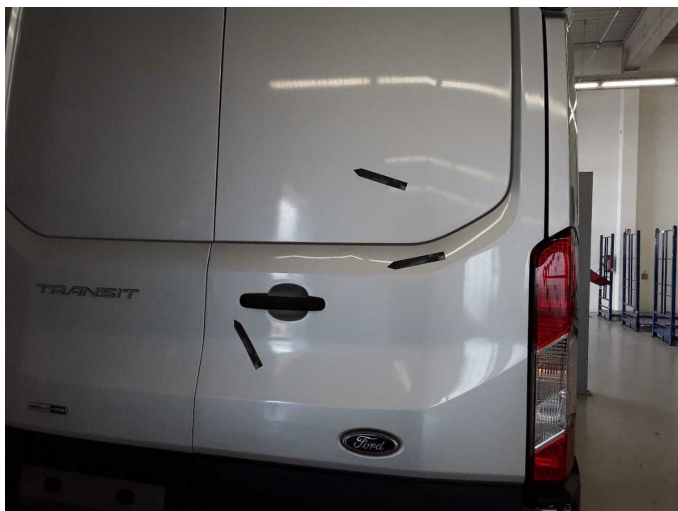
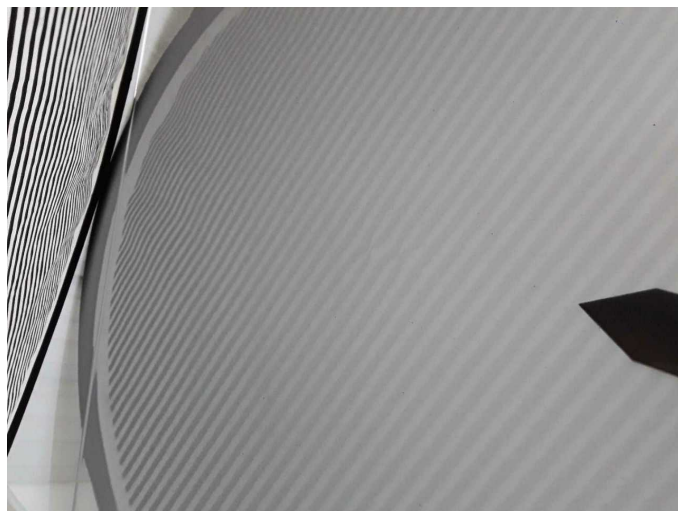
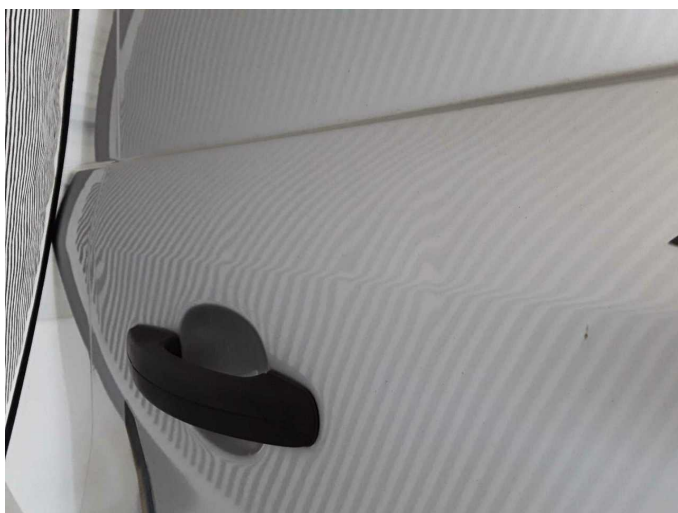
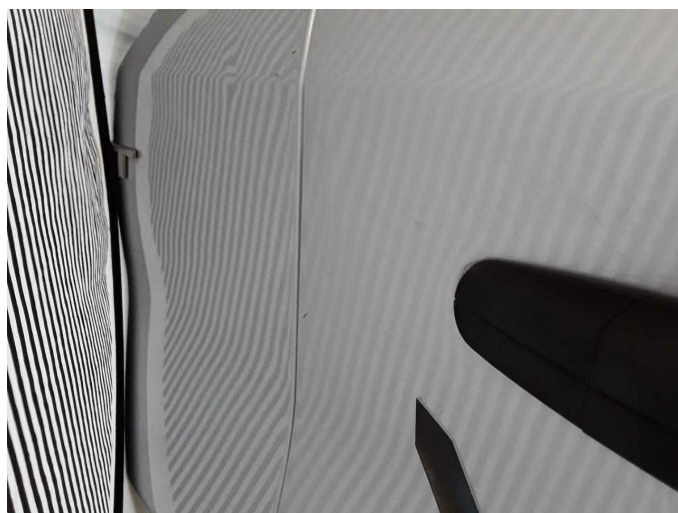
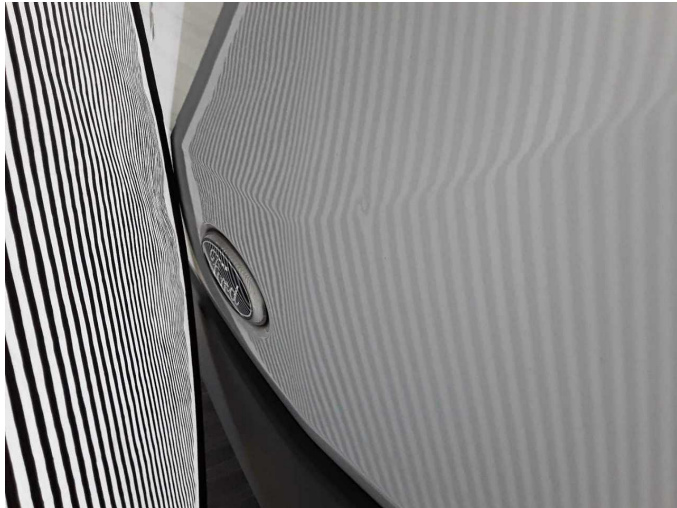
| No. | Component group | Description |
|---|---|---|
| 13 | Boot lid / rear door | Rear door - right side - dent(s) - Smart repair |

**Damage 13:** Boot lid / rear door: Rear door - right side - dent(s) - Smart repair

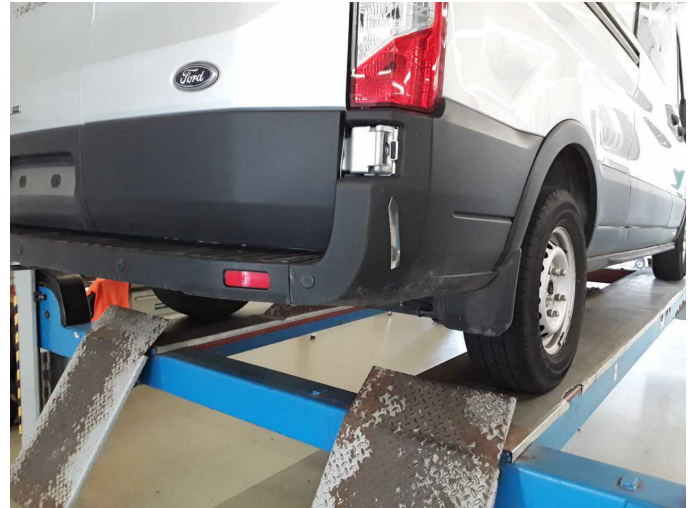
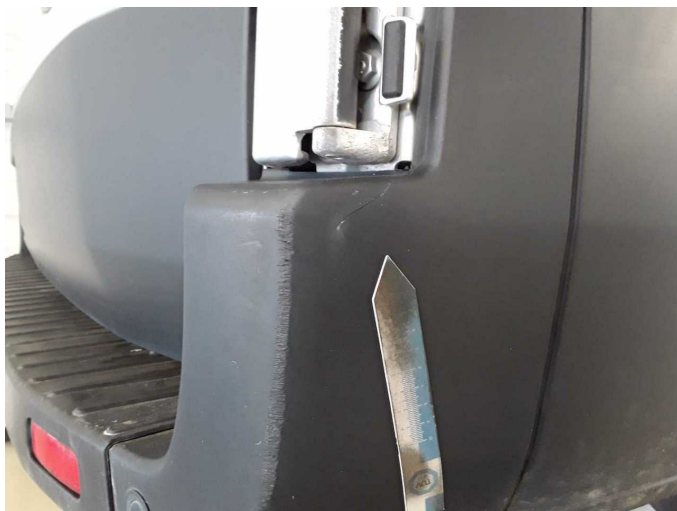
| No. | Component group | Description |
|---|---|---|
| 14 | Rear bumper | Bumper - rear right side - Broken / torn - Replace |

**Damage 14:** Rear bumper: Bumper - rear right side - Broken / torn - Replace

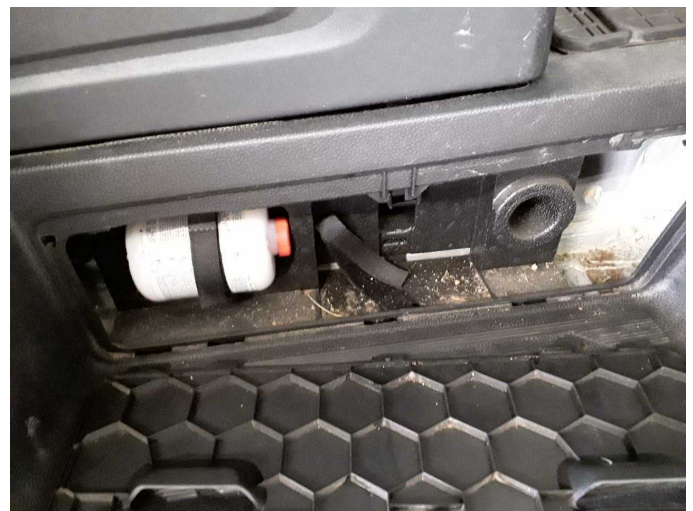
Equipment - Tirefit compressor

**Missing part 1:** Equipment: Tirefit compressor - Missing - Replace
