Expertise

Protocol number: 46673298  
Order No. / Reference: 26606617-1  
Inspection date: 20 Jul 2026

Manufacturer: Opel

Model: Zafira Life 2.0 D L Aut. Tourer

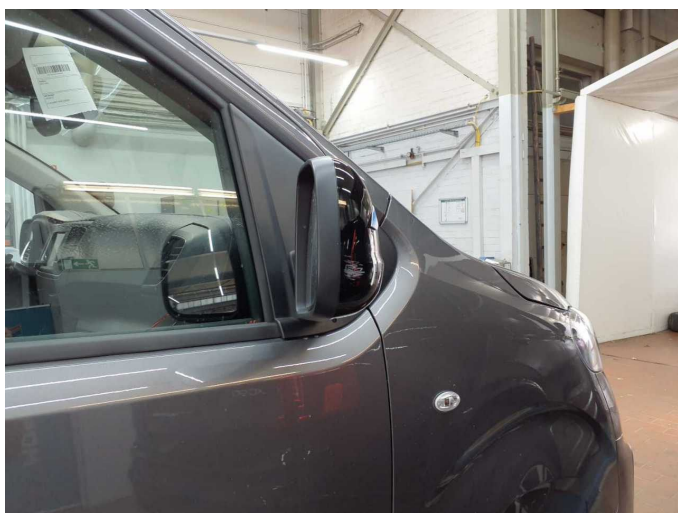
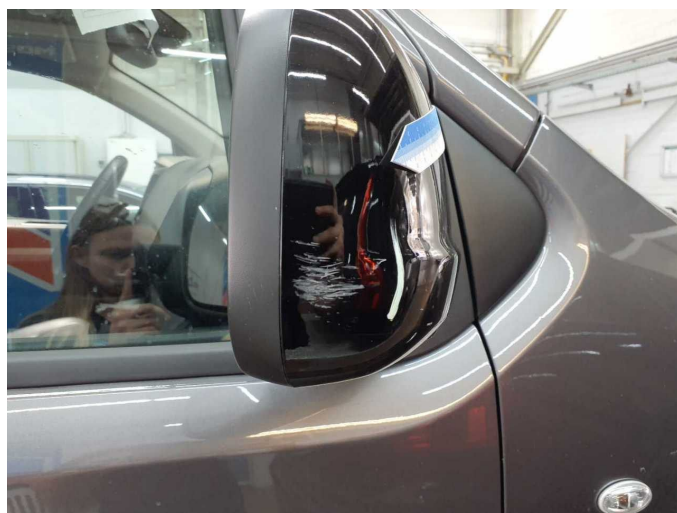
| No. | Component group | Description |
|---|---|---|
| 1 | Wing mirror - right side | Cap - Scratched - Smart repair |

**Damage 1:** Wing mirror - right side: Cap - Scratched - Smart repair

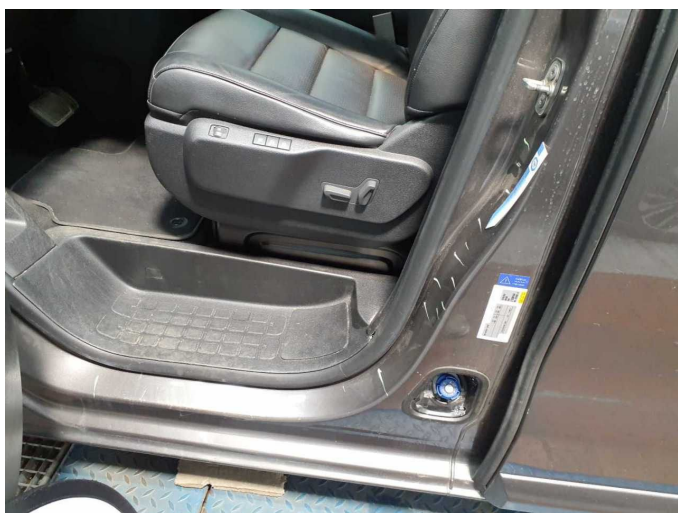
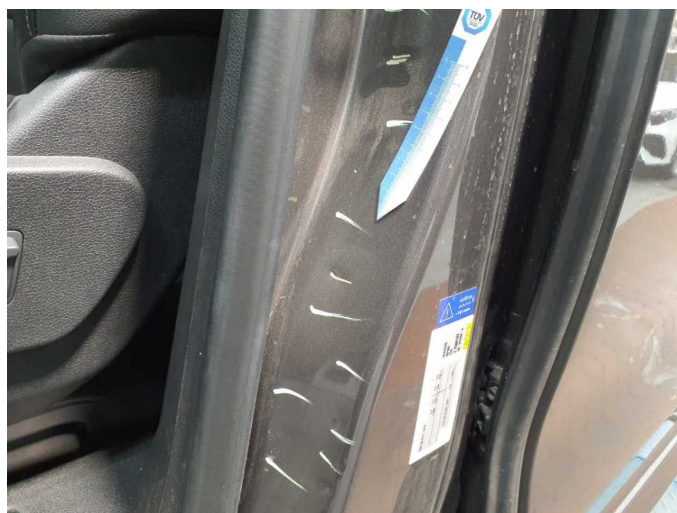
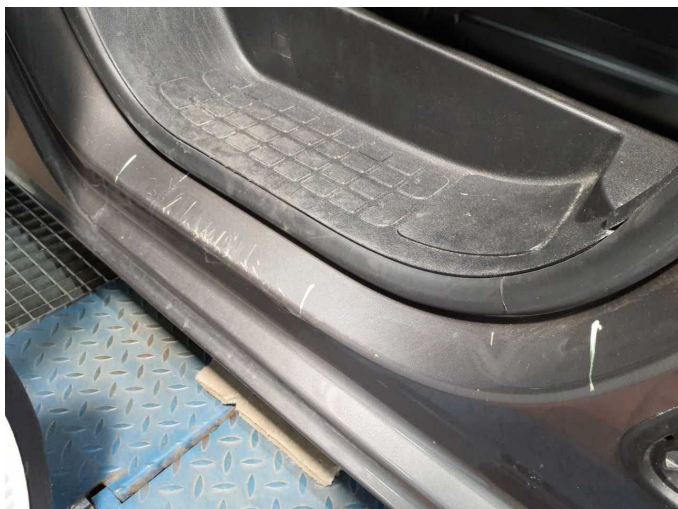
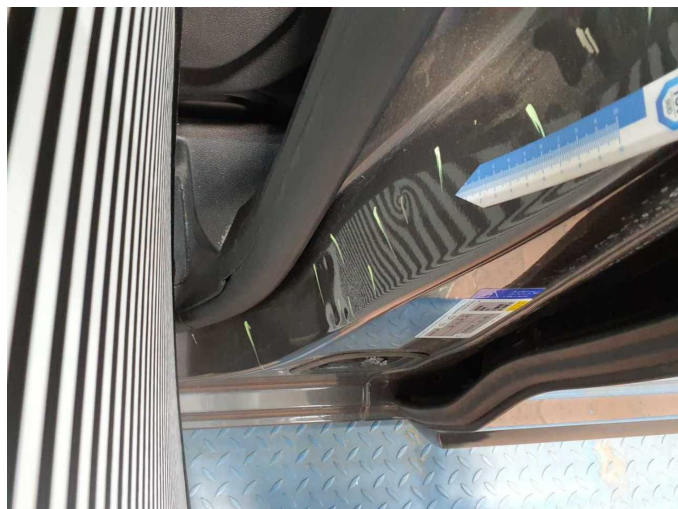
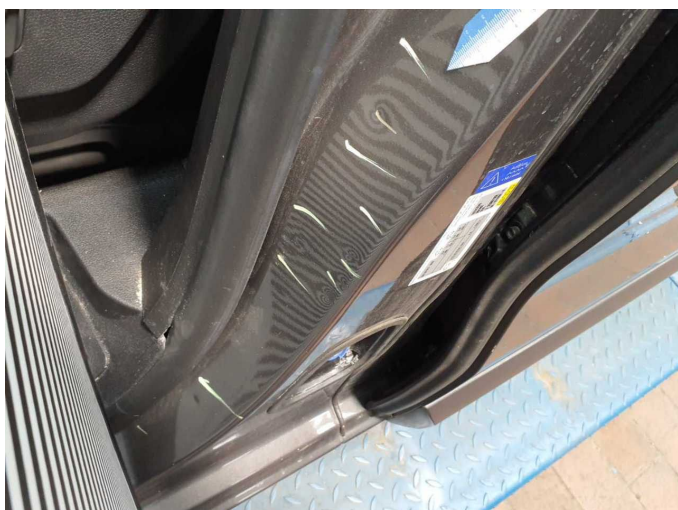
| No. | Component group | Description |
|---|---|---|
| 2 | Sill - left side | Sill - Dent / paintcoat damage - Smart repair |

**Damage 2:** Sill - left side: Sill - Dent / paintcoat damage - Smart repair

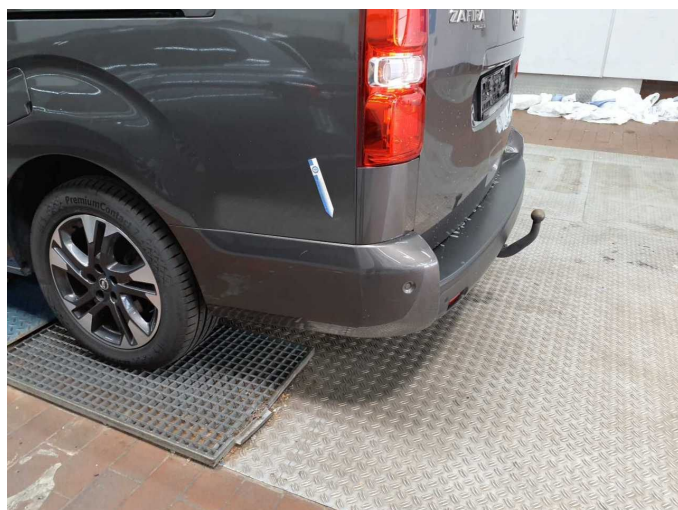
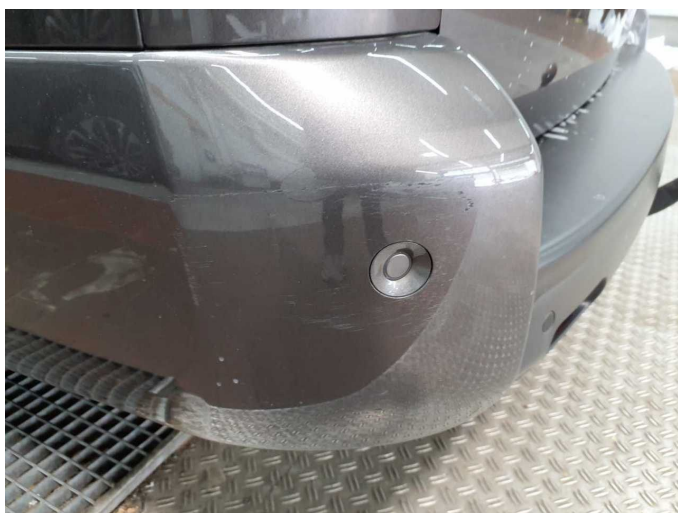
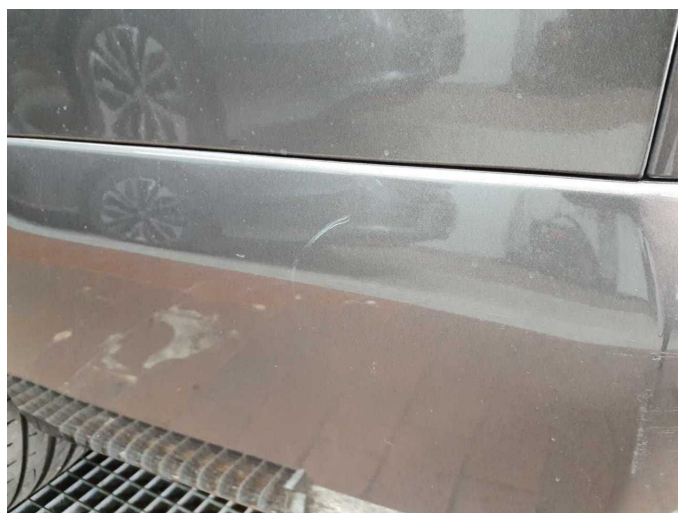
| No. | Component group | Description |
|---|---|---|
| 3 | Rear bumper | Rear bumper - Scratched - Smart repair |

**Damage 3:** Rear bumper: Rear bumper - Scratched - Smart repair

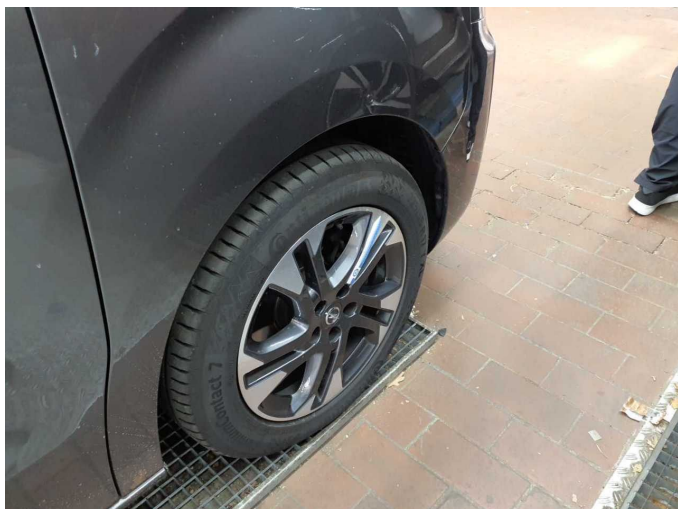
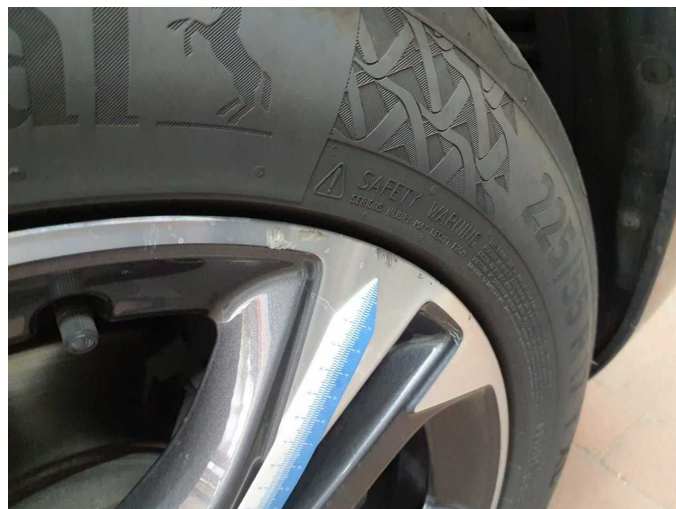
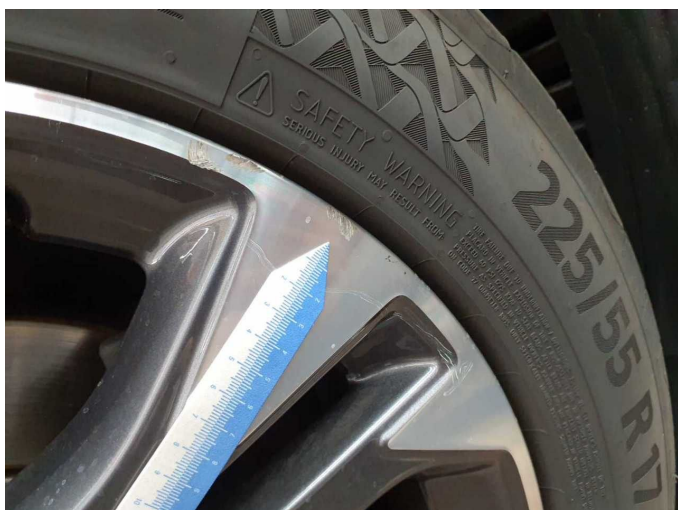
| No. | Component group | Description |
|---|---|---|
| 4 | Wheel / tyres | Alloy rim - front right side - Scratched - Loss in value |

**Damage 4:** Wheel / tyres: Alloy rim - front right side - Scratched - Loss in value

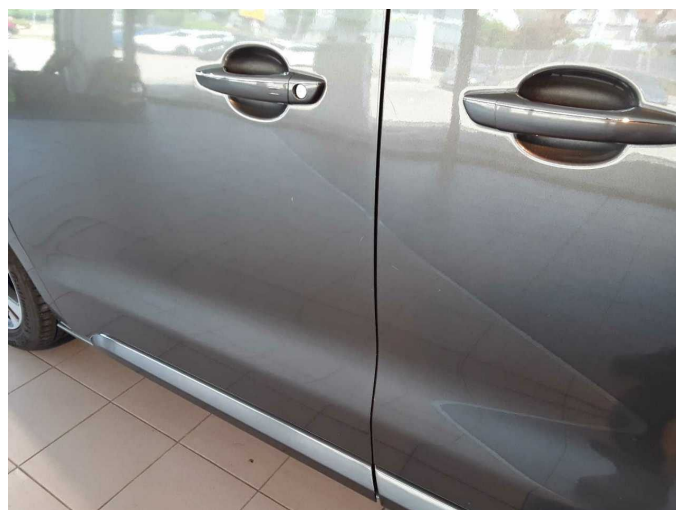
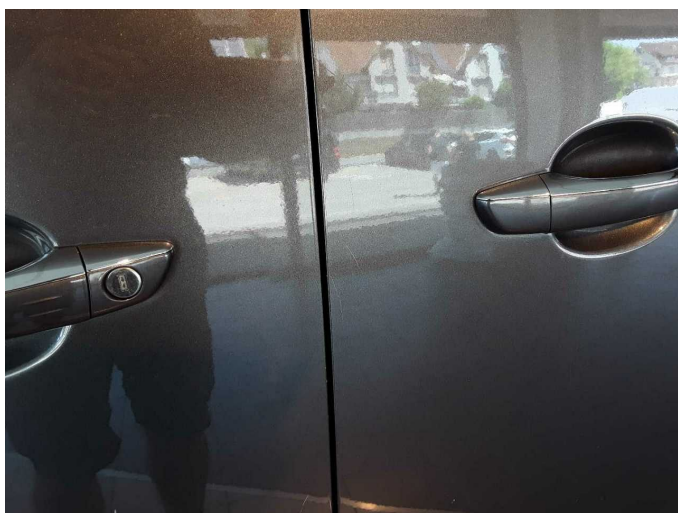
| No. | Component group | Description |
|---|---|---|
| 1 | Door - rear left side | Door - Scratched - No deduction |

**Wear and tear 1:** Door - rear left side: Door - Scratched - No deduction

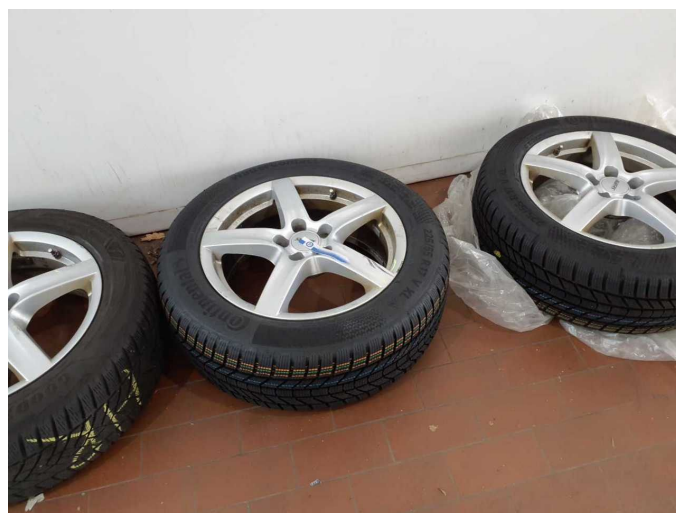
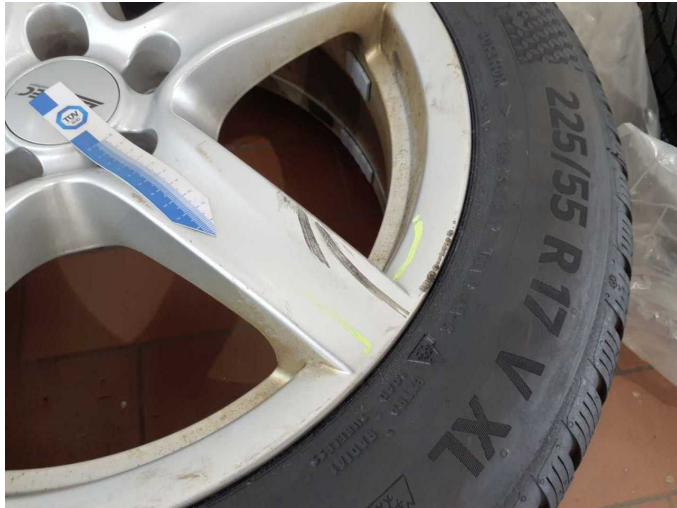
| No. | Component group | Description |
|---|---|---|
| 2 | 2nd wheel set | 1 alloy rim - Scratched - No deduction |

**Wear and tear 2:** 2nd wheel set: 1 alloy rim - Scratched - No deduction

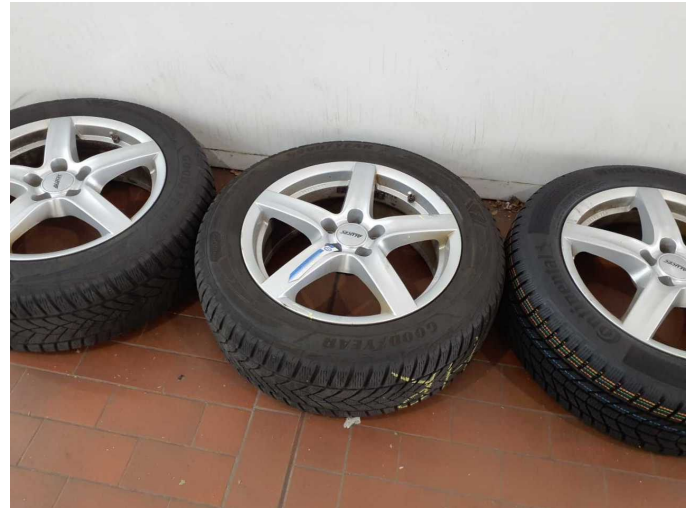
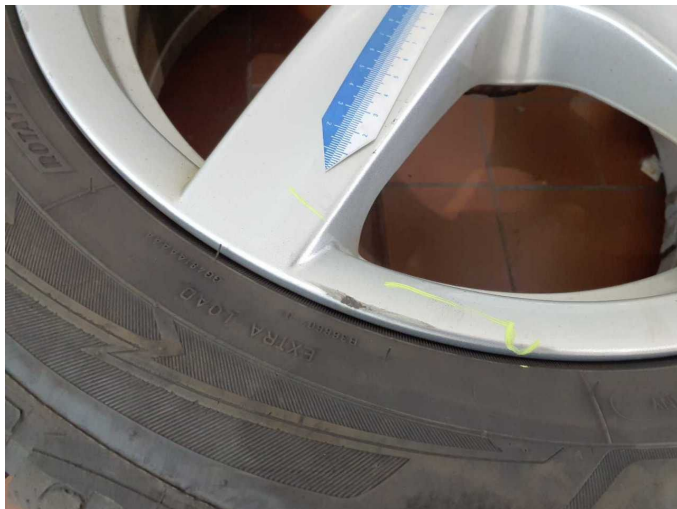
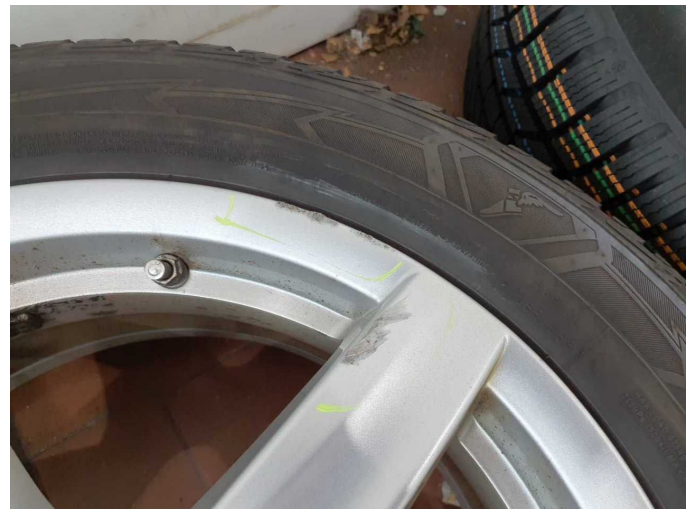
| No. | Component group | Description |
|---|---|---|
| 3 | 2nd wheel set | 1 alloy rim - Scratched - No deduction |

**Wear and tear 3:** 2nd wheel set: 1 alloy rim - Scratched - No deduction

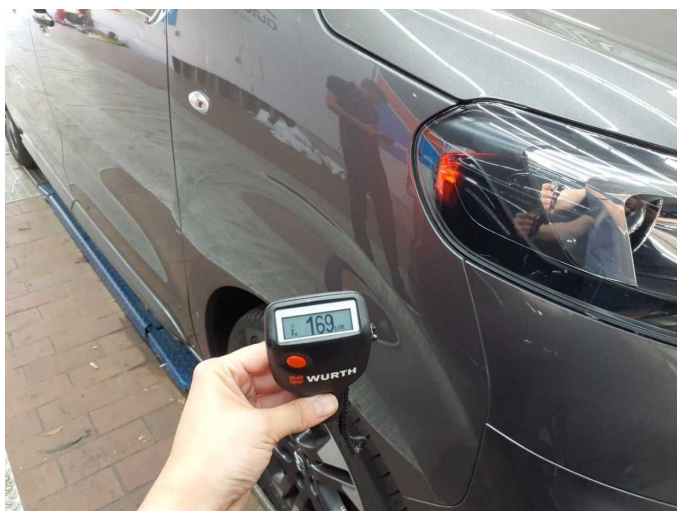
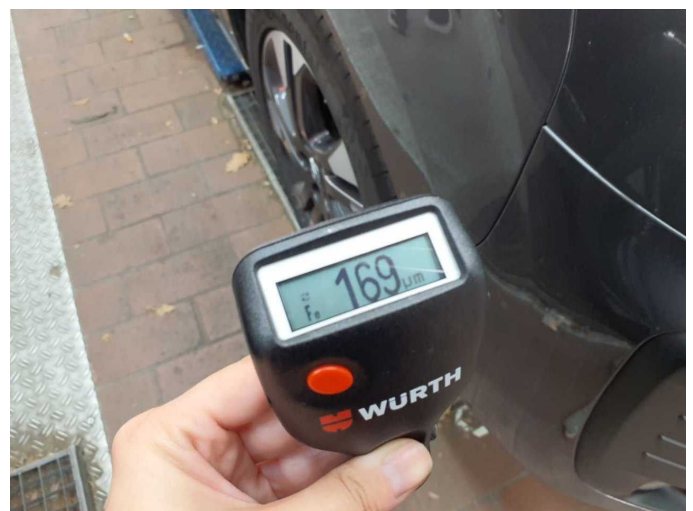
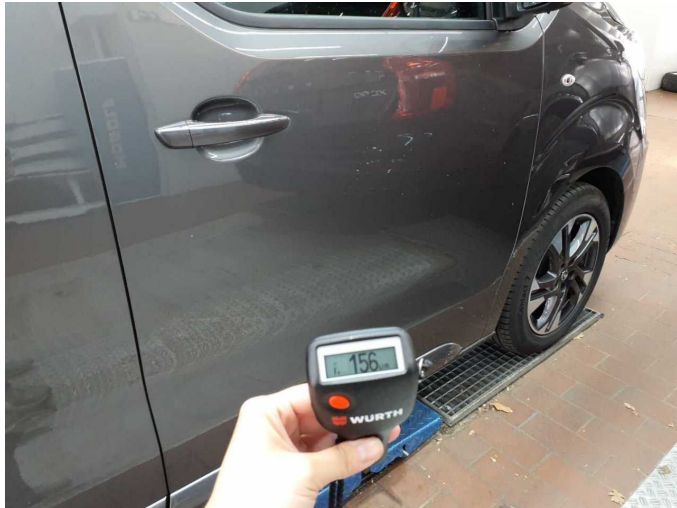
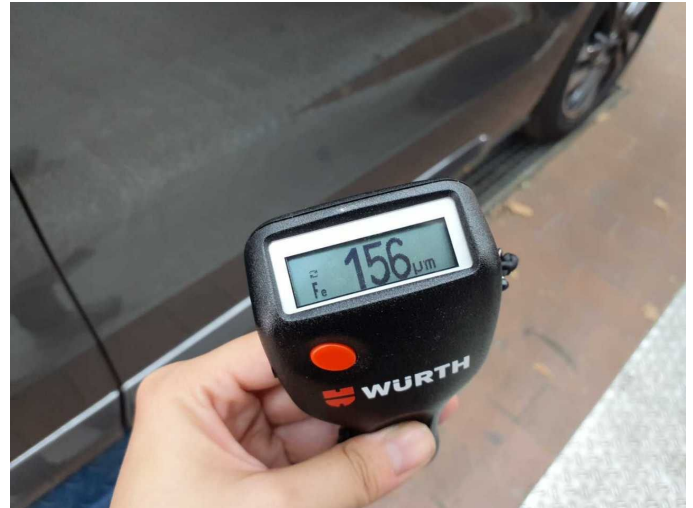
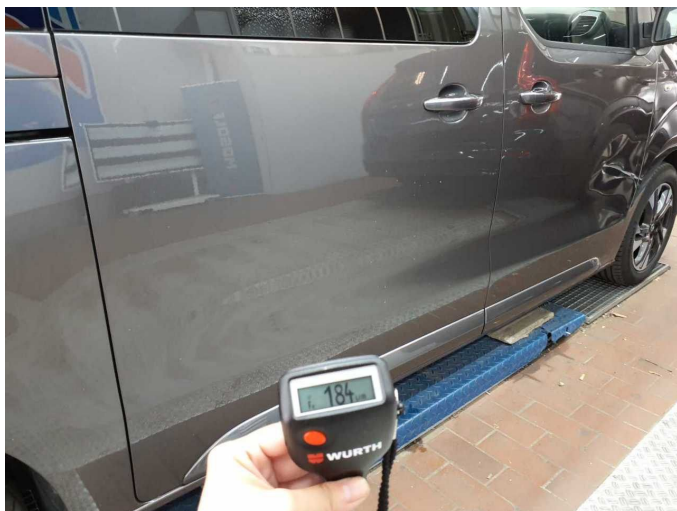
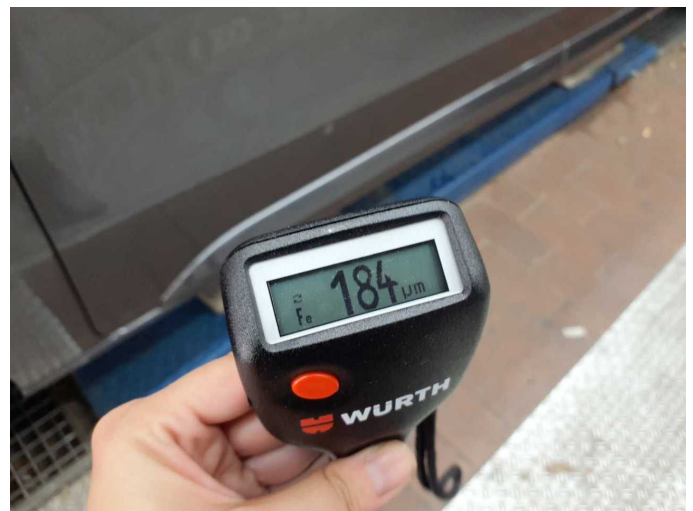
| No. | Repainting |
|---|---|
| 1 | Mudguard - right side, Door - rear right side, Door - front right side, Professionally carried out, Invoice of repair done |

**Repainting 1:** Mudguard - right side, Door - rear right side, Door - front right side

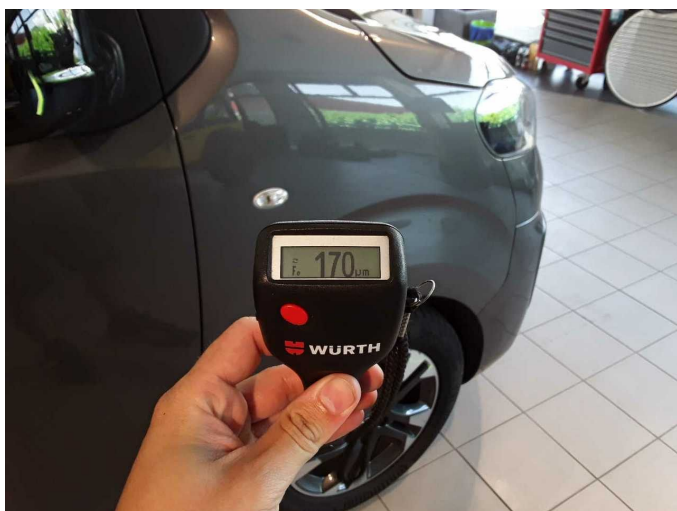
| Mudguard - right side | 169 µm | Bonnet | 95 µm |

**Mudguard - right side:** 169 µm

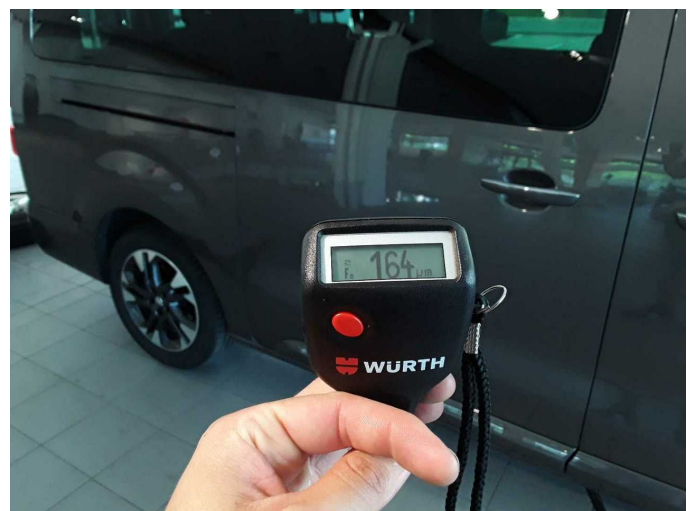
| Door - rear left side | 93 µm | Door - rear right side | 184 µm |

**Door - rear right side:** 184 µm

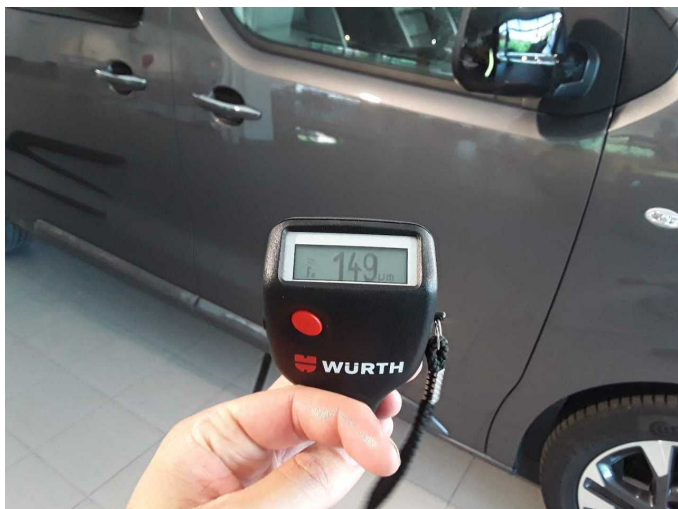
| Door - front left side | 103 µm | Door - front right side | 156 µm |

Door - front right side: 156 µm
