Expertise

Protocol number: 46470823  
Order No. / Reference: 26208749  
Inspection date: 9 Jul 2026

Manufacturer: Mercedes-Benz

Model: Vito 116 CDI Lang HA Aut. PRO Kasten

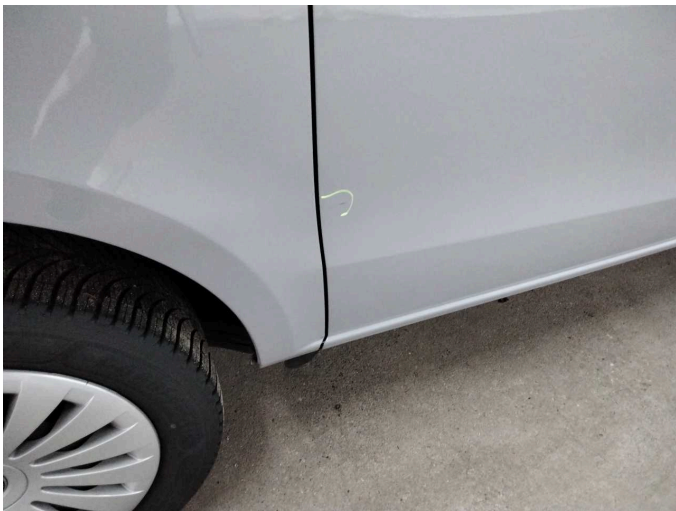
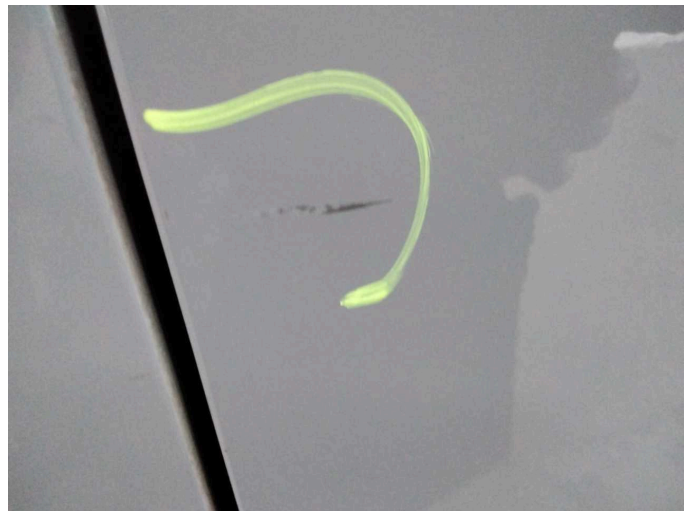
| No. | Component group | Description |
|---|---|---|
| 1 | Sliding door, right | Sliding door - Scratch(es) - Smart repair |

**Damage 1:** Sliding door, right: Sliding door - Scratch(es) - Smart repair

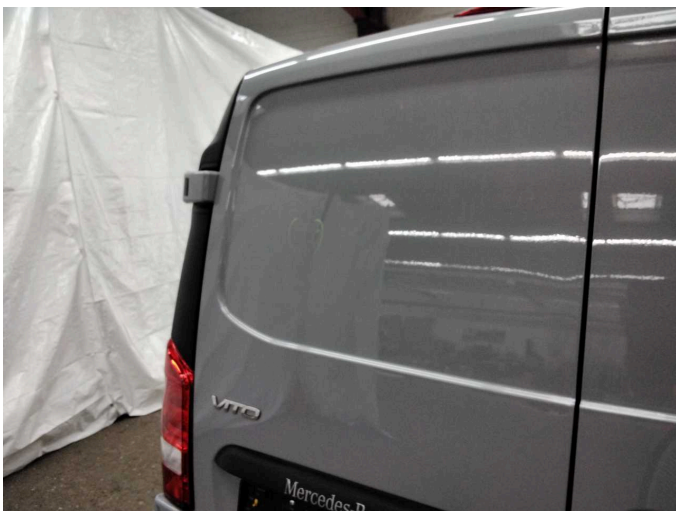
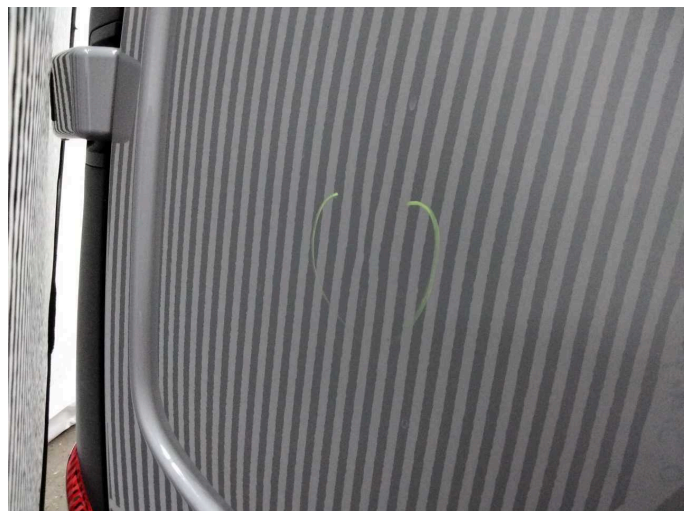
| No. | Component group | Description |
|---|---|---|
| 2 | Boot lid / rear door | Rear door - left side - dent(s) - Smooth repair work |

**Damage 2:** Boot lid / rear door: Rear door - left side - dent(s) - Smooth repair work

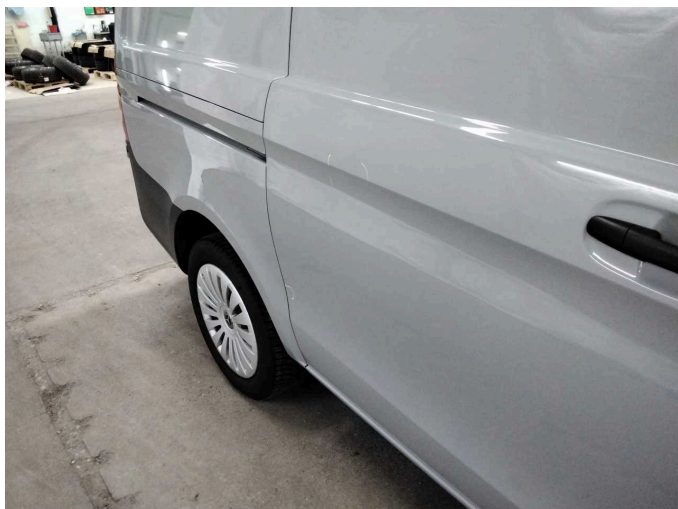
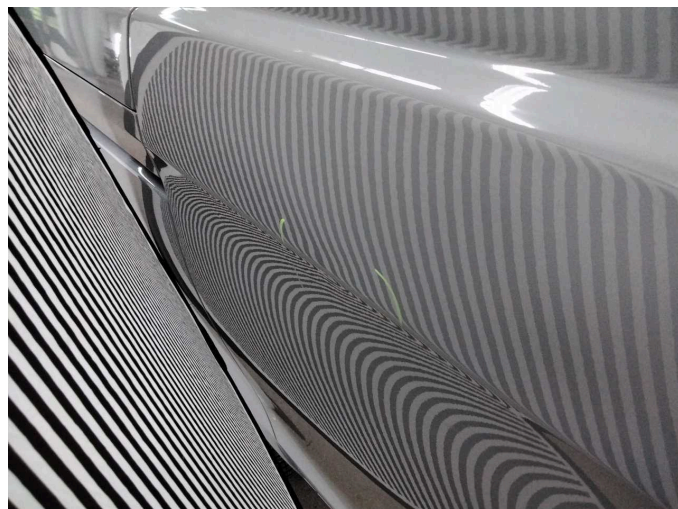
| No. | Component group | Description |
|---|---|---|
| 3 | Sliding door, right | Sliding door - dent(s) - Smooth repair work |

**Damage 3:** Sliding door, right: Sliding door - dent(s) - Smooth repair work

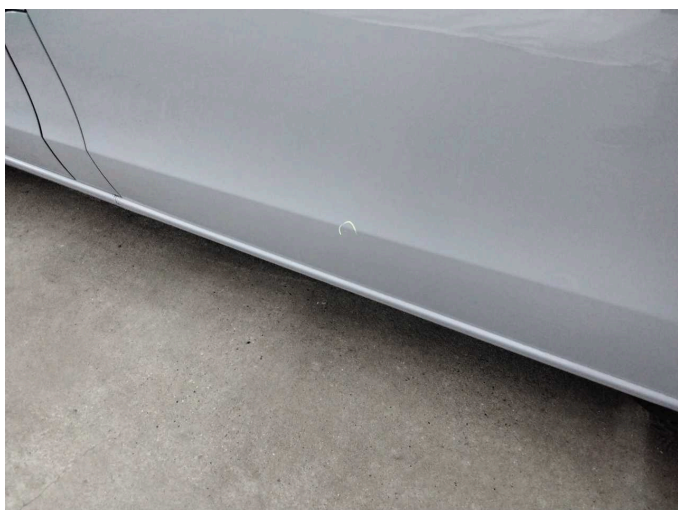
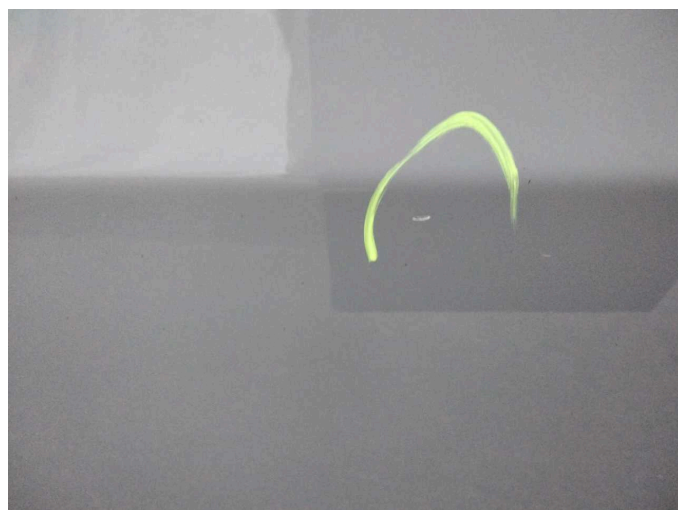
| No. | Component group | Description |
|---|---|---|
| 4 | Side panel - rear left side | Side panel - Scratch(es) - Smart repair |

**Damage 4:** Side panel - rear left side: Side panel - Scratch(es) - Smart repair

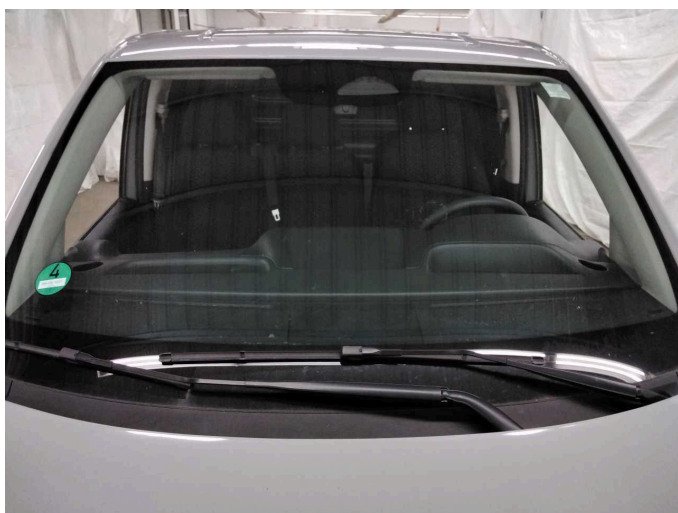
| No. | Component group | Description |
|---|---|---|
| 1 | Vehicle glazing | Windscreen - Stone chips - No deduction |

**Wear and tear 1:** Vehicle glazing: Windscreen - Stone chips - No deduction
