Expertise

Protocol number: 46040560
Order No. / Reference: 26184089
Inspection date: 16 Jun 2026

Manufacturer: Mercedes-Benz

Model: 319 CDI Sprinter Standard HA PRO

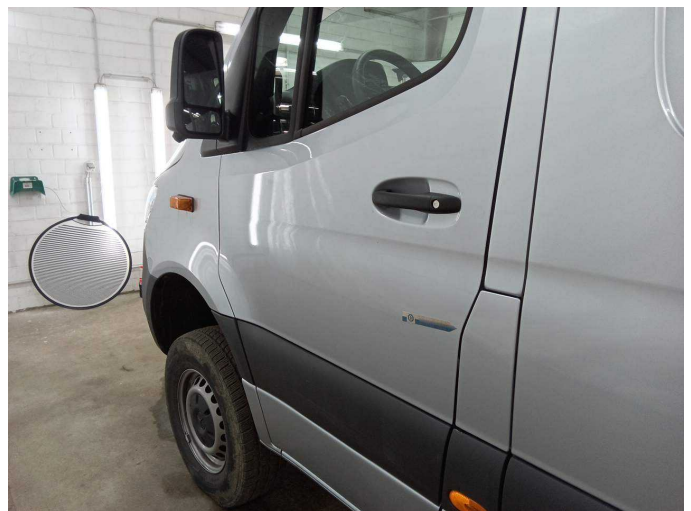
Damage 3: Door - front left side: Door edge - Scratch(es) - Smart repair

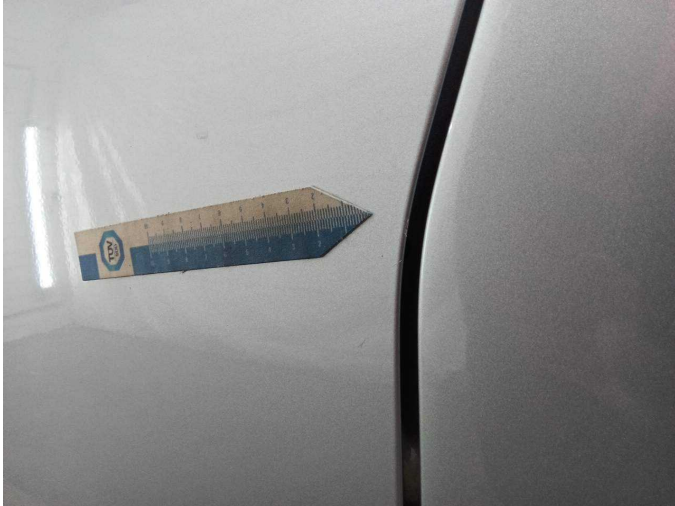
Damage 3: Door - front left side: Door edge - Scratch(es) - Smart repair

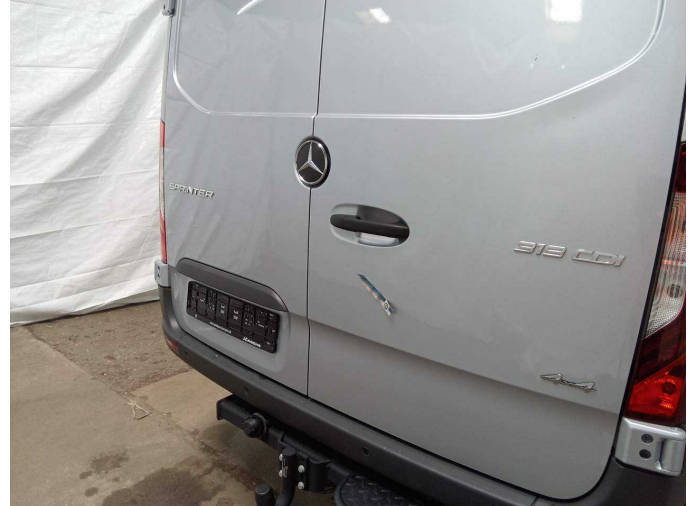
Damage 4: Boot lid / rear door: Rear door - right side - Dent / paintcoat damage - Smart repair

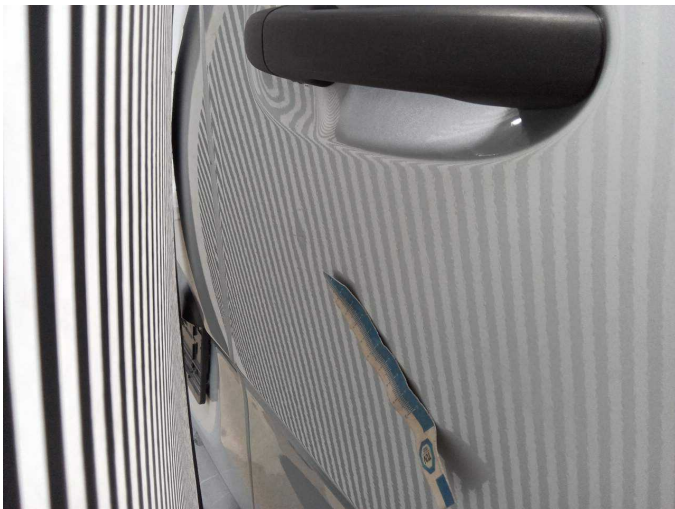
Damage 4: Boot lid / rear door: Rear door - right side - Dent / paintcoat damage - Smart repair

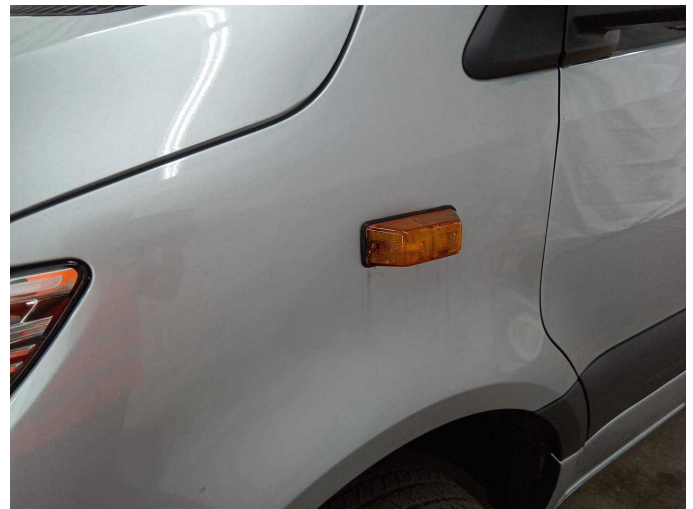
Damage 5: Indicator - front: Indicator lamp - front left side (Wassereintritt) - Leaking - Replace

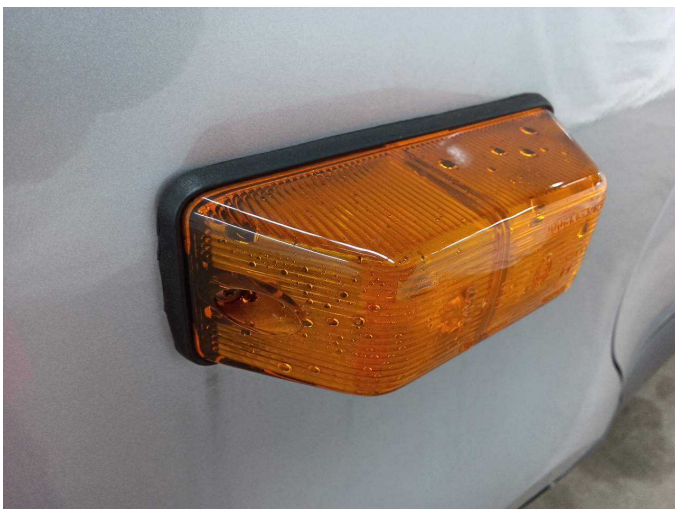
Damage 5: Indicator - front: Indicator lamp - front left side (Wassereintritt) - Leaking - Replace

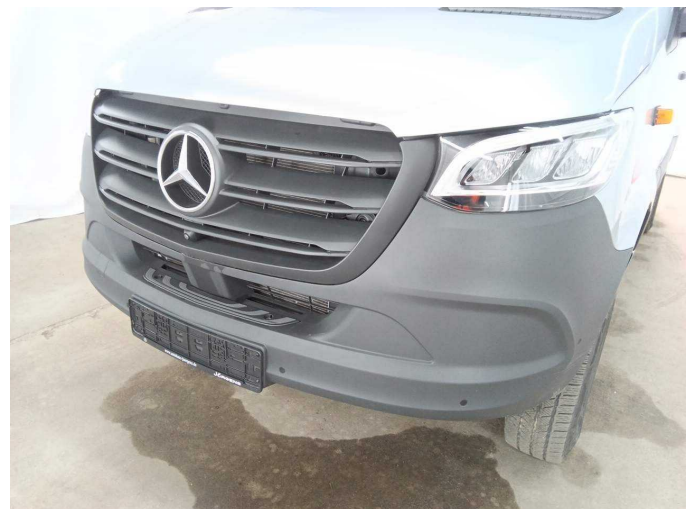
Damage 6: Front bumper: Front bumper - Scratched - Loss in value

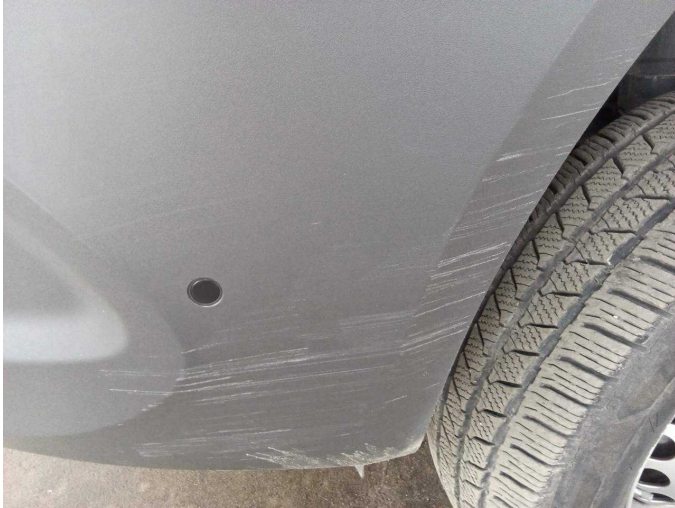
Damage 6: Front bumper: Front bumper - Scratched - Loss in value

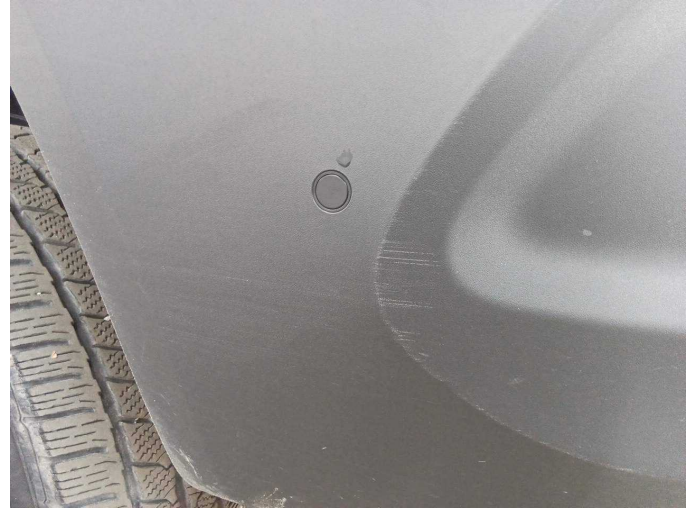
Damage 6: Front bumper: Front bumper - Scratched - Loss in value

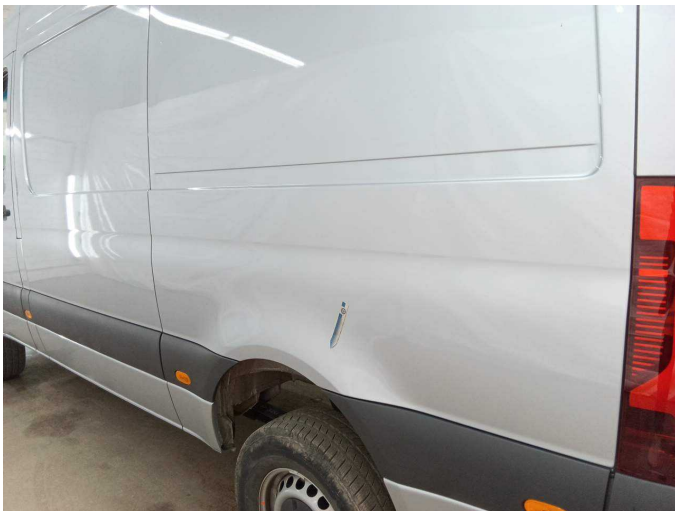
Damage 7: Side panel - rear left side: Side panel - Scratch(es) - Smart repair

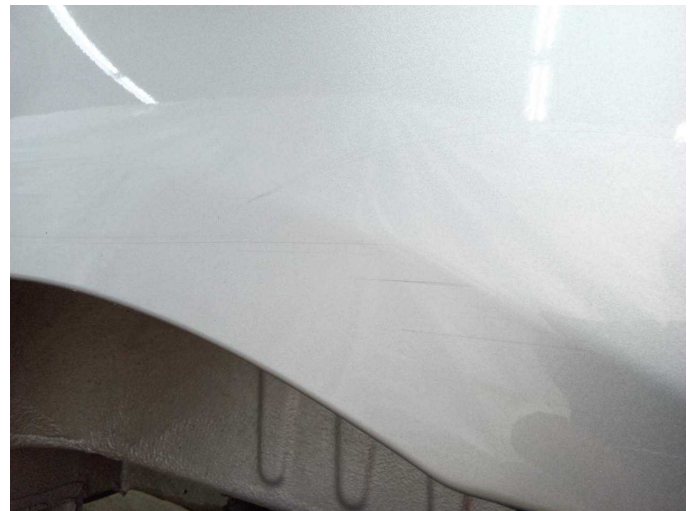
Damage 7: Side panel - rear left side: Side panel - Scratch(es) - Smart repair

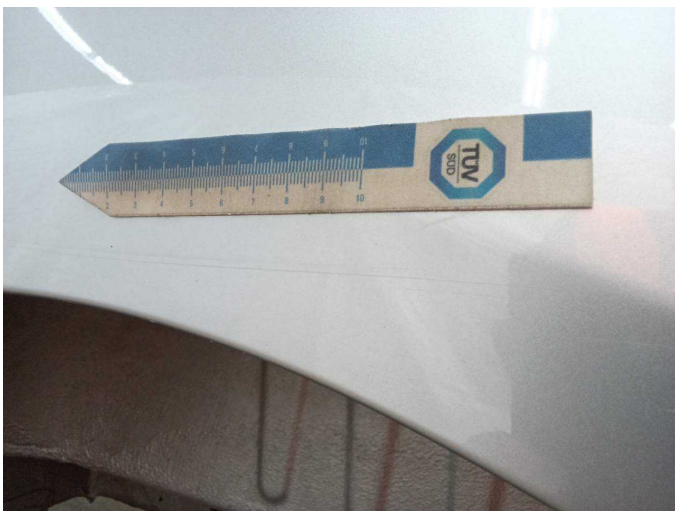
Damage 7: Side panel - rear left side: Side panel - Scratch(es) - Smart repair

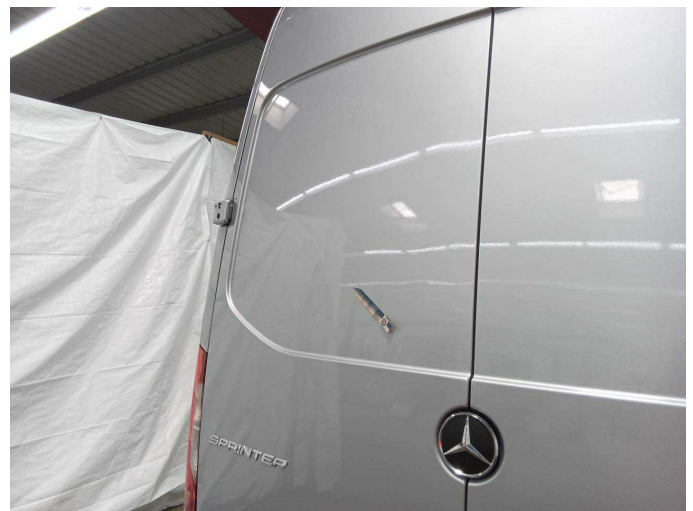
Damage 8: Boot lid / rear door: Rear door - left side (4) - dent(s) - Smooth repair work

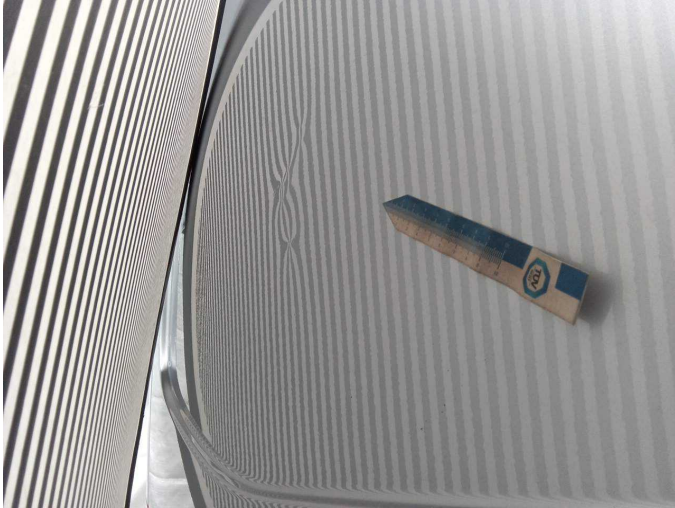
Damage 8: Boot lid / rear door: Rear door - left side (4) - dent(s) - Smooth repair work

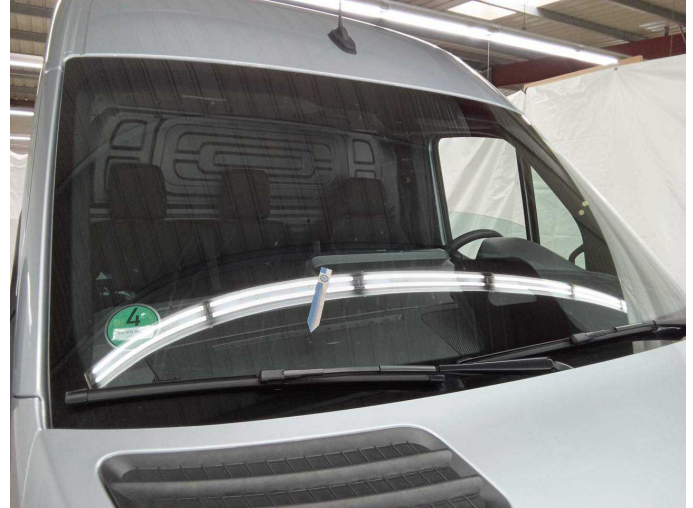
Damage 9: Vehicle glazing: Windscreen (kein Staubschutz) - Broken / torn - repair according to calculation

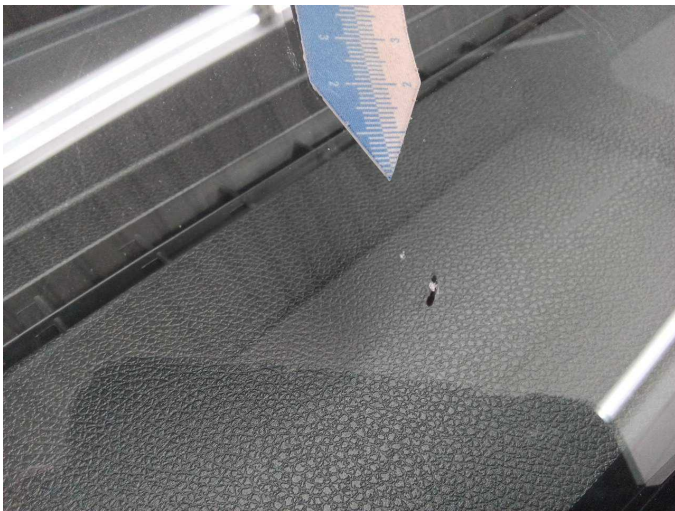
Damage 9: Vehicle glazing: Windscreen (kein Staubschutz) - Broken / torn - repair according to calculation
