Expertise

Protocol number: 46741248  
Order No. / Reference: 26639293  
Inspection date: 24 Jul 2026

Manufacturer: Ford

Model: Transit Connect 230 L2 Trend

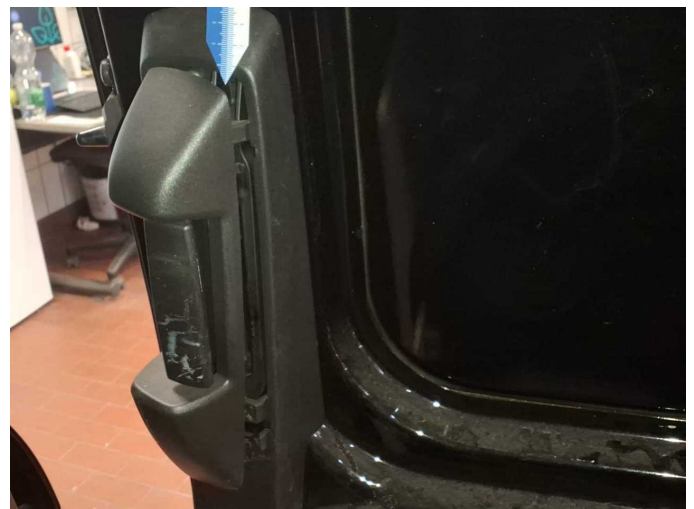
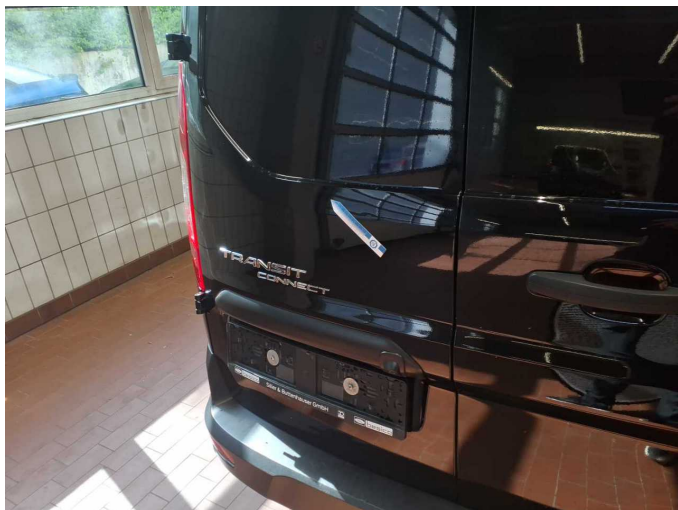
| No. | Component group | Description |
|---|---|---|
| 2 | Sliding door, right | Door handle - inside (Verkleidung; Mehrkosten möglich) - Loose - Diagnosed and repair if necessary |

Damage 2: Sliding door, right: Door handle - inside (Verkleidung; Mehrkosten möglich) - Loose - Diagnosed and repair if necessary

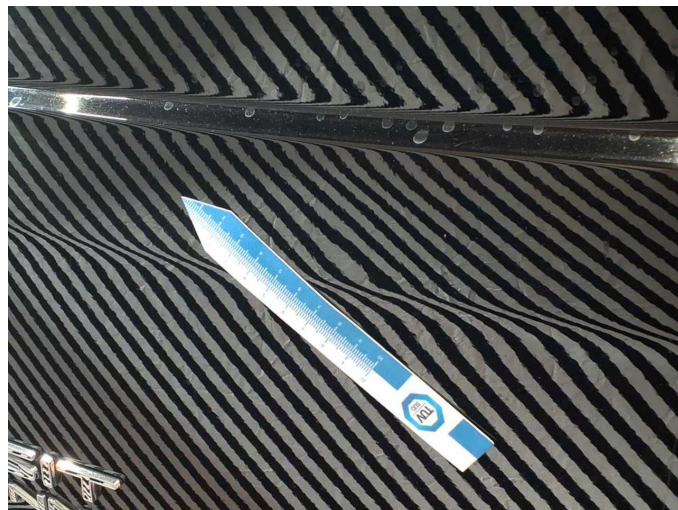
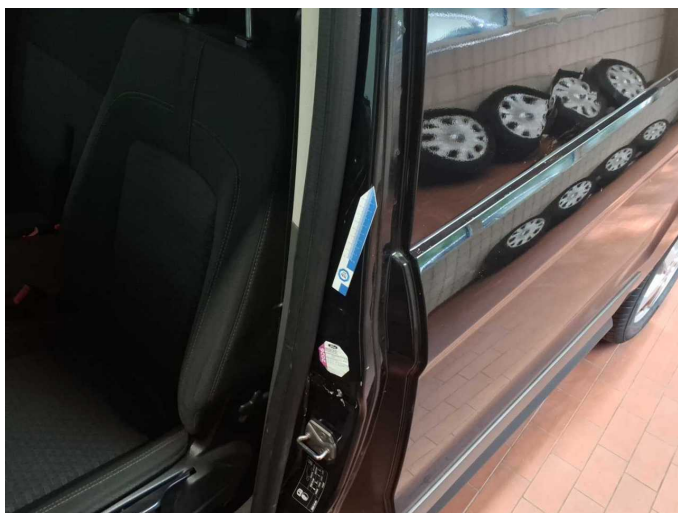
| No. | Component group | Description |
|---|---|---|
| 3 | Boot lid / rear door | Rear door - left side (Innen Kratzer Gebrauchspur) - dent(s) - Smooth repair work |

**Damage 3:** Boot lid / rear door: Rear door - left side (Innen Kratzer Gebrauchspur) - dent(s) - Smooth repair work

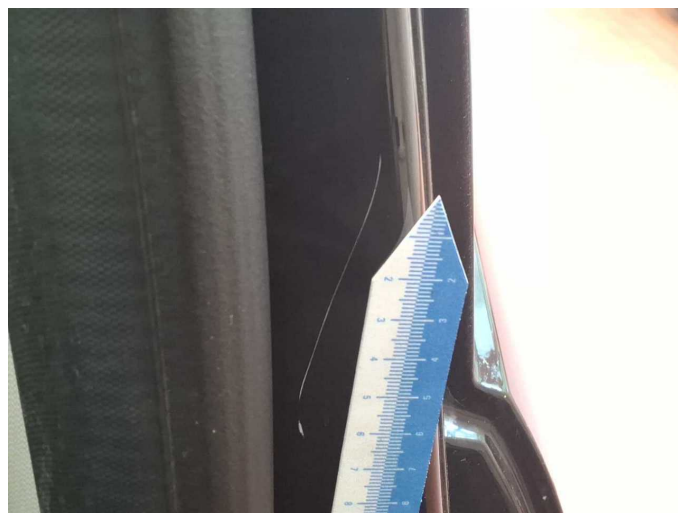
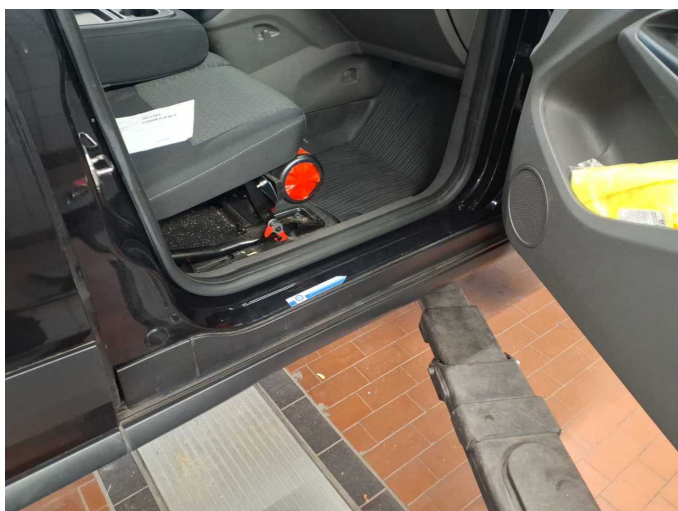
| No. | Component group | Description |
|---|---|---|
| 4 | Body | B-pillar - left side - Scratch(es) - Smart repair |

**Damage 4:** Body: B-pillar - left side - Scratch(es) - Smart repair

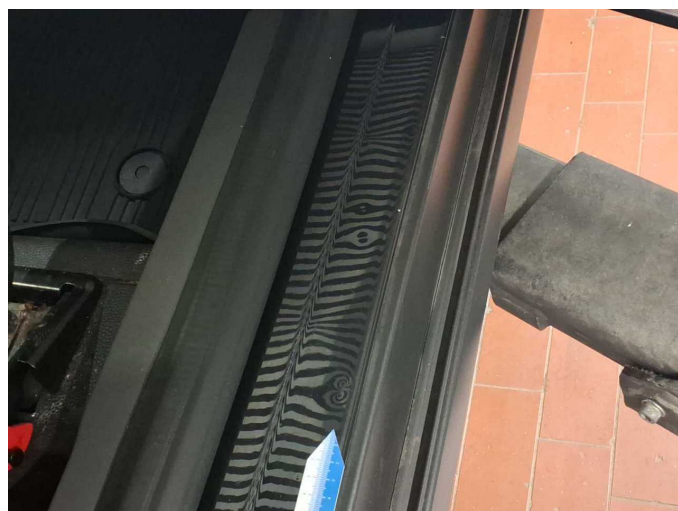
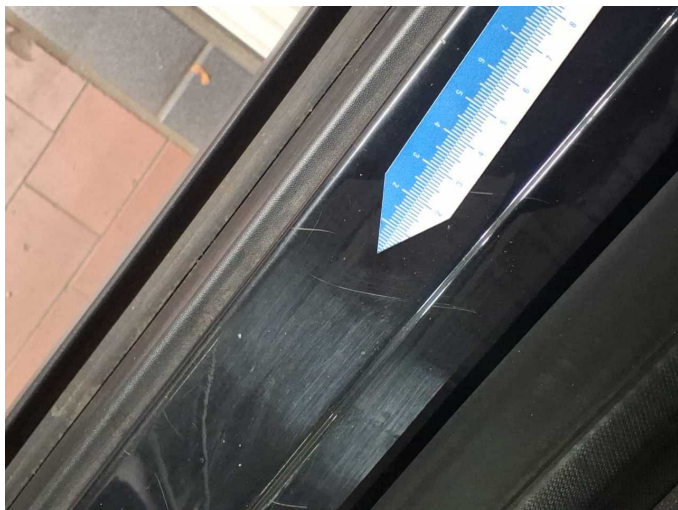
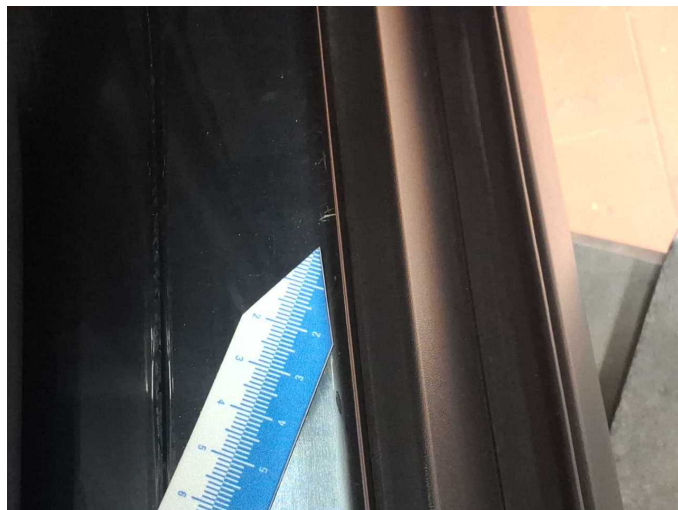
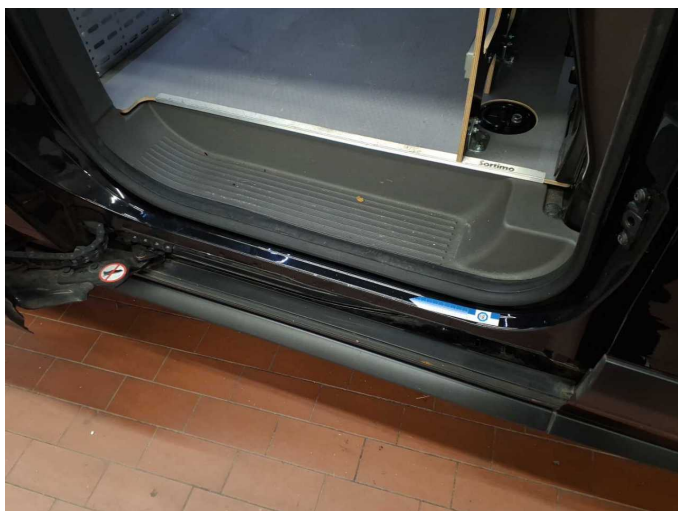
| No. | Component group | Description |
|---|---|---|
| 5 | Sill - right side | Sill - Dent / paintcoat damage - Smart repair |

**Damage 5:** Sill - right side: Sill - Dent / paintcoat damage - Smart repair

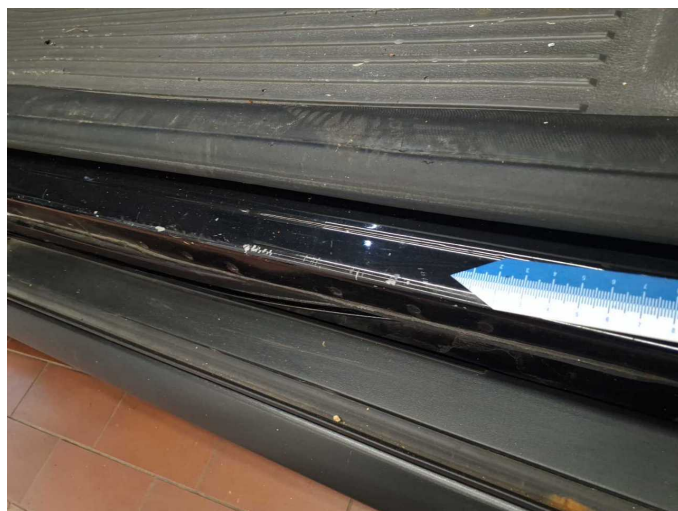
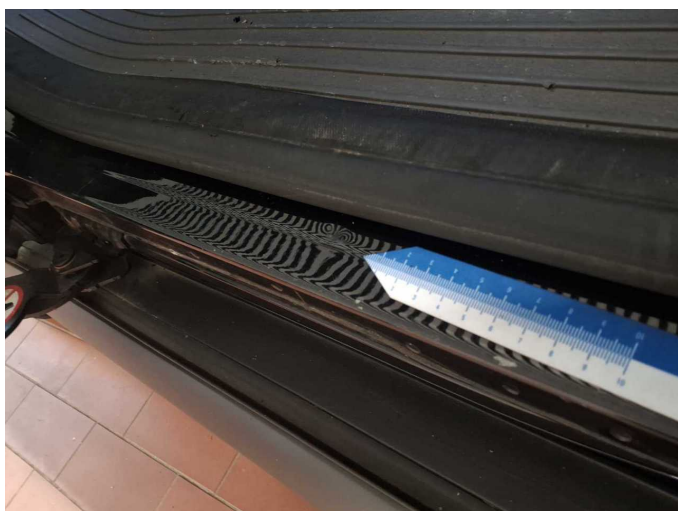
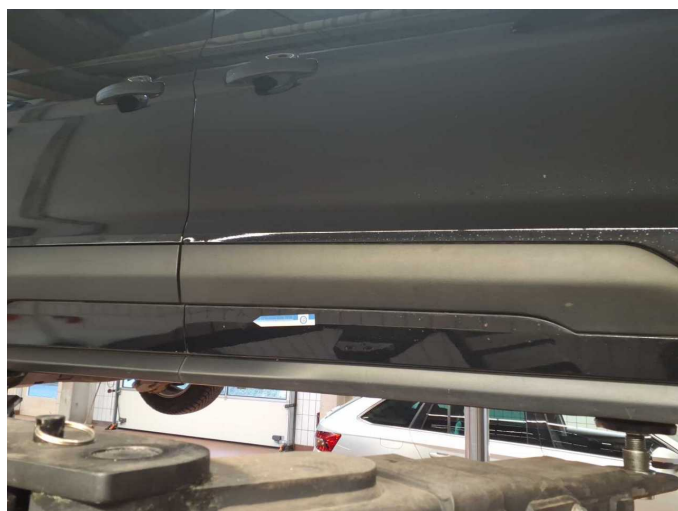
| No. | Component group | Description |
|---|---|---|
| 6 | Side panel - rear right side | Sill - Dent / paintcoat damage - Smart repair |

**Damage 6:** Side panel - rear right side: Sill - Dent / paintcoat damage - Smart repair

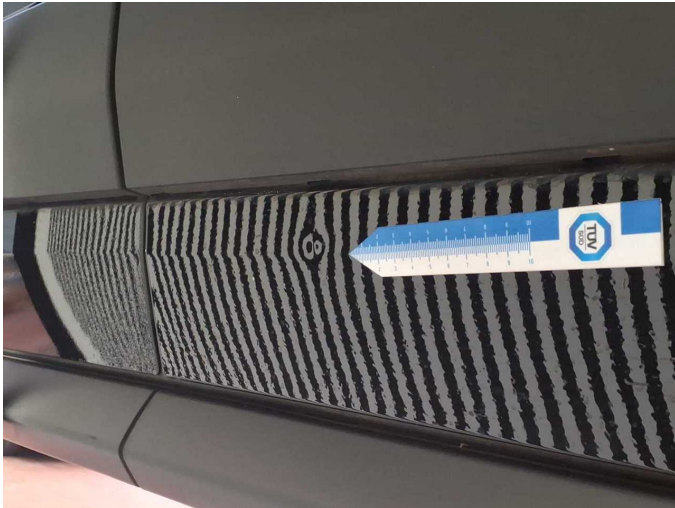
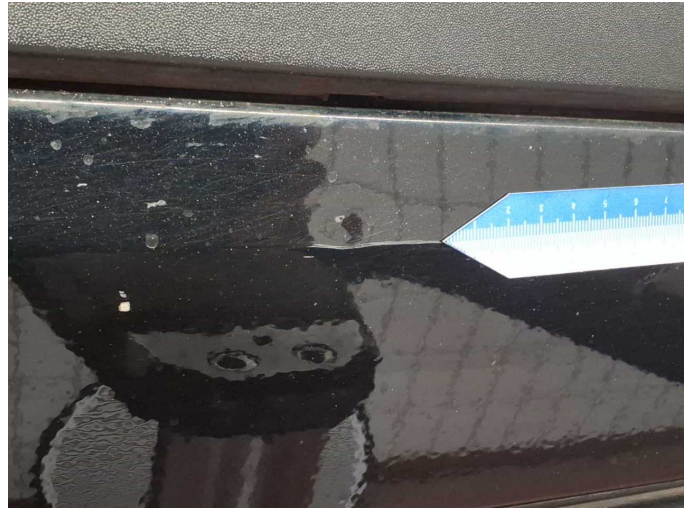
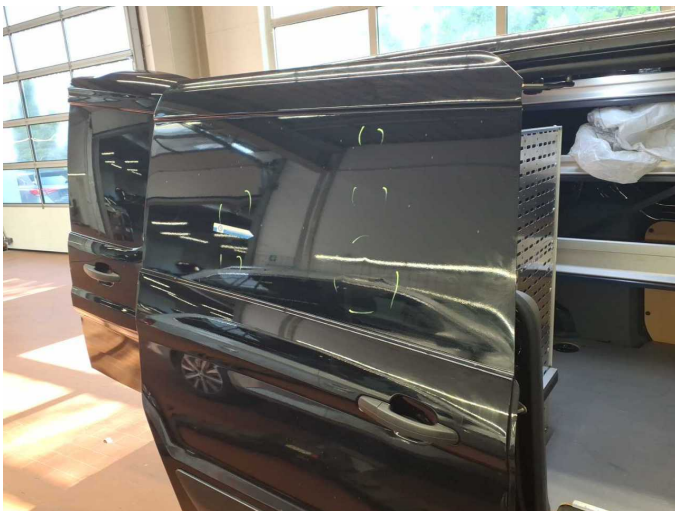
| No. | Component group | Description |
|---|---|---|
| 7 | Door - front right side | Door (an Kante) - dent(s) - Smart repair |

**Damage 7:** Door - front right side: Door (an Kante) - dent(s) - Smart repair

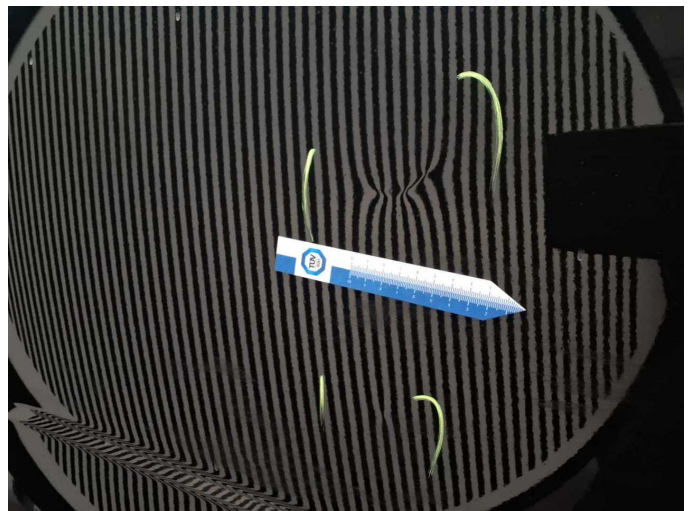
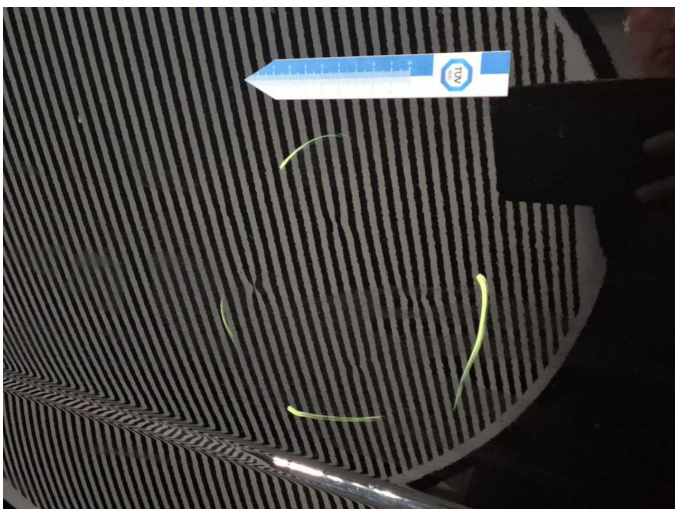
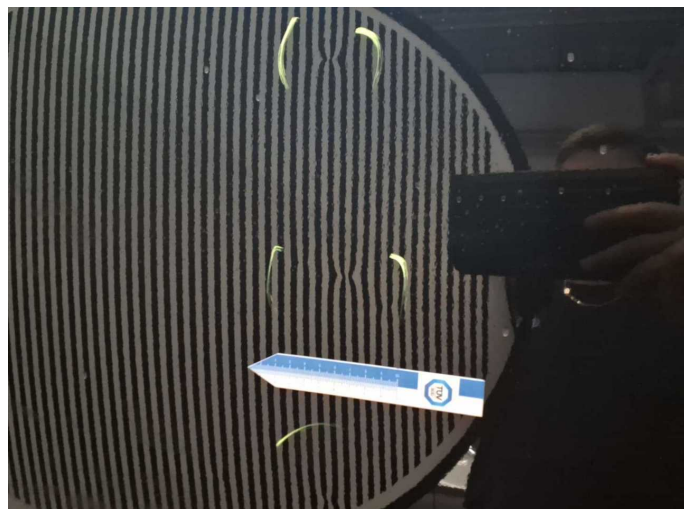
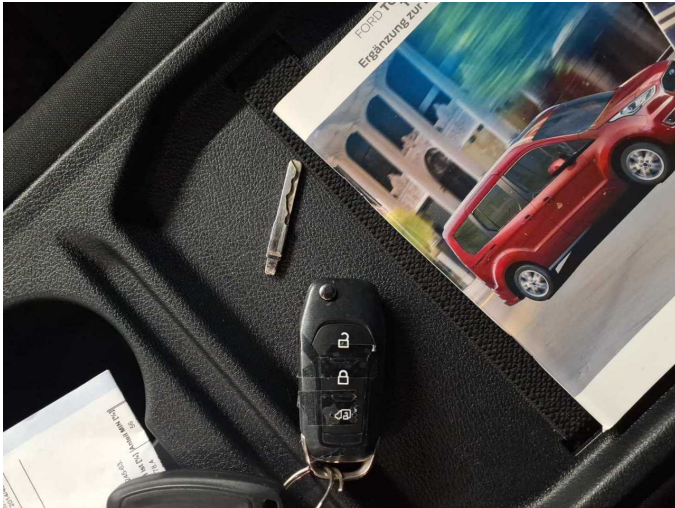
| No. | Component group | Description |
|---|---|---|
| 8 | Sliding door, right | Sliding door (Beulen) - dent(s) - Smooth repair work |

**Damage 8:** Sliding door, right: Sliding door (Beulen) - dent(s) - Smooth repair work

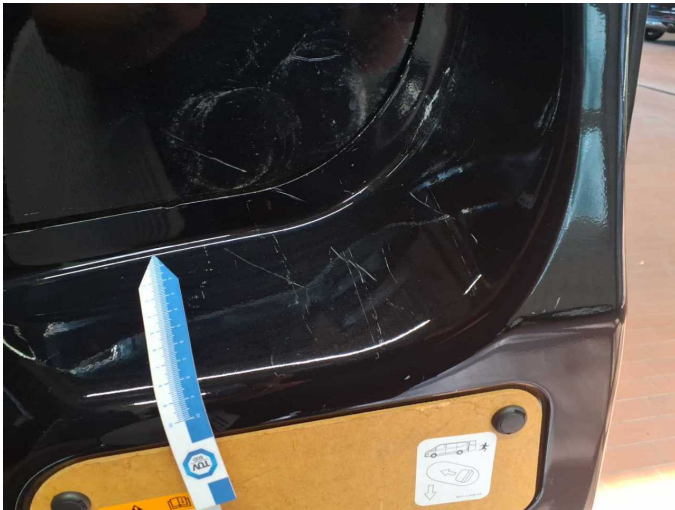
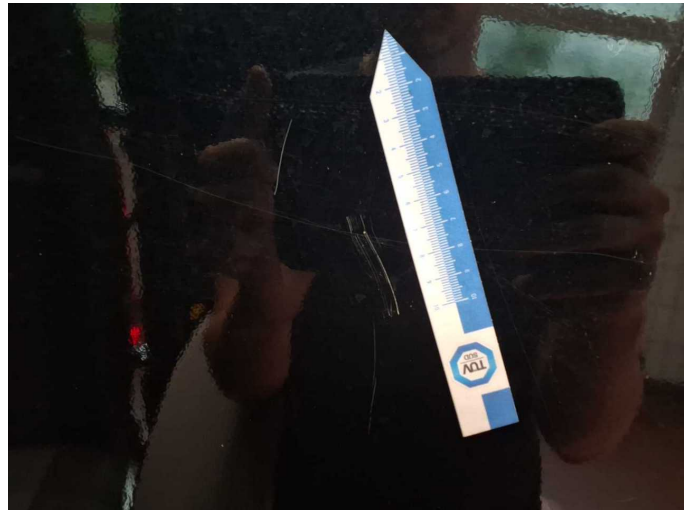
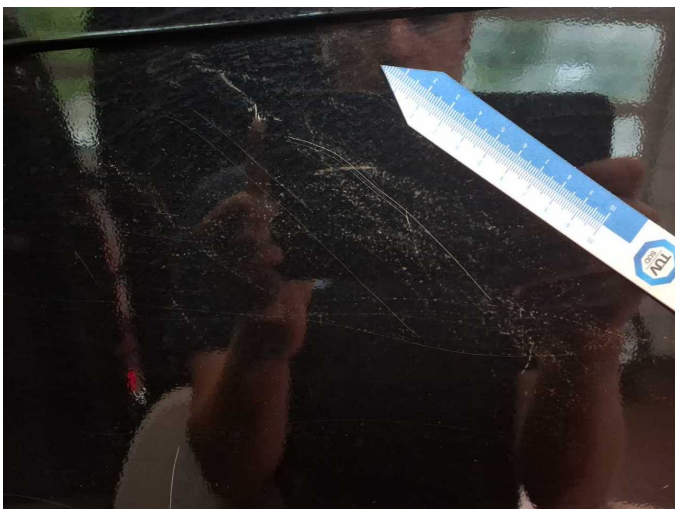
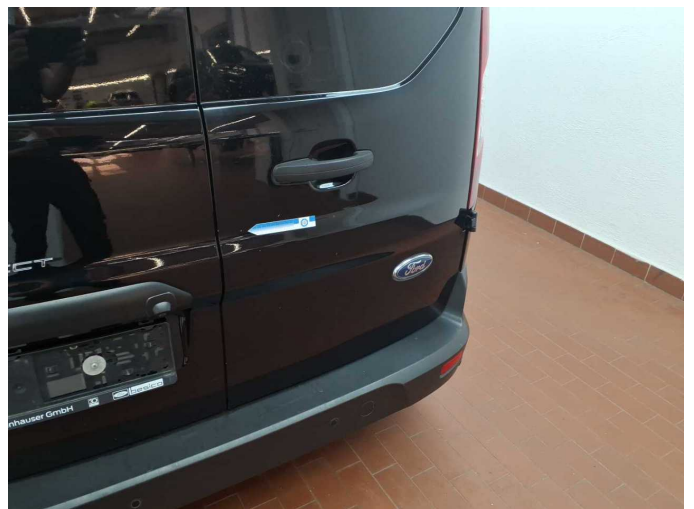
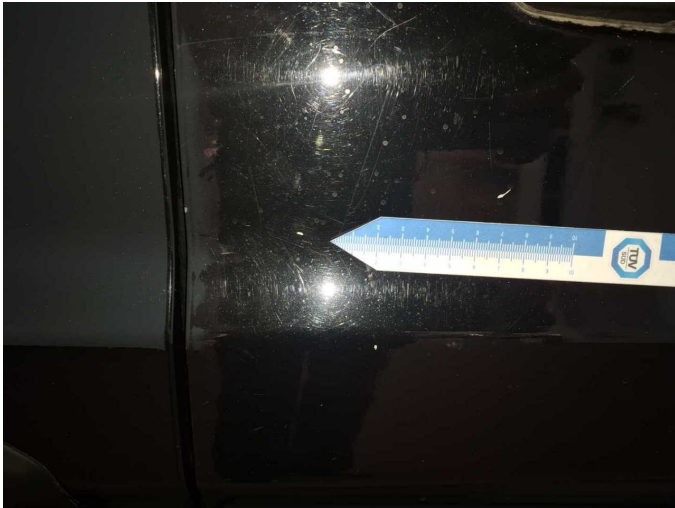
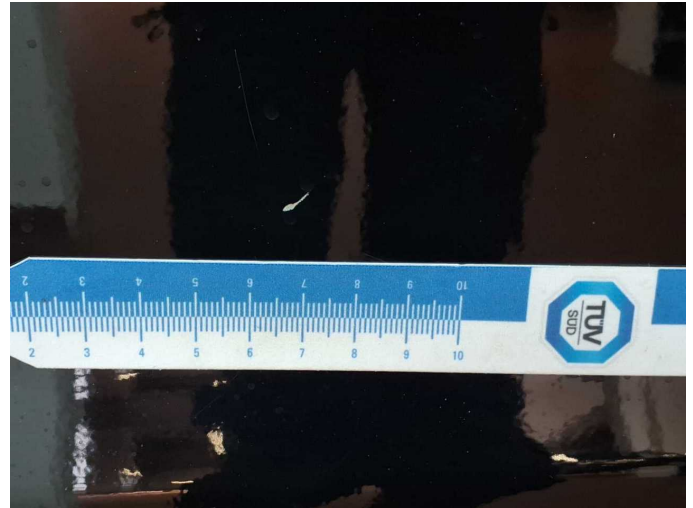
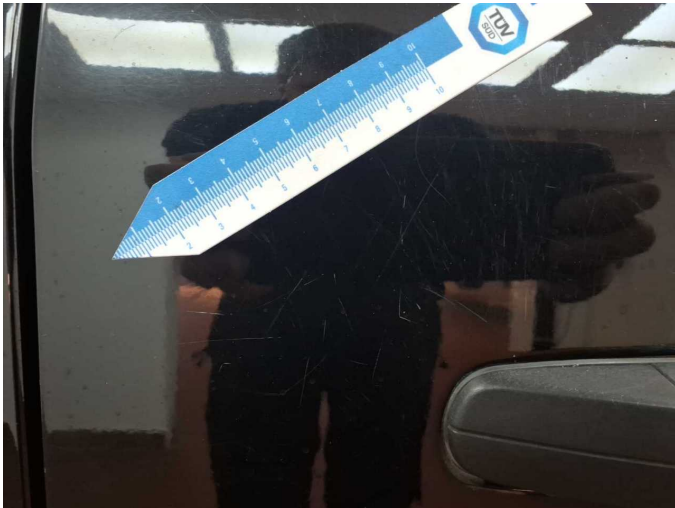
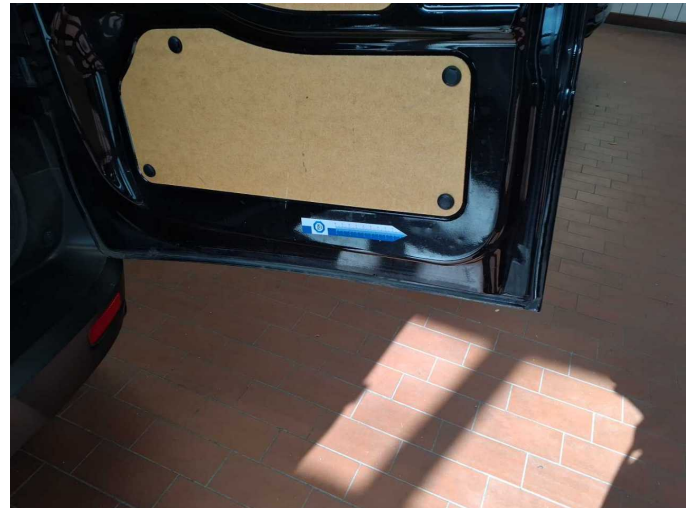
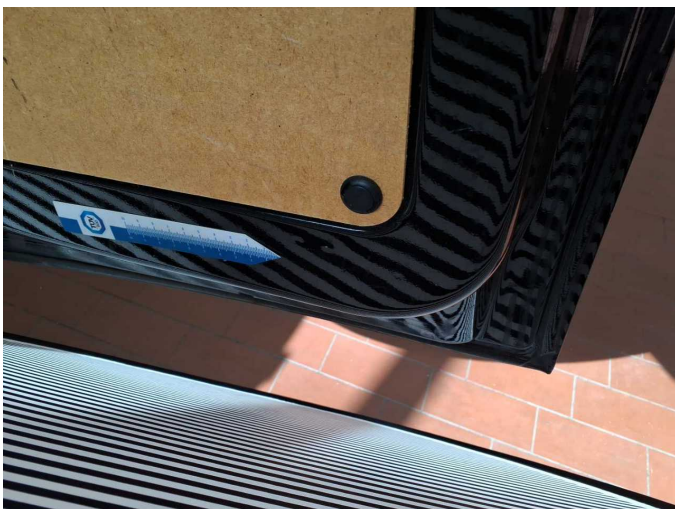
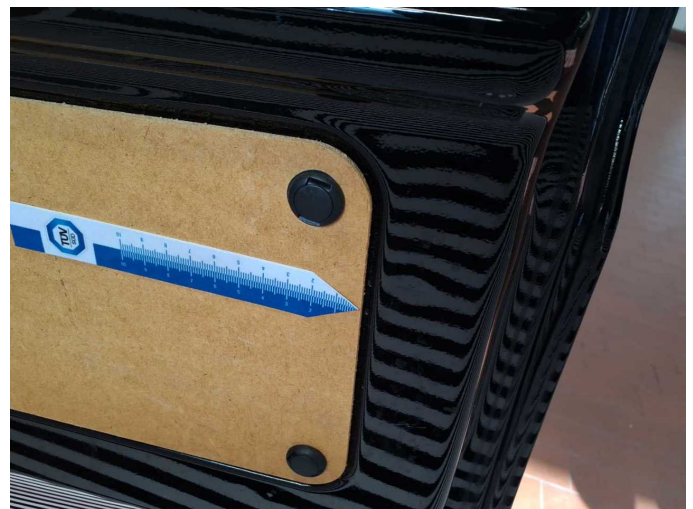
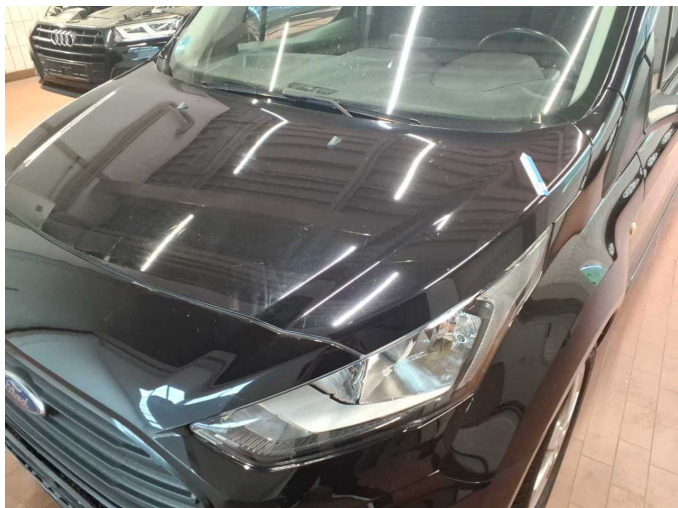
| No. | Component group | Description |
|---|---|---|
| 10 | Boot lid / rear door | Rear door - right side - Dent / paintcoat damage - Paint |

**Damage 10:** Boot lid / rear door: Rear door - right side - Dent / paintcoat damage - Paint

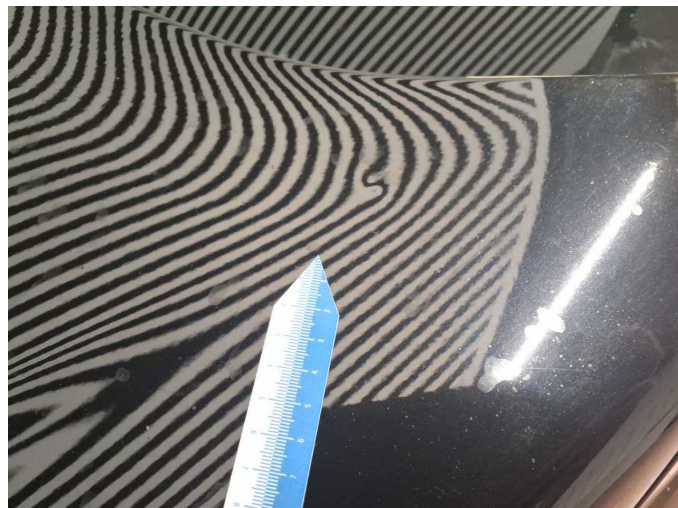
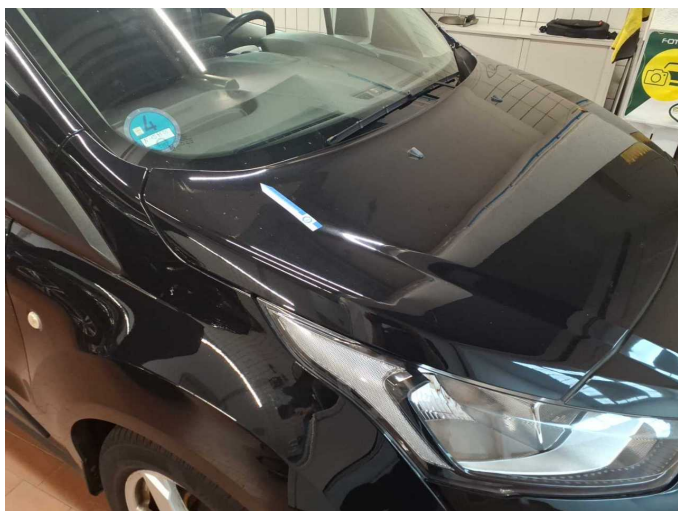
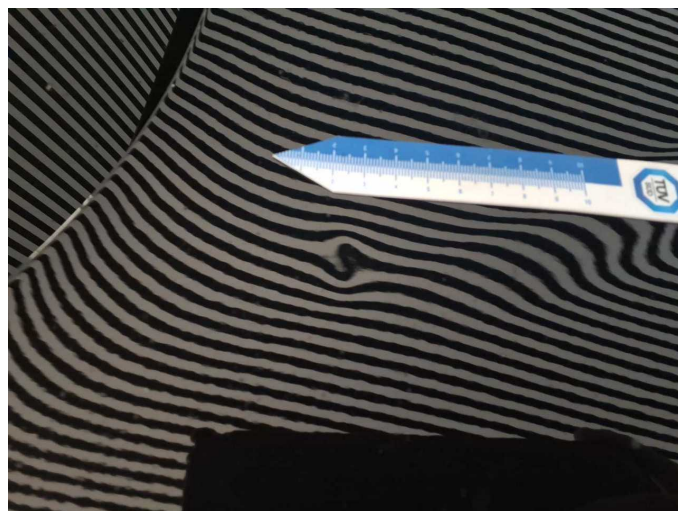
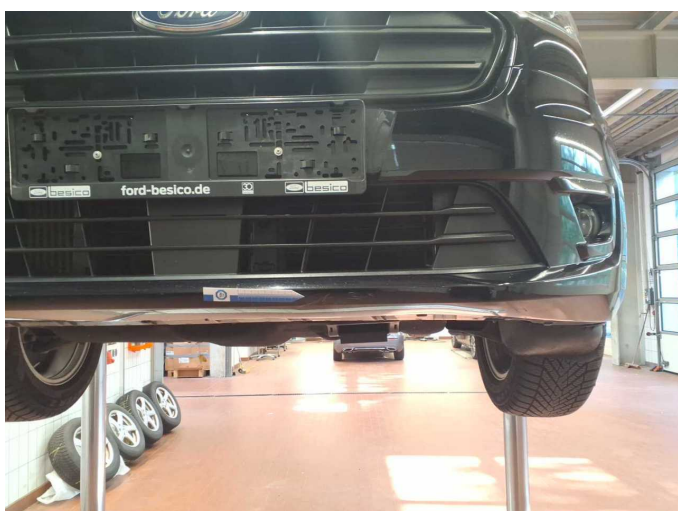
| No. | Component group | Description |
|---|---|---|
| 11 | Bonnet | Bonnet (+ Steinschläge) - dent(s) - Paint |

**Damage 11:** Bonnet: Bonnet (+ Steinschläge) - dent(s) - Paint

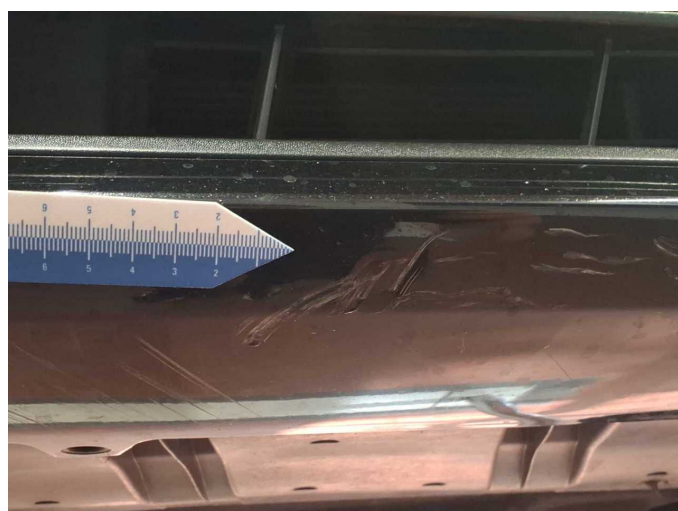
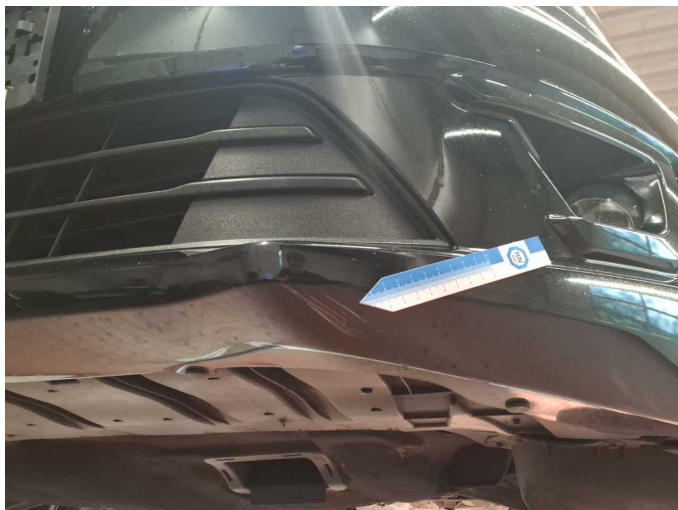
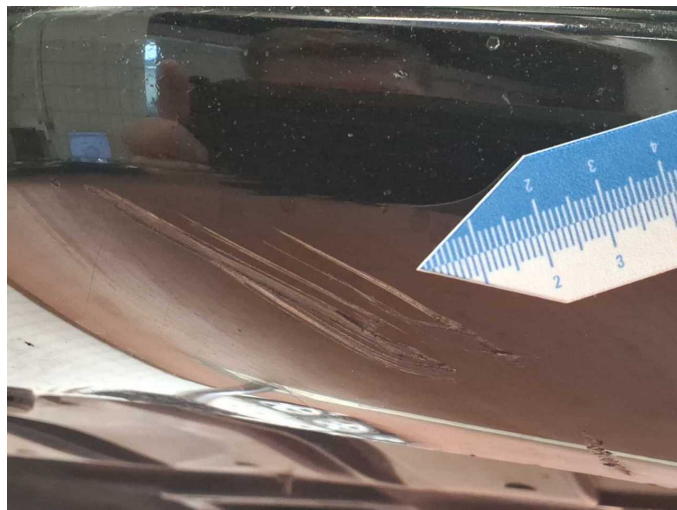
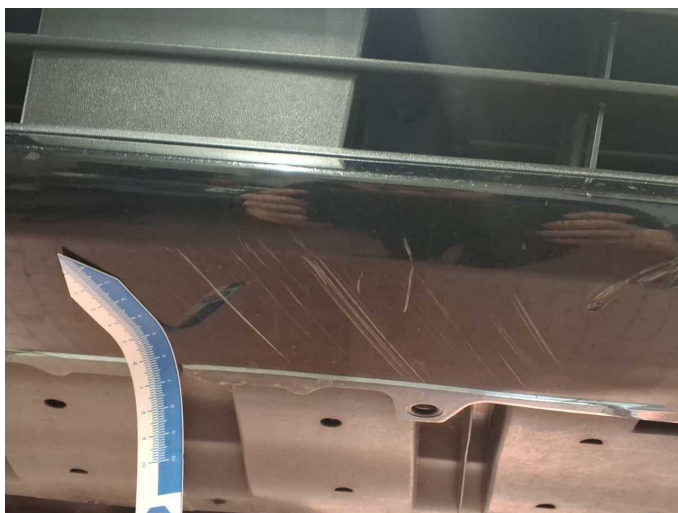
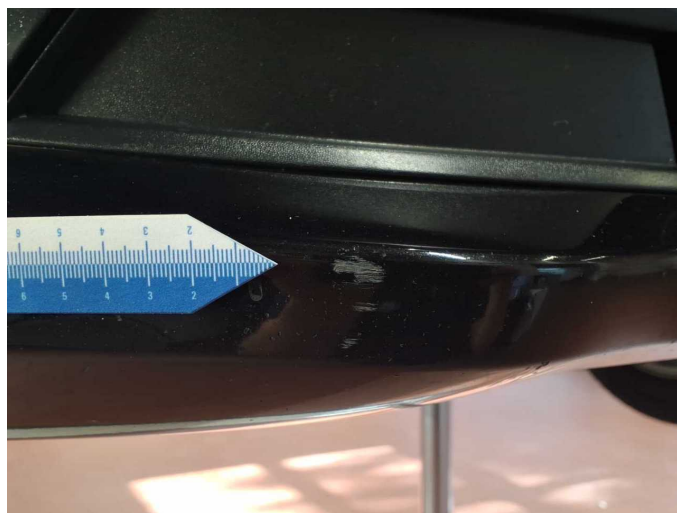
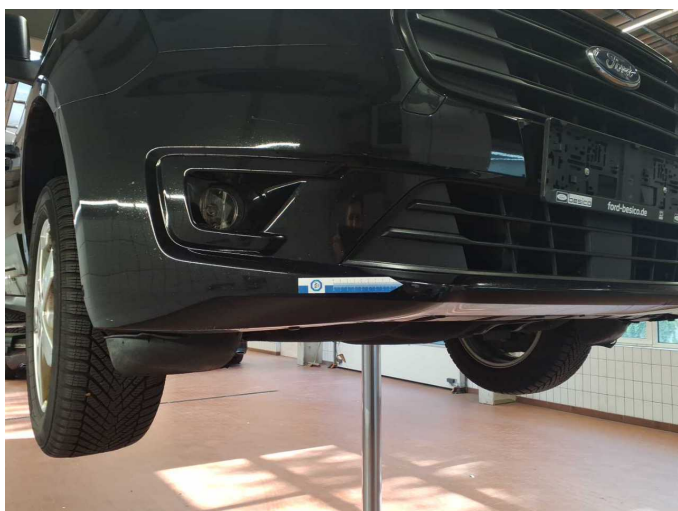
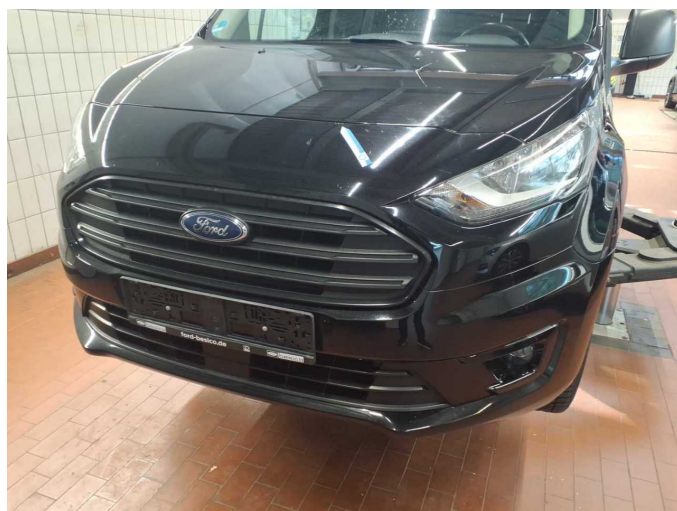
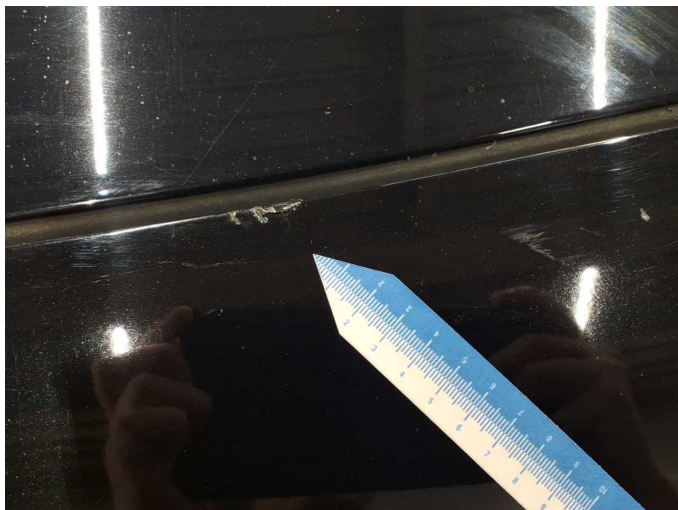
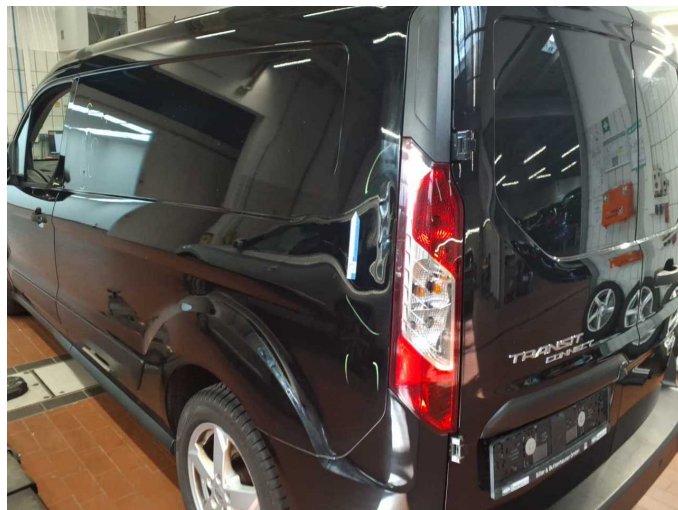
| No. | Component group | Description |
|---|---|---|
| 12 | Front bumper | Front bumper - Scratched - Paint |

**Damage 12:** Front bumper: Front bumper - Scratched - Paint

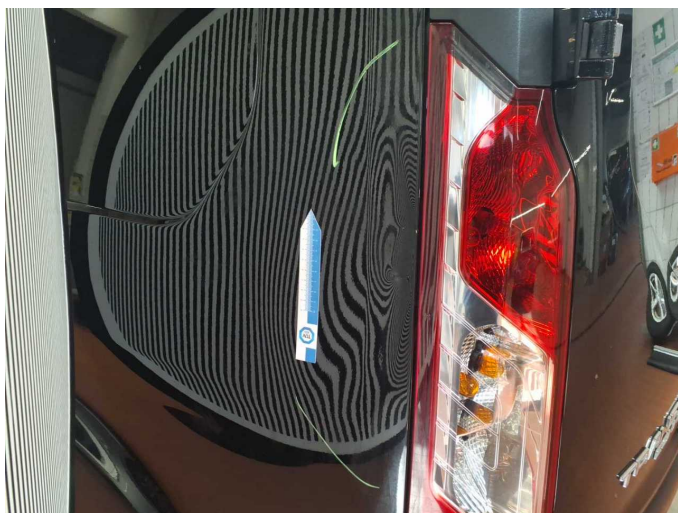
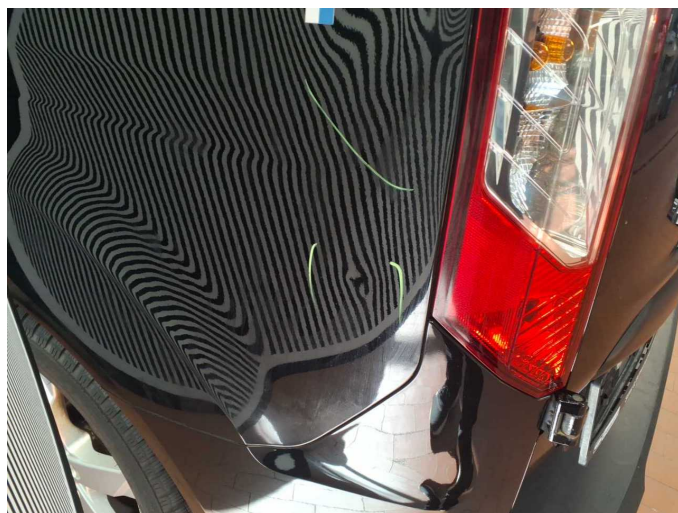
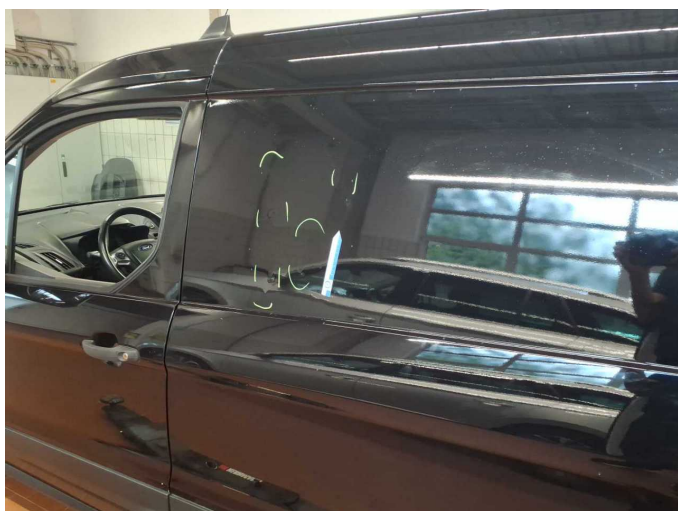
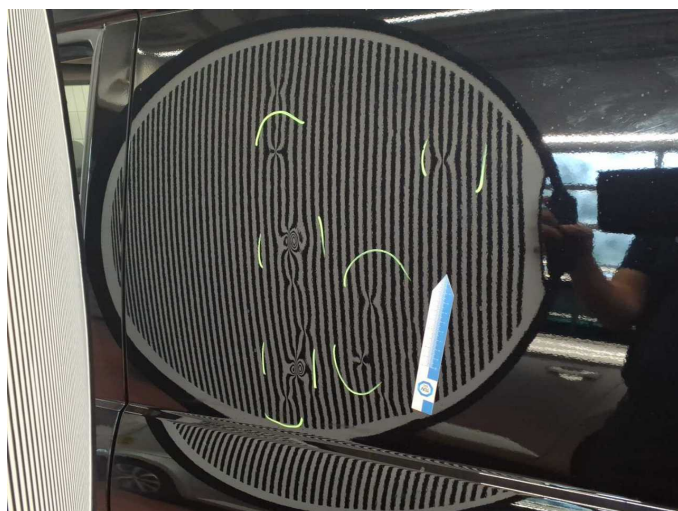
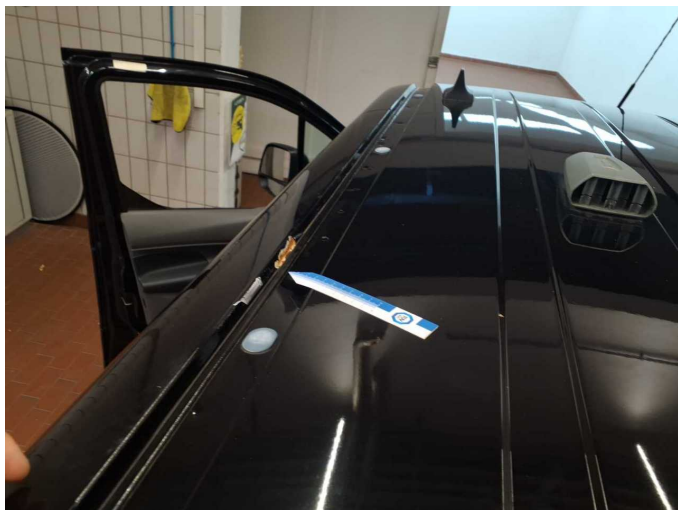
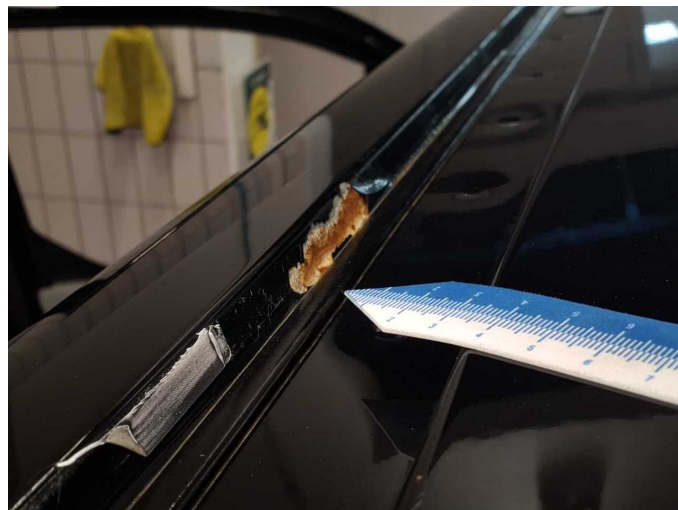
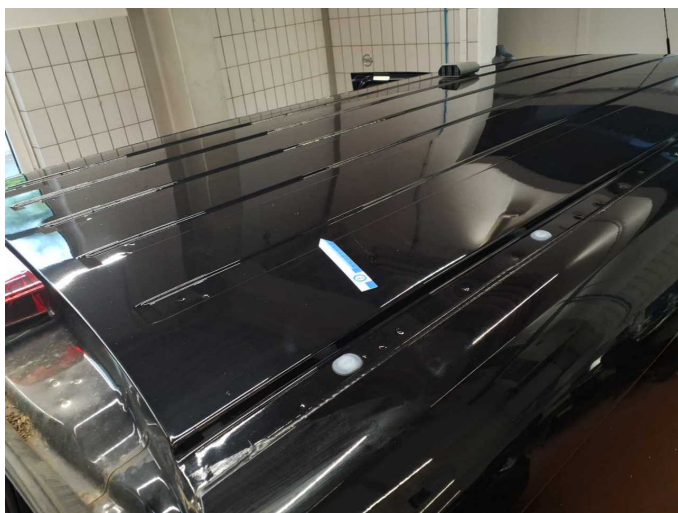
| No. | Component group | Description |
|---|---|---|
| 13 | Side panel - rear left side | Side panel (+ Korrosion) - Deformed - Repair and paint |

**Damage 13:** Side panel - rear left side: Side panel (+ Korrosion) - Deformed - Repair and paint

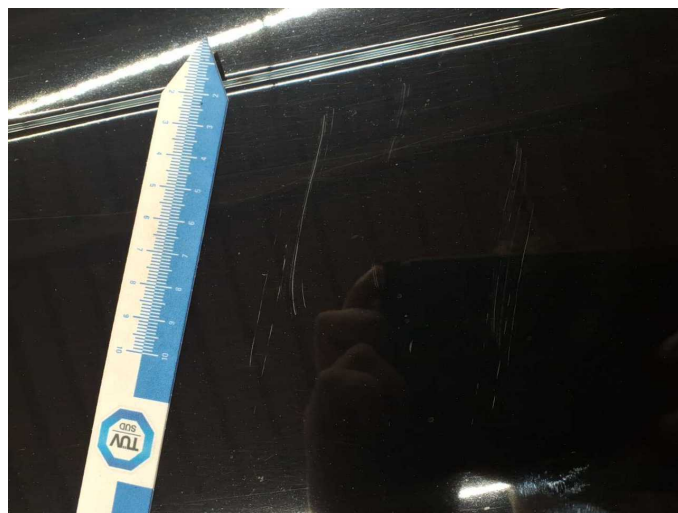
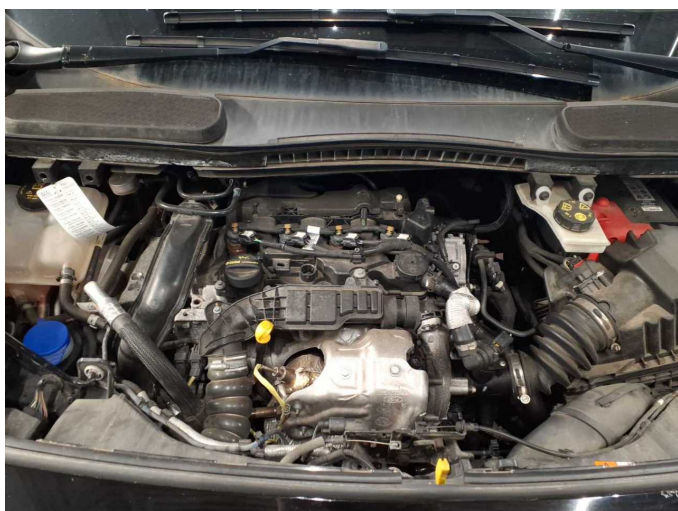
| No. | Component group | Description |
|---|---|---|
| 14 | Roof | Roof - Dent / paintcoat damage - Paint |

**Damage 14:** Roof: Roof - Dent / paintcoat damage - Paint
