Expertise

Protocol number: 46673916  
Order No. / Reference: 26670629  
Inspection date: 23 Jul 2026

Manufacturer: Peugeot

Model: 2008 BlueHDi 130 EAT8 GT Pack

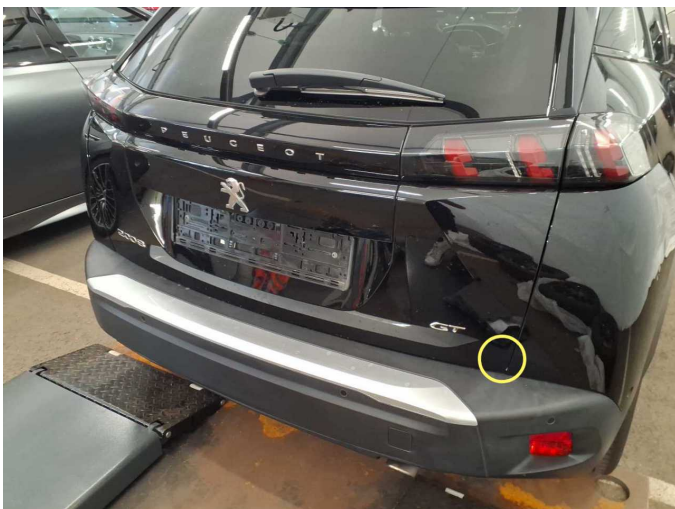
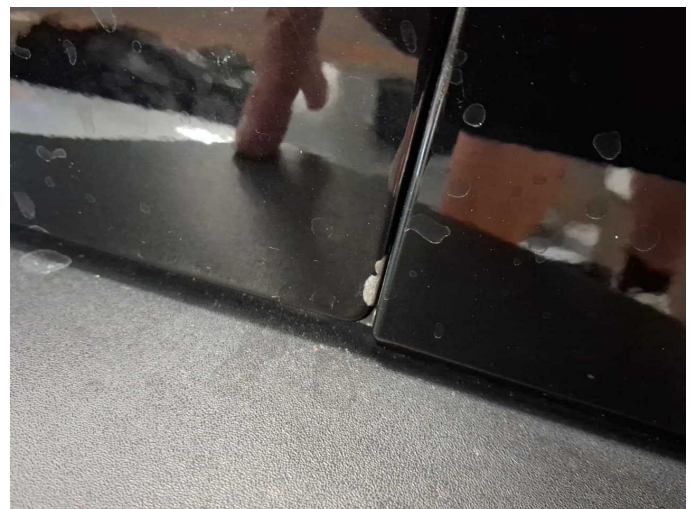
| No. | Component group | Description |
|---|---|---|
| 1 | Boot lid / rear door | Boot lid - Scratch(es) - Smart repair |

Damage 1: Boot lid / rear door: Boot lid - Scratch(es) - Smart repair

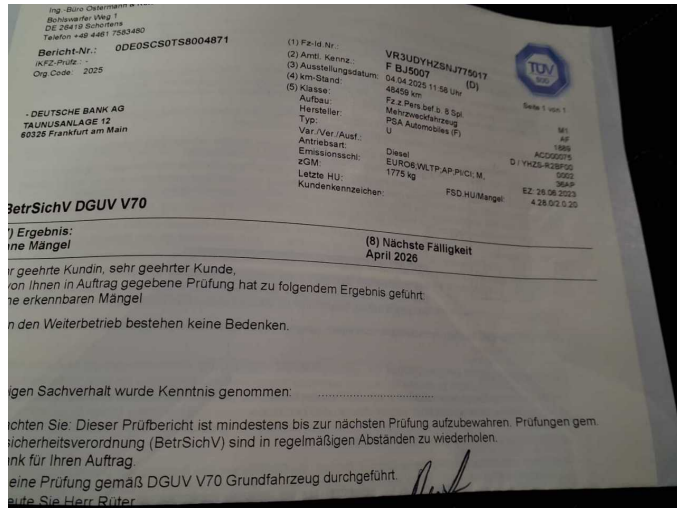
| No. | Component group | Description |
|---|---|---|
| 2 | Misc. | Main inspection - Due - Perform |

**Damage 2:** Misc.: Main inspection - Due - Perform

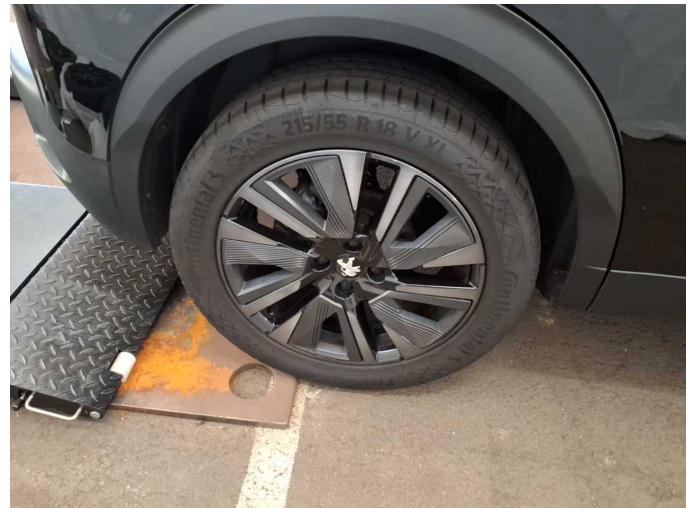
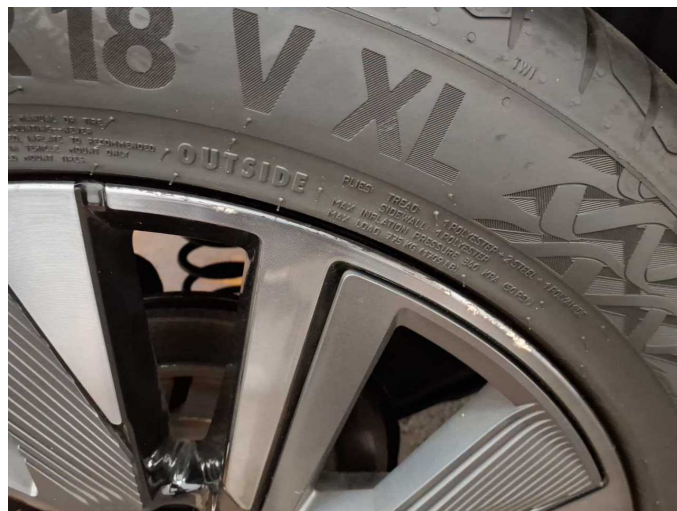
| No. | Component group | Description |
|---|---|---|
| 3 | Wheel / tyres | Alloy rim - rear right side - Scratch(es) - Loss in value |

**Damage 3:** Wheel / tyres: Alloy rim - rear right side - Scratch(es) - Loss in value

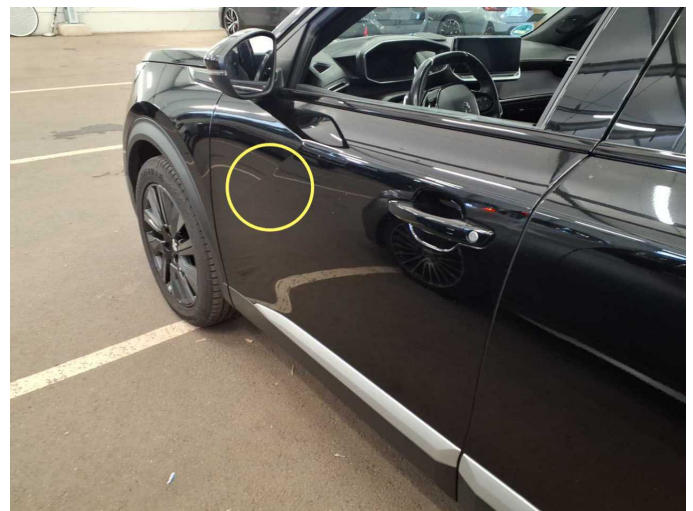
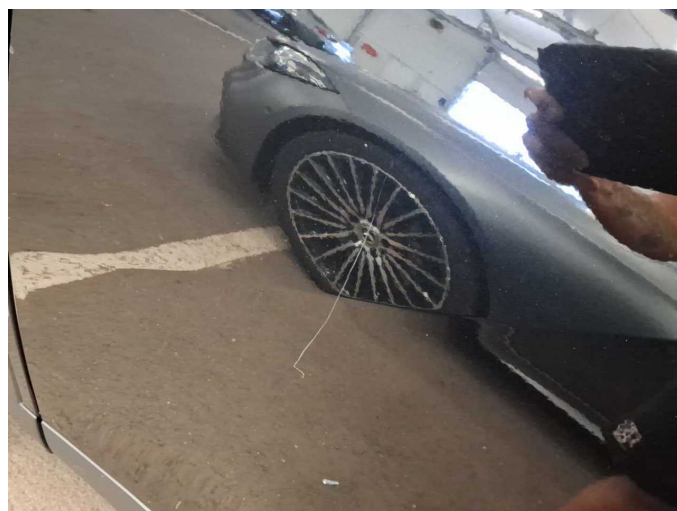
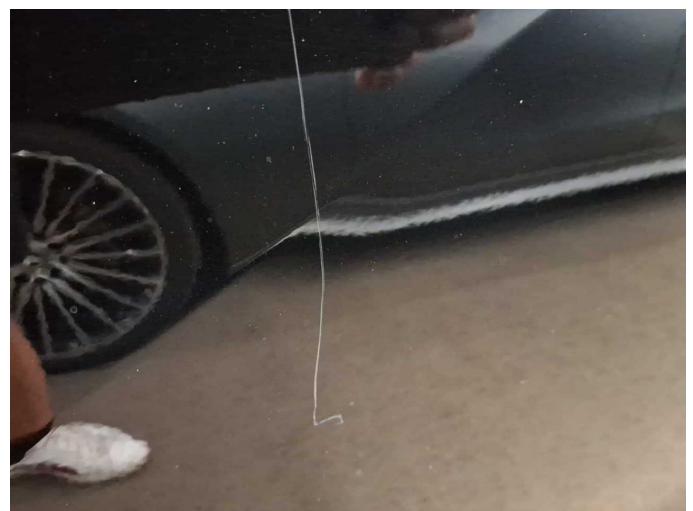
| No. | Component group | Description |
|---|---|---|
| 5 | Door - front left side | Door - Scratch(es) - Paint |

**Damage 5:** Door - front left side: Door - Scratch(es) - Paint

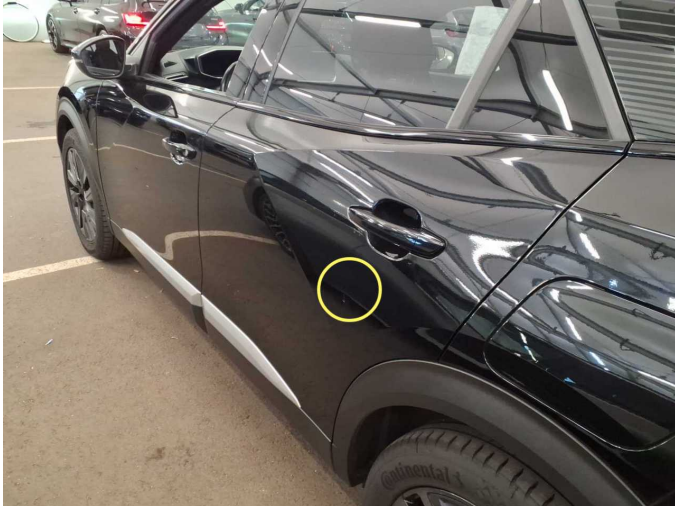
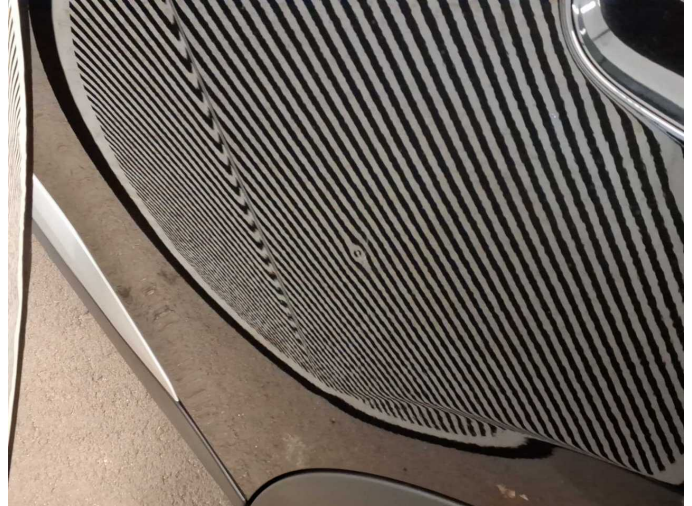
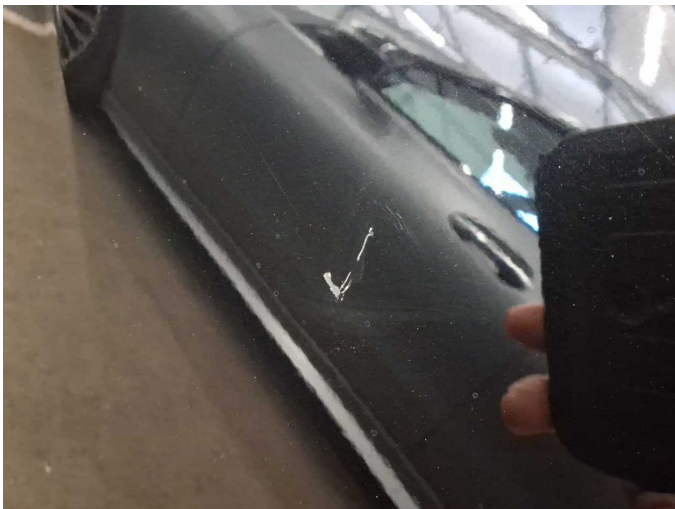
| No. | Component group | Description |
|---|---|---|
| 6 | Door - rear left side | Door - Dent / paintcoat damage - Repair and paint |

**Damage 6:** Door - rear left side: Door - Dent / paintcoat damage - Repair and paint
