Expertise

Protocol number: 46547477  
Order No. / Reference: 26555063  
Inspection date: 14 Jul 2026

Manufacturer: Opel

Model: Astra 1.2 Turbo Business Elegance

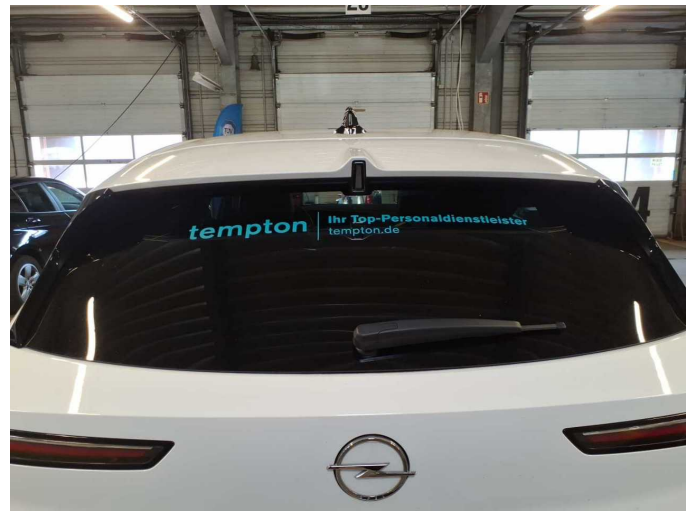
| No. | Component group | Description |
|---|---|---|
| 2 | Vehicle glazing | Rear window - Glued / labelled - De-glue / neutralise |

Damage 2: Vehicle glazing: Rear window - Glued / labelled - De-glue / neutralise

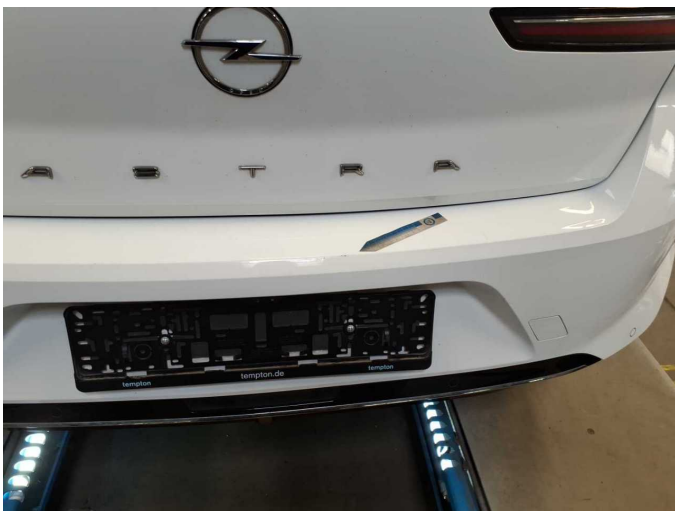
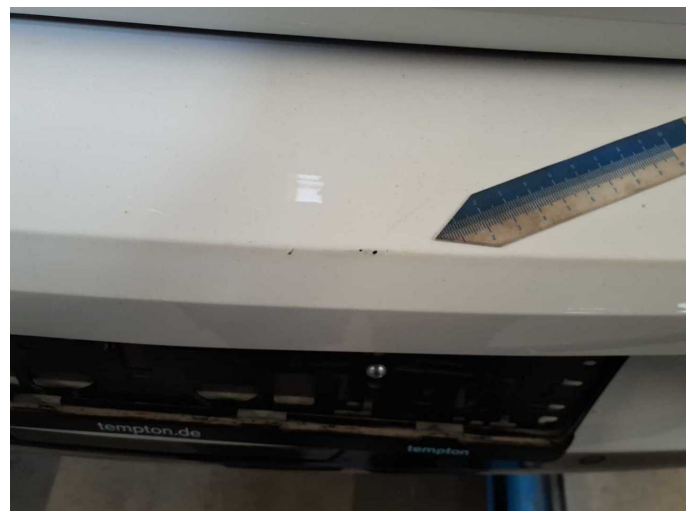
| No. | Component group | Description |
|---|---|---|
| 3 | Rear bumper | Rear bumper - Scratched - Smart repair |

Damage 3: Rear bumper: Rear bumper - Scratched - Smart repair

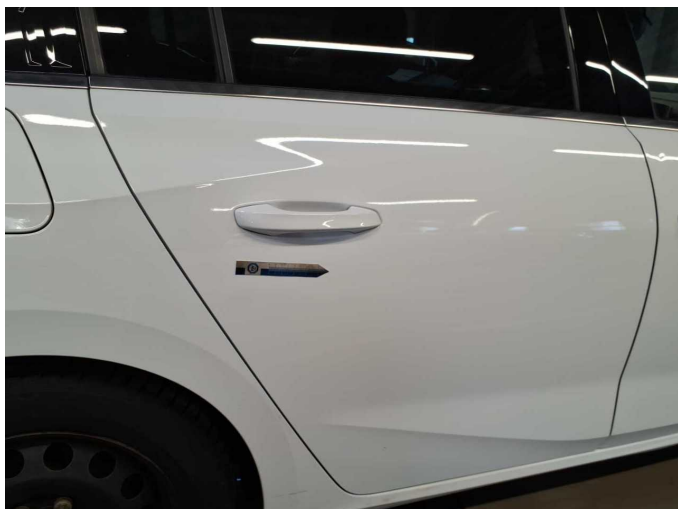
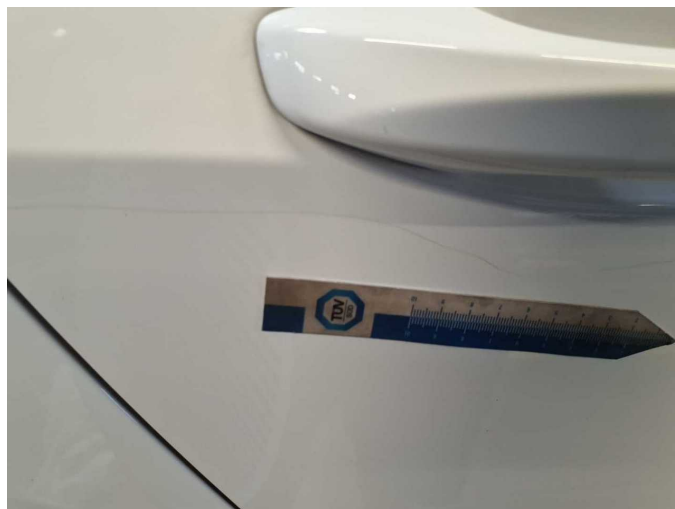
| No. | Component group | Description |
|---|---|---|
| 4 | Door - rear right side | Door (Mehrkosten möglich) - Scratched - Conditioning |

**Damage 4:** Door - rear right side: Door (Mehrkosten möglich) - Scratched - Conditioning

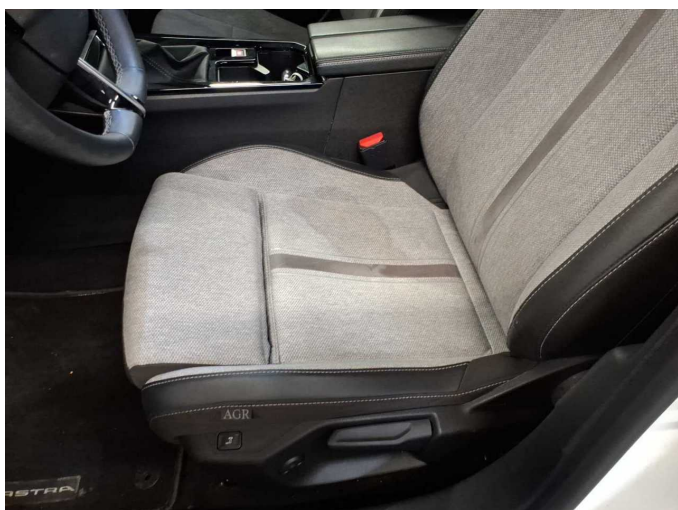
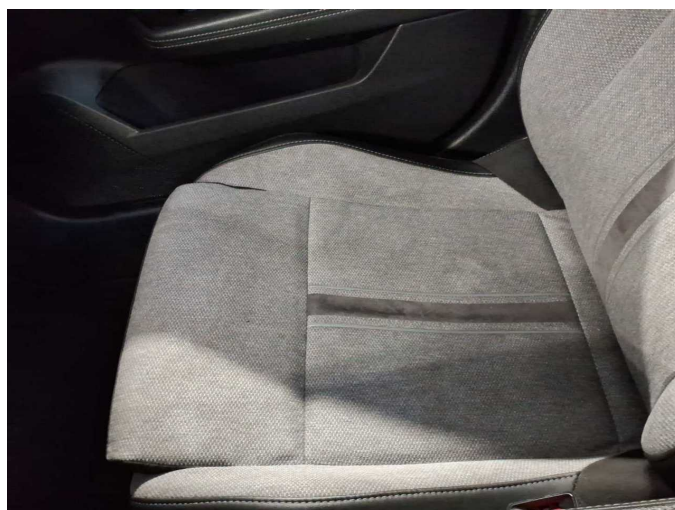
| No. | Component group | Description |
|---|---|---|
| 5 | Interior | Interior - Soiled - Clean |

**Damage 5:** Interior: Interior - Soiled - Clean

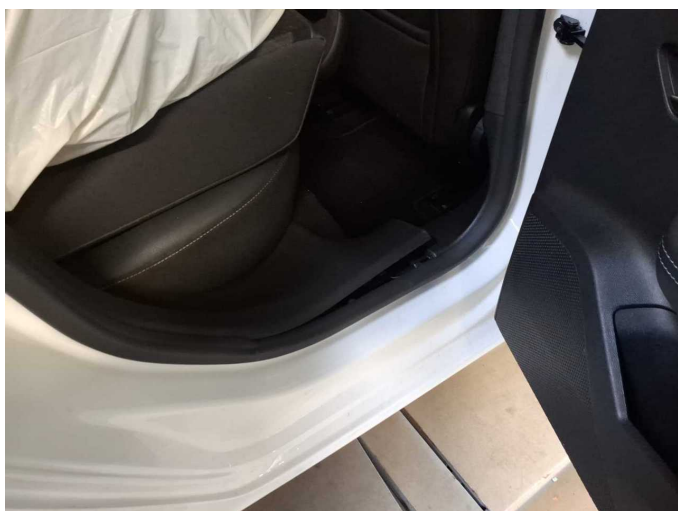
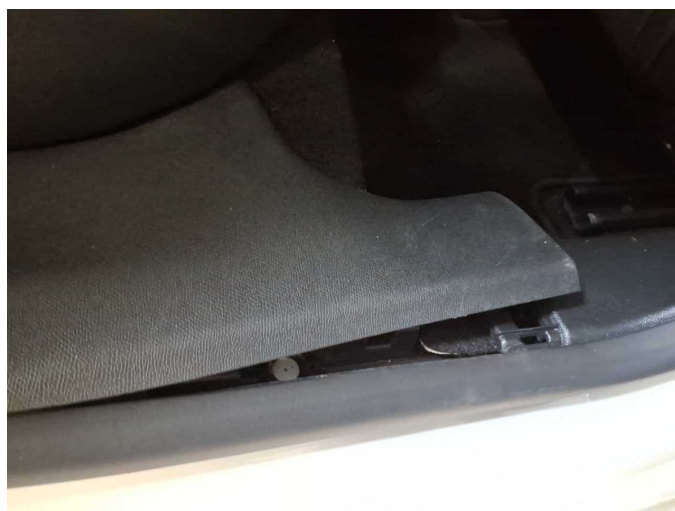
| No. | Component group | Description |
|---|---|---|
| 6 | Trim / covers | Sill - front right side - Damaged - Replace |

**Damage 6:** Trim / covers: Sill - front right side - Damaged - Replace

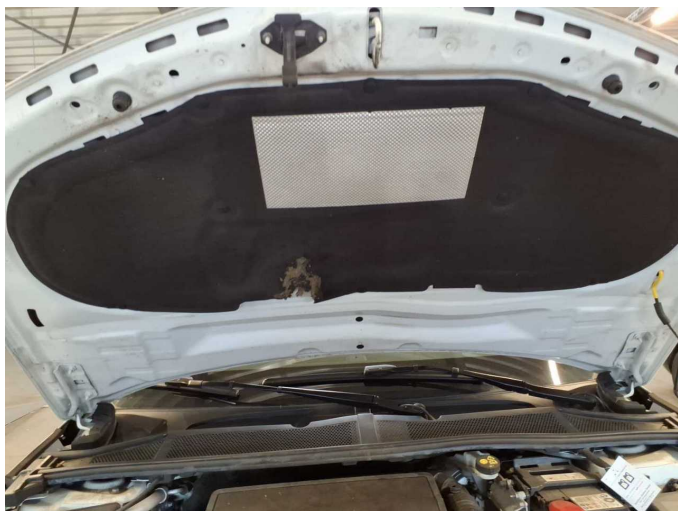
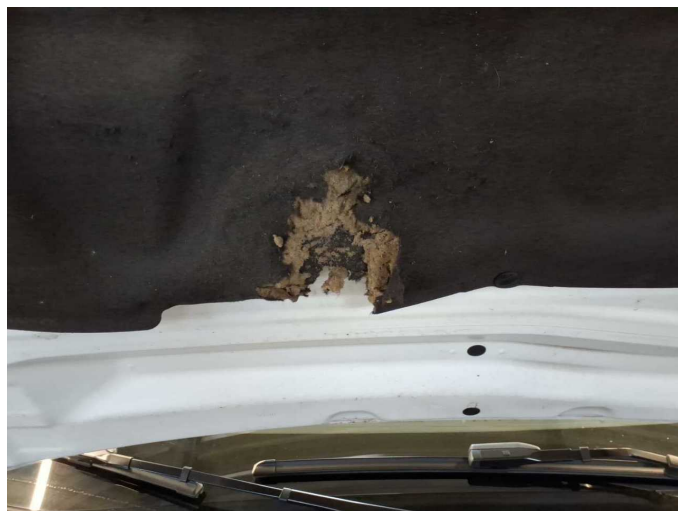
| No. | Component group | Description |
|---|---|---|
| 7 | Bonnet | Insulation lining - Damage caused by marten / rodent - Replace |

**Damage 7:** Bonnet: Insulation lining - Damage caused by marten / rodent - Replace

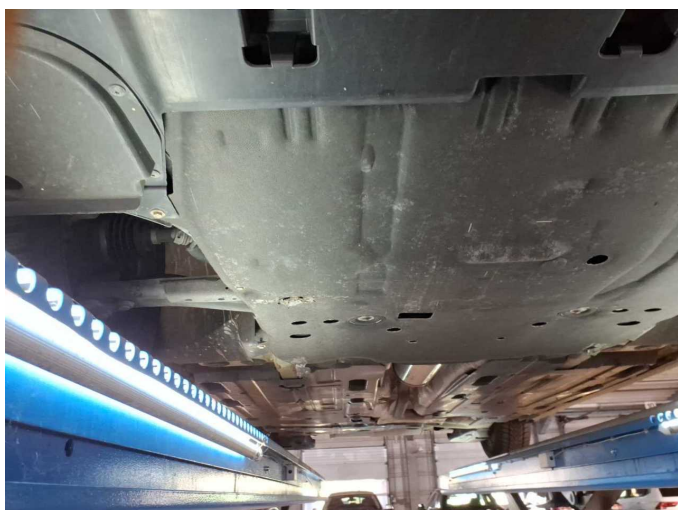
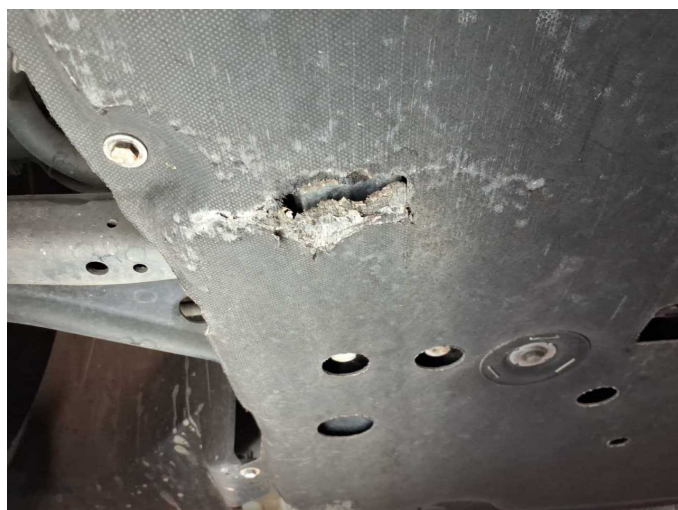
| No. | Component group | Description |
|---|---|---|
| 8 | Body | Underbody panelling - Damaged - Replace |

**Damage 8:** Body: Underbody panelling - Damaged - Replace

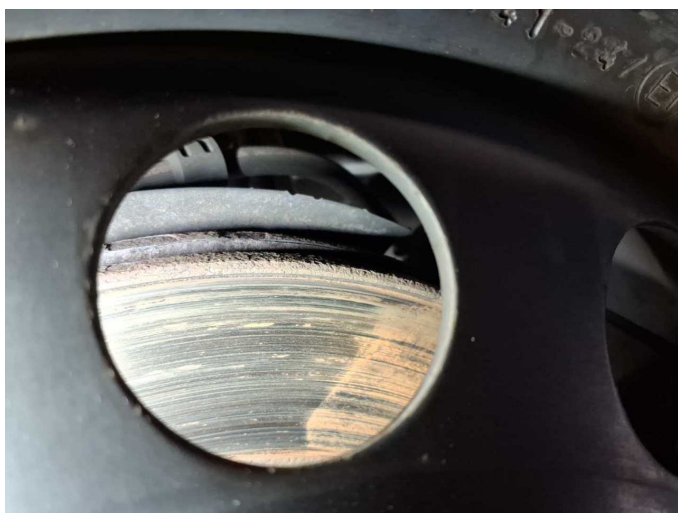
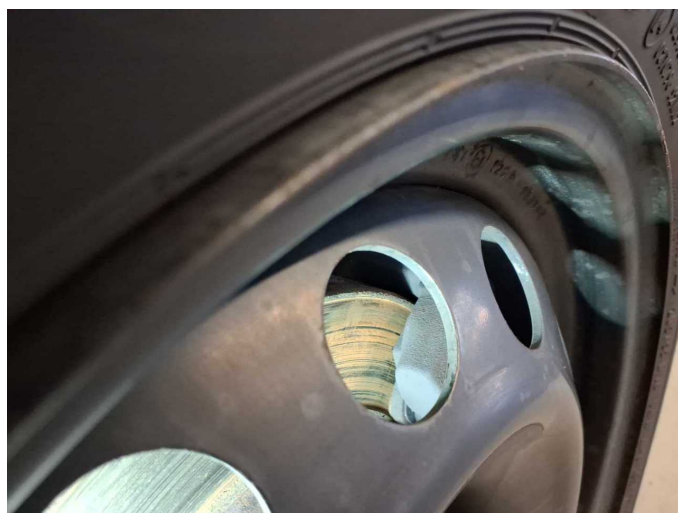
| No. | Component group | Description |
|---|---|---|
| 9 | Braking system | Brake discs and brake pads - front (Tragbild mangelhaft,Rost) - Worn - Replace |

**Damage 9:** Braking system: Brake discs and brake pads - front (Tragbild mangelhaft, Rost) - Worn - Replace

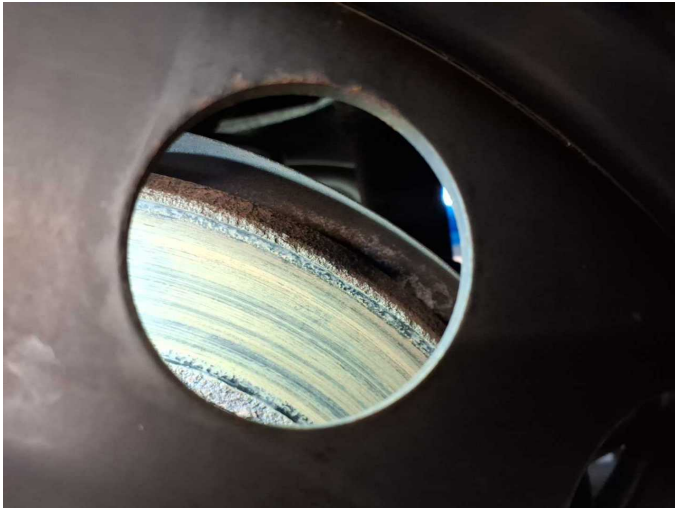
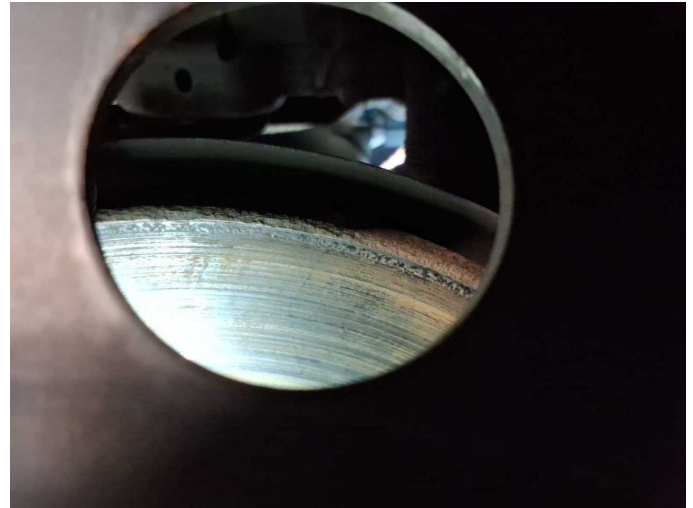
| No. | Component group | Description |
|---|---|---|
| 10 | Braking system | Brake discs and pads - rear (Tragbild mangelhaft,Rost) - Worn - Replace |

**Damage 10:** Braking system: Brake discs and pads - rear (Tragbild mangelhaft, Rost) - Worn - Replace

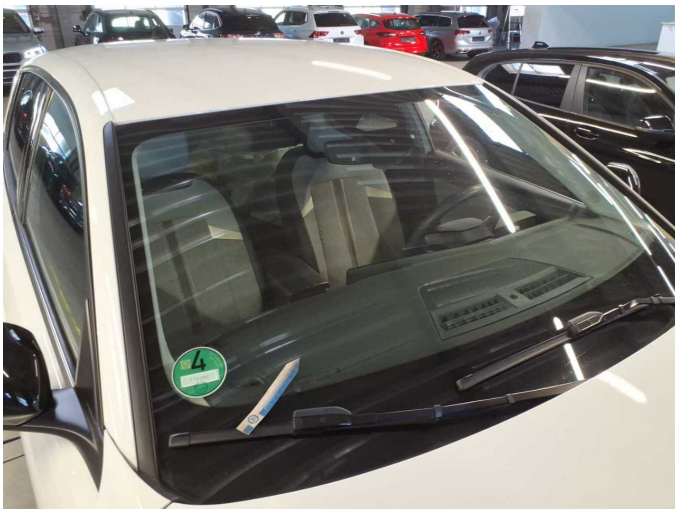
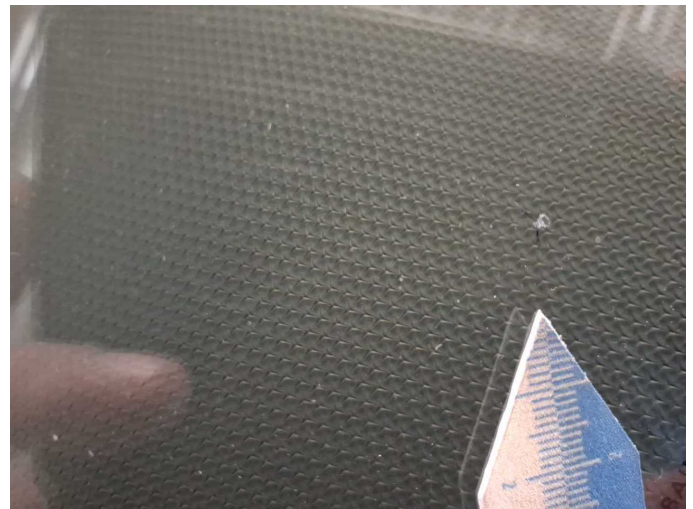
| No. | Component group | Description |
|---|---|---|
| 11 | Vehicle glazing | Windscreen - Broken / torn - Replace |

**Damage 11:** Vehicle glazing: Windscreen - Broken / torn - Replace

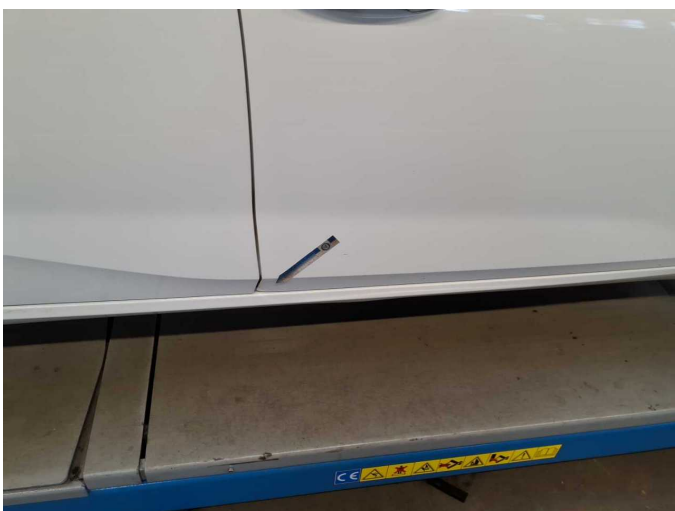
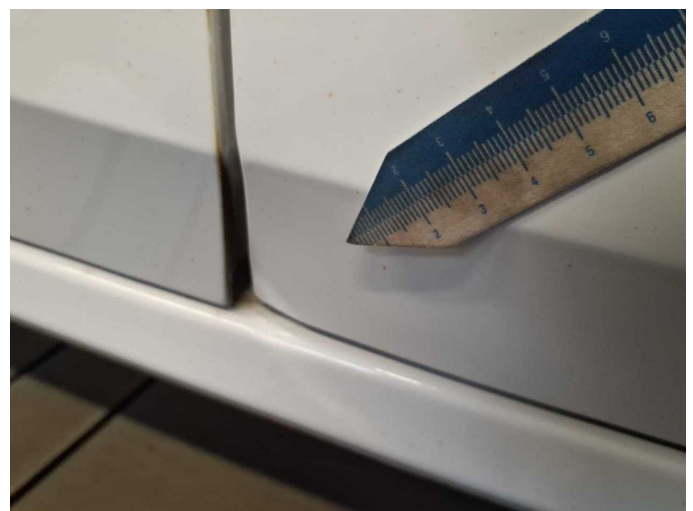
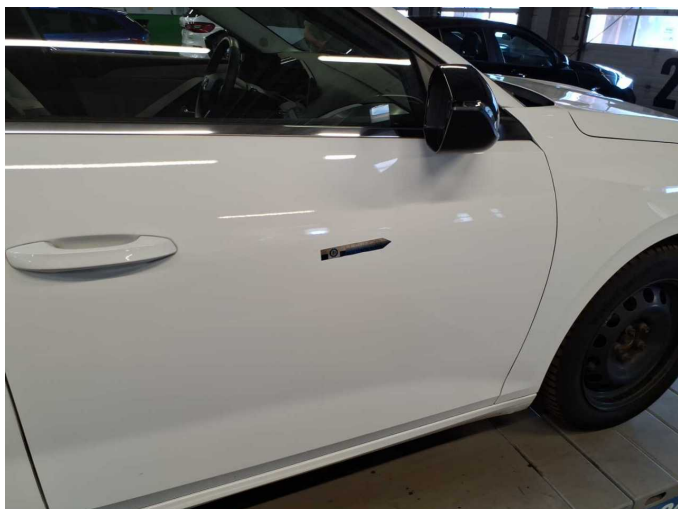
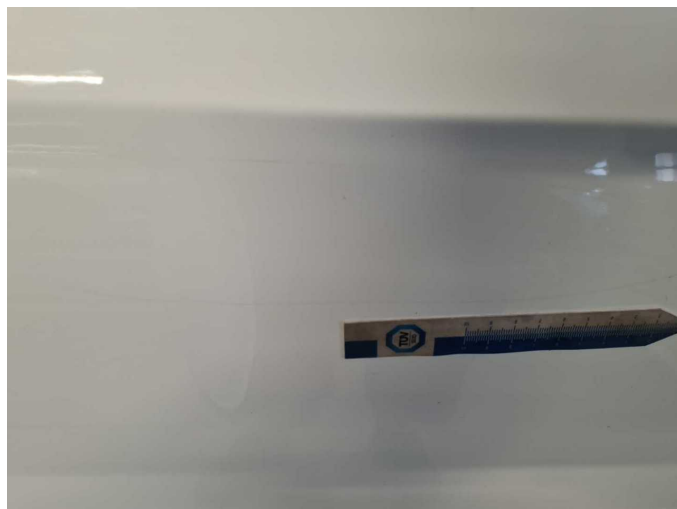
| No. | Component group | Description |
|---|---|---|
| 12 | Door - front right side | Door - Dent / paintcoat damage - Repair and paint |

**Damage 12:** Door - front right side: Door - Dent / paintcoat damage - Repair and paint

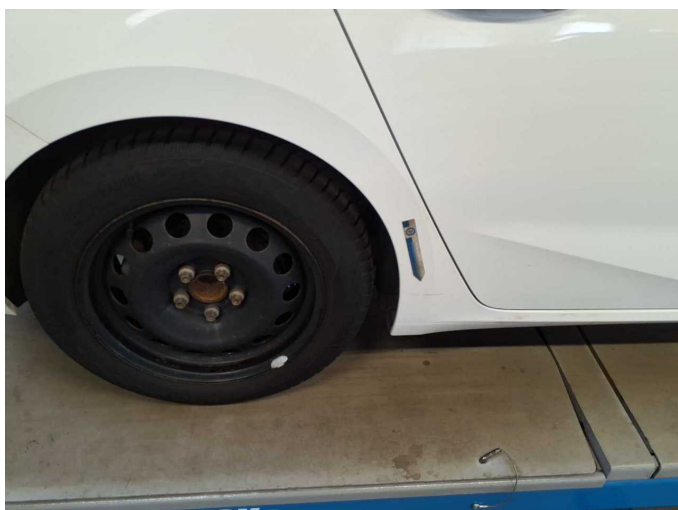
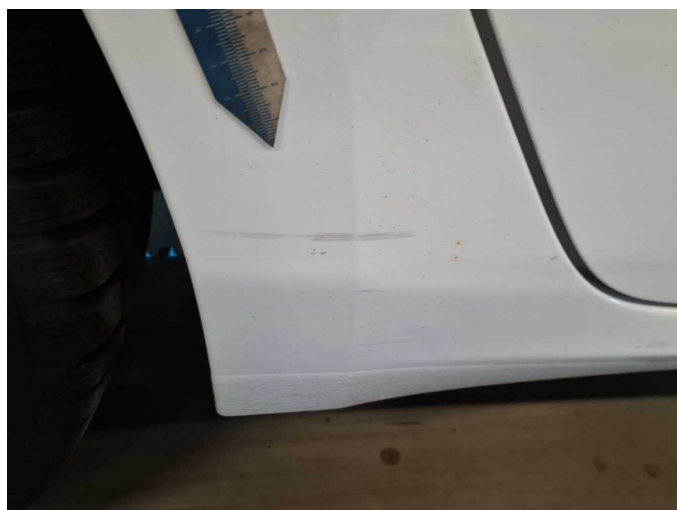
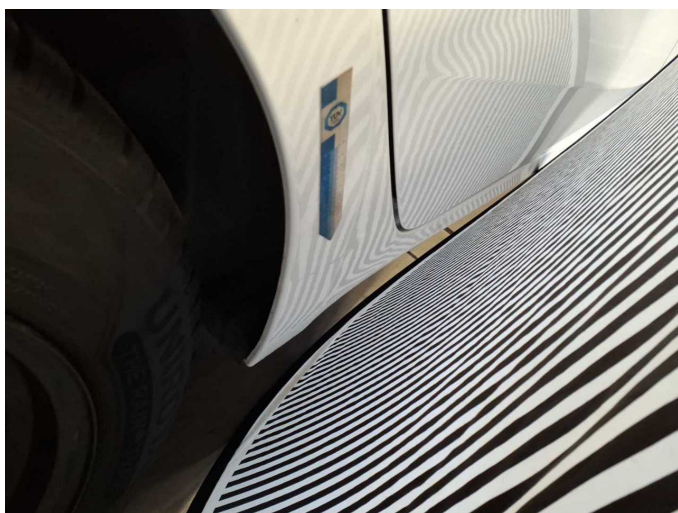
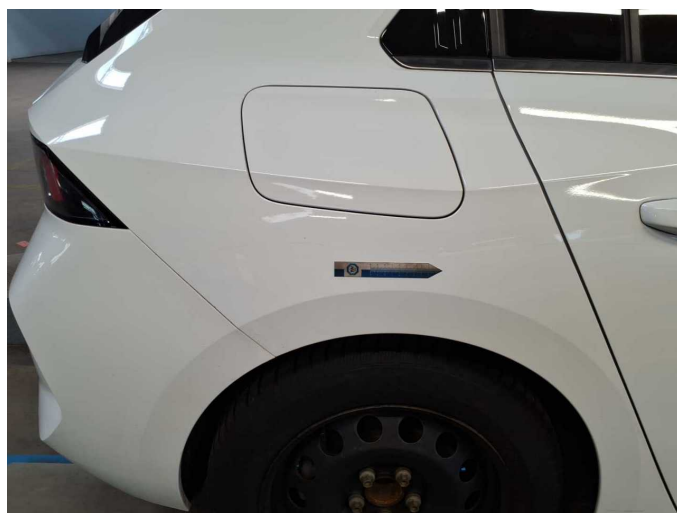
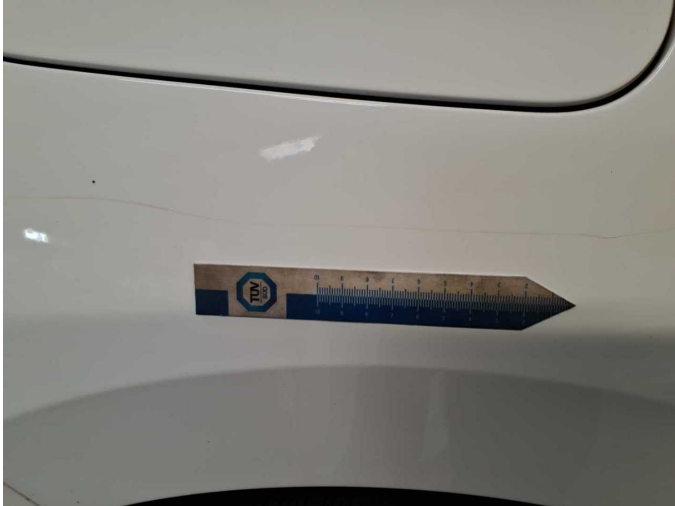
| No. | Component group | Description |
|---|---|---|
| 13 | Side panel - rear right side | Side panel (Rost) - Dent / paintcoat damage - Repair and paint |

**Damage 13:** Side panel - rear right side: Side panel (Rost) - Dent / paintcoat damage - Repair and paint

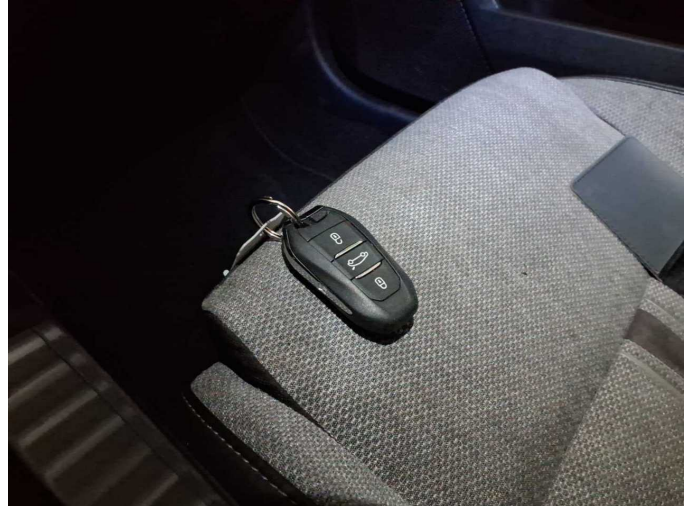
Equipment - Vehicle key

**Missing part 1:** Equipment: Vehicle key - Missing - Replace

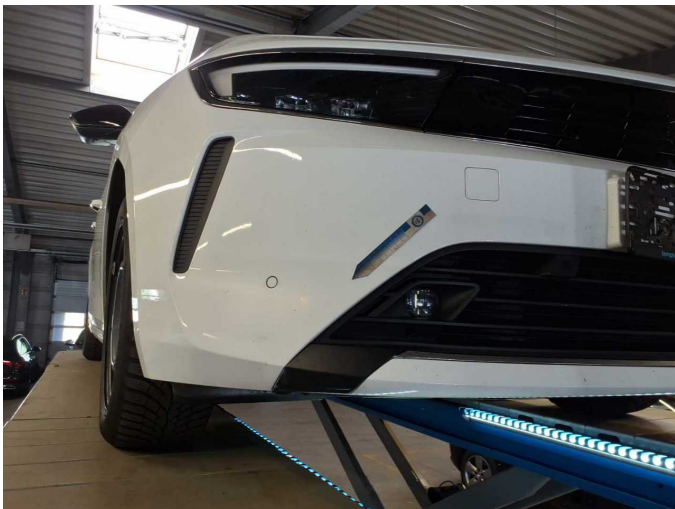
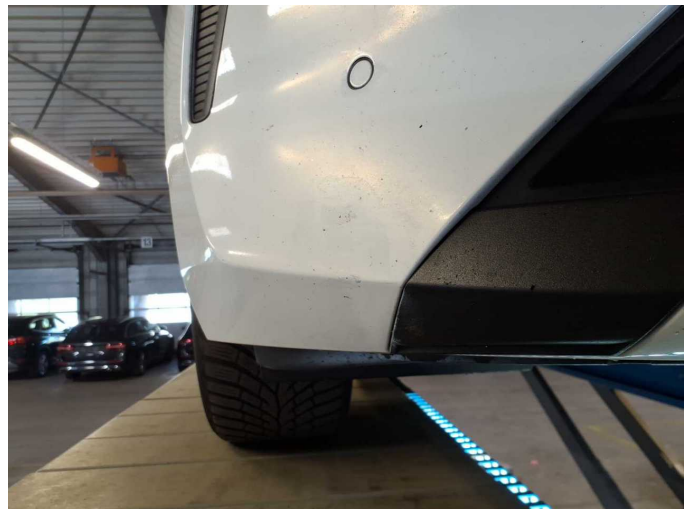
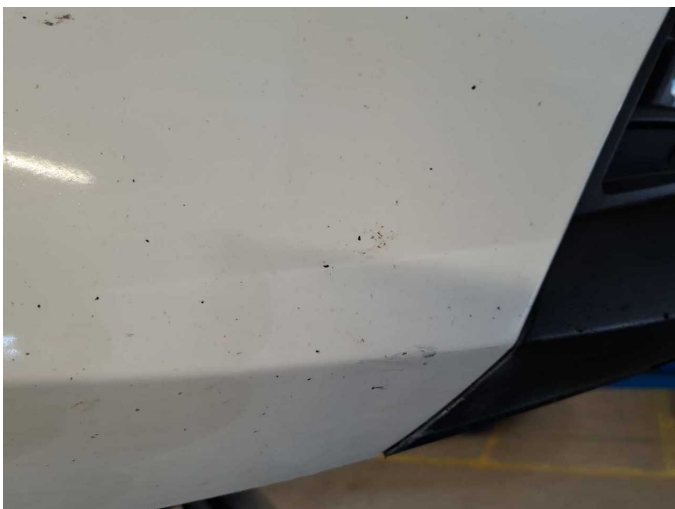
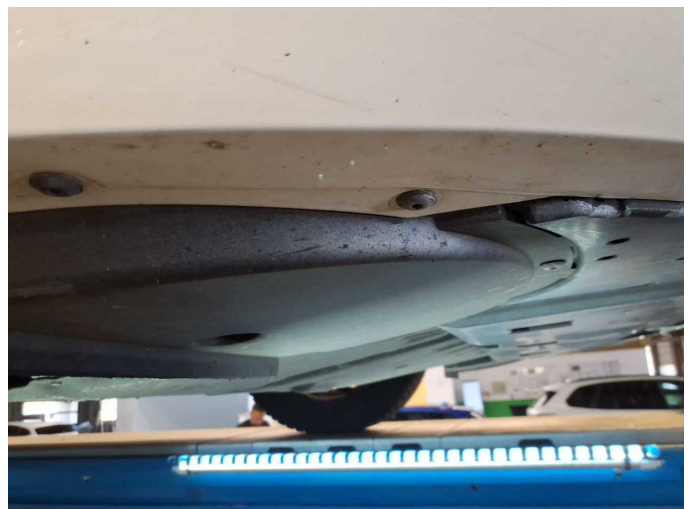
| No. | Previous damage | Extent of damage (Net) |
|---|---|---|
| 1 | Front, not professionally repaired, Invoice of repair done Non-existent | |

An unprofessionally repaired previous damage was found at the vehicle.

**Previous damage 1:** Front
