Expertise

Protocol number: 46015774
Order No. / Reference: 26451786
Inspection date: 16 Jun 2026

Model: Vivaro 2.0 D Cargo L EHZ Autm. Elegance

VIN: VXEVFEHZ7N7022942

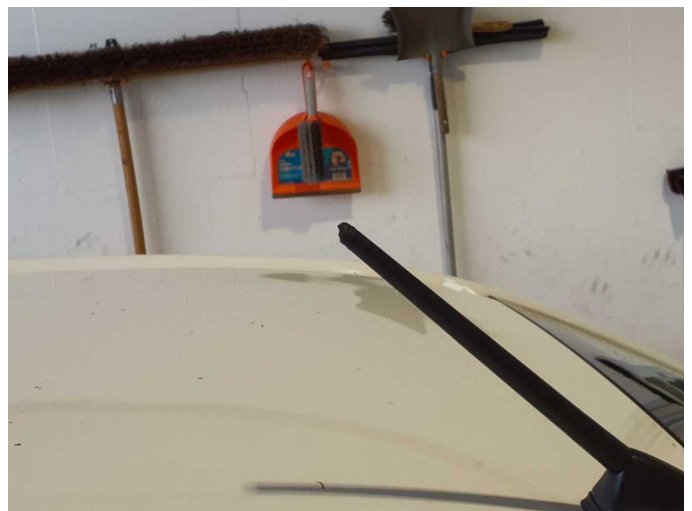
Damage 2: Roof: Stub aerial - Broken / torn - Replace

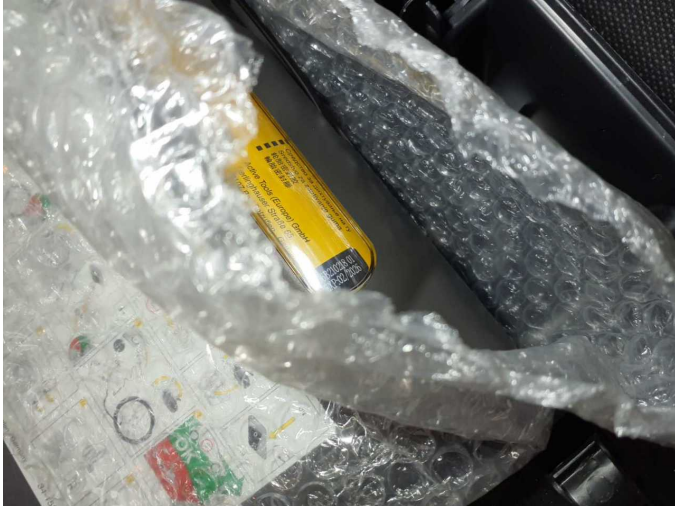
Damage 3: Equipment: Tirefit filler - Expired - Replace

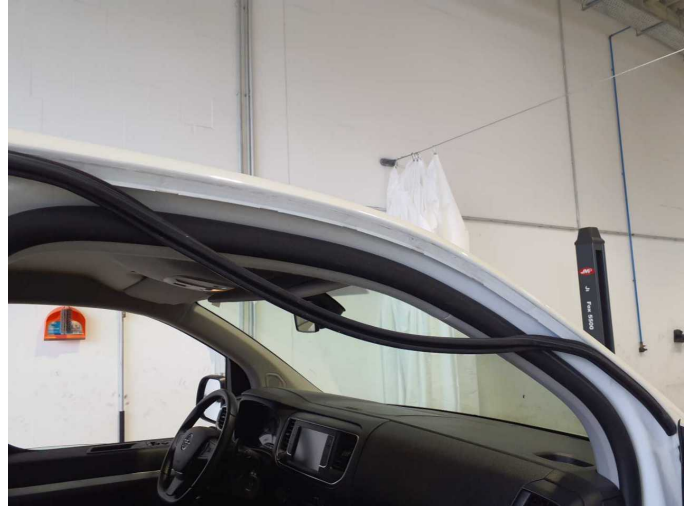
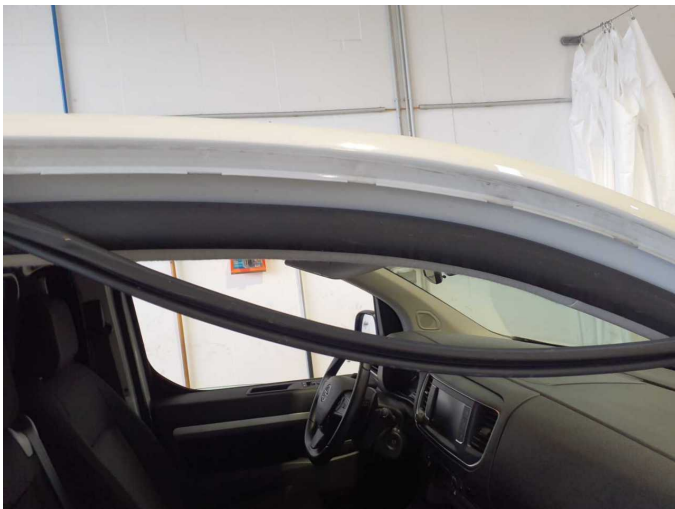
Damage 4: Door - front right side: Door seal - Loose - Un- / install

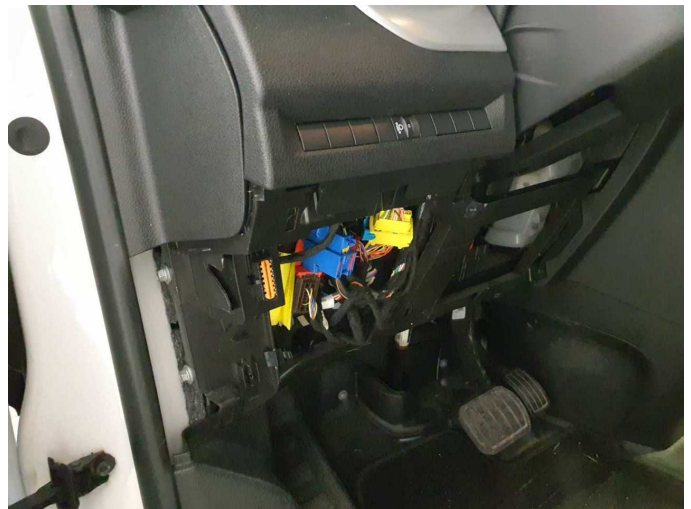
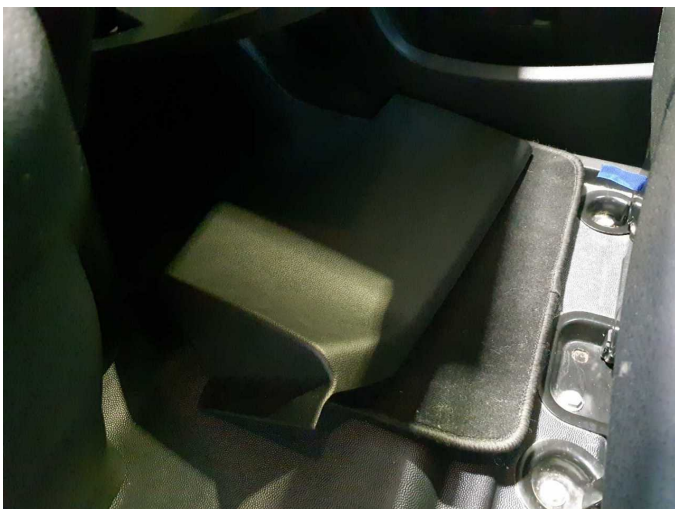
Damage 5: Trim / covers: Trim / covers - Loose - Un- / install

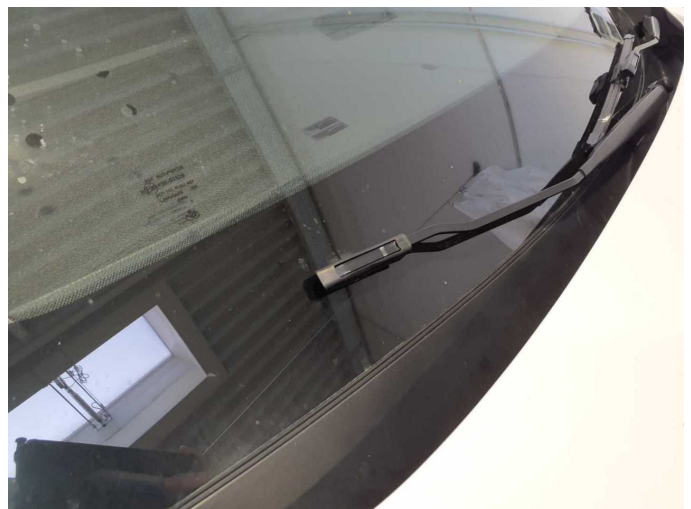
Damage 6: Screen cleaning: Wiper blades - front - Missing - Replace

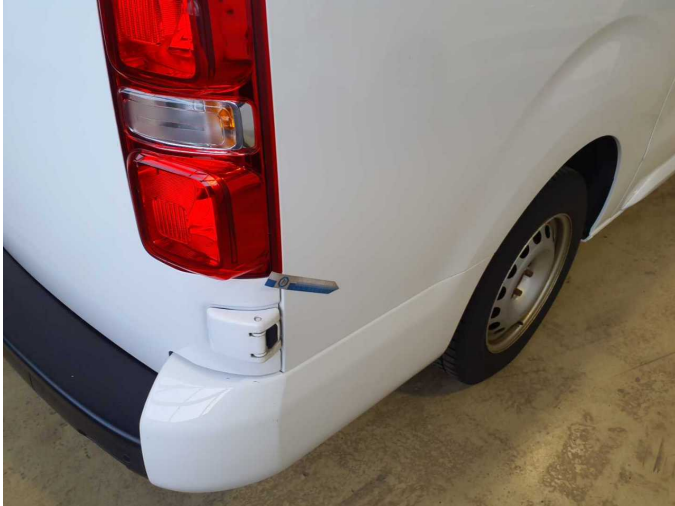
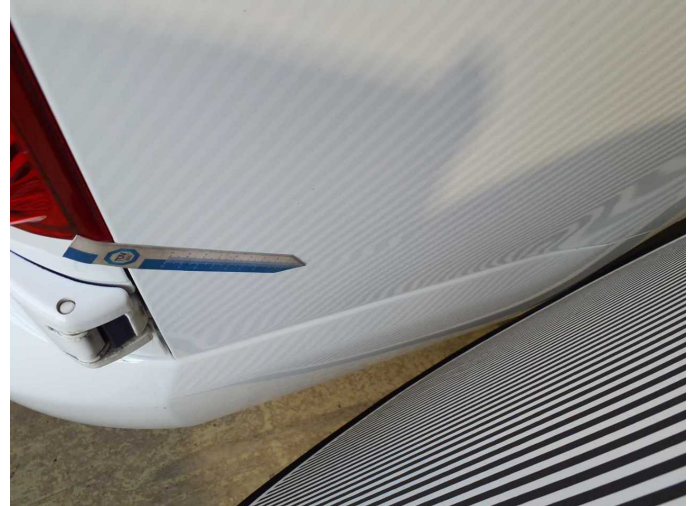
Damage 7: Side panel - rear right side: Side panel - dent(s) - Smooth repair work

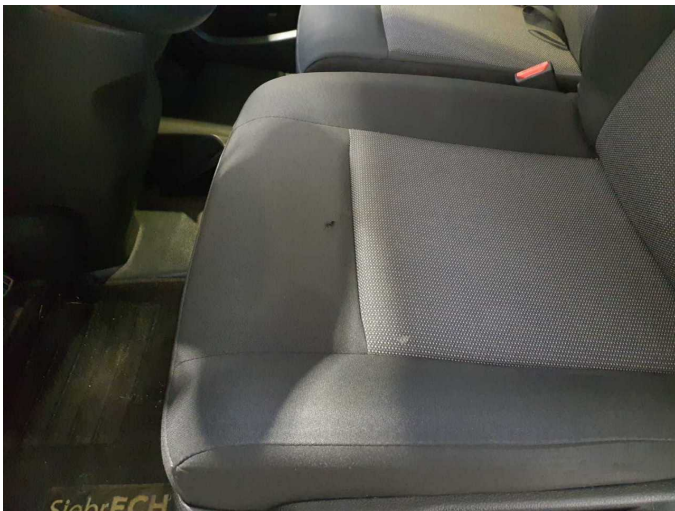
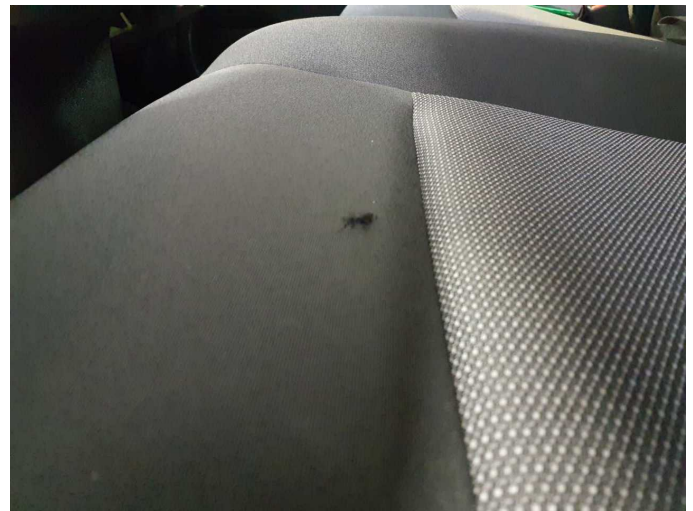
Damage 8: Seat - front: Seat cover - left side - Scratch(es) - Smart repair

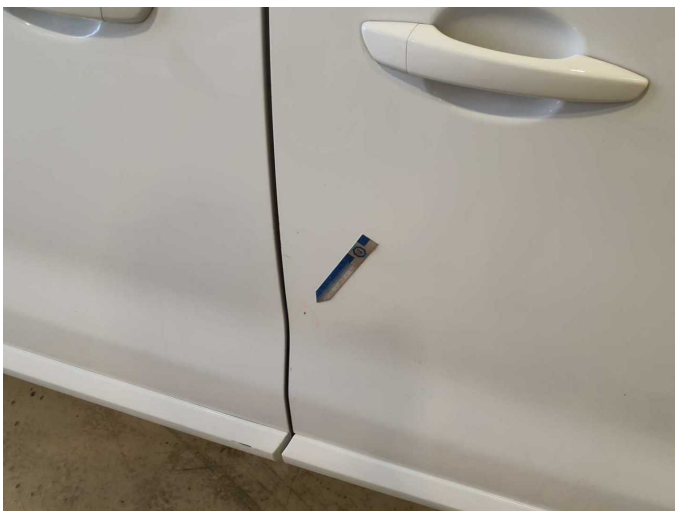
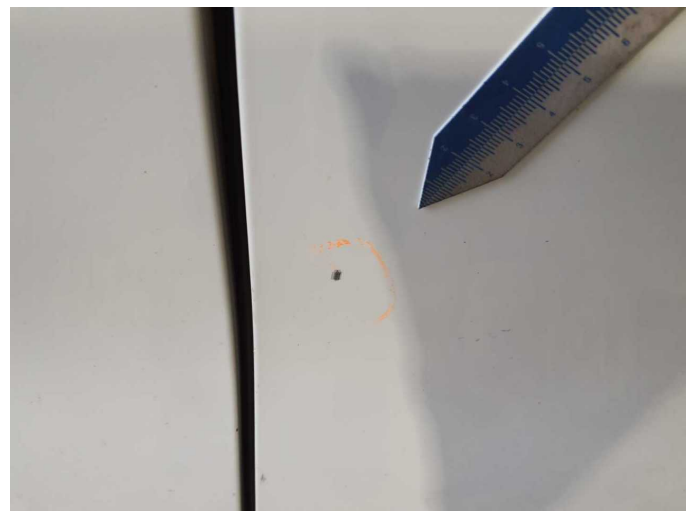
Damage 9: Door - front right side: Door - Scratch(es) - Smart repair

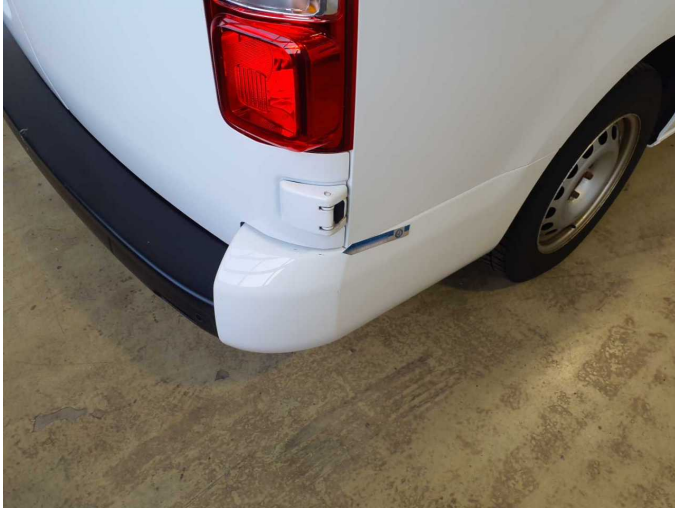
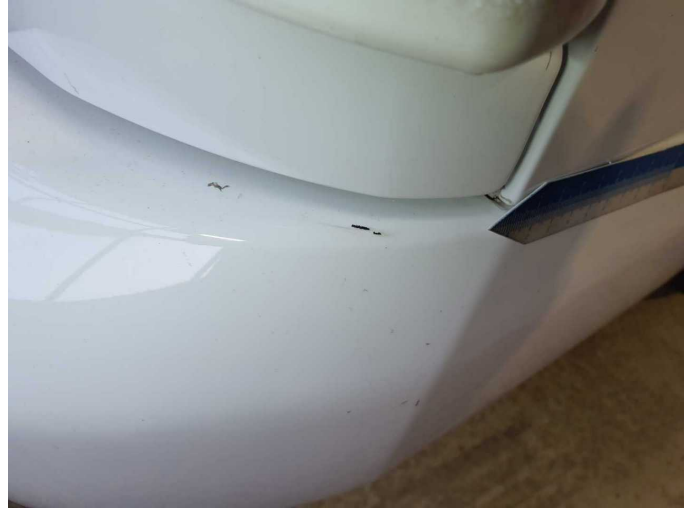
Damage 10: Rear bumper: Bumper - rear right side - Scratch(es) - Smart repair

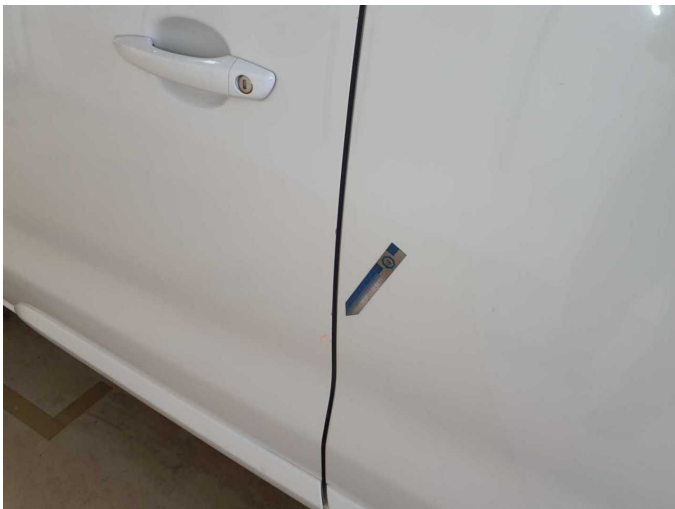
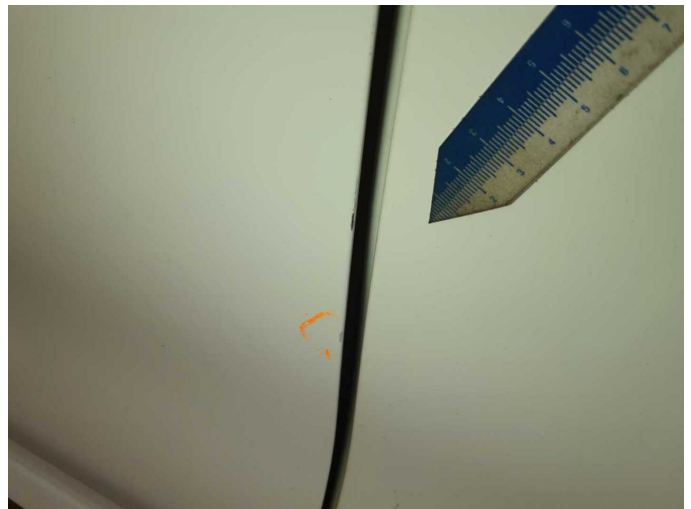
Damage 11: Door - front left side: Door - Scratch(es) - Smart repair

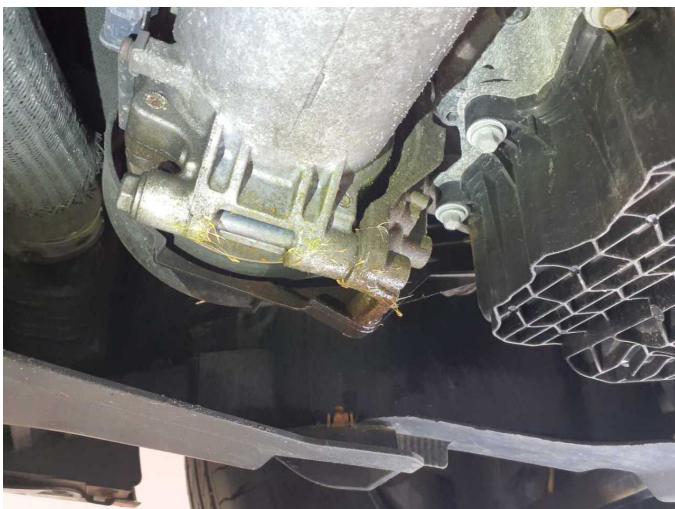
Damage 12: Engine: Engine - Leaking - Perform diagnosis

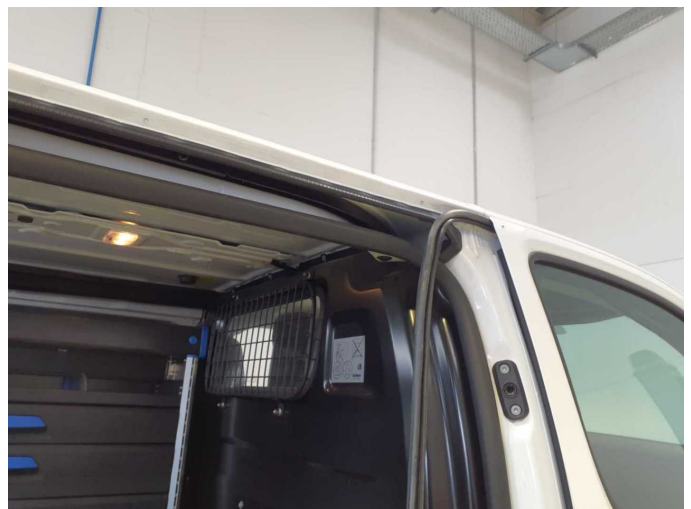
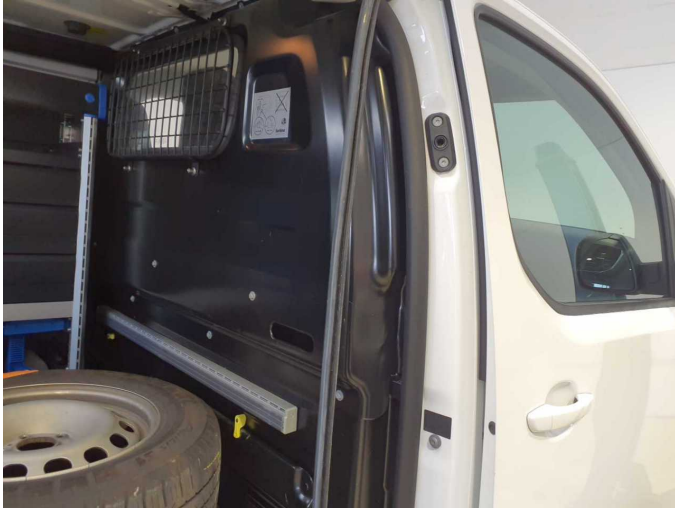
Damage 13: Sliding door, right: Door seal - Broken / torn - Replace

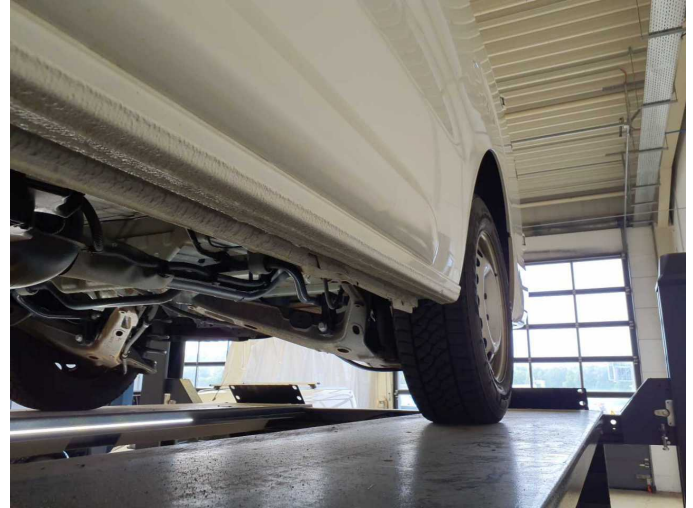
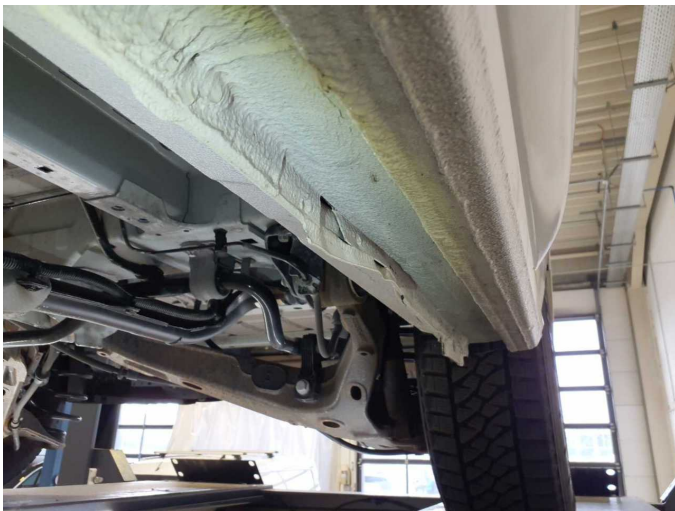
Damage 14: Sill - left side: Sill - dent(s) - Smart repair

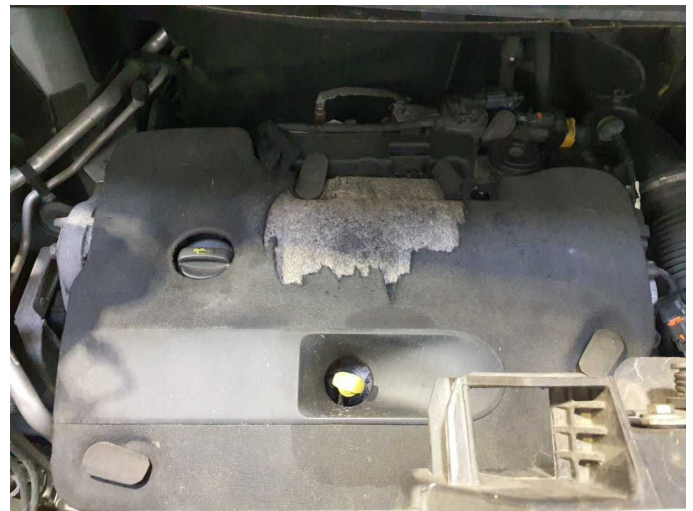
Damage 15: Engine: Engine cover - Damage caused by marten / rodent - Replace

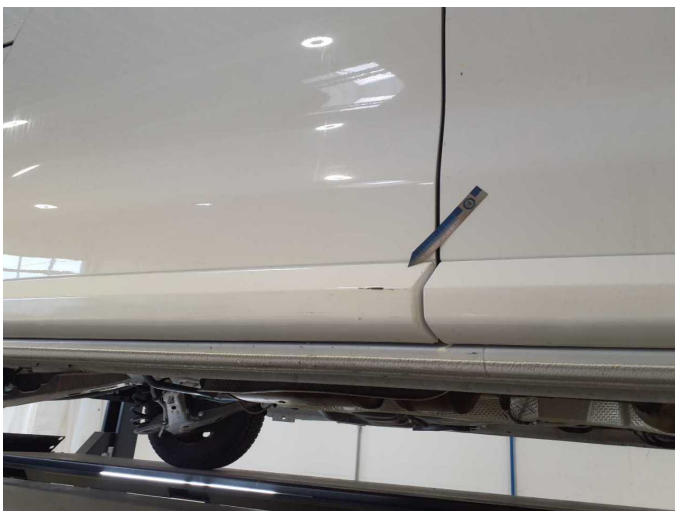
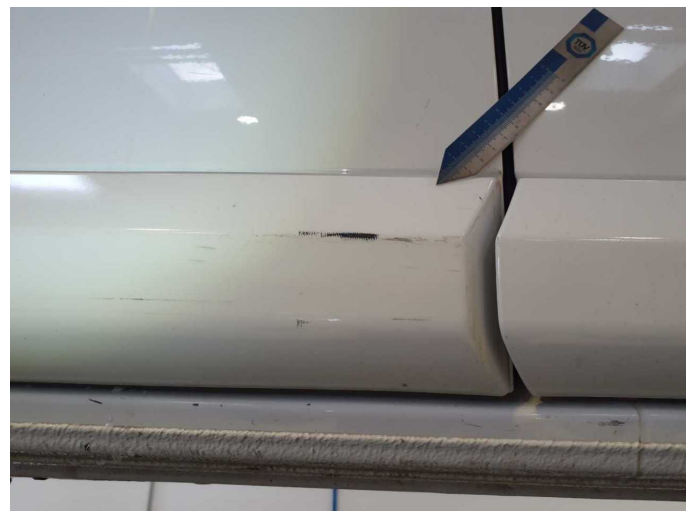
Damage 16: Door - rear right side: Brightware - lower - Scratch(es) - Paint

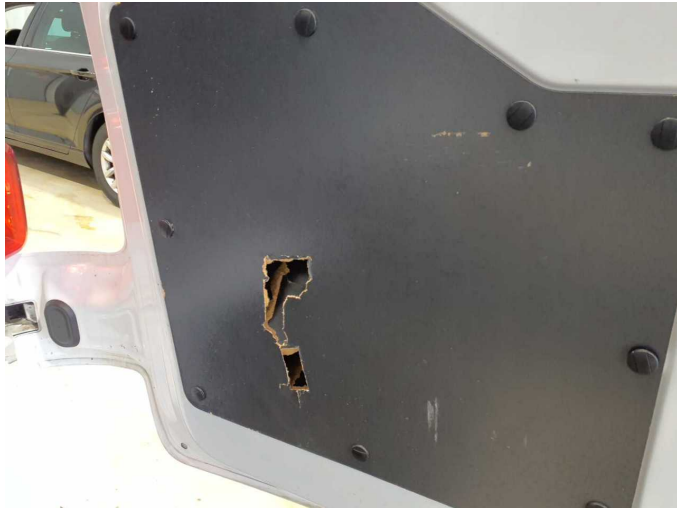
Damage 17: Trim / covers: Door trim - rear right side - Broken / torn - Replace

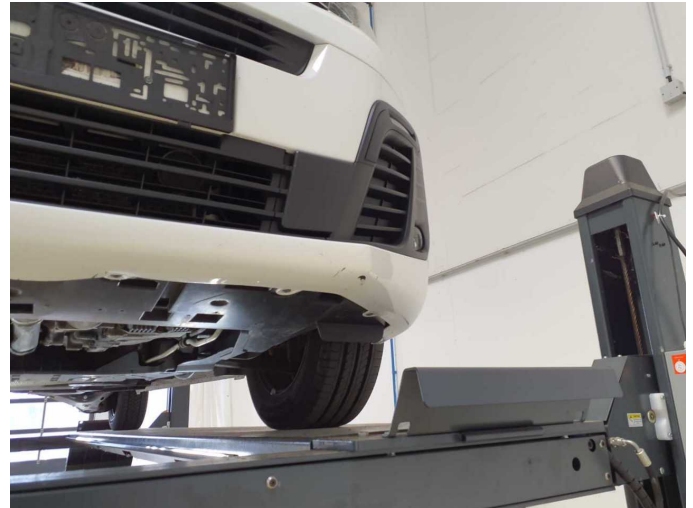
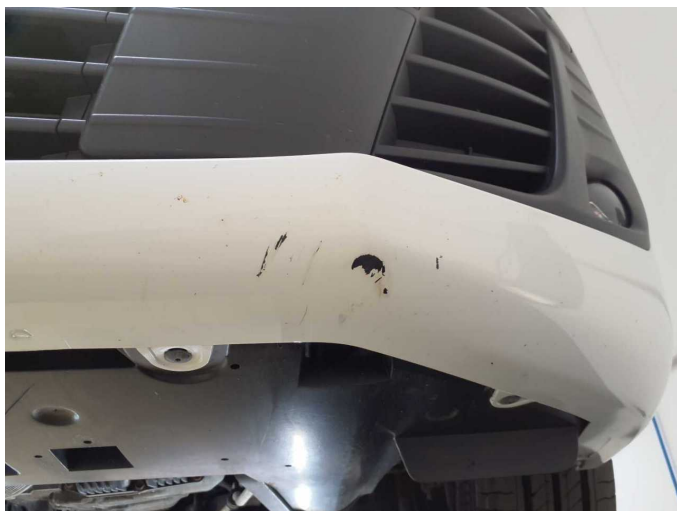
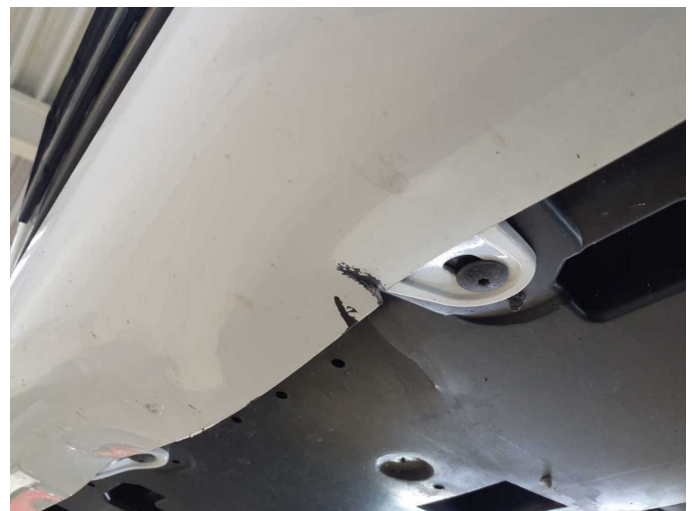
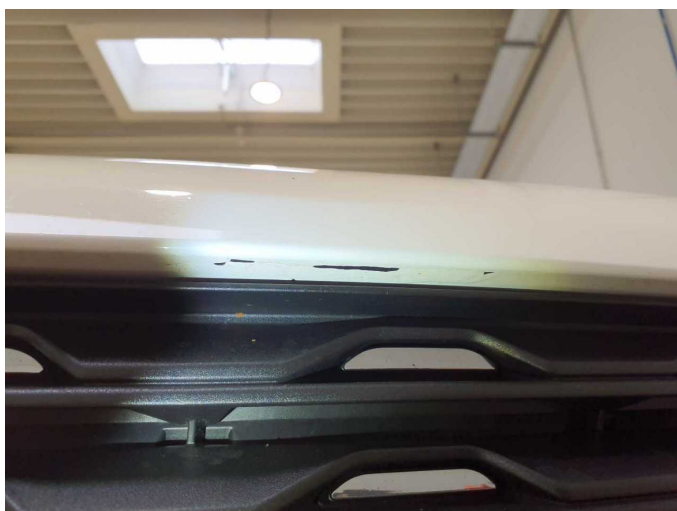
17	Trim / covers	Door trim - rear right side - Broken / torn - Replace
18	Front bumper	Front bumper - Broken / torn - repair according to calculation

Damage 18: Front bumper: Front bumper - Broken / torn - repair according to calculation

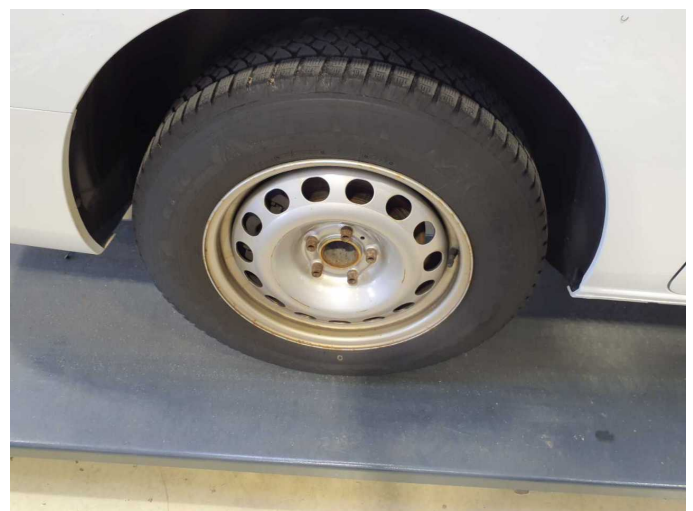
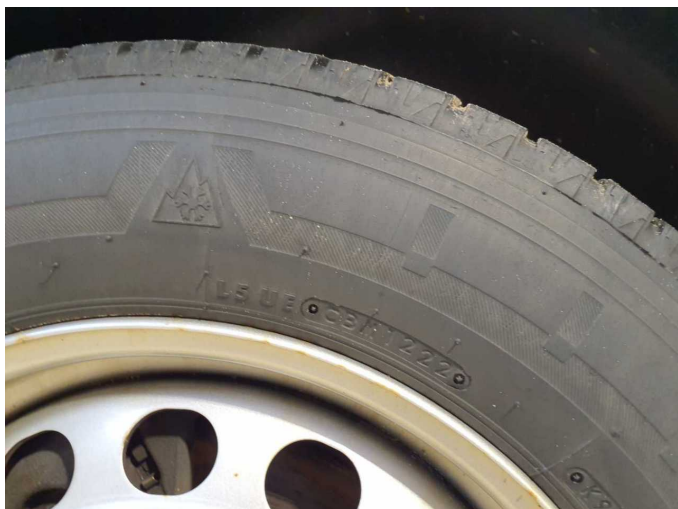
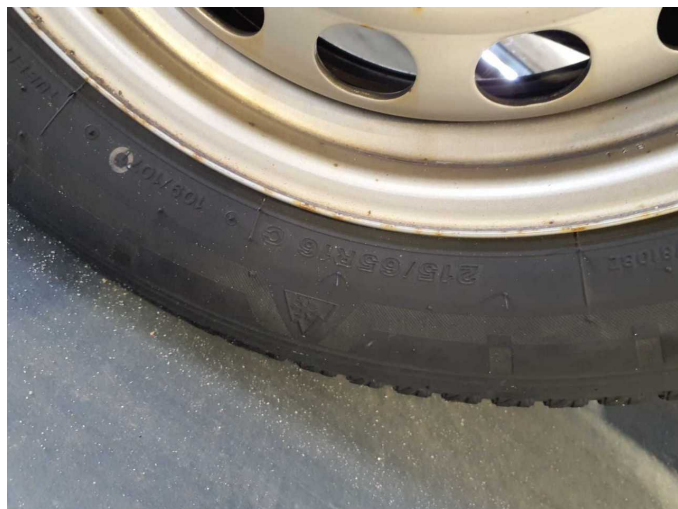
Wear and tear 6: Wheel / tyres: Tyre - right - Differs from the original configuration - No deduction
