Expertise

Protocol number: 47166167  
Order No. / Reference: 26827524  
Inspection date: 19 Aug 2026

Manufacturer: Opel

Model: Crossland X 1.5 Diesel Start/Stop Innovation

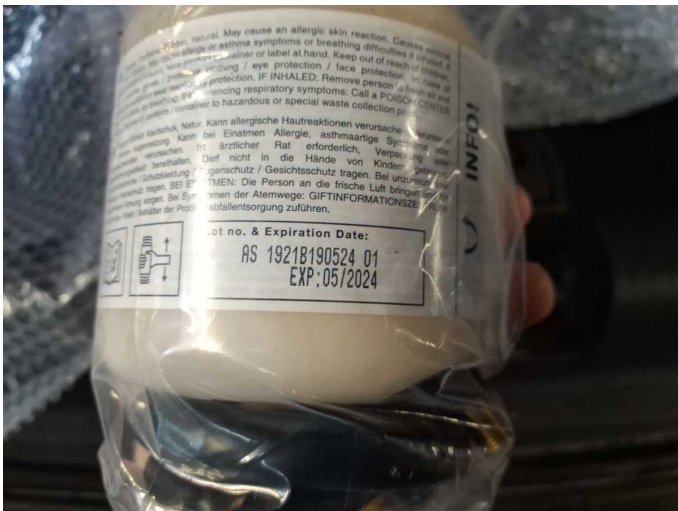
| No. | Component group | Description |
|---|---|---|
| 1 | Equipment | Tirefit filler - Expired - Replace |

Damage 1: Equipment: Tirefit filler - Expired - Replace

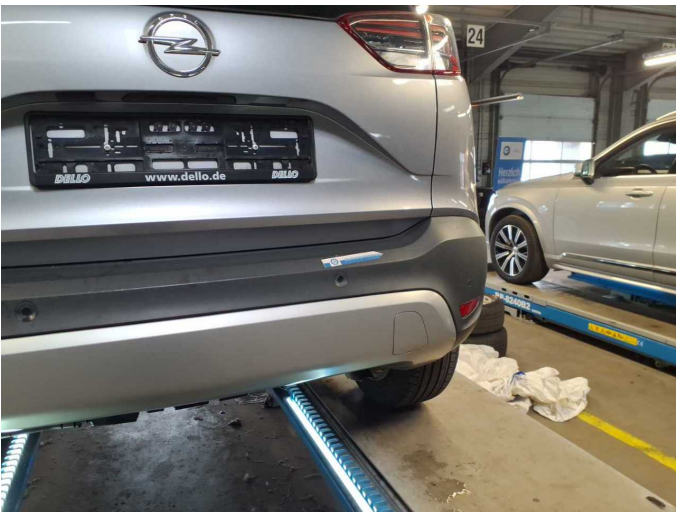
| No. | Component group | Description |
|---|---|---|
| 2 | Rear bumper | Rear bumper - Scratch(es) - Loss in value |

Damage 2: Rear bumper: Rear bumper - Scratch(es) - Loss in value

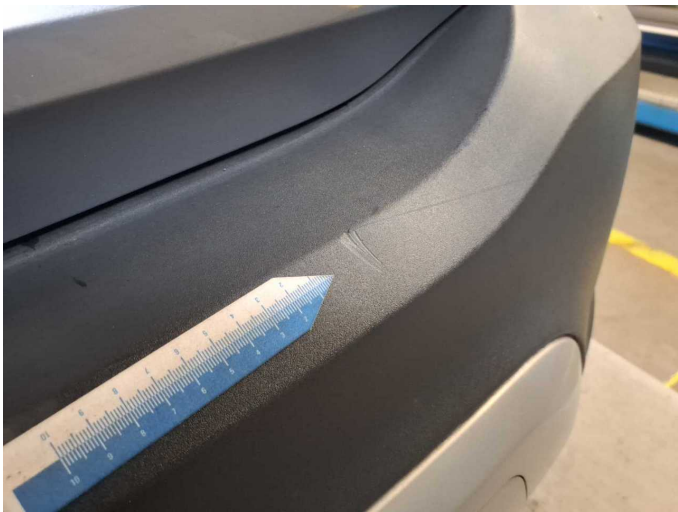
Damage 2: Rear bumper: Rear bumper - Scratch(es) - Loss in value

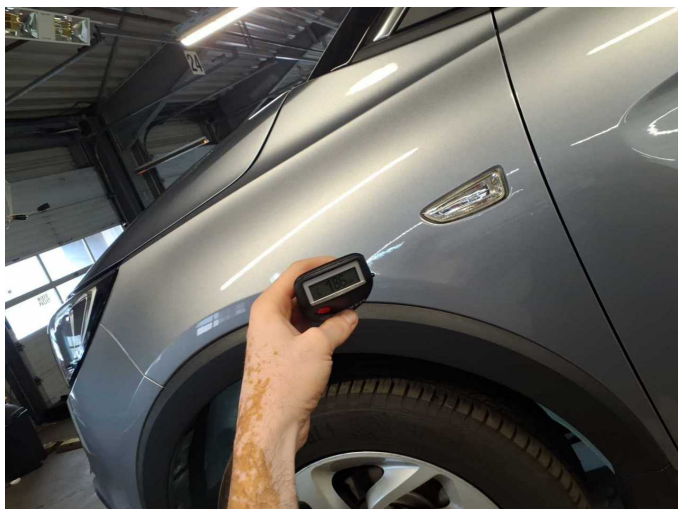
| No. | Repainting |
|---|---|
| 1 | Mudguard - left side |

**Repainting 1:** Mudguard - left side

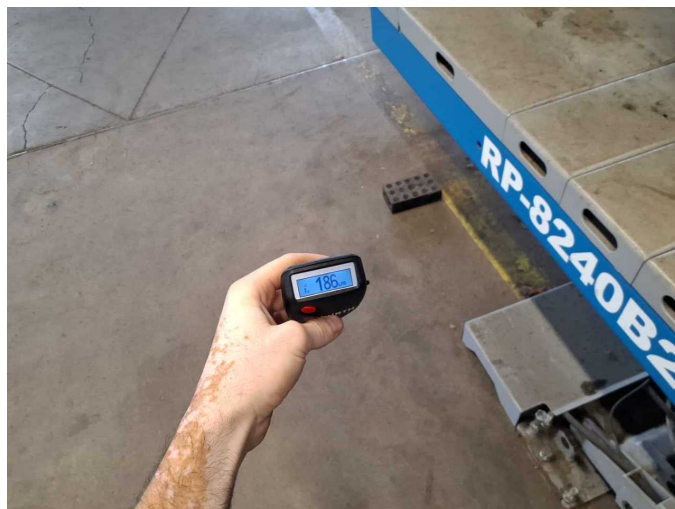
**Repainting 1:** Mudguard - left side

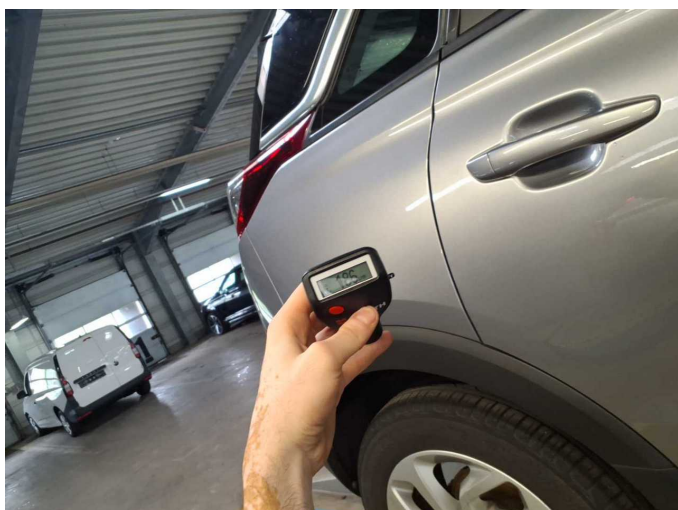
| No. | Repainting |
|---|---|
| 2 | Side panel - rear right side |

**Repainting 2:** Side panel - rear right side

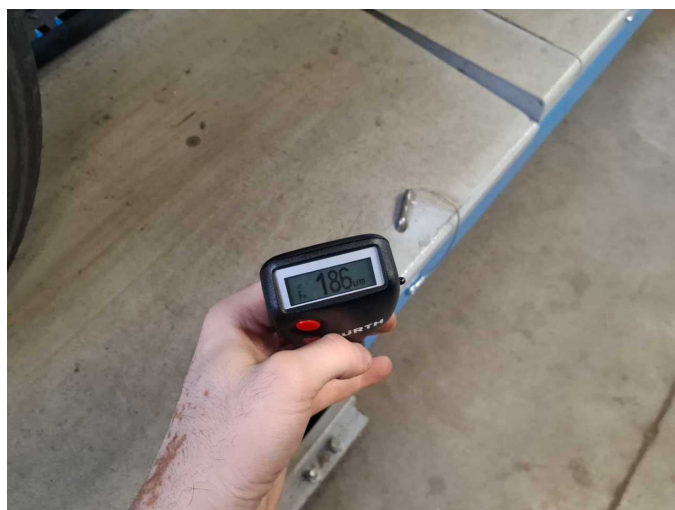
**Repainting 2:** Side panel - rear right side

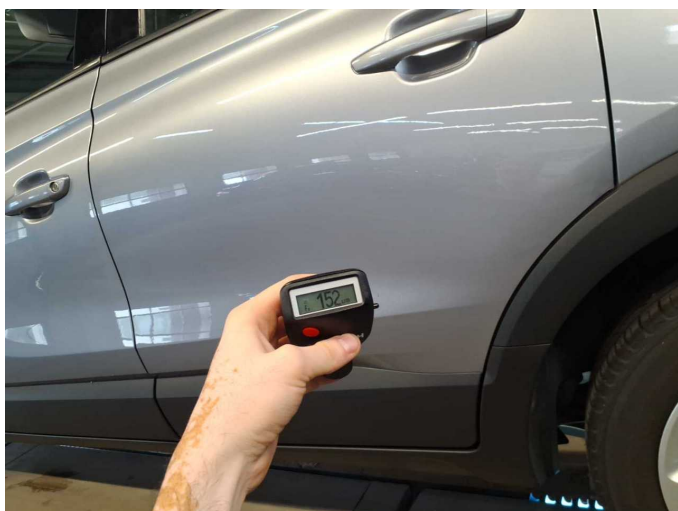
| No. | Repainting |
|---|---|
| 3 | Door - rear left side |

**Repainting 3:** Door - rear left side

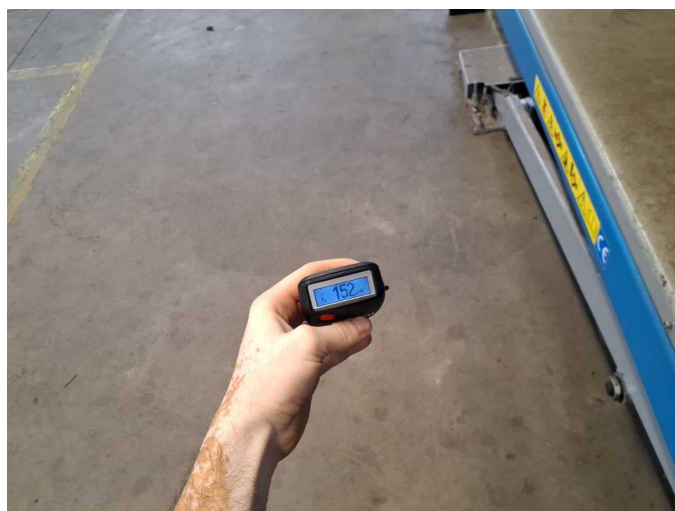
**Repainting 3:** Door - rear left side

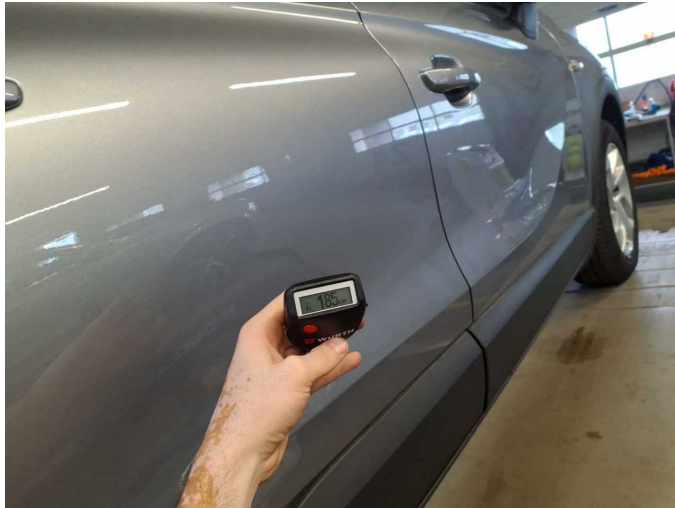
| No. | Repainting |
|---|---|
| 4 | Door - rear right side |

**Repainting 4:** Door - rear right side

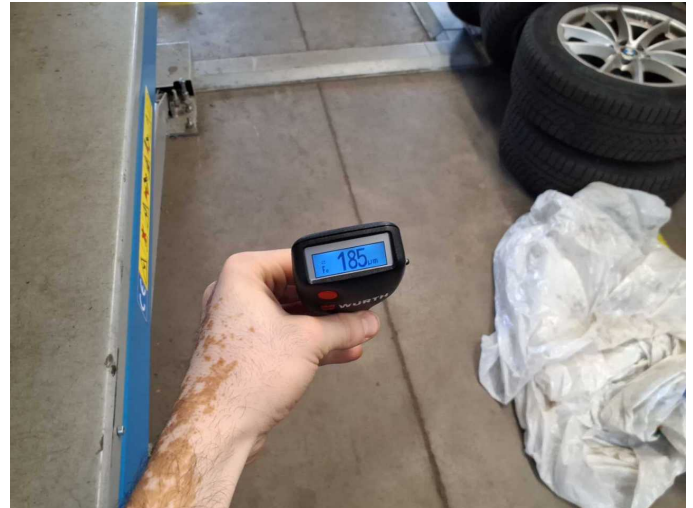
**Repainting 4:** Door - rear right side

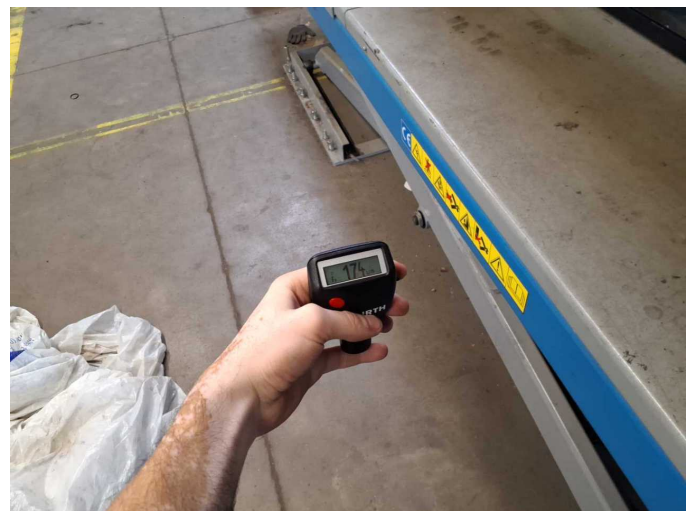
| No. | Repainting |
|---|---|
| 5 | Door - front right side |

**Repainting 5:** Door - front right side
