Protocol number: 46015388
Order No. / Reference: 26450208
Inspection date: 16 Jun 2026

Manufacturer: Ford

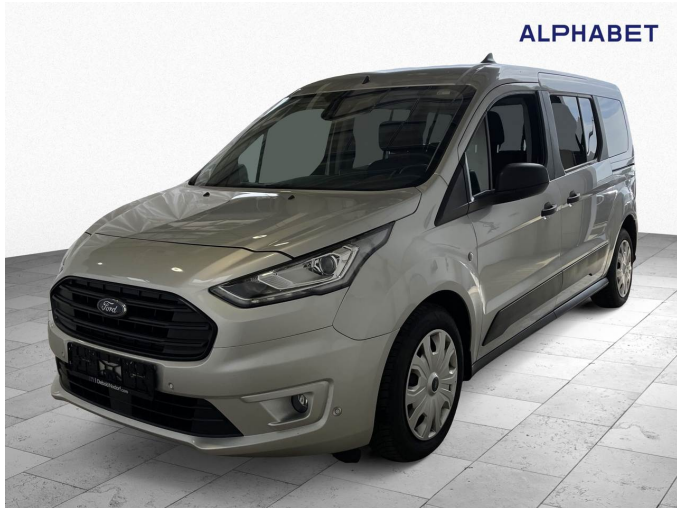
Figure 1: Diagonal front (left)

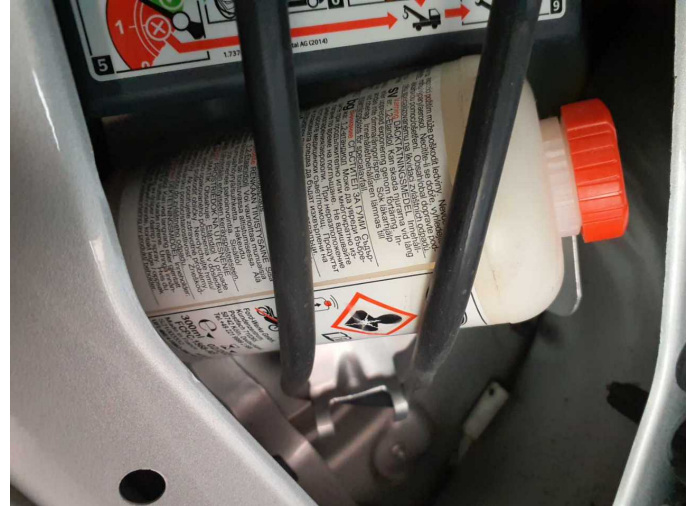
Damage 1: Equipment: Tirefit filler - Expired - Replace

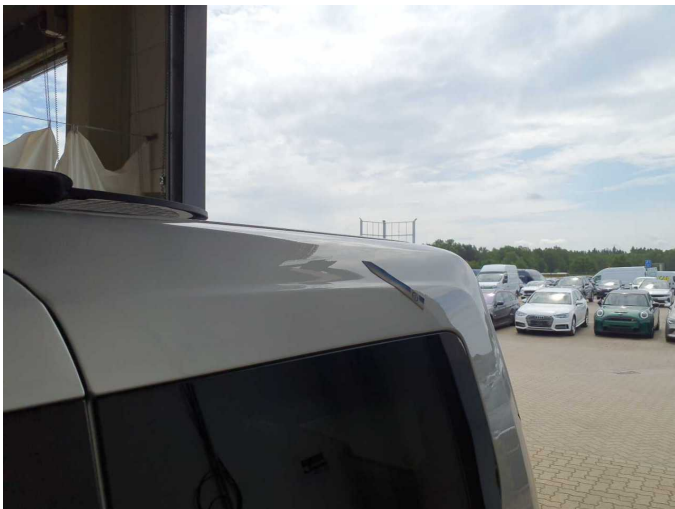
Damage 2: Roof: Roof rail - left side - dent(s) - Smooth repair work

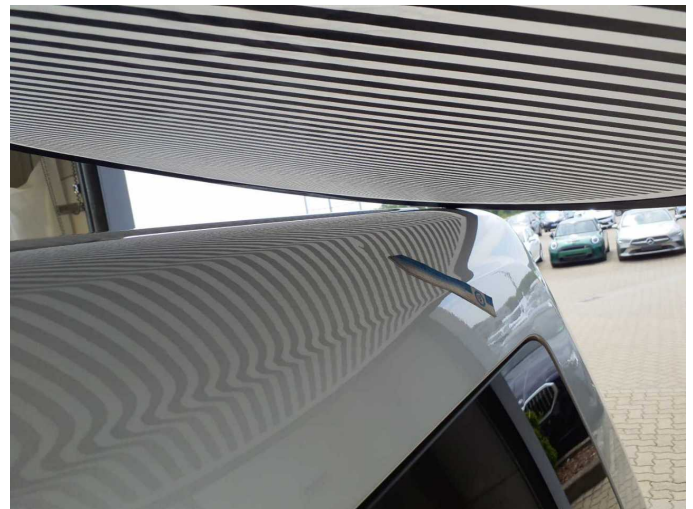
Damage 2: Roof: Roof rail - left side - dent(s) - Smooth repair work

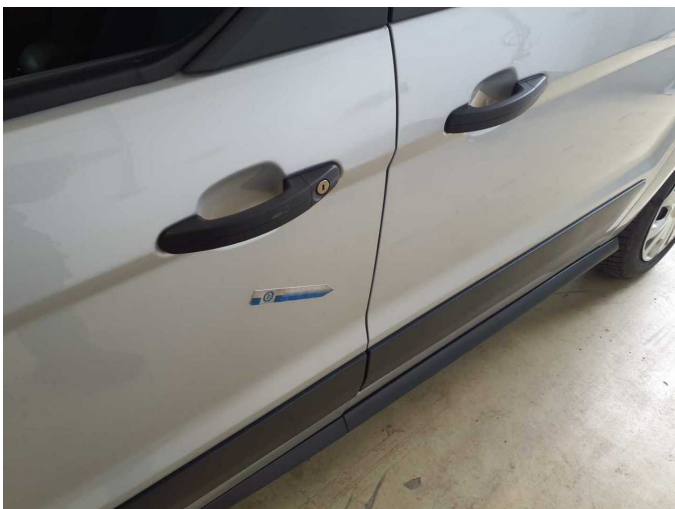
Damage 3: Door - front left side: Door - dent(s) - Smooth repair work

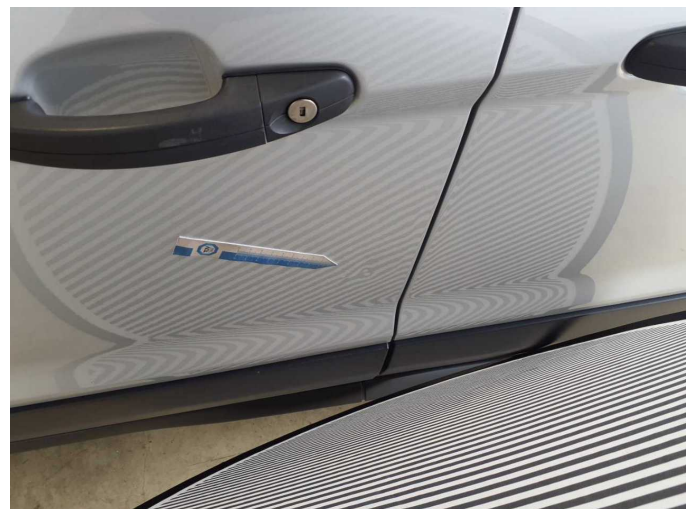
Damage 3: Door - front left side: Door - dent(s) - Smooth repair work

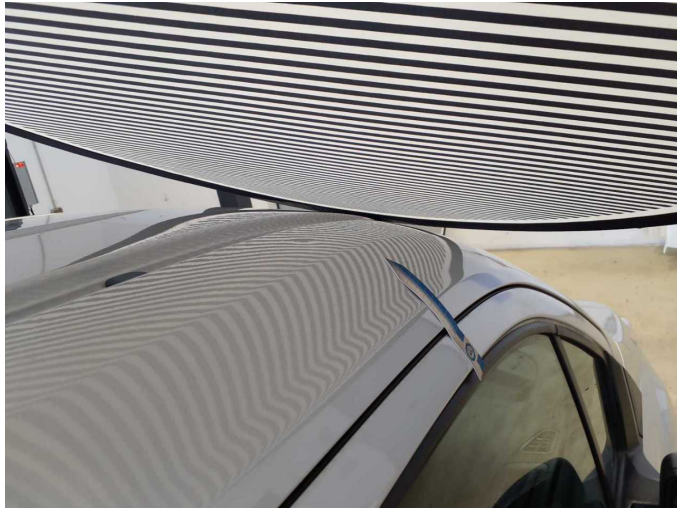
Damage 4: Roof: Roof rail - right side - dent(s) - Smooth repair work

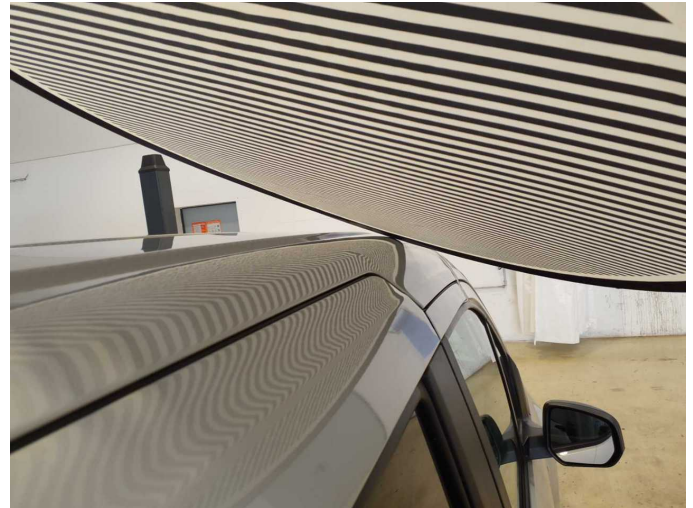
Damage 4: Roof: Roof rail - right side - dent(s) - Smooth repair work

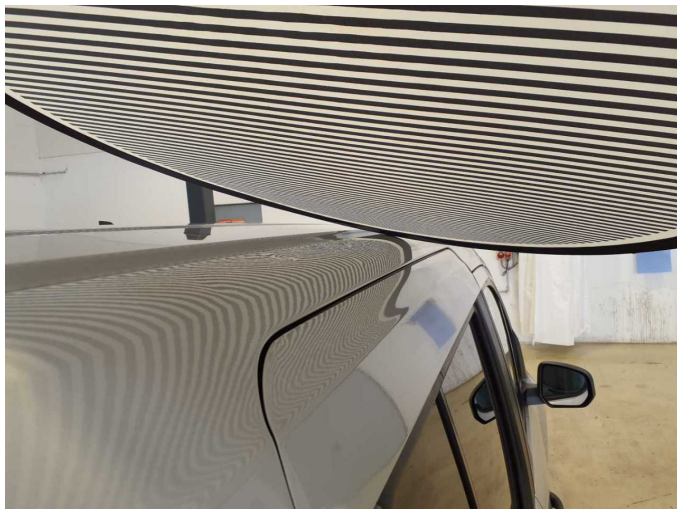
Damage 4: Roof: Roof rail - right side - dent(s) - Smooth repair work

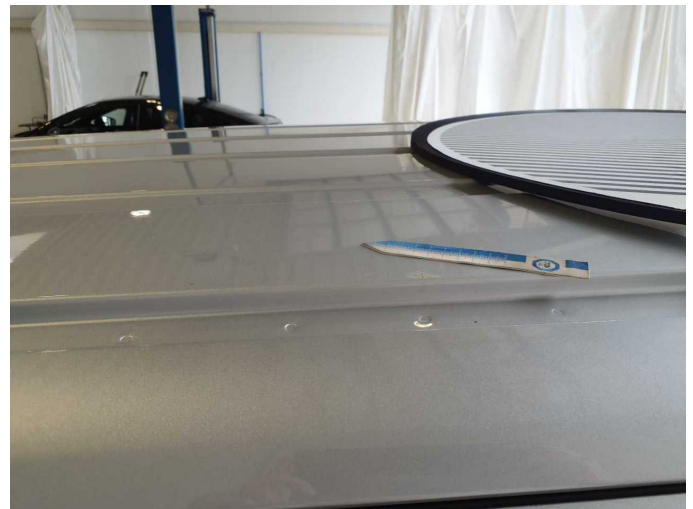
Damage 5: Roof: Roof - dent(s) - Smooth repair work

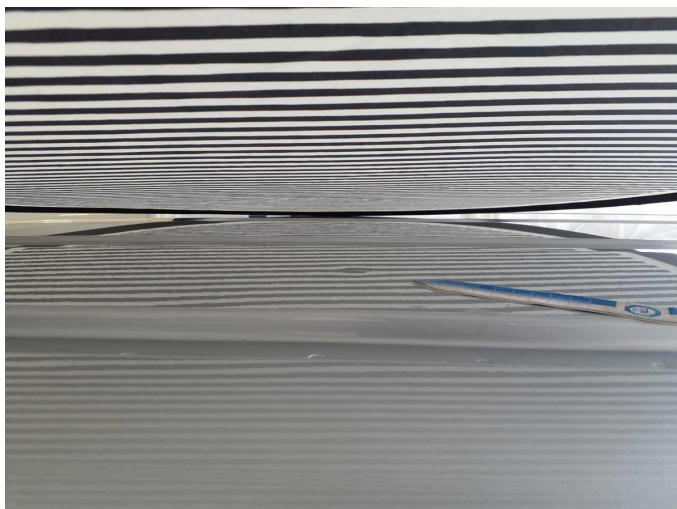
Damage 5: Roof: Roof - dent(s) - Smooth repair work

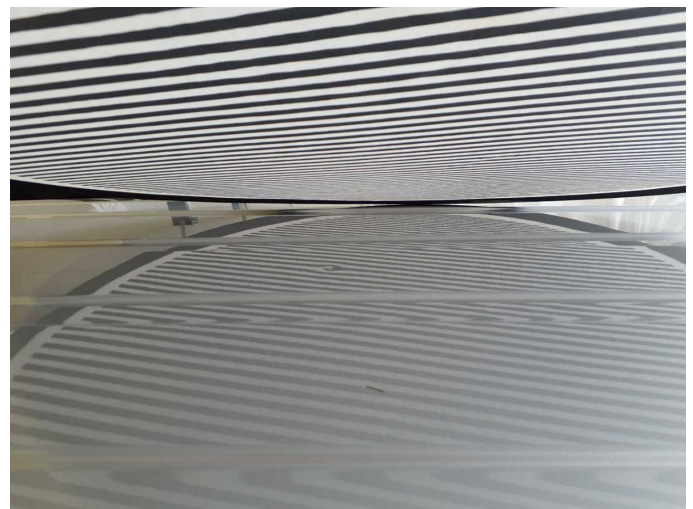
Damage 5: Roof: Roof - dent(s) - Smooth repair work

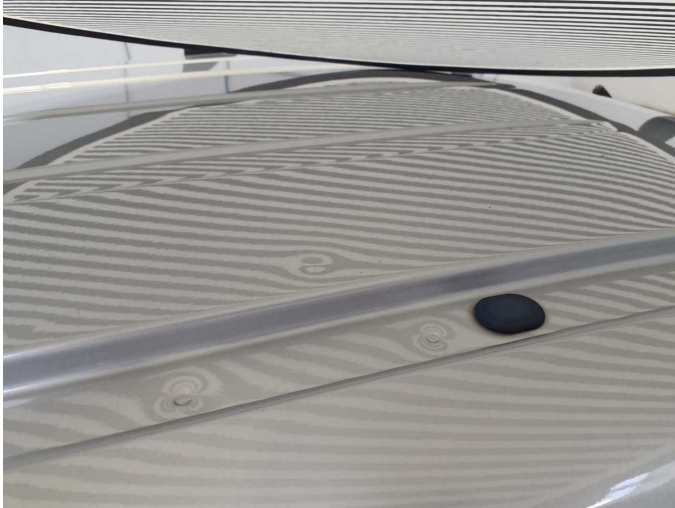
Damage 5: Roof: Roof - dent(s) - Smooth repair work

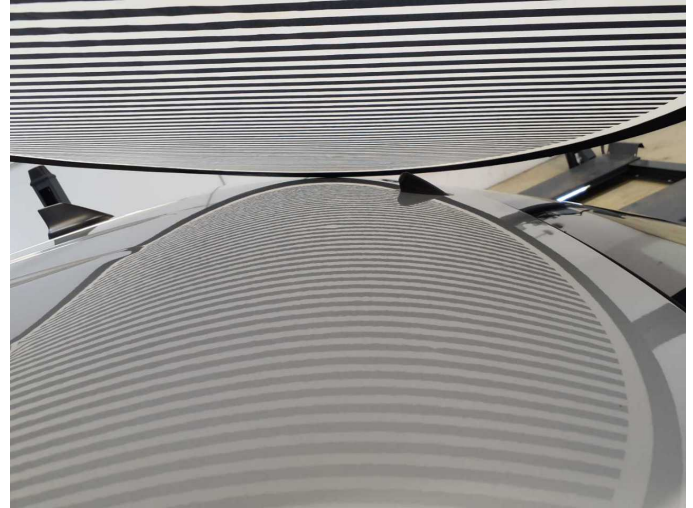
Damage 5: Roof: Roof - dent(s) - Smooth repair work

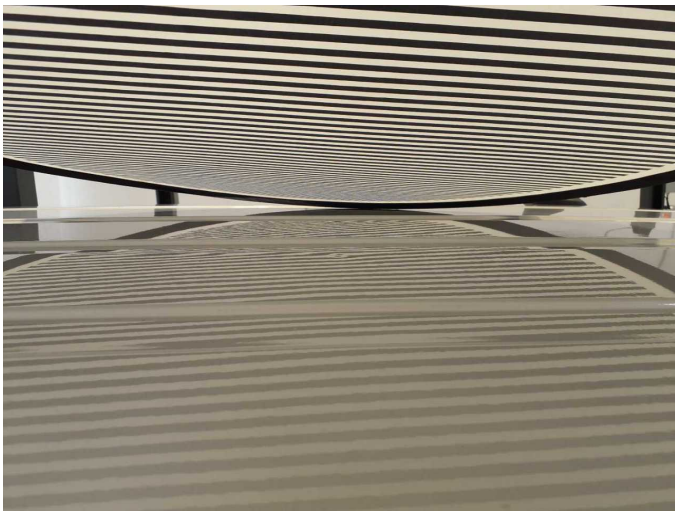
Damage 5: Roof: Roof - dent(s) - Smooth repair work

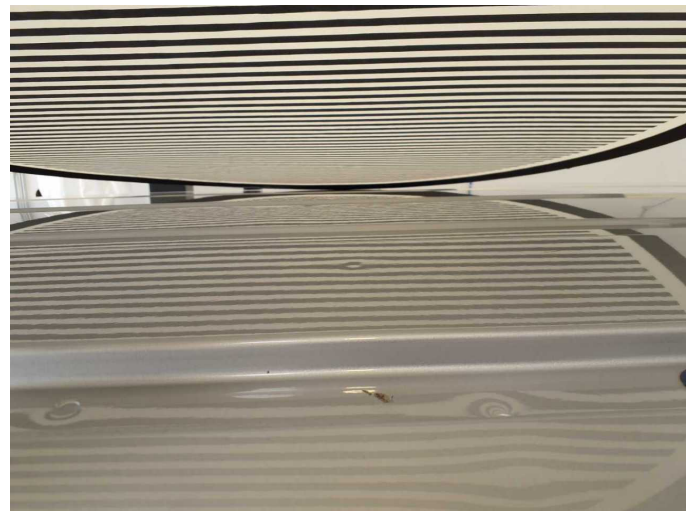
Damage 5: Roof: Roof - dent(s) - Smooth repair work

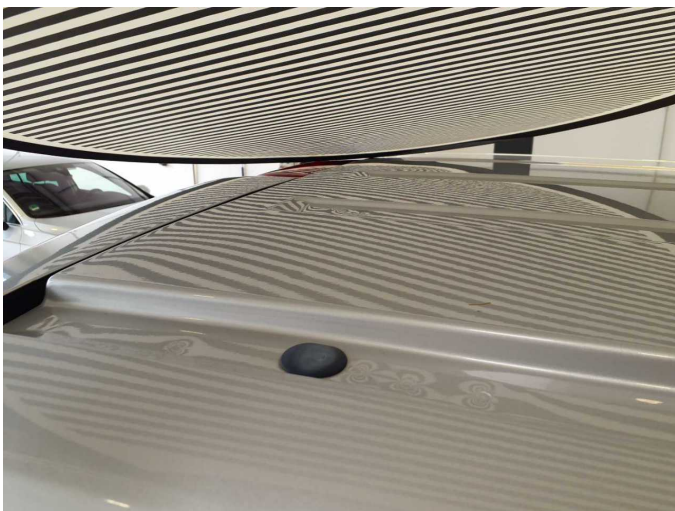
Damage 5: Roof: Roof - dent(s) - Smooth repair work

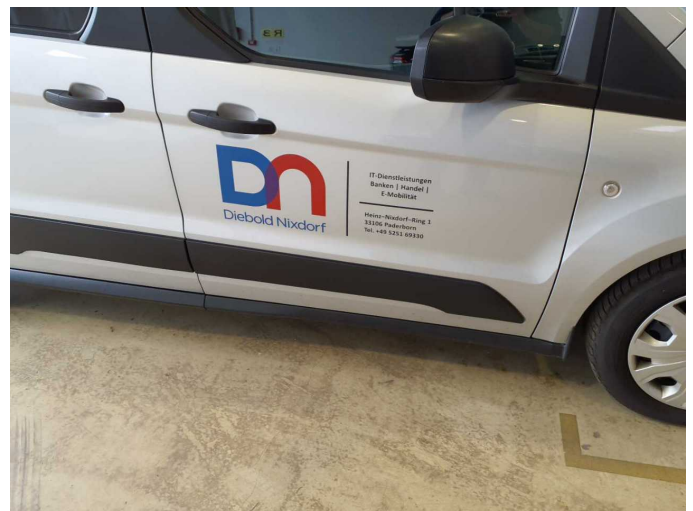
Damage 6: Body: Body - Glued / labelled - De-glude / neutralise

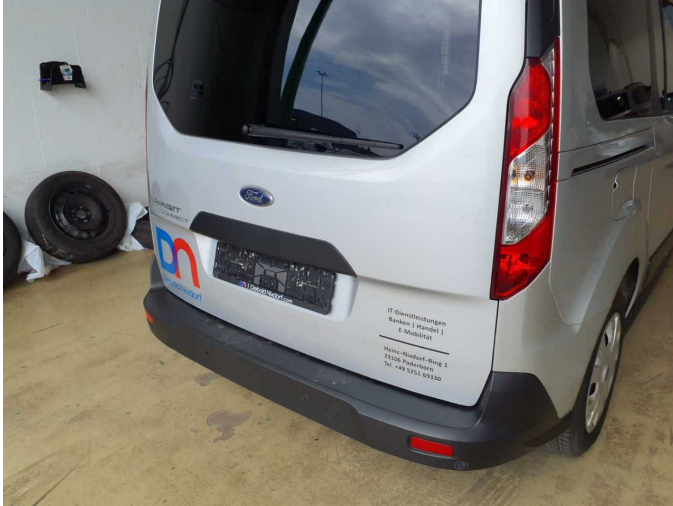
Damage 6: Body: Body - Glued / labelled - De-glue / neutralise

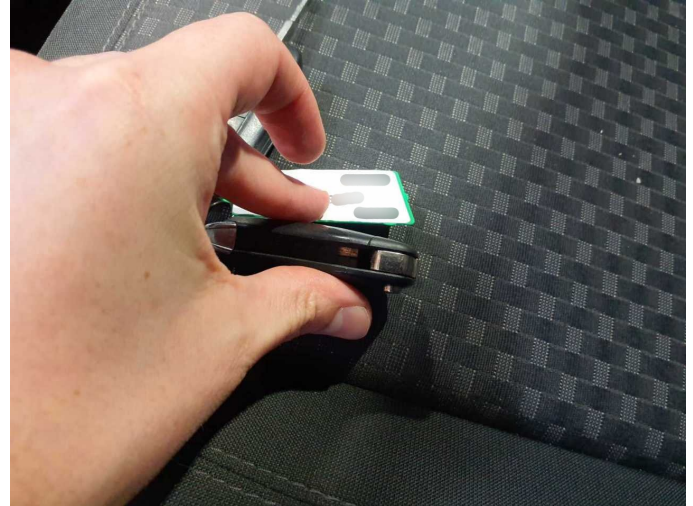
Damage 7: Equipment: Vehicle key - Broken / torn - Replace

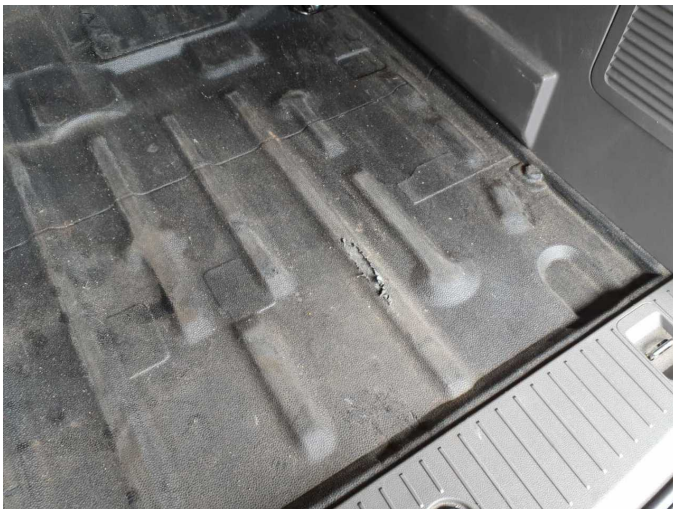
Damage 8: Interior: Cargo area floor - Broken / torn - Replace

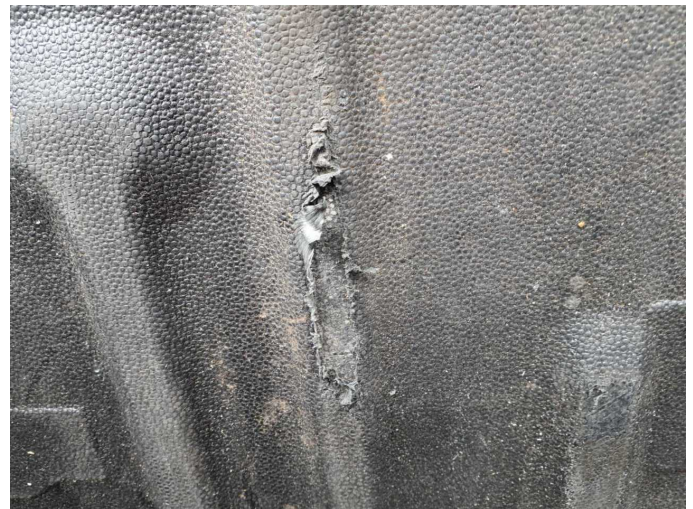
Damage 8: Interior: Cargo area floor - Broken / torn - Replace

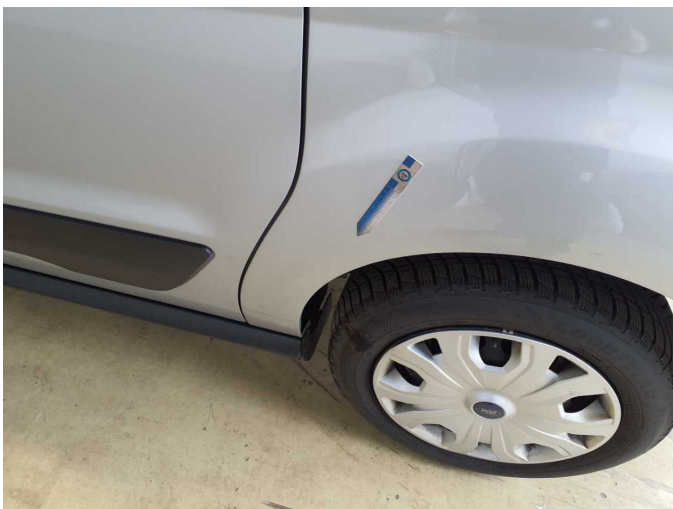
Damage 9: Side panel - rear left side: Side panel (Spachtel eingefallen) - Unprofessionally repaired - Paint

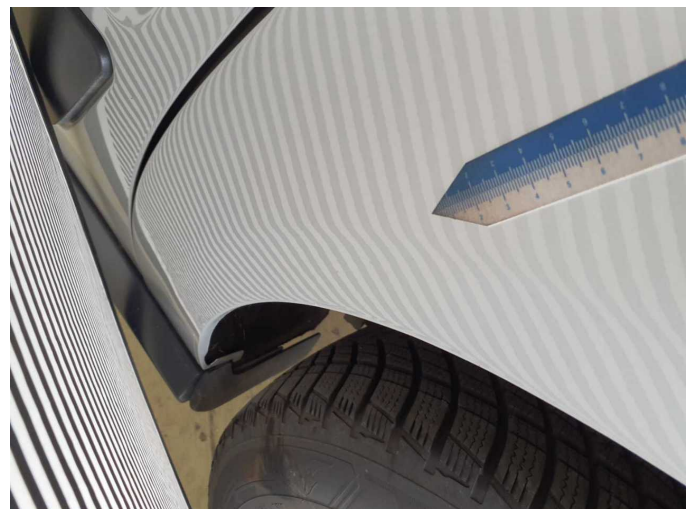
Damage 9: Side panel - rear left side: Side panel (Spachtel eingefallen) - Unprofessionally repaired - Paint

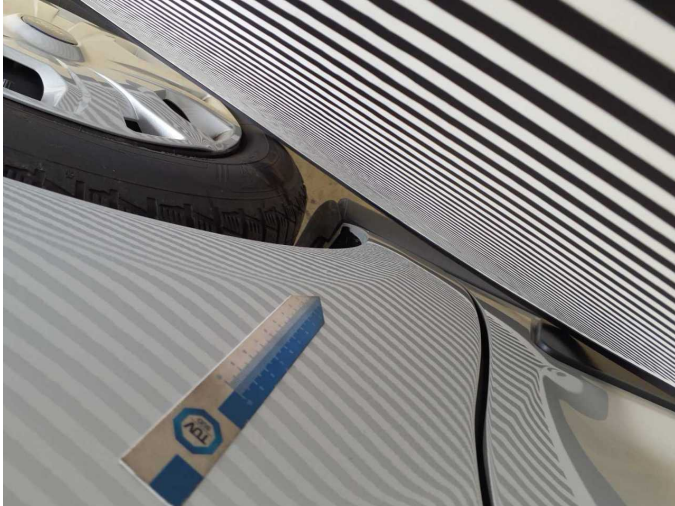
Damage 9: Side panel - rear left side: Side panel (Spachtel eingefallen) - Unprofessionally repaired - Paint

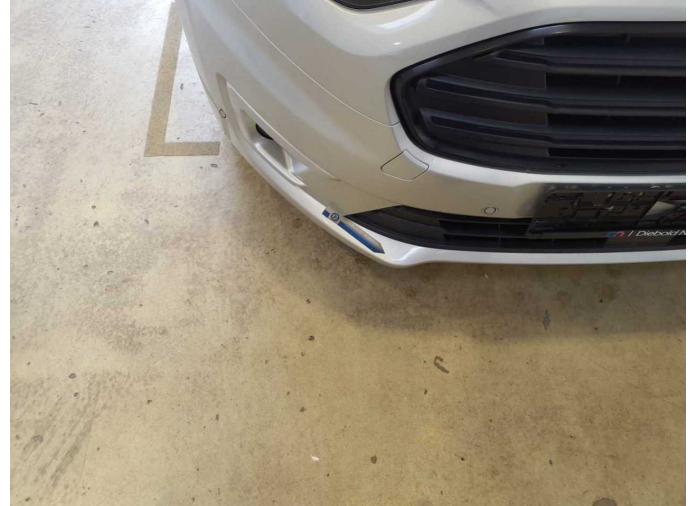
Damage 10: Front bumper: Front bumper - Dent / paintcoat damage - Paint

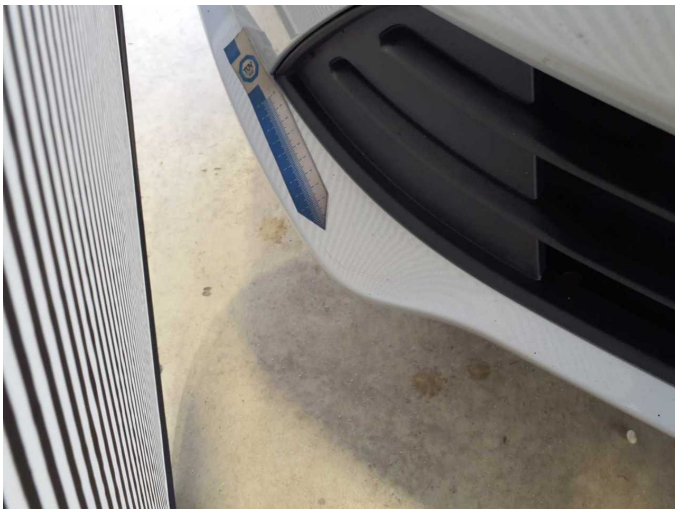
Damage 10: Front bumper: Front bumper - Dent / paintcoat damage - Paint

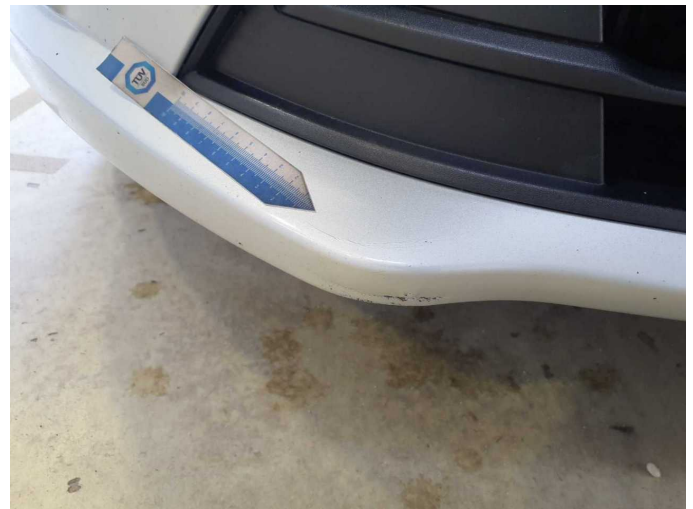
Damage 10: Front bumper: Front bumper - Dent / paintcoat damage - Paint

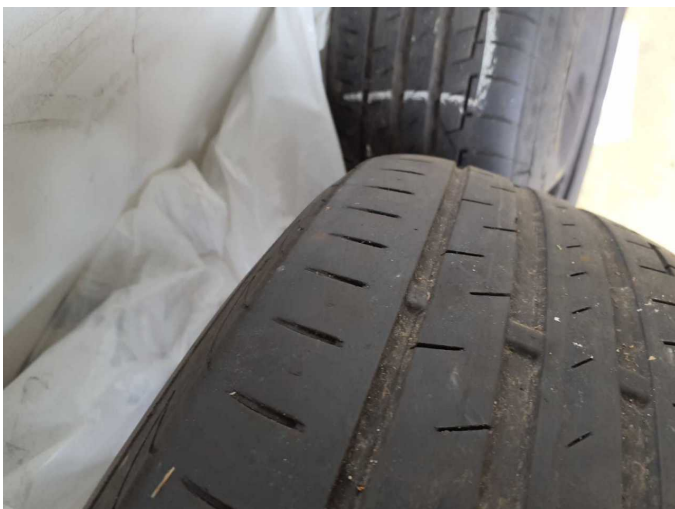
Wear and tear 4: 2nd wheel set: Tyres - complete set (Kein Teil der Ausstattung) - Worn - No deduction

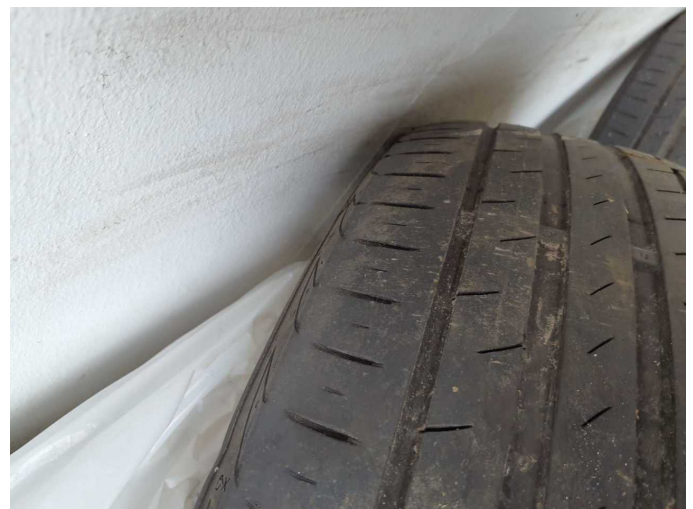
Wear and tear 4: 2nd wheel set: Tyres - complete set (Kein Teil der Ausstattung) - Worn - No deduction

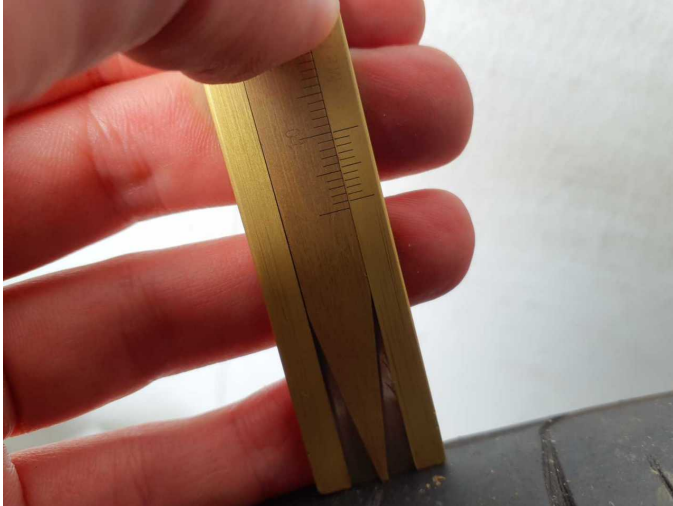
Wear and tear 4: 2nd wheel set: Tyres - complete set (Kein Teil der Ausstattung) - Worn - No deduction

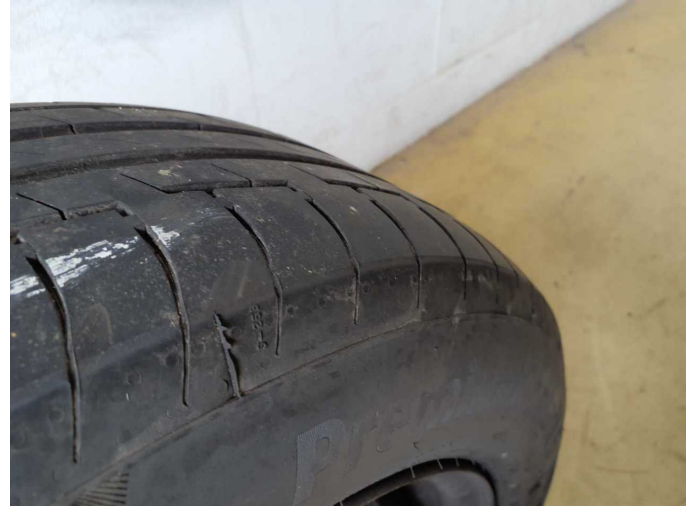
Wear and tear 4: 2nd wheel set: Tyres - complete set (Kein Teil der Ausstattung) - Worn - No deduction

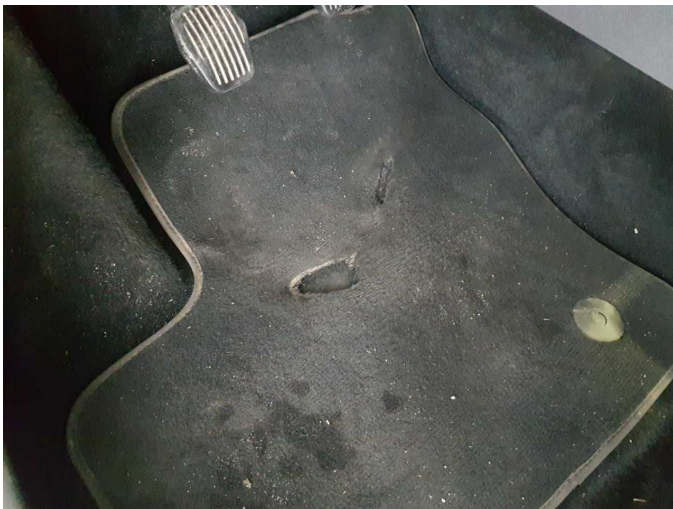
Wear and tear 5: Trim / covers: Floor mats - Broken / torn - No deduction

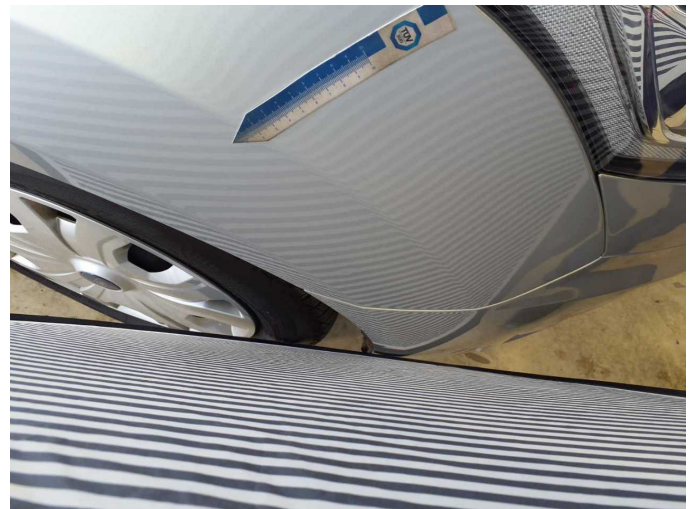
Wear and tear 6: Mudguard - right side: Mudguard - right side - Dent / paintcoat damage - Paint

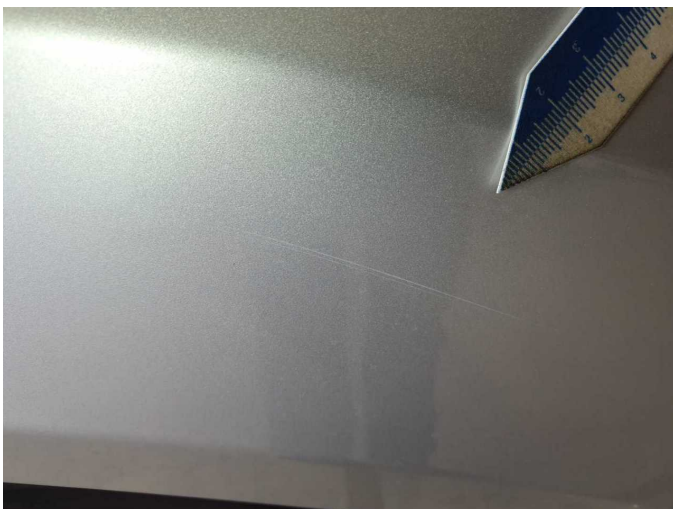
Wear and tear 6: Mudguard - right side: Mudguard - right side - Dent / paintcoat damage - Paint

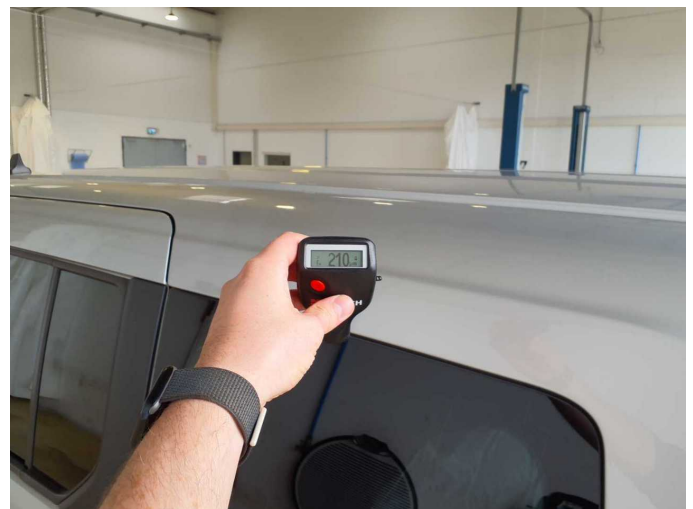
Repainting 1: Roof rail - left side
