Expertise

Protocol number: 46380169  
Order No. / Reference: 26512104  
Inspection date: 7 Jul 2026

Manufacturer: Seat

Model: Ateca 2.0 TDI DSG Style

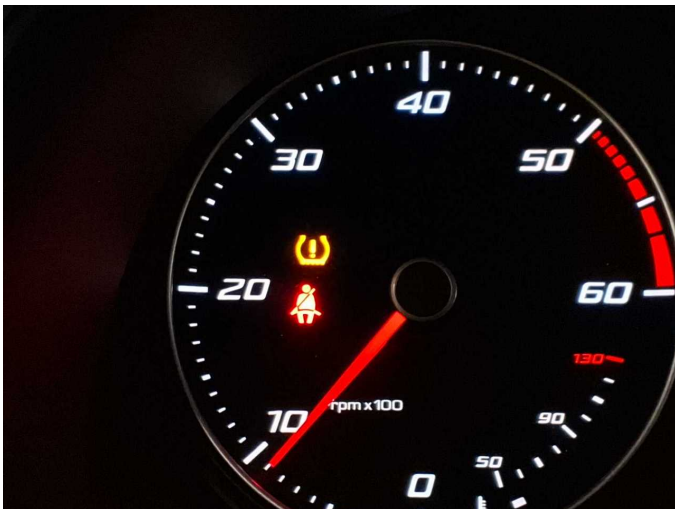
| No. | Component group | Description |
|---|---|---|
| 1 | Wheel / tyres | Pressure sensor - Functional / admissibility - Perform diagnosis |

**Damage 1:** Wheel / tyres: Pressure sensor - Functional / admissibility - Perform diagnosis

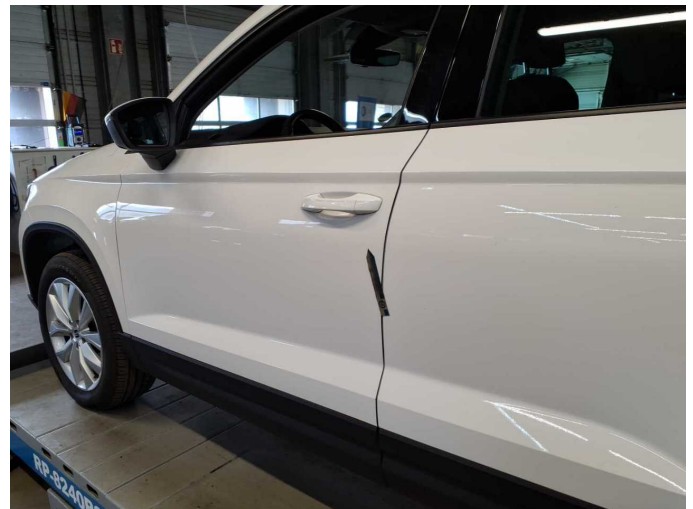
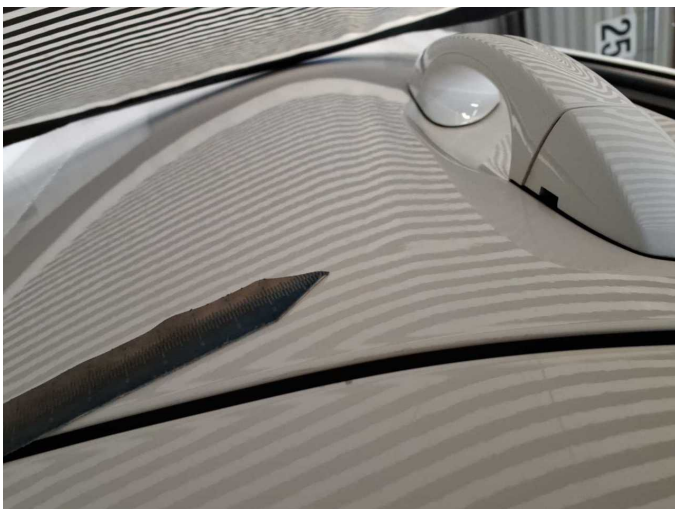
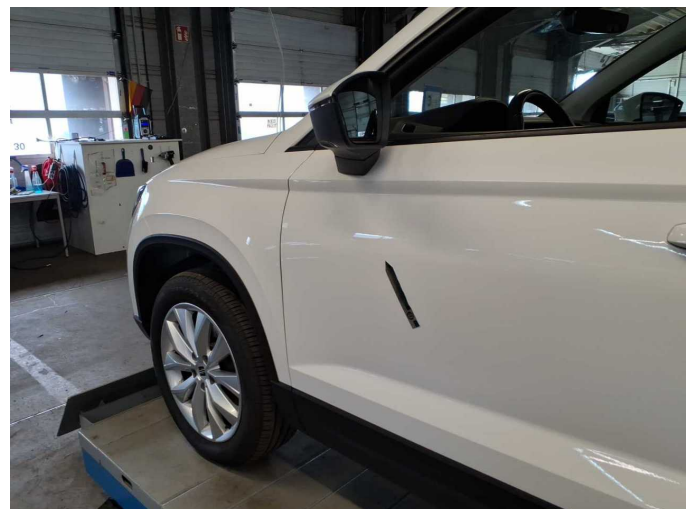
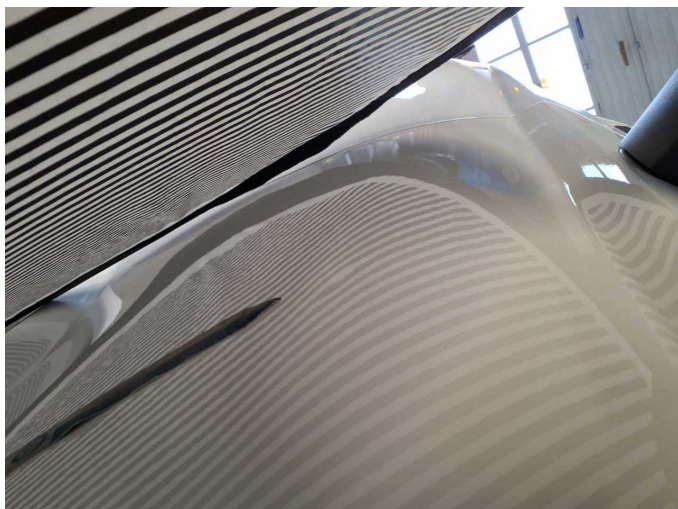
| No. | Component group | Description |
|---|---|---|
| 2 | Door - front left side | Door - dent(s) - Smooth repair work |

**Damage 2:** Door - front left side: Door - dent(s) - Smooth repair work

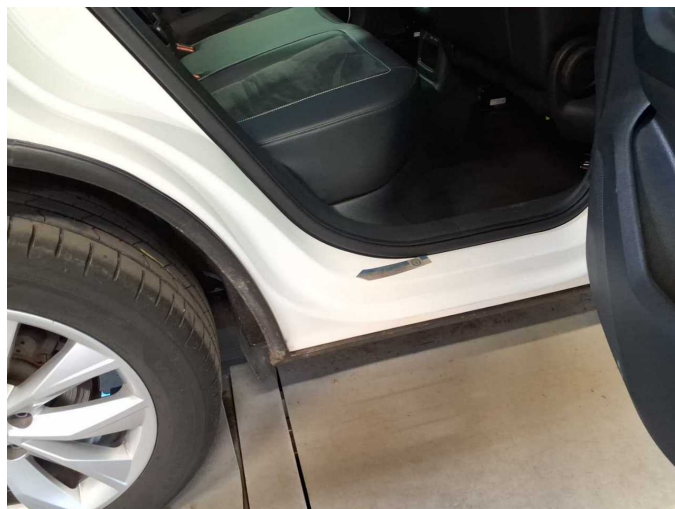
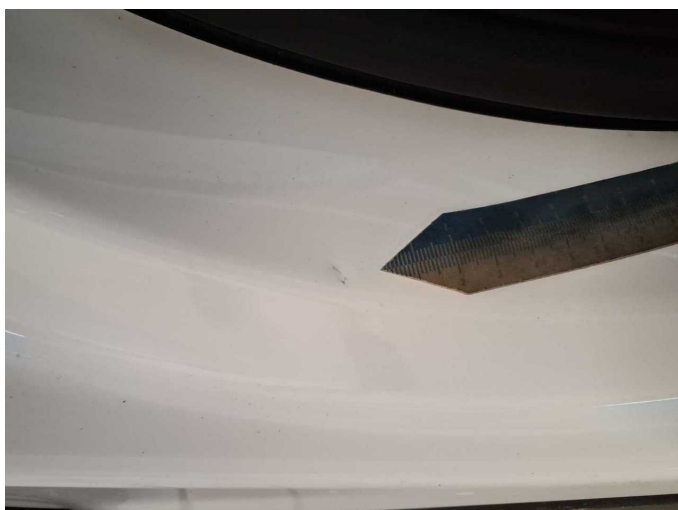
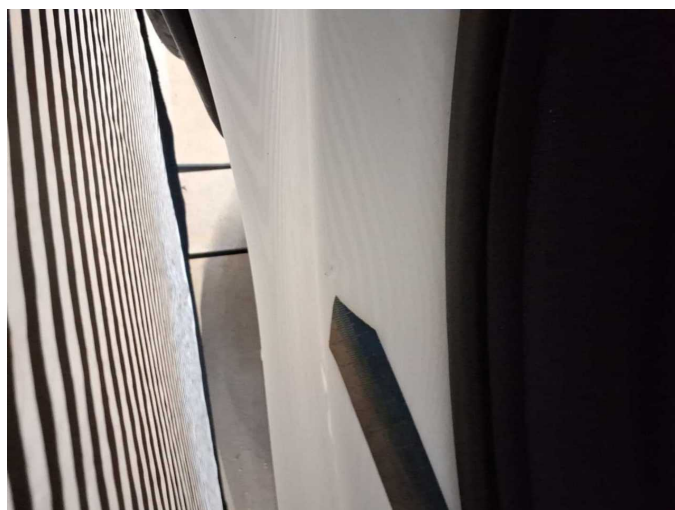
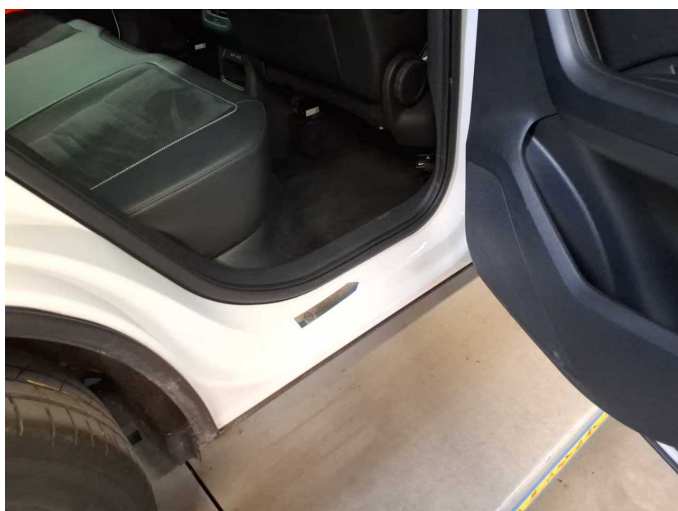
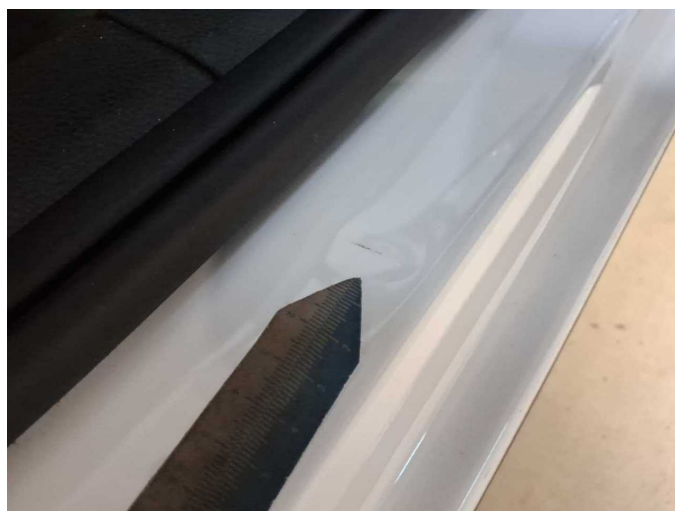
| No. | Component group | Description |
|---|---|---|
| 3 | Side panel - rear right side | Sill - Dent / paintcoat damage - Smart repair |

**Damage 3:** Side panel - rear right side: Sill - Dent / paintcoat damage - Smart repair

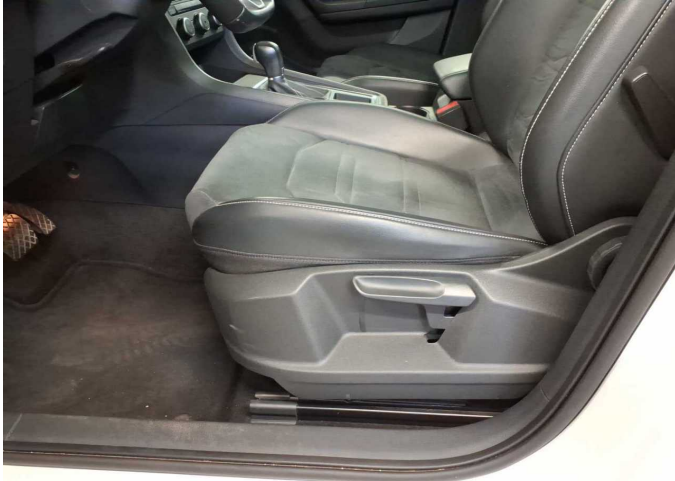
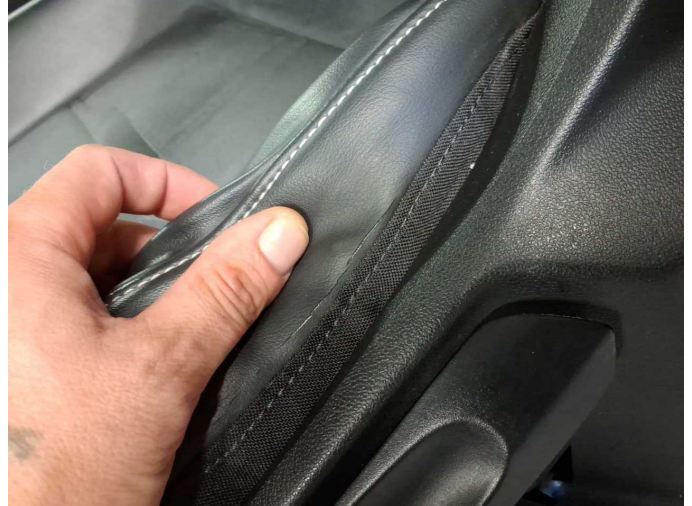
| No. | Component group | Description |
|---|---|---|
| 4 | Seat - front | Seat cover - left side (Wange) - Broken / torn - Replace |

**Damage 4:** Seat - front: Seat cover - left side (Wange) - Broken / torn - Replace

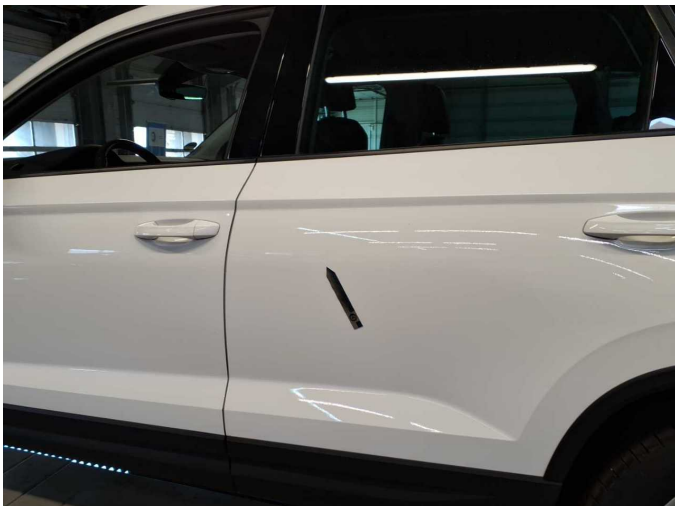
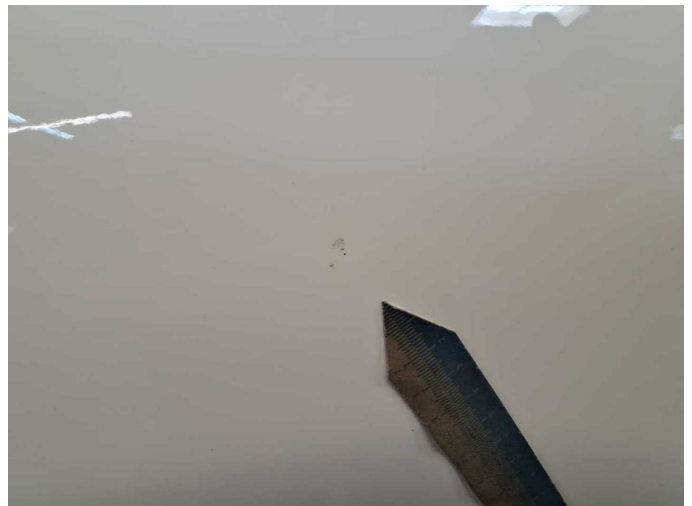
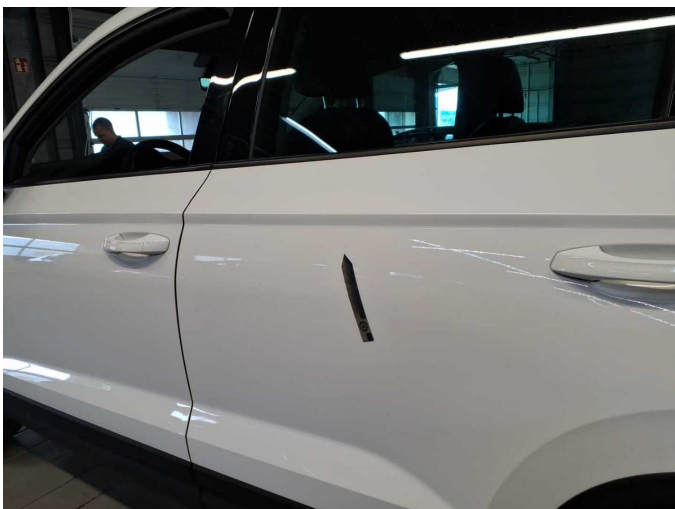
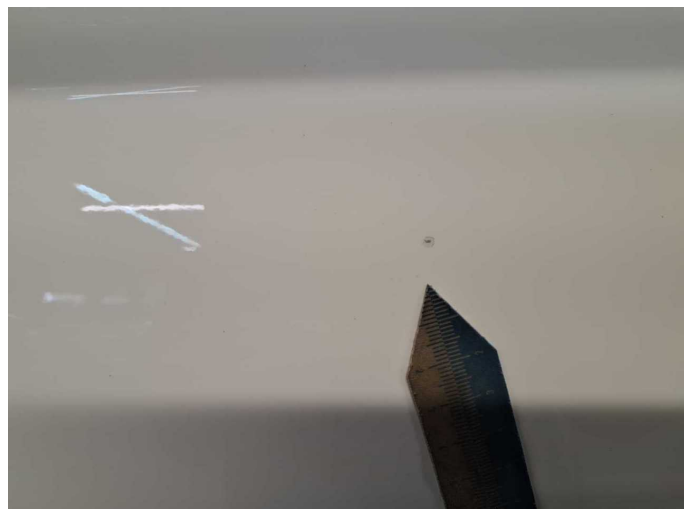
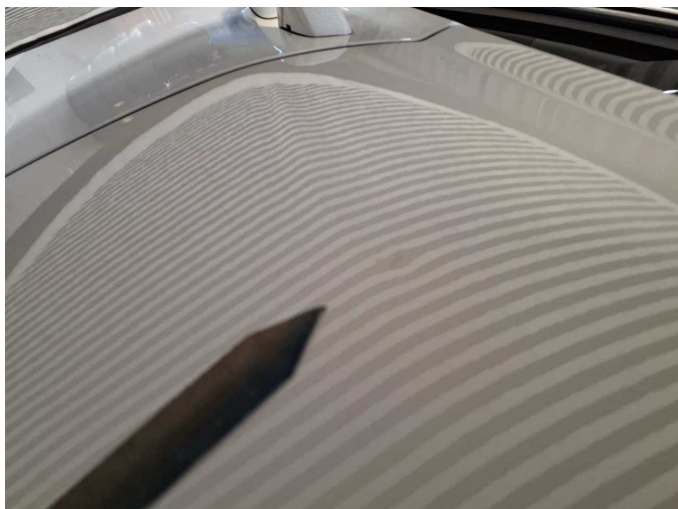
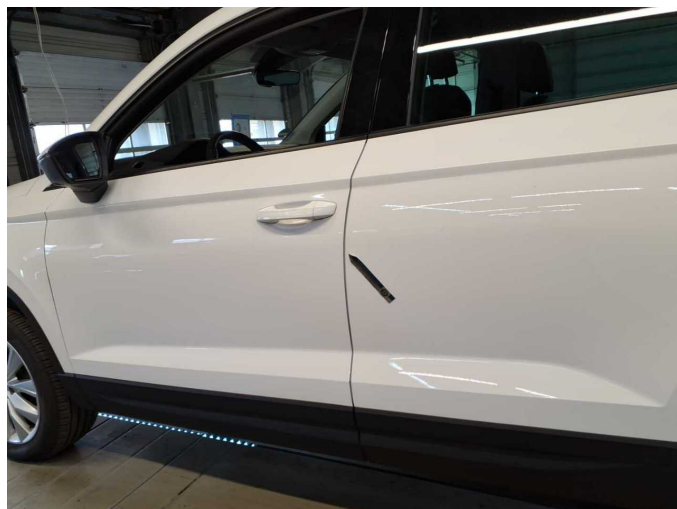
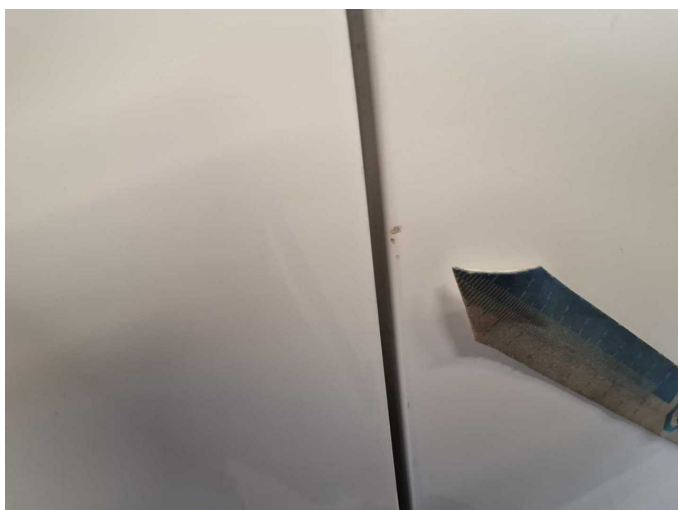
| No. | Component group | Description |
|---|---|---|
| 5 | Door - rear left side | Door - Dent / paintcoat damage - Repair and paint |

**Damage 5:** Door - rear left side: Door - Dent / paintcoat damage - Repair and paint

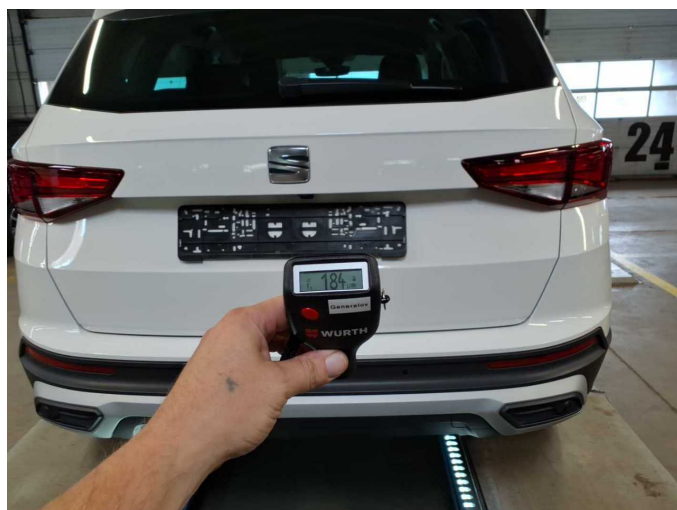
**Repainting 1:** Boot lid / rear door

| No. | Repainting |
|---|---|
| 1 | Boot lid / rear door, Professionally carried out, Invoice of repair done Non-existent |

| Boot lid / rear door | 184 µm |
