Expertise

Protocol number: 46508190  
Order No. / Reference: 26727330  
Inspection date: 13 Jul 2026

Model: Ibiza 1.0 MPI S&S Reference

VIN: VSSZZKJZNR047587

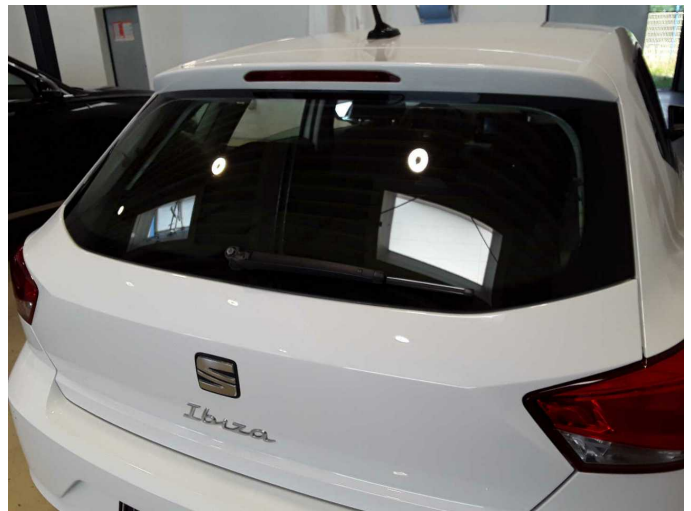
| No. | Component group | Description |
|---|---|---|
| 1 | Screen cleaning | Wiper arm - rear (Kappe fehlt) - Differs from the original configuration - Replace |

**Damage 1:** Screen cleaning: Wiper arm - rear (Kappe fehlt) - Differs from the original configuration - Replace

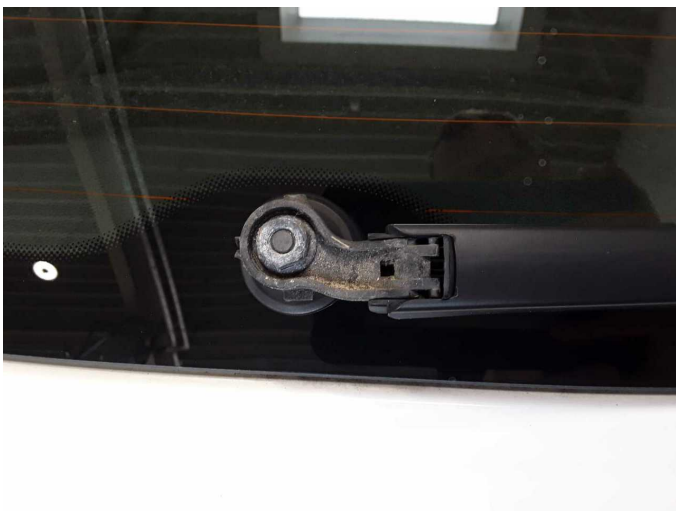
**Damage 1:** Screen cleaning: Wiper arm - rear (Kappe fehlt) - Differs from the original configuration - Replace

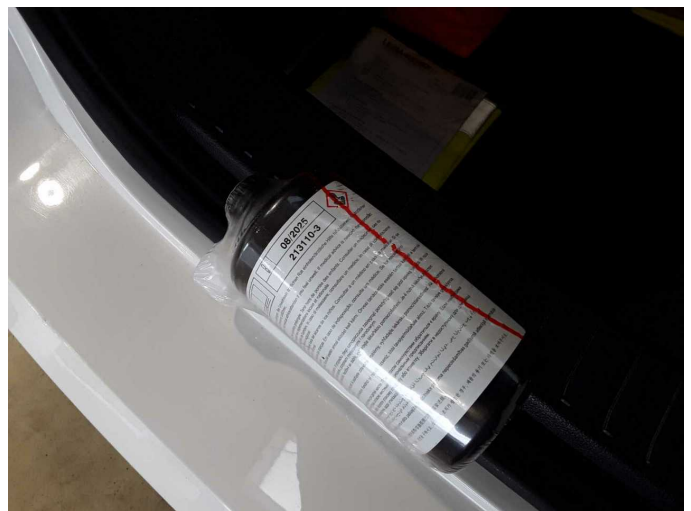
| No. | Component group | Description |
|---|---|---|
| 2 | Equipment | Tirefit filler - Expired - Replace |

**Damage 2:** Equipment: Tirefit filler - Expired - Replace

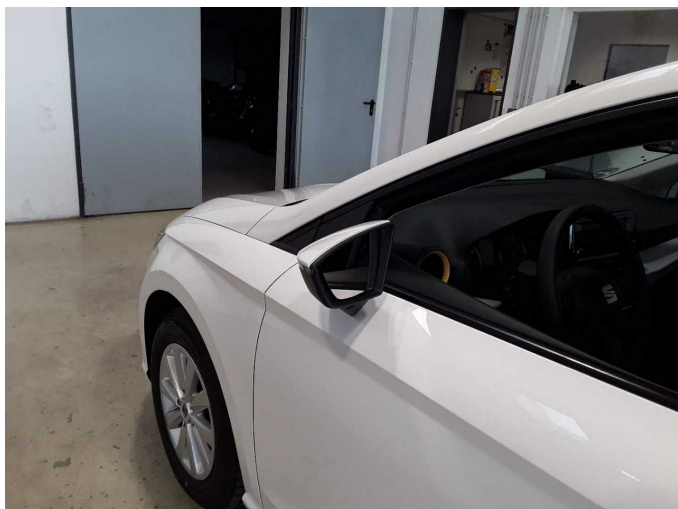
| No. | Component group | Description |
|---|---|---|
| 3 | Wing mirror - left side | Mirror glass - Scratch(es) - Replace |

**Damage 3:** Wing mirror - left side: Mirror glass - Scratch(es) - Replace

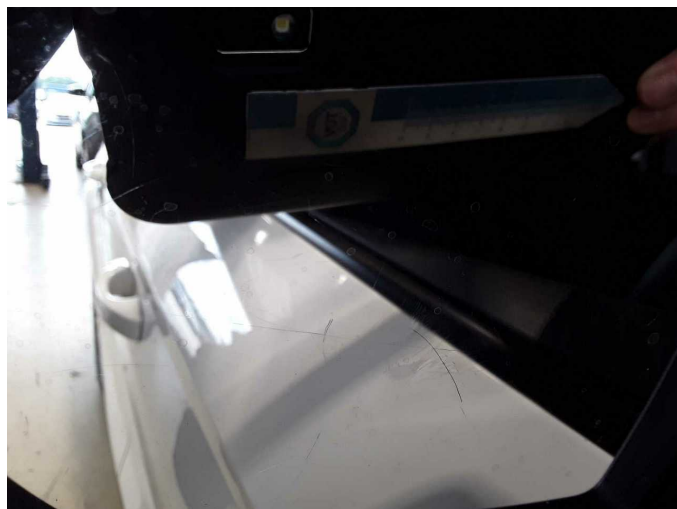
**Damage 3:** Wing mirror - left side: Mirror glass - Scratch(es) - Replace

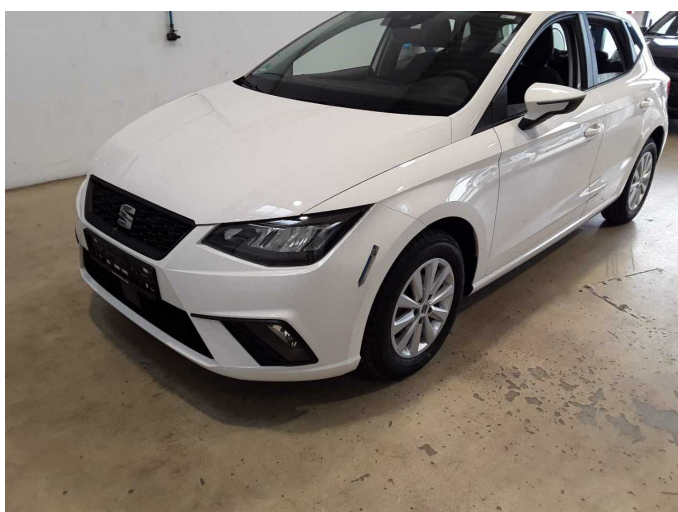
| No. | Component group | Description |
|---|---|---|
| 4 | Front bumper | Front bumper - Scratch(es) - Paint |

**Damage 4:** Front bumper: Front bumper - Scratch(es) - Paint

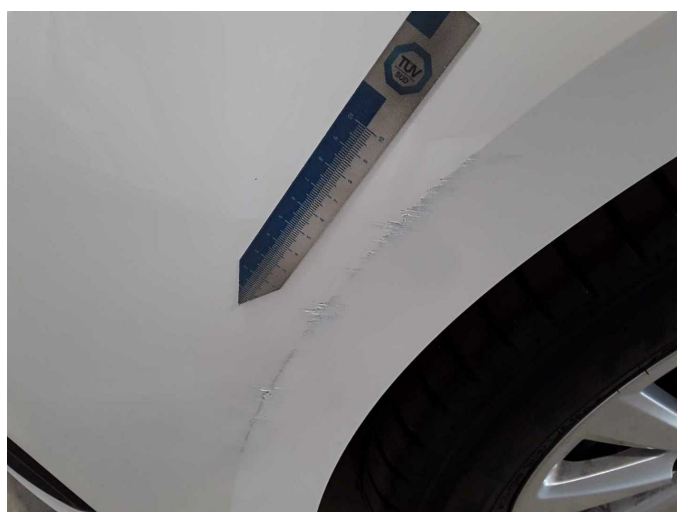
**Damage 4:** Front bumper: Front bumper - Scratch(es) - Paint

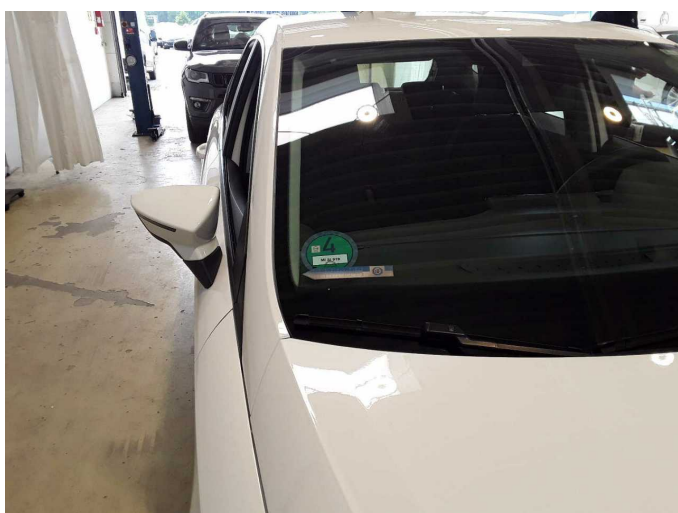
| No. | Component group | Description |
|---|---|---|
| 5 | Vehicle glazing | Windscreen - Broken / torn - Replace |

**Damage 5:** Vehicle glazing: Windscreen - Broken / torn - Replace

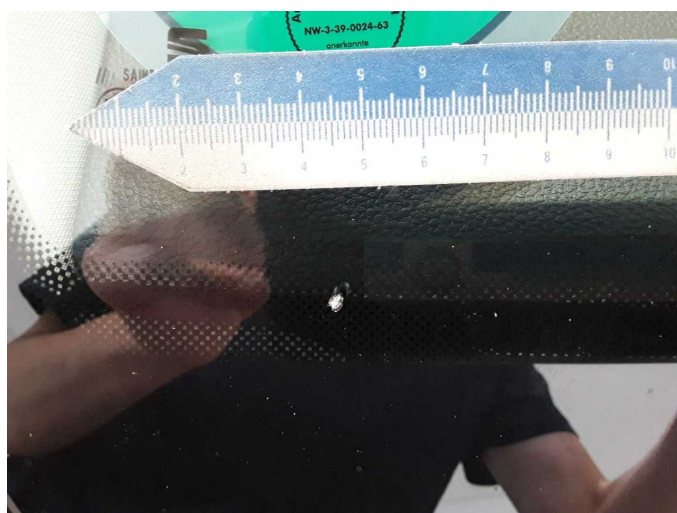
**Damage 5:** Vehicle glazing: Windscreen - Broken / torn - Replace

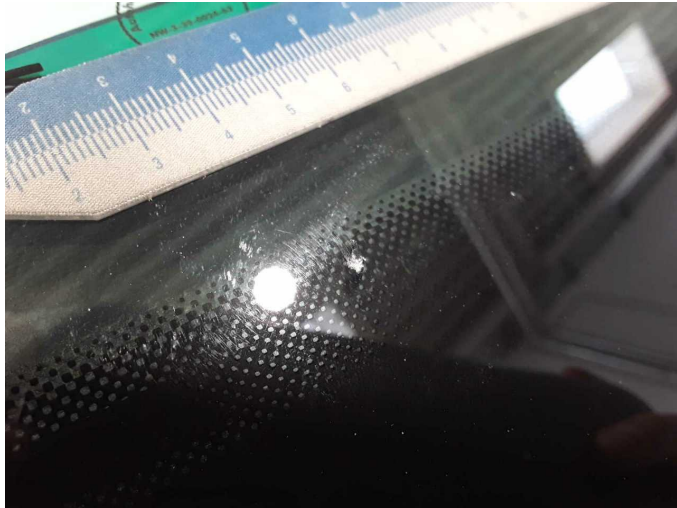
**Damage 5:** Vehicle glazing: Windscreen - Broken / torn - Replace

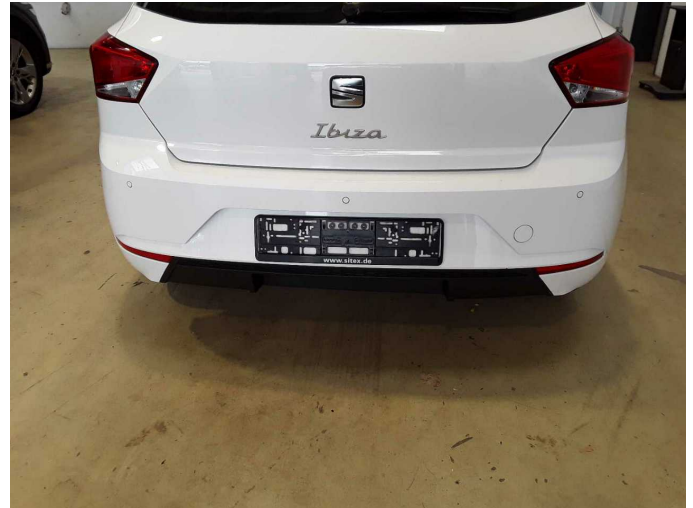
| No. | Component group | Description |
|---|---|---|
| 3 | Rear bumper | Spoiler - Scratch(es) - No deduction |

**Wear and tear 3:** Rear bumper: Spoiler - Scratch(es) - No deduction

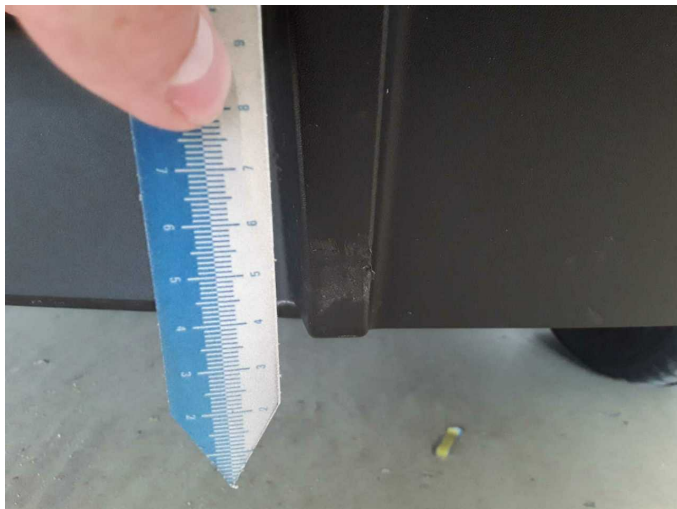
**Wear and tear 3:** Rear bumper: Spoiler - Scratch(es) - No deduction
