Expertise

Protocol number: 46847470  
Order No. / Reference: 26734603  
Inspection date: 3 Aug 2026

Manufacturer: Opel

Model: Astra 1.5 D Start/Stop Sports Tourer Automatik Business Elegance

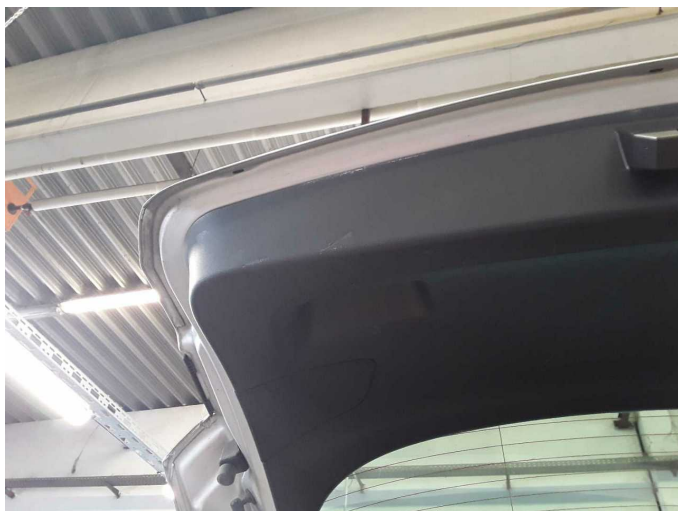
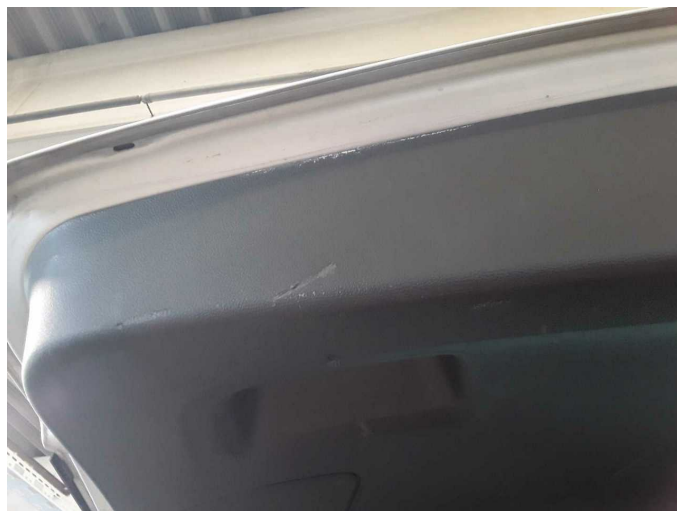
| No. | Component group | Description |
|---|---|---|
| 1 | Trim / covers | Boot lid - interior trim - Scratched - Loss in value |

**Damage 1:** Trim / covers: Boot lid - interior trim - Scratched - Loss in value

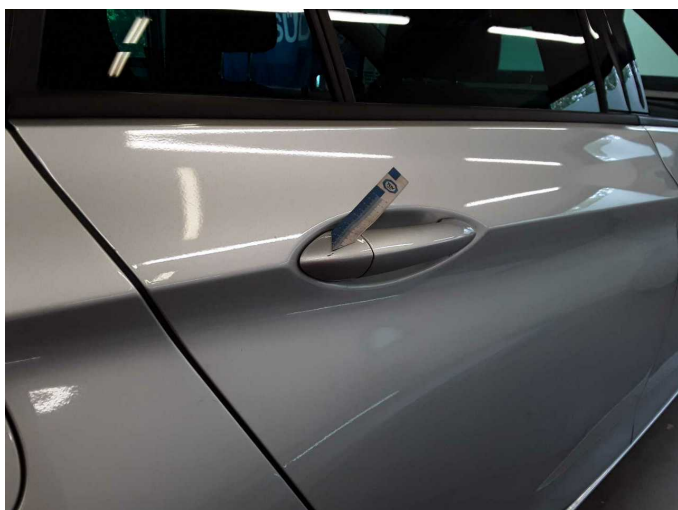
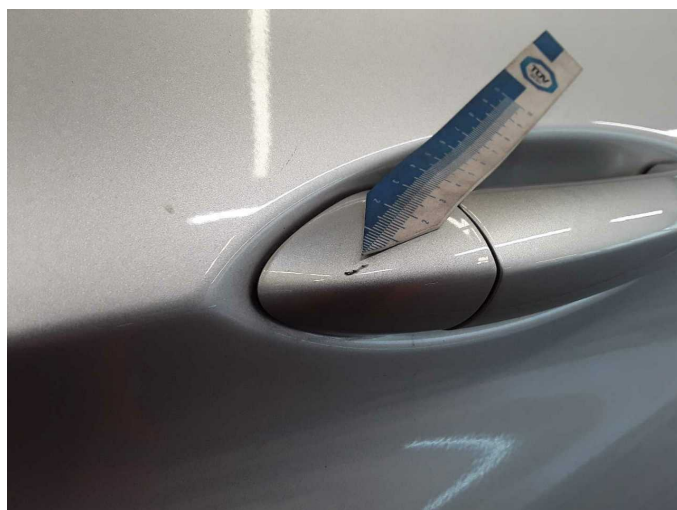
| No. | Component group | Description |
|---|---|---|
| 2 | Door - rear right side | Door handle - outside - Scratched - Smart repair |

**Damage 2:** Door - rear right side: Door handle - outside - Scratched - Smart repair

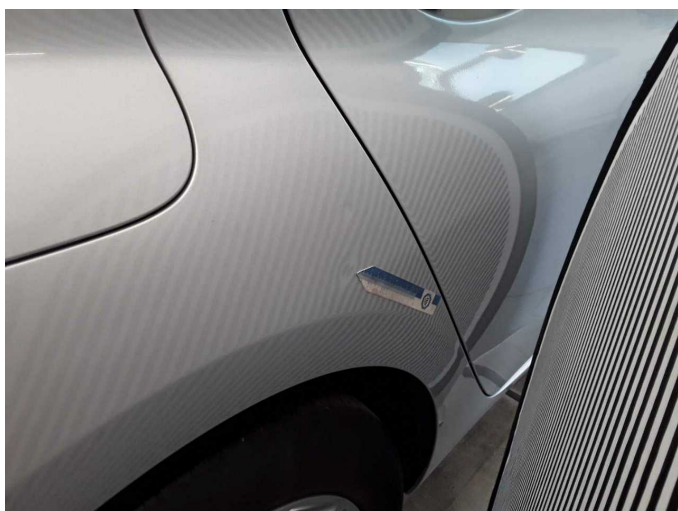
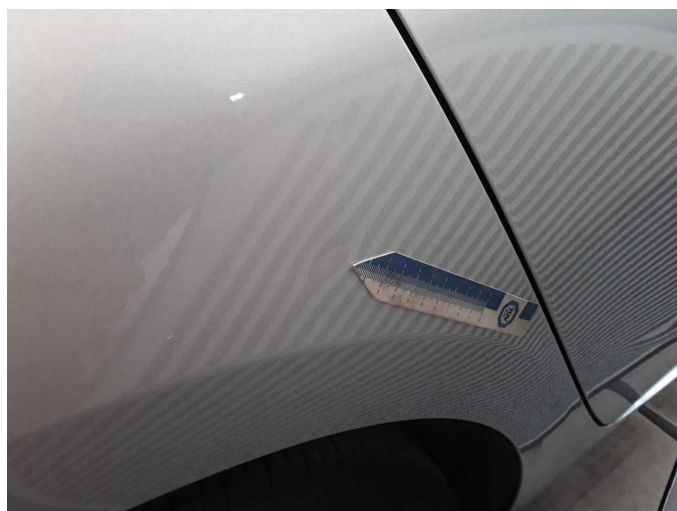
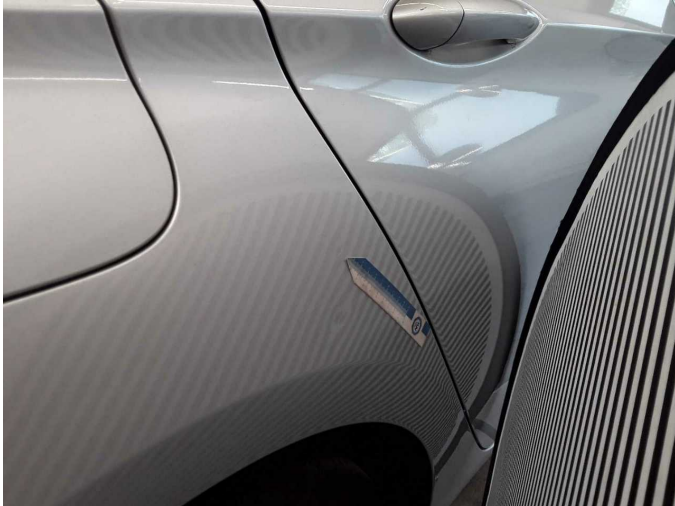
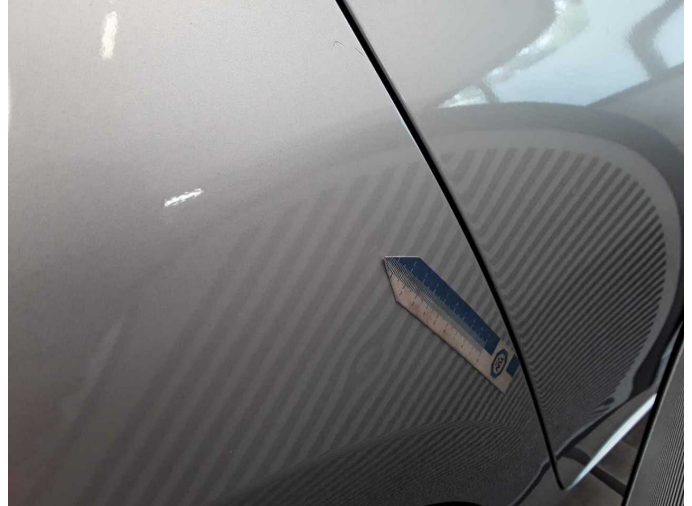
| No. | Component group | Description |
|---|---|---|
| 3 | Side panel - rear right side | Side panel - dent(s) - Smooth repair work |

**Damage 3:** Side panel - rear right side: Side panel - dent(s) - Smooth repair work

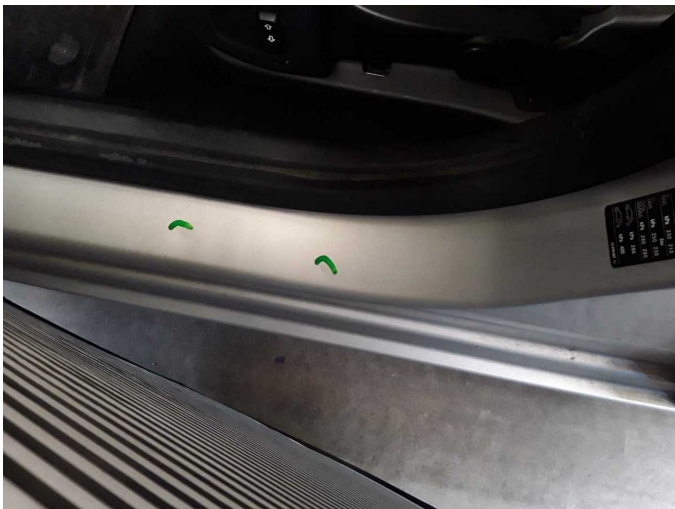
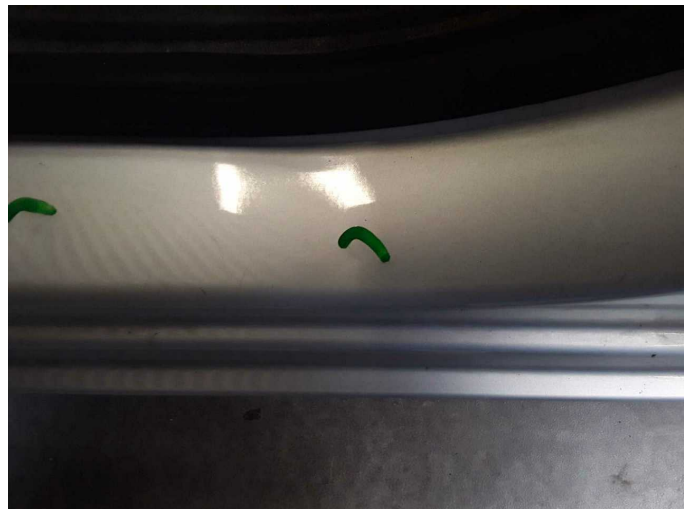
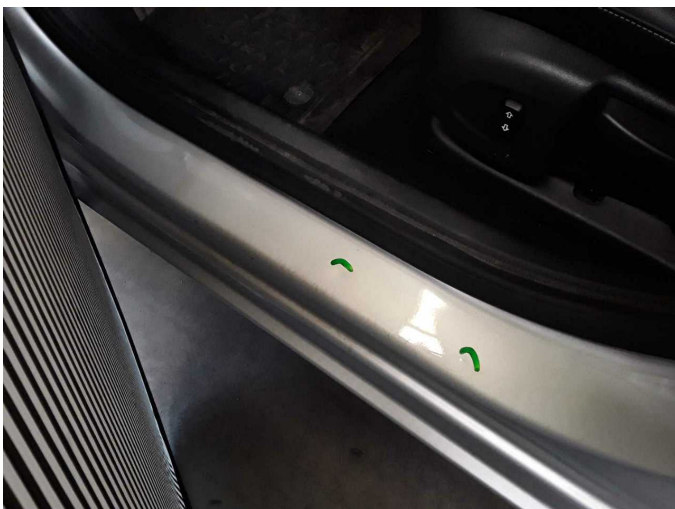
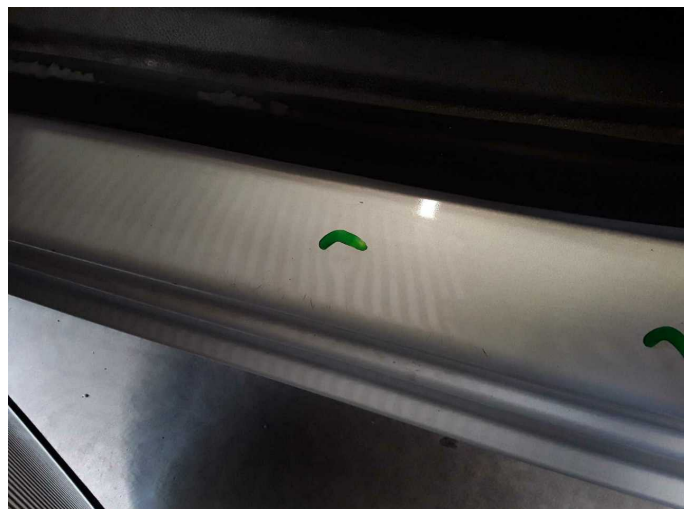
| No. | Component group | Description |
|---|---|---|
| 4 | Sill - left side | Sill - Dent / paintcoat damage - Smart repair |

**Damage 4:** Sill - left side: Sill - Dent / paintcoat damage - Smart repair

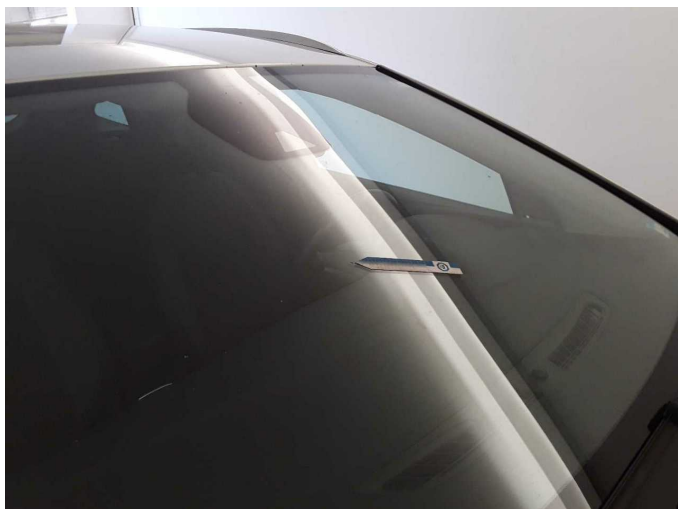
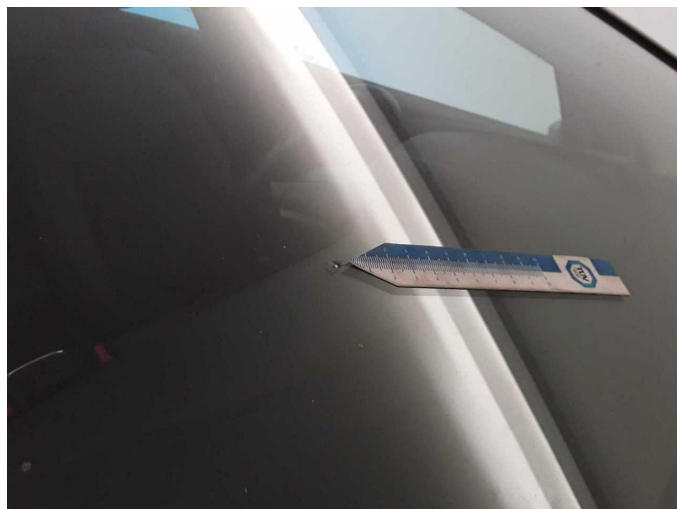
| No. | Component group | Description |
|---|---|---|
| 5 | Vehicle glazing | Windscreen (Mehrkosten möglich) - Stone chips - Smart repair |

**Damage 5:** Vehicle glazing: Windscreen (Mehrkosten möglich) - Stone chips - Smart repair

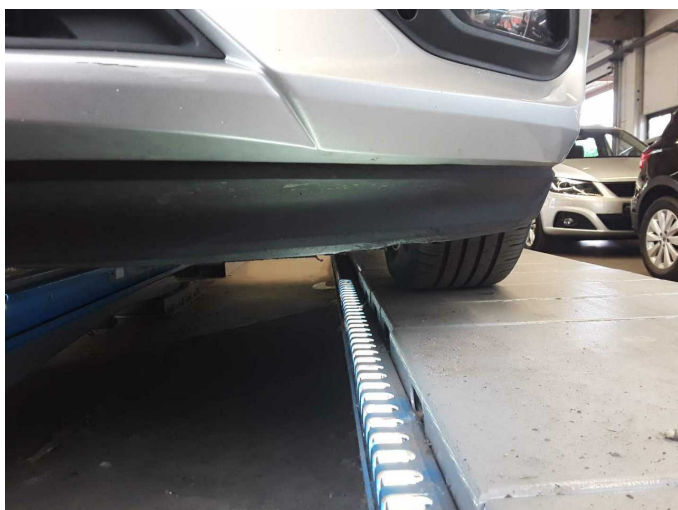
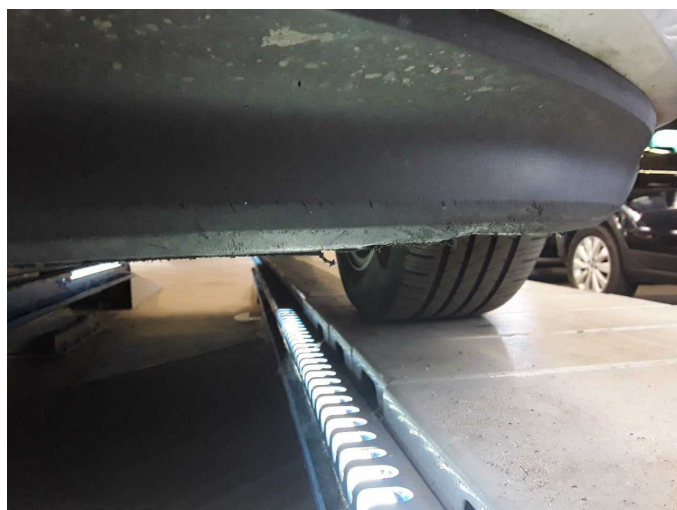
| No. | Component group | Description |
|---|---|---|
| 6 | Front bumper | Spoiler - Scratched - Replace |

**Damage 6:** Front bumper: Spoiler - Scratched - Replace

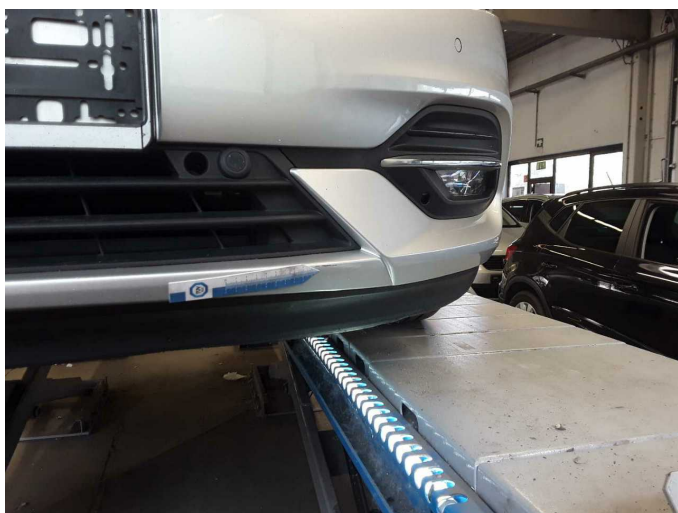
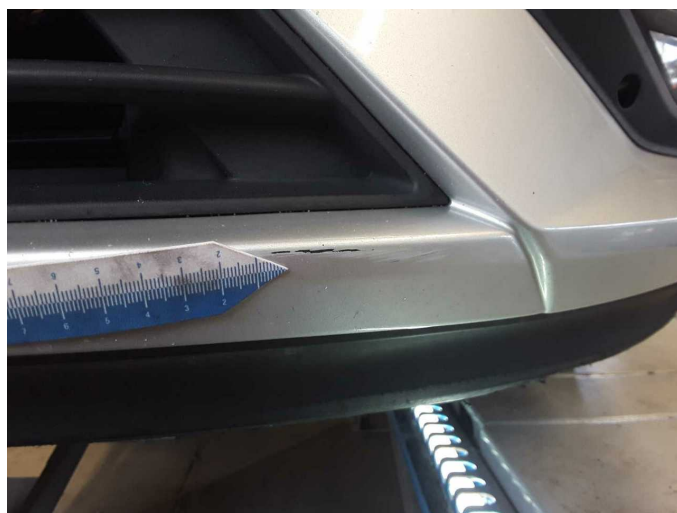
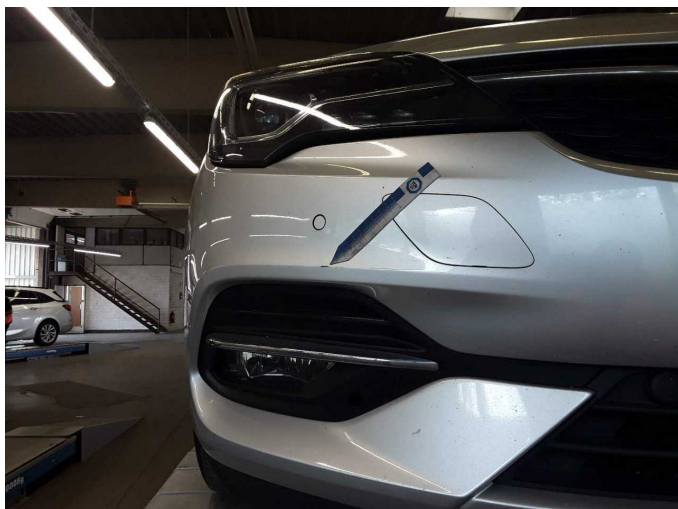
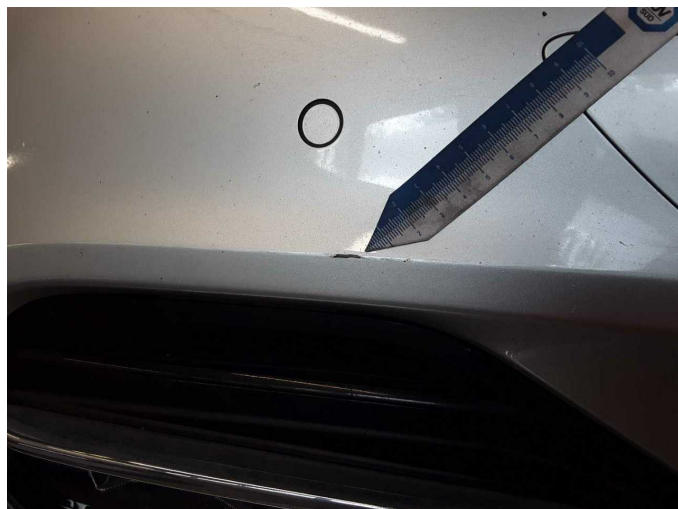
| No. | Component group | Description |
|---|---|---|
| 7 | Front bumper | Front bumper - Scratched - Paint |

**Damage 7:** Front bumper: Front bumper - Scratched - Paint

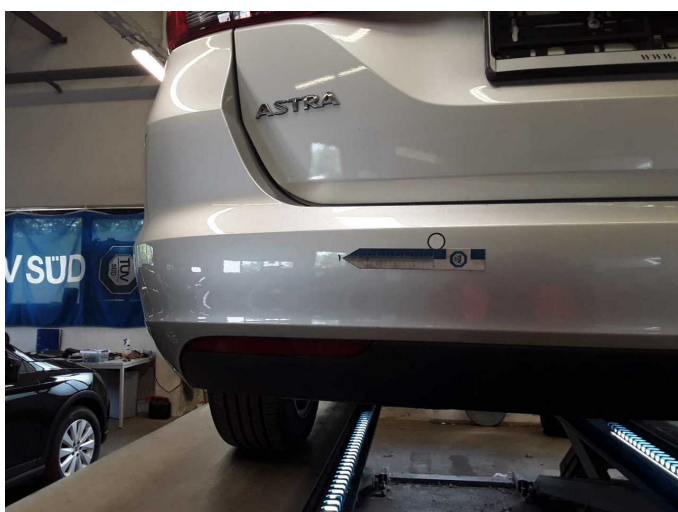
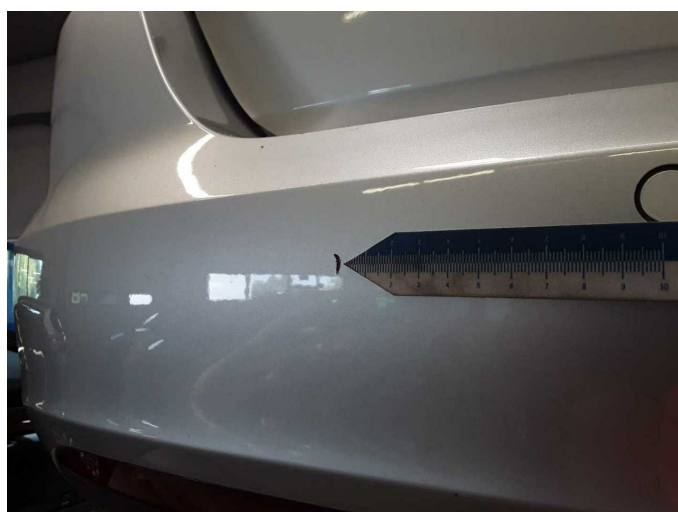
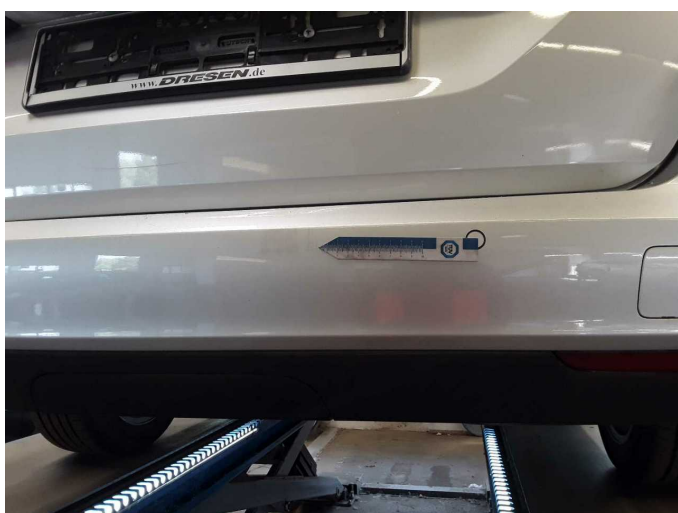
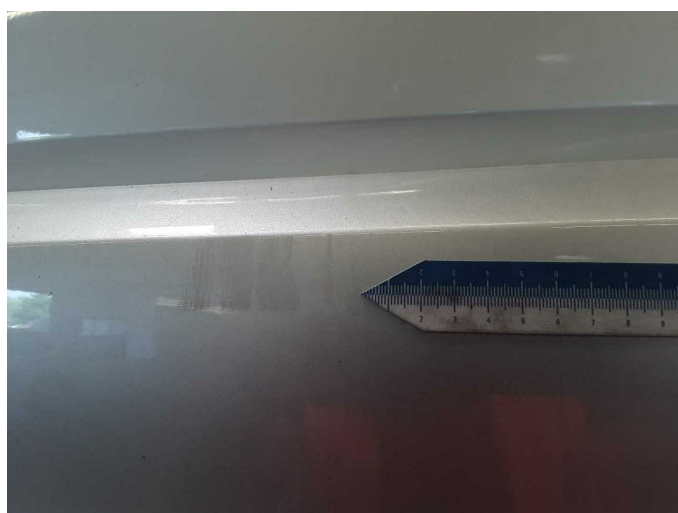
| No. | Component group | Description |
|---|---|---|
| 8 | Rear bumper | Rear bumper - Scratched - Paint |

**Damage 8:** Rear bumper: Rear bumper - Scratched - Paint

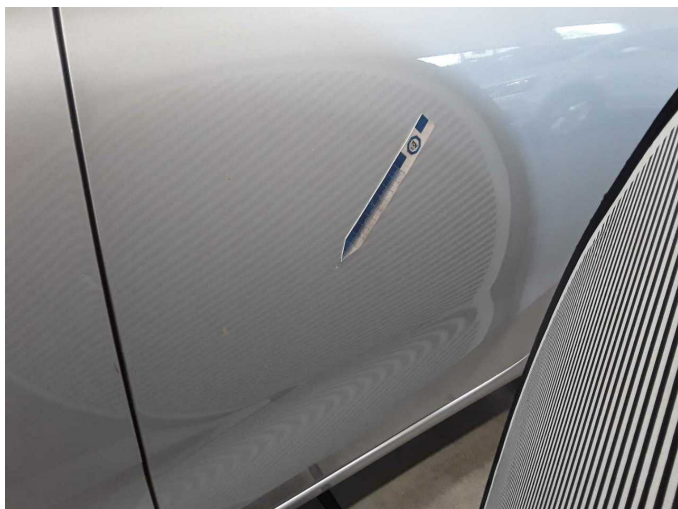
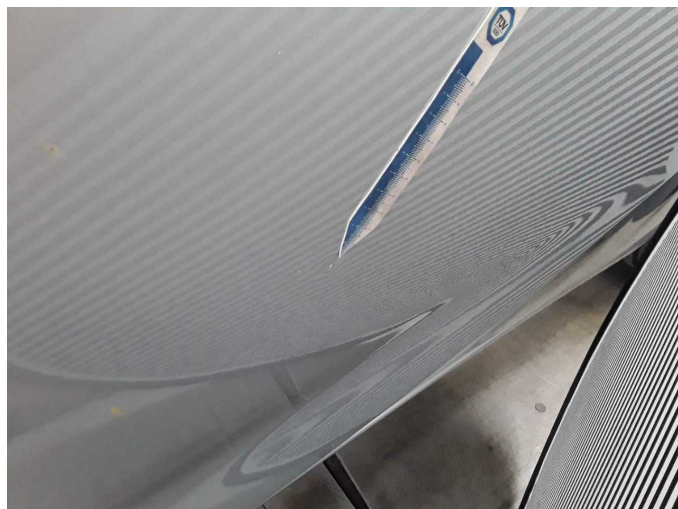
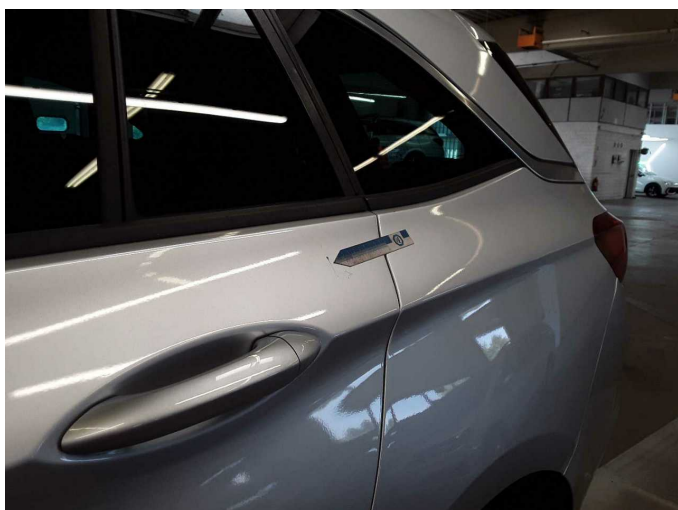
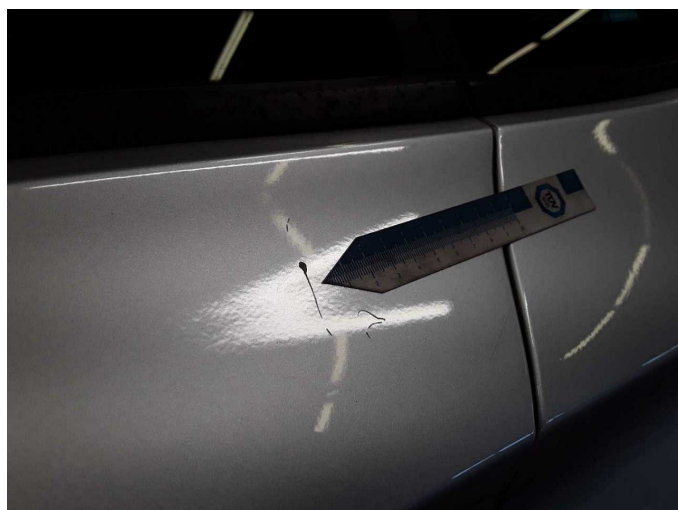
| No. | Component group | Description |
|---|---|---|
| 9 | Door - rear left side | Door - Dent / paintcoat damage - Repair and paint |

**Damage 9:** Door - rear left side: Door - Dent / paintcoat damage - Repair and paint

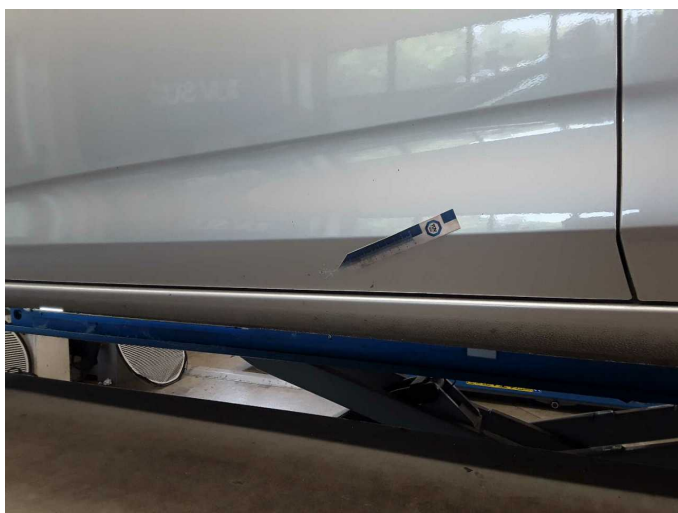
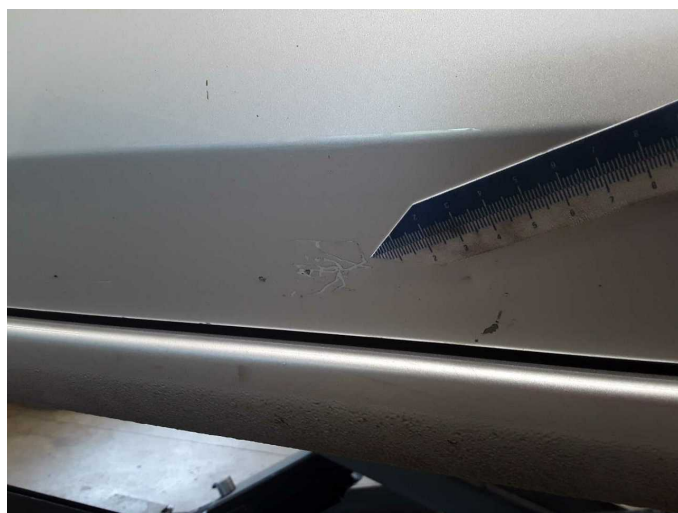
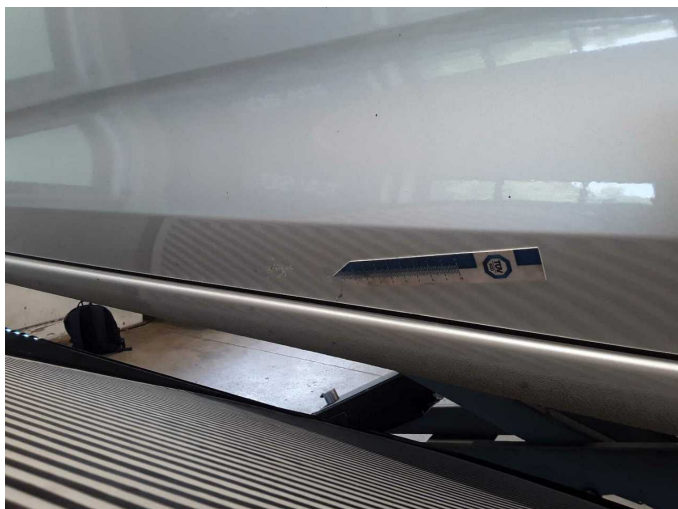
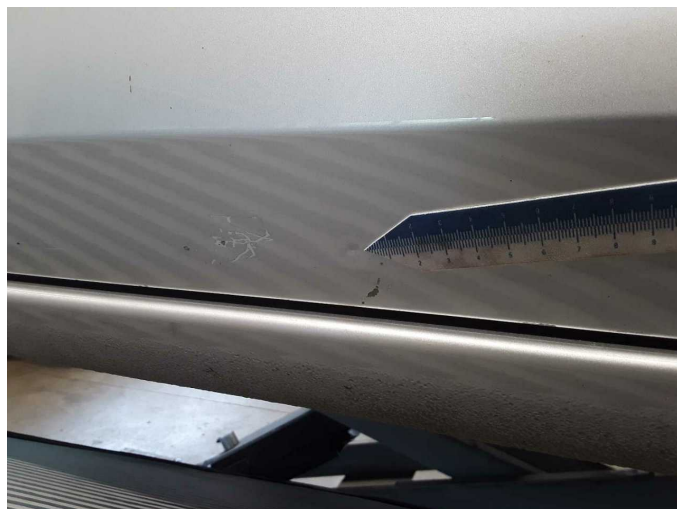
| No. | Component group | Description |
|---|---|---|
| 10 | Door - front left side | Door - Dent / paintcoat damage - Repair and paint |

**Damage 10:** Door - front left side: Door - Dent / paintcoat damage - Repair and paint

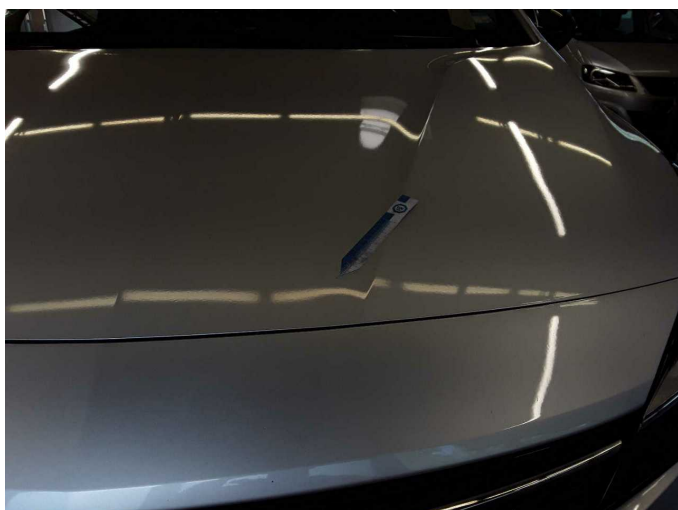
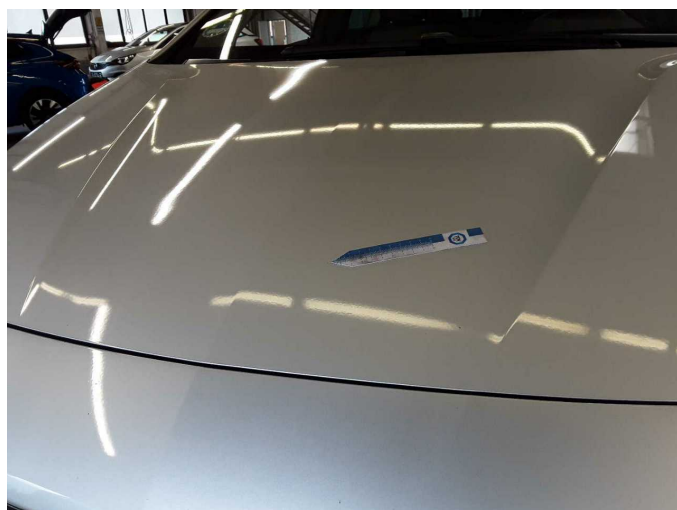
| No. | Component group | Description |
|---|---|---|
| 2 | Bonnet | Bonnet - Stone chips - No deduction |

**Wear and tear 2:** Bonnet: Bonnet - Stone chips - No deduction

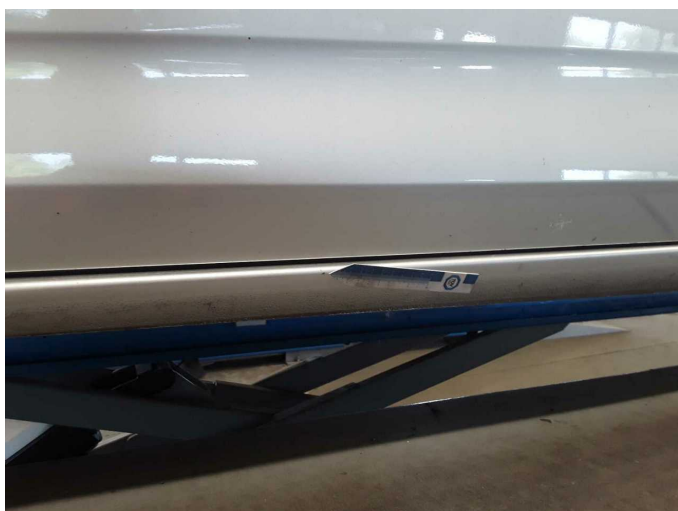
| No. | Component group | Description |
|---|---|---|
| 3 | Sill - left side | Sill - Stone chips - No deduction |

**Wear and tear 3:** Sill - left side: Sill - Stone chips - No deduction

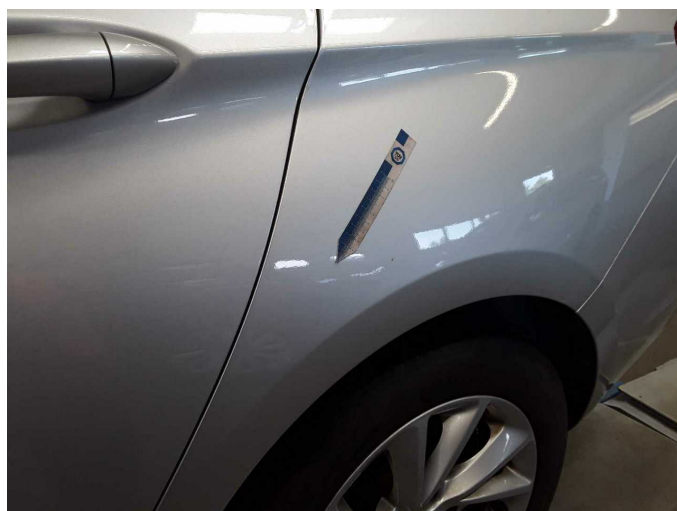
| No. | Component group | Description |
|---|---|---|
| 4 | Side panel - rear left side | Side panel - Scratch(es) - No deduction |

**Wear and tear 4:** Side panel - rear left side: Side panel - Scratch(es) - No deduction
