Expertise

Protocol number: 46149769
Order No. / Reference: 26520021
Inspection date: 24 Jun 2026

Manufacturer: Opel

Model: Movano 2.2 D L1H1 2WD VA Edition

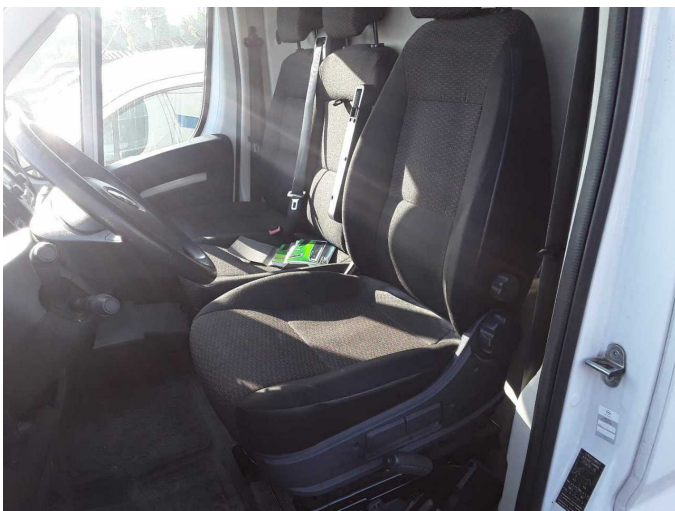
Damage 1: Seat - front: Seat cover - left side (Sitze) - Soiled - Clean

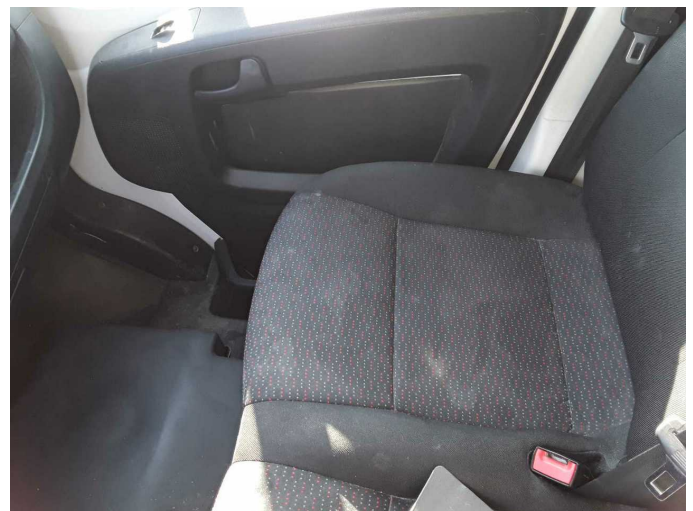
Damage 1: Seat - front: Seat cover - left side (Sitze) - Soiled - Clean

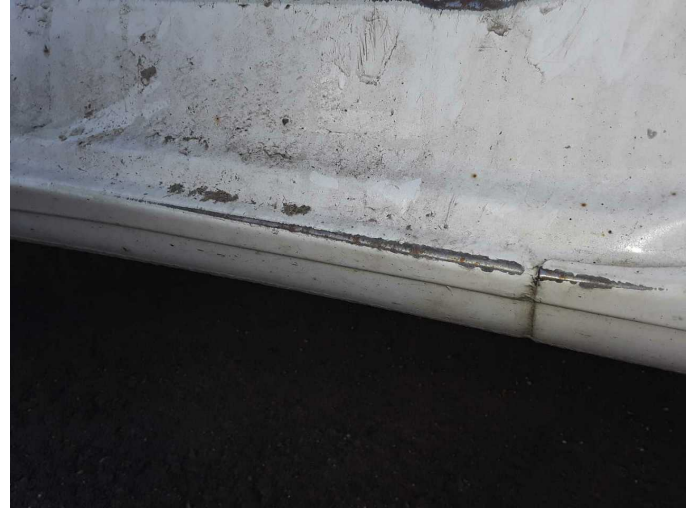
Damage 3: Sill - left side: Sill - Scratch(es) - Smart repair

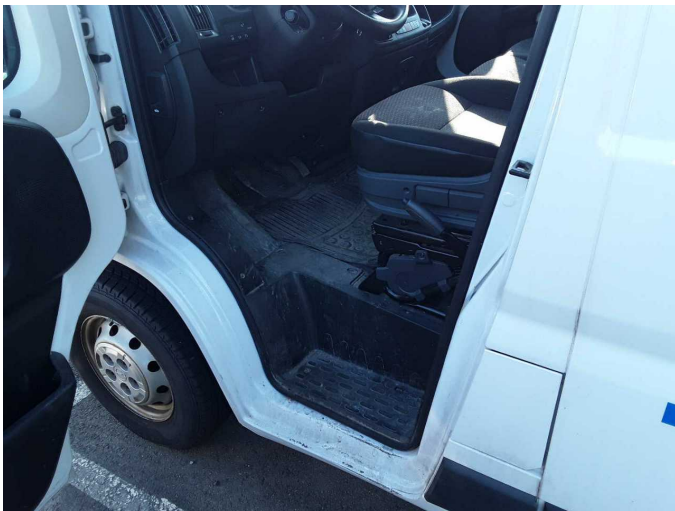
Damage 3: Sill - left side: Sill - Scratch(es) - Smart repair

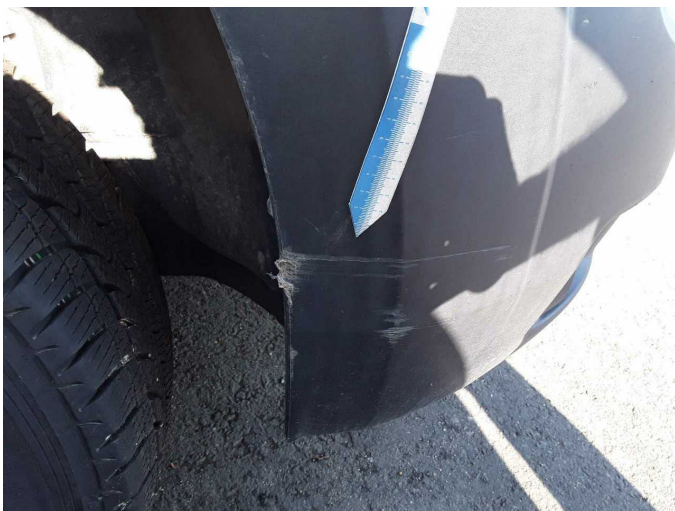
Damage 4: Front bumper: Front bumper (Unlackiert) - Scratch(es) - Loss in value

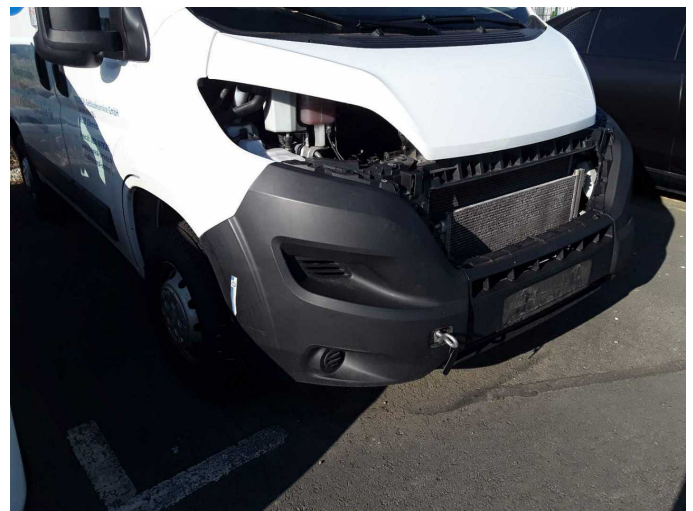
Damage 4: Front bumper: Front bumper (Unlackiert) - Scratch(es) - Loss in value

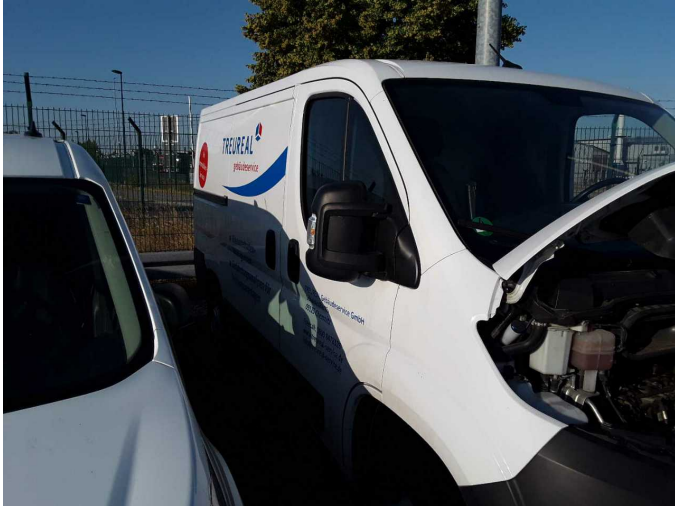
Damage 4: Front bumper: Front bumper (Unlackiert) - Scratch(es) - Loss in value

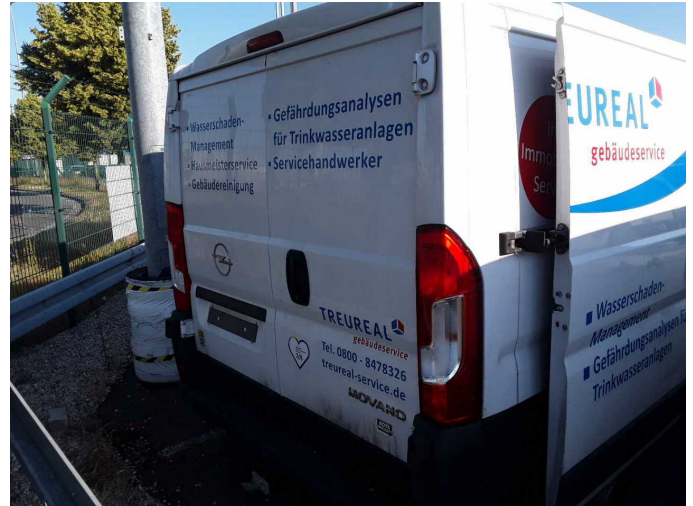
Damage 5: Body: Body - Glued / labelled - De-glue / neutralise

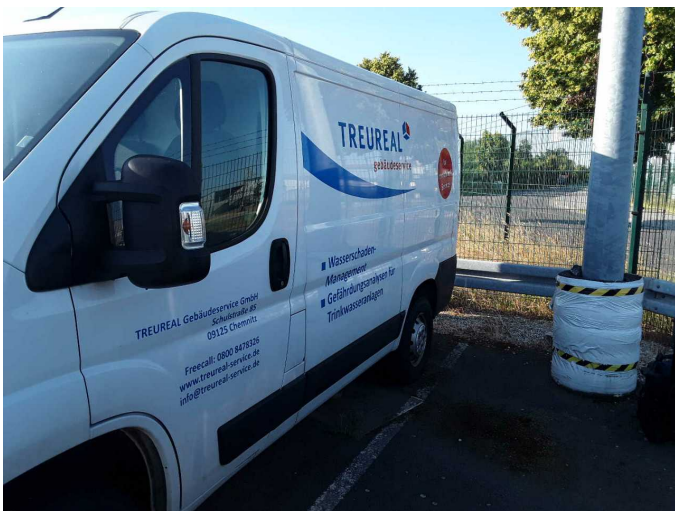
Damage 5: Body: Body - Glued / labelled - De-glue / neutralise

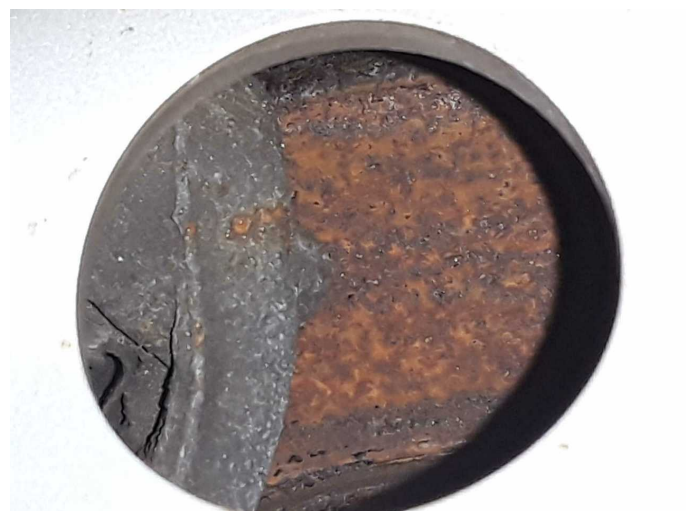
Damage 6: Braking system: Brake discs and pads - rear - Corrosion - Replace

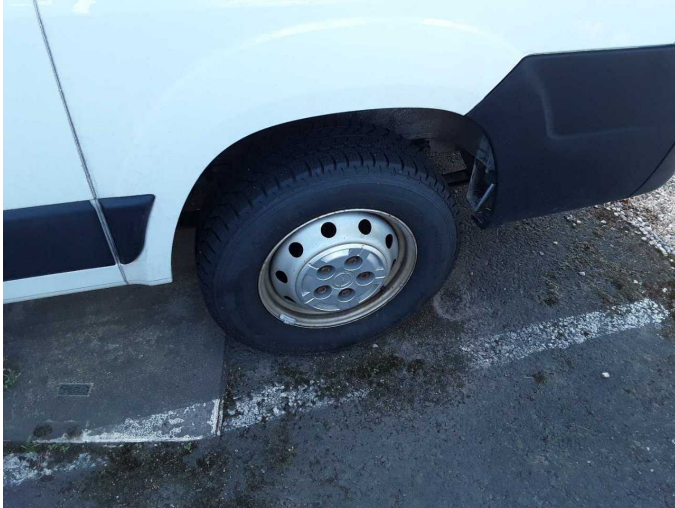
Damage 6: Braking system: Brake discs and pads - rear - Corrosion - Replace

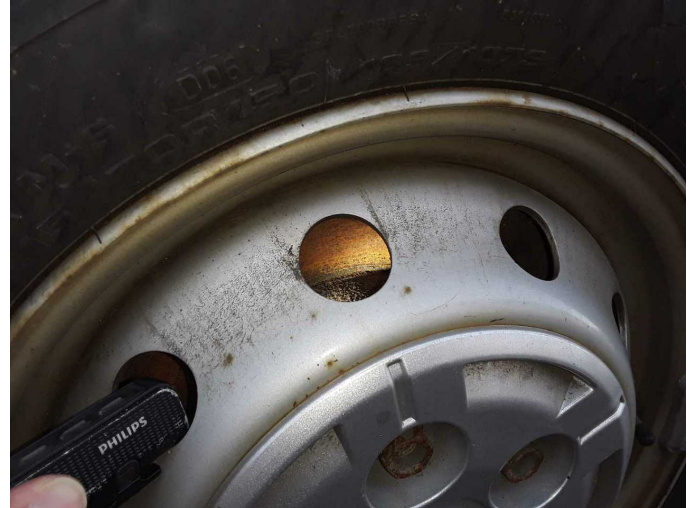
Damage 6: Braking system: Brake discs and pads - rear - Corrosion - Replace

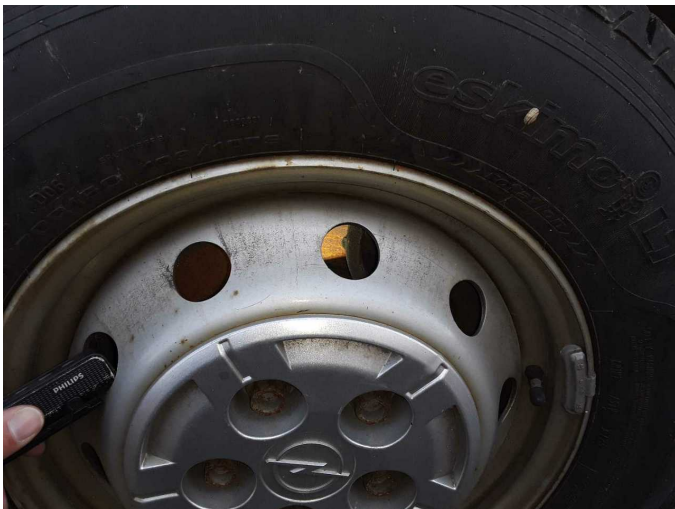
Damage 6: Braking system: Brake discs and pads - rear - Corrosion - Replace

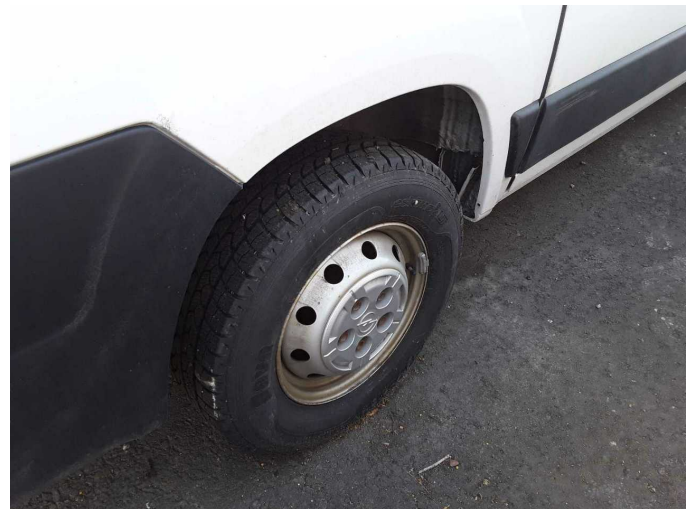
Damage 6: Braking system: Brake discs and pads - rear - Corrosion - Replace

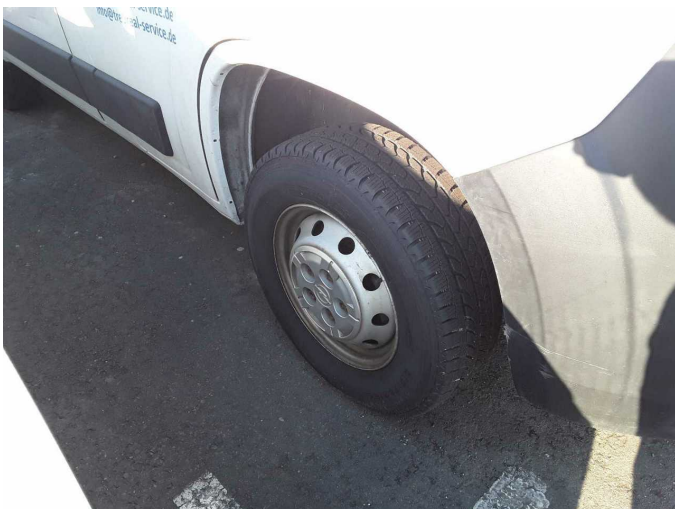
Damage 6: Braking system: Brake discs and pads - rear - Corrosion - Replace

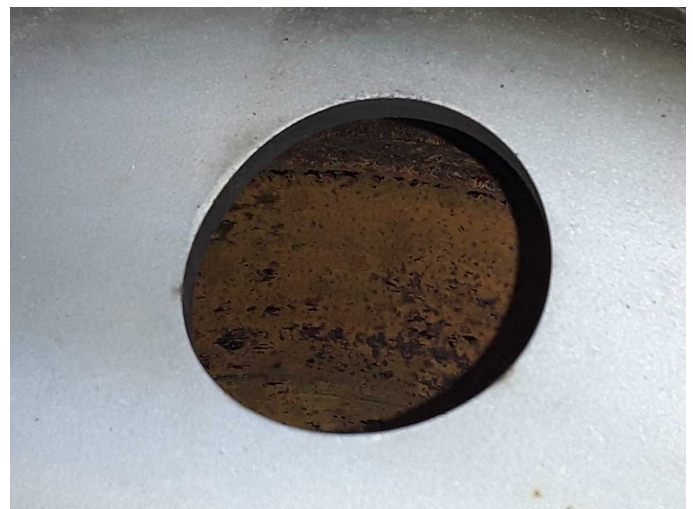
Damage 7: Braking system: Brake discs and brake pads - front - Corrosion - Replace

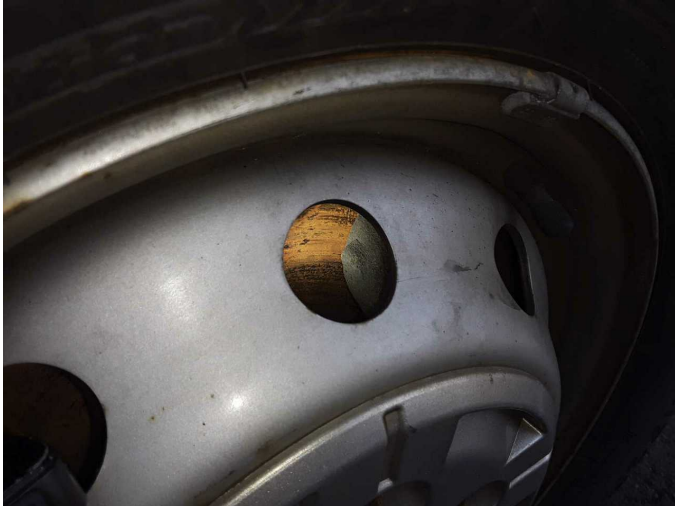
Damage 7: Braking system: Brake discs and brake pads - front - Corrosion - Replace

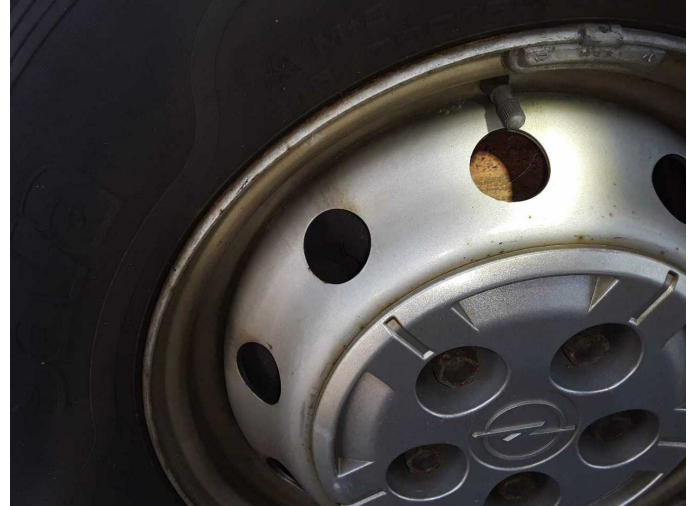
Damage 7: Braking system: Brake discs and brake pads - front - Corrosion - Replace

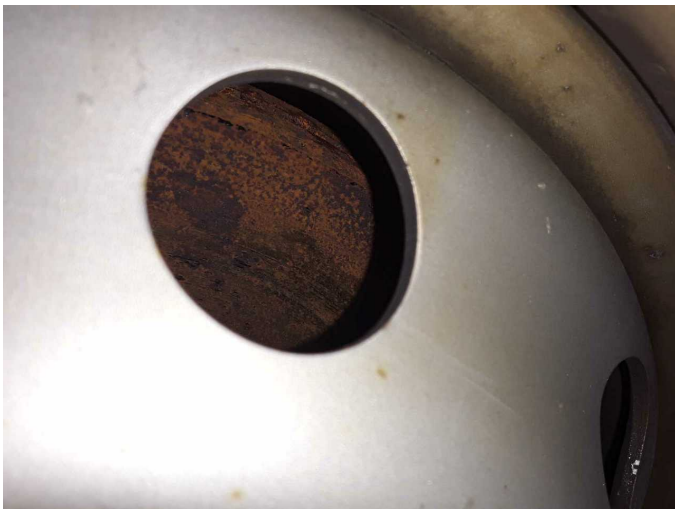
Damage 7: Braking system: Brake discs and brake pads - front - Corrosion - Replace

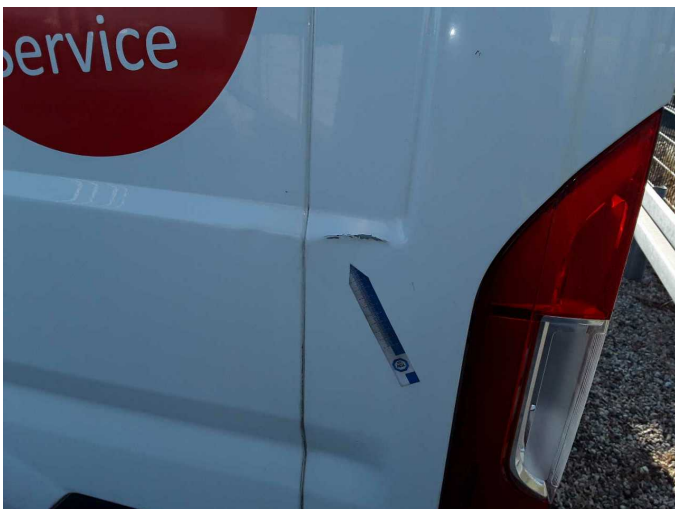
Damage 8: Side panel - rear left side: Side panel (Eckteil) - Dent / paintcoat damage - Repair and paint

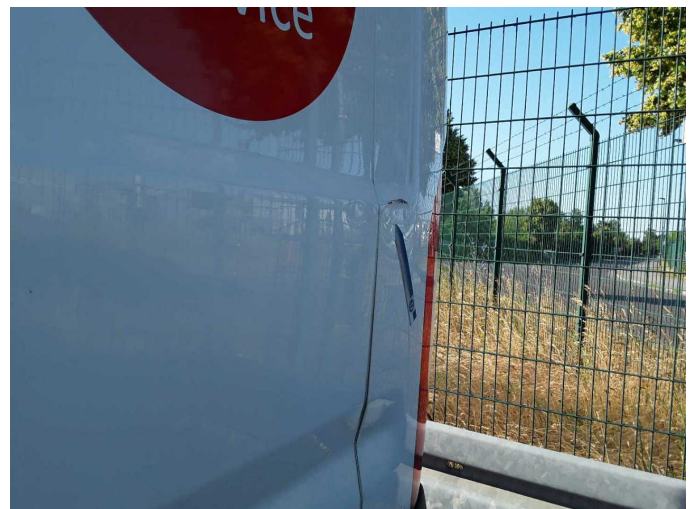
Damage 8: Side panel - rear left side: Side panel (Eckteil) - Dent / paintcoat damage - Repair and paint

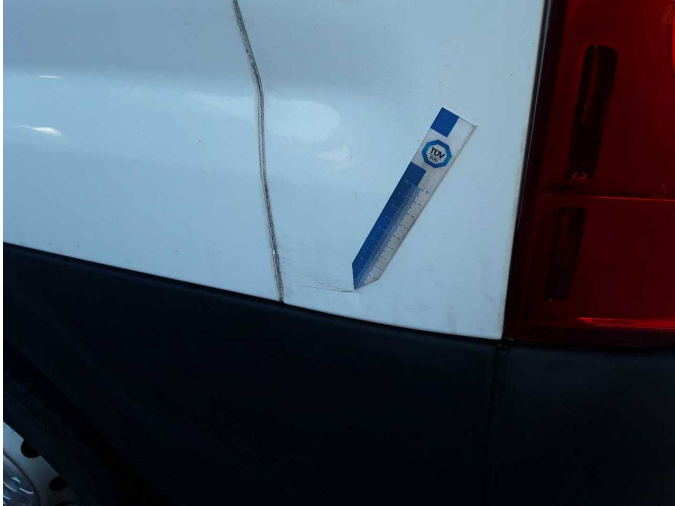
Damage 8: Side panel - rear left side: Side panel (Eckteil) - Dent / paintcoat damage - Repair and paint

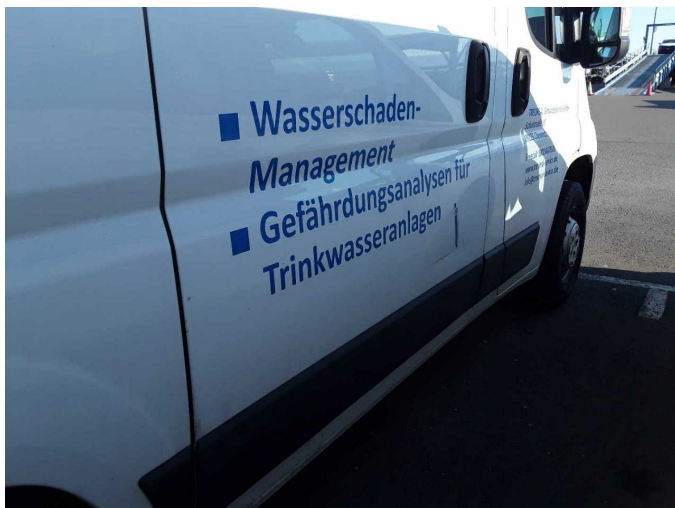
Damage 9: Sliding door, right: Sliding door - Dent / paintcoat damage - Repair and paint

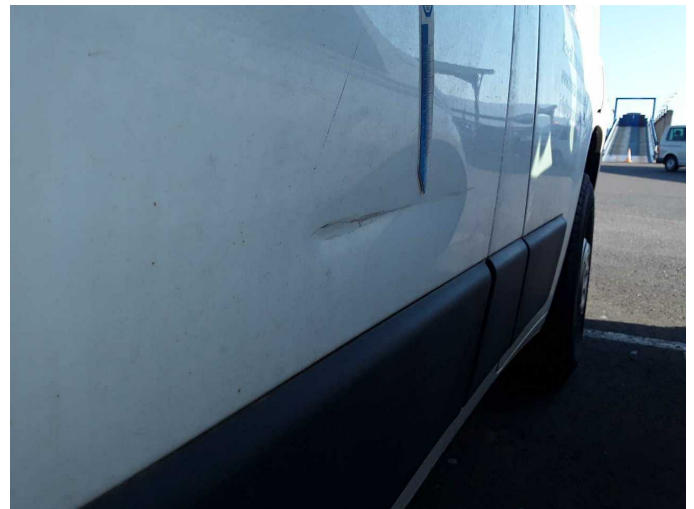
Damage 9: Sliding door, right: Sliding door - Dent / paintcoat damage - Repair and paint

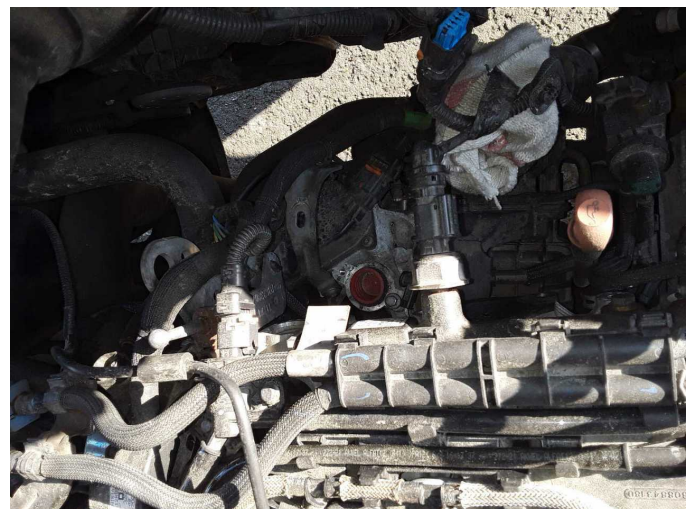
Motorraum im Zerlegten Zustand !

Damage 10: Engine: Engine (Siehe Kostenvoranschlag) - Defective - Replace

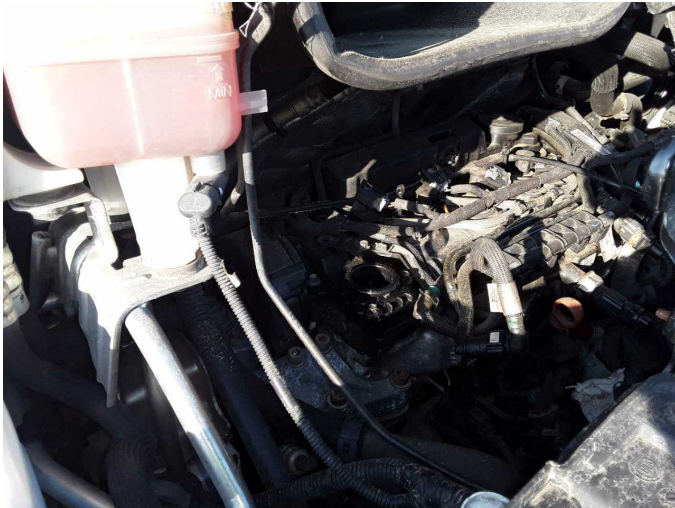
Damage 10: Engine: Engine (Siehe Kostenvoranschlag) - Defective - Replace

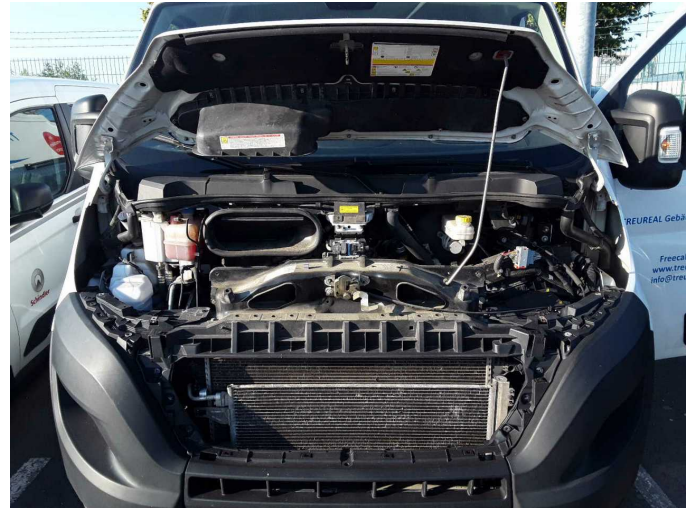
Damage 10: Engine: Engine (Siehe Kostenvoranschlag) - Defective - Replace

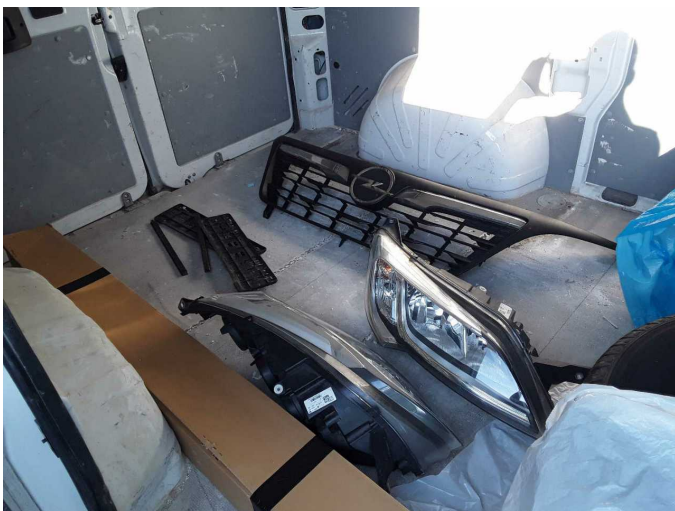
Damage 10: Engine: Engine (Siehe Kostenvoranschlag) - Defective - Replace

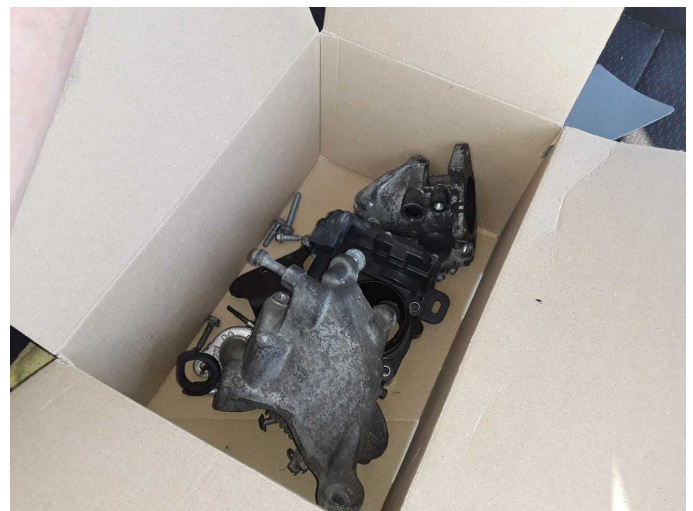
Damage 10: Engine: Engine (Siehe Kostenvoranschlag) - Defective - Replace

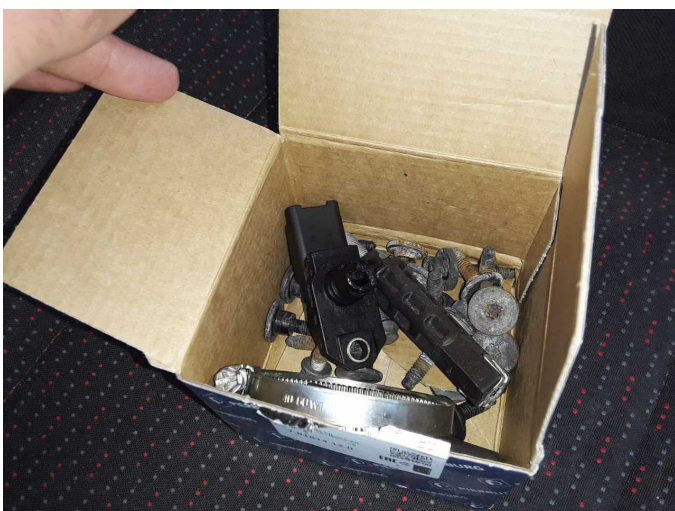
Damage 10: Engine: Engine (Siehe Kostenvoranschlag) - Defective - Replace

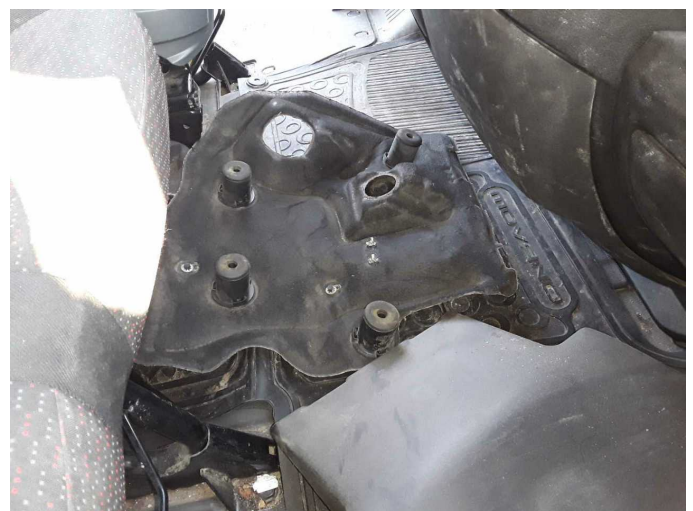
Damage 10: Engine: Engine (Siehe Kostenvoranschlag) - Defective - Replace
