Expertise

Protocol number: 46431369  
Order No. / Reference: 26412223  
Inspection date: 9 Jul 2026

Manufacturer: Opel

Model: Combo Life 1.2 Turbo Start/Stop Edition

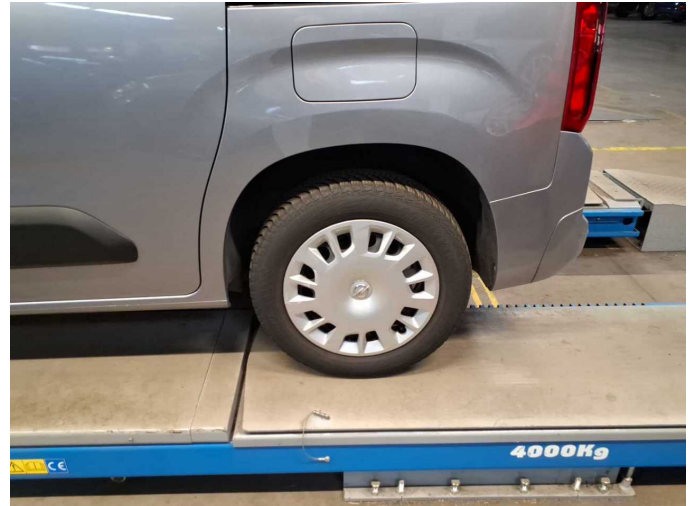
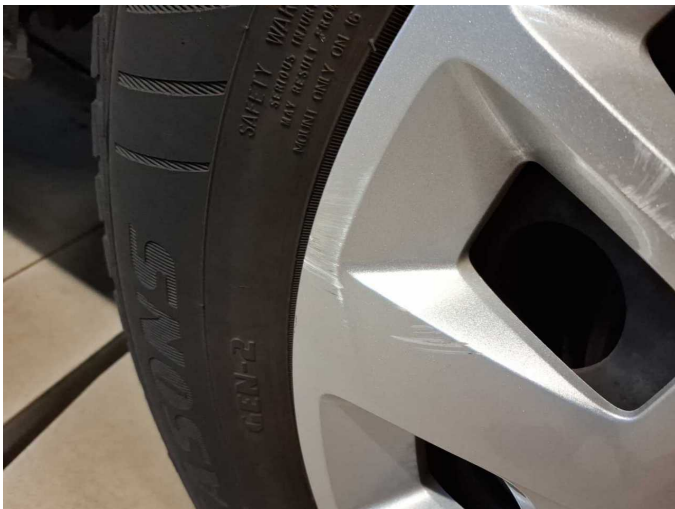
| No. | Component group | Description |
|---|---|---|
| 1 | Wheel / tyres | Wheel cover - rear left side - Scratch(es) - Replace |

**Damage 1:** Wheel / tyres: Wheel cover - rear left side - Scratch(es) - Replace

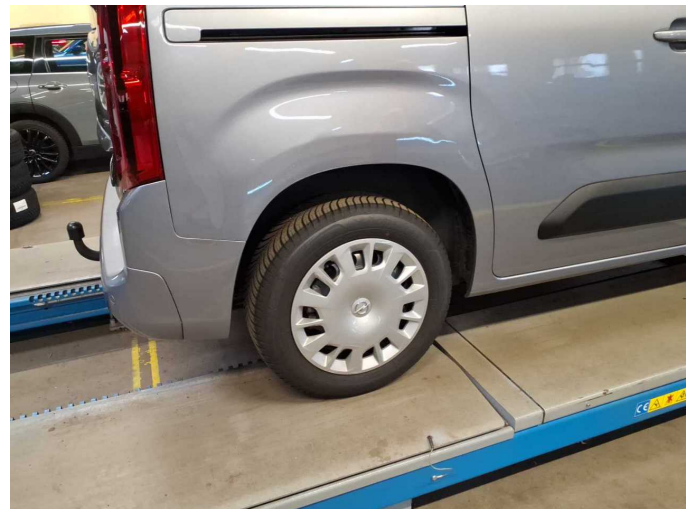
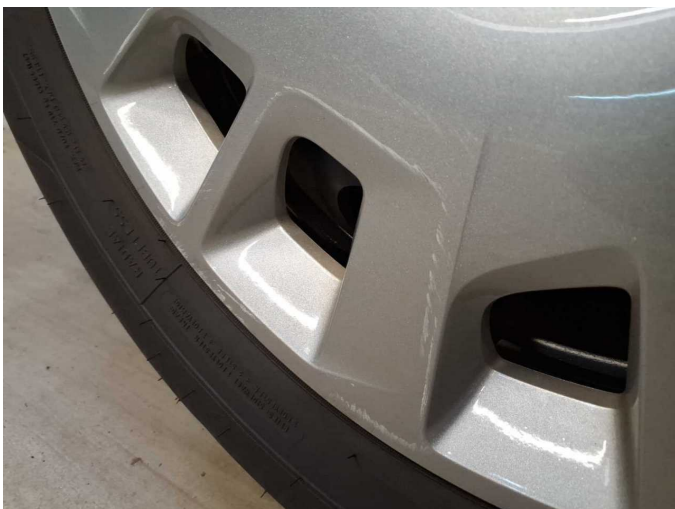
| No. | Component group | Description |
|---|---|---|
| 2 | Wheel / tyres | Wheel cover - rear right side - Scratch(es) - Replace |

**Damage 2:** Wheel / tyres: Wheel cover - rear right side - Scratch(es) - Replace

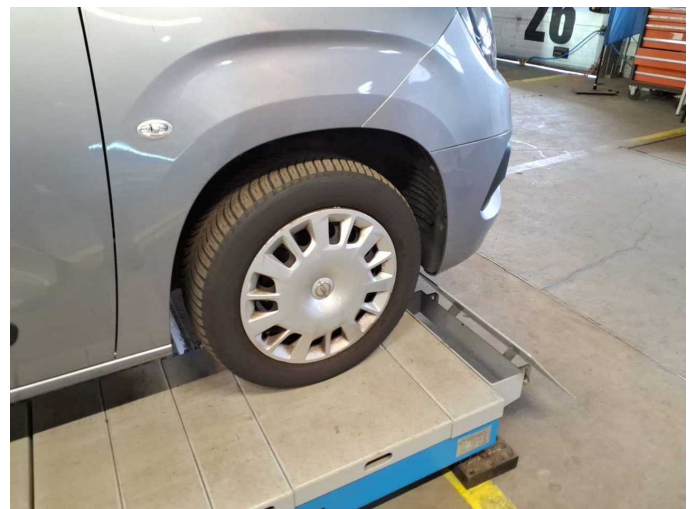
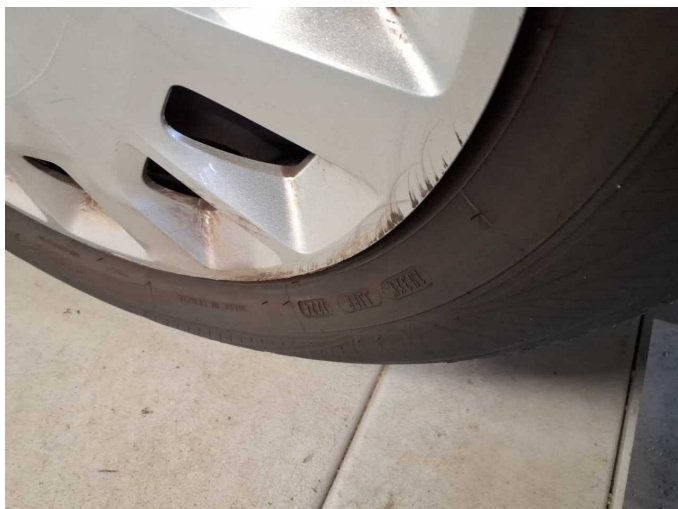
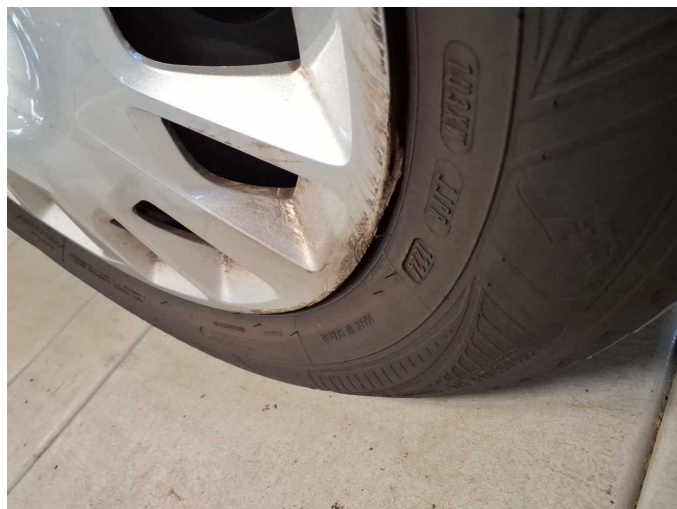
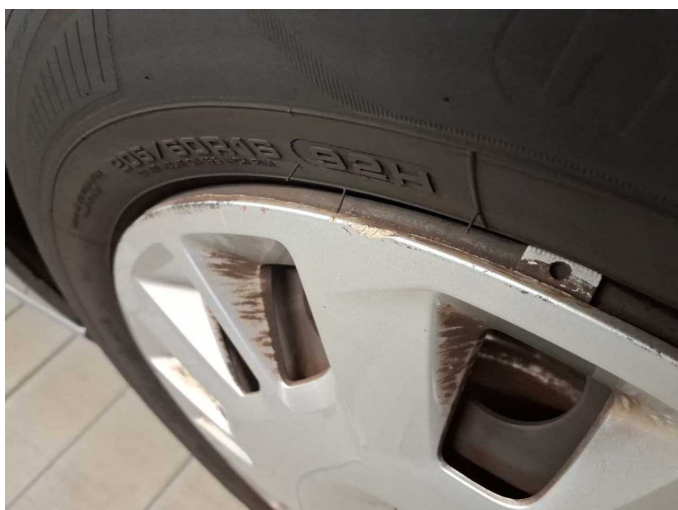
| No. | Component group | Description |
|---|---|---|
| 3 | Wheel / tyres | Wheel cover - front right side - Scratched - Replace |

**Damage 3:** Wheel / tyres: Wheel cover - front right side - Scratched - Replace

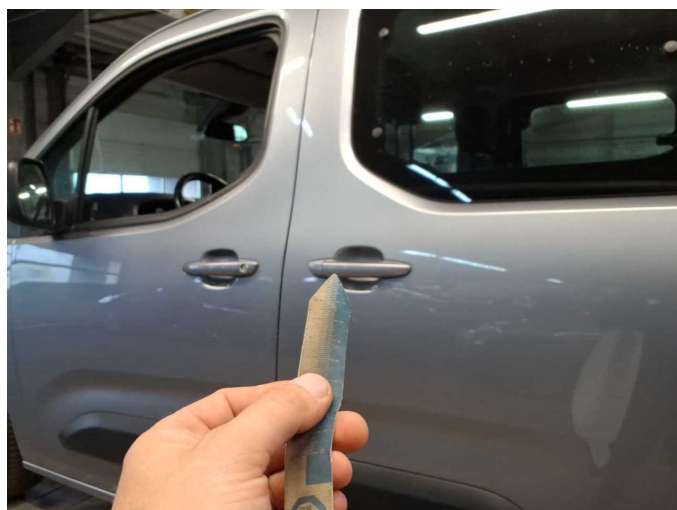
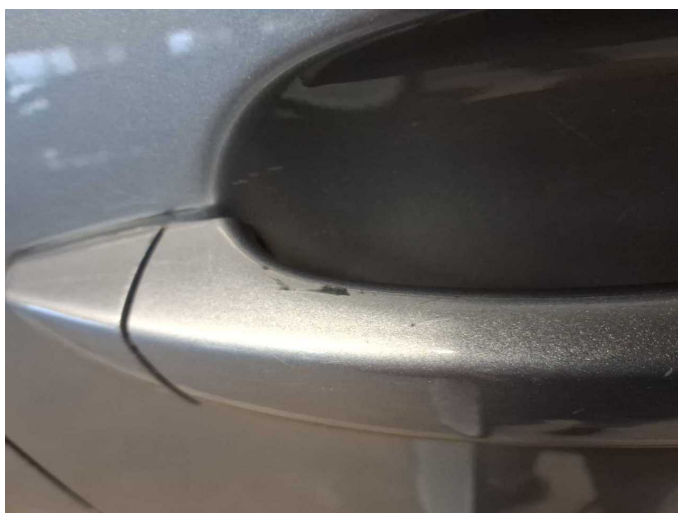
| No. | Component group | Description |
|---|---|---|
| 4 | Door - rear left side | Door handle - outside - Scratch(es) - Smart repair |

**Damage 4:** Door - rear left side: Door handle - outside - Scratch(es) - Smart repair

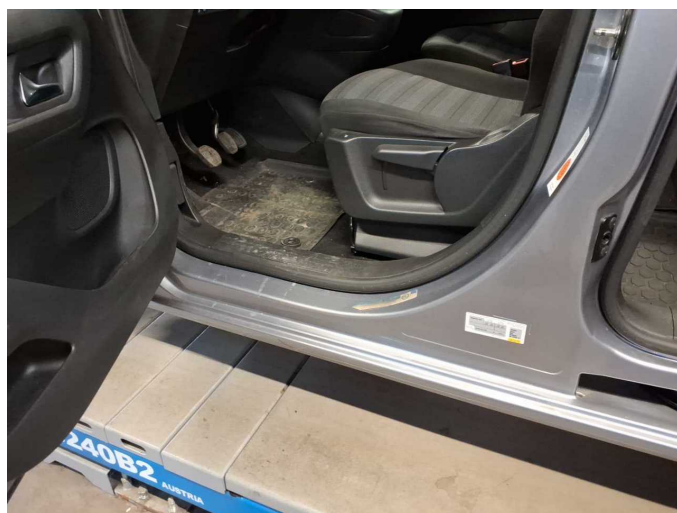
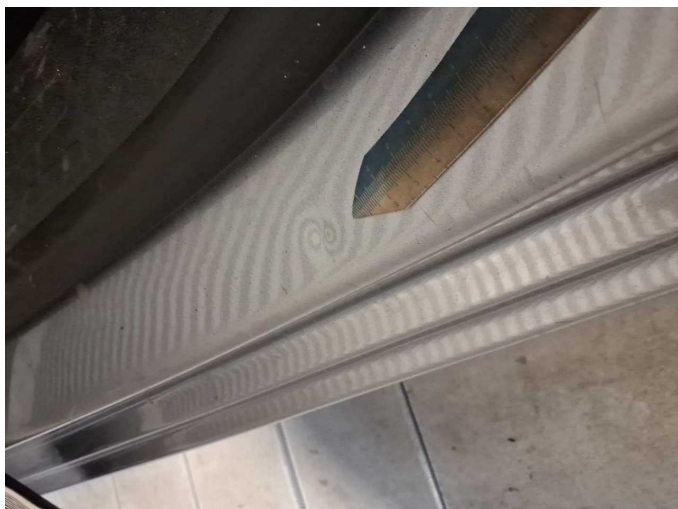
| No. | Component group | Description |
|---|---|---|
| 5 | Sill - left side | Sill - dent(s) - Smooth repair work |

**Damage 5:** Sill - left side: Sill - dent(s) - Smooth repair work

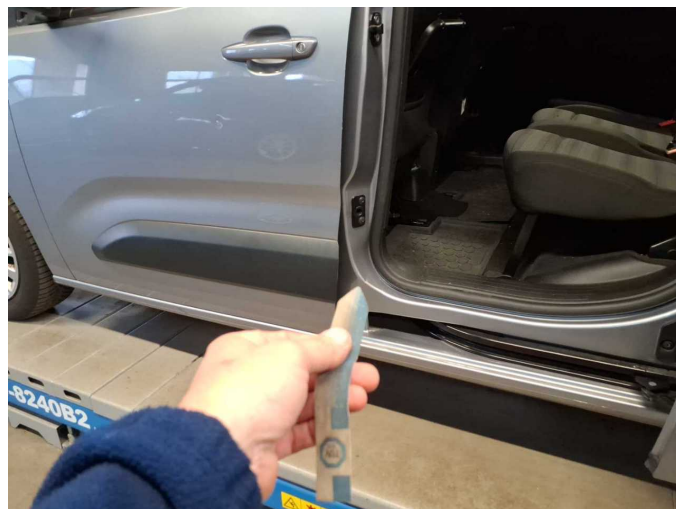
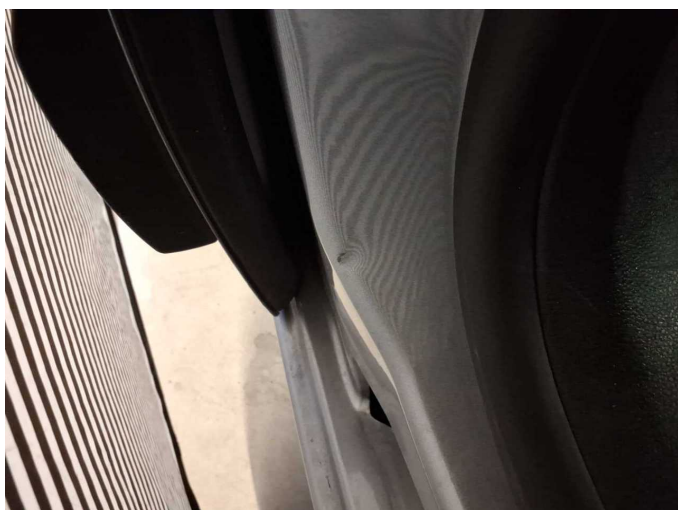
| No. | Component group | Description |
|---|---|---|
| 6 | Body | B-pillar - left side - dent(s) - Smooth repair work |

**Damage 6:** Body: B-pillar - left side - dent(s) - Smooth repair work

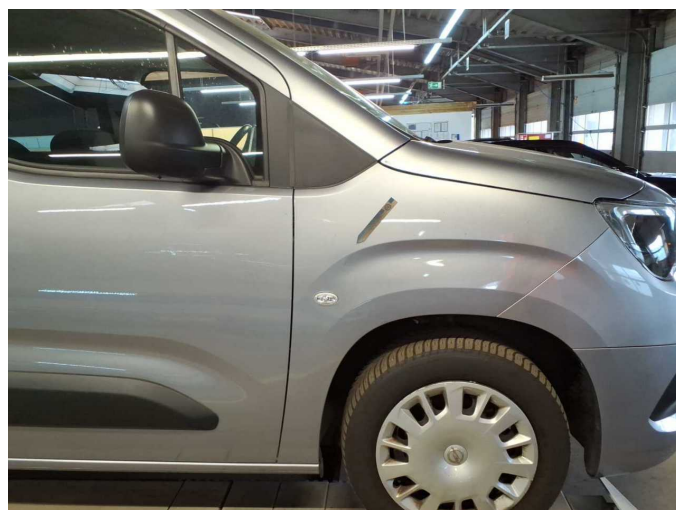
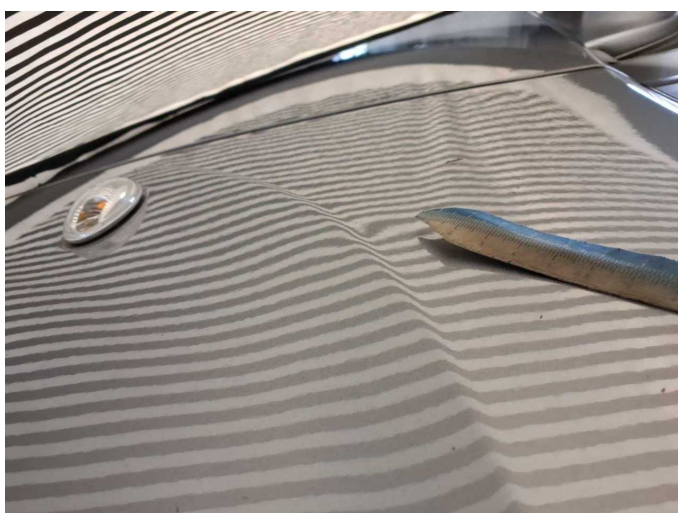
| No. | Component group | Description |
|---|---|---|
| 7 | Mudguard - right side | Mudguard - right side - dent(s) - Smooth repair work |

**Damage 7:** Mudguard - right side: Mudguard - right side - dent(s) - Smooth repair work

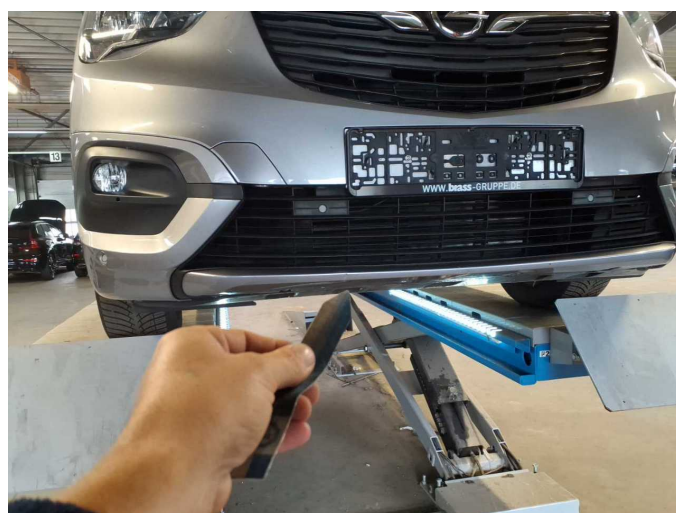
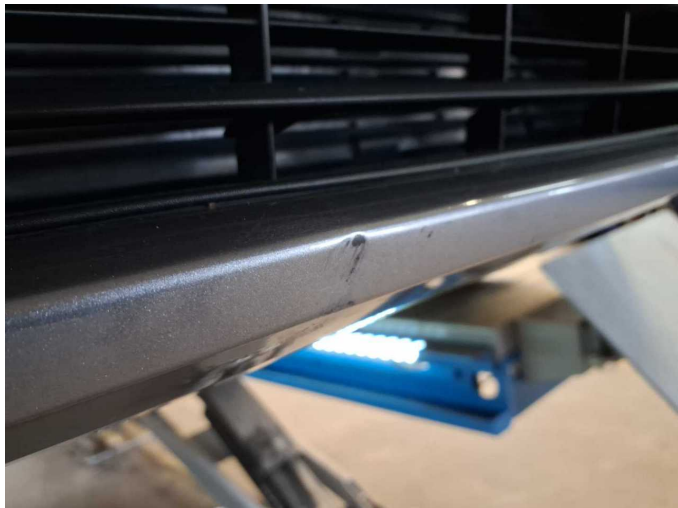
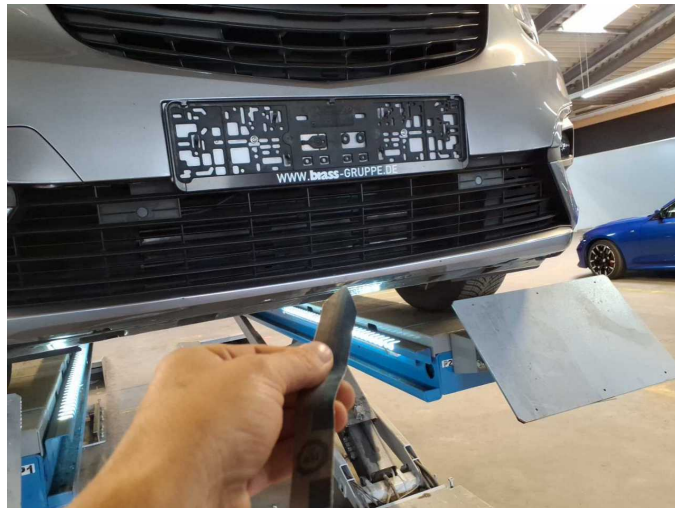
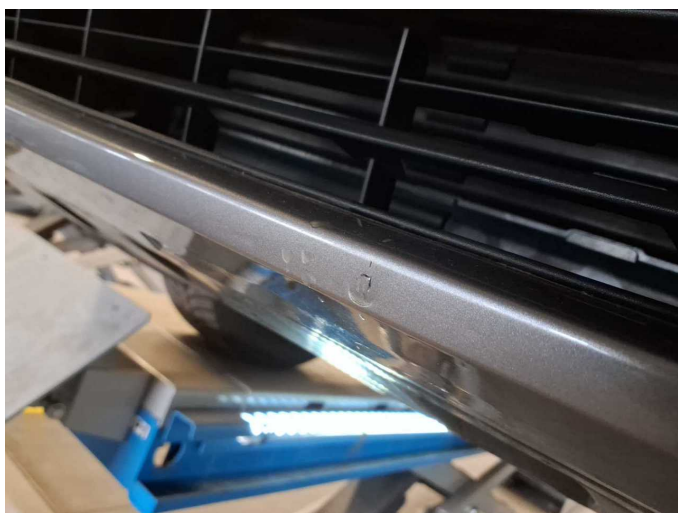
| No. | Component group | Description |
|---|---|---|
| 8 | Front bumper | Spoiler - Scratch(es) - Smart repair |

**Damage 8:** Front bumper: Spoiler - Scratch(es) - Smart repair

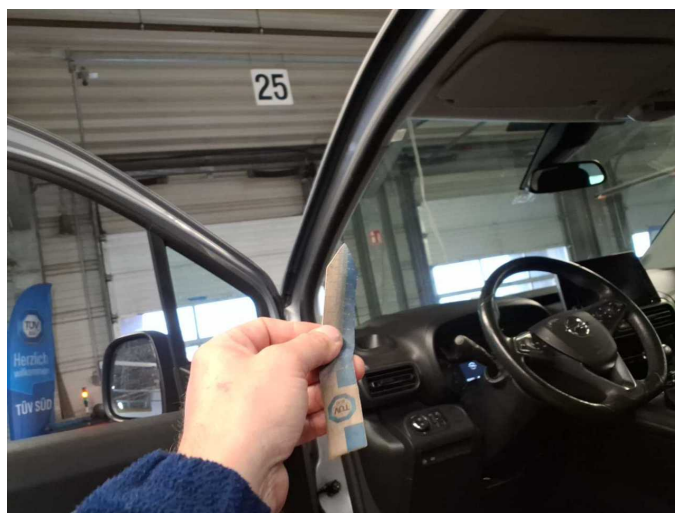
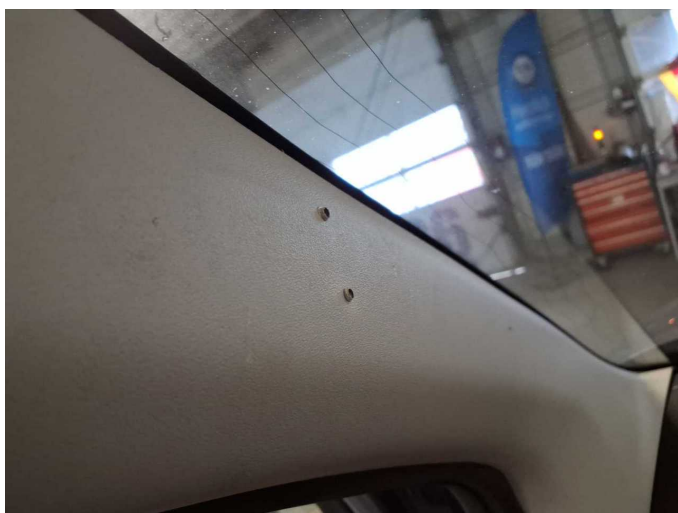
| No. | Component group | Description |
|---|---|---|
| 9 | Trim / covers | A-pillar - trim - interior, left side - Holes - Replace |

**Damage 9:** Trim / covers: A-pillar - trim - interior, left side - Holes - Replace

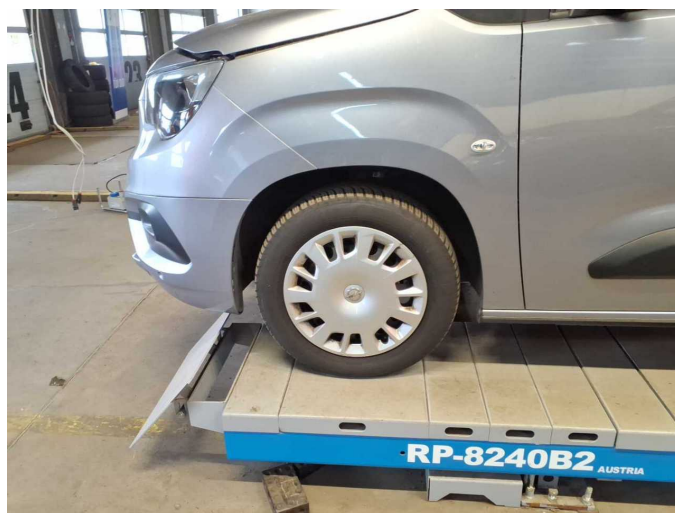
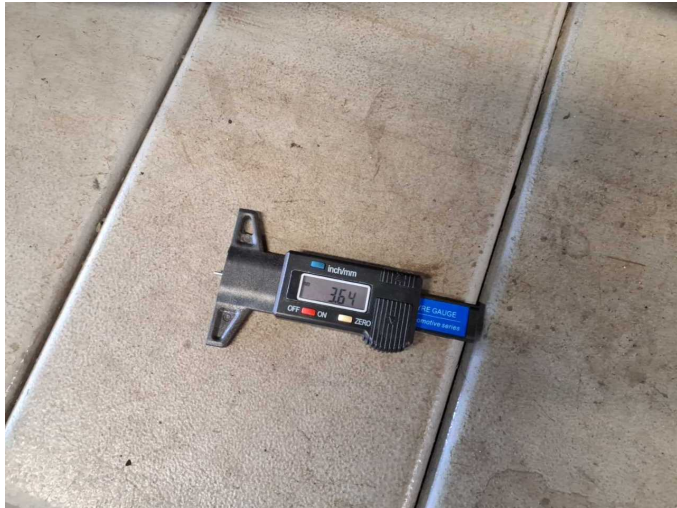
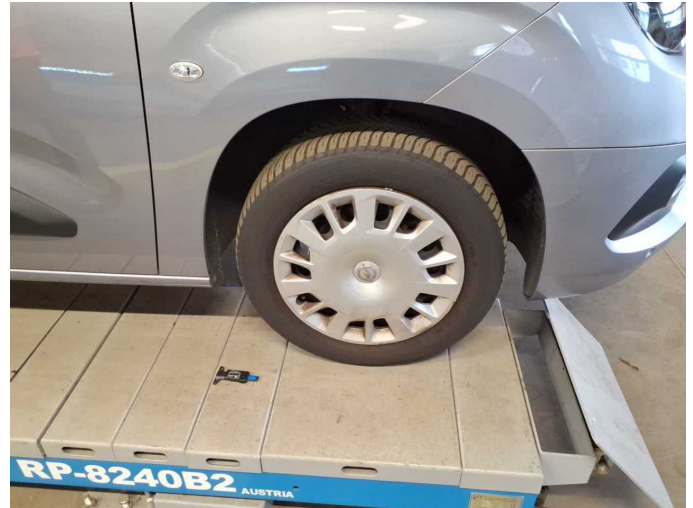
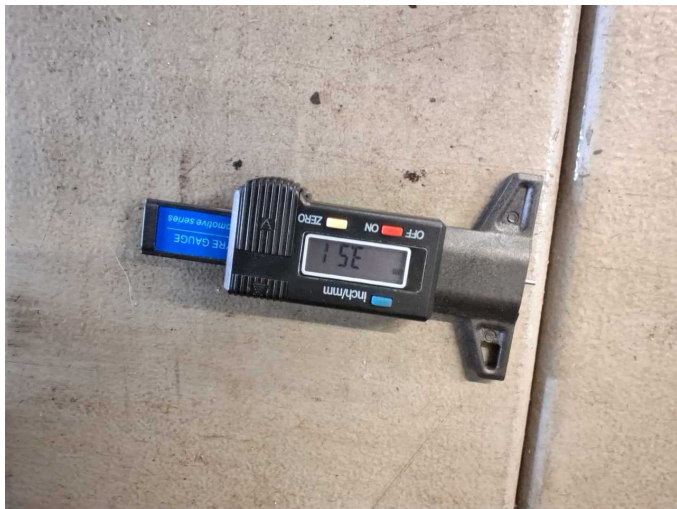
| No. | Component group | Description |
|---|---|---|
| 10 | Wheel / tyres | Tyre - front - Does not meet the leasing specifications - Replace |

**Damage 10:** Wheel / tyres: Tyre - front - Does not meet the leasing specifications - Replace

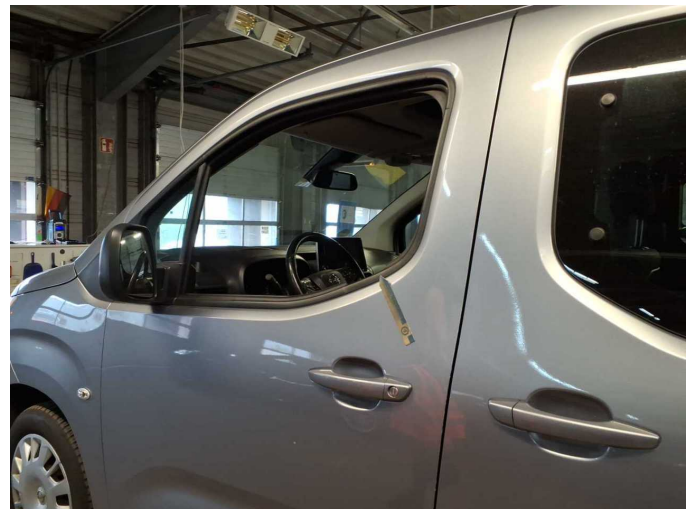
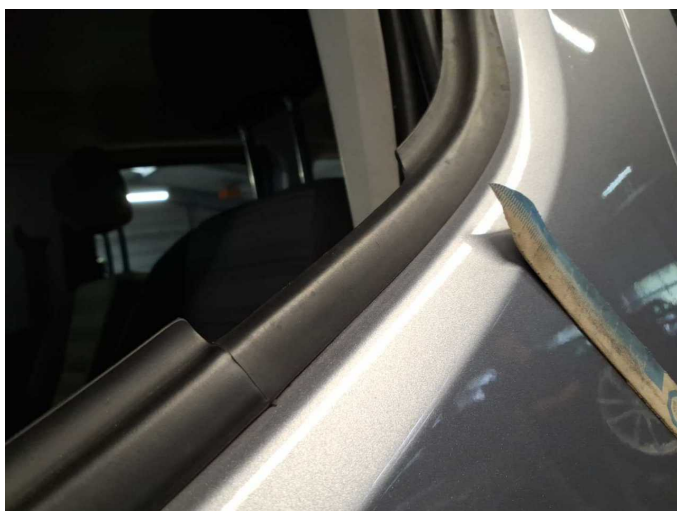
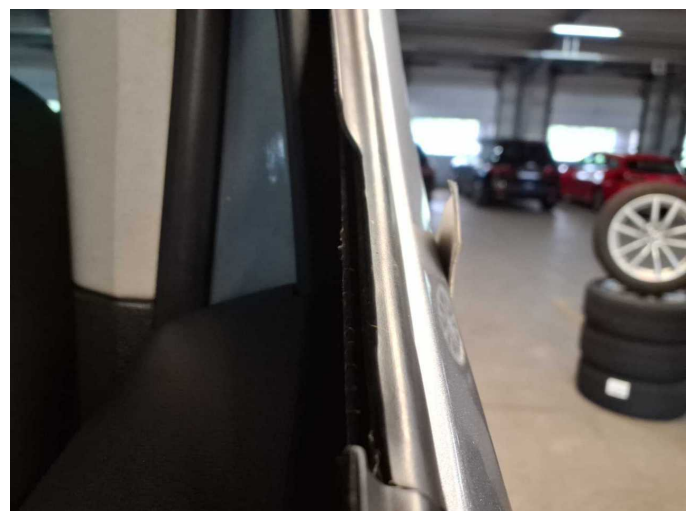
| No. | Component group | Description |
|---|---|---|
| 11 | Cab | Door rubber seal - left side - Broken / torn - Replace |

**Damage 11:** Cab: Door rubber seal - left side - Broken / torn - Replace

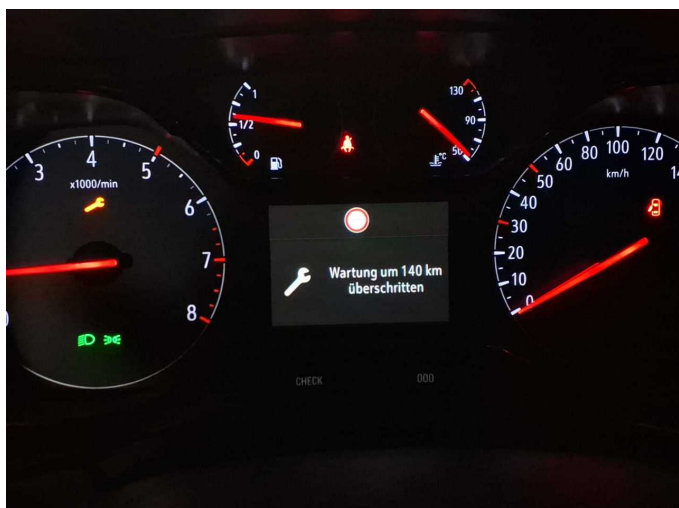
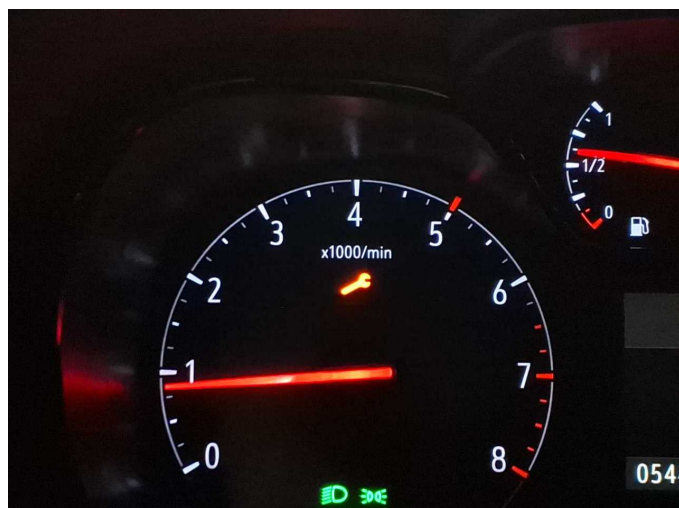
| No. | Component group | Description |
|---|---|---|
| 12 | Misc. | Inspection / maintenance - Due - Perform |

**Damage 12:** Misc.: Inspection / maintenance - Due - Perform

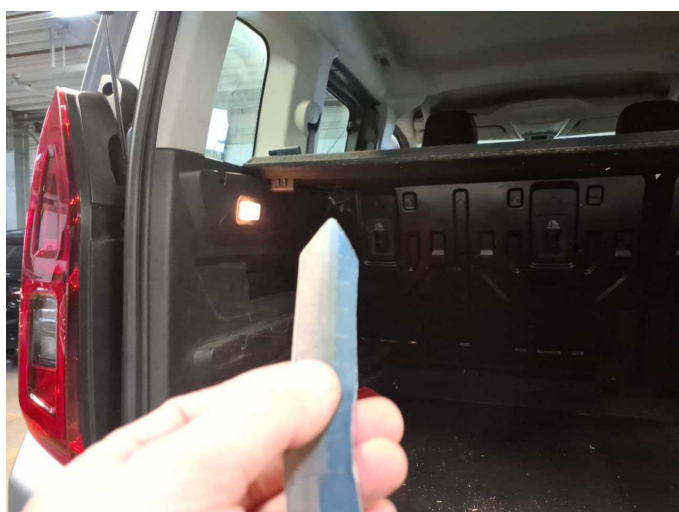
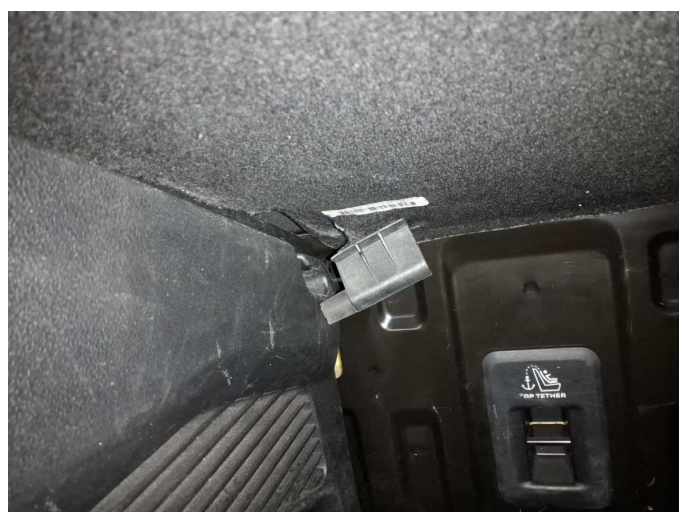
| No. | Component group | Description |
|---|---|---|
| 13 | Interior | Rear shelf (Halter) - Broken / torn - Replace |

**Damage 13:** Interior: Rear shelf (Halter) - Broken / torn - Replace

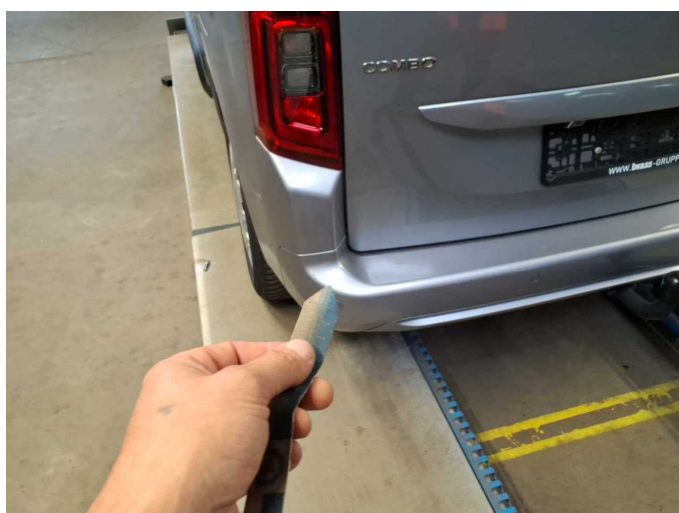
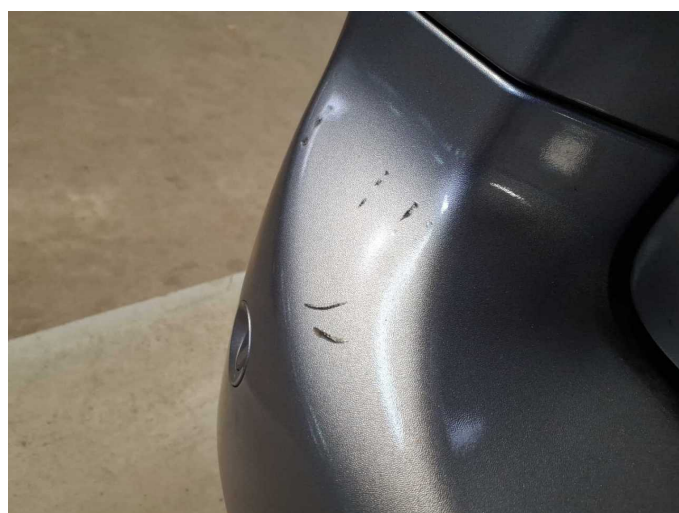
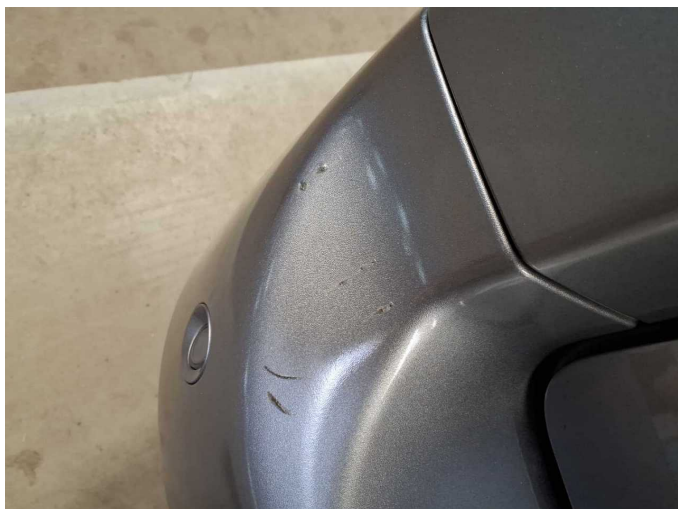
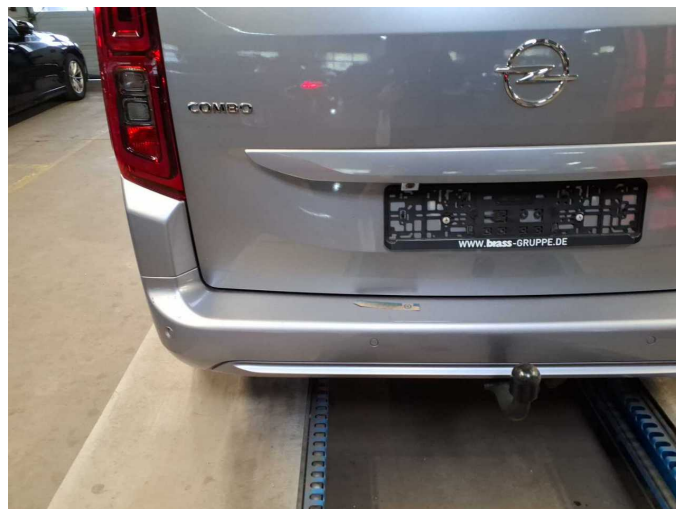
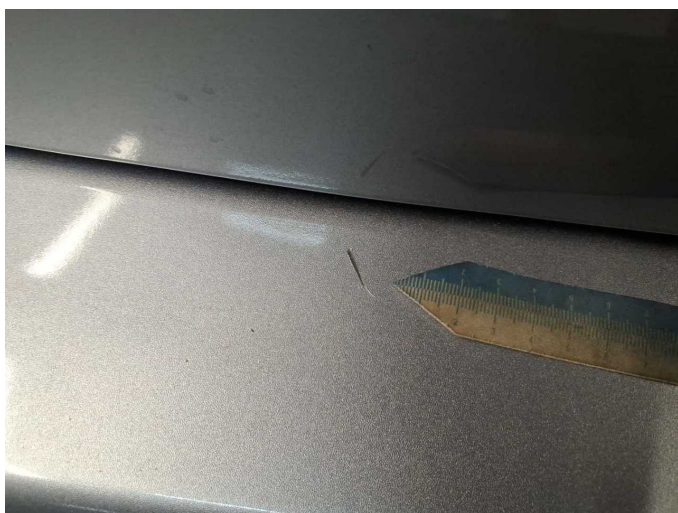
| No. | Component group | Description |
|---|---|---|
| 14 | Rear bumper | Rear bumper - Scratched - Paint |

**Damage 14:** Rear bumper: Rear bumper - Scratched - Paint

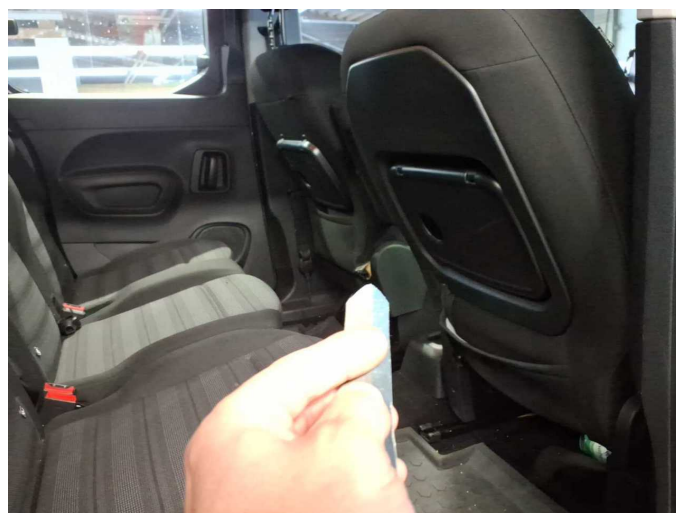
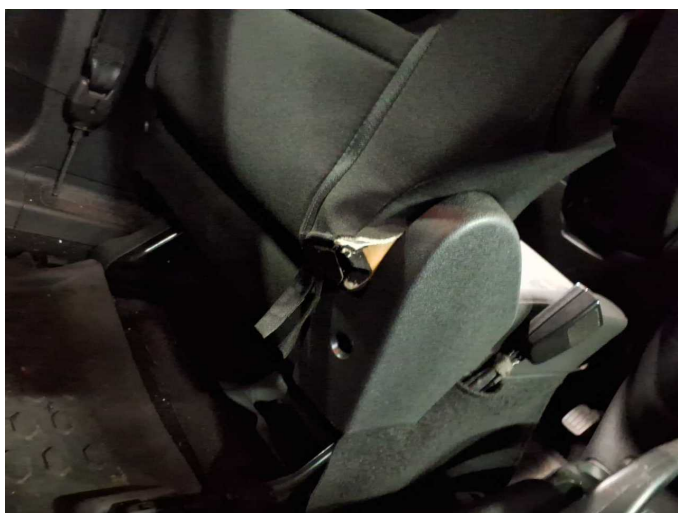
| No. | Component group | Description |
|---|---|---|
| 15 | Seat - front | Backrest cover - left side - Broken / torn - Replace |

**Damage 15:** Seat - front: Backrest cover - left side - Broken / torn - Replace

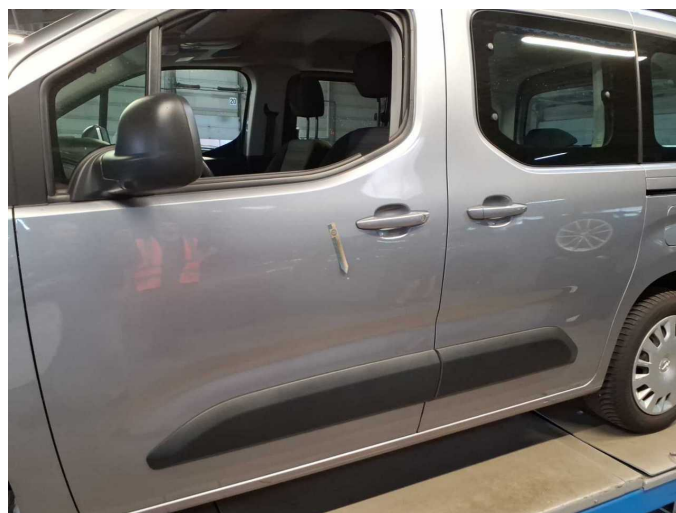
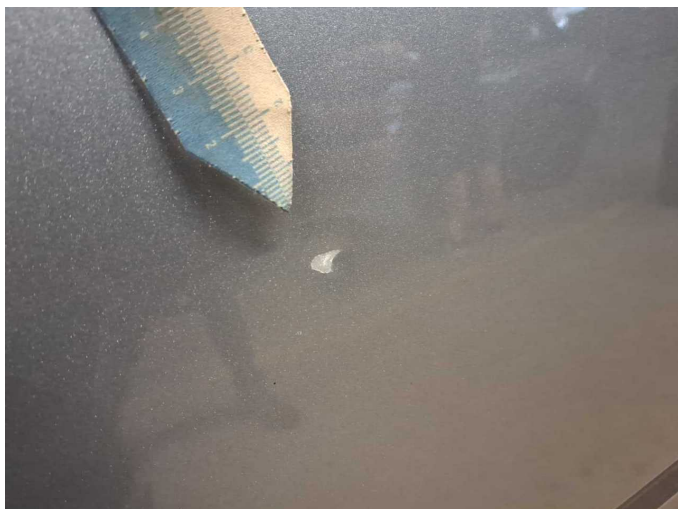
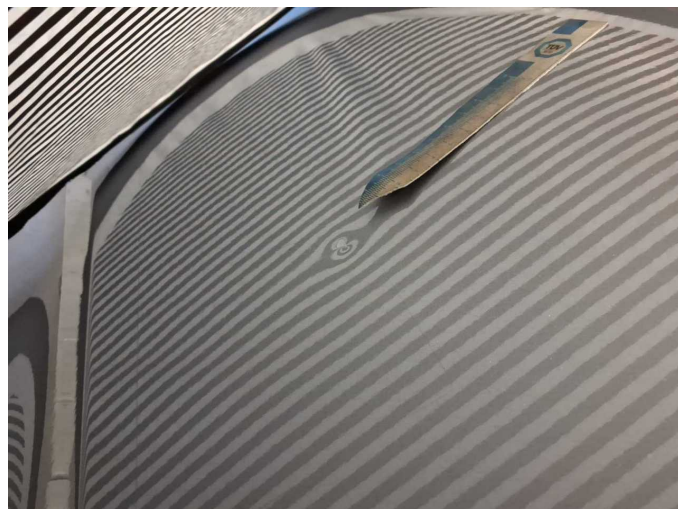
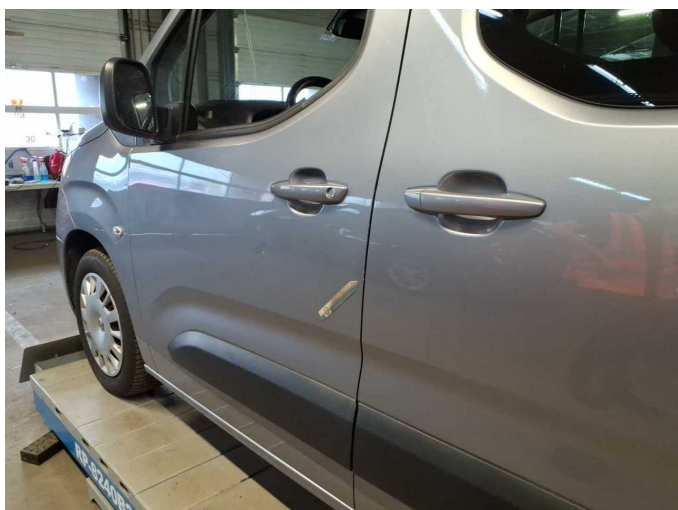
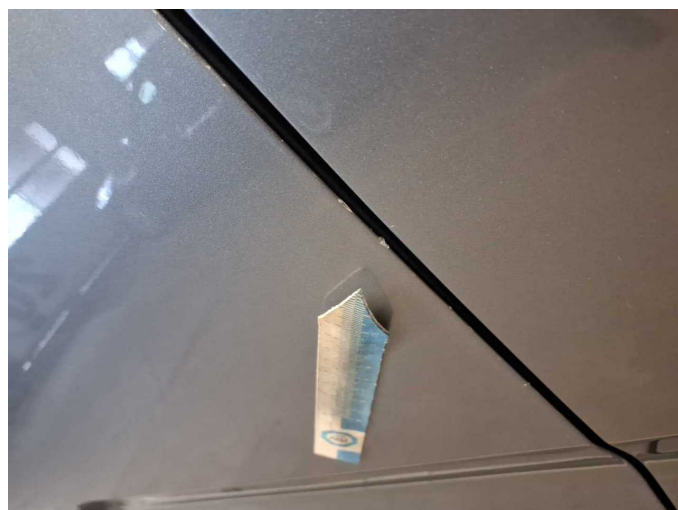
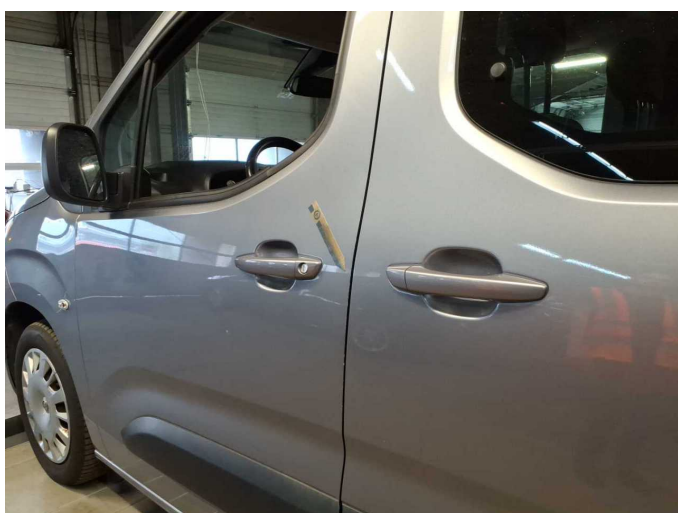
| No. | Component group | Description |
|---|---|---|
| 16 | Door - front left side | Door - Dent / paintcoat damage - Repair and paint |

**Damage 16:** Door - front left side: Door - Dent / paintcoat damage - Repair and paint

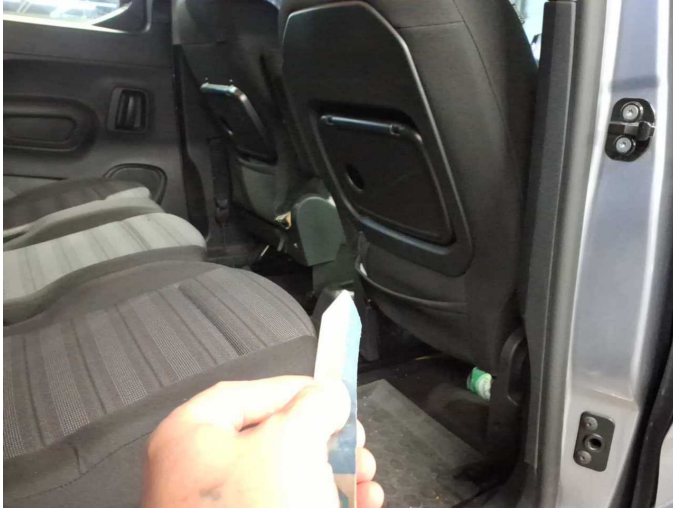
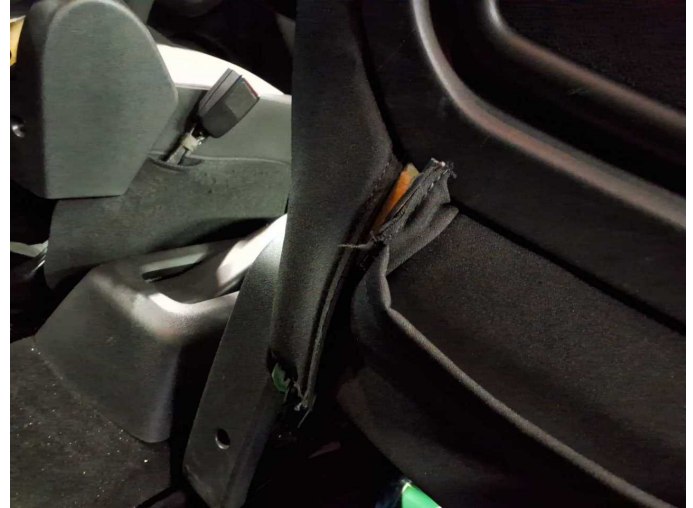
| No. | Component group | Description |
|---|---|---|
| 17 | Seat - front | Backrest cover - right side - Broken / torn - Replace |

**Damage 17:** Seat - front: Backrest cover - right side - Broken / torn - Replace

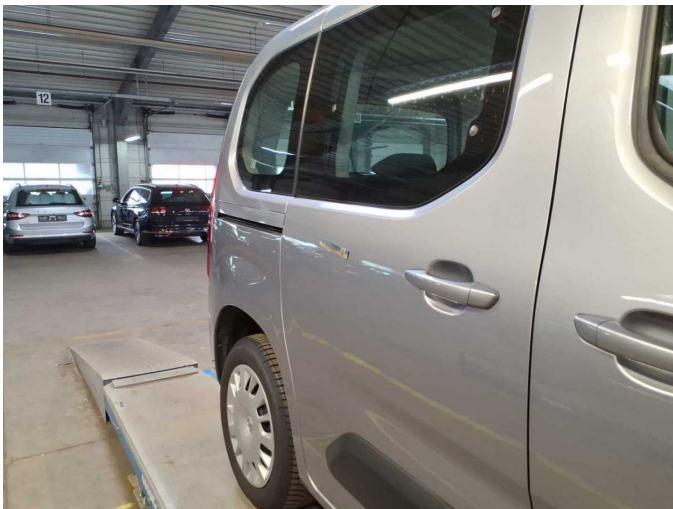
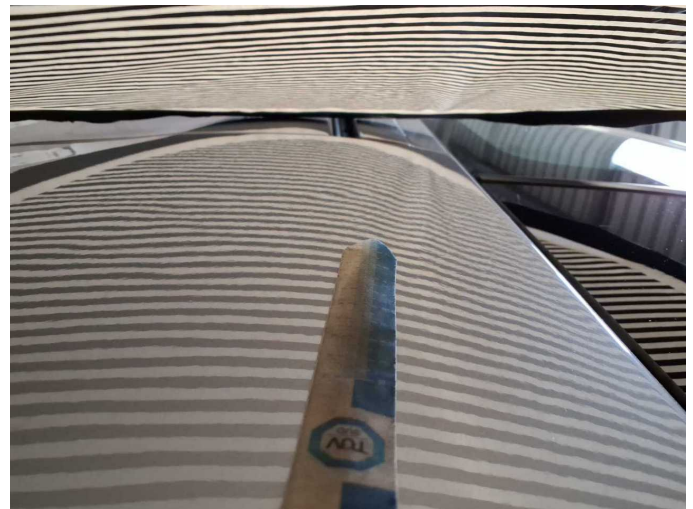
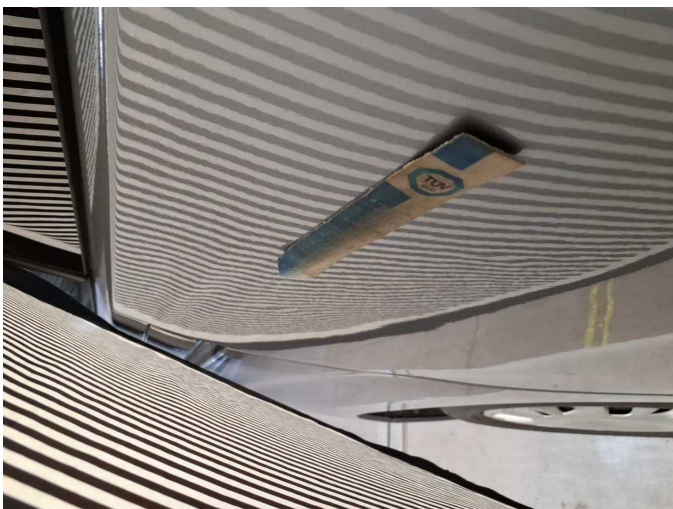
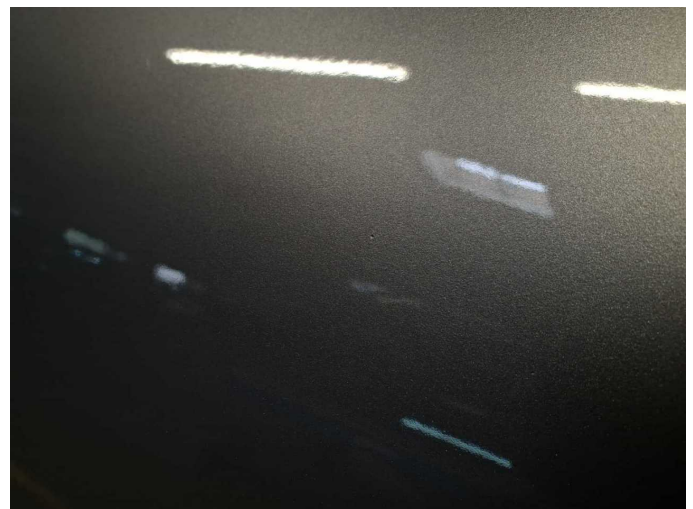
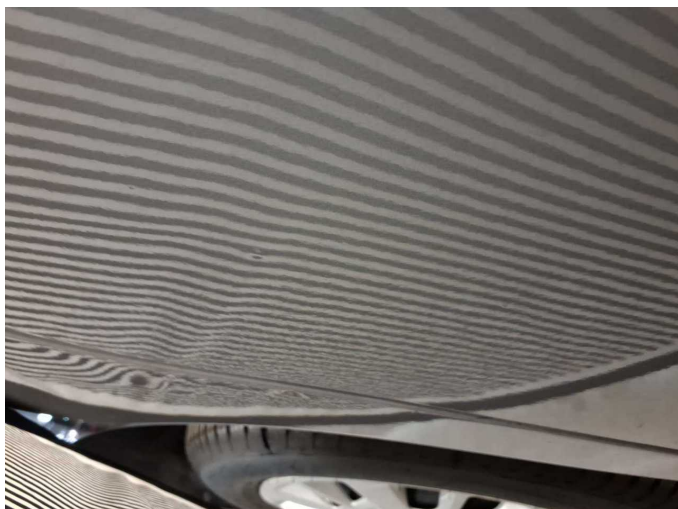
| No. | Component group | Description |
|---|---|---|
| 18 | Sliding door, right | Sliding door with glass panel (Wellig, Einschlüsse) - Unprofessionally repaired - Repair and paint |

**Damage 18:** Sliding door, right: Sliding door with glass panel (Wellig, Einschlüsse) - Unprofessionally repaired - Repair and paint

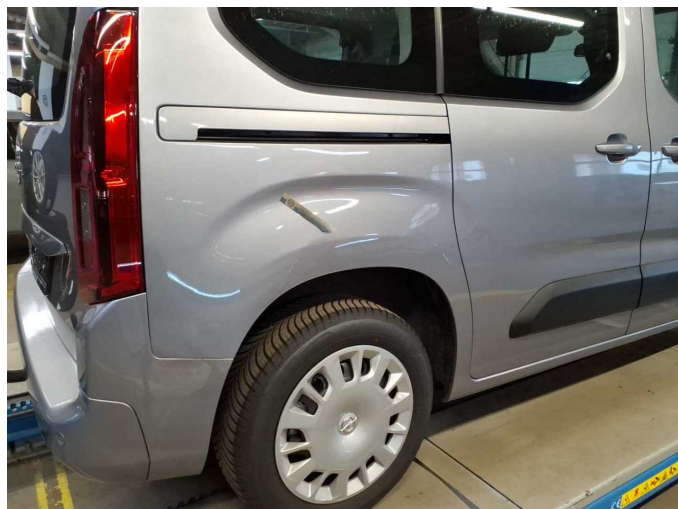
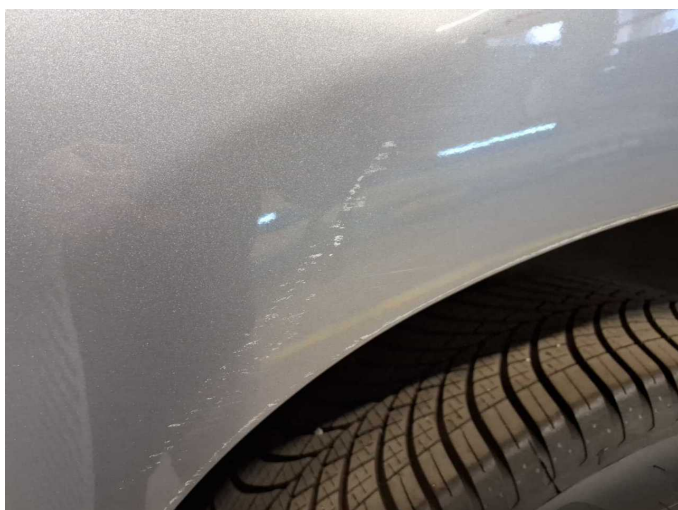
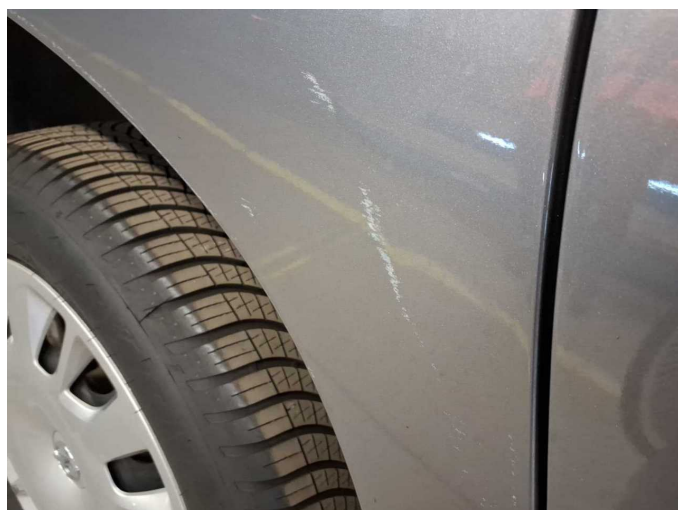
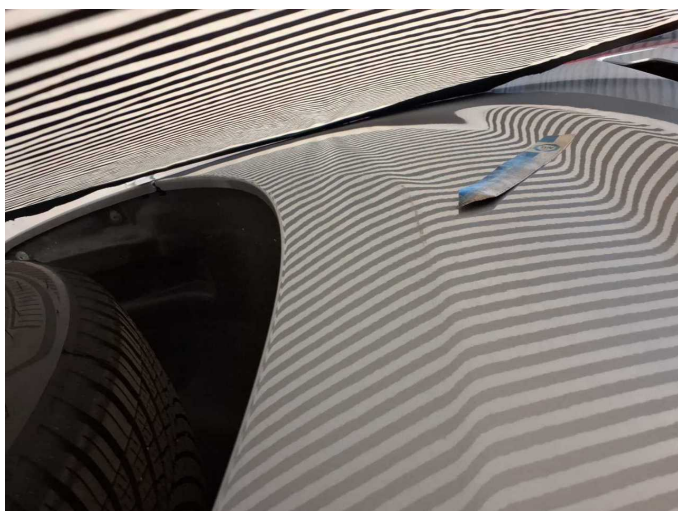
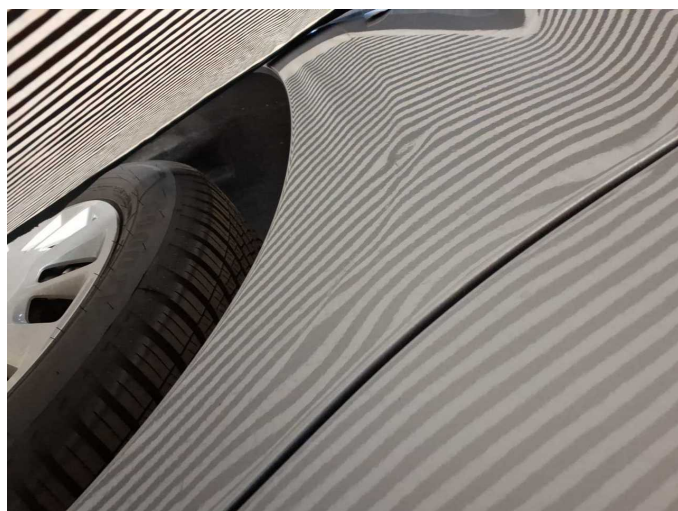
| No. | Component group | Description |
|---|---|---|
| 19 | Side panel - rear right side | Side panel (Verkratzt) - Deformed - Repair and paint |

**Damage 19:** Side panel - rear right side: Side panel (Verkratzt) - Deformed - Repair and paint

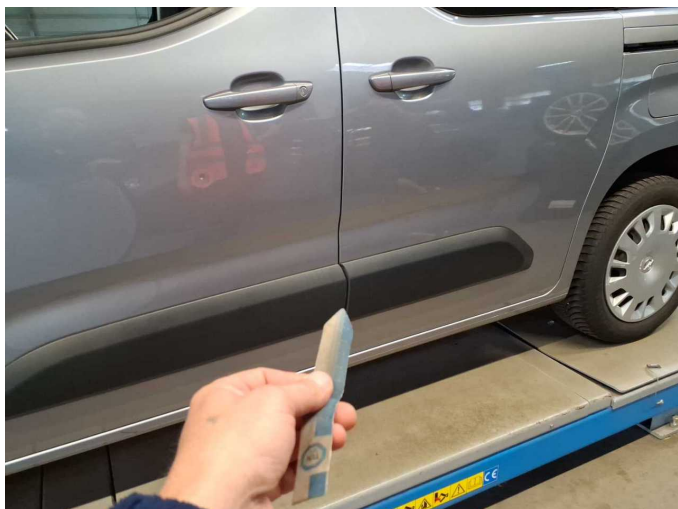
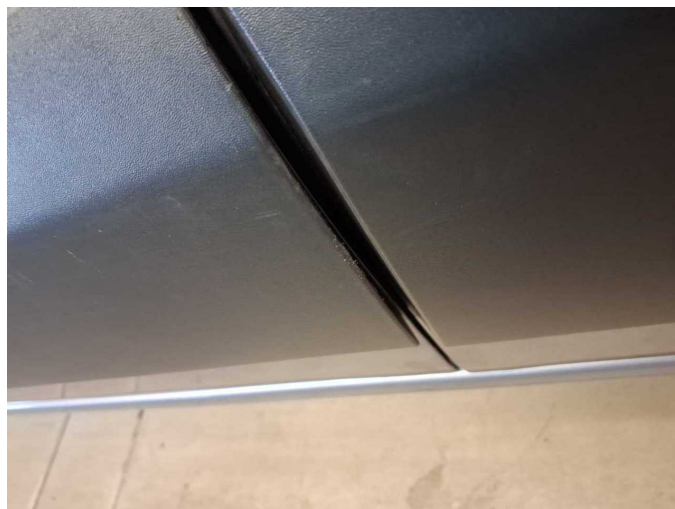
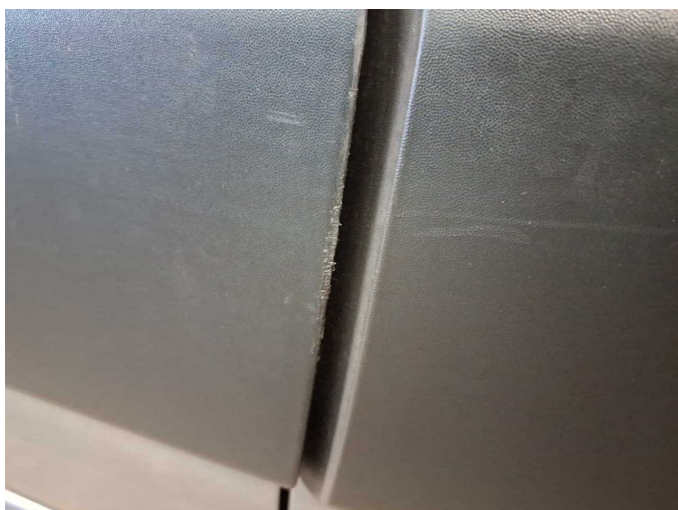
| No. | Component group | Description |
|---|---|---|
| 3 | Door - front left side | Brightware - lower - Scratch(es) - No deduction |

**Wear and tear 3:** Door - front left side: Brightware - lower - Scratch(es) - No deduction
