Expertise

Protocol number: 46593844  
Order No. / Reference: 26685214  
Inspection date: 20 Jul 2026

Manufacturer: Mercedes-Benz  
VIN: W1V44760314135152

Model: Vito 114 CDI Lang HA PRO

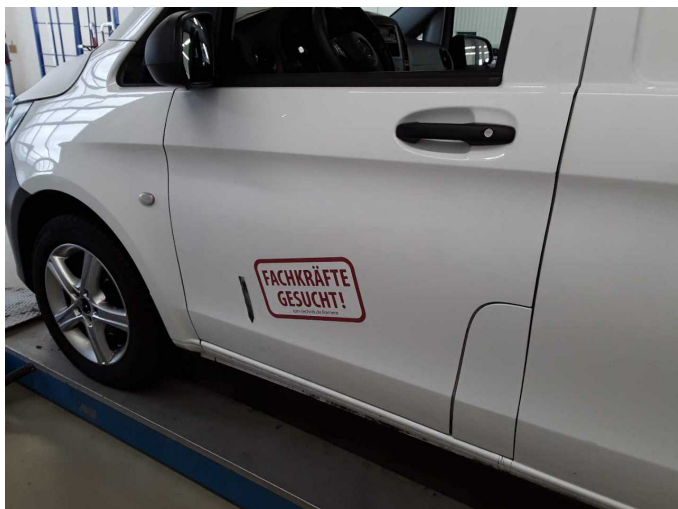
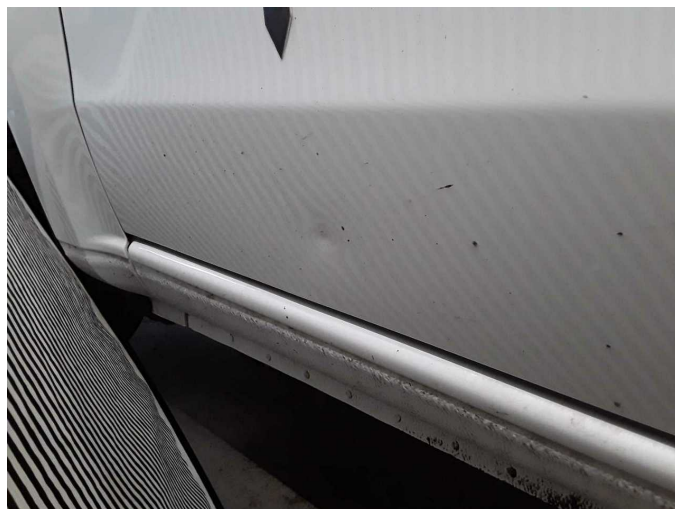
| No. | Component group | Description |
|---|---|---|
| 1 | Door - front left side | Door - dent(s) - Smart repair |

**Damage 1:** Door - front left side: Door - dent(s) - Smart repair

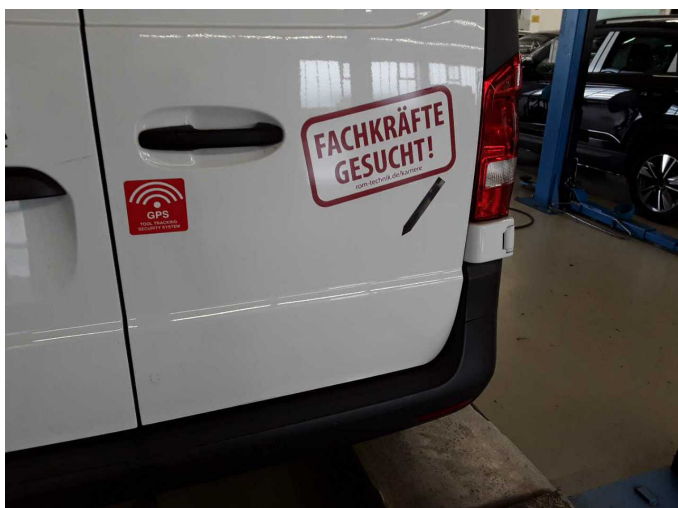
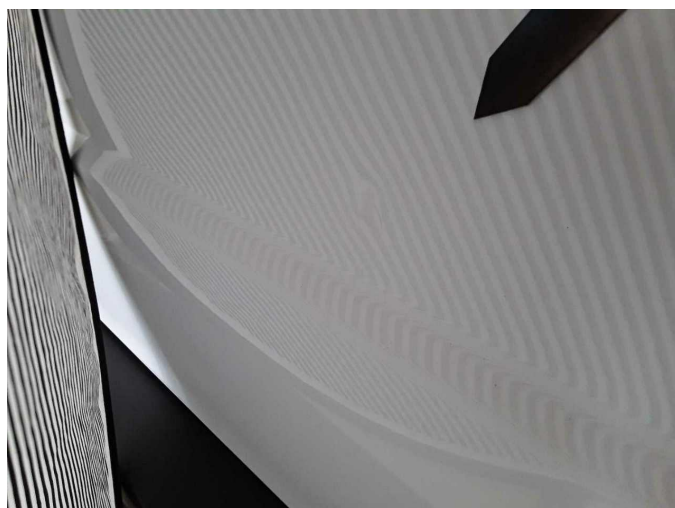
| No. | Component group | Description |
|---|---|---|
| 2 | Boot lid / rear door | Rear door - right side - dent(s) - Smart repair |

**Damage 2:** Boot lid / rear door: Rear door - right side - dent(s) - Smart repair

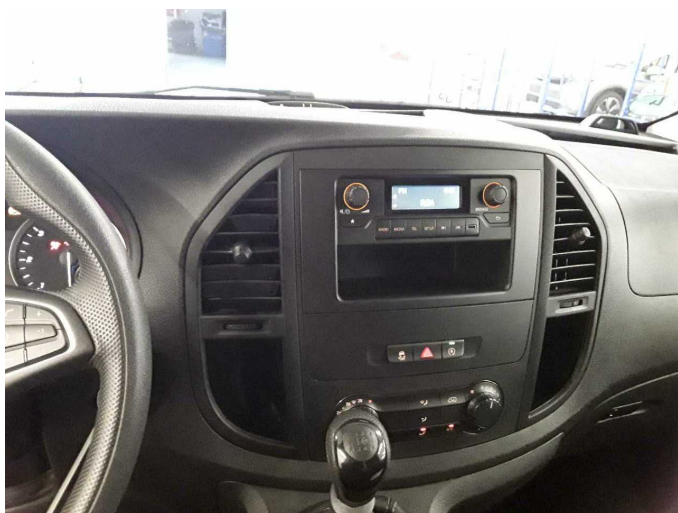
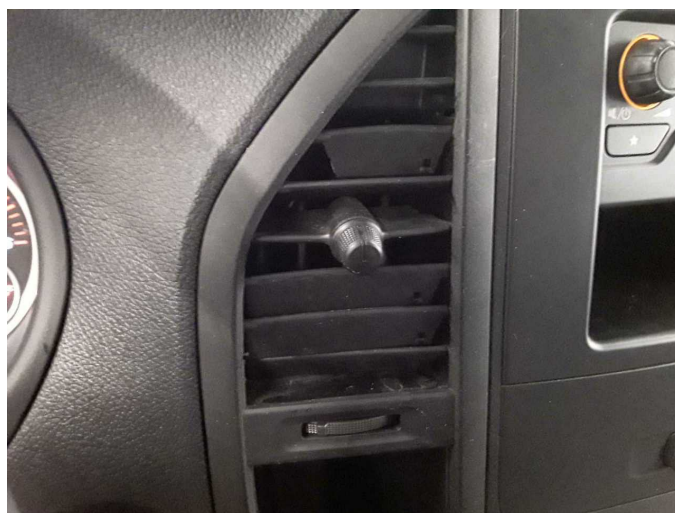
| No. | Component group | Description |
|---|---|---|
| 3 | Instrument panel | Air nozzle - centre (links) - Broken / torn - Replace |

**Damage 3:** Instrument panel: Air nozzle - centre (links) - Broken / torn - Replace

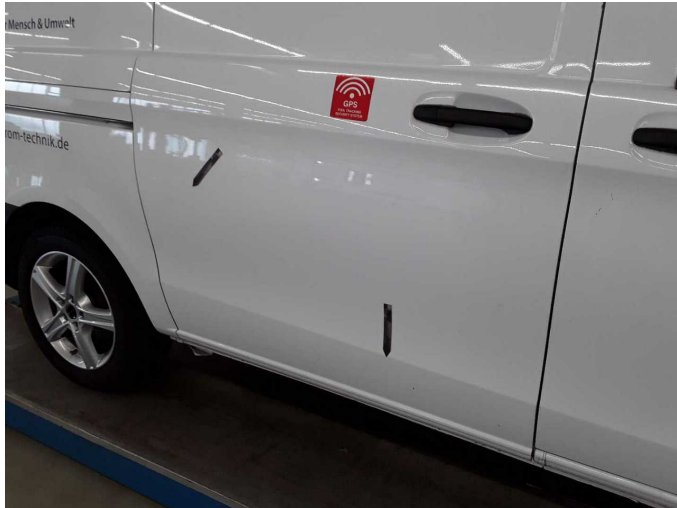
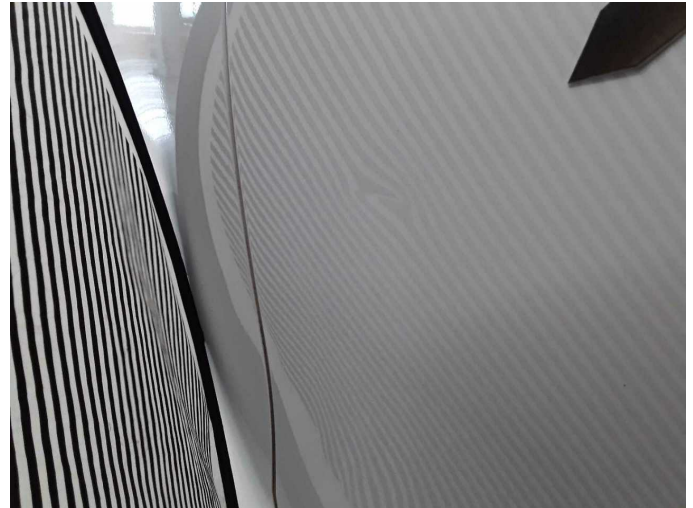
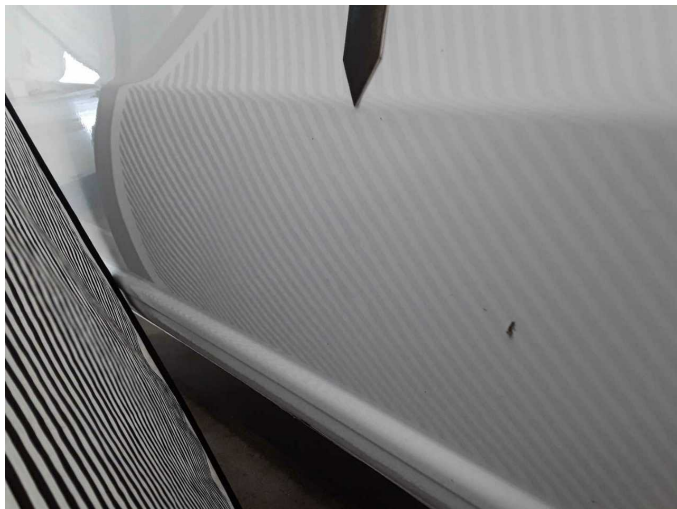
| No. | Component group | Description |
|---|---|---|
| 4 | Sliding door, right | Sliding door - dent(s) - Smart repair |

**Damage 4:** Sliding door, right: Sliding door - dent(s) - Smart repair

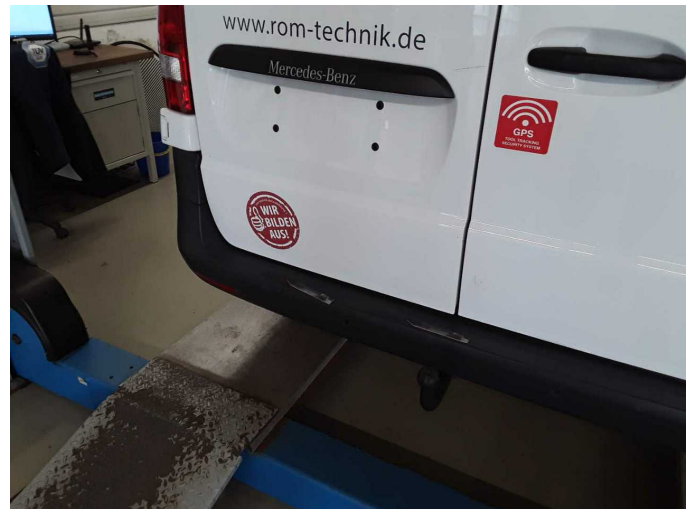
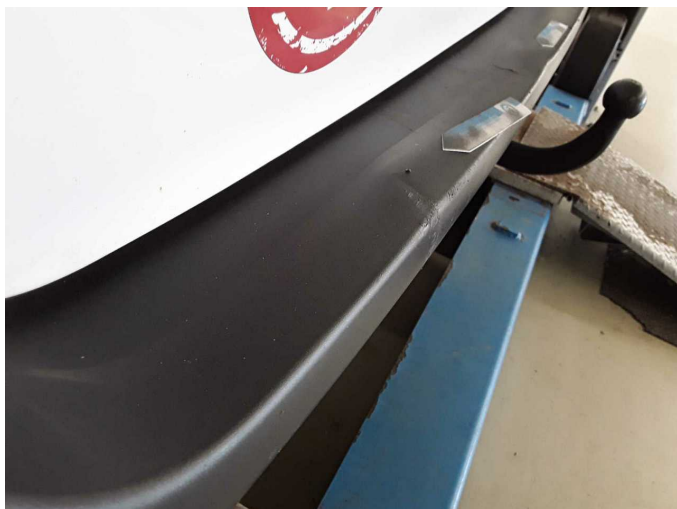
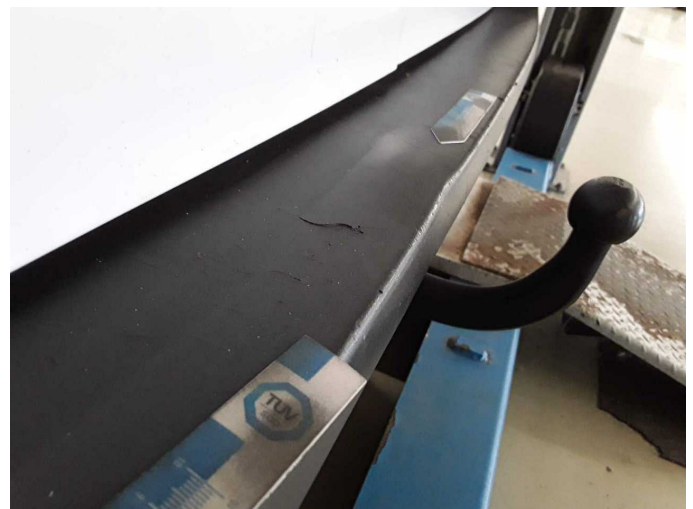
| No. | Component group | Description |
|---|---|---|
| 5 | Rear bumper | Bumper with Parktronic - Deformed - Loss in value |

**Damage 5:** Rear bumper: Bumper with Parktronic - Deformed - Loss in value

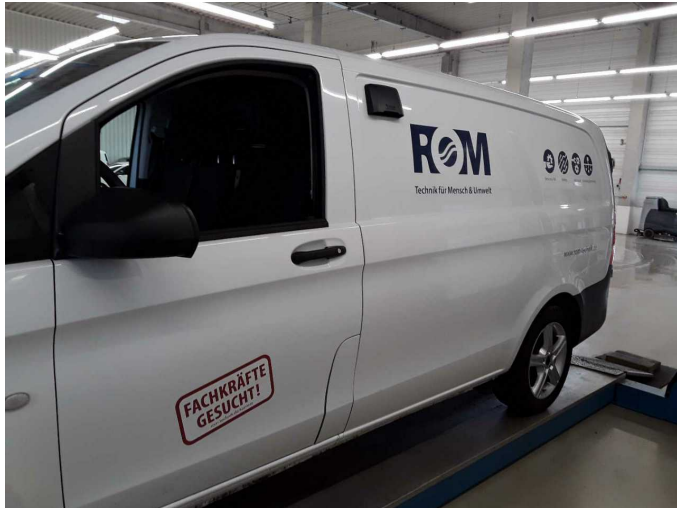
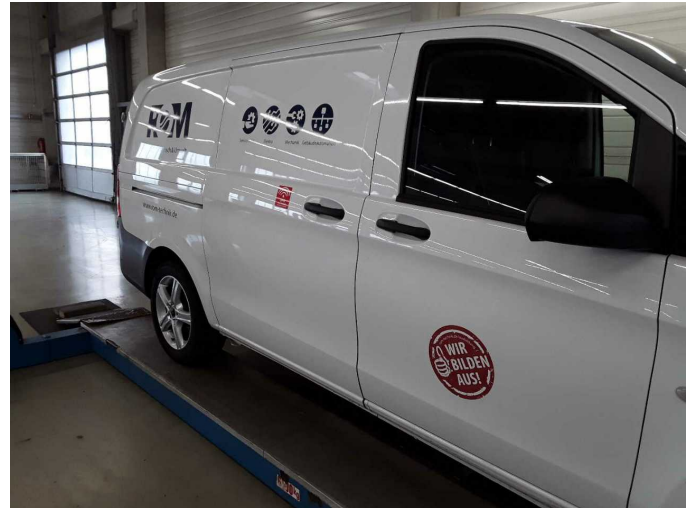
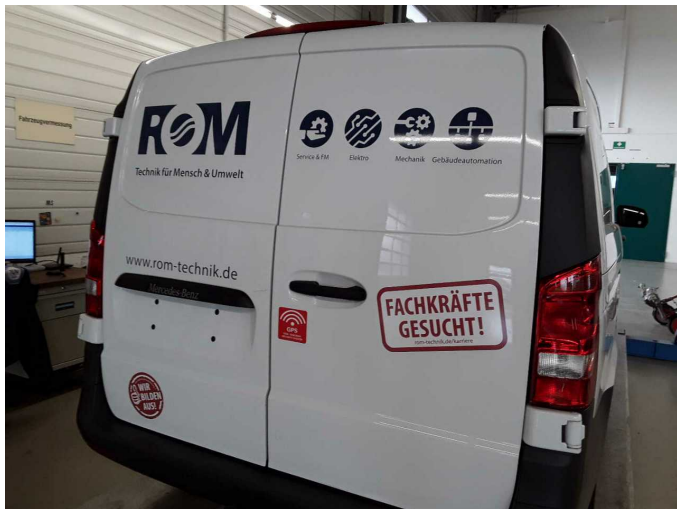
| No. | Component group | Description |
|---|---|---|
| 6 | Body | Body (Zusatzkosten können entstehen) - Glued / labelled - De-glue / neutralise |

**Damage 6:** Body: Body (Zusatzkosten können entstehen) - Glued / labelled - De-glue / neutralise

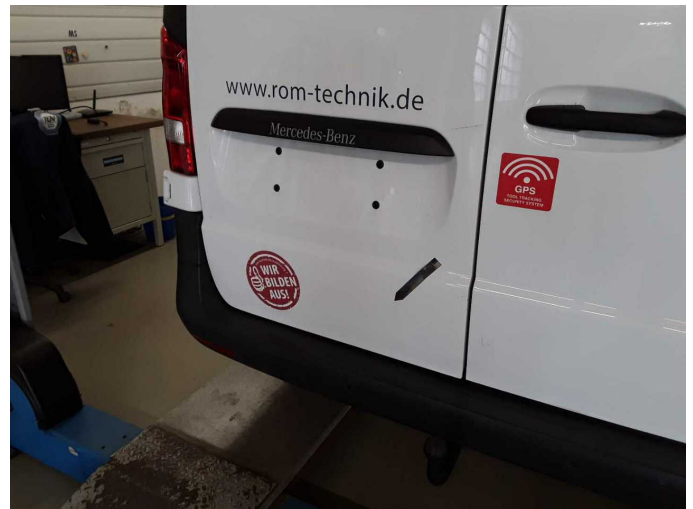
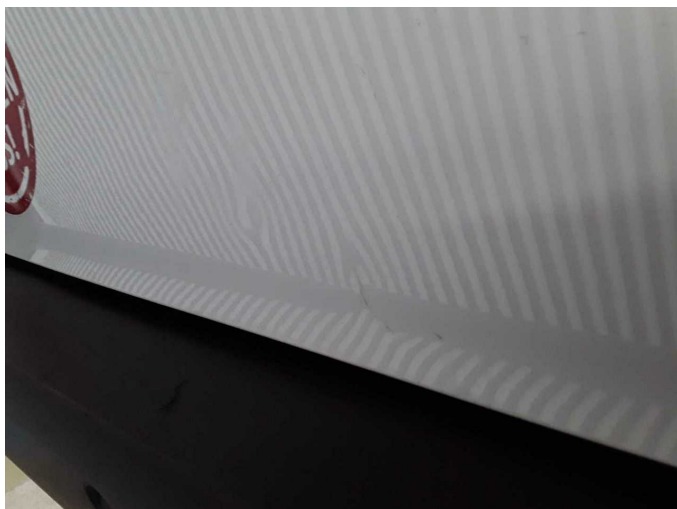
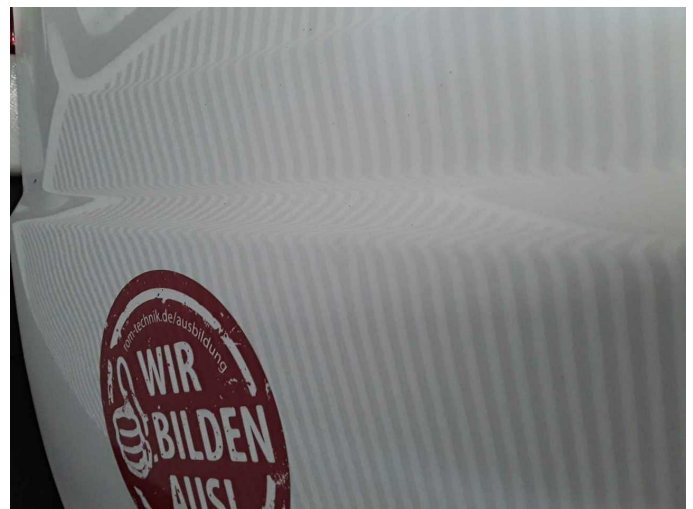
| No. | Component group | Description |
|---|---|---|
| 7 | Boot lid / rear door | Rear door - left side - dent(s) - Repair and paint |

**Damage 7:** Boot lid / rear door: Rear door - left side - dent(s) - Repair and paint

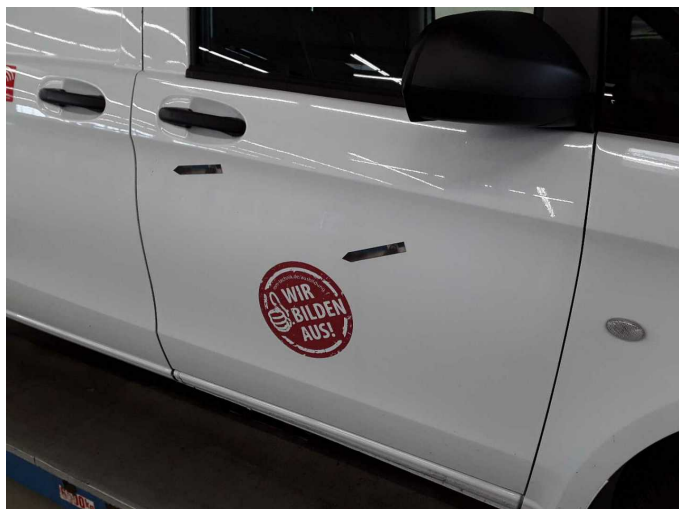
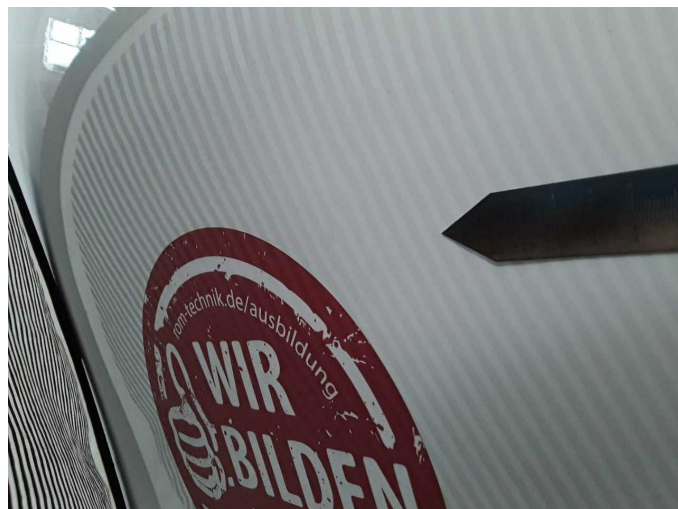
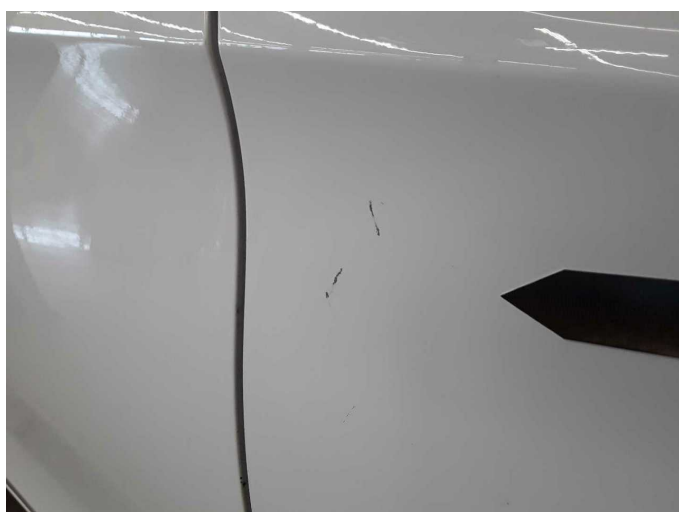
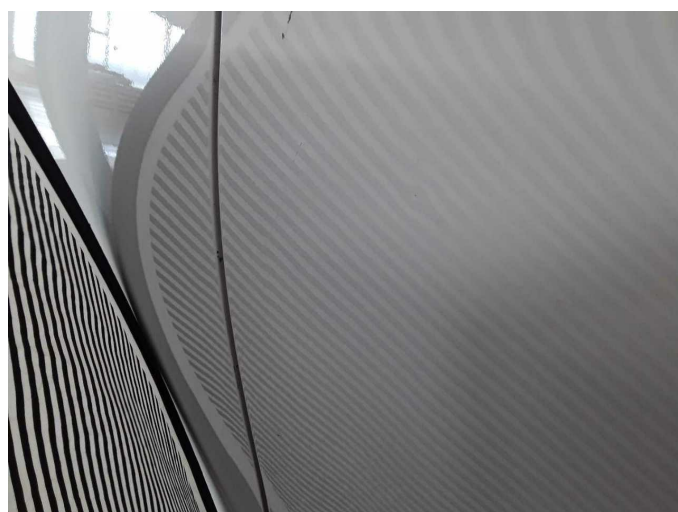
| No. | Component group | Description |
|---|---|---|
| 8 | Door - front right side | Door - Dent / paintcoat damage - Repair and paint |

**Damage 8:** Door - front right side: Door - Dent / paintcoat damage - Repair and paint

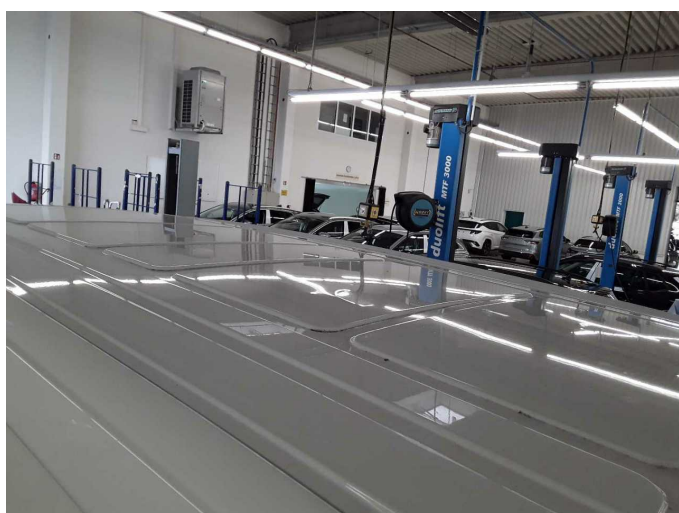
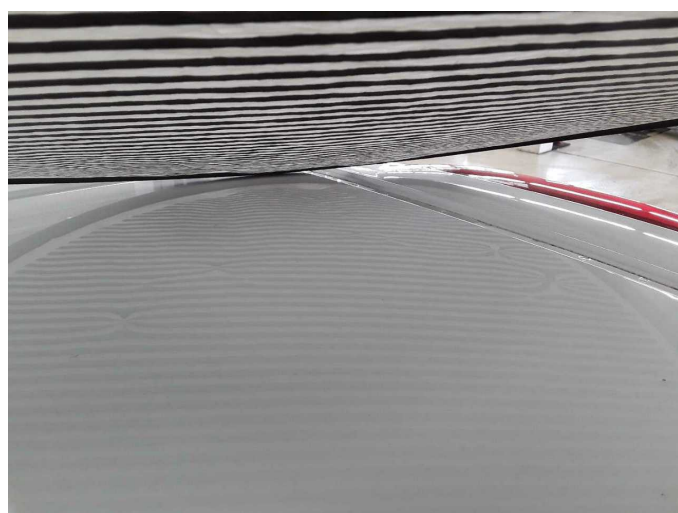
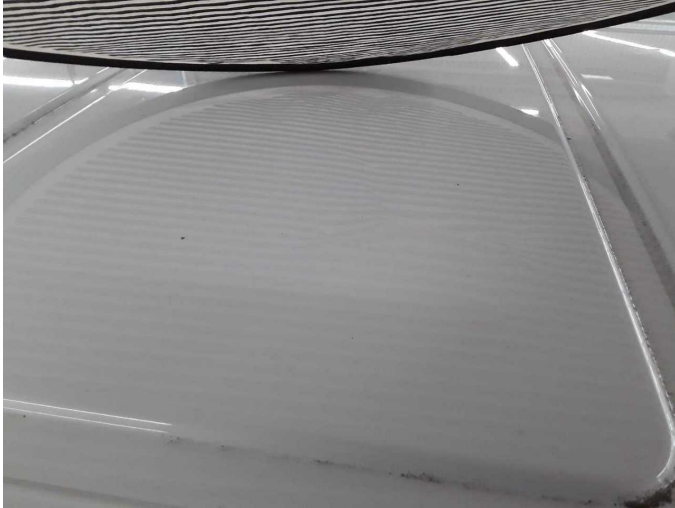
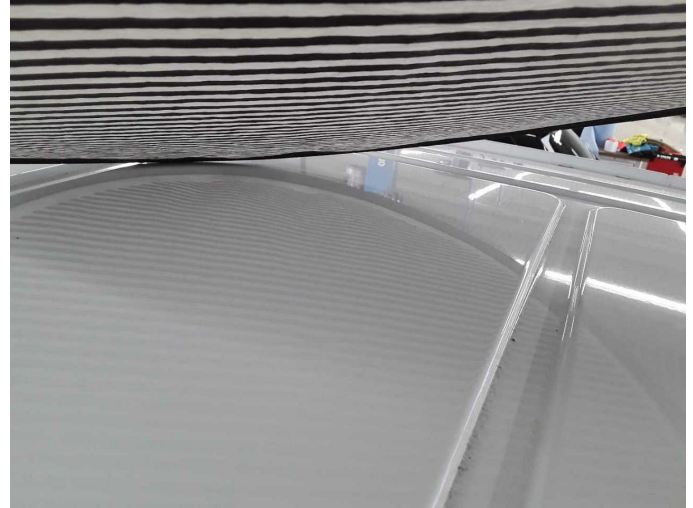
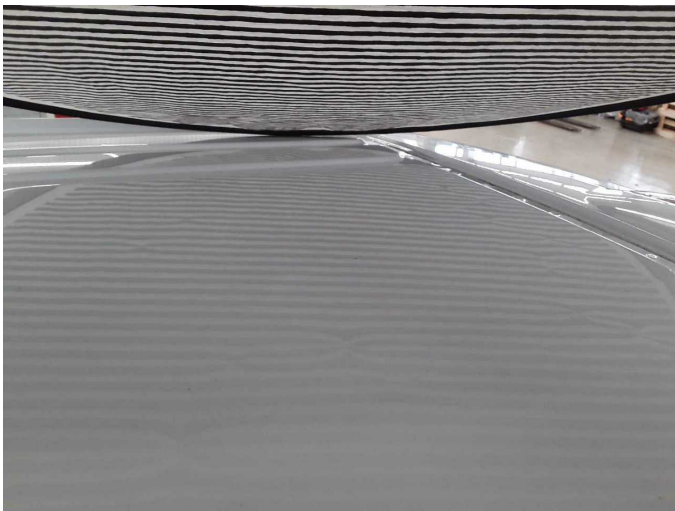
| No. | Component group | Description |
|---|---|---|
| 9 | Roof | Roof - Dent / paintcoat damage - Repair and paint |

**Damage 9:** Roof: Roof - Dent / paintcoat damage - Repair and paint
