Expertise

Protocol number: 46421681  
Order No. / Reference: 26348952  
Inspection date: 6 Jul 2026

Manufacturer: Mercedes-Benz  
VIN: W1N4M1AB0RW348699

Model: GLB 180 d 8G-DCT Entry

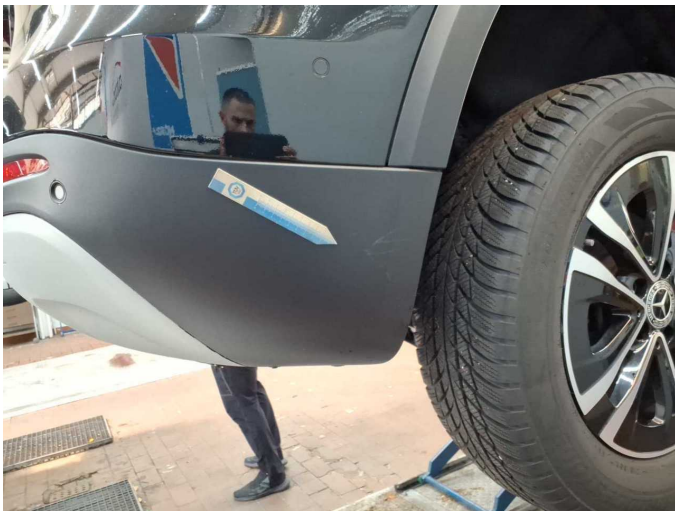
| No. | Component group | Description |
|---|---|---|
| 1 | Rear bumper | Spoiler - Scratch(es) - Loss in value |

**Damage 1:** Rear bumper: Spoiler - Scratch(es) - Loss in value

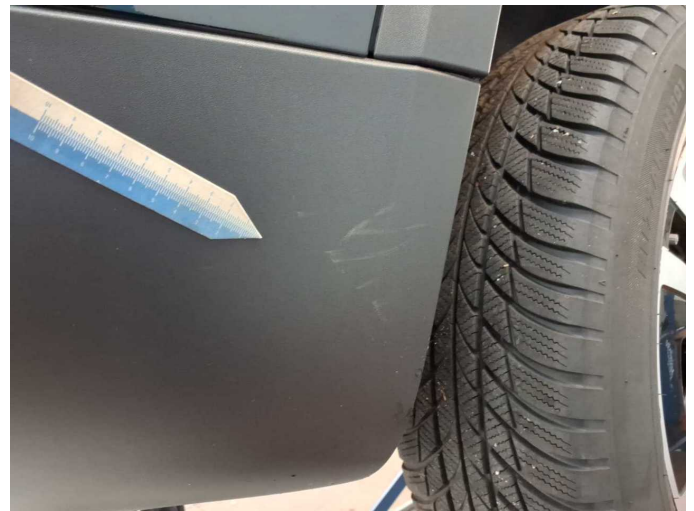
**Damage 1:** Rear bumper: Spoiler - Scratch(es) - Loss in value

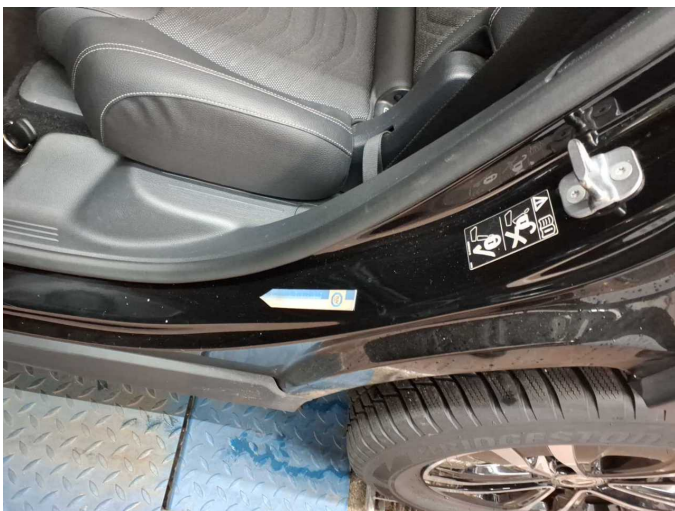
| No. | Component group | Description |
|---|---|---|
| 2 | Side panel - rear left side | Sill - dent(s) - Smooth repair work |

**Damage 2:** Side panel - rear left side: Sill - dent(s) - Smooth repair work

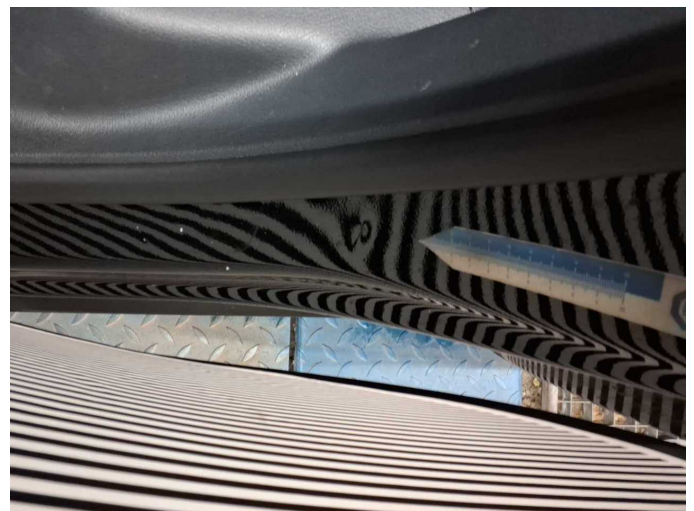
**Damage 2:** Side panel - rear left side: Sill - dent(s) - Smooth repair work

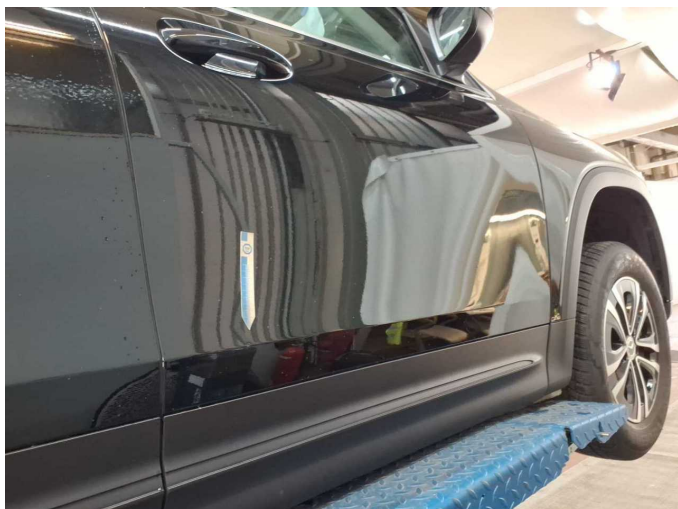
| No. | Component group | Description |
|---|---|---|
| 3 | Door - front right side | Door (kratzer) - Dent / paintcoat damage - Paint |

**Damage 3:** Door - front right side: Door (kratzer) - Dent / paintcoat damage - Paint

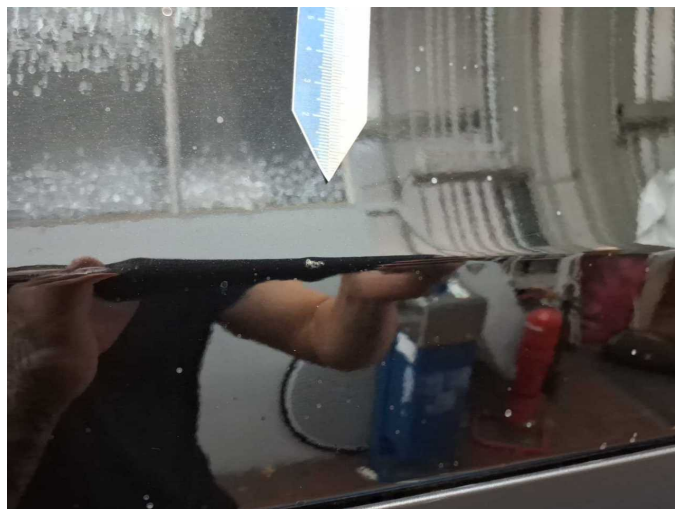
**Damage 3:** Door - front right side: Door (kratzer) - Dent / paintcoat damage - Paint

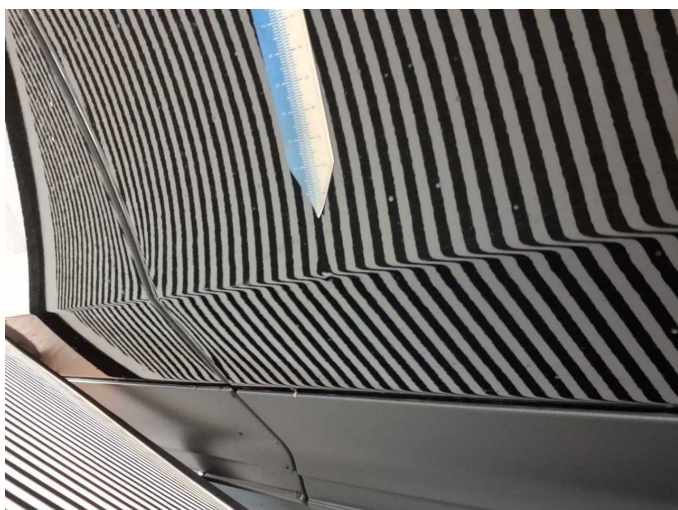
**Damage 3:** Door - front right side: Door (kratzer) - Dent / paintcoat damage - Paint

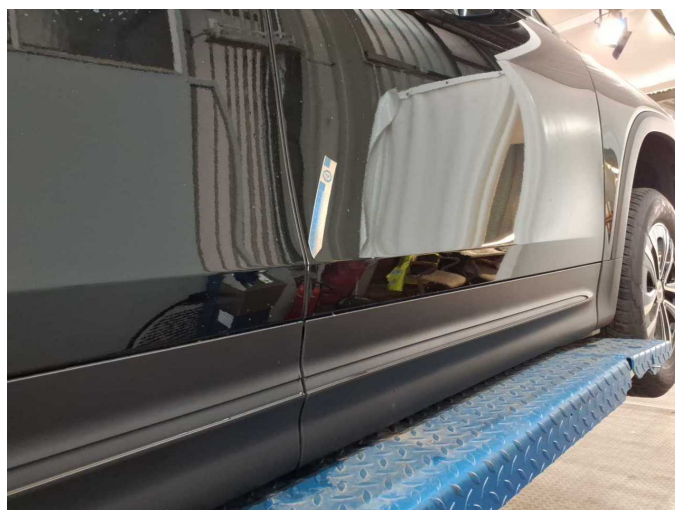
**Damage 3:** Door - front right side: Door (kratzer) - Dent / paintcoat damage - Paint

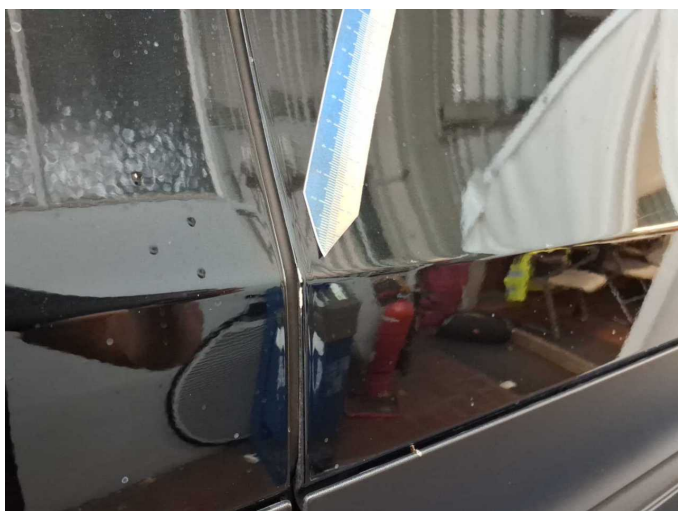
**Damage 3:** Door - front right side: Door (kratzer) - Dent / paintcoat damage - Paint

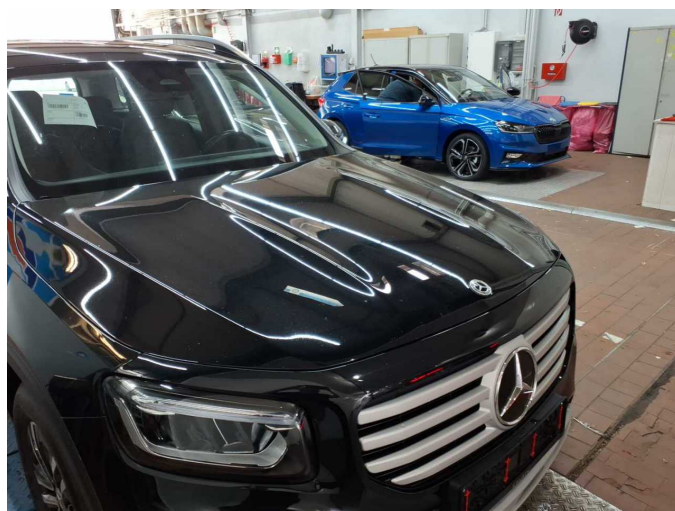
| No. | Component group | Description |
|---|---|---|
| 4 | Bonnet | Bonnet - Stone chips - Paint |

**Damage 4:** Bonnet: Bonnet - Stone chips - Paint

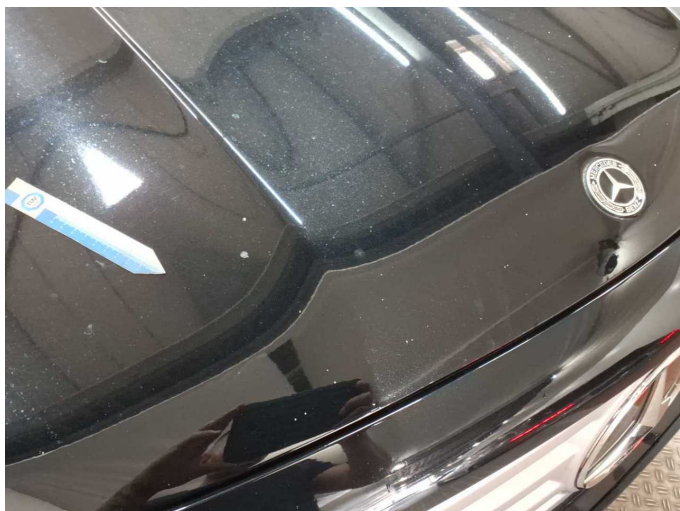
**Damage 4:** Bonnet: Bonnet - Stone chips - Paint

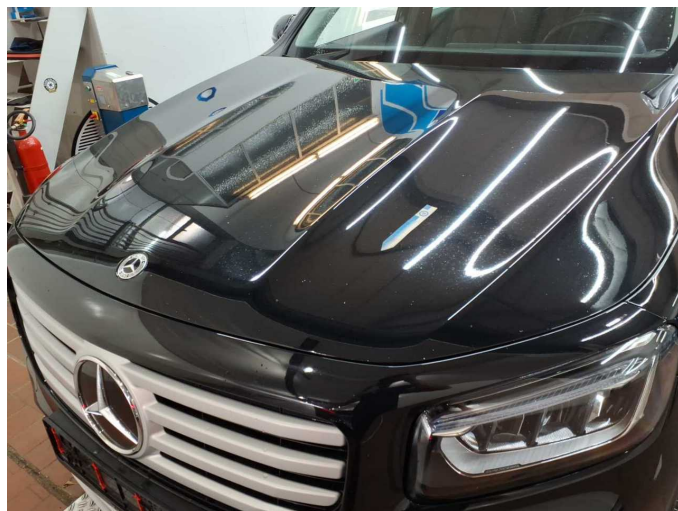
**Damage 4:** Bonnet: Bonnet - Stone chips - Paint

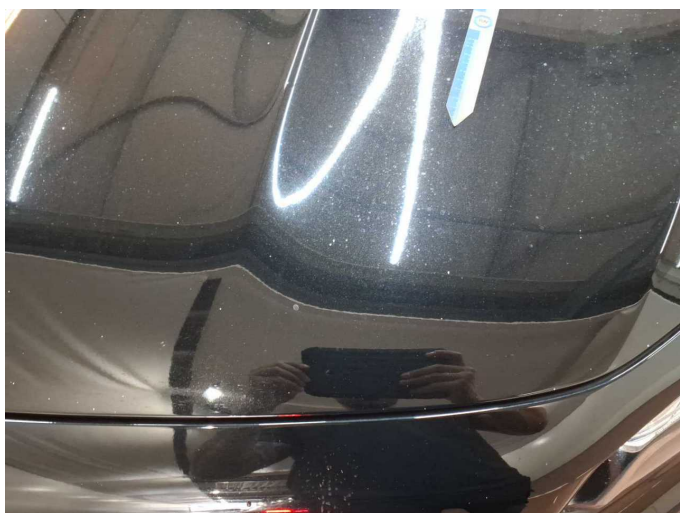
**Damage 4:** Bonnet: Bonnet - Stone chips - Paint

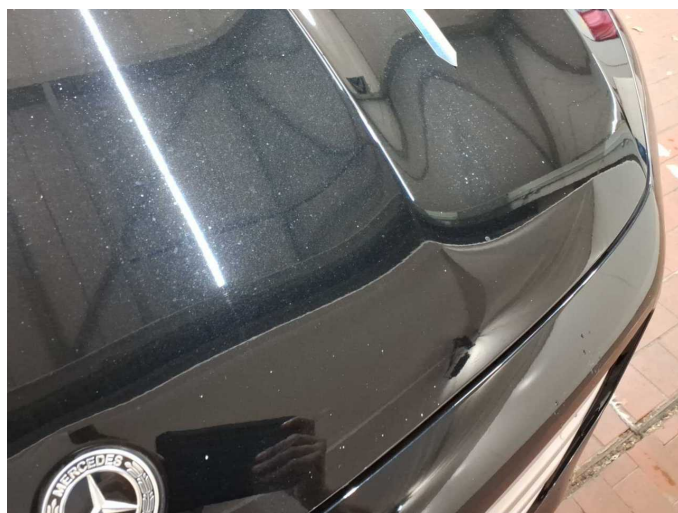
**Damage 4:** Bonnet: Bonnet - Stone chips - Paint

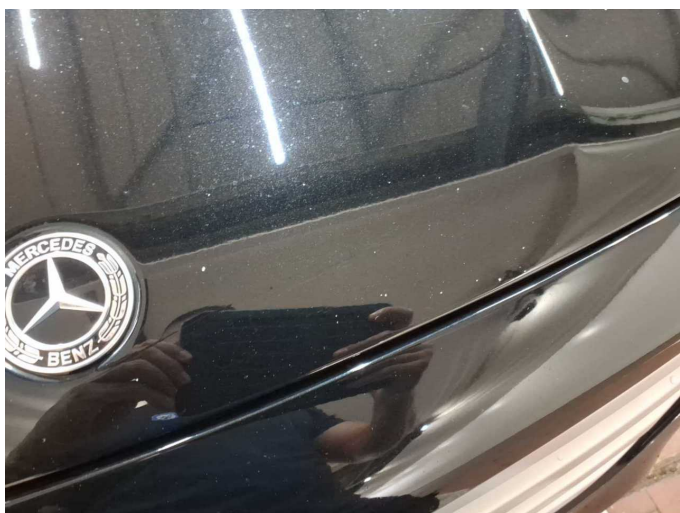
**Damage 4:** Bonnet: Bonnet - Stone chips - Paint

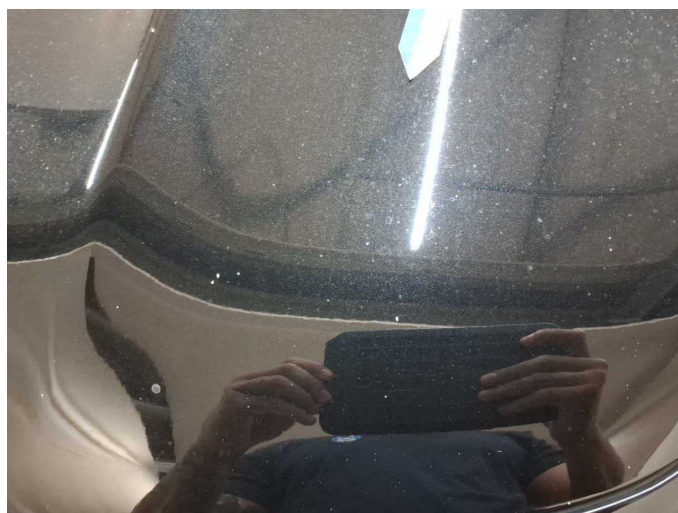
**Damage 4:** Bonnet: Bonnet - Stone chips - Paint

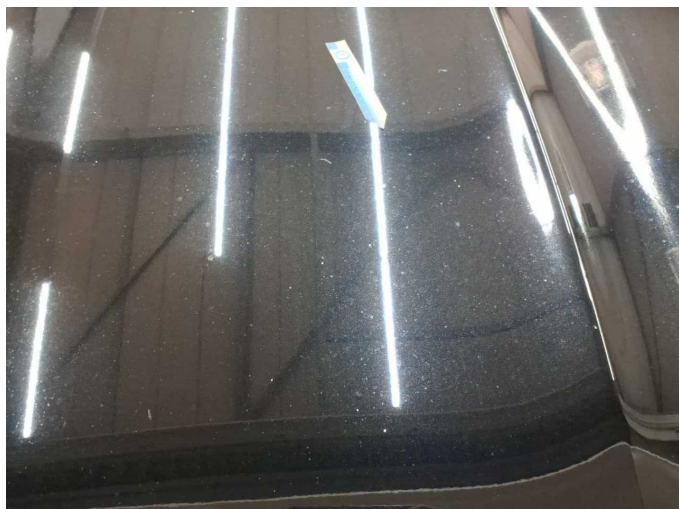
**Damage 4:** Bonnet: Bonnet - Stone chips - Paint

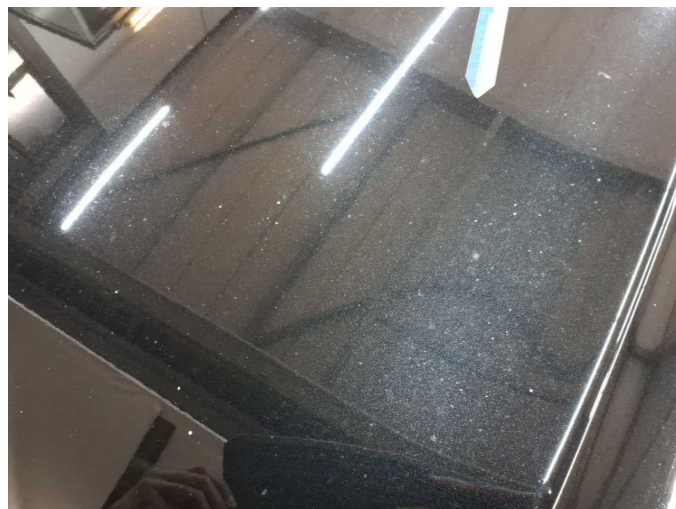
**Damage 4:** Bonnet: Bonnet - Stone chips - Paint
