Expertise

Protocol number: 46497916  
Order No. / Reference: 26152024  
Inspection date: 29 Jun 2026

Manufacturer: Mercedes-Benz  
VIN: W1VVLCEZ9T4565360

Model: Vito 116 CDI Extralang HA Aut. PRO

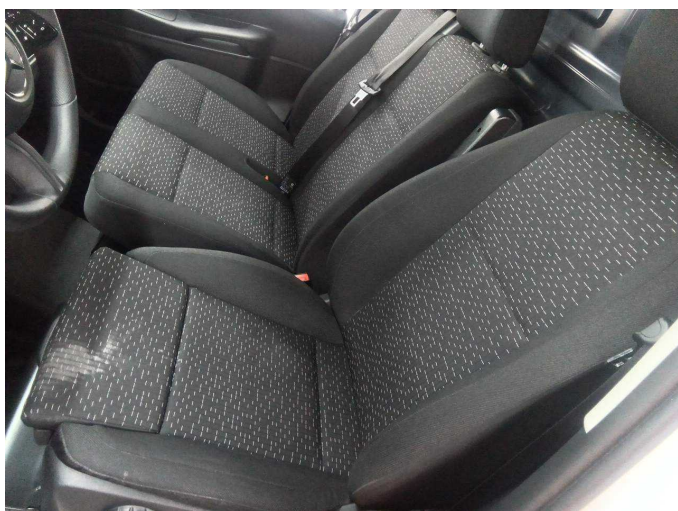
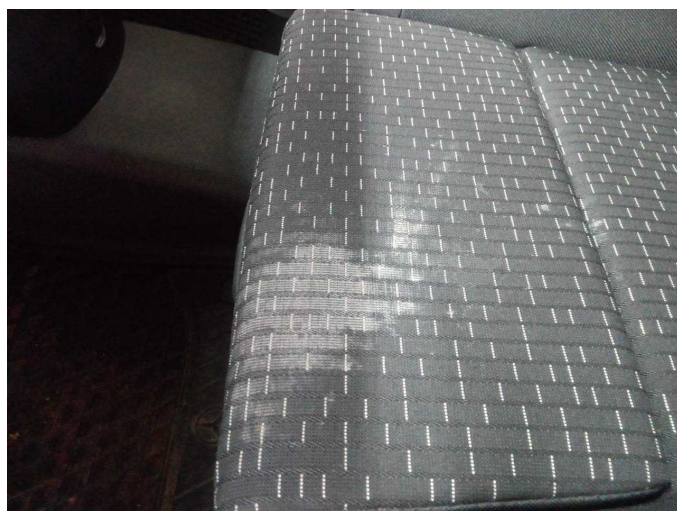
| No. | Component group | Description |
|---|---|---|
| 1 | Seat - front | Seat cover - left side (Fleck) - Clean |

Damage 1: Seat - front: Seat cover - left side (Fleck) - Clean

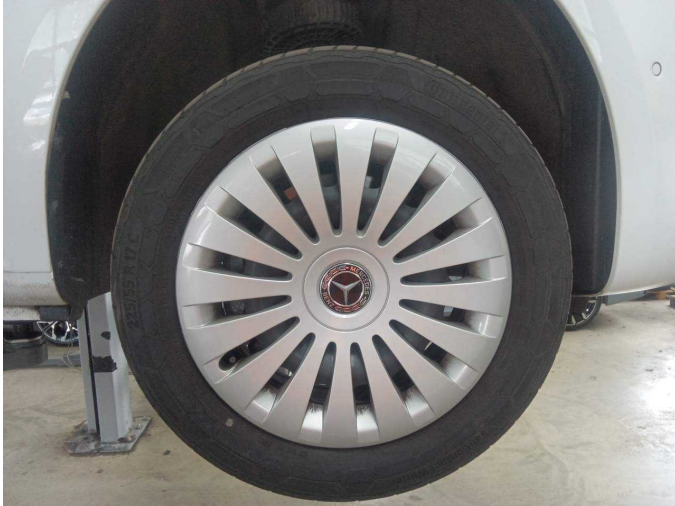
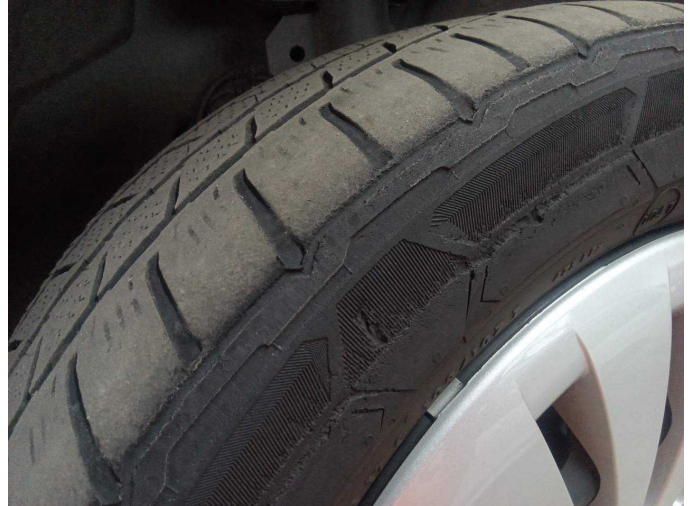
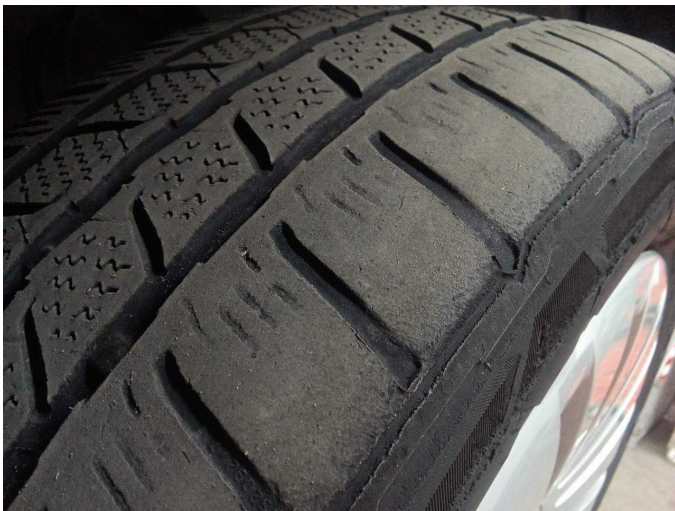
| # | Tyre size | Type of tyre | Manufacturer | Tread depth |
|---|---|---|---|---|
| 1) | 225/55 R17 109T | Winter tyres on Steel rim with wheel cover | Continental | 4mm / 3mm |

| No. | Component group | Description |
|---|---|---|
| 2 | Wheel / tyres | Tyre - front right side (Restlichen 3 Reifen 4,5mm) - Worn - Replace |

**Damage 2:** Wheel / tyres: Tyre - front right side (Restlichen 3 Reifen 4,5mm) - Worn - Replace

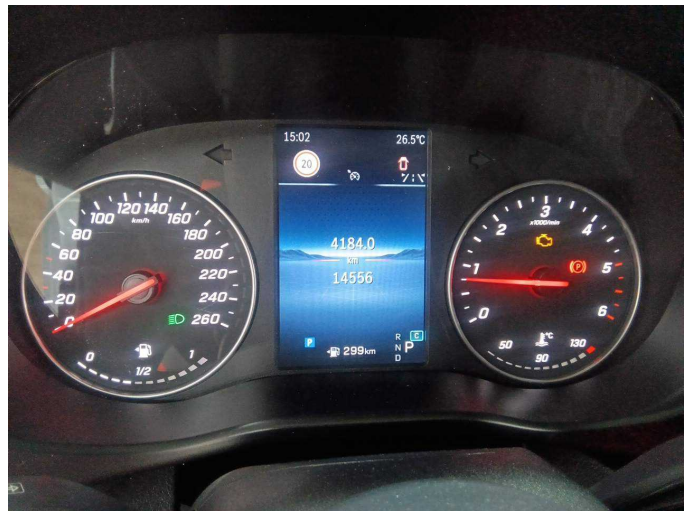
| No. | Component group | Description |
|---|---|---|
| 3 | Instrument panel | Indicator light (Motorkontrolle) - on - Perform diagnosis |

**Damage 3:** Instrument panel: Indicator light (Motorkontrolle) - on - Perform diagnosis

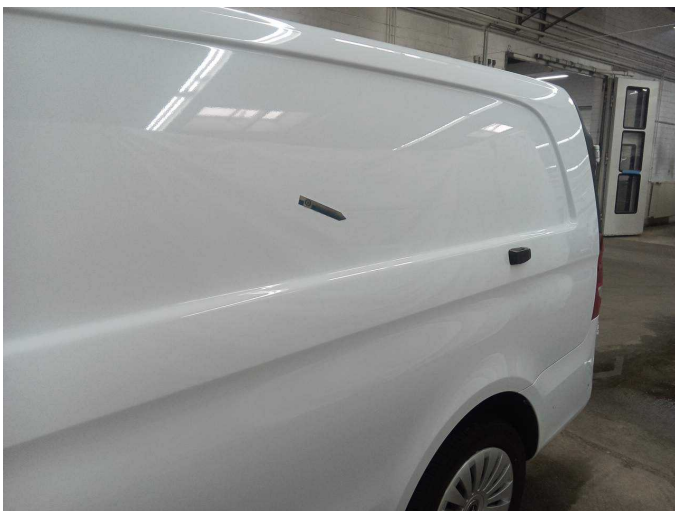
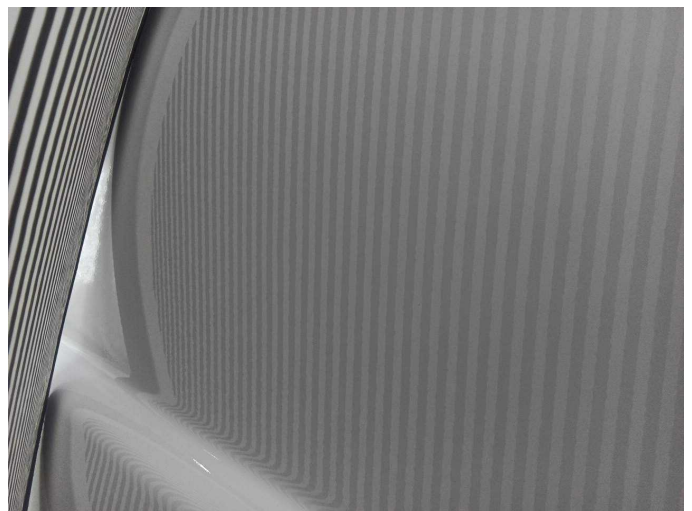
| No. | Component group | Description |
|---|---|---|
| 1 | Side panel - rear left side | Side panel - dent(s) - No deduction |

**Wear and tear 1:** Side panel - rear left side: Side panel - dent(s) - No deduction
