Expertise

Protocol number: 47216325  
Order No. / Reference: 26861449  
Inspection date: 20 Aug 2026

Manufacturer: Opel

Model: Astra 1.5 D Start/Stop Business Edition

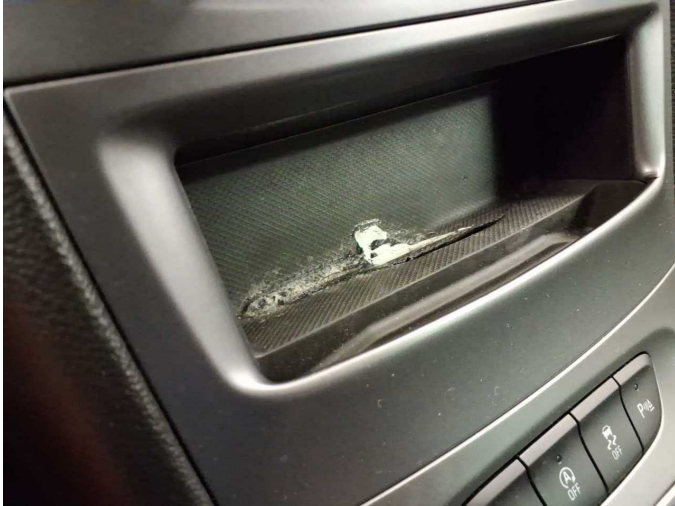
| No. | Component group | Description |
|---|---|---|
| 1 | Instrument panel | Stowage compartment (Kleberreste) - Soiled - Replace |

**Damage 1:** Instrument panel: Stowage compartment (Kleberreste) - Soiled - Replace

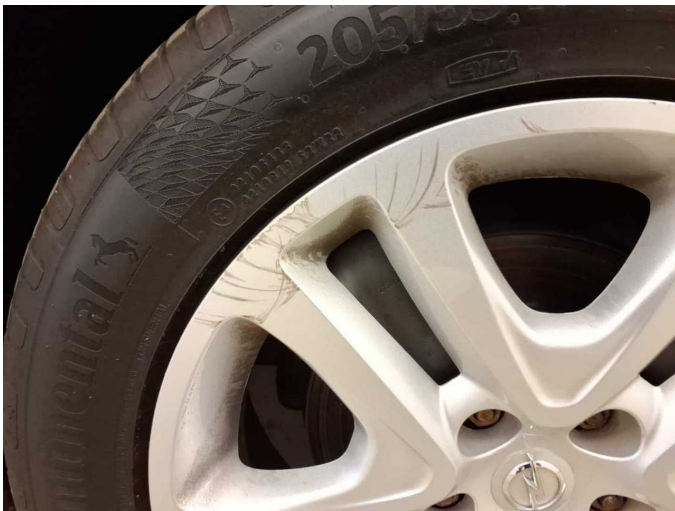
| No. | Component group | Description |
|---|---|---|
| 2 | Wheel / tyres | Wheel cover - front right side - Scratched - Replace |

**Damage 2:** Wheel / tyres: Wheel cover - front right side - Scratched - Replace

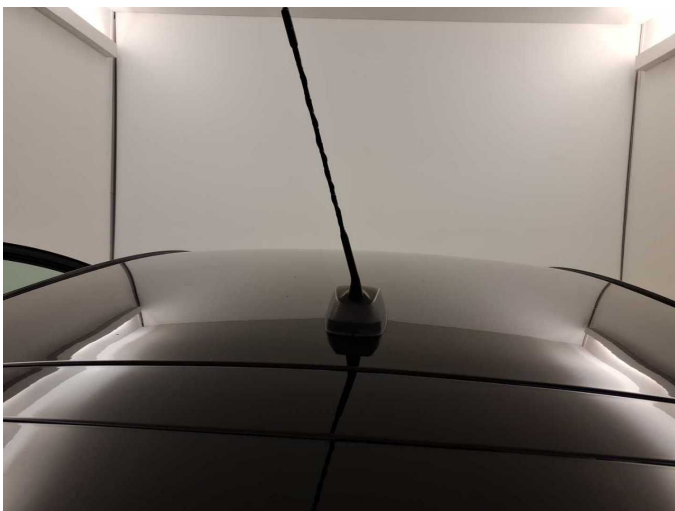
| No. | Component group | Description |
|---|---|---|
| 3 | Roof | Stub aerial - Broken / torn - Replace |

**Damage 3:** Roof: Stub aerial - Broken / torn - Replace

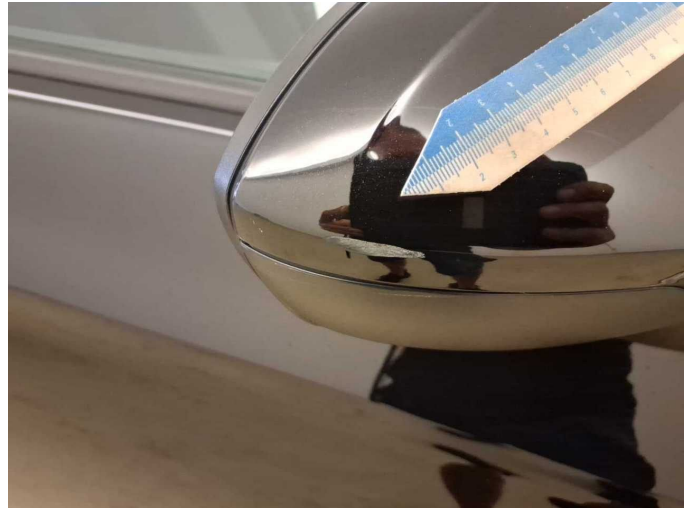
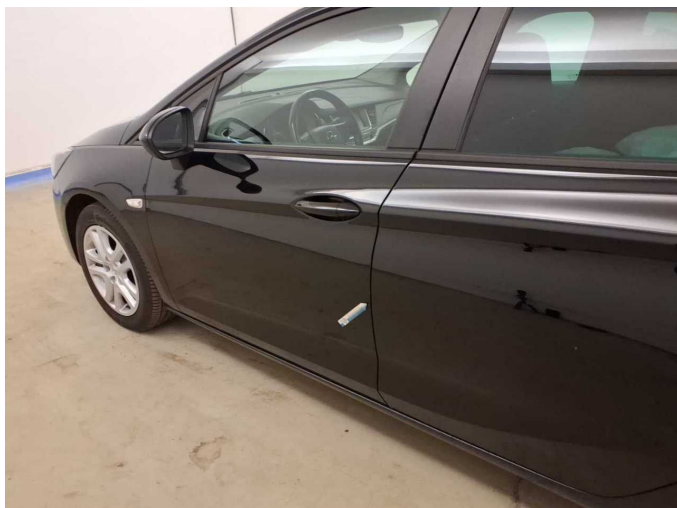
| No. | Component group | Description |
|---|---|---|
| 5 | Wing mirror - right side | Cap - Scratch(es) - Smart repair |

**Damage 5:** Wing mirror - right side: Cap - Scratch(es) - Smart repair

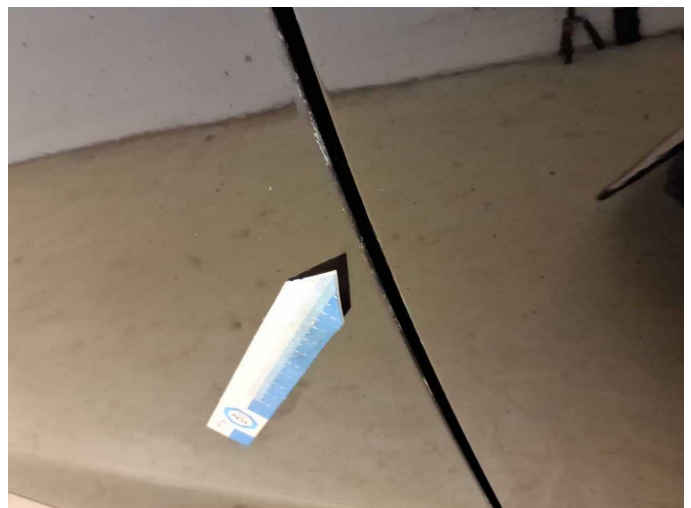
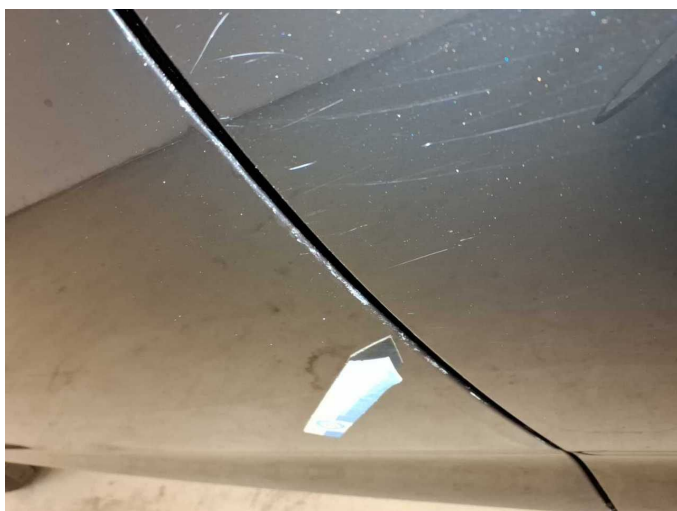
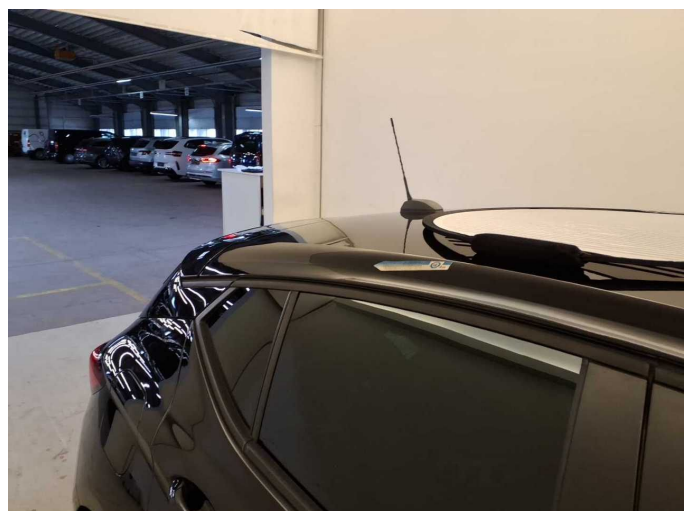
| No. | Component group | Description |
|---|---|---|
| 6 | Door - front left side | Door edge - Scratch(es) - Smart repair |

**Damage 6:** Door - front left side: Door edge - Scratch(es) - Smart repair

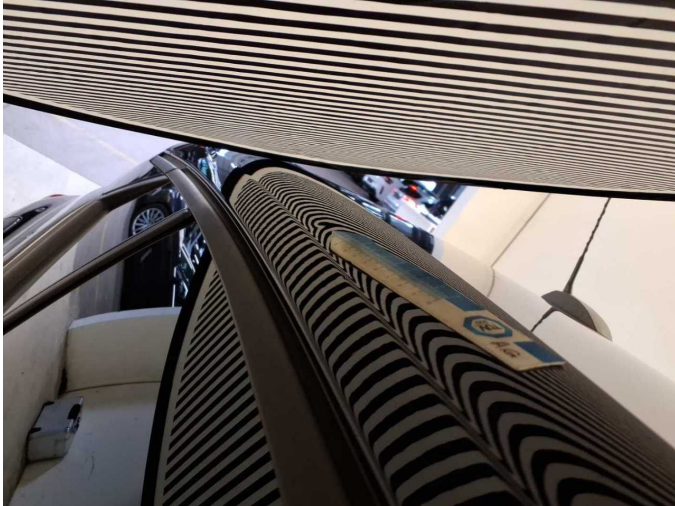
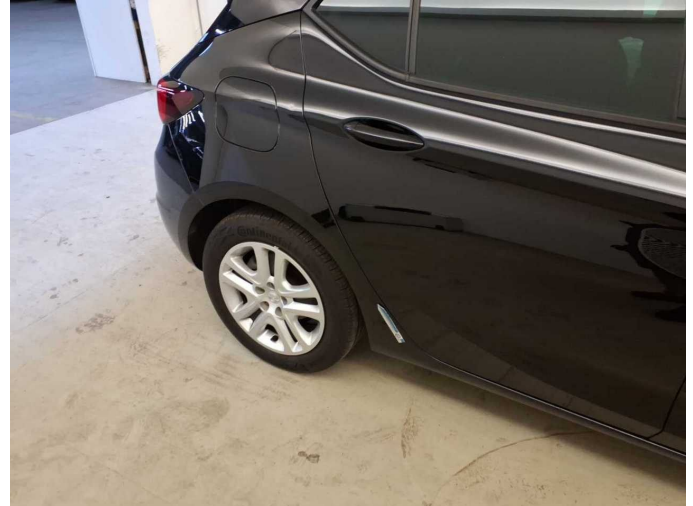
| No. | Component group | Description |
|---|---|---|
| 7 | Roof | Roof rail - right side - dent(s) - Smooth repair work |

**Damage 7:** Roof: Roof rail - right side - dent(s) - Smooth repair work

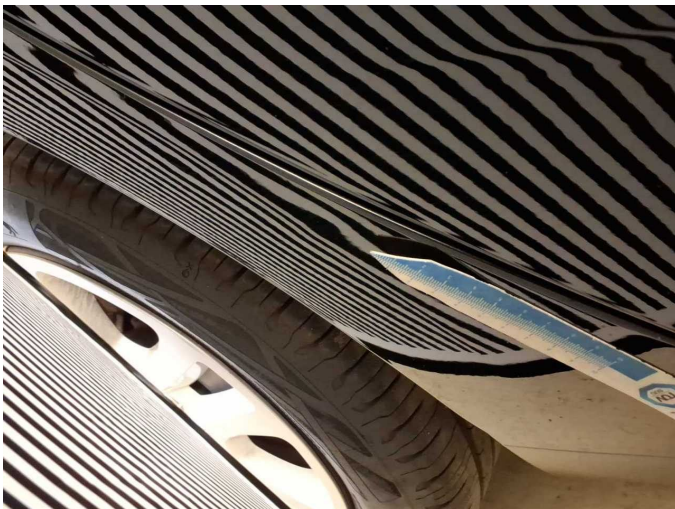
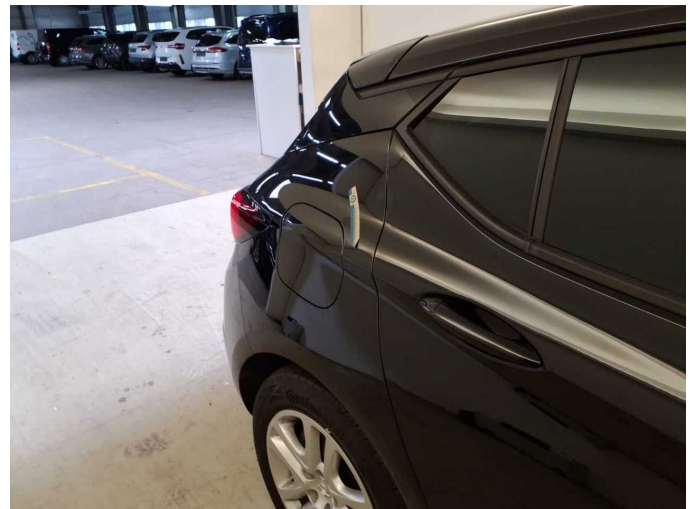
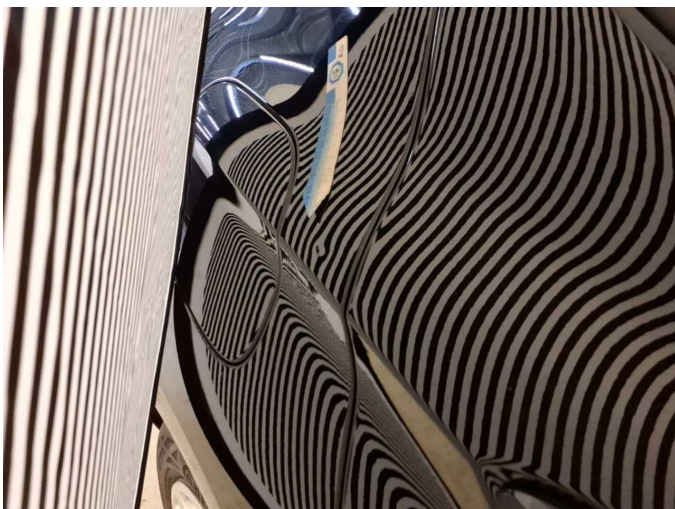
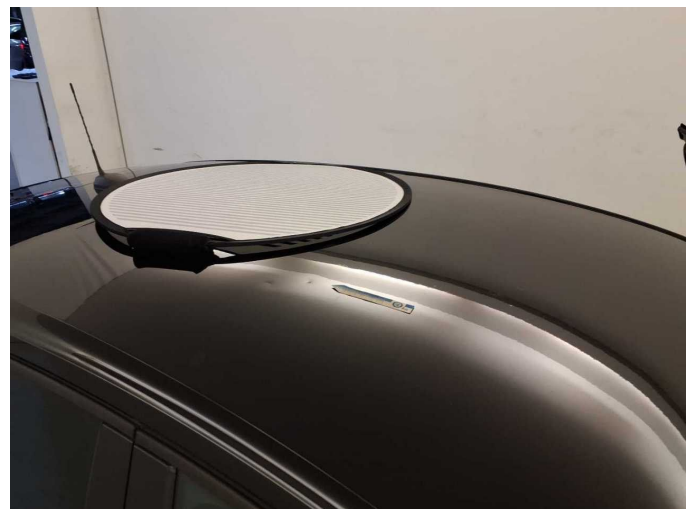
| No. | Component group | Description |
|---|---|---|
| 8 | Side panel - rear right side | Side panel - dent(s) - Smooth repair work |

**Damage 8:** Side panel - rear right side: Side panel - dent(s) - Smooth repair work

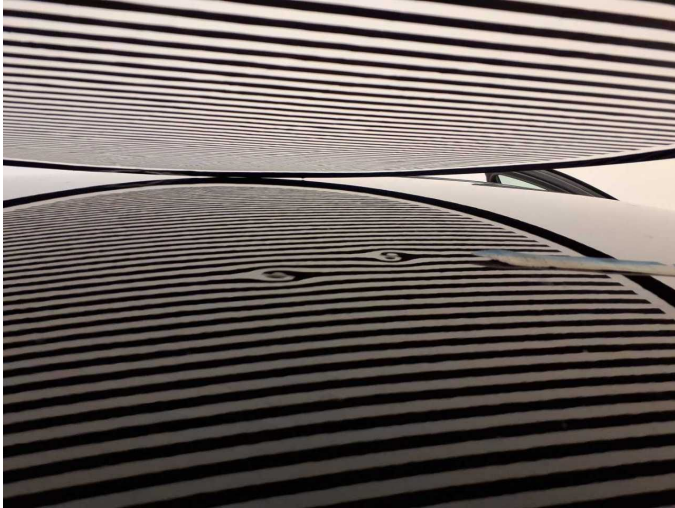
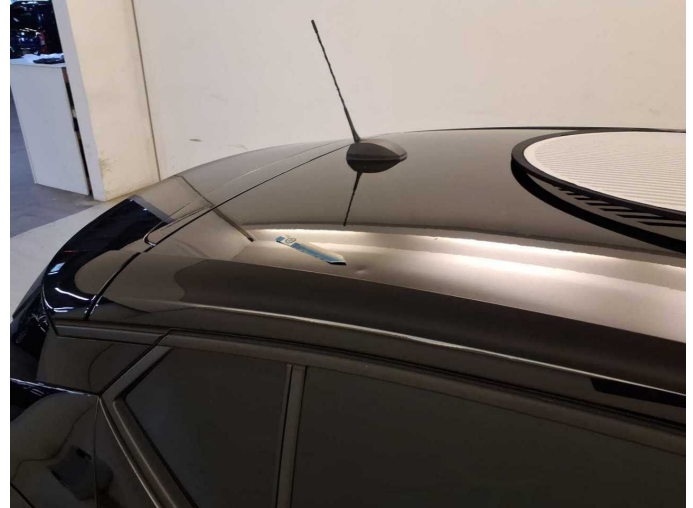
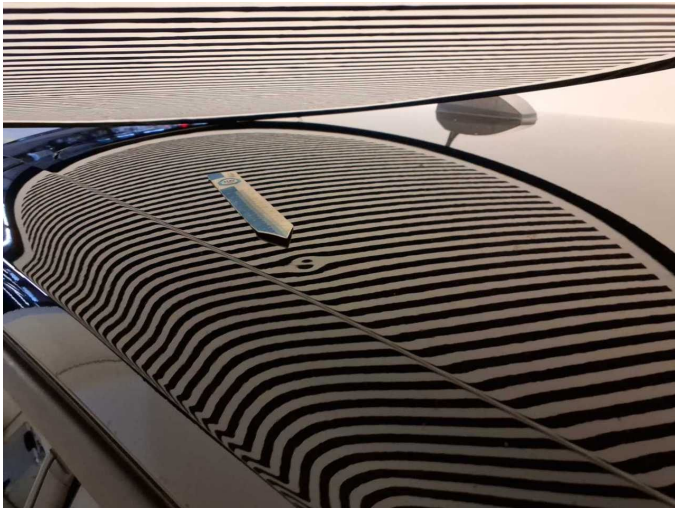
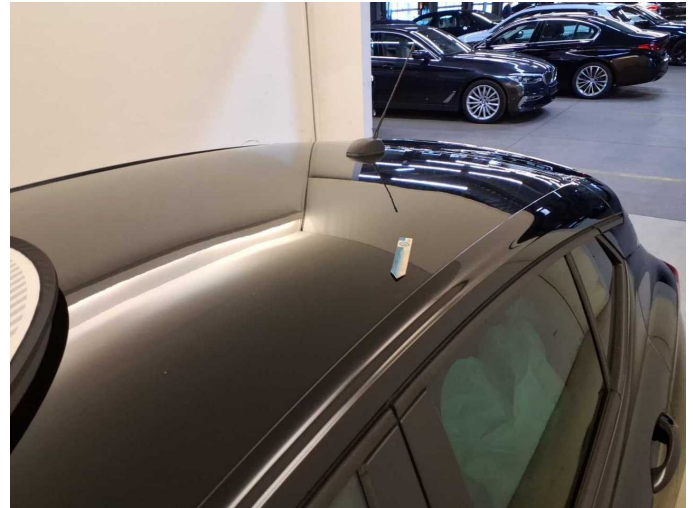
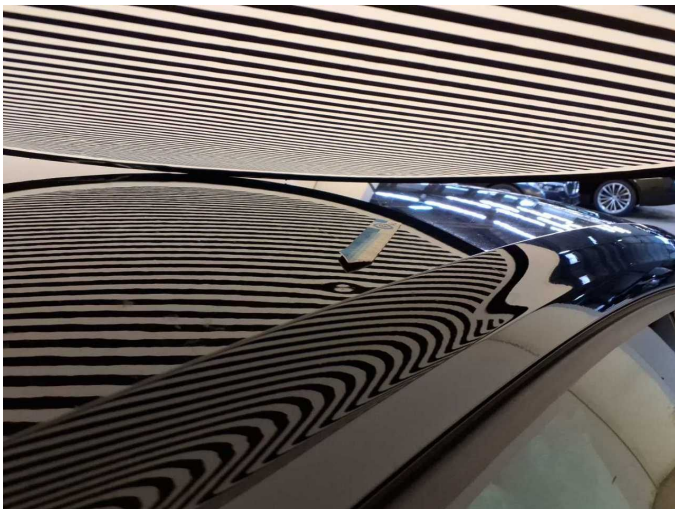
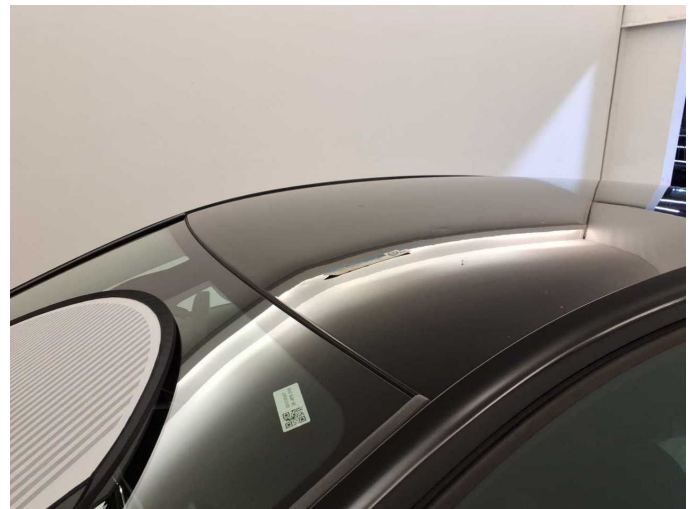
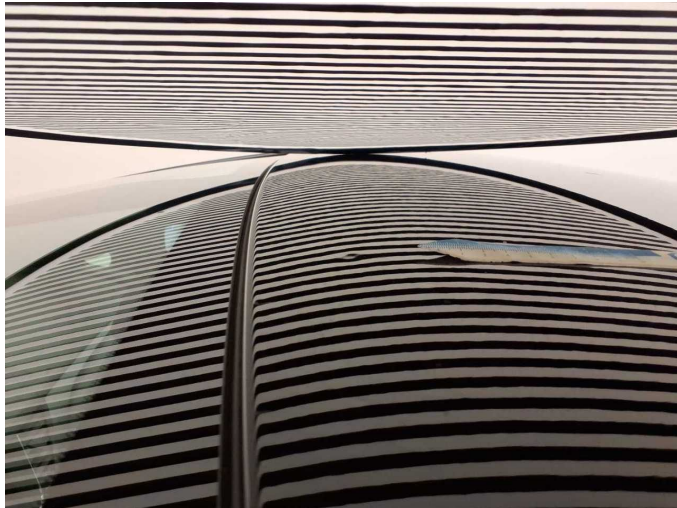
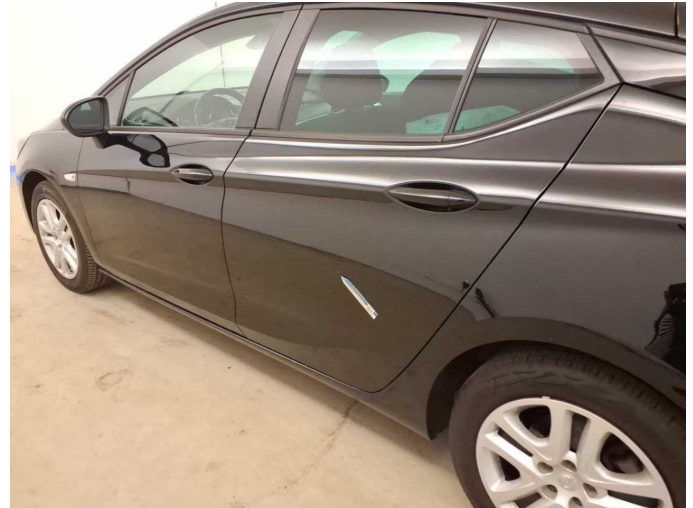
| No. | Component group | Description |
|---|---|---|
| 9 | Roof | Roof - dent(s) - Smooth repair work |

**Damage 9:** Roof: Roof - dent(s) - Smooth repair work

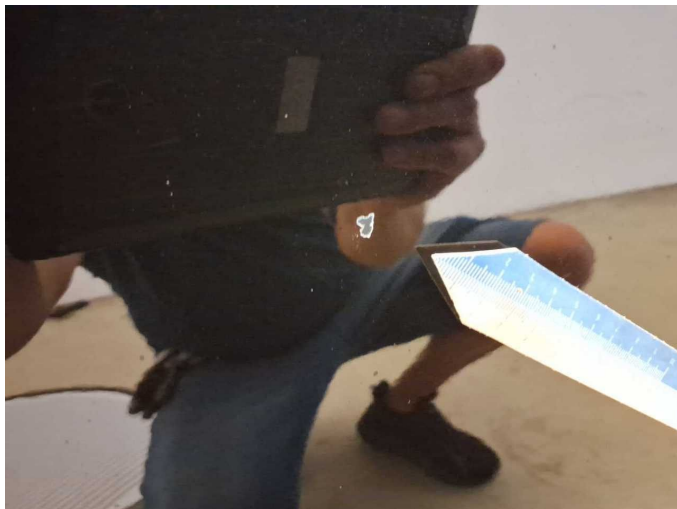
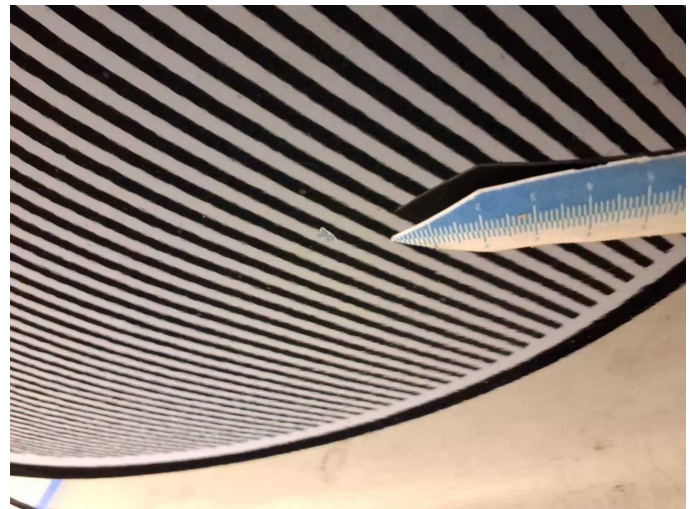
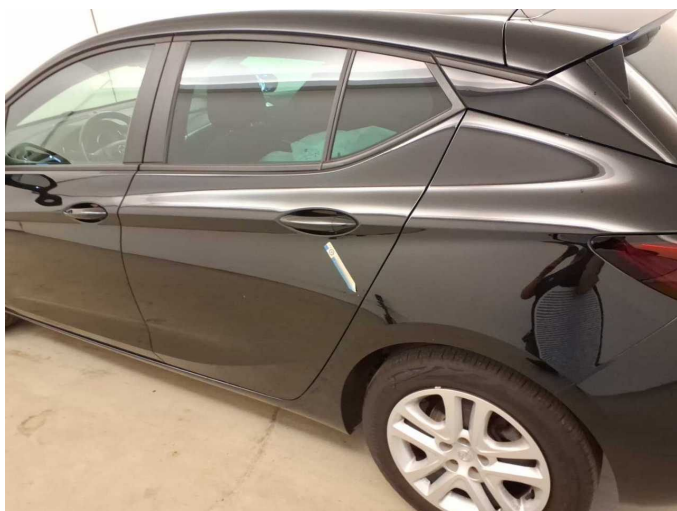
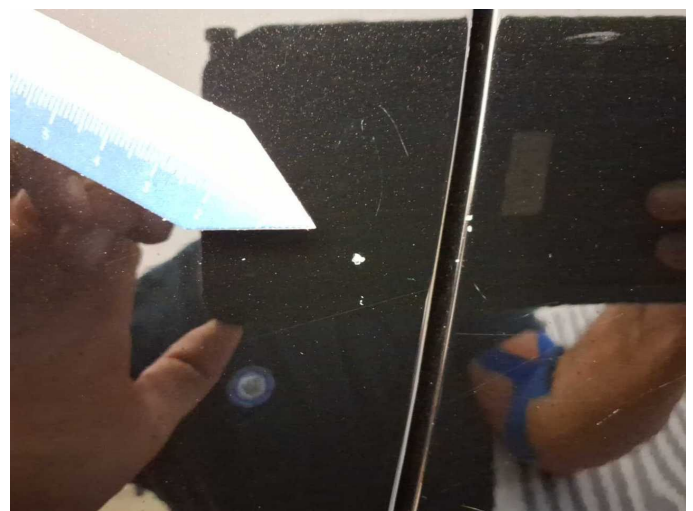
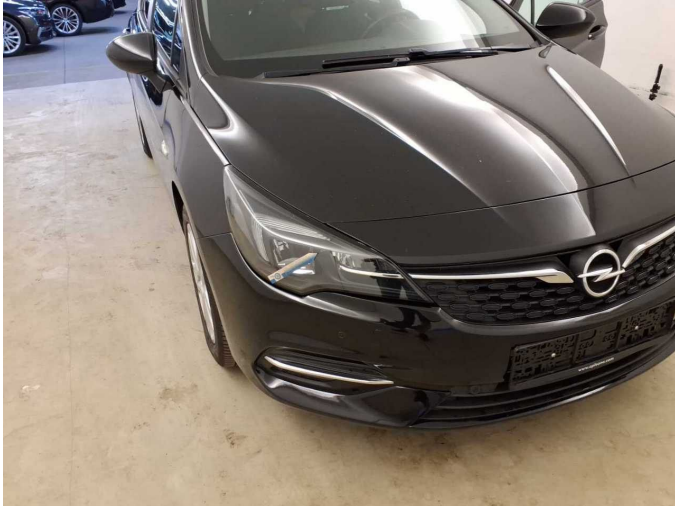
| No. | Component group | Description |
|---|---|---|
| 10 | Door - rear left side | Door - Scratch(es) - Paint |

**Damage 10:** Door - rear left side: Door - Scratch(es) - Paint

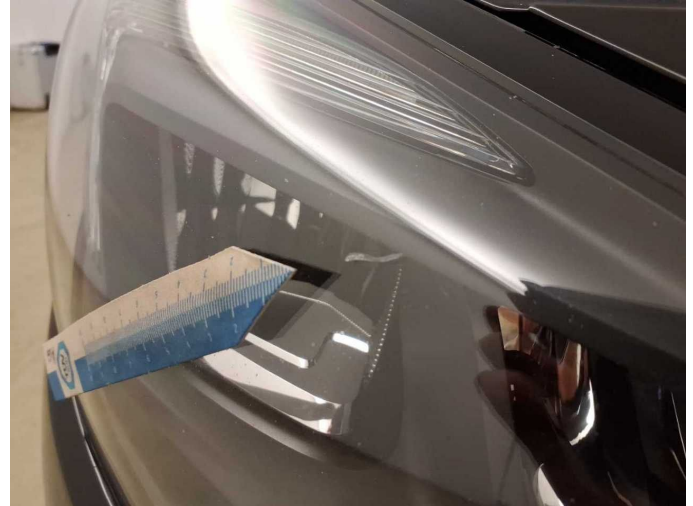
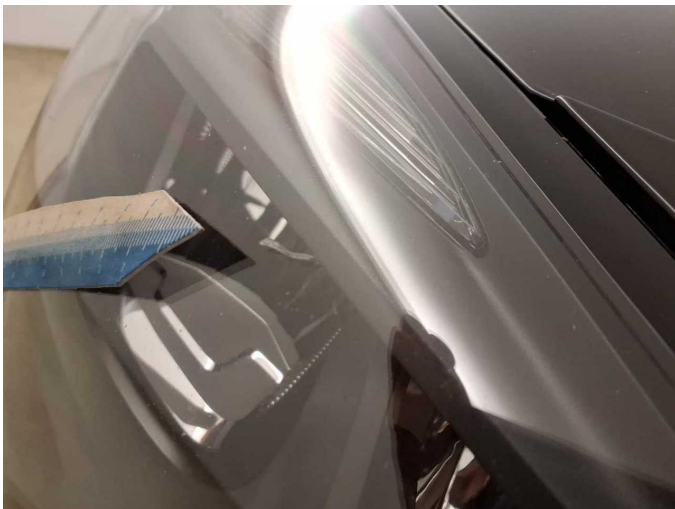
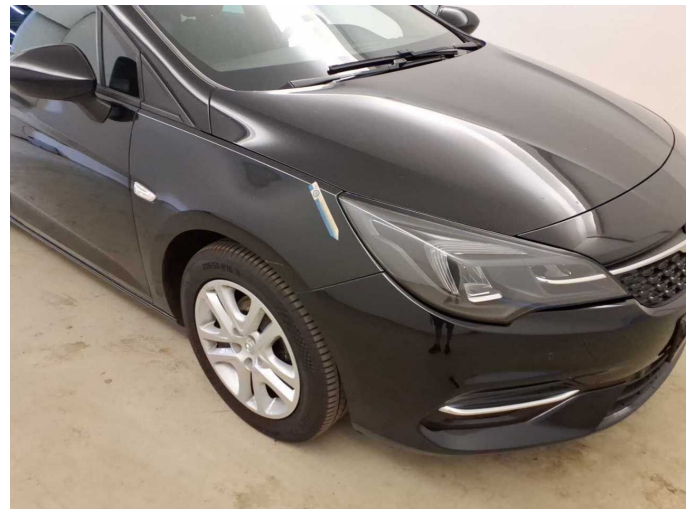
| No. | Component group | Description |
|---|---|---|
| 11 | Headlight | Headlight - right side - Scratch(es) - Replace |

**Damage 11:** Headlight: Headlight - right side - Scratch(es) - Replace

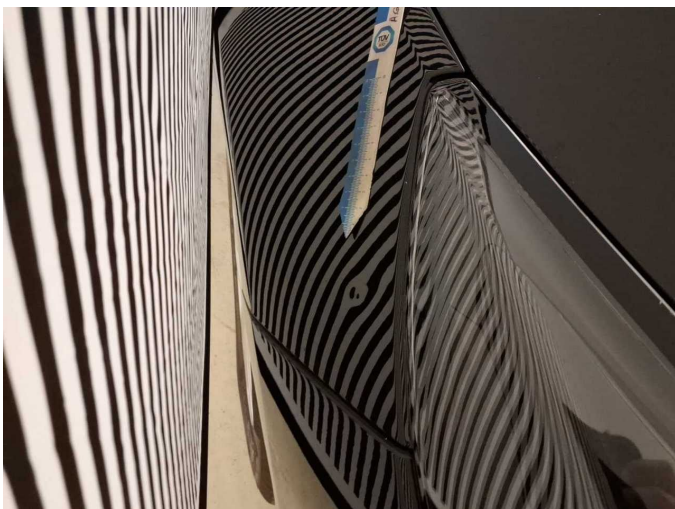
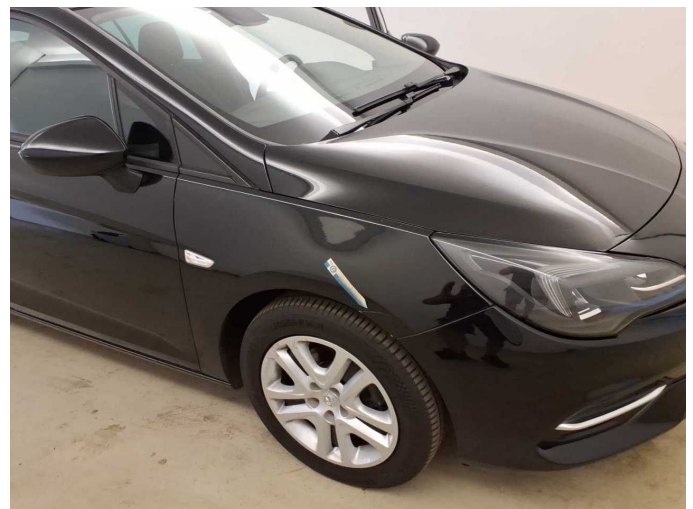
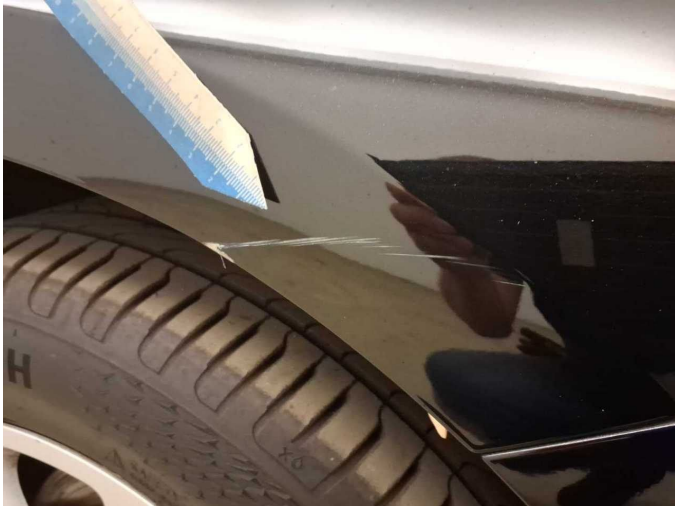
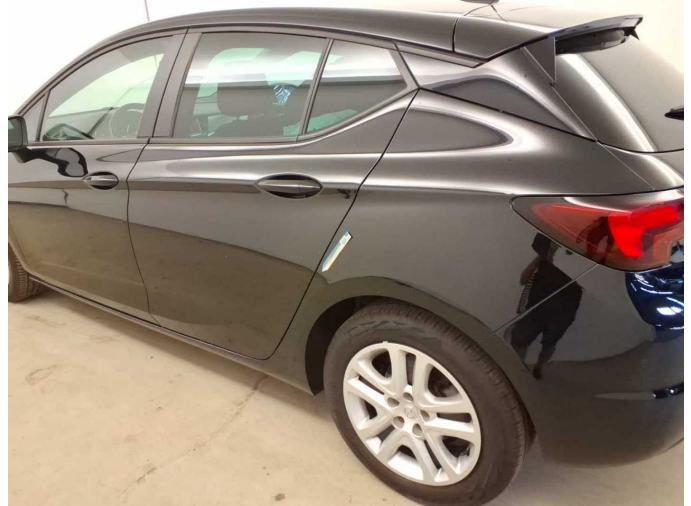
| No. | Component group | Description |
|---|---|---|
| 12 | Mudguard - right side | Mudguard - right side - Dent / paintcoat damage - Repair and paint |

**Damage 12:** Mudguard - right side: Mudguard - right side - Dent / paintcoat damage - Repair and paint

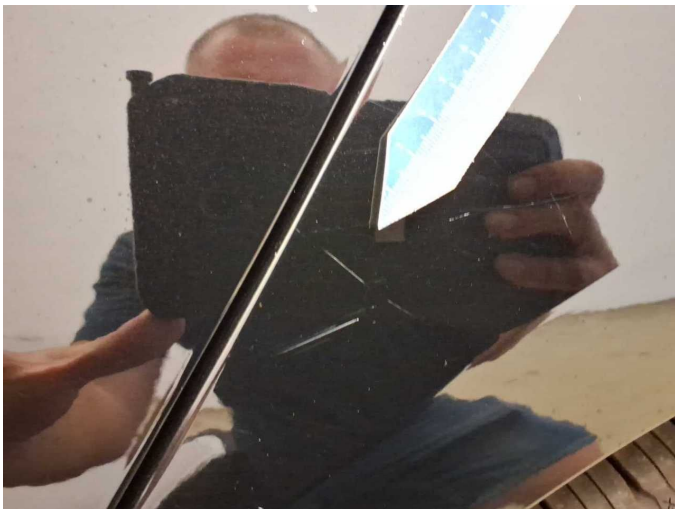
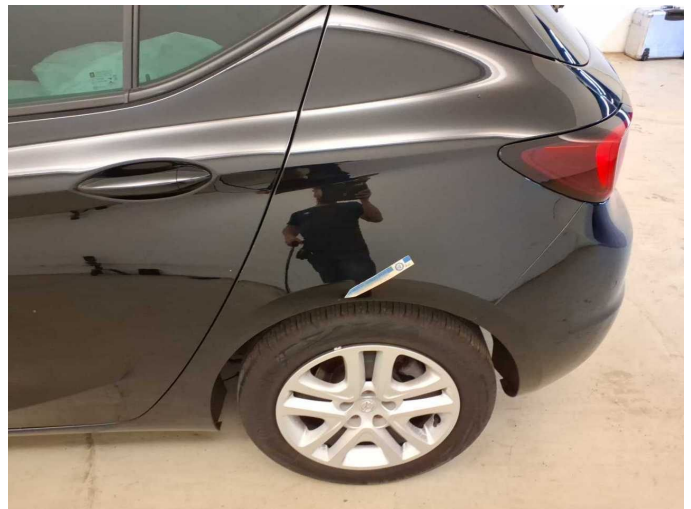
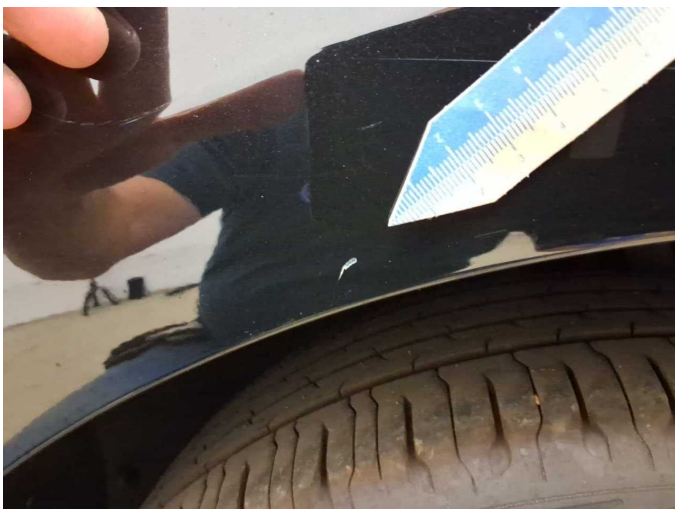
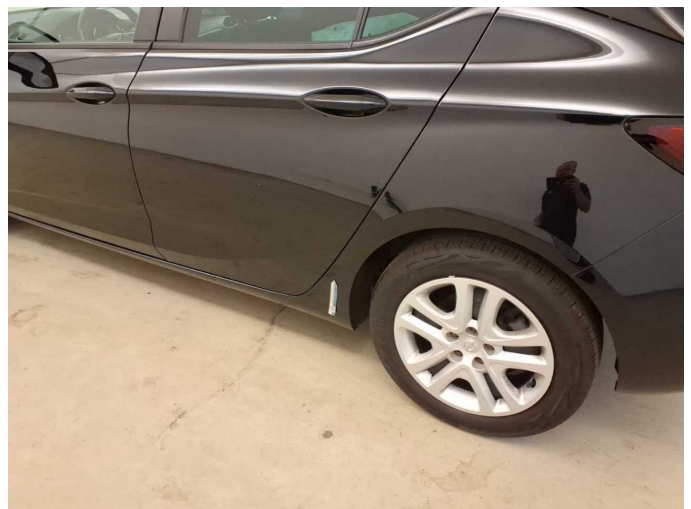
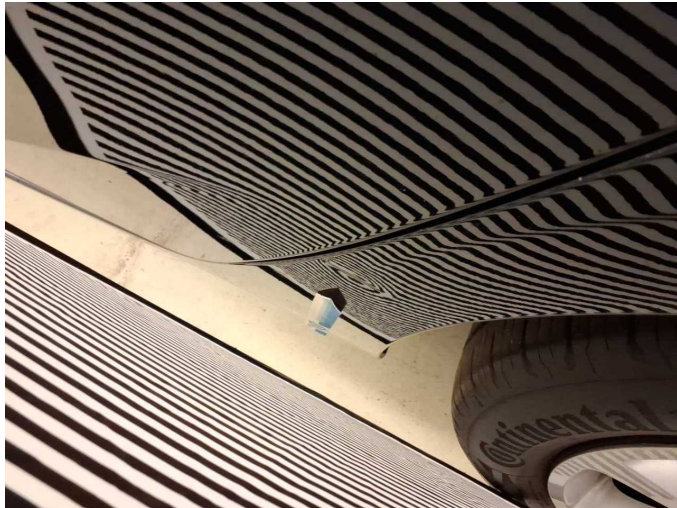
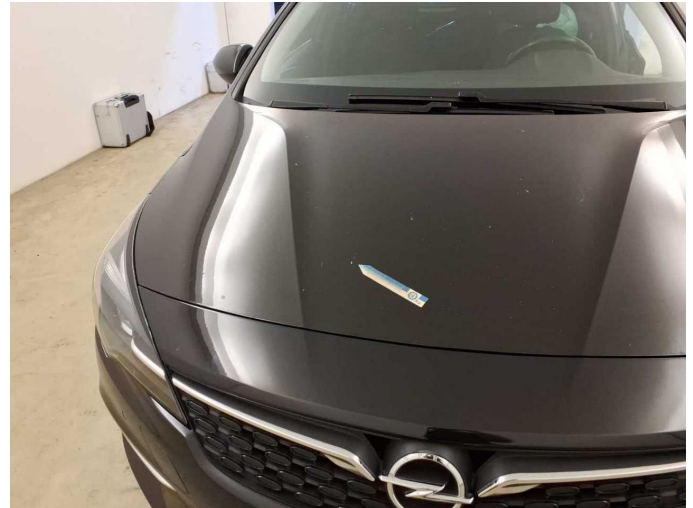
| No. | Component group | Description |
|---|---|---|
| 13 | Side panel - rear left side | Side panel - Dent / paintcoat damage - Repair and paint |

**Damage 13:** Side panel - rear left side: Side panel - Dent / paintcoat damage - Repair and paint

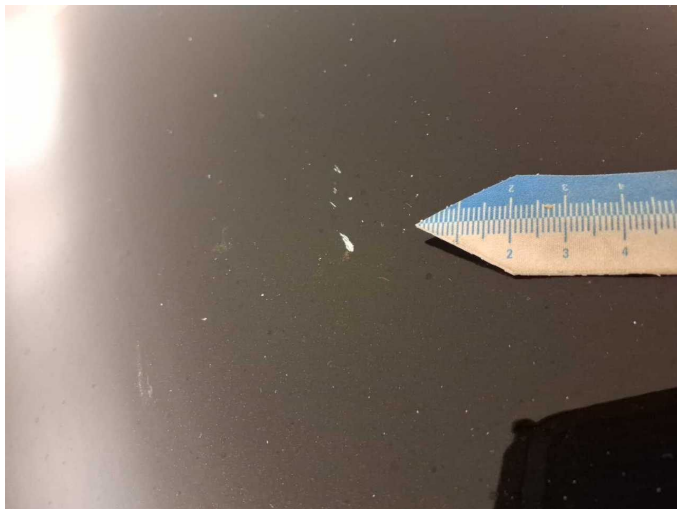
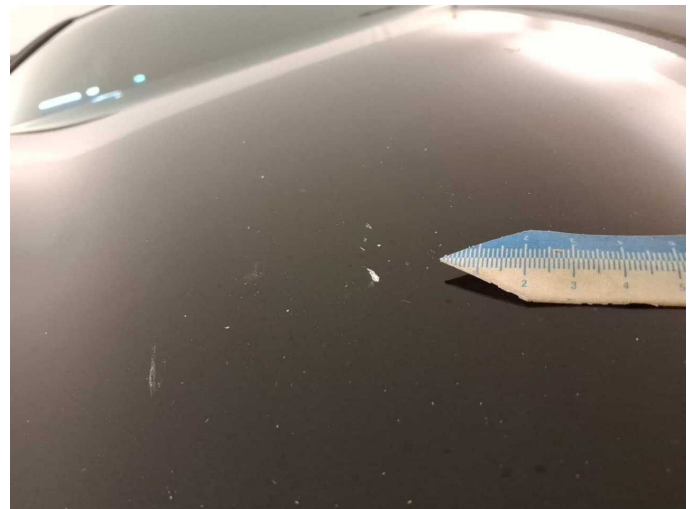
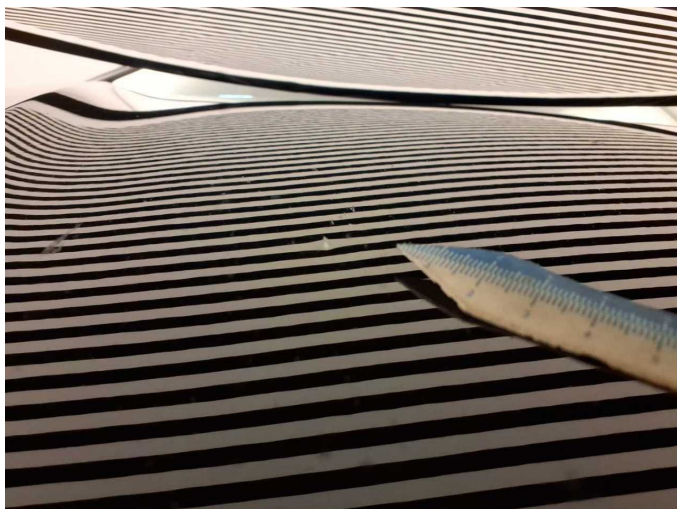
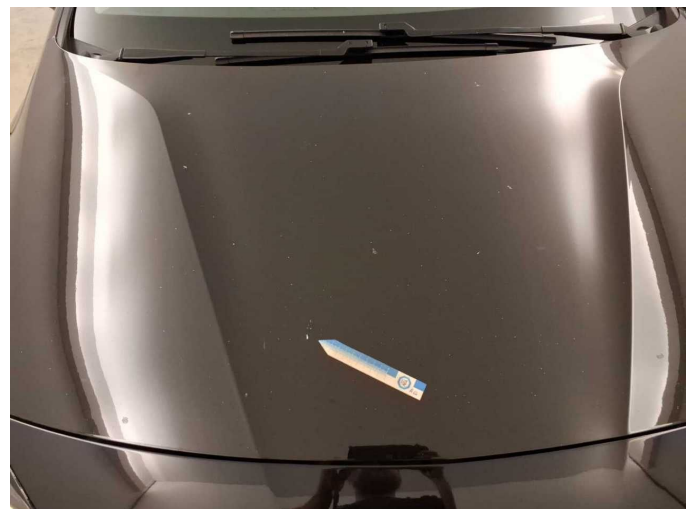
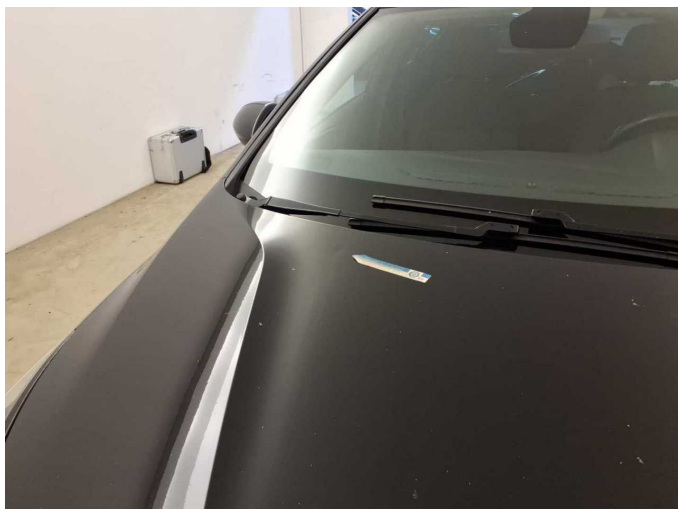
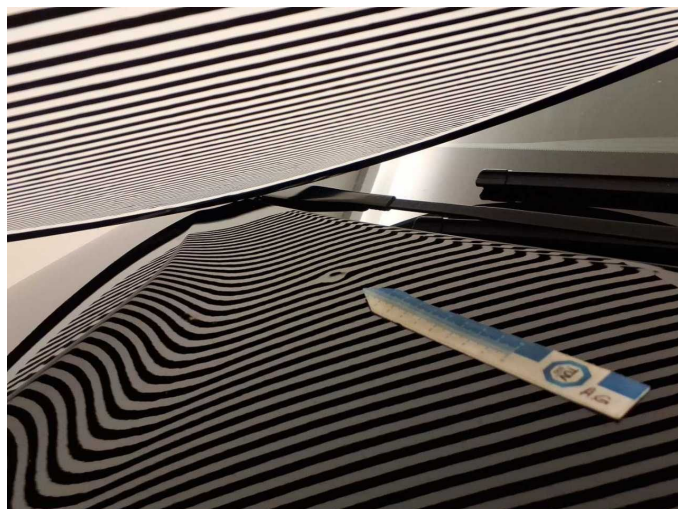
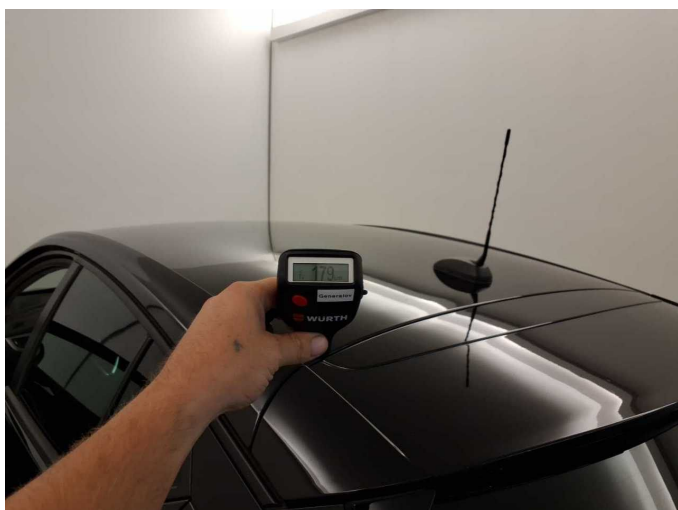
| No. | Component group | Description |
|---|---|---|
| 14 | Bonnet | Bonnet - Dent / paintcoat damage - Repair and paint |

**Damage 14:** Bonnet: Bonnet - Dent / paintcoat damage - Repair and paint

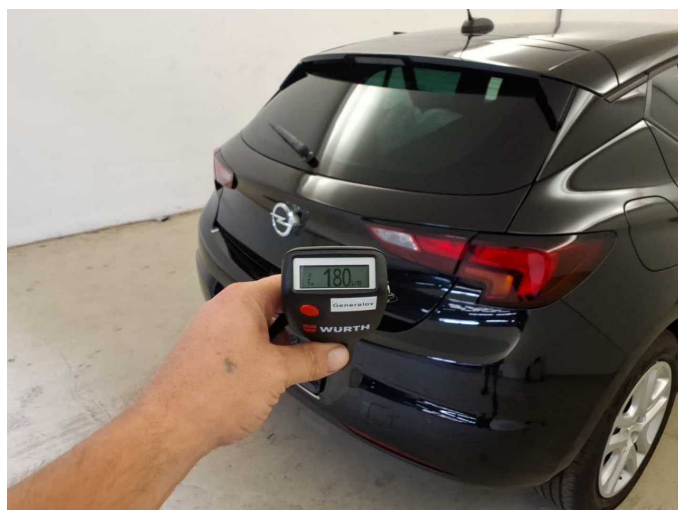
| No. | Repainting |
|---|---|
| 1 | Roof, Professionally carried out, Invoice of repair done Non-existent |

| Roof | 179 µm | Boot lid / rear door | 180 µm |

**Repainting 1:** Roof
