Expertise

Protocol number: 46124012
Order No. / Reference: 26542790
Inspection date: 22 Jun 2026

Manufacturer: Opel

Model: Astra 1.5 D Start/Stop Sports Tourer Automatik Edition

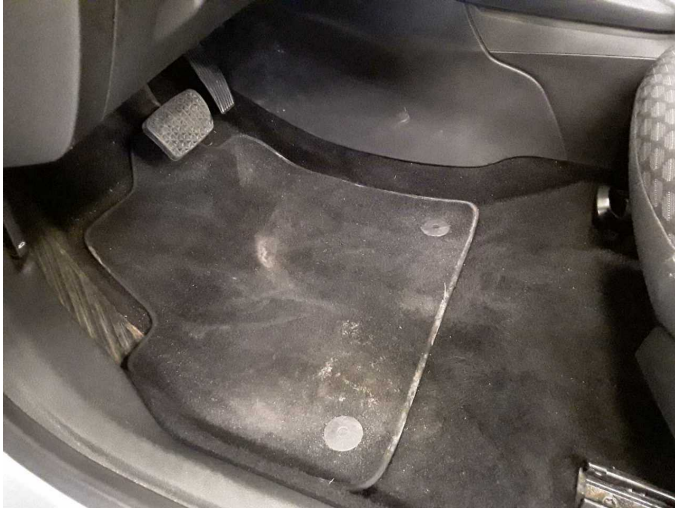
Damage 1: Trim / covers: Floor mats - Damaged - Replace

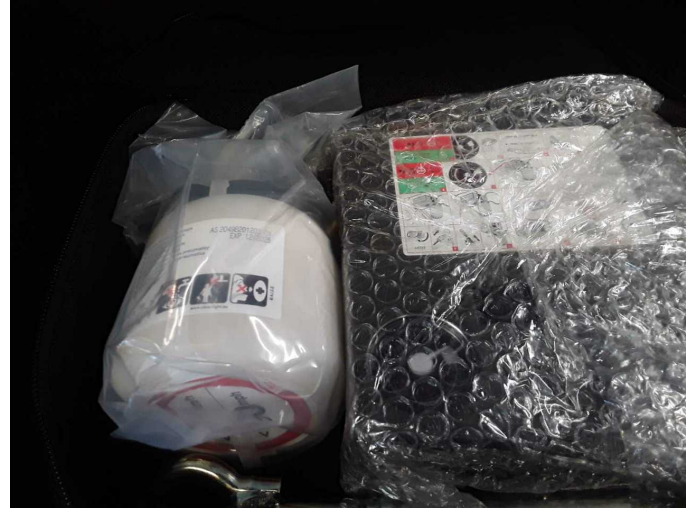
Damage 2: Equipment: Tirefit filler - Expired - Replace

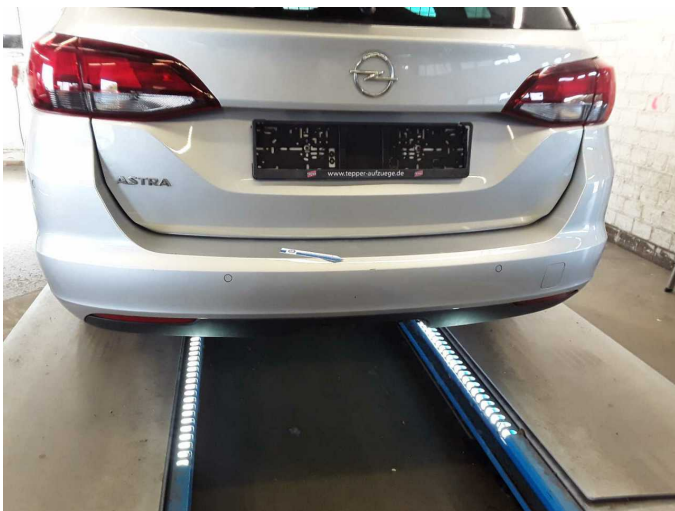
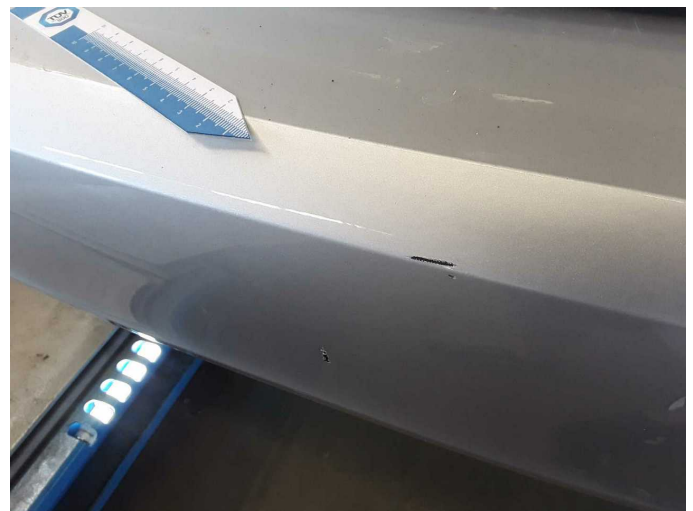
Damage 3: Rear bumper: Rear bumper - Scratch(es) - Paint

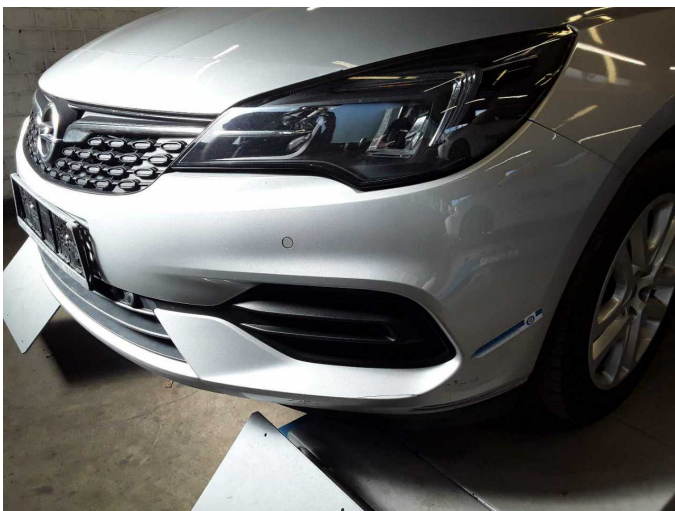
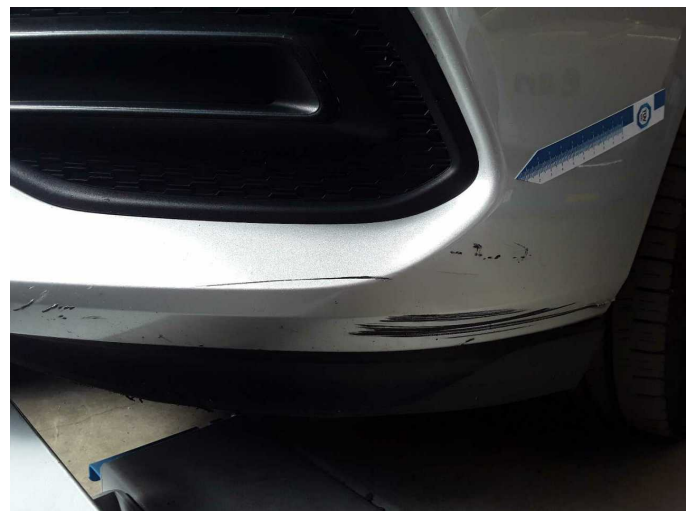
Damage 4: Front bumper: Front bumper - Scratch(es) - Paint

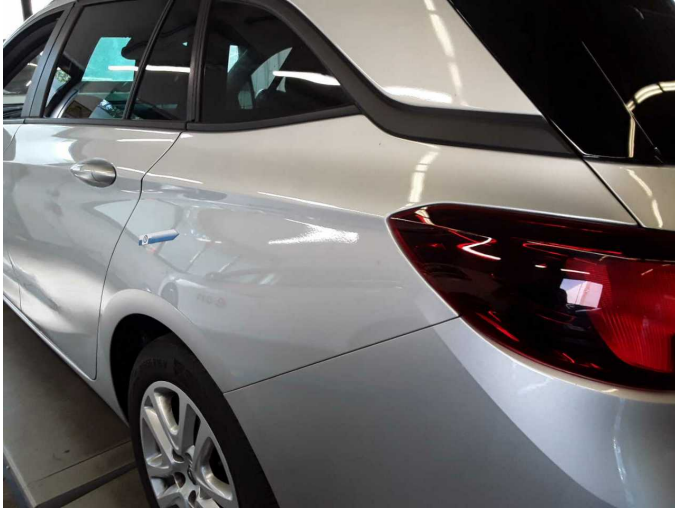
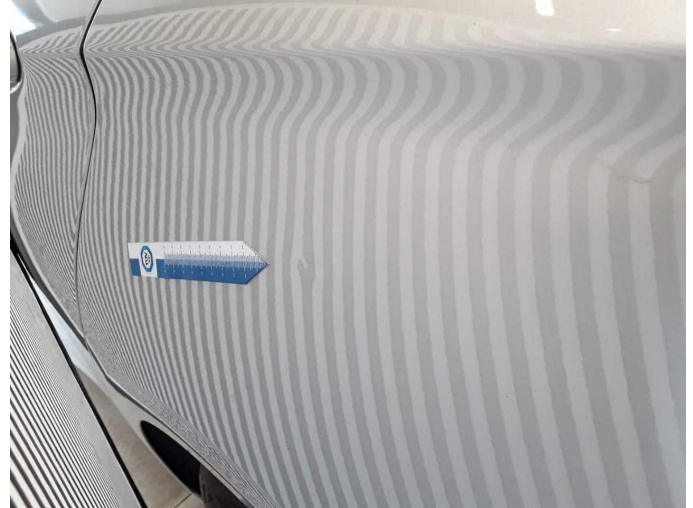
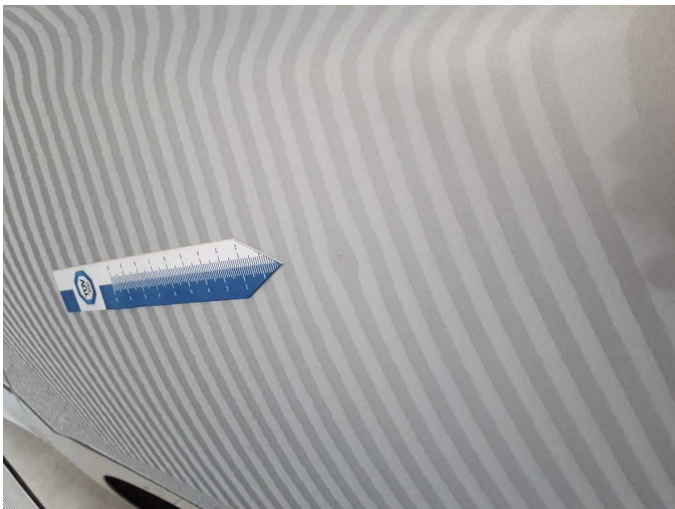
Damage 5: Side panel - rear left side: Side panel - Dent / paintcoat damage - Repair and paint

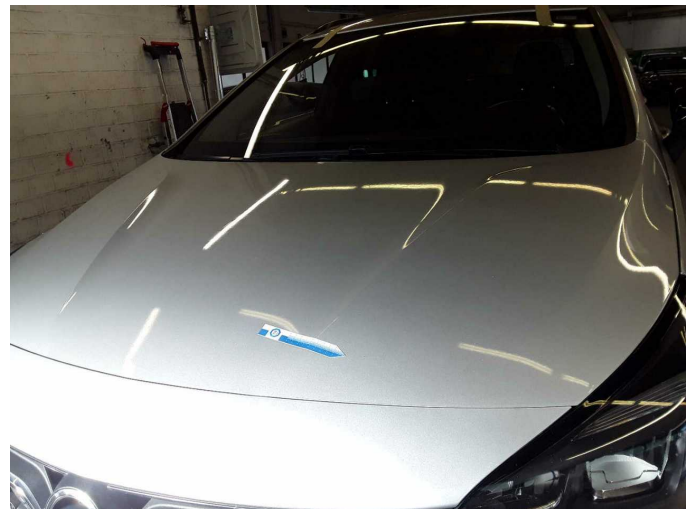
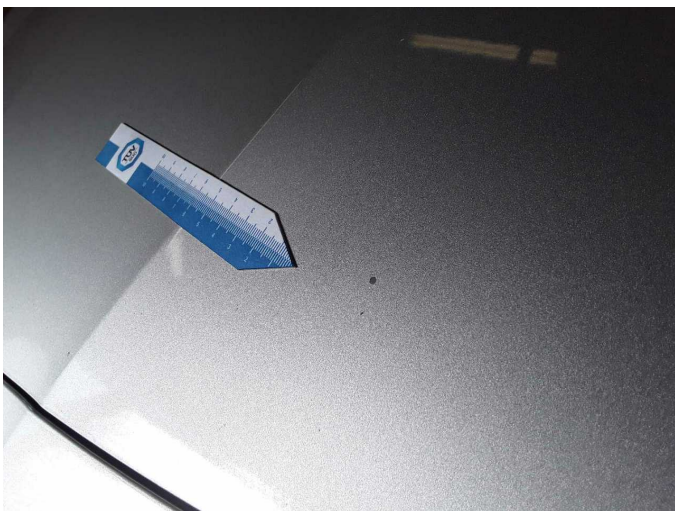
Wear and tear 1: Bonnet: Bonnet - Stone chips - No deduction
