Expertise

Protocol number: 44647121
Order number / reference: 26112886
Inspection date: 25 Mar 2026

Manufacturer: Mercedes-Benz

Model: Vito 116 CDI Tourer Lang Aut. PRO

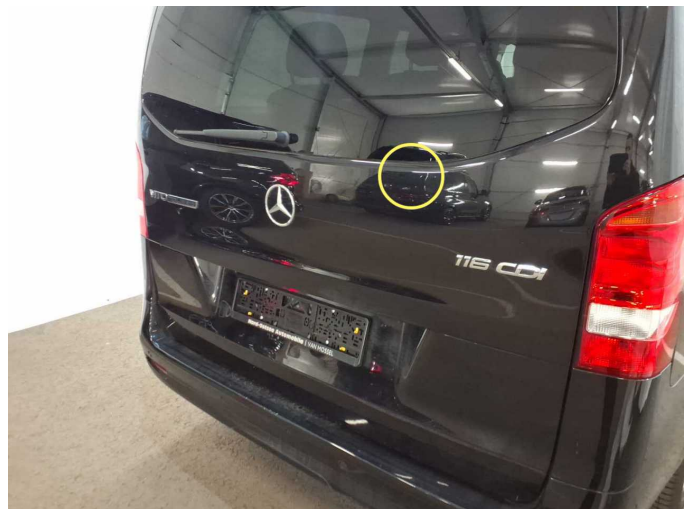
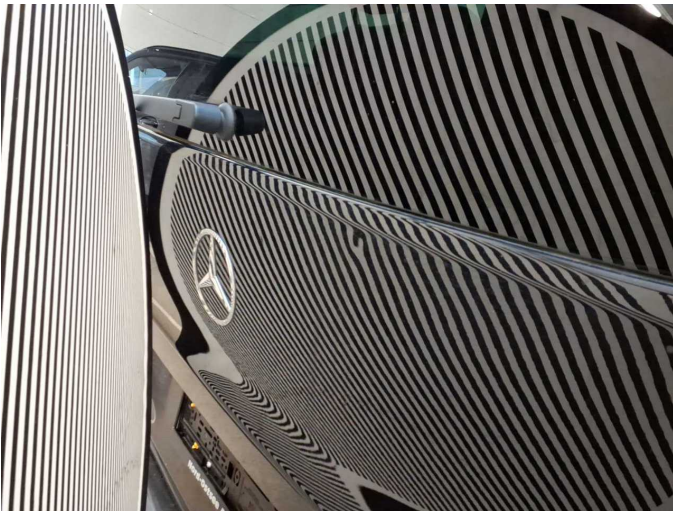
Damage 1: Boot lid / rear door: Boot lid - dent(s) - Smooth repair work

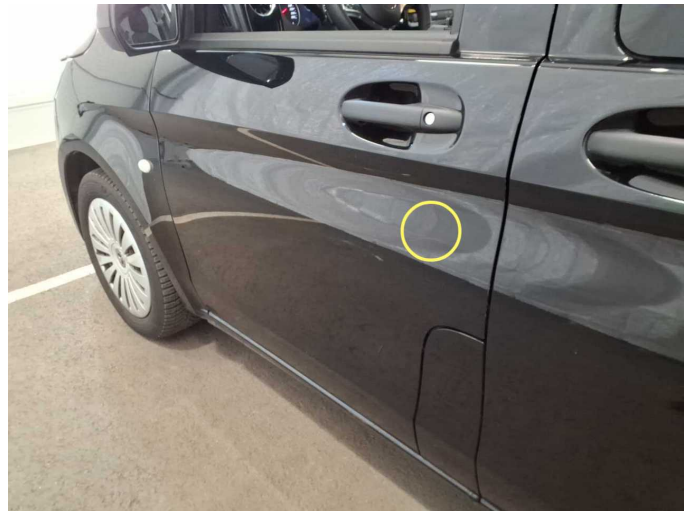
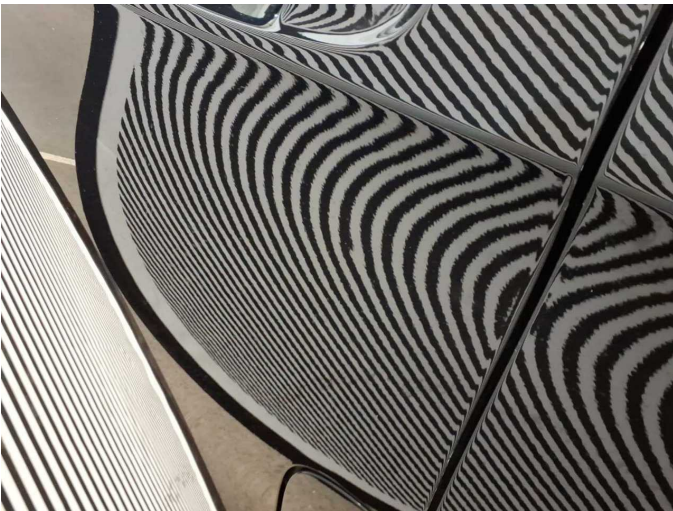
Damage 2: Door - front left side: Door - dent(s) - Smooth repair work

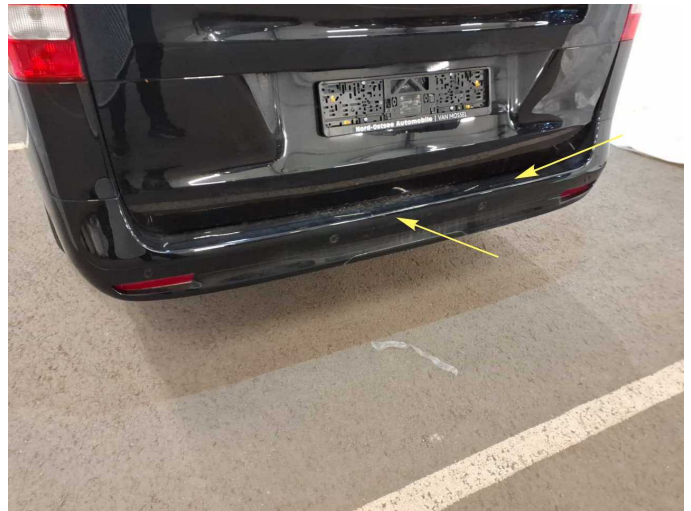
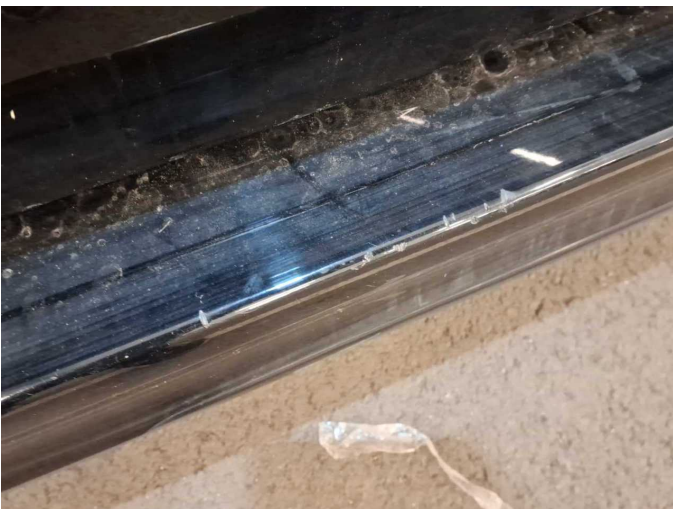
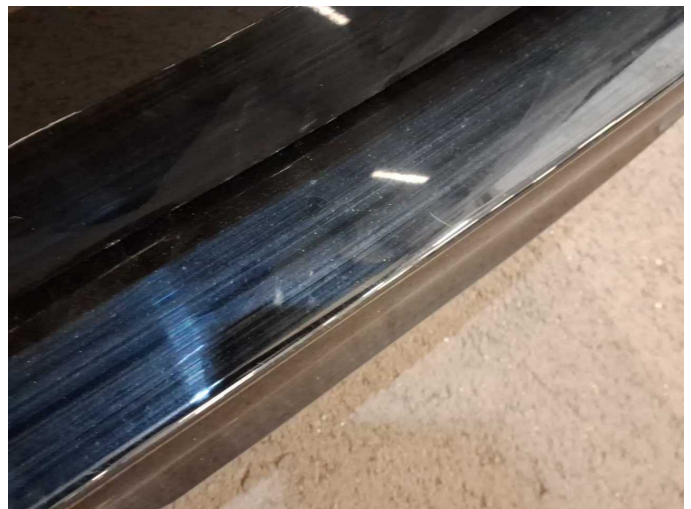
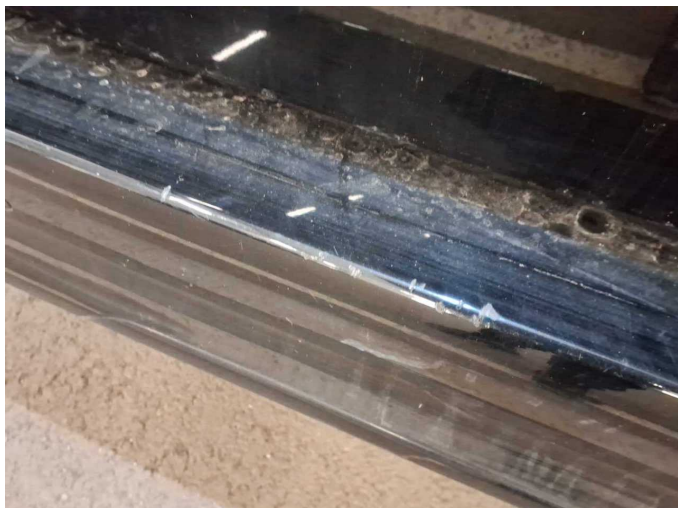
Damage 3: Rear bumper: Rear bumper - Scratch(es) - Paint
