Expertise

Protocol number: 46486575  
Order No. / Reference: 26018655  
Inspection date: 13 Jul 2026

Manufacturer: Mercedes-Benz  
VIN: W1VVLCEZ3T4565077

Model: Vito 116 CDI Extralang HA Aut. PRO

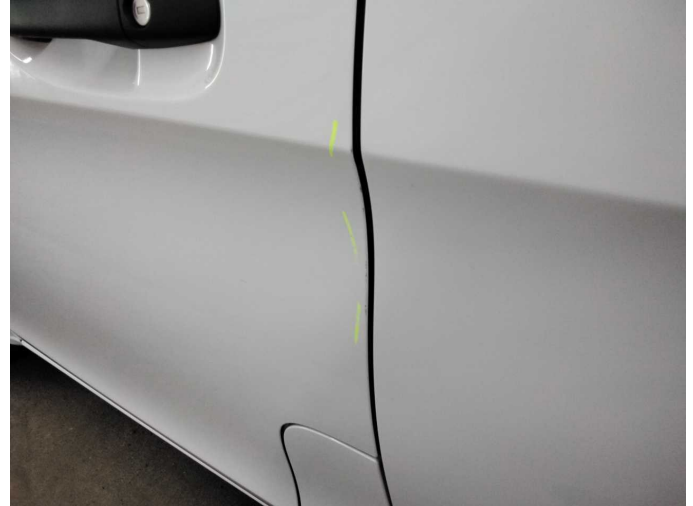
| No. | Component group | Description |
|---|---|---|
| 1 | Door - front left side | Door edge - Scratch(es) - Smart repair |

**Damage 1:** Door - front left side: Door edge - Scratch(es) - Smart repair

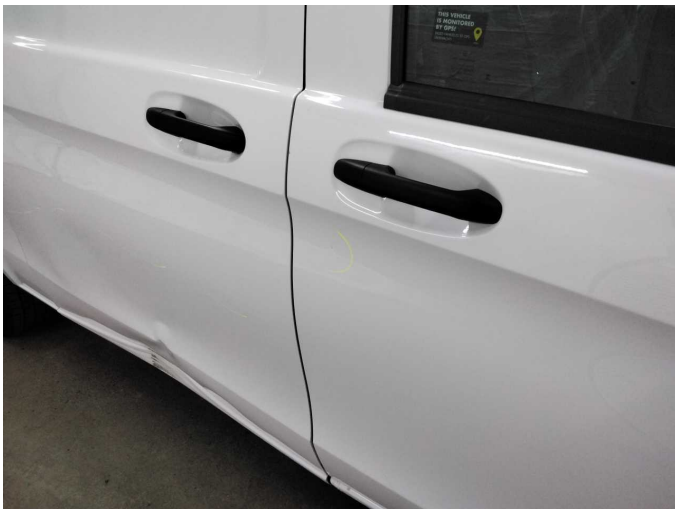
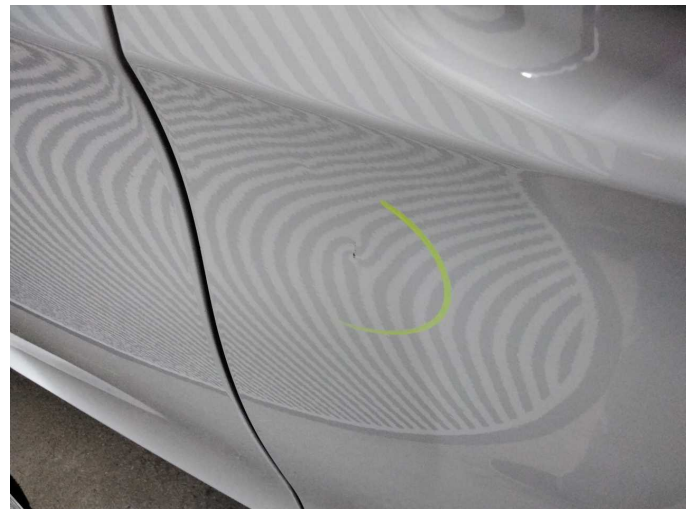
| No. | Component group | Description |
|---|---|---|
| 2 | Door - front right side | Door - Dent / paintcoat damage - Smart repair |

**Damage 2:** Door - front right side: Door - Dent / paintcoat damage - Smart repair

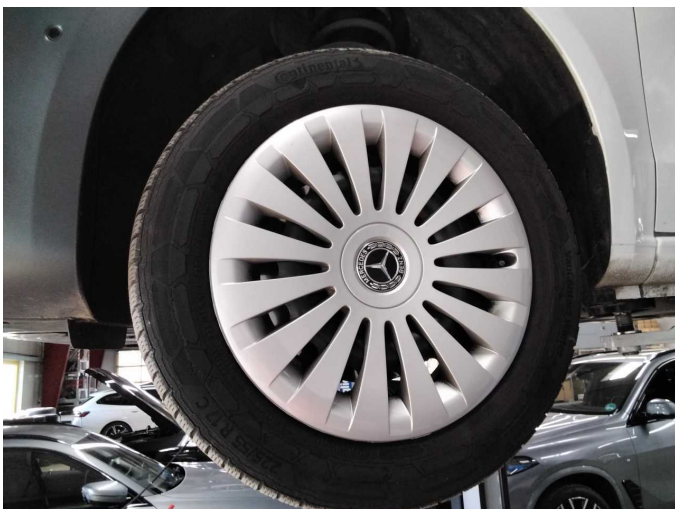
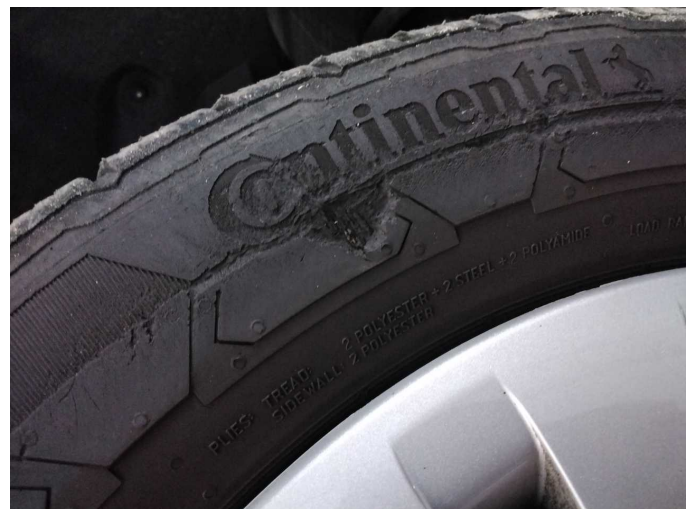
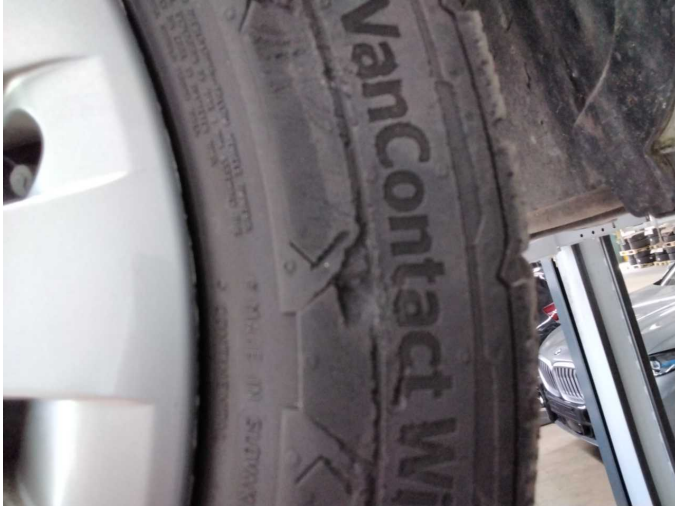
| No. | Component group | Description |
|---|---|---|
| 3 | Wheel / tyres | Tyre - front left side (nicht fahrbereit) - Damaged - Replace |

**Damage 3:** Wheel / tyres: Tyre - front left side (nicht fahrbereit) - Damaged - Replace

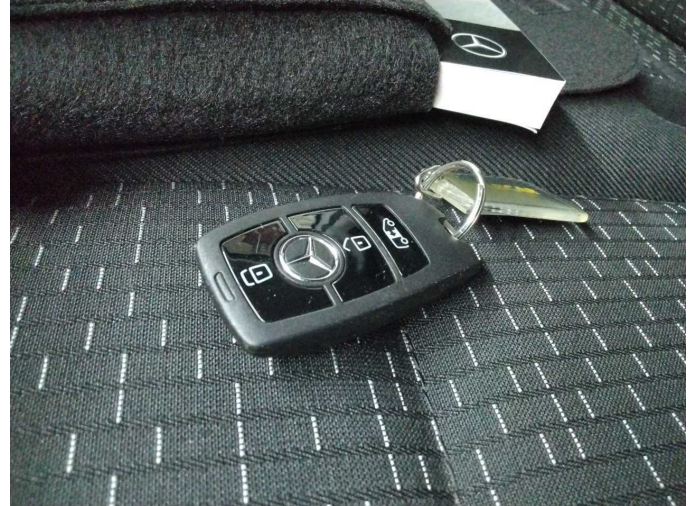
Equipment - Vehicle key

**Missing part 1:** Equipment: Vehicle key - Missing - Replace

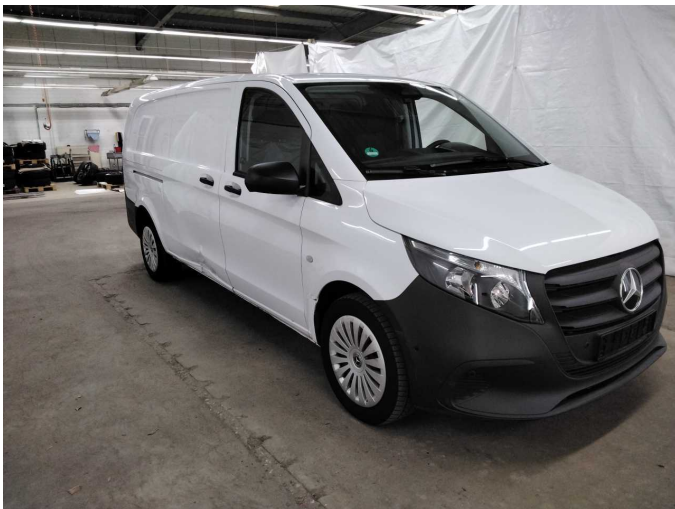
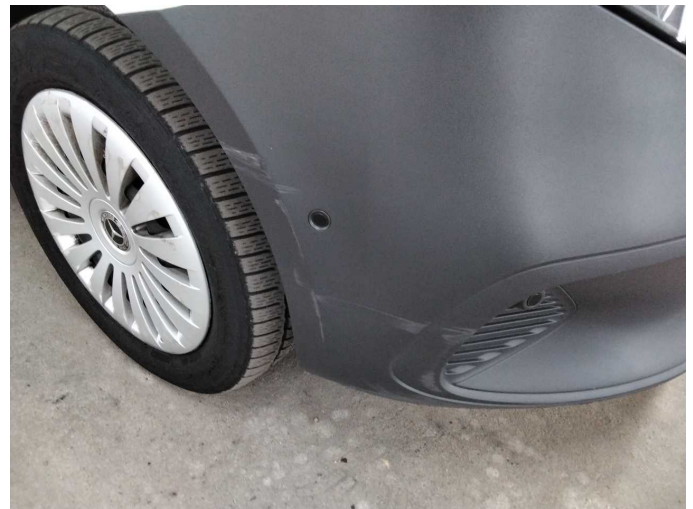
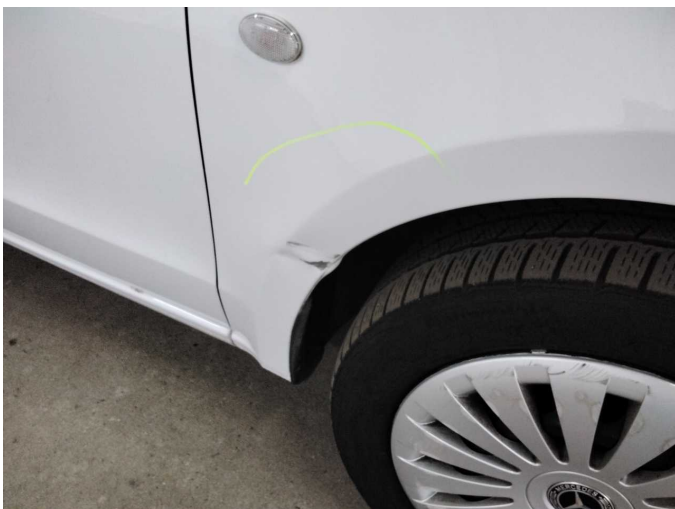
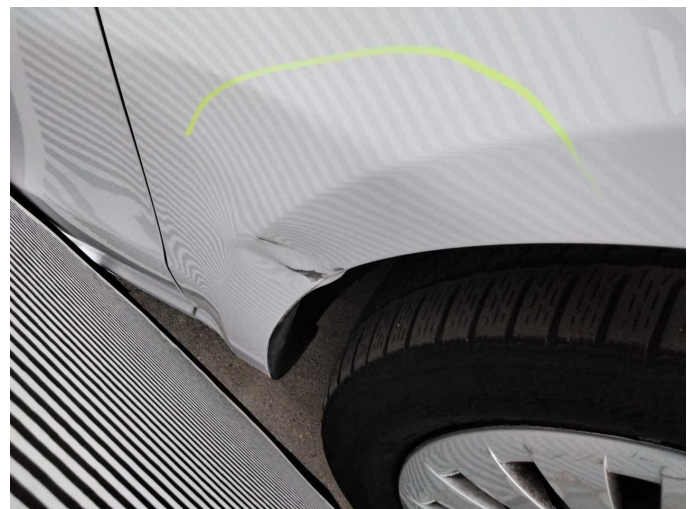
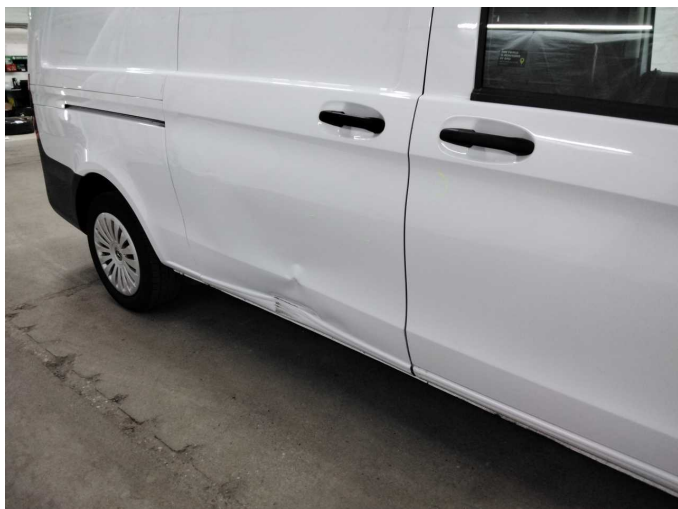
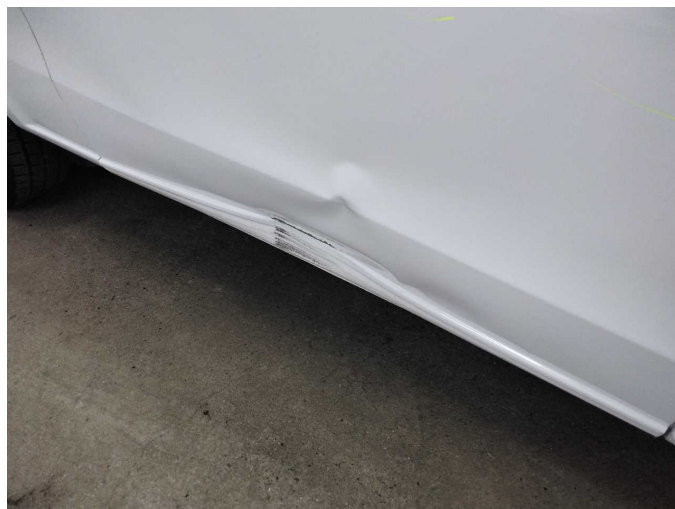
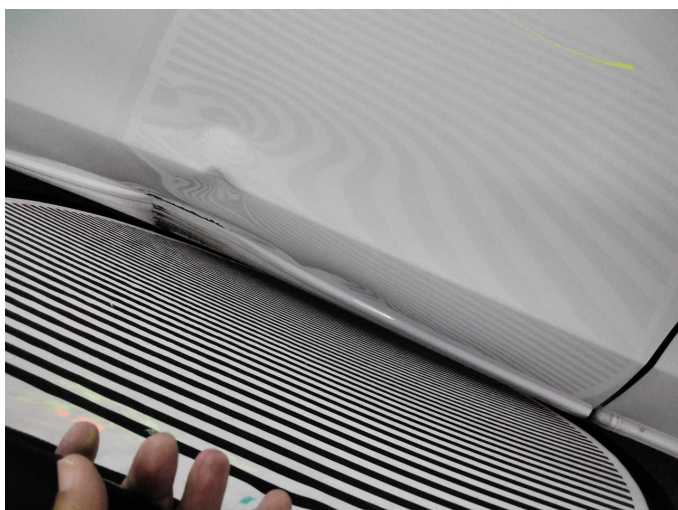
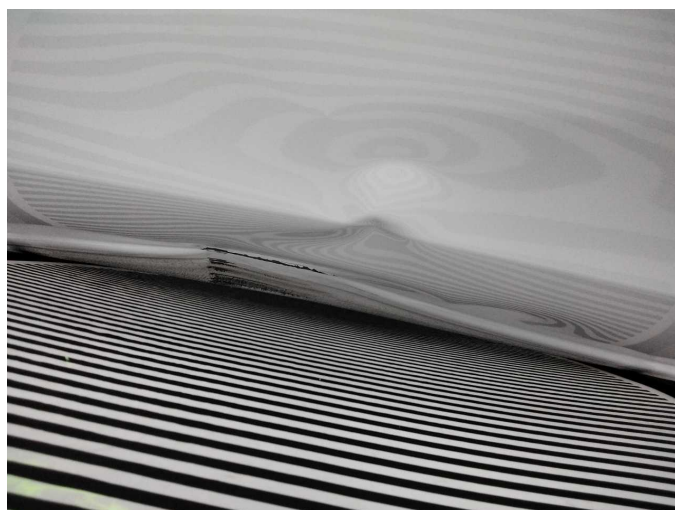
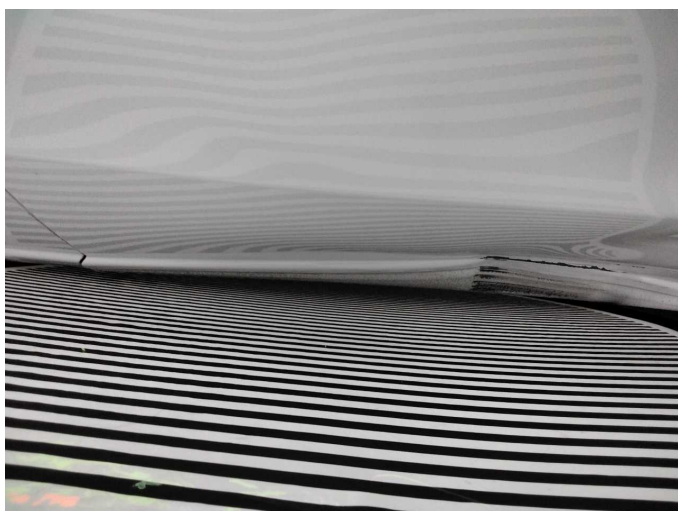
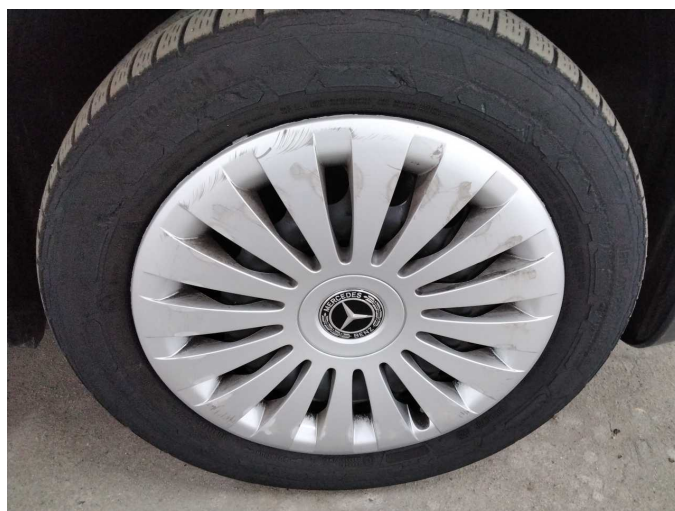
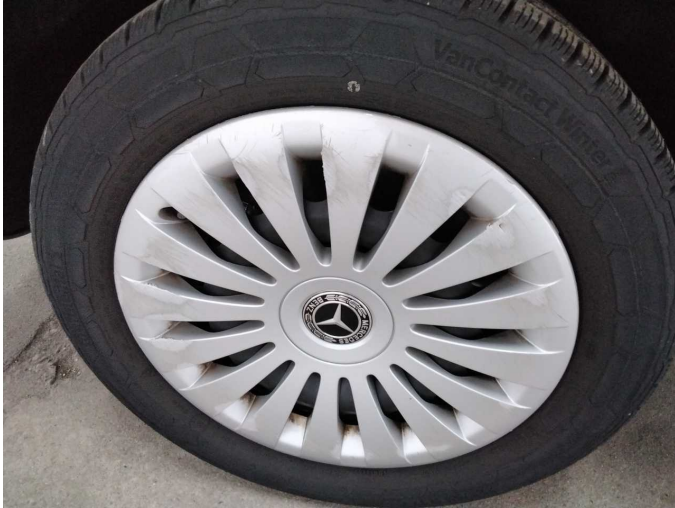
**Accident 1:** Side right

- Side right

Non-repaired previous damages were found at the vehicle. The necessary repair costs are listed in the expert report or if necessary, are listed in detail in a separately enclosed repair cost calculation.
