Expertise

Protocol number: 46067728  
Order No. / Reference: 26479307  
Inspection date: 22 Jun 2026

Manufacturer: Opel

Model: Astra 1.5 D Automatik Business Elegance

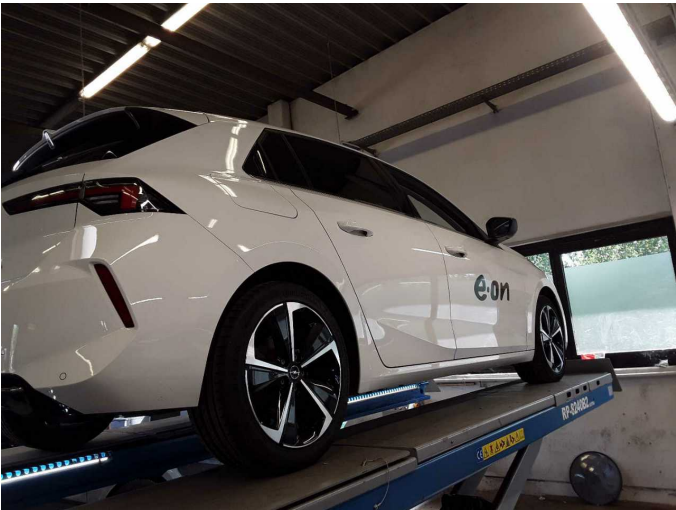
| No. | Component group | Description |
|---|---|---|
| 1 | Body | Body - Glued / labelled - De-glue / neutralise |

Damage 1: Body: Body - Glued / labelled - De-glue / neutralise

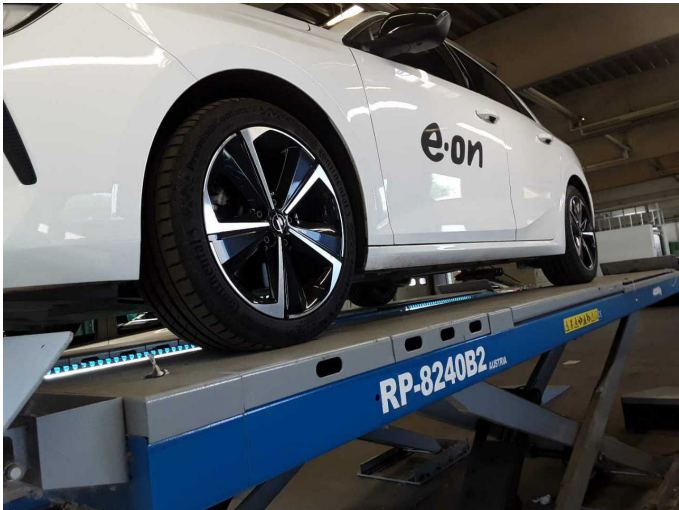
Damage 1: Body: Body - Glued / labelled - De-glue / neutralise

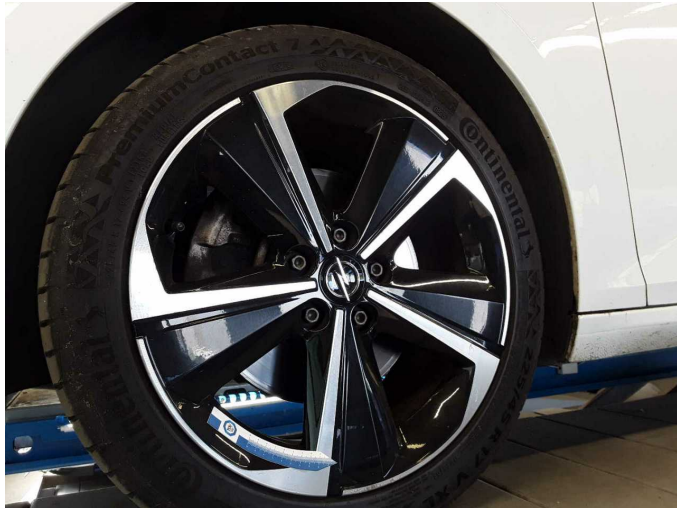
| No. | Component group | Description |
|---|---|---|
| 3 | Wheel / tyres | Alloy rim - front left side - Scratched - Loss in value |

**Damage 3:** Wheel / tyres: Alloy rim - front left side - Scratched - Loss in value

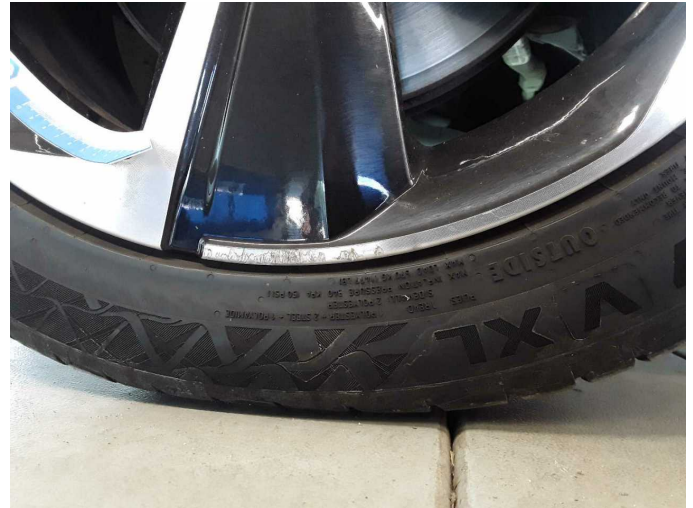
**Damage 3:** Wheel / tyres: Alloy rim - front left side - Scratched - Loss in value

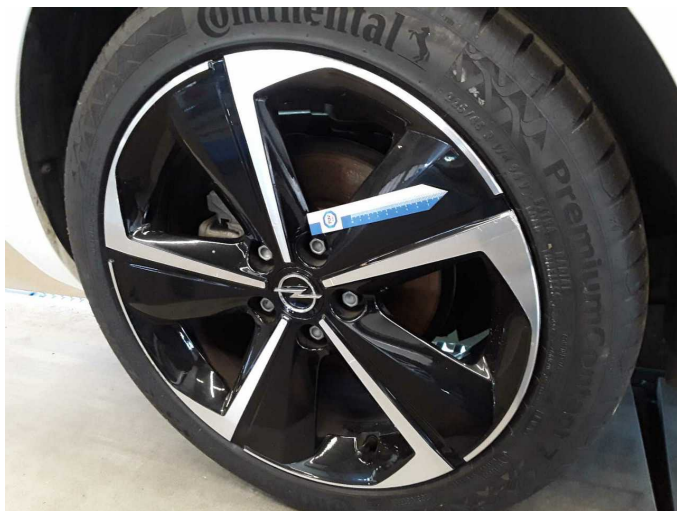
| No. | Component group | Description |
|---|---|---|
| 4 | Wheel / tyres | Alloy rim - rear right side - Scratched - Loss in value |

**Damage 4:** Wheel / tyres: Alloy rim - rear right side - Scratched - Loss in value

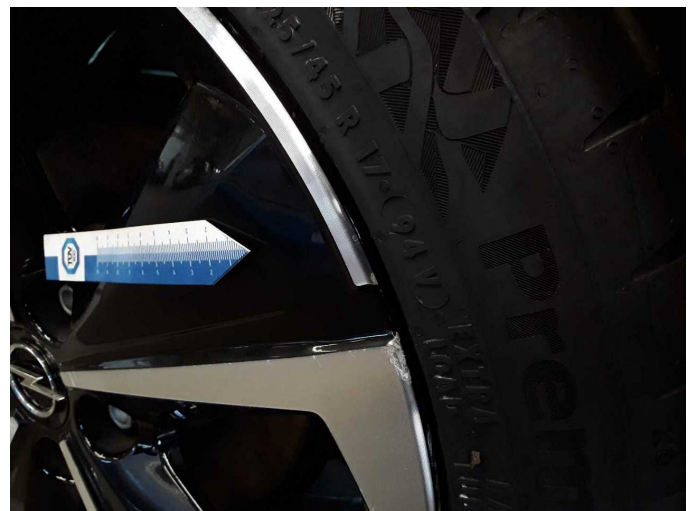
**Damage 4:** Wheel / tyres: Alloy rim - rear right side - Scratched - Loss in value

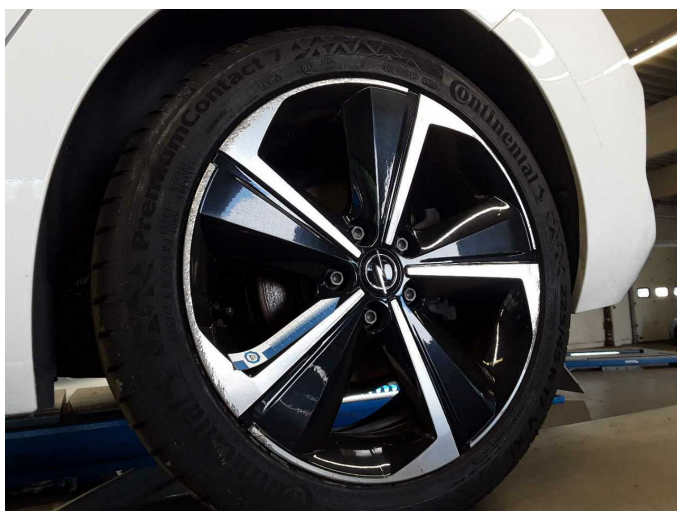
| No. | Component group | Description |
|---|---|---|
| 5 | Wheel / tyres | Alloy rim - rear left side (Materialabtrag) - Scratched - Replace |

**Damage 5:** Wheel / tyres: Alloy rim - rear left side (Materialabtrag) - Scratched - Replace

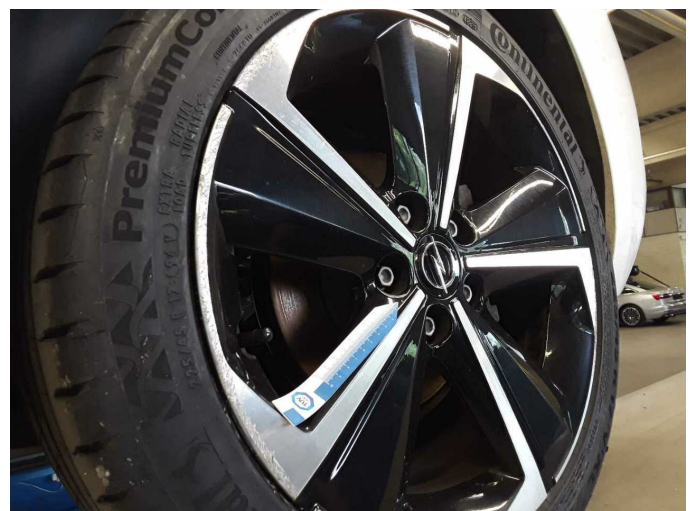
**Damage 5:** Wheel / tyres: Alloy rim - rear left side (Materialabtrag) - Scratched - Replace

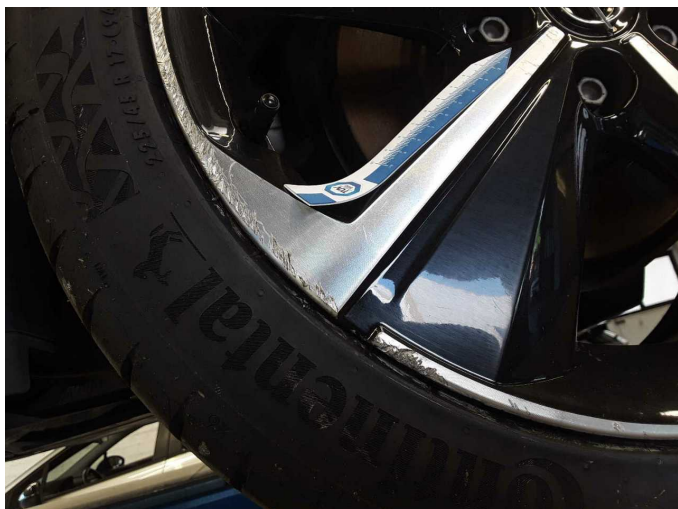
**Damage 5:** Wheel / tyres: Alloy rim - rear left side (Materialabtrag) - Scratched - Replace

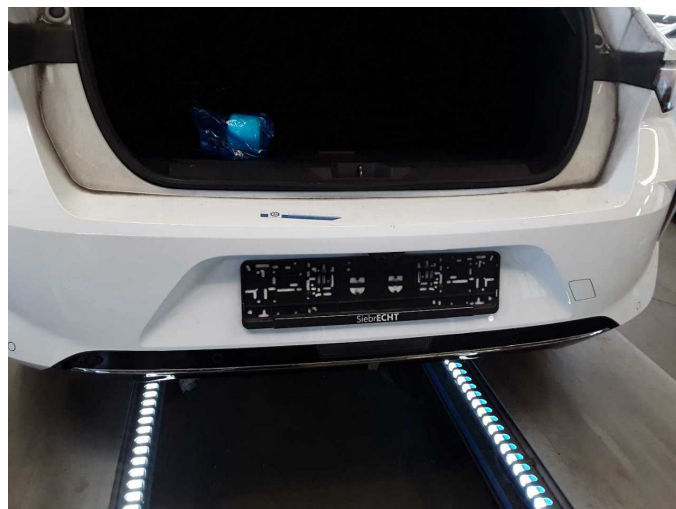
| No. | Component group | Description |
|---|---|---|
| 6 | Rear bumper | Rear bumper - Scratch(es) - Paint |

**Damage 6:** Rear bumper: Rear bumper - Scratch(es) - Paint

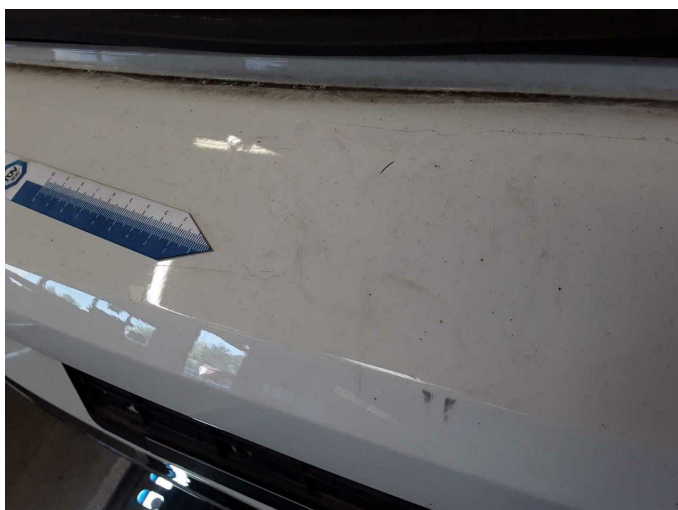
**Damage 6:** Rear bumper: Rear bumper - Scratch(es) - Paint

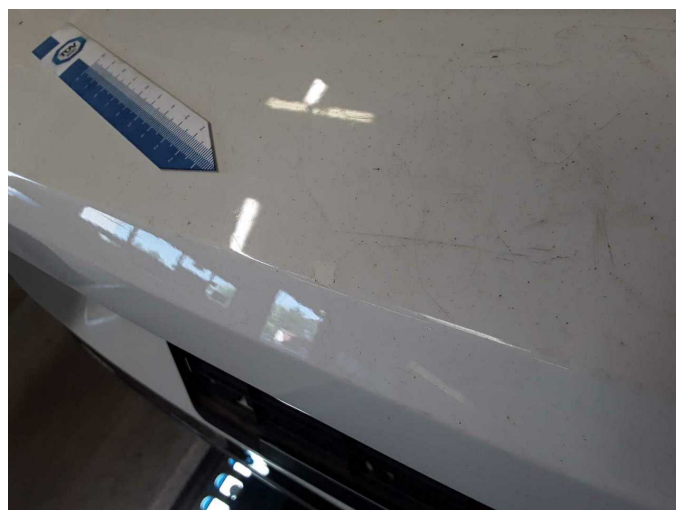
**Damage 6:** Rear bumper: Rear bumper - Scratch(es) - Paint

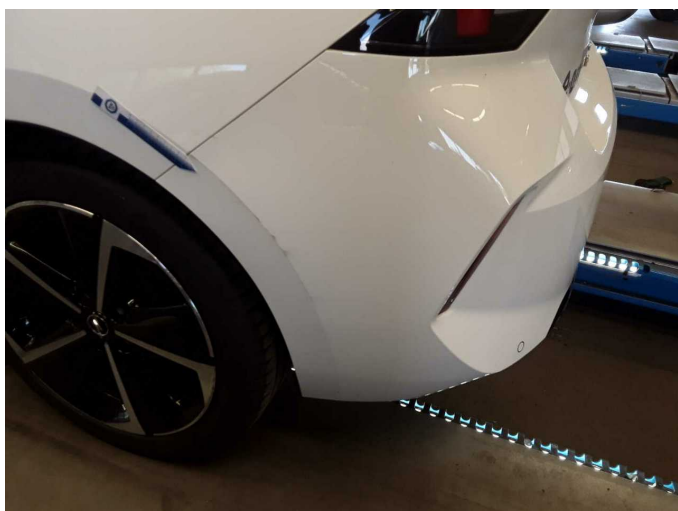
**Damage 6:** Rear bumper: Rear bumper - Scratch(es) - Paint

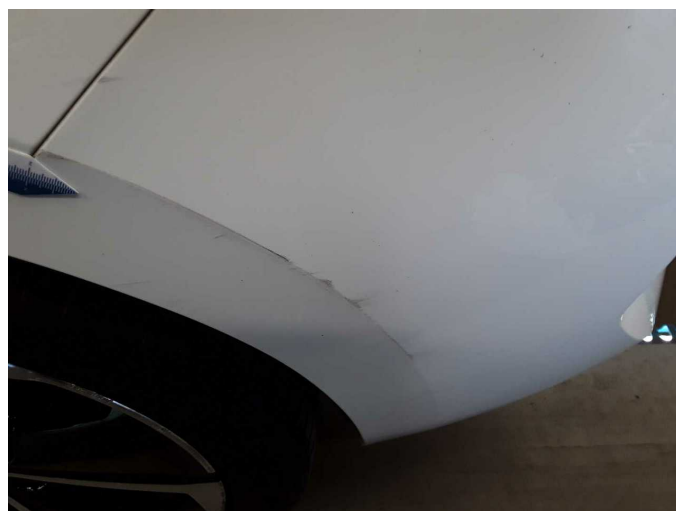
**Damage 6:** Rear bumper: Rear bumper - Scratch(es) - Paint

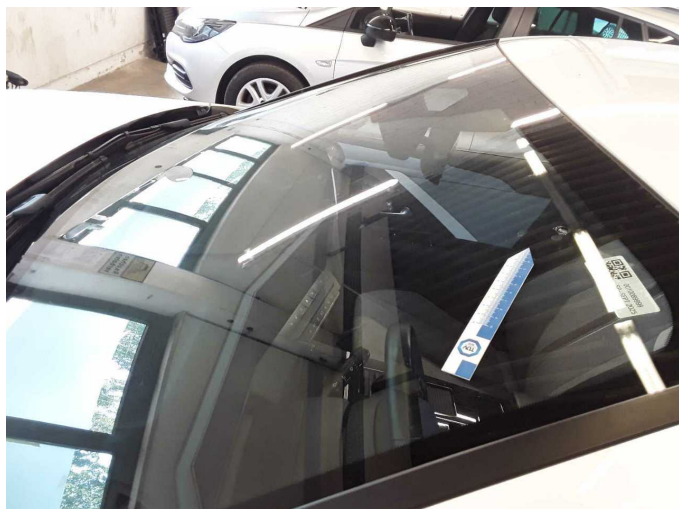
| No. | Component group | Description |
|---|---|---|
| 7 | Vehicle glazing | Windscreen (Rissbildung) - Stone chips - Replace |

**Damage 7:** Vehicle glazing: Windscreen (Rissbildung) - Stone chips - Replace

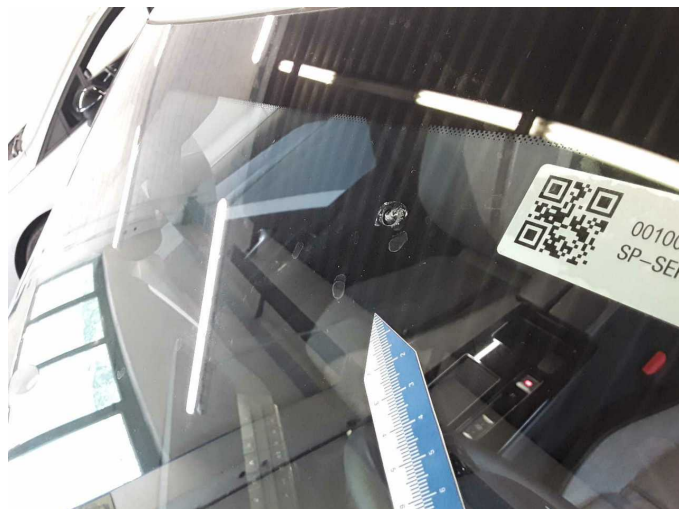
**Damage 7:** Vehicle glazing: Windscreen (Rissbildung) - Stone chips - Replace

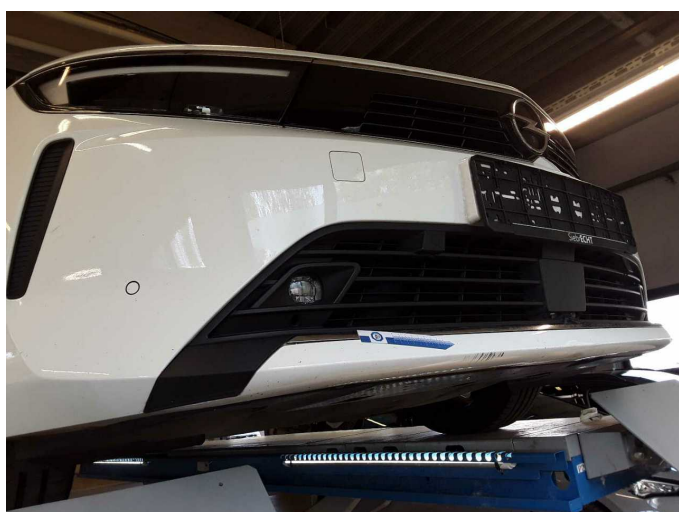
| No. | Component group | Description |
|---|---|---|
| 8 | Front bumper | Front bumper - Scratch(es) - Paint |

**Damage 8:** Front bumper: Front bumper - Scratch(es) - Paint

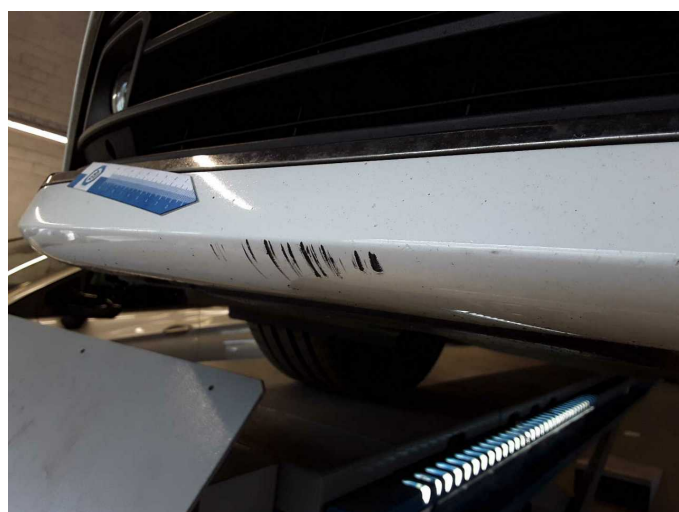
**Damage 8:** Front bumper: Front bumper - Scratch(es) - Paint

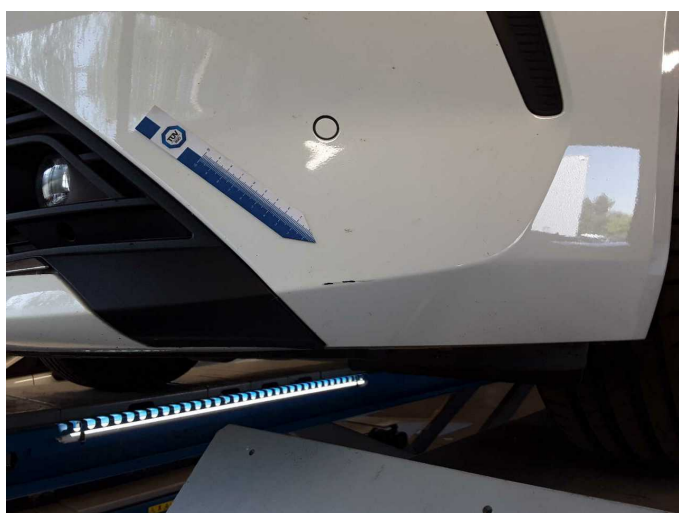
**Damage 8:** Front bumper: Front bumper - Scratch(es) - Paint

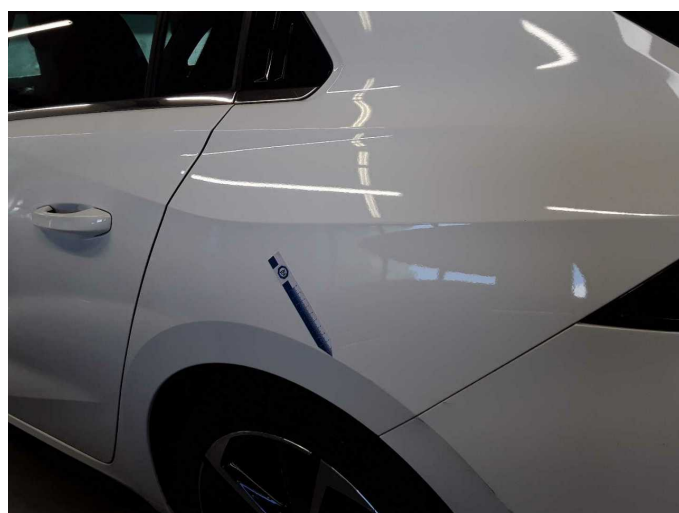
| No. | Component group | Description |
|---|---|---|
| 2 | Body | Body (Waschanlagekratzer) - Scratch(es) - No deduction |

**Wear and tear 2:** Body: Body (Waschanlagekratzer) - Scratch(es) - No deduction

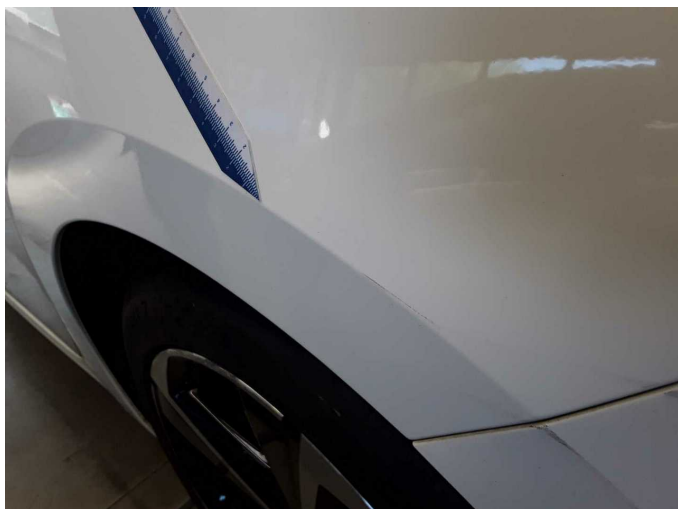
**Wear and tear 2:** Body: Body (Waschanlagekratzer) - Scratch(es) - No deduction

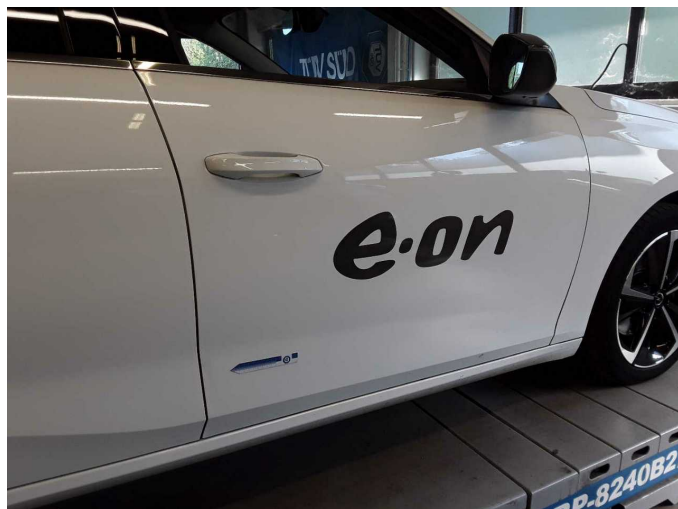
| No. | Component group | Description |
|---|---|---|
| 4 | Door - front right side | Door - dent(s) - Smooth repair work |

**Wear and tear 4:** Door - front right side: Door - dent(s) - Smooth repair work

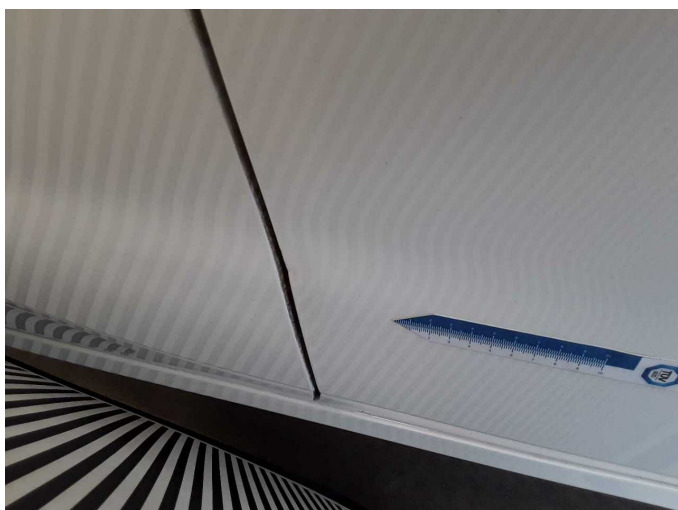
**Wear and tear 4:** Door - front right side: Door - dent(s) - Smooth repair work

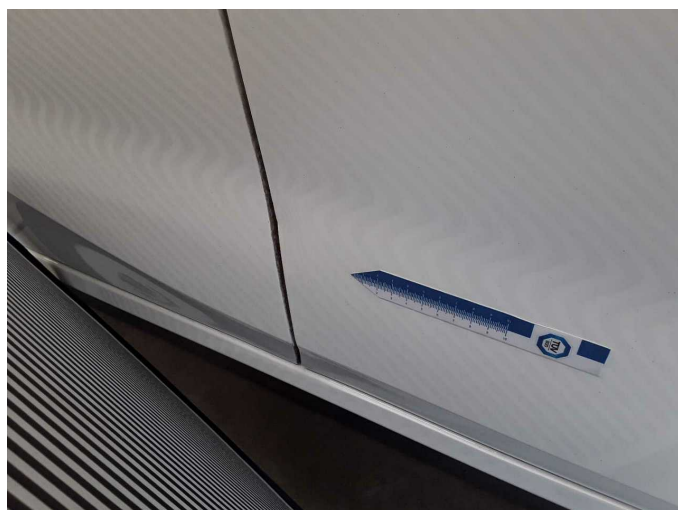
**Wear and tear 4:** Door - front right side: Door - dent(s) - Smooth repair work
