Expertise

Protocol number: 46337276
Order No. / Reference: 26300938
Inspection date: 6 Jul 2026

Manufacturer: Ford

Model: Transit Connect 210 L2 S&S Trend

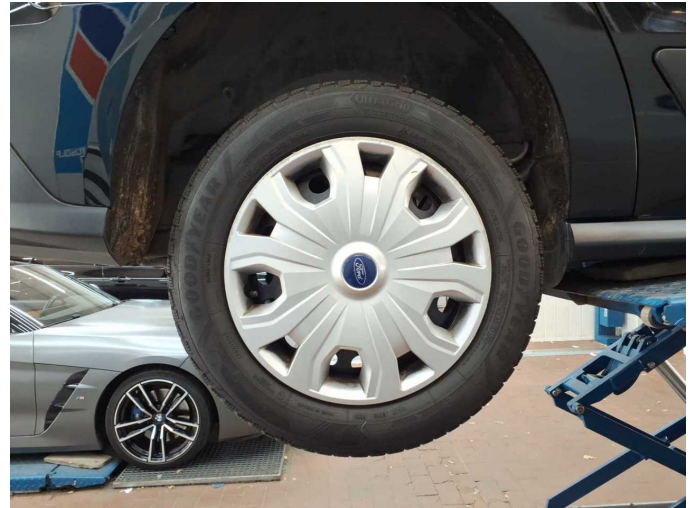
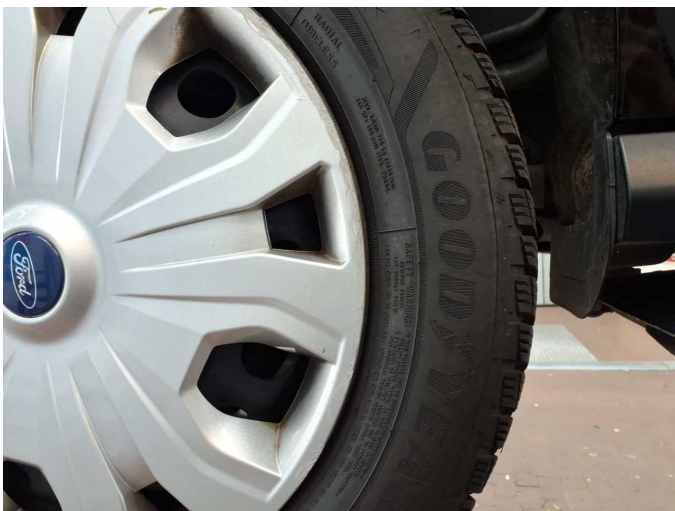
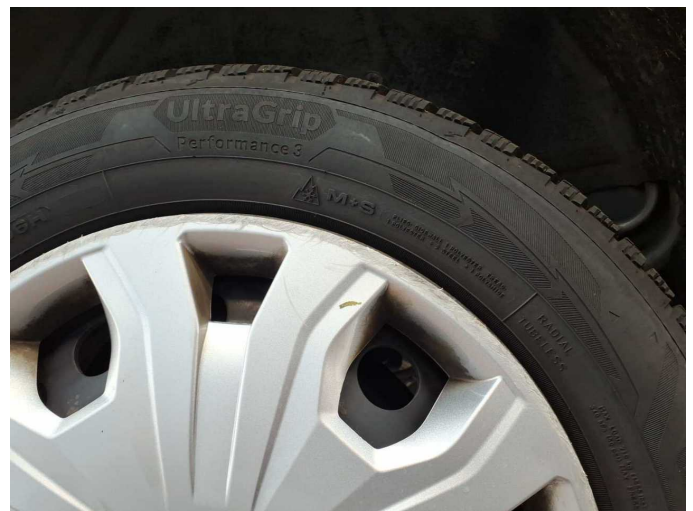
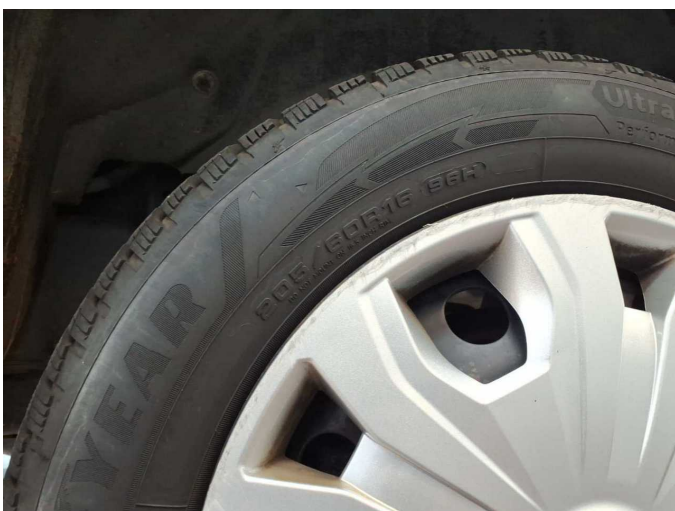
Damage 1: Wheel / tyres: Wheel cover - rear right side - Scratch(es) - Replace

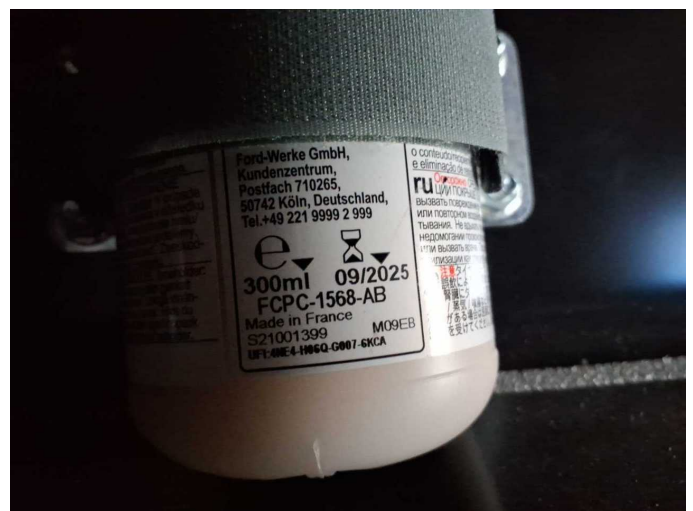
Damage 2: Equipment: Tirefit filler - Expired - Replace

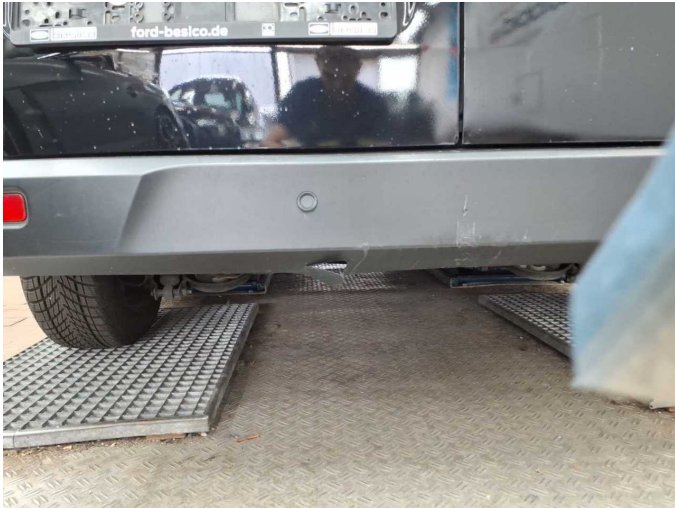
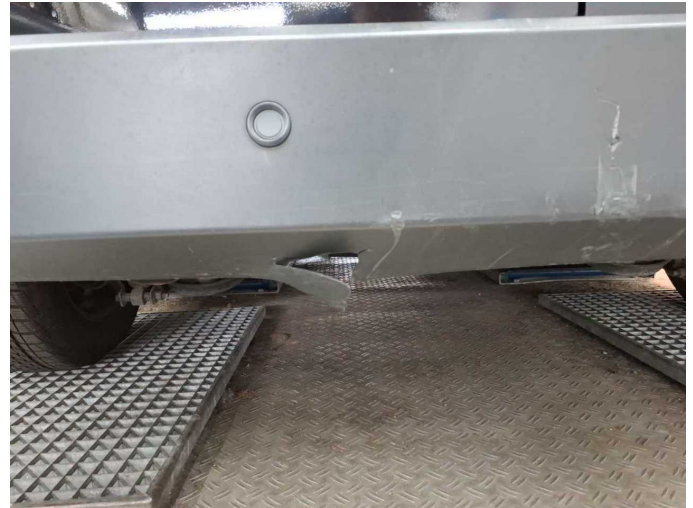
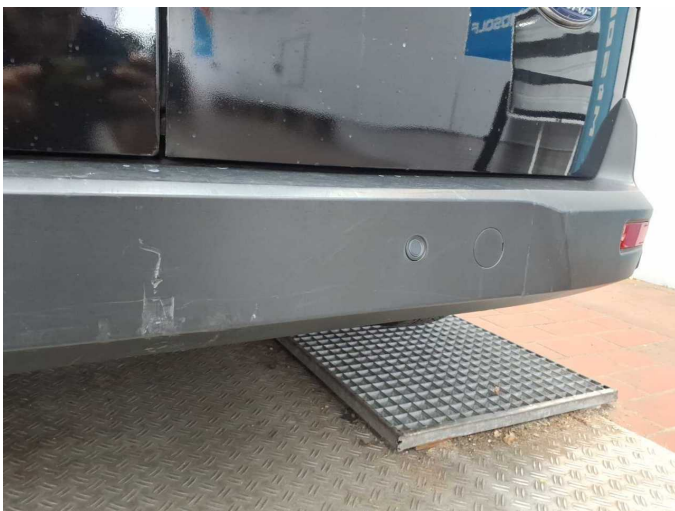
Damage 3: Rear bumper: Rear bumper - Broken / torn - Replace

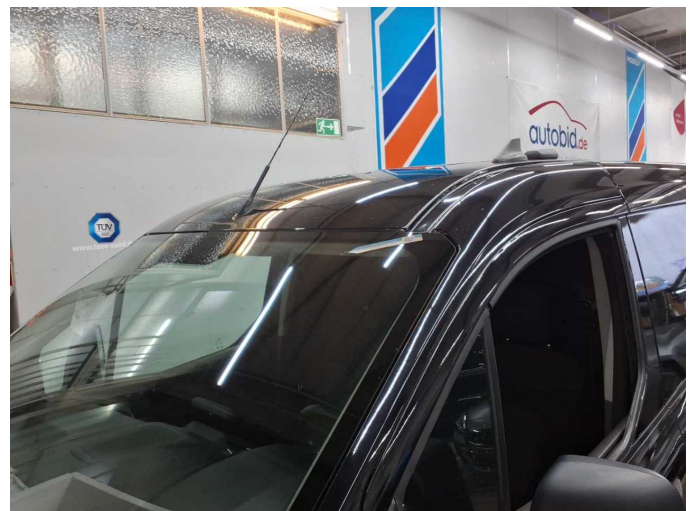
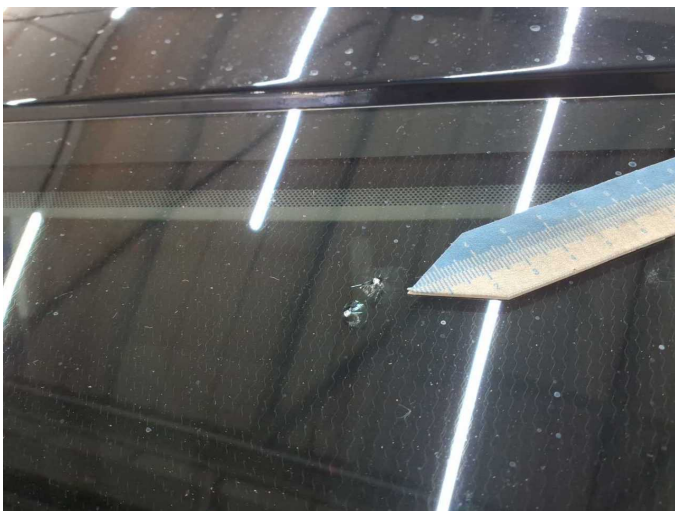
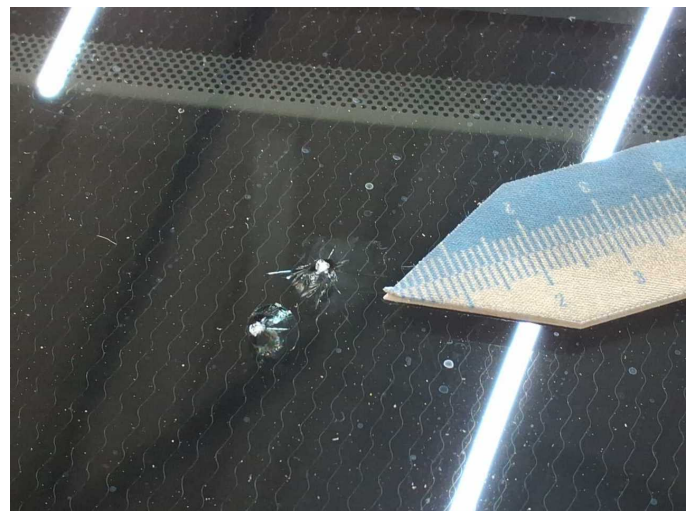
Damage 4: Vehicle glazing: Windscreen - Stone chips - repair according to calculation

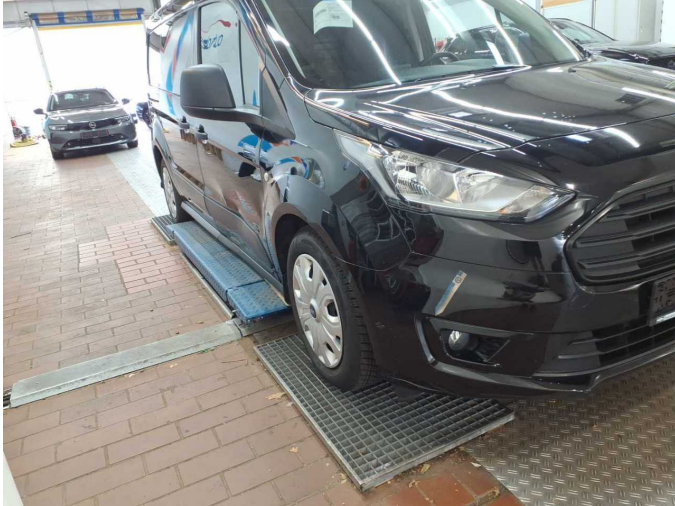
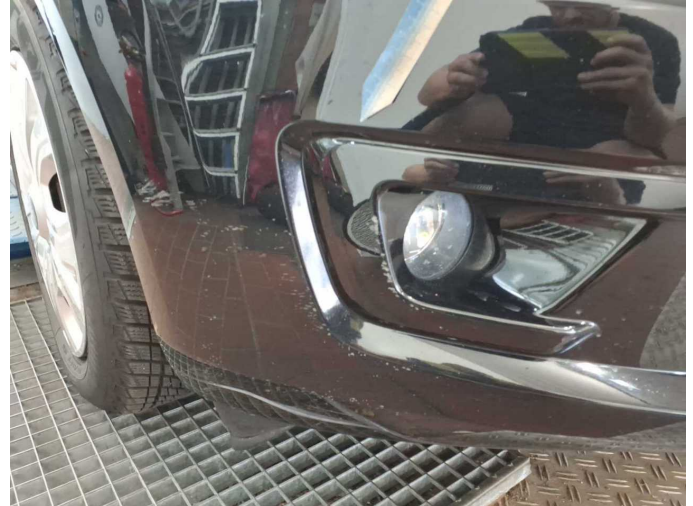
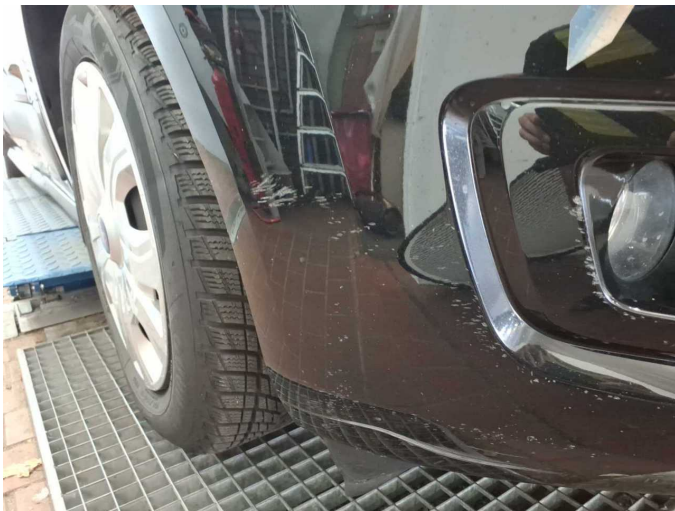
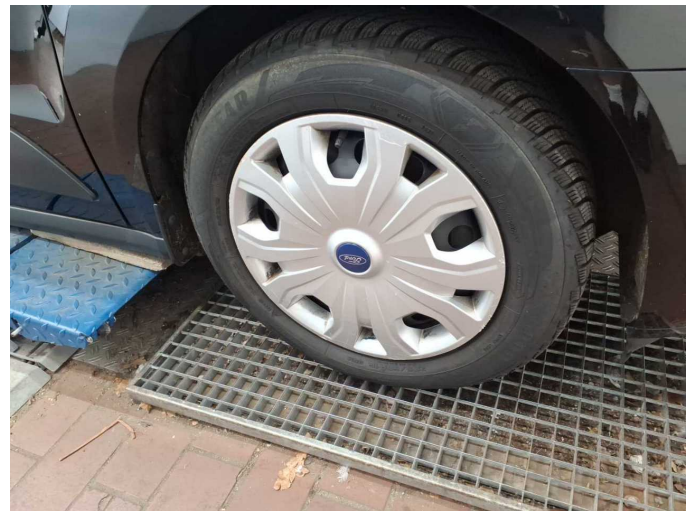
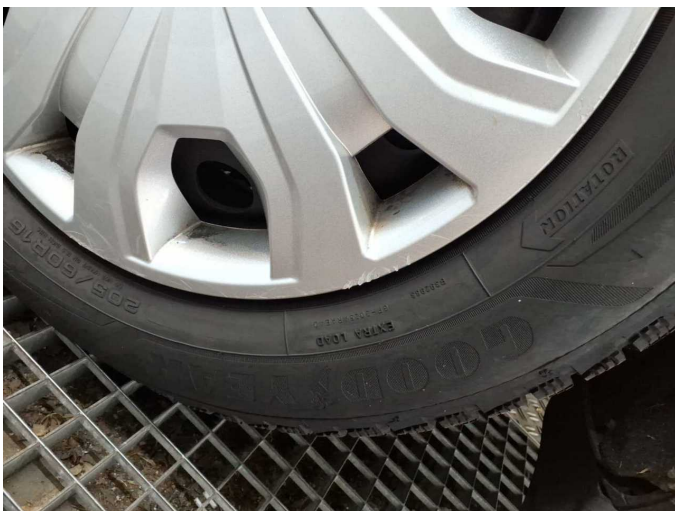
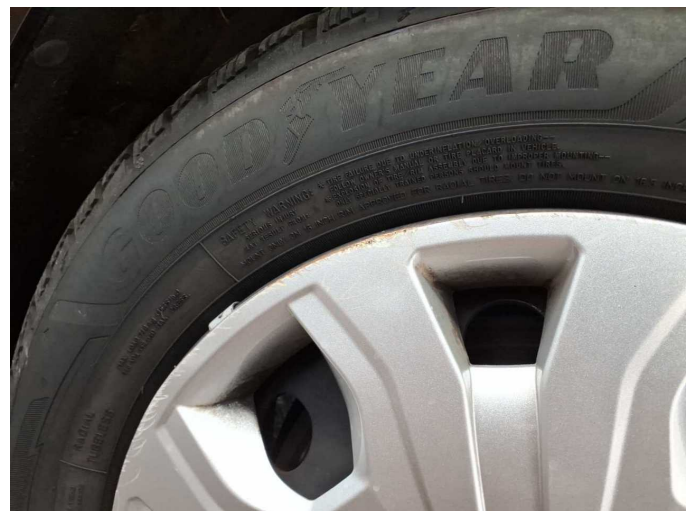
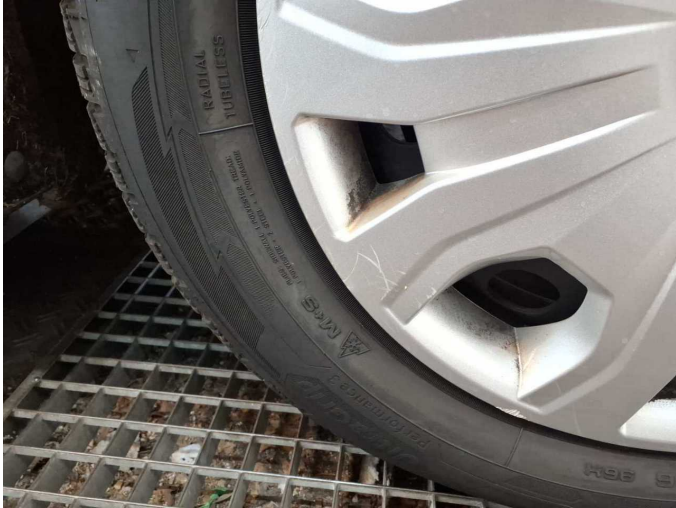
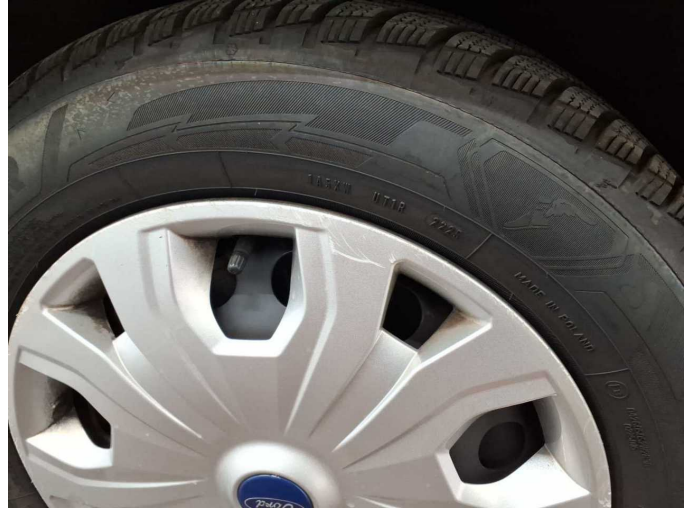
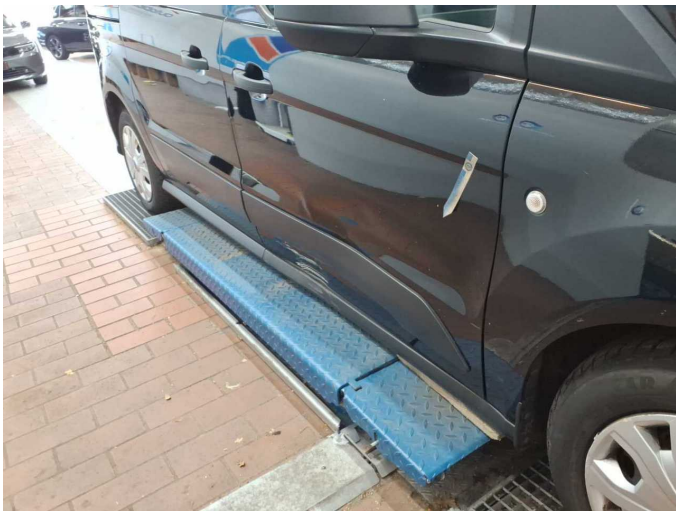
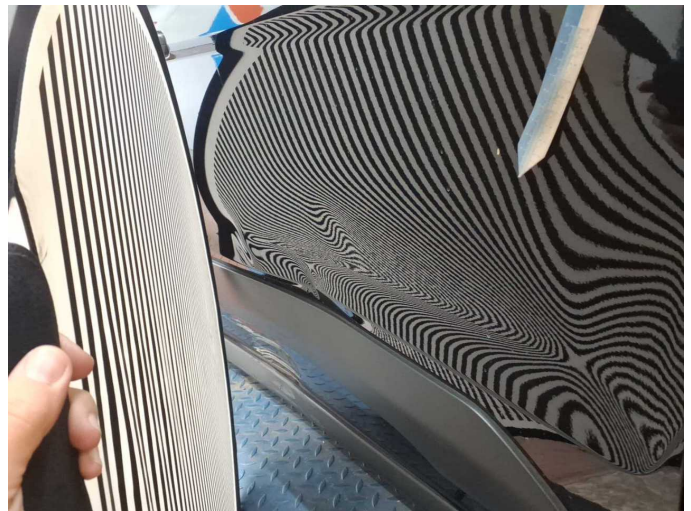
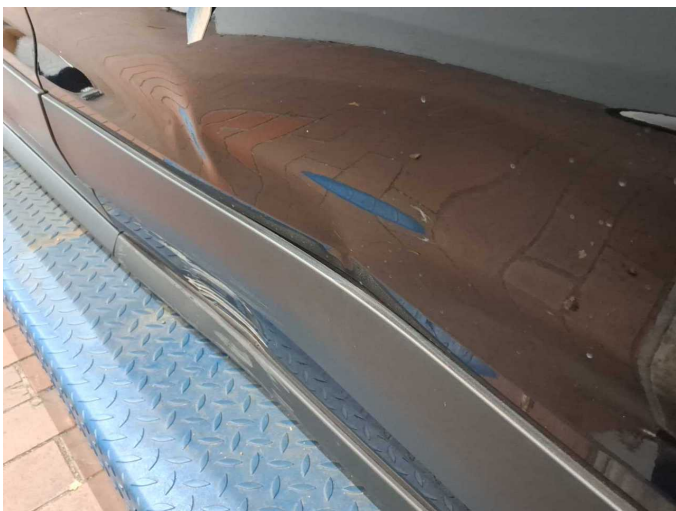
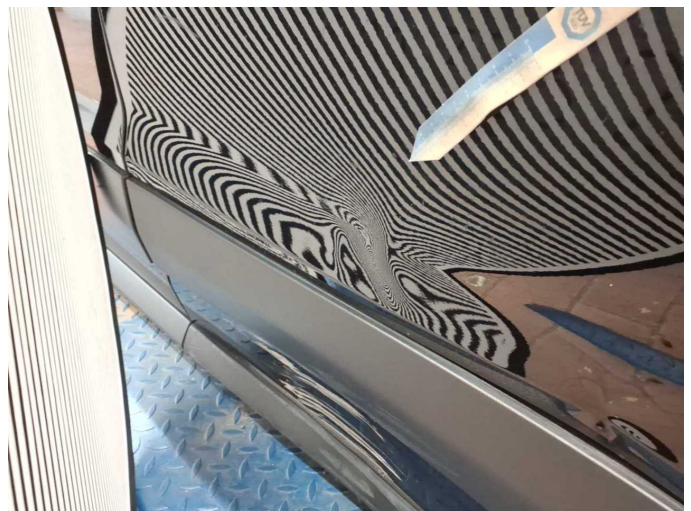
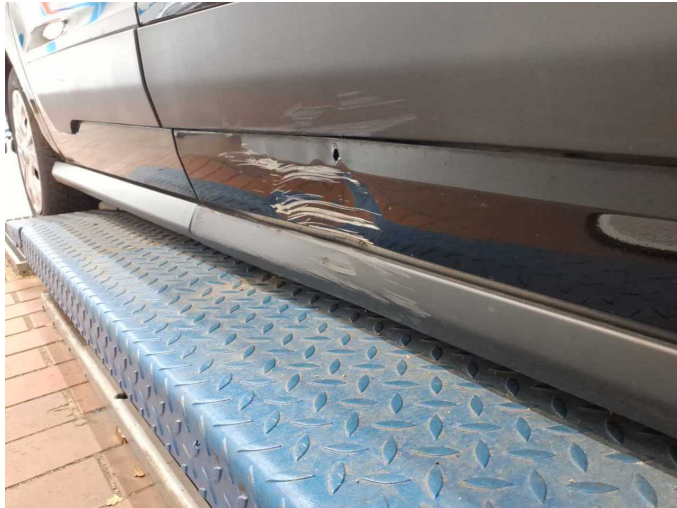
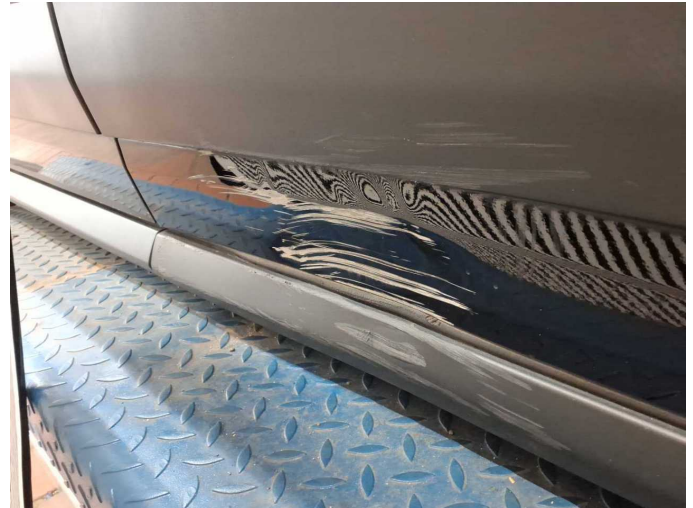
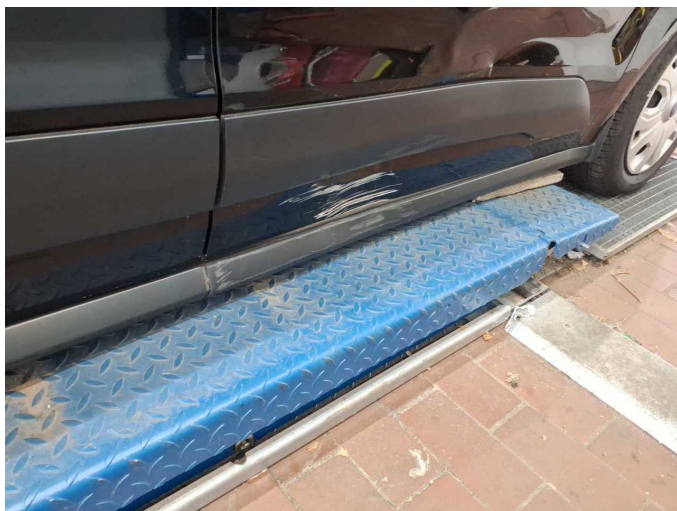
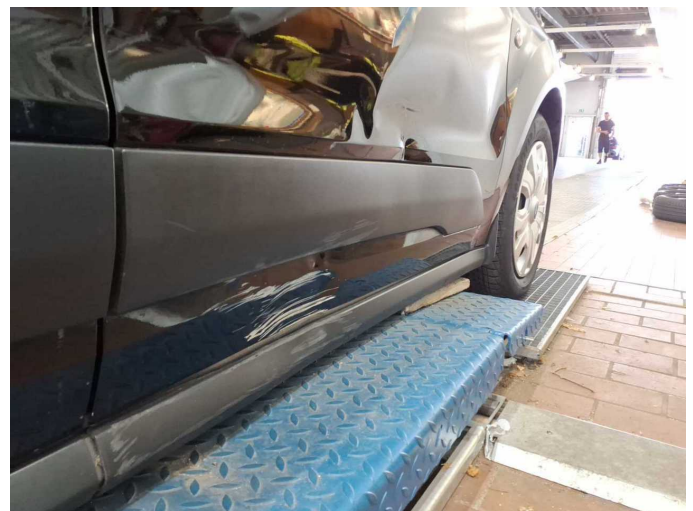
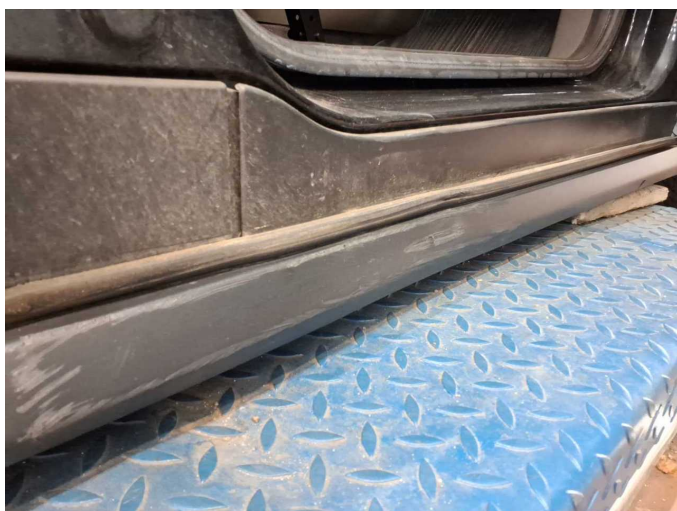
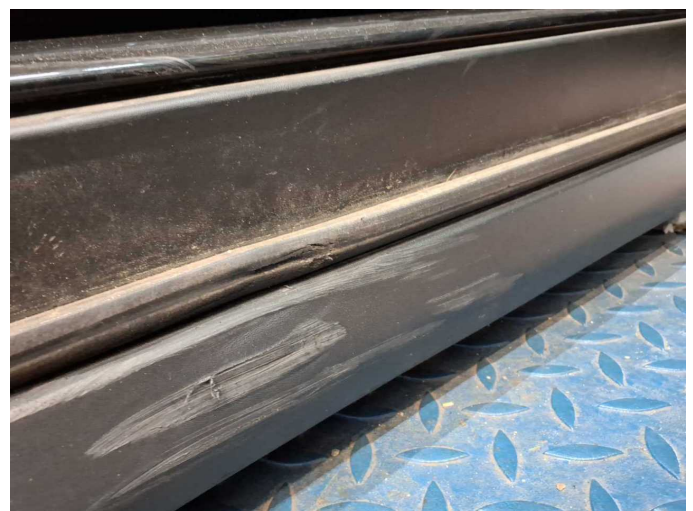
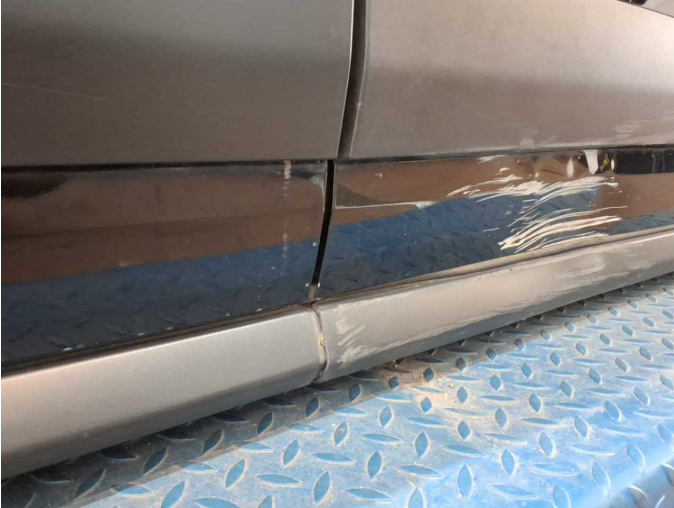
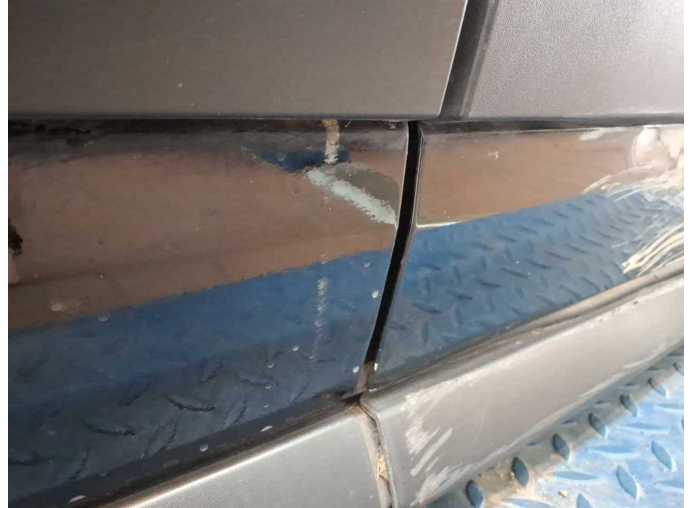
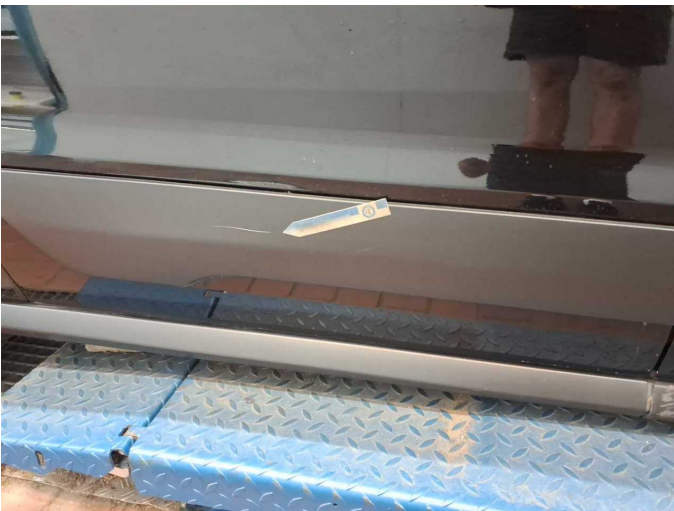
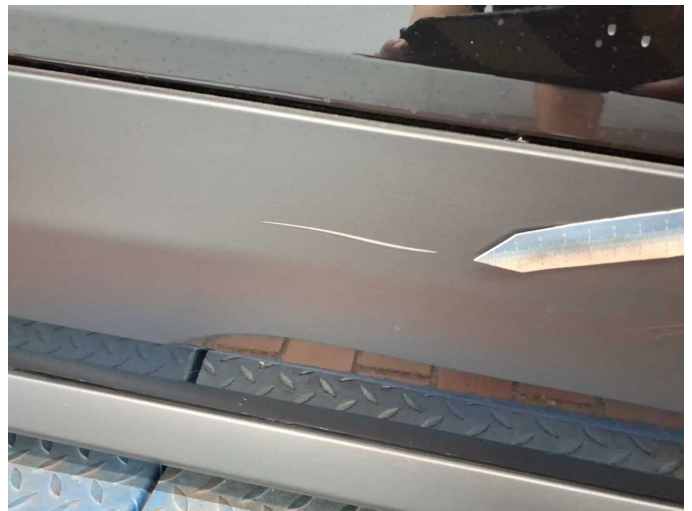
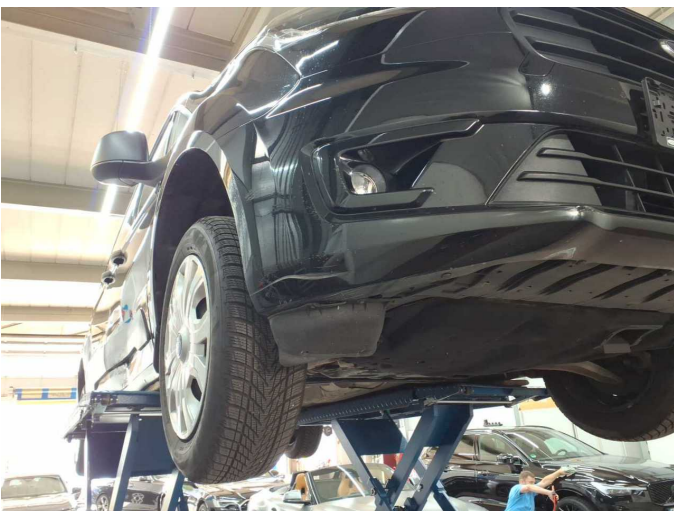
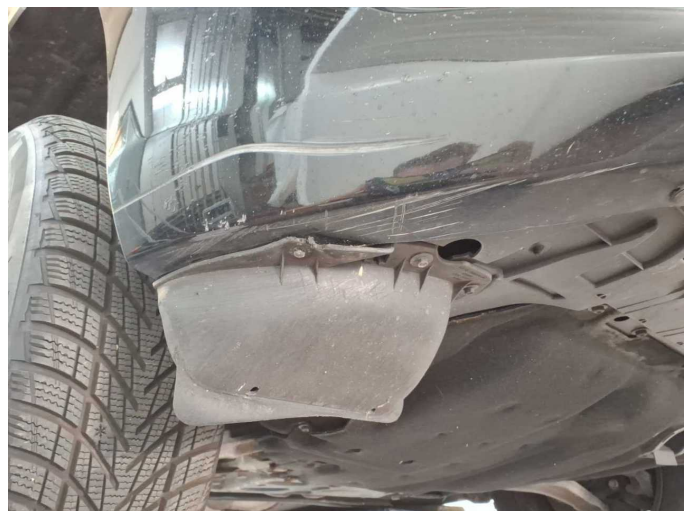
Accident 1: Front, Side right
