## Expertise

Protocol number: 46269991  
Order No. / Reference: 26530357  
Inspection date: 26 Jun 2026

Model: Leon Sportstourer 1.5 eTSI ACT OPF DSG Xcellence

VIN: VSSZZZKLZNR001081

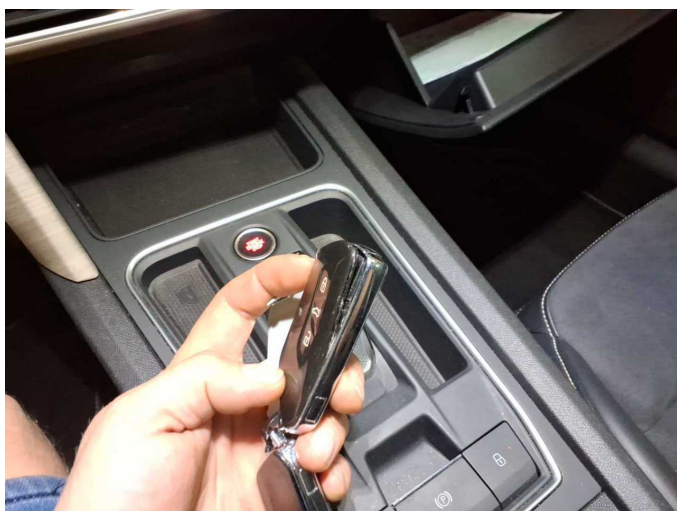
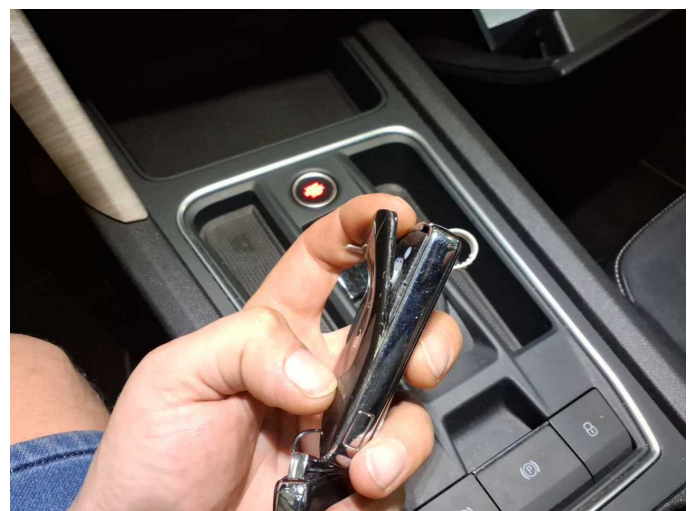
**Damage 1:** Equipment: Vehicle key with remote control (Abdeckung lose - Mehrkosten möglich) - Malposition - Diagnosed and repair if necessary

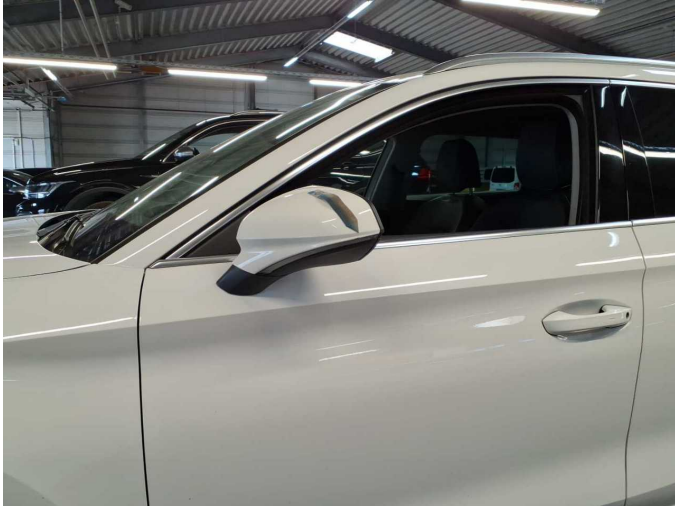
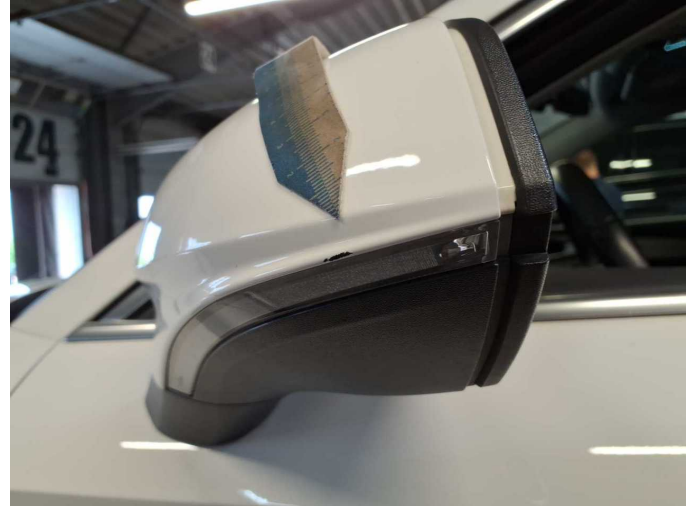
**Damage 3:** Wing mirror - left side: Cap - Scratch(es) - Smart repair

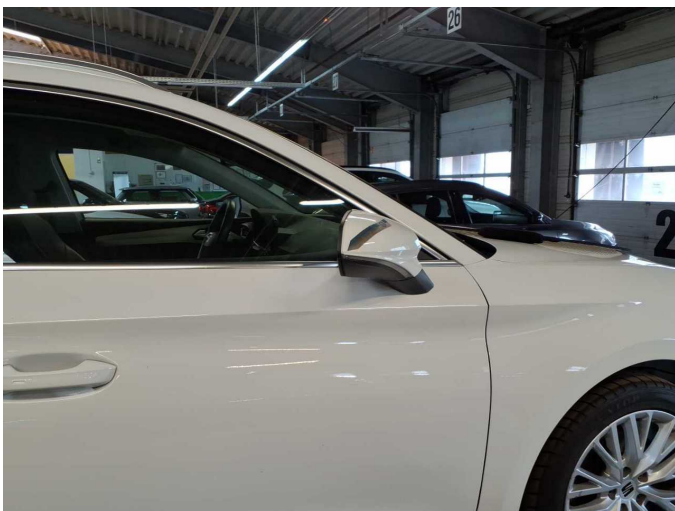
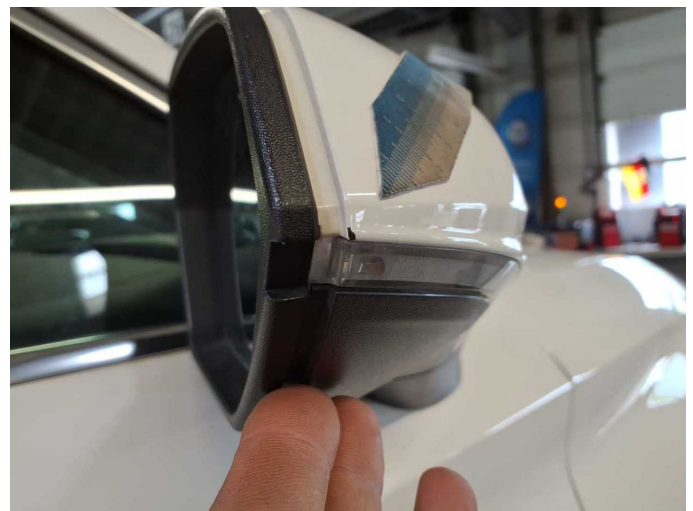
**Damage 4:** Wing mirror - right side: Cap - Scratch(es) - Smart repair

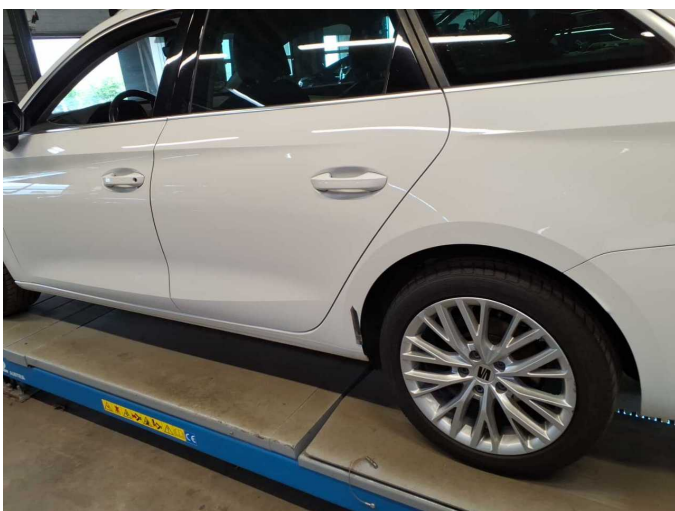
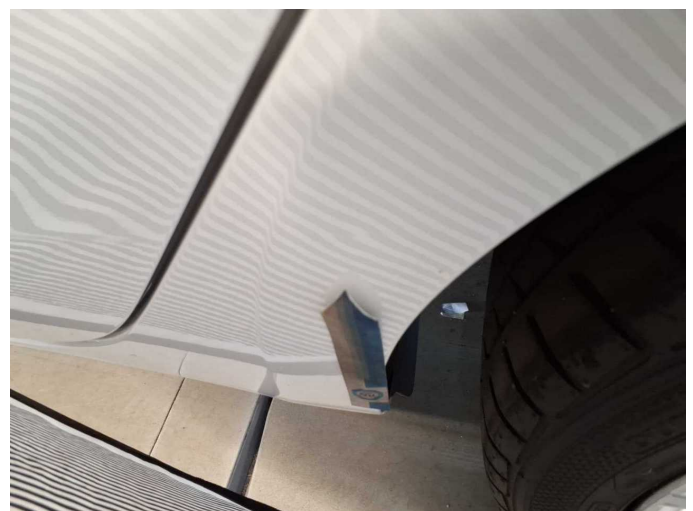
**Damage 5:** Side panel - rear left side: Side panel - dent(s) - Smooth repair work

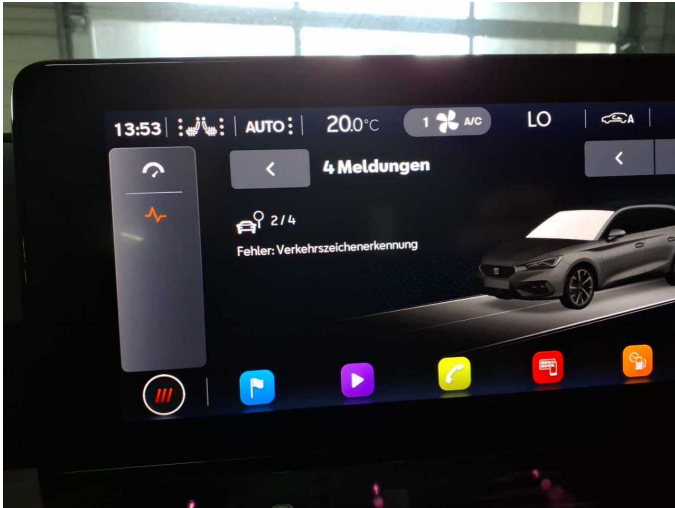
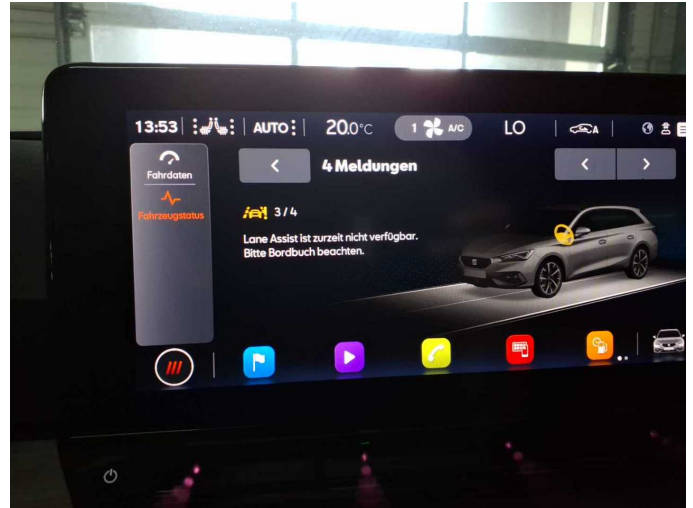
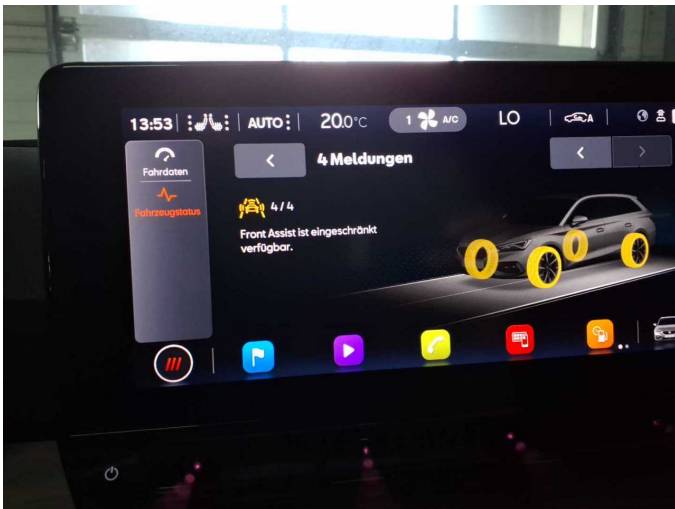
**Damage 6:** Electronic systems: Electronic systems (Fahrassistenzsysteme - Folgekosten möglich) - Specify findings - Perform diagnosis

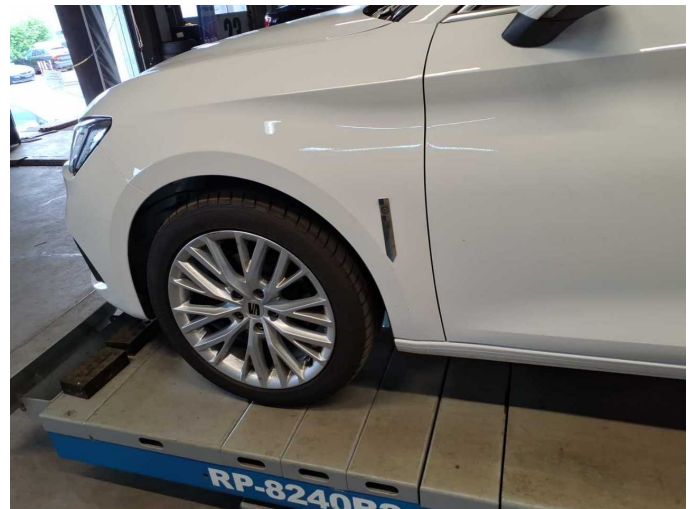
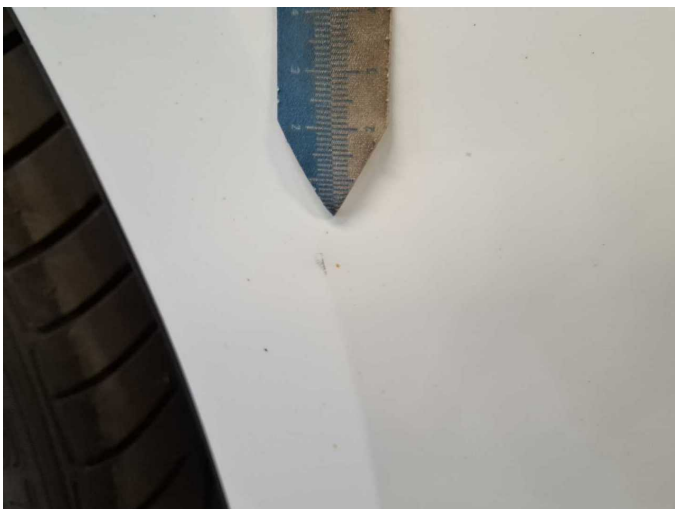
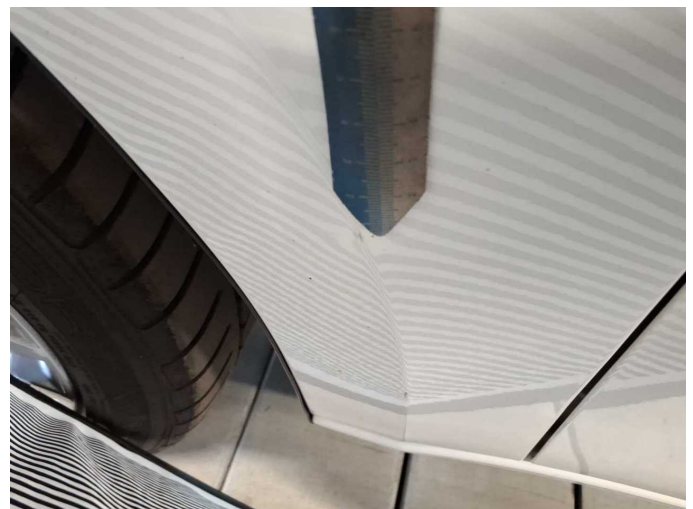
**Damage 7:** Mudguard - left side: Mudguard - left side - Dent / paintcoat damage - Smart repair

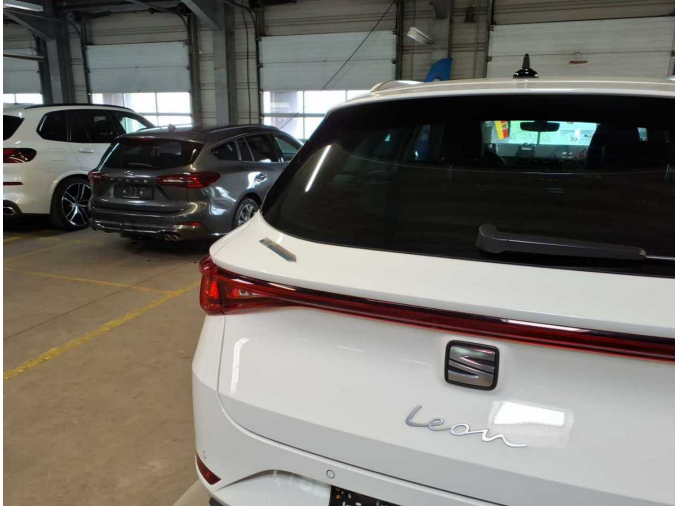
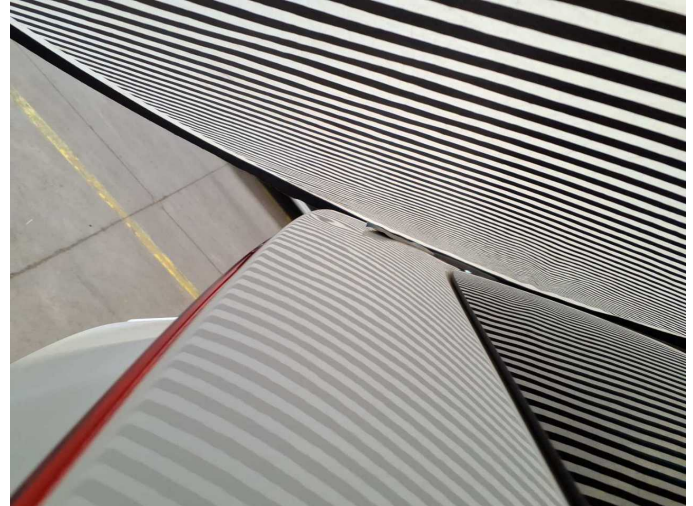
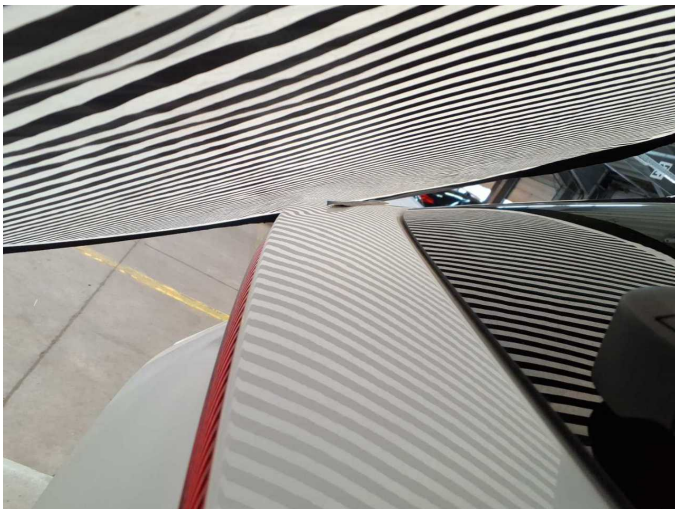
**Damage 8:** Boot lid / rear door: Boot lid - dent(s) - Smooth repair work

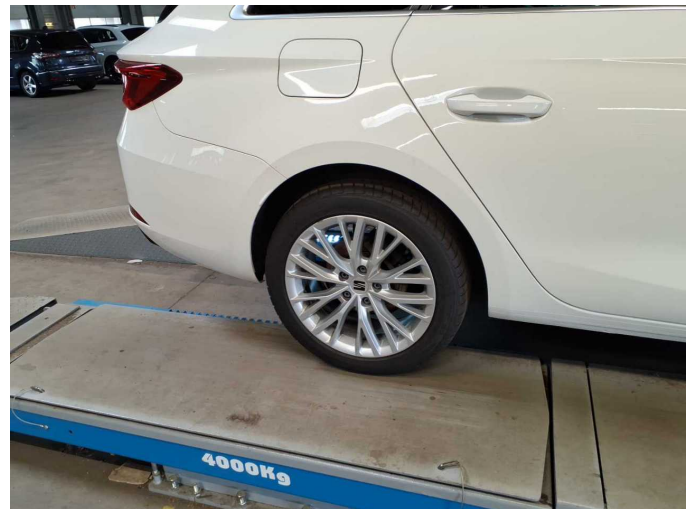
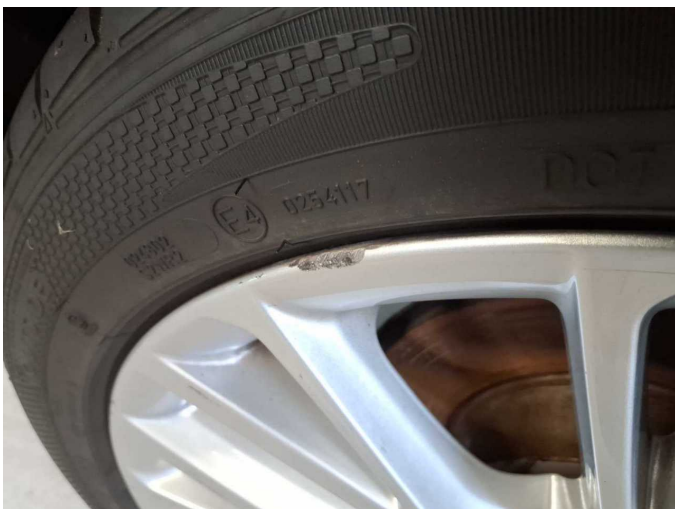
**Damage 9:** Wheel / tyres: Alloy rim - rear right side - Scratched - Loss in value

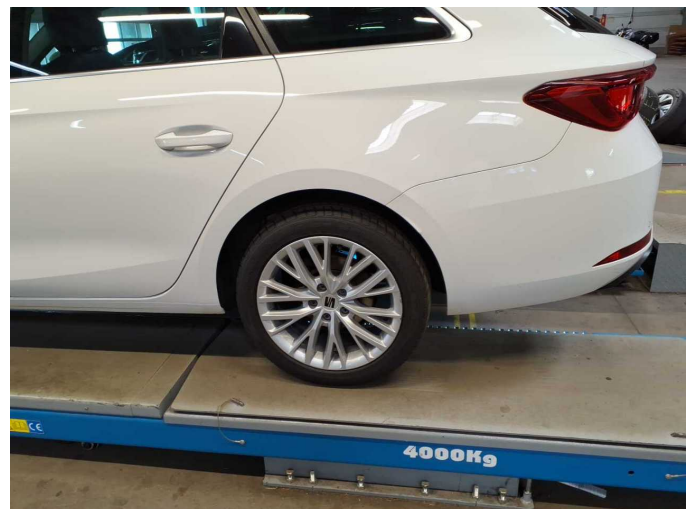
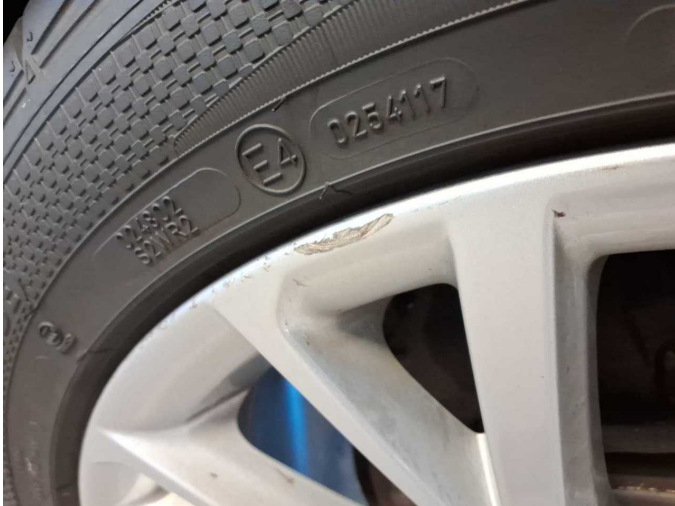
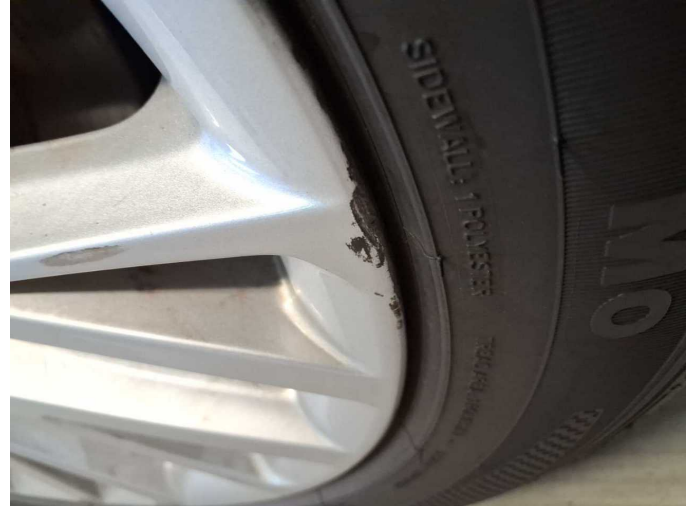
**Damage 10:** Wheel / tyres: Alloy rim - rear left side - Scratched - Loss in value

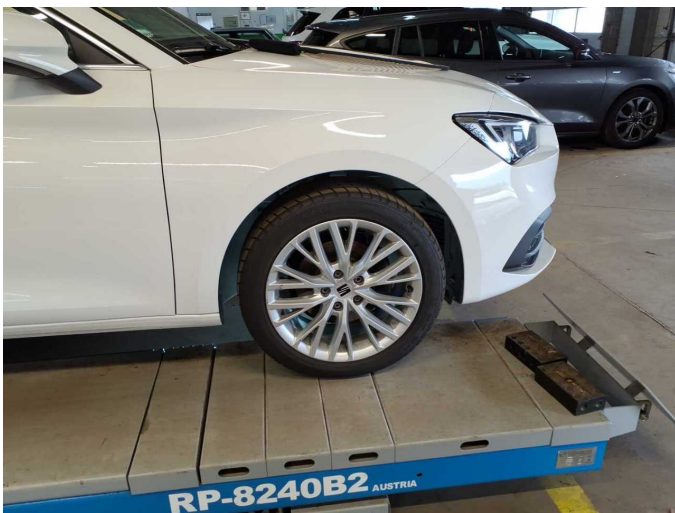
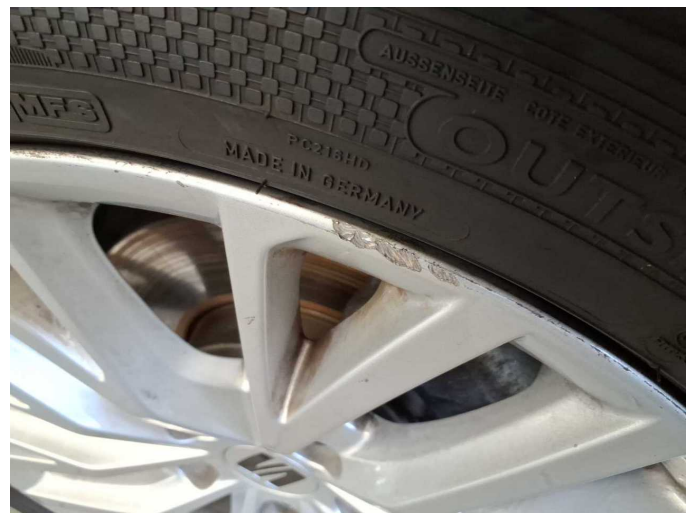
**Damage 11:** Wheel / tyres: Alloy rim - front right side - Scratch(es) - Loss in value

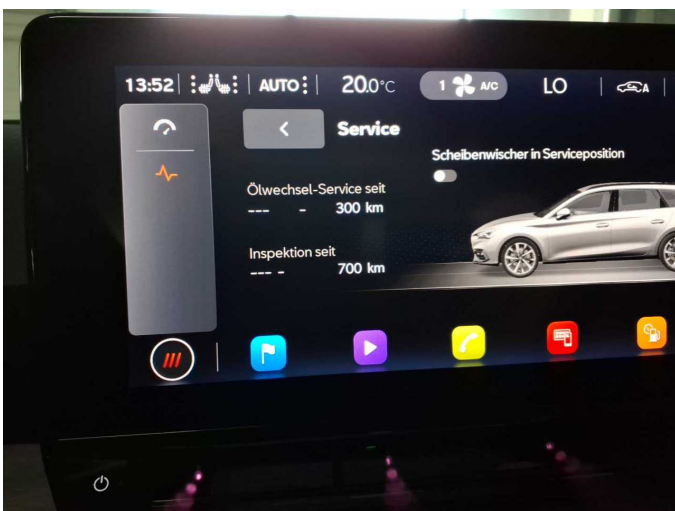
**Damage 12:** Misc.: Inspection / maintenance - Due - Perform

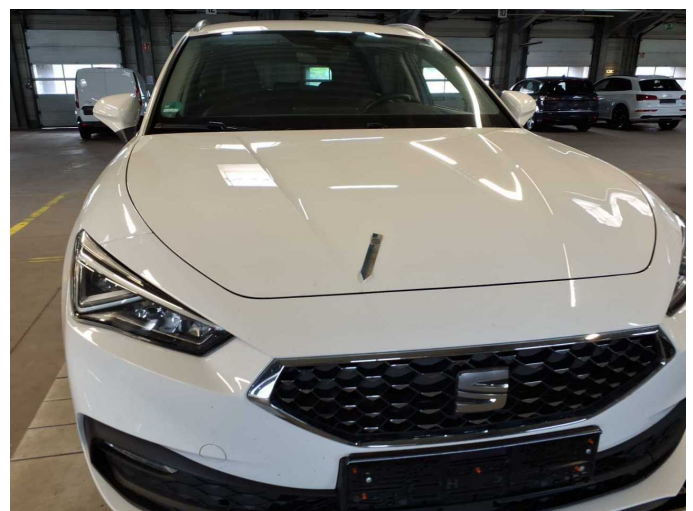
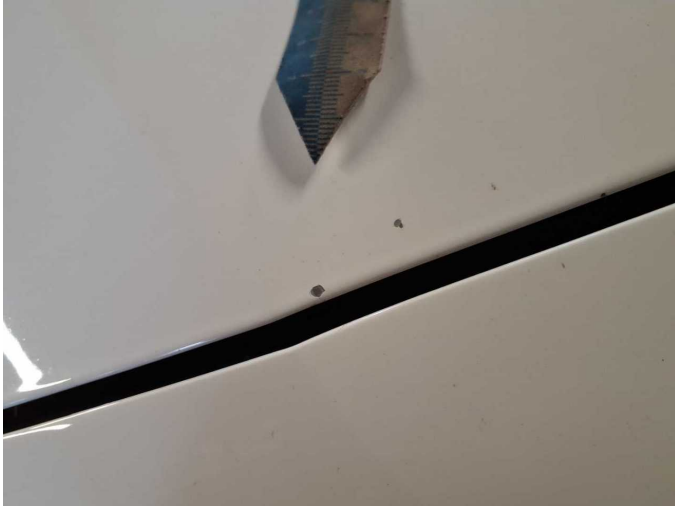
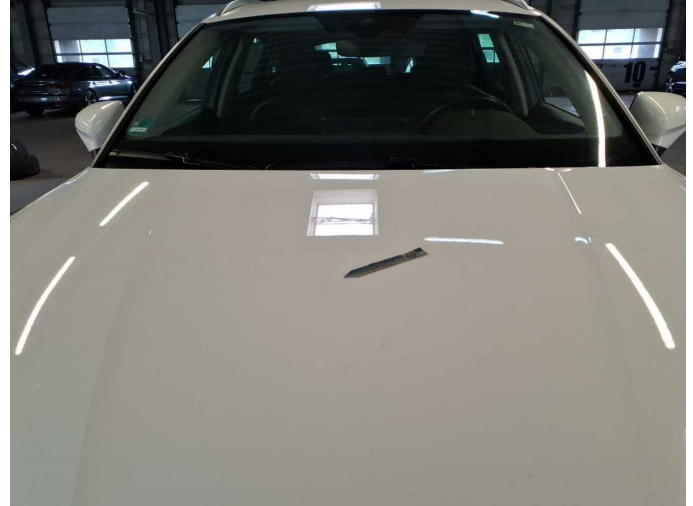
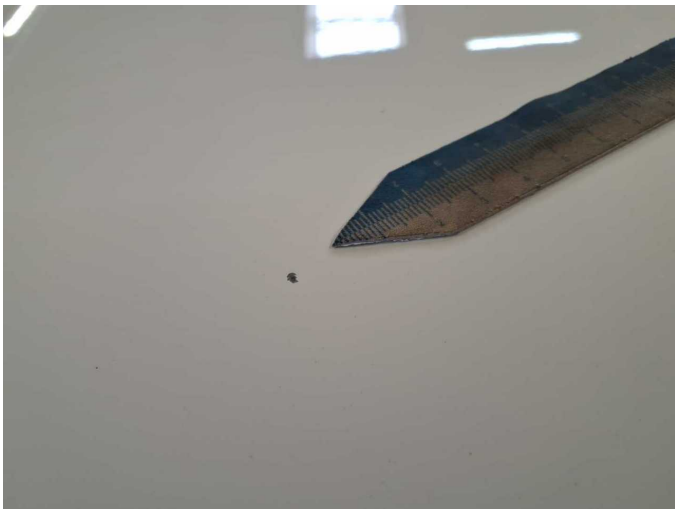
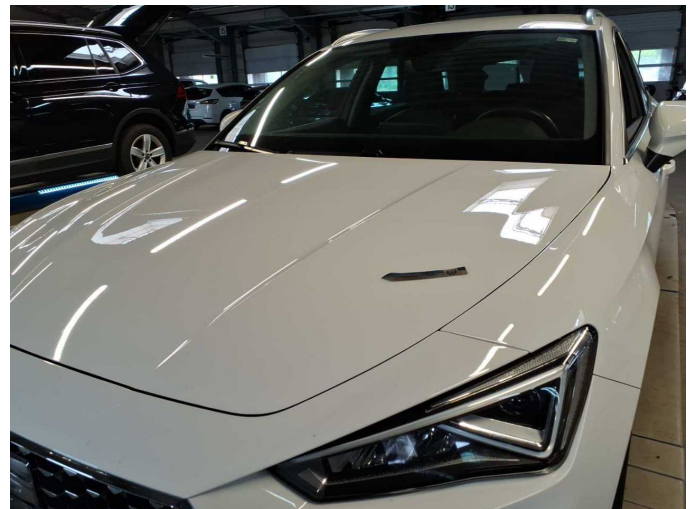
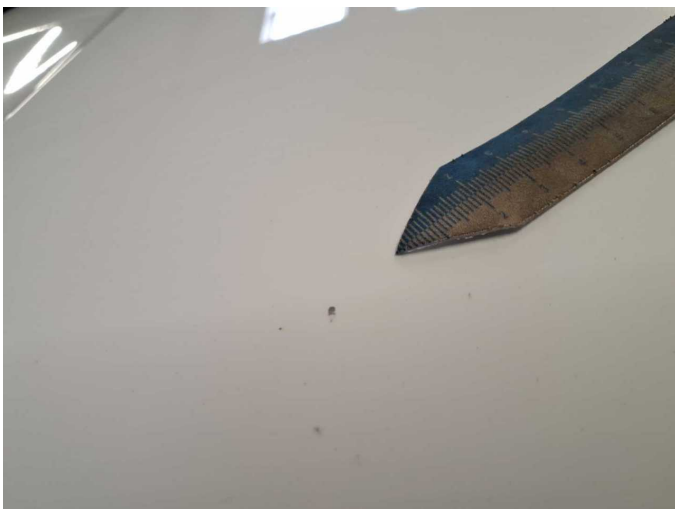
**Damage 13:** Bonnet: Bonnet - Stone chips - Paint

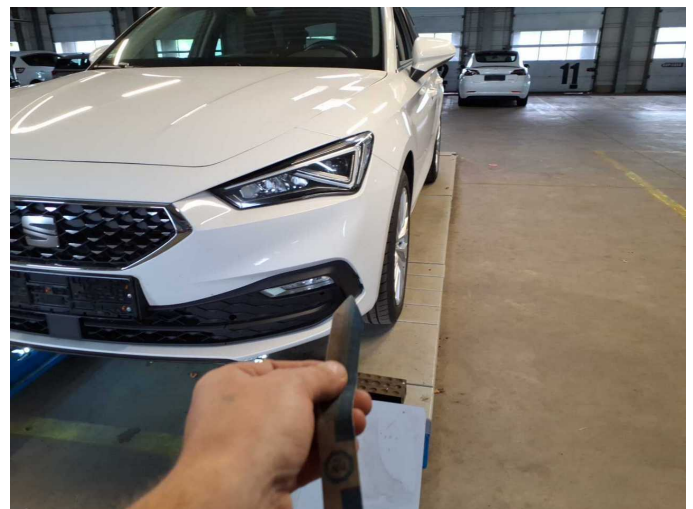
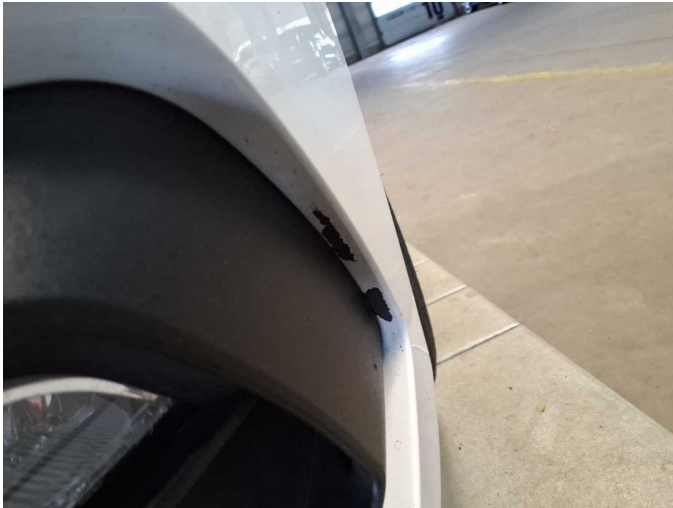
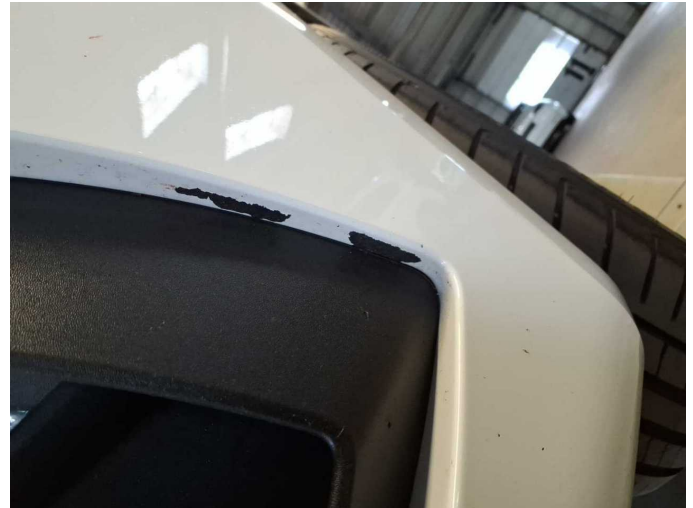
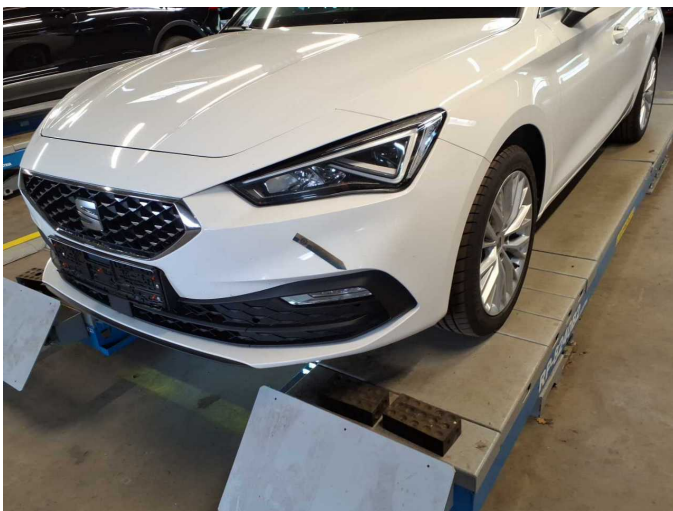
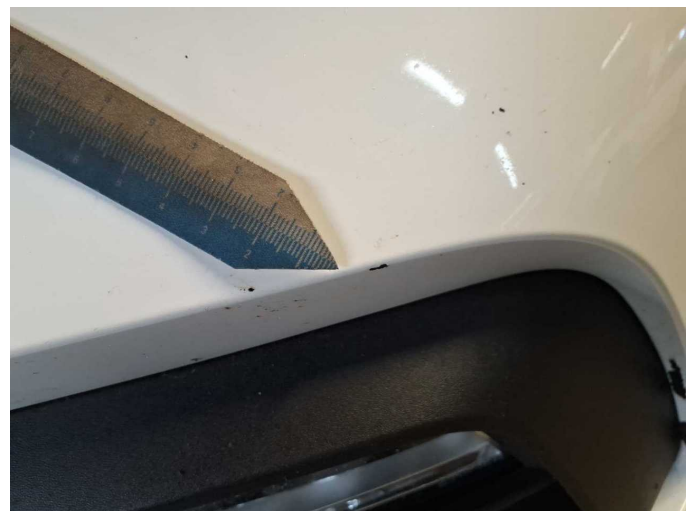
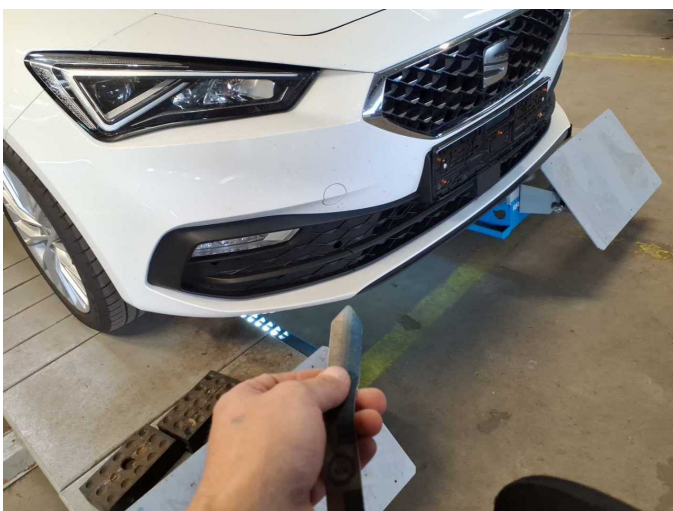
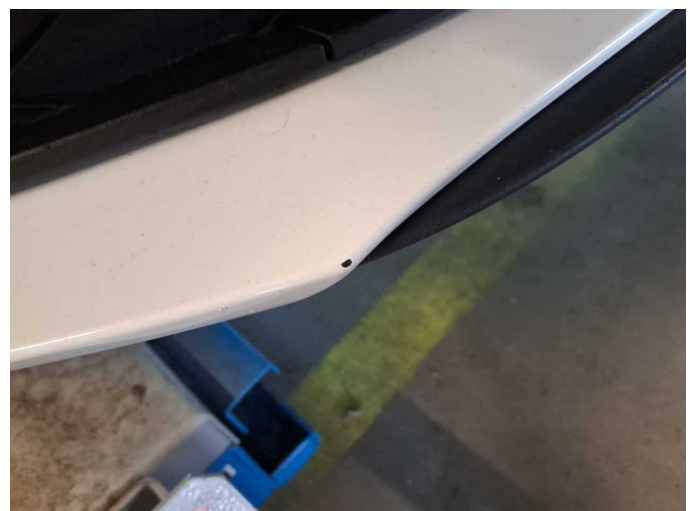
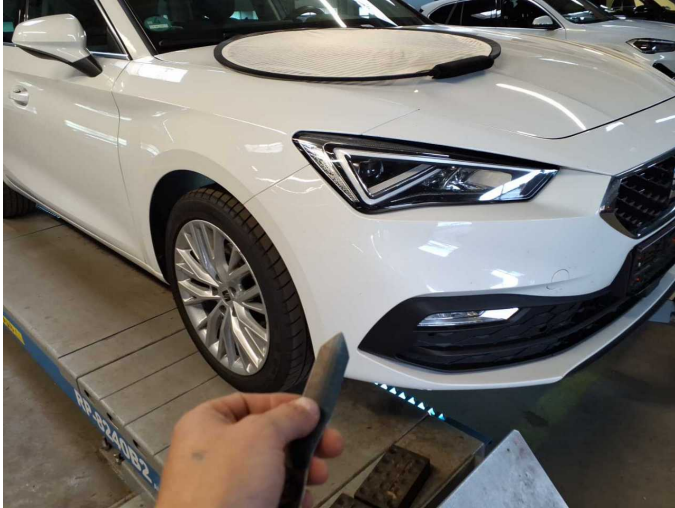
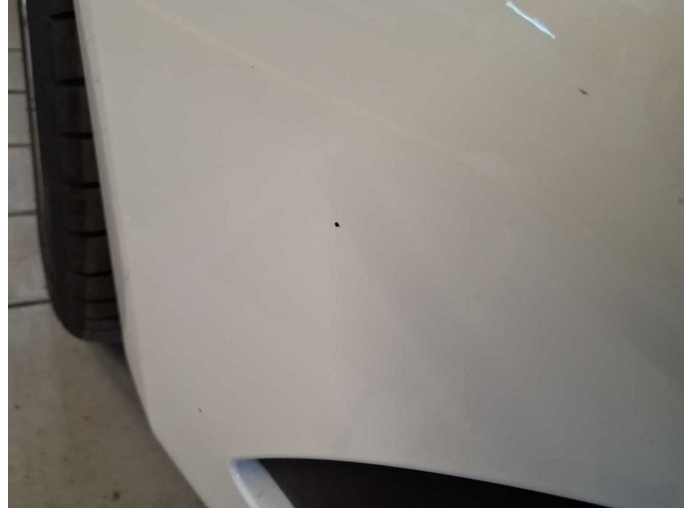
**Damage 14:** Front bumper: Front bumper - Scratched - Paint

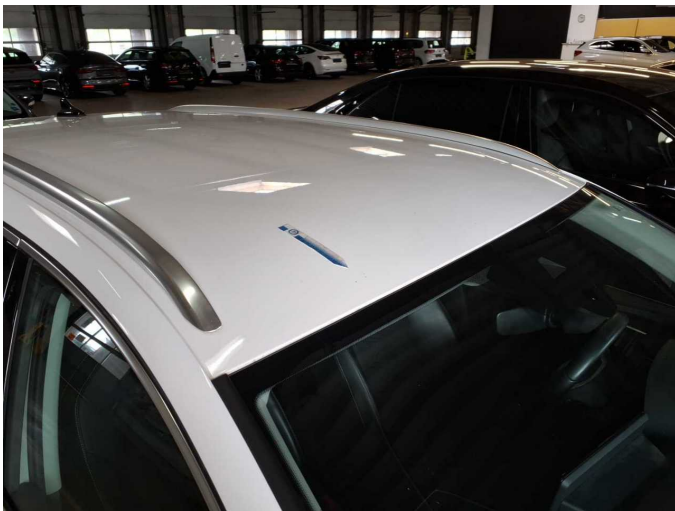
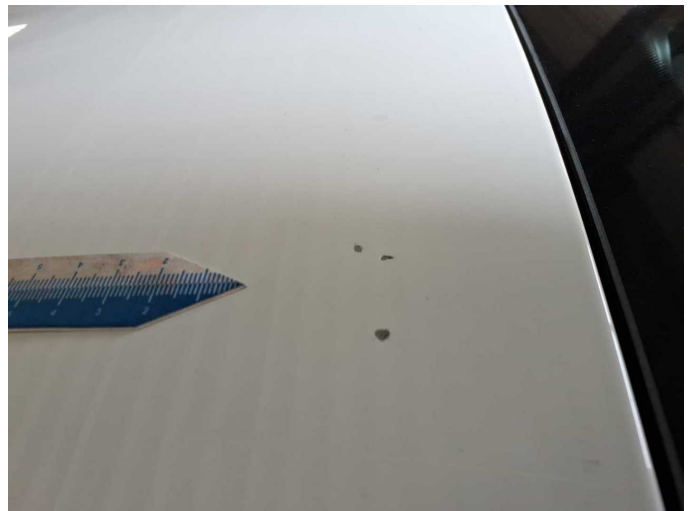
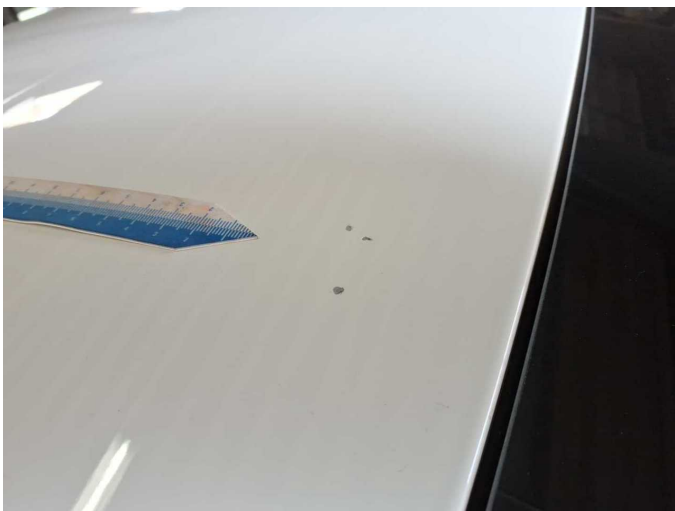
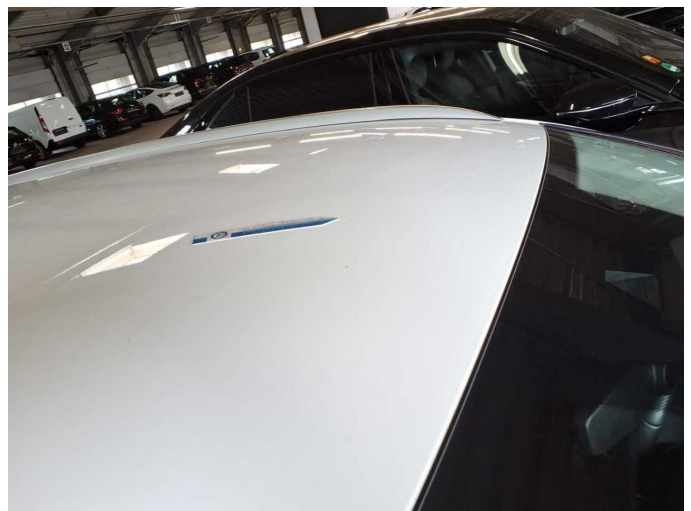
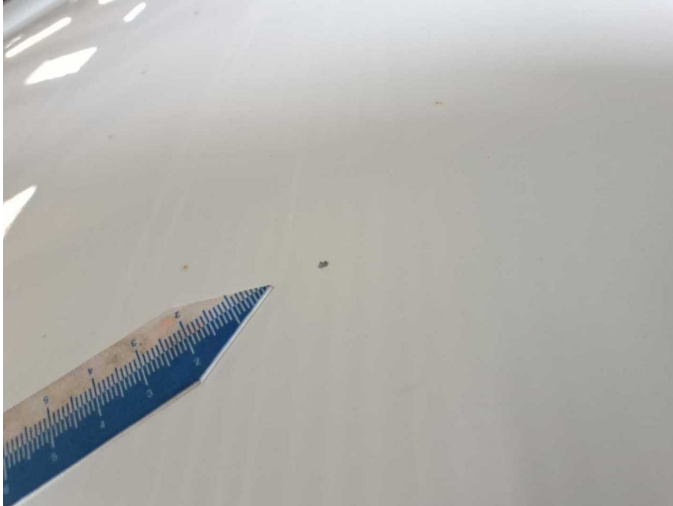
**Damage 15:** Roof: Roof - Stone chips - Paint

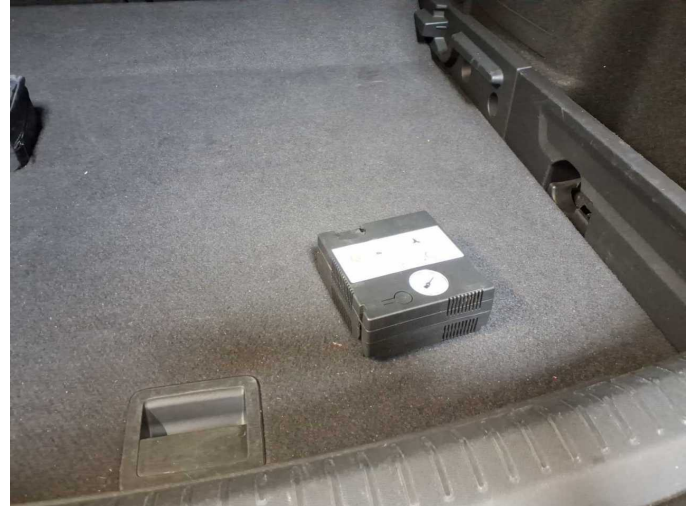
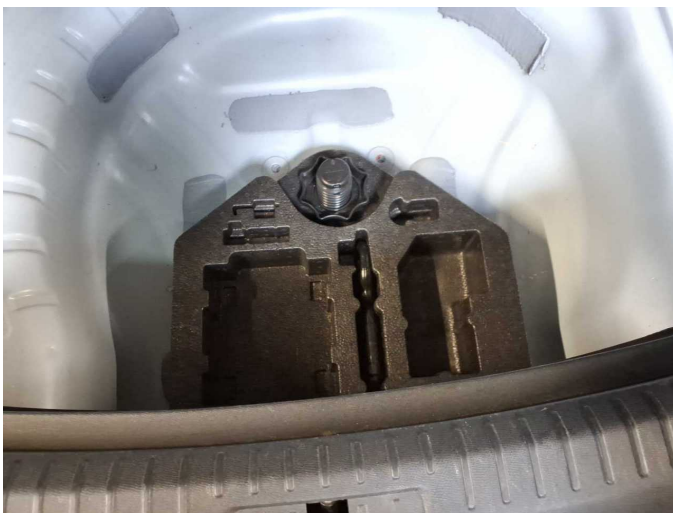
**Missing part 1:** Equipment: Tirefit filler - Missing - Replace

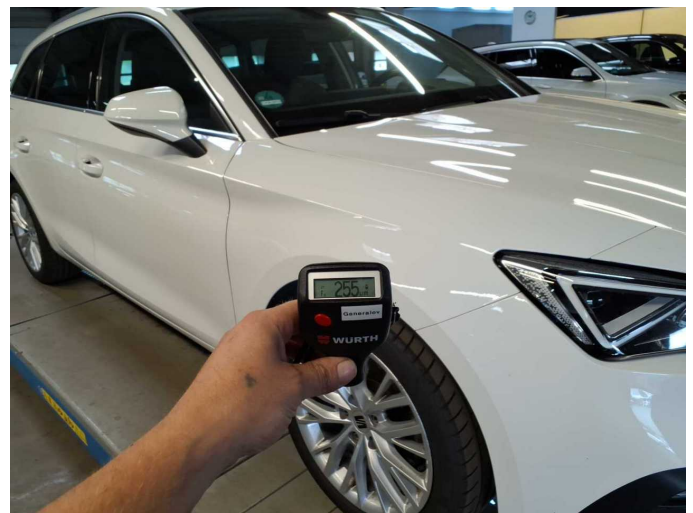
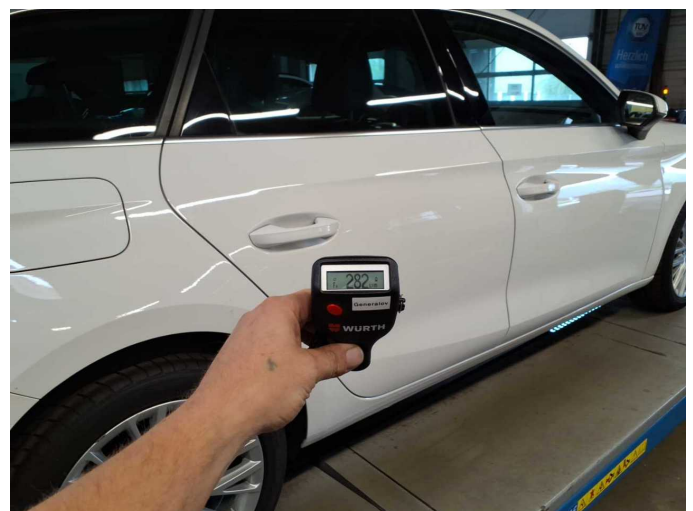
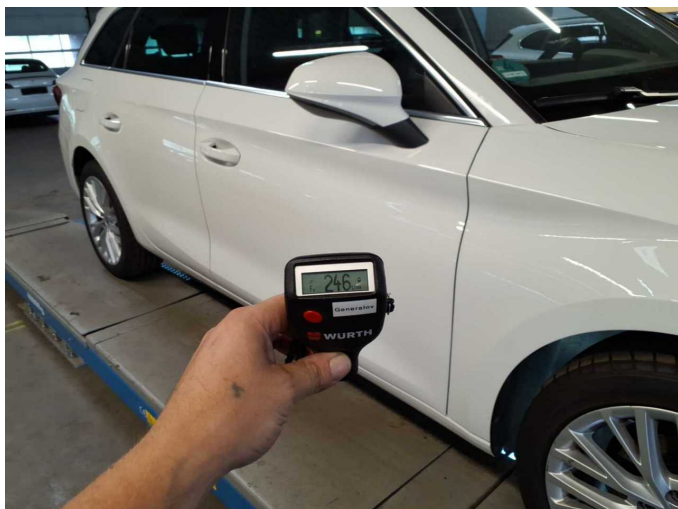
1	Mudguard - right side, Side panel - rear right side, Door - rear right side, Door - front right side, Professionally carried out, Invoice of repair done Non-existent
---	--

Mudguard - right side	255 µm	Side panel - rear right side	207 µm
Door - rear right side	282 µm	Door - front right side	246 µm

**Repainting 1:** Mudguard - right side, Side panel - rear right side, Door - rear right side, Door - front right side
