Expertise

Protocol number: 47130753  
Order No. / Reference: 26812934  
Inspection date: 18 Aug 2026

Manufacturer: Ford

Model: Mondeo Turnier 2.0 EcoBlue Aut. Titanium

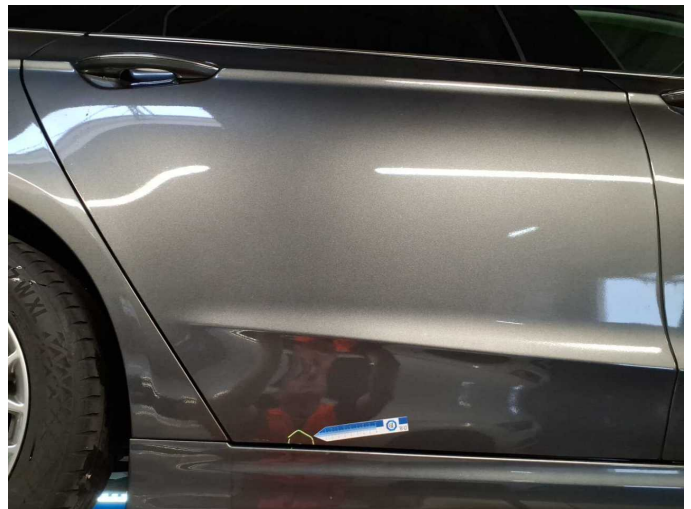
| No. | Component group | Description |
|---|---|---|
| 1 | Door - rear right side | Door edge - Scratch(es) - Smart repair |

**Damage 1:** Door - rear right side: Door edge - Scratch(es) - Smart repair

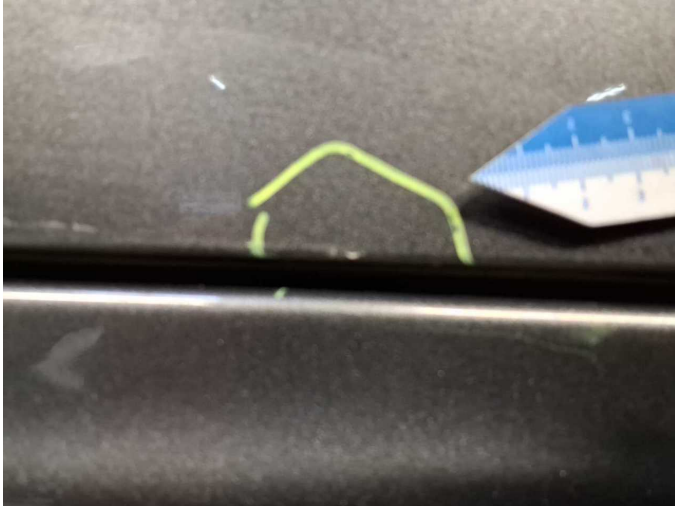
**Damage 1:** Door - rear right side: Door edge - Scratch(es) - Smart repair

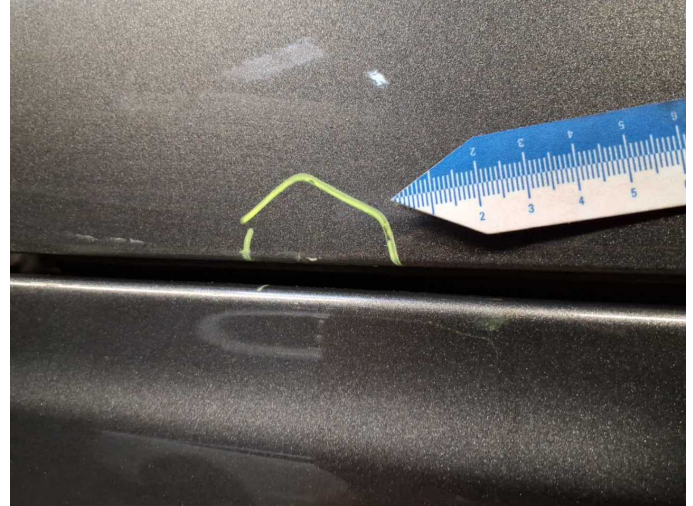
**Damage 1:** Door - rear right side: Door edge - Scratch(es) - Smart repair

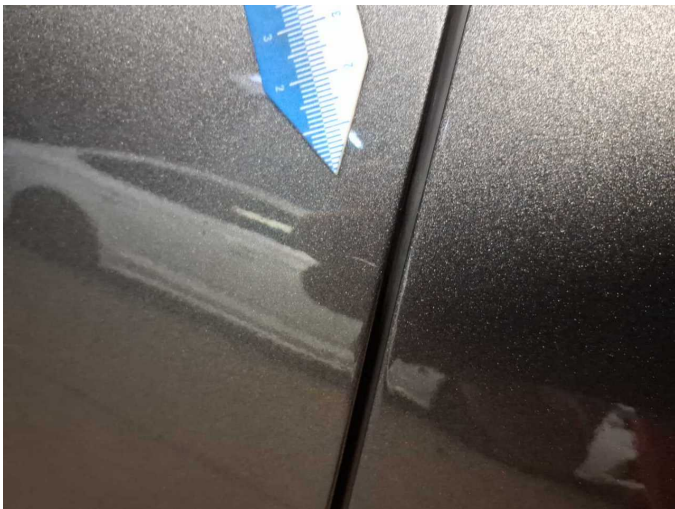
**Damage 1:** Door - rear right side: Door edge - Scratch(es) - Smart repair

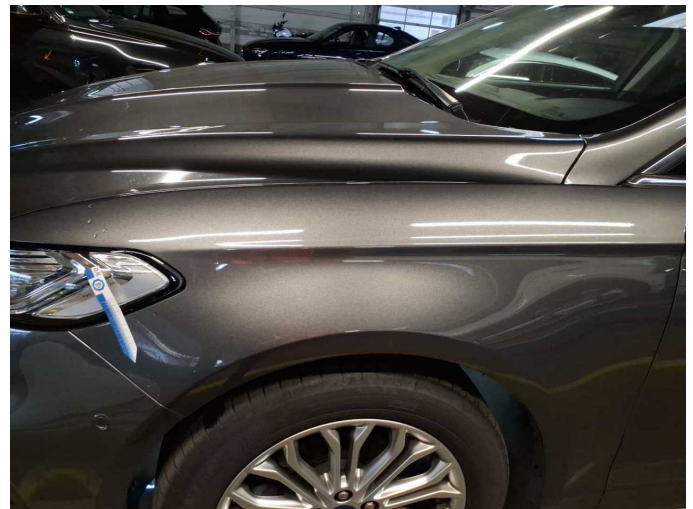
| No. | Component group | Description |
|---|---|---|
| 2 | Mudguard - left side | Mudguard - left side - Stone chips - Paint |

**Damage 2:** Mudguard - left side: Mudguard - left side - Stone chips - Paint

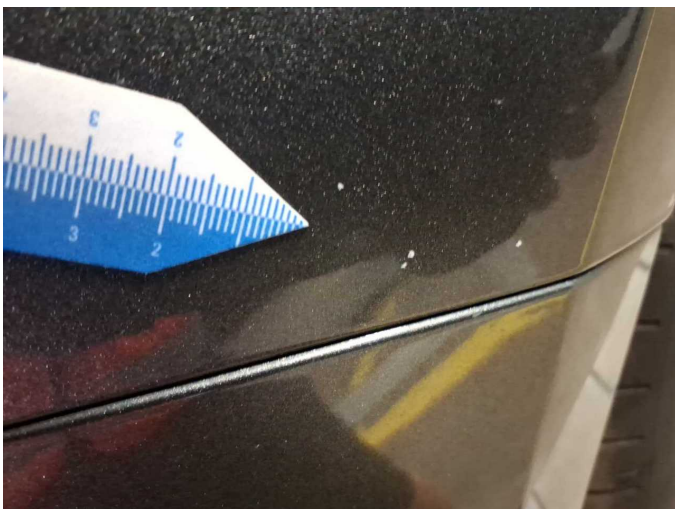
**Damage 2:** Mudguard - left side: Mudguard - left side - Stone chips - Paint

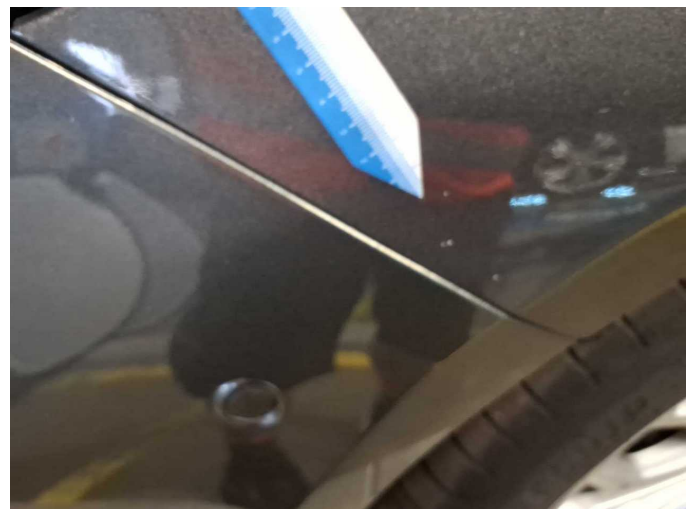
**Damage 2:** Mudguard - left side: Mudguard - left side - Stone chips - Paint

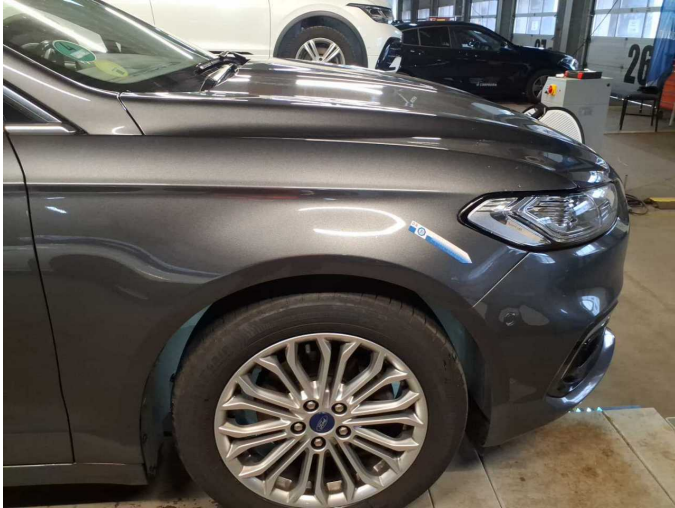
| No. | Component group | Description |
|---|---|---|
| 3 | Mudguard - right side | Mudguard - right side - Stone chips - Paint |

**Damage 3:** Mudguard - right side: Mudguard - right side - Stone chips - Paint

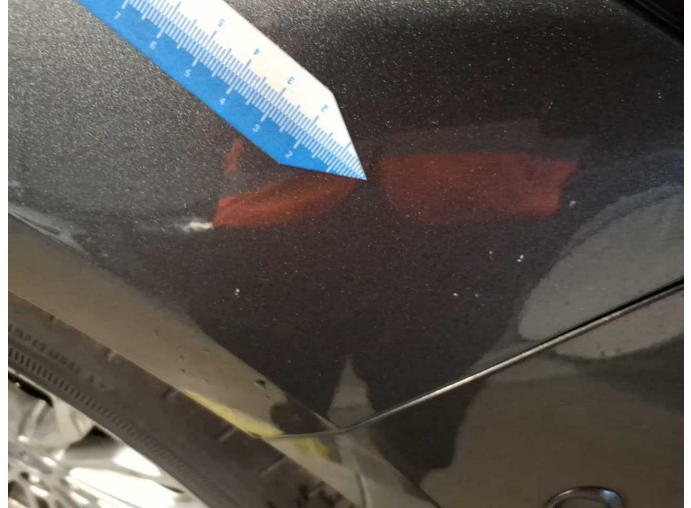
**Damage 3:** Mudguard - right side: Mudguard - right side - Stone chips - Paint

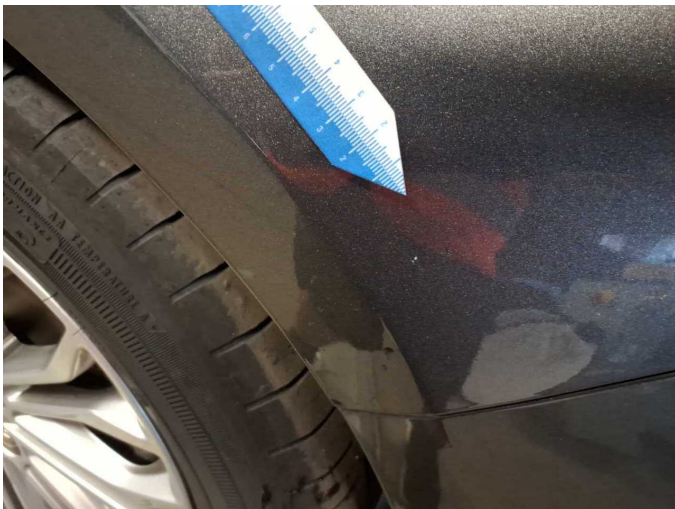
**Damage 3:** Mudguard - right side: Mudguard - right side - Stone chips - Paint

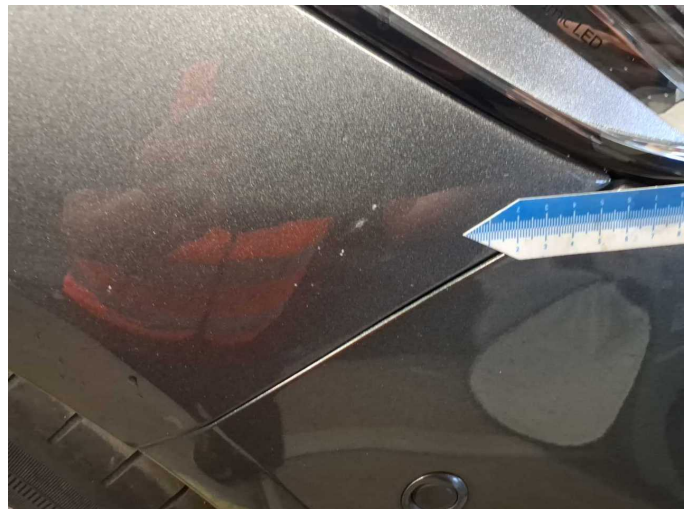
**Damage 3:** Mudguard - right side: Mudguard - right side - Stone chips - Paint

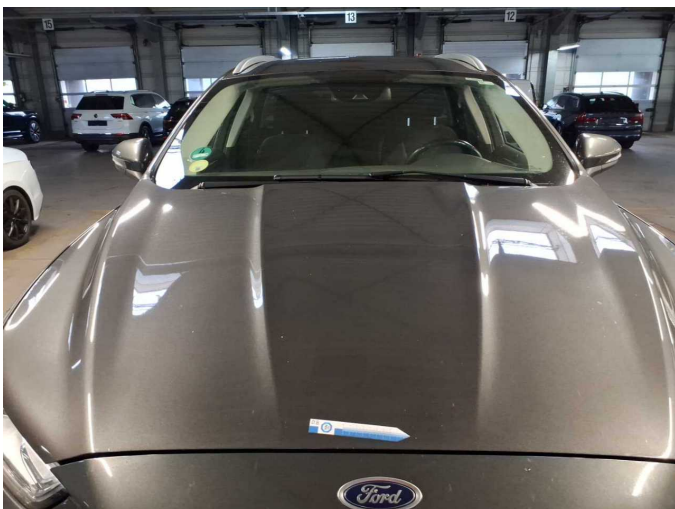
| No. | Component group | Description |
|---|---|---|
| 4 | Bonnet | Bonnet - Stone chips - Paint |

**Damage 4:** Bonnet: Bonnet - Stone chips - Paint

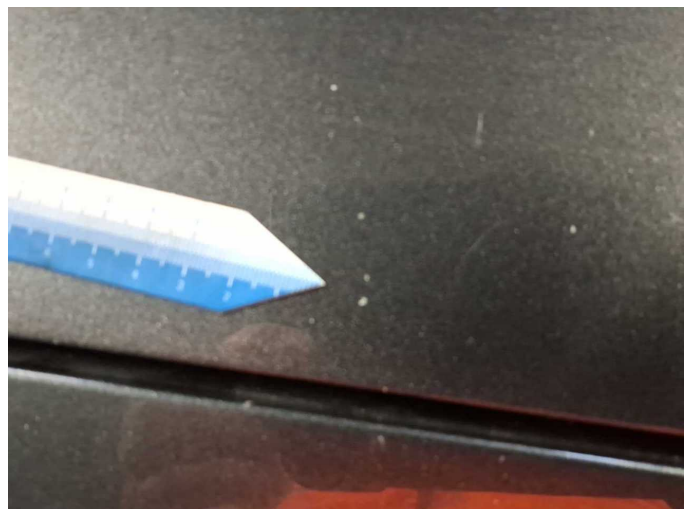
**Damage 4:** Bonnet: Bonnet - Stone chips - Paint

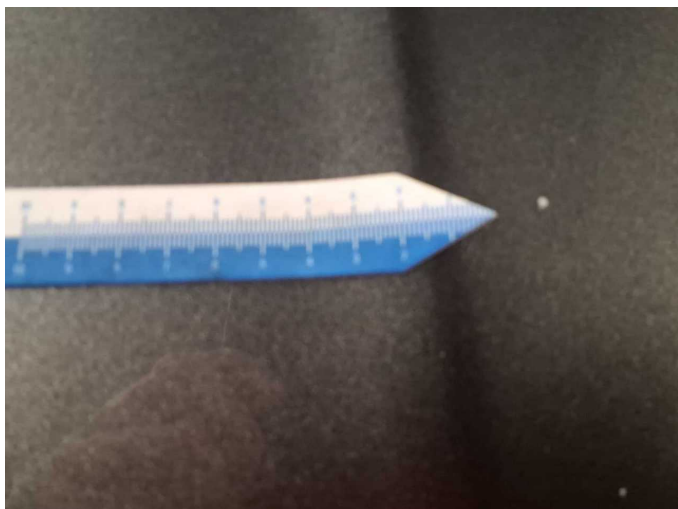
**Damage 4:** Bonnet: Bonnet - Stone chips - Paint

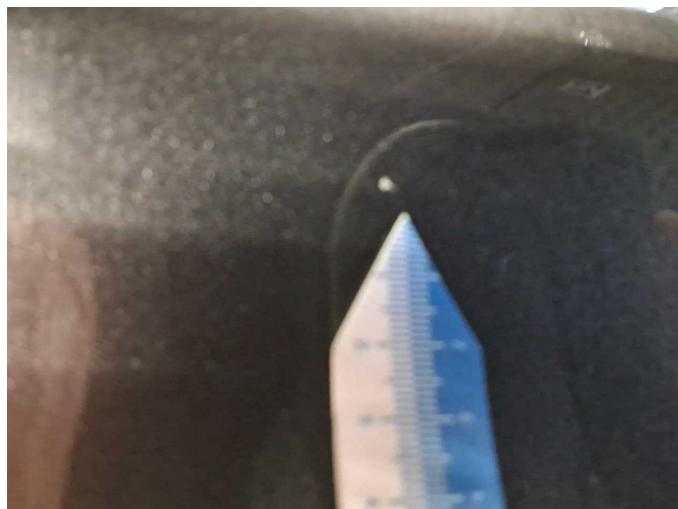
**Damage 4:** Bonnet: Bonnet - Stone chips - Paint

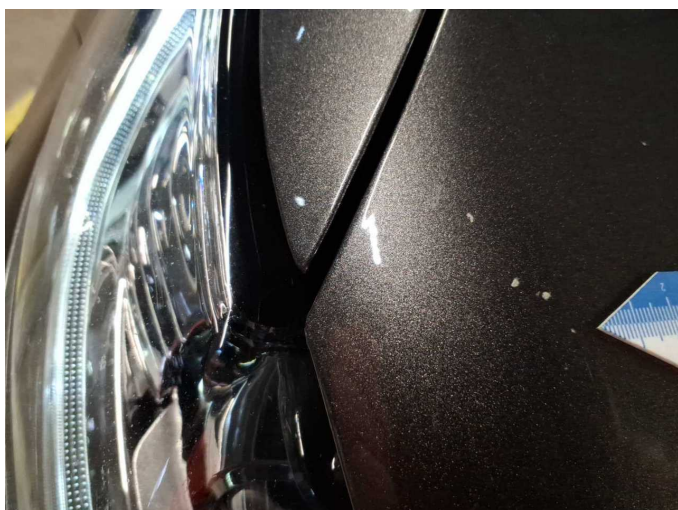
**Damage 4:** Bonnet: Bonnet - Stone chips - Paint

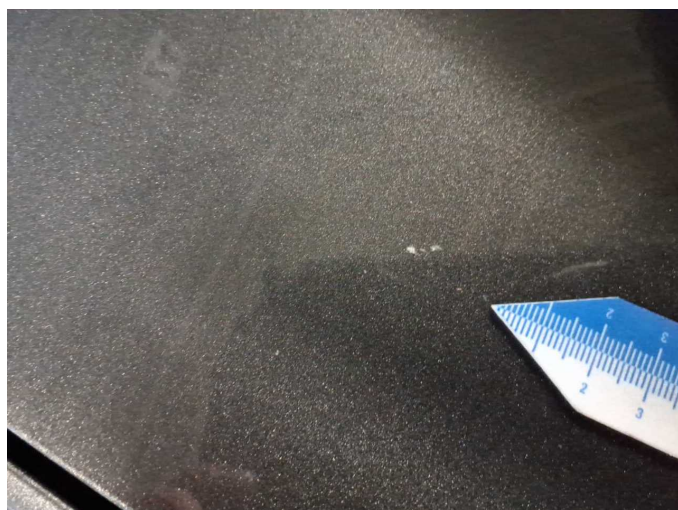
**Damage 4:** Bonnet: Bonnet - Stone chips - Paint
