Expertise

Protocol number: 46366292
Order No. / Reference: 26587387
Inspection date: 2 Jul 2026

Manufacturer: Ford

Model: Transit Connect 230 L2 LKW S&S Autm. Trend

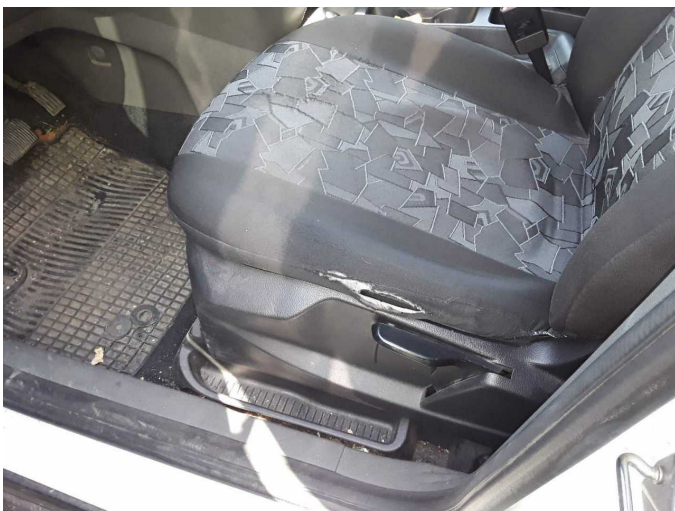
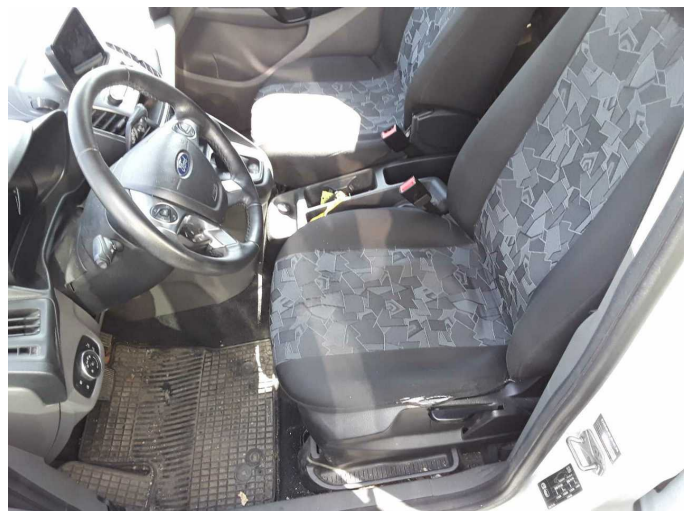
Damage 1: Seat - front: Protective Cover - left side - Broken / torn - Replace

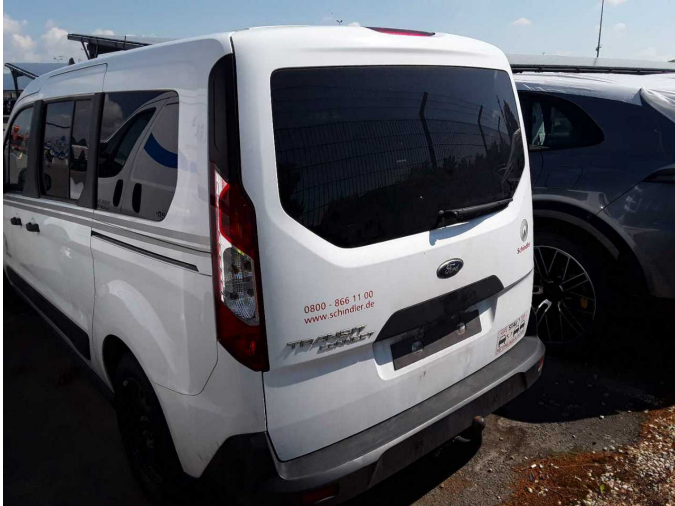
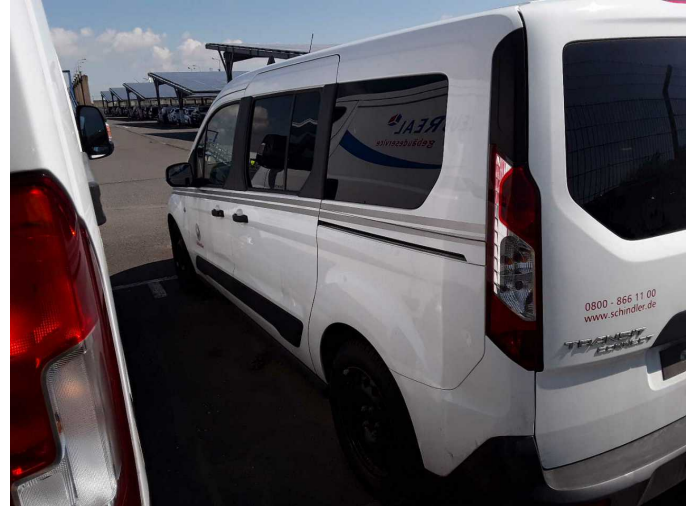
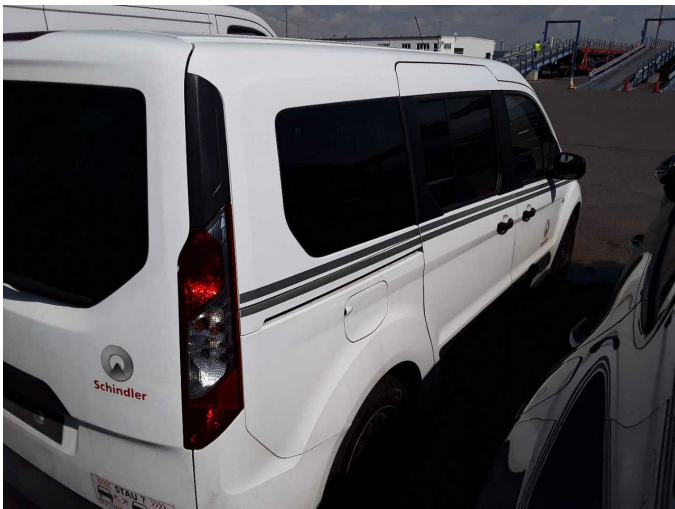
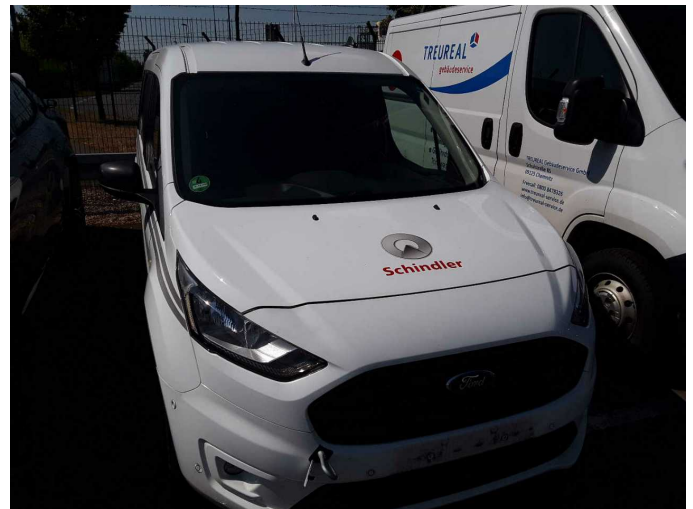
Damage 2: Body: Body - Glued / labelled - De-glue / neutralise

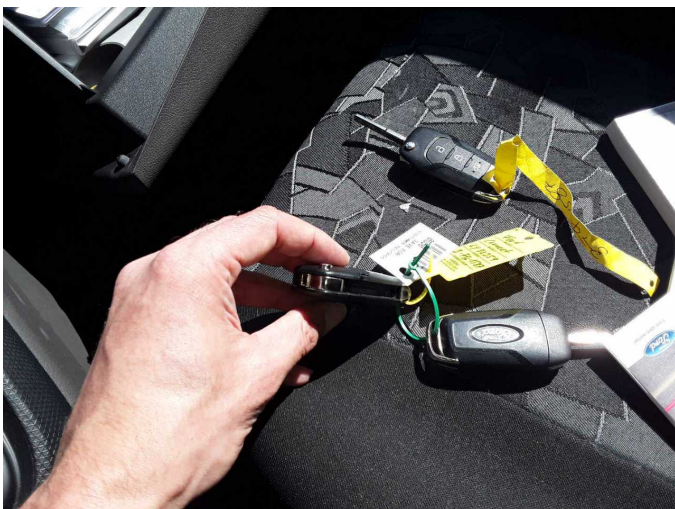
Damage 3: Equipment: Vehicle key with remote control - Broken / torn - Replace

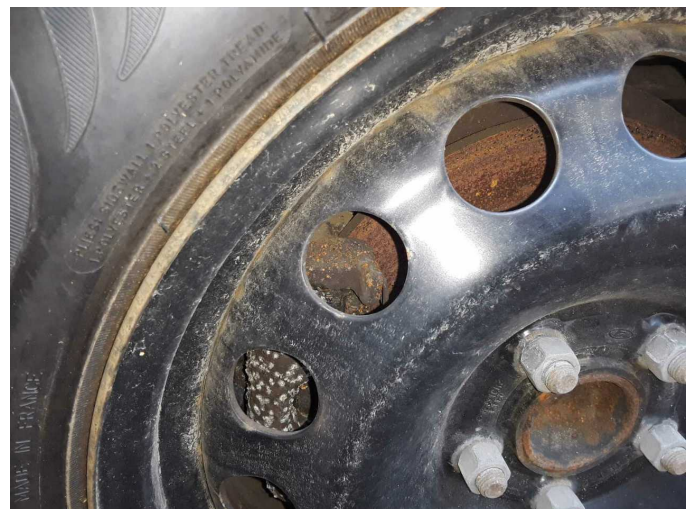
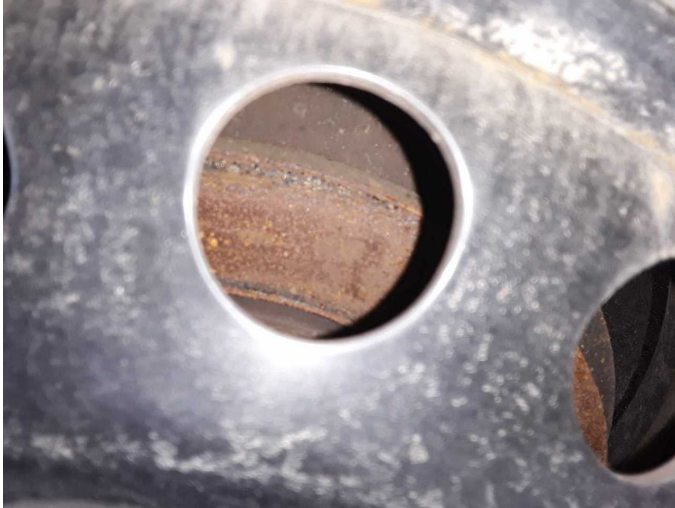
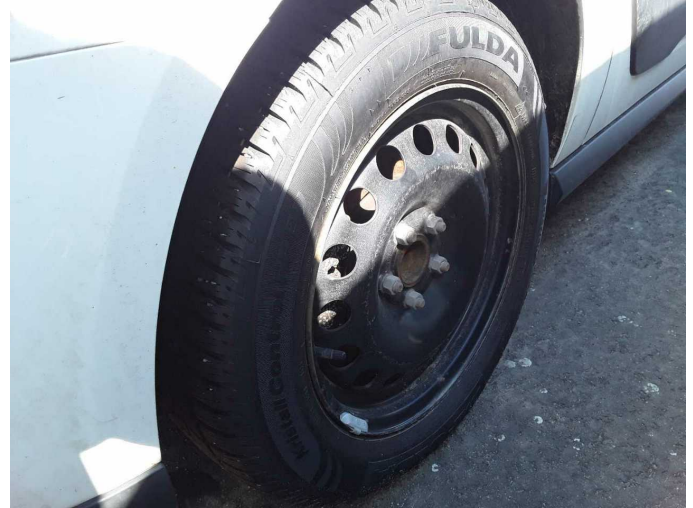
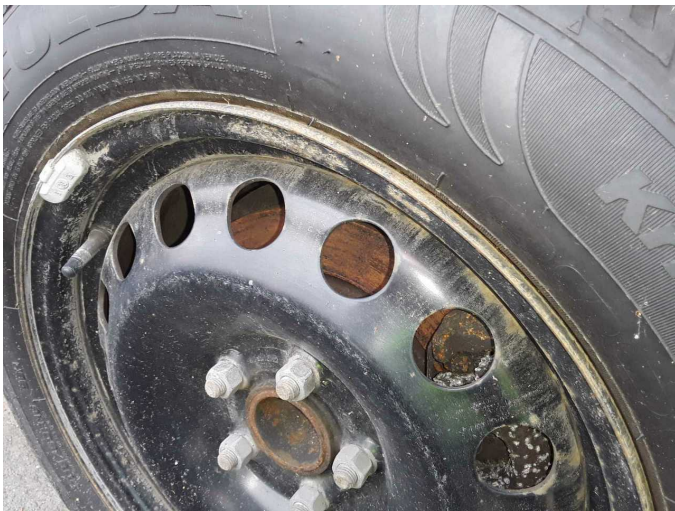
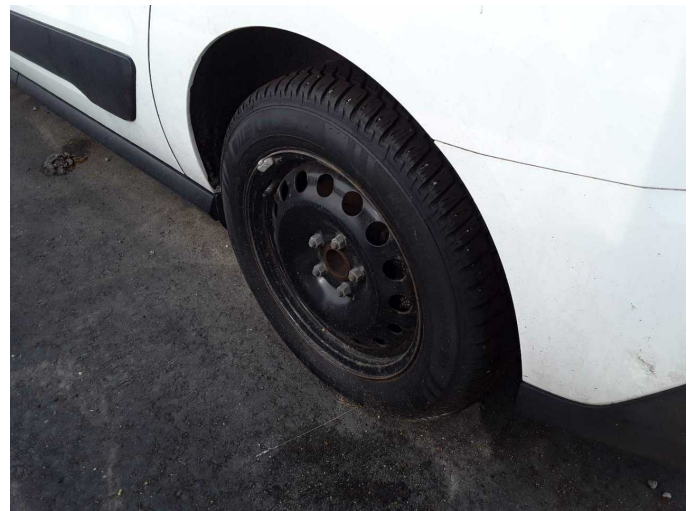
Damage 4: Braking system: Brake discs and pads - rear (Stand Schaden) - Corrosion - Replace

Damage 4: Braking system: Brake discs and pads - rear (Standsschaden)
- Corrosion - Replace

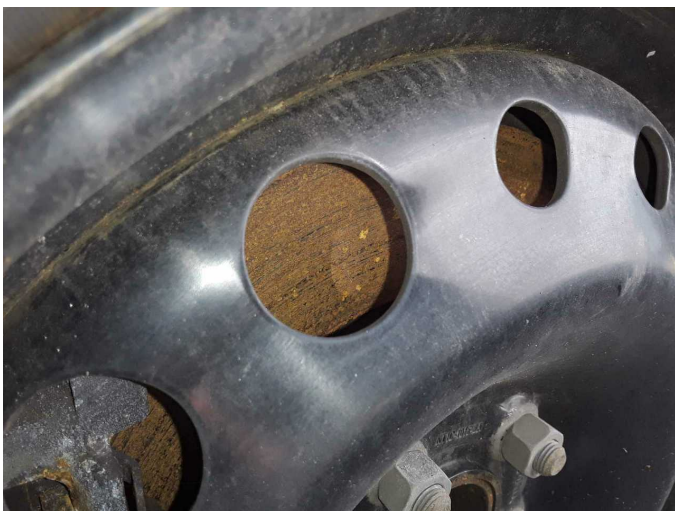
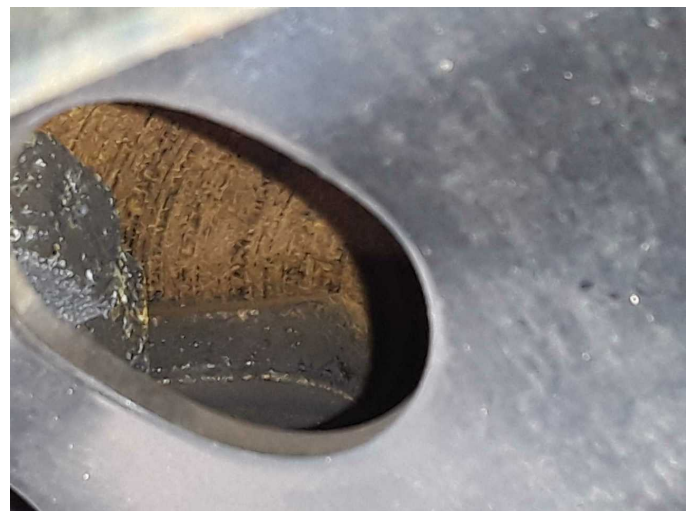
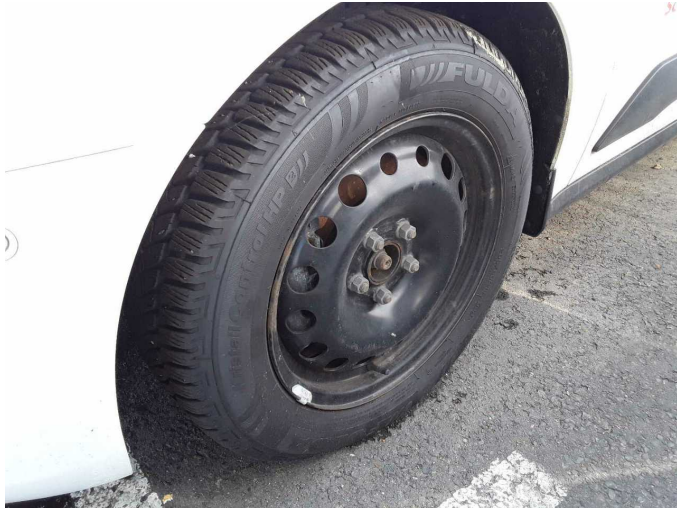
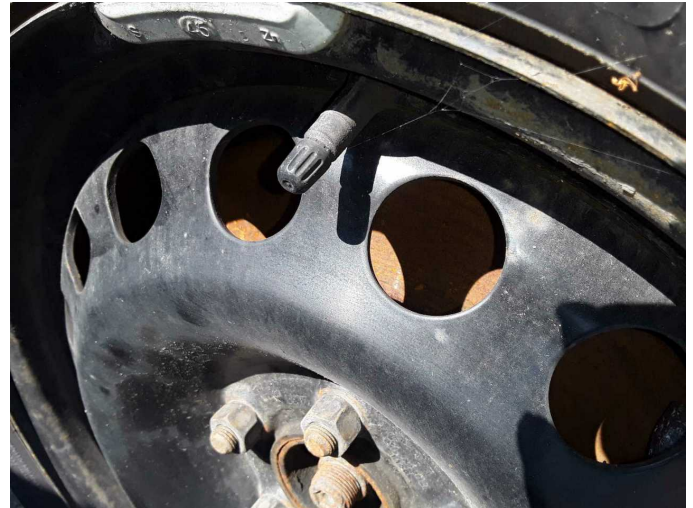
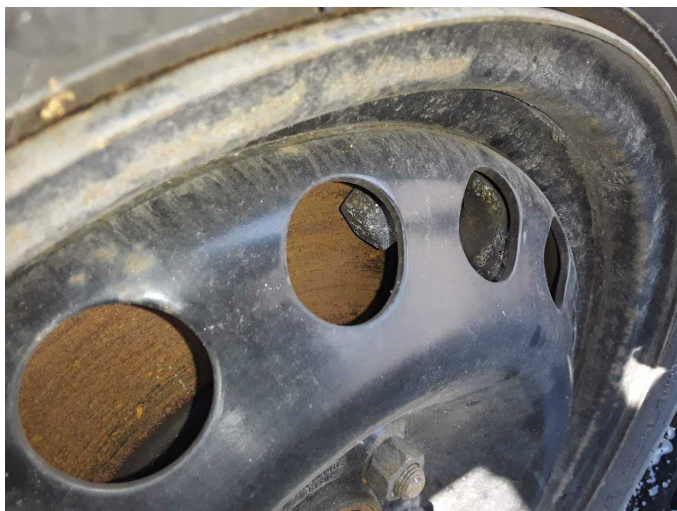
Damage 5: Braking system: Brake discs and brake pads - front
(Standsschaden) - Corrosion - Replace

Damage 5: Braking system: Brake discs and brake pads - front (Standsschaden) - Corrosion - Replace

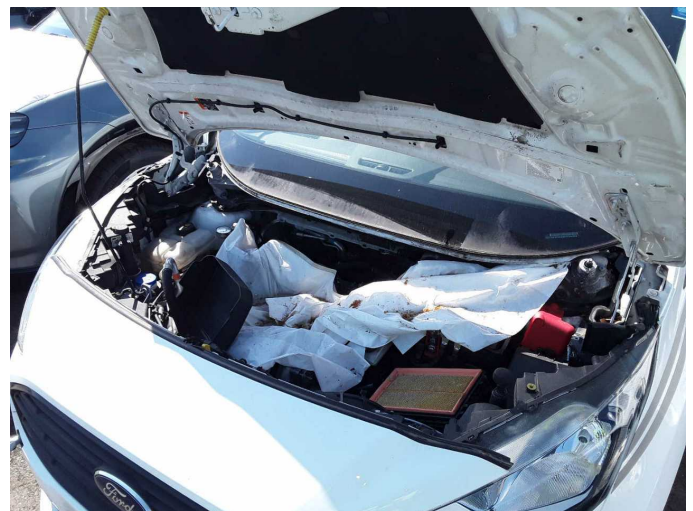
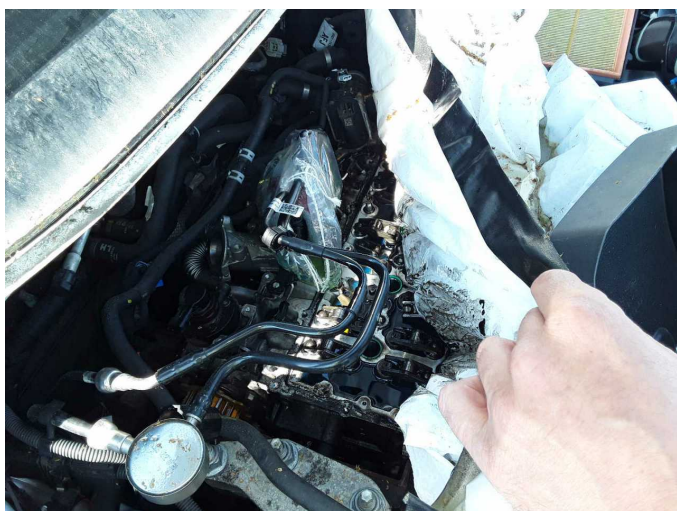
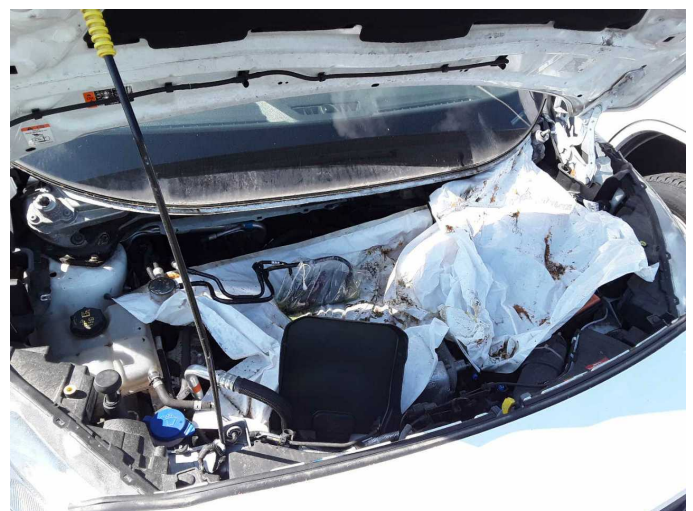
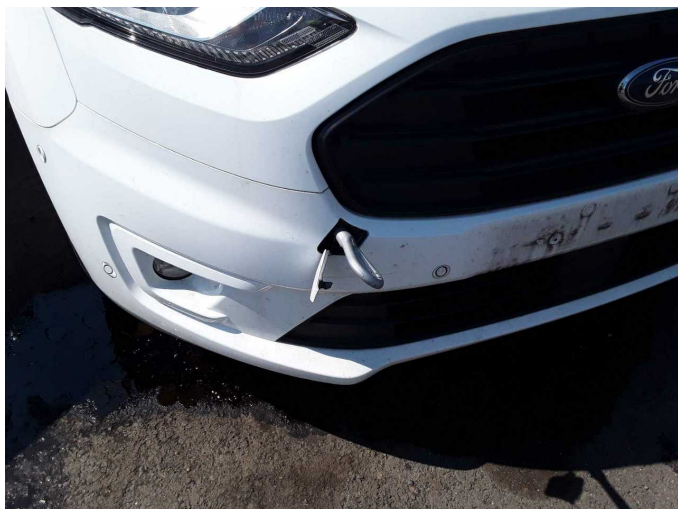
- Winterradsatz ist kein Bestandteil des Auslieferungsumfangs.
- Keine Besichtigung des Unterbodens, Begutachtung Fahrwerk/Achsen/Aggregate nur bedingt möglich, Zusatzkosten können entstehen.
- Ein Motorprobelauf, Getriebefunktionstest sowie Funktionstest der Bordelektronik konnte aufgrund des zerlegten/beschädigten Zustandes des Fahrzeuges, nicht durchgeführt werden. Zusatzkosten können entstehen.
- Fahrzeug teilzerlegt. Demontierte Teile wurden im Innenraum gelagert. Besichtigung Fahrzeuginnenraum nur bedingt möglich. Das Vorhandensein und die Beschädigungsfreiheit der vorliegenden Teile konnte nicht geprüft werden. Fahrzeugzugang eingeschränkt. Mehrkosten möglich
- Umweltbelastung durch teilzerlegten Motor!

Damage 6: Engine: Engine (Motor zerlegt, Siehe Kostenvoranschlag) - Electrical fault - Replace

Damage 6: Engine: Engine (Motor zerlegt, Siehe Kostenvoranschlag) -
Electrical fault - Replace

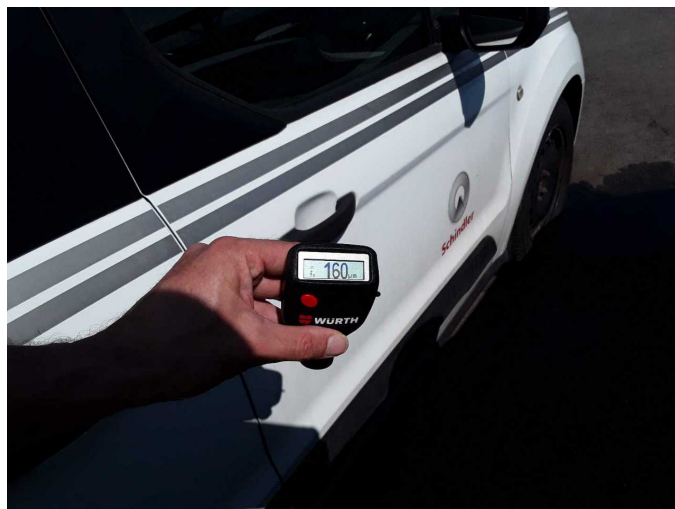
No.	Repainting
1	Door - front right side, Professionally carried out

Door - front right side: 160 µm
