# Assessment

- Vehicle Inspection Report -

Number: 10438456  
From: 16.04.2026

<b>Vehicle category:</b>	Passenger Car
<b>Vehicle type:</b>	EstateCar
<b>Make:</b>	Volkswagen
<b>Model:</b>	Passat
<b>Manufacturers and type code:</b>	0603 / BQS
<b>Date of first registration:</b>	19.03.2024
<b>Mileage:</b>	77,428 km
<b>Proof of mileage:</b>	ReadOff
<b>Exterior colour:</b>	Pyritsilber Metallic
<b>Roof colour:</b>	Pyritsilber Metallic
<b>Propulsion:</b>	Front
<b>Fuel:</b>	Diesel
<b>Engine size (cc):</b>	2,000 ccm
<b>Performance:</b>	110 kW (150 PS)
<b>Length:</b>	
<b>Height:</b>	
<b>Width:</b>	
<b>Permitted total weight:</b>	
<b>Wheelbase:</b>	
<b>Number of powered axles:</b>	2
<b>Cylinders:</b>	4
<b>Euronorm:</b>	Euro 6
<b>Number of doors:</b>	5
<b>Number of seats:</b>	5
<b>Gearbox:</b>	Automatic 7-speed
<b>Upholstery type:</b>	Lining semi-leather
<b>Interior colour:</b>	Titanschwarz/Titanschwarz/Titanschwarz
<b>Number of keys:</b>	1

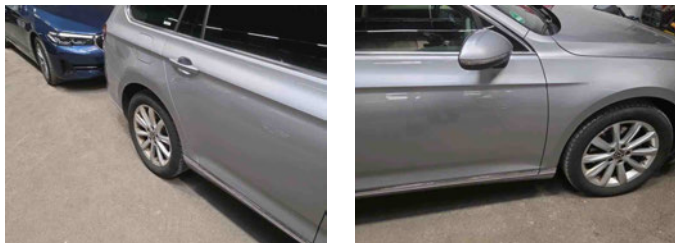
7 - Bodywork - Scratch(es) - Polish	Repaircosts:	€ 300.00
	Net cost:	€ 300.00
Fixed Price		€ 300.00

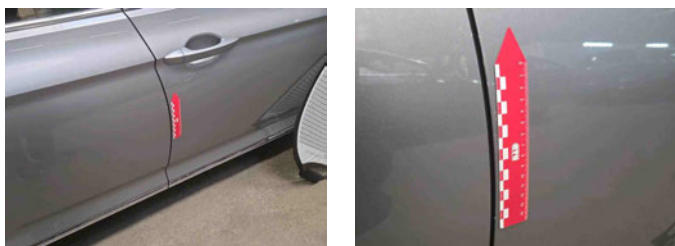
9 - Door FR - Scratch(es) - Spot repair	Repaircosts:	€ 150.00
	Net cost:	€ 150.00
Fixed Price		€ 150.00

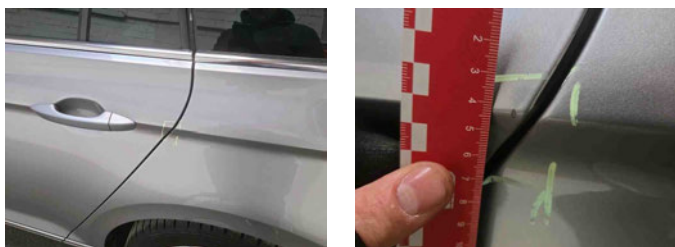
10 - Door RL - Scratch(es) - Spot repair	Repaircosts:	€ 150.00
	Net cost:	€ 150.00
Fixed Price		€ 150.00
