Expertise

Protocol number: 46049082  
Order No. / Reference: 26554667  
Inspection date: 16 Jun 2026

Manufacturer: Volvo

Model: XC40 Recharge Single Motor Plus

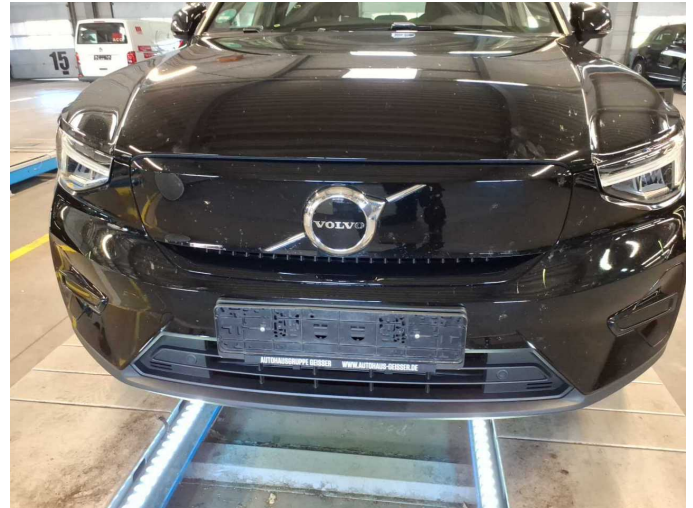
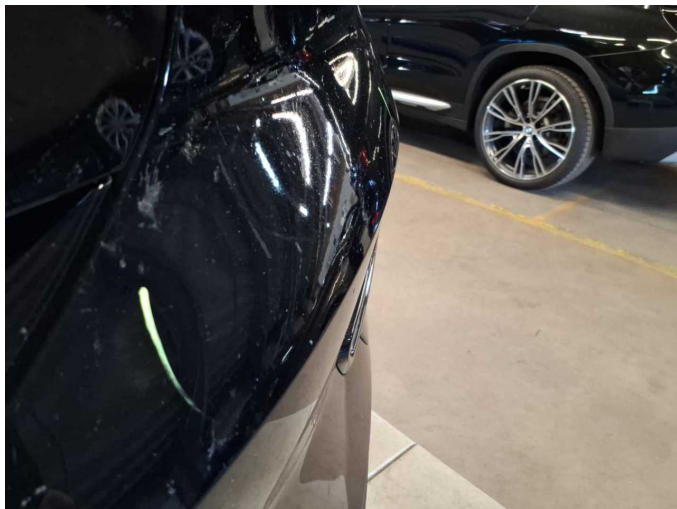
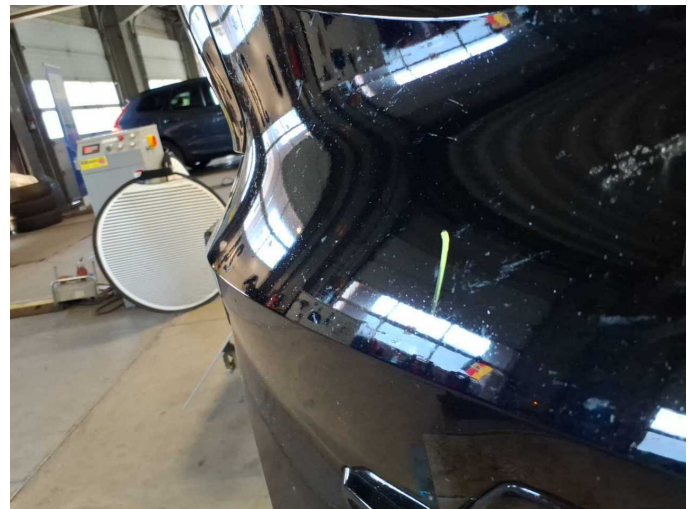
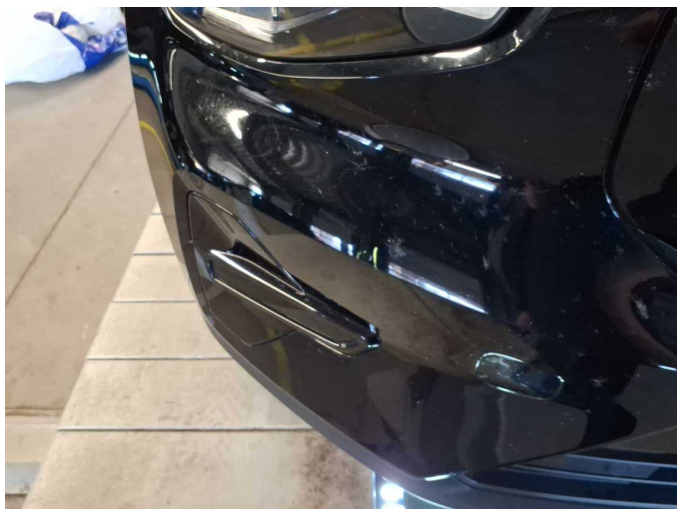
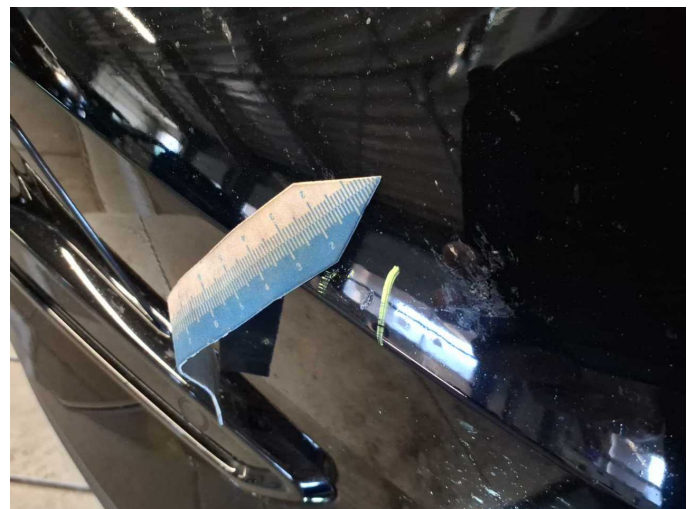
| No. | Component group | Description |
|---|---|---|
| 1 | Front bumper | Front bumper (Sandstrahleffekt) - Stone chips - Paint |

**Damage 1:** Front bumper: Front bumper (Sandstrahleffekt) - Stone chips  
- Paint

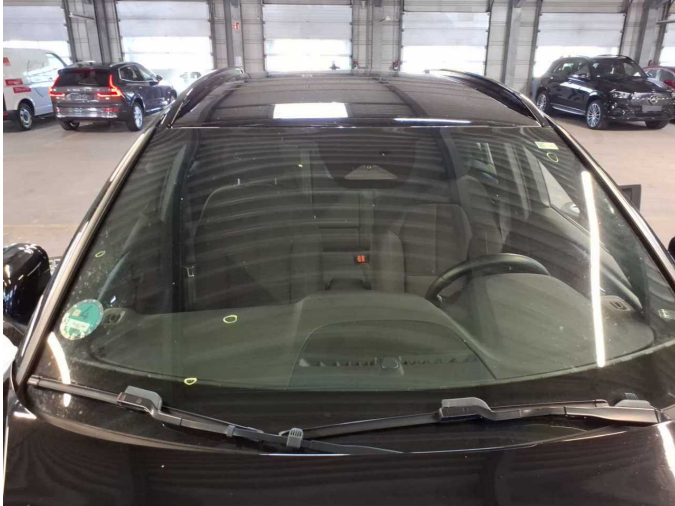
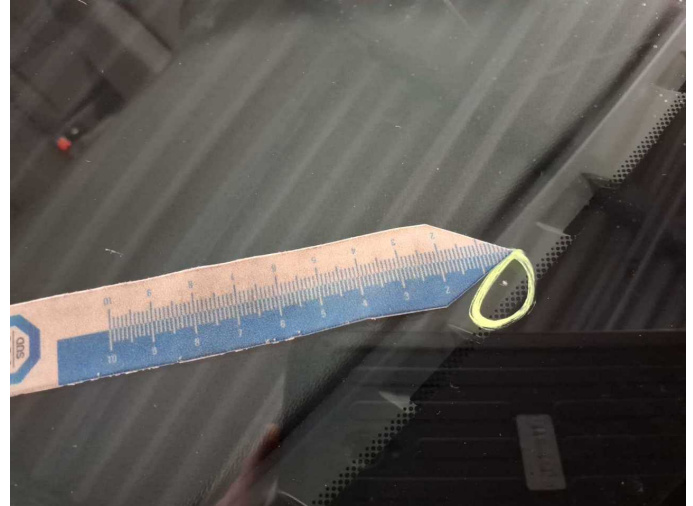
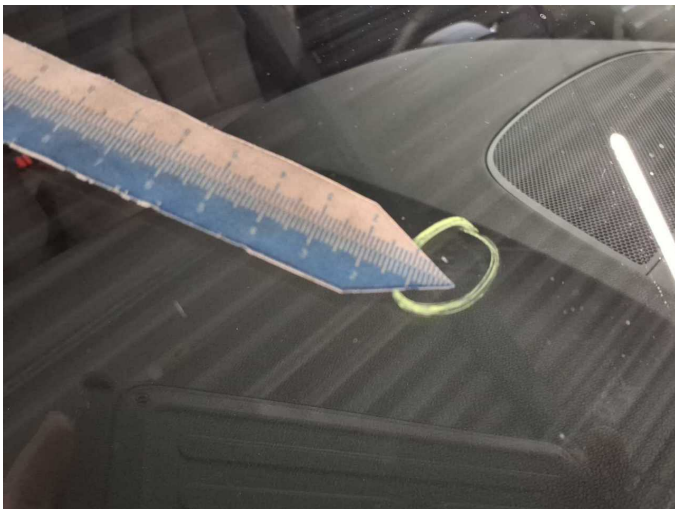
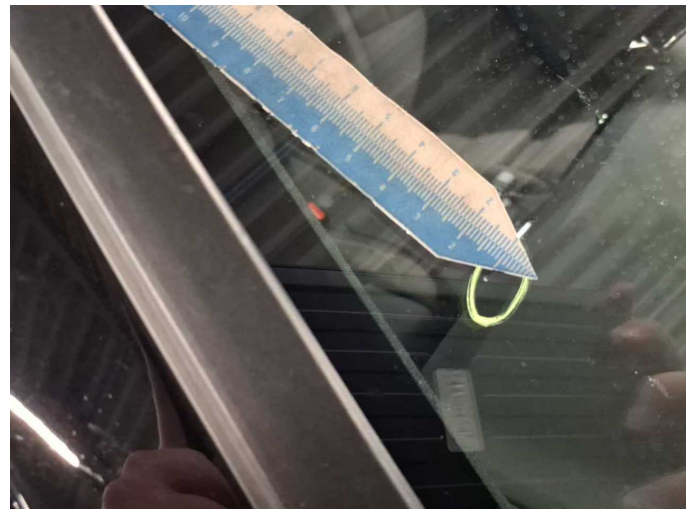
| No. | Component group | Description |
|---|---|---|
| 1 | Vehicle glazing | Windscreen - Stone chips |

**Wear and tear 1:** Vehicle glazing: Windscreen - Stone chips

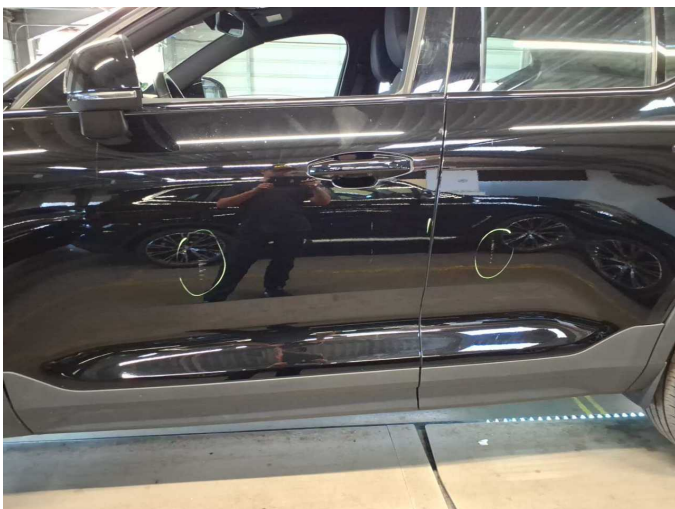
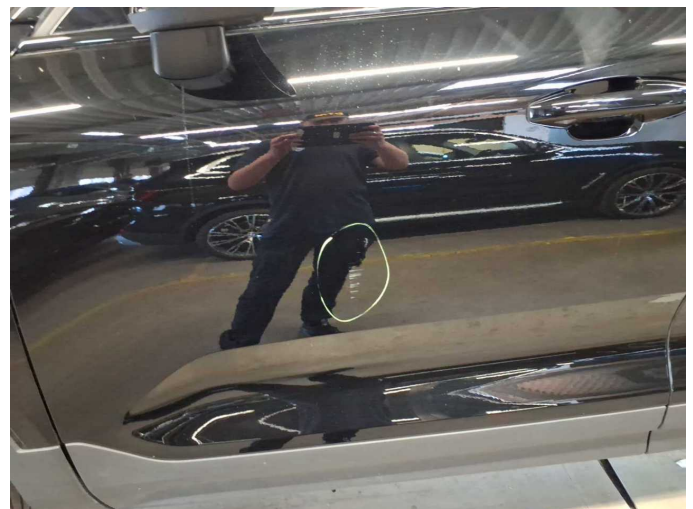
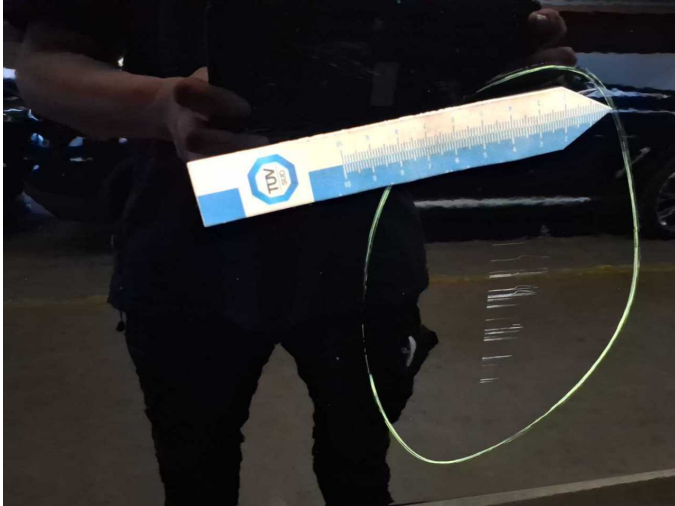
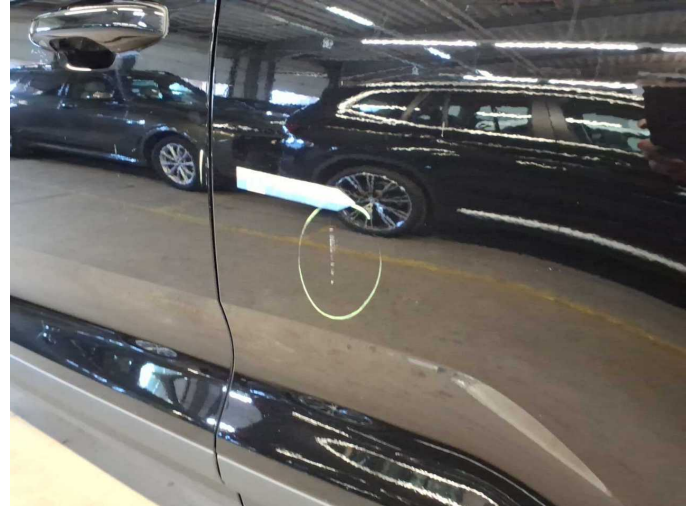
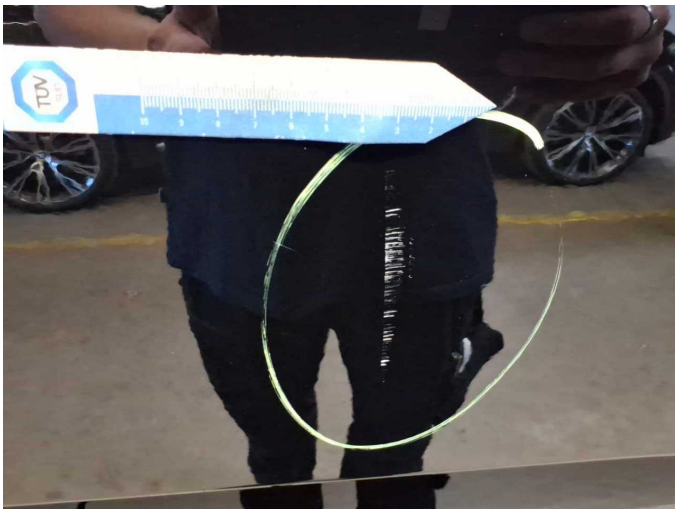
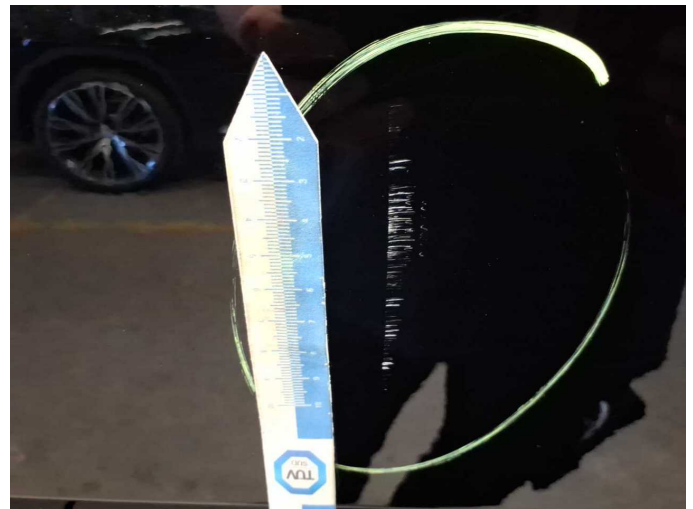
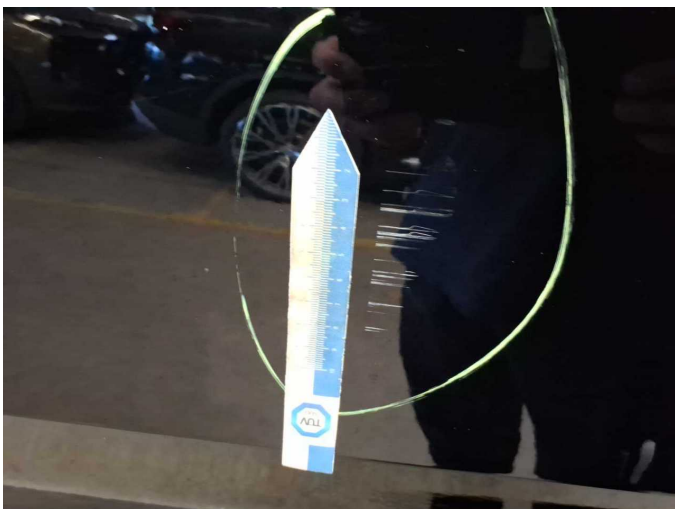
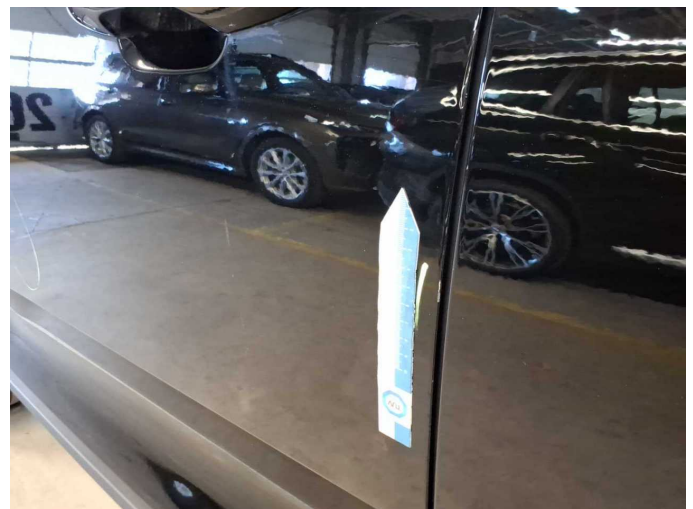
| No. | Previous damage | Extent of damage (Net) |
|---|---|---|
| 1 | Side - left, Provided by user / customer, from 5 May 2026 | 1.289,95 € |

1 Side - left

**Accident 1:** Side - left

**Accident 1: Side - left**
