Expertise

Protocol number: 46231795
Order No. / Reference: 26510637
Inspection date: 25 Jun 2026

Manufacturer: Ford

Model: Mondeo Turnier 2.0 EcoBlue Titanium

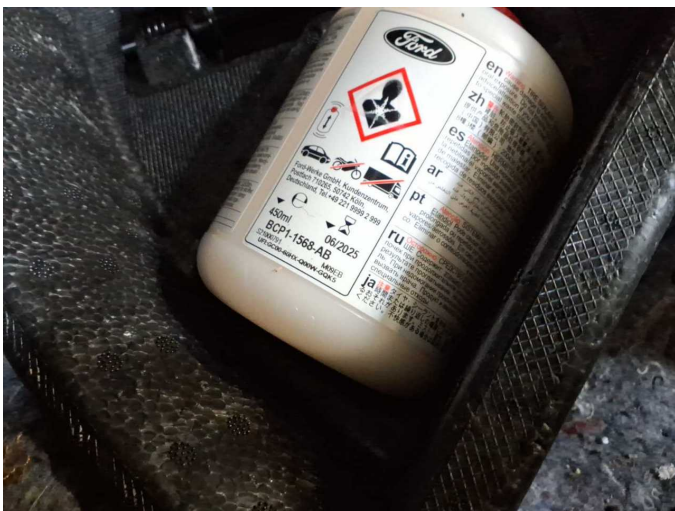
Damage 1: Equipment: Tirefit filler - Expired - Replace

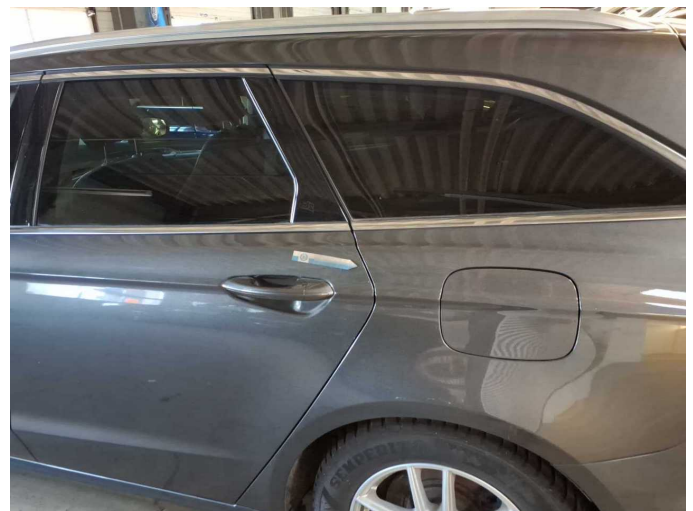
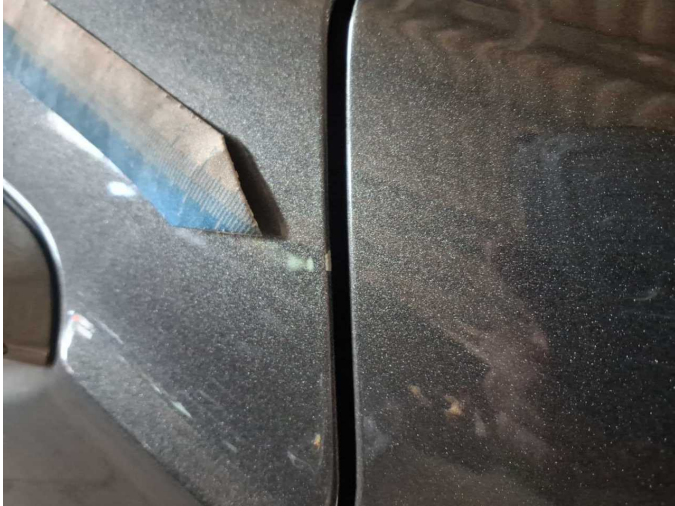
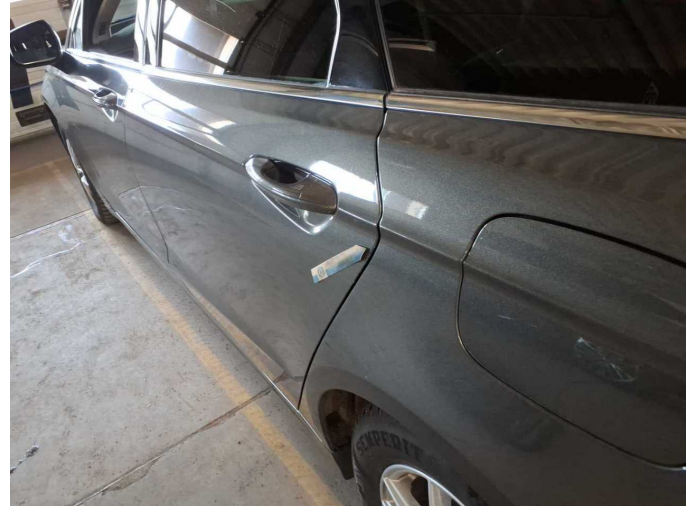
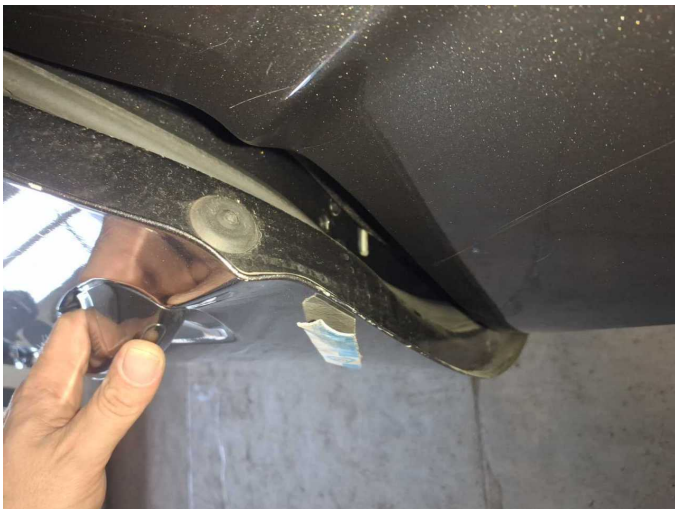
Damage 2: Door - rear left side: Door edge - Scratch(es) - Smart repair

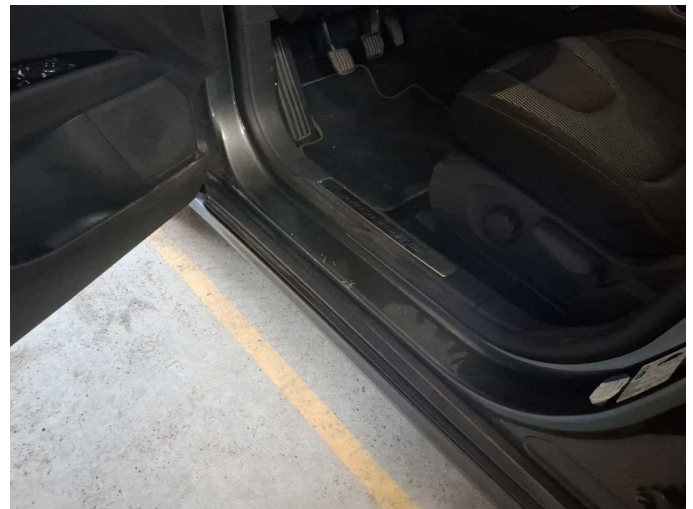
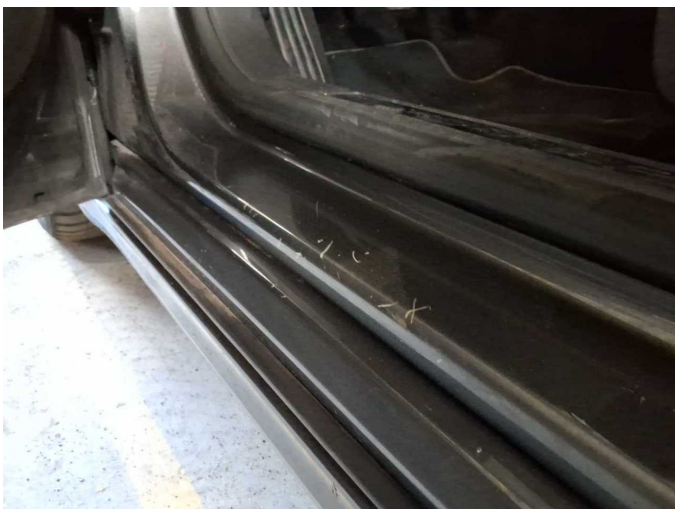
Damage 3: Sill - left side: Sill - Scratch(es) - Smart repair

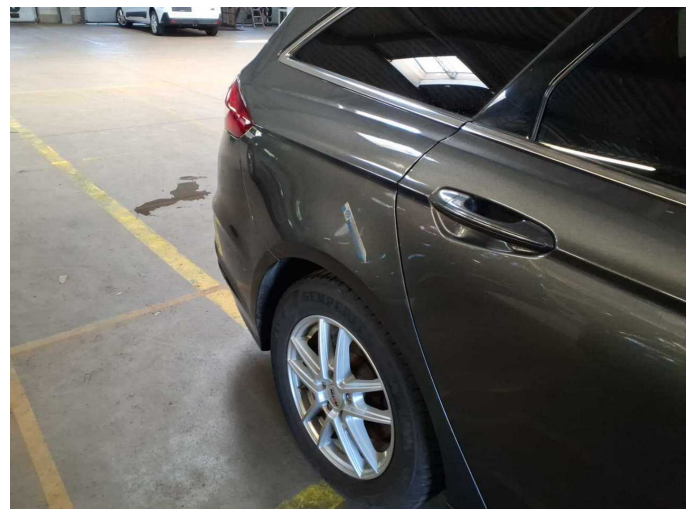
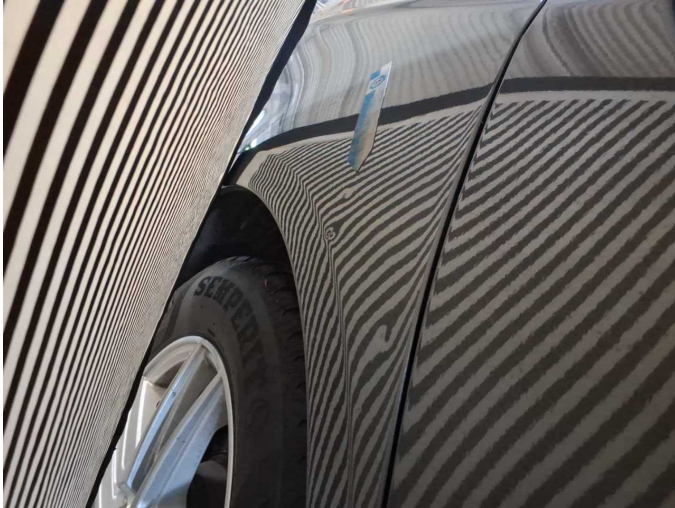
Damage 4: Side panel - rear right side: Side panel - dent(s) - Smooth repair work

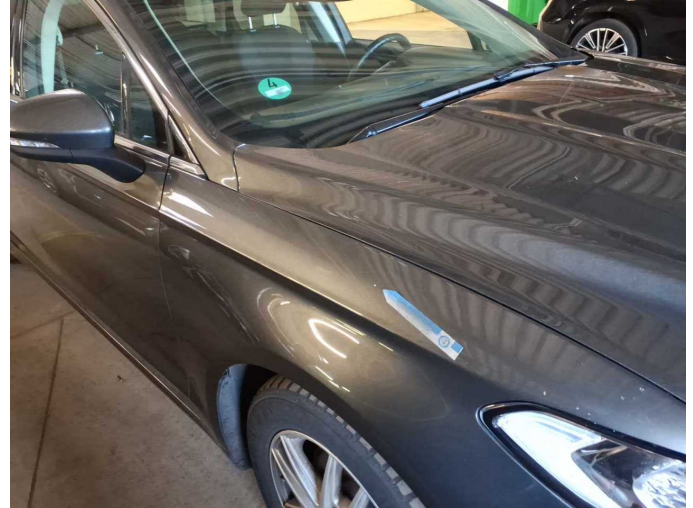
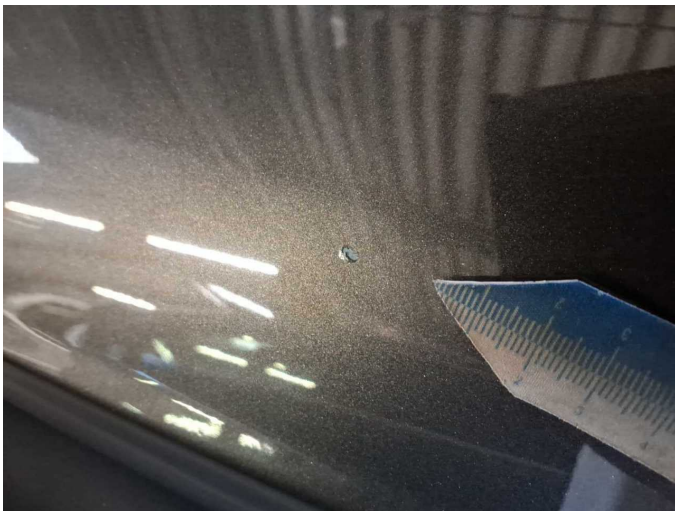
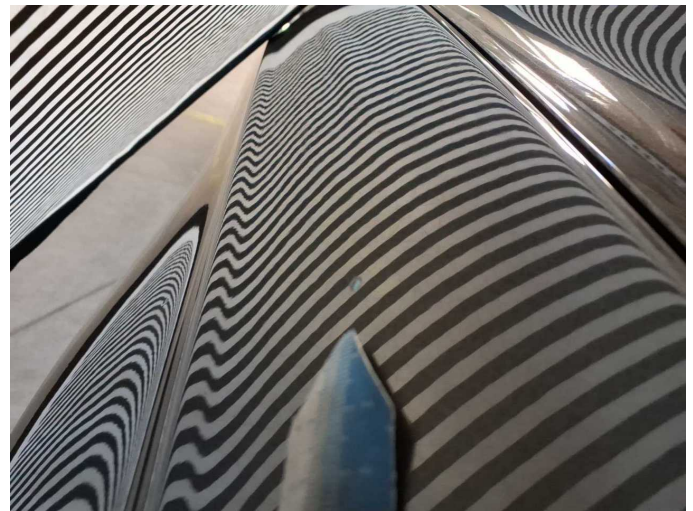
Damage 5: Mudguard - right side: Mudguard - right side - Stone chips - Smart repair

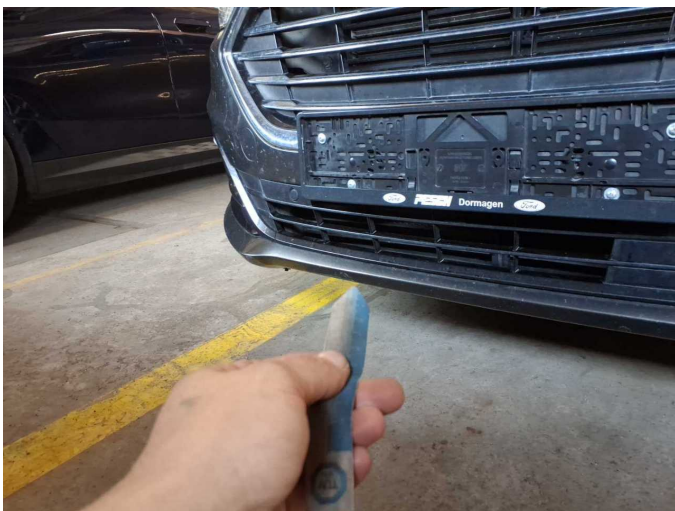
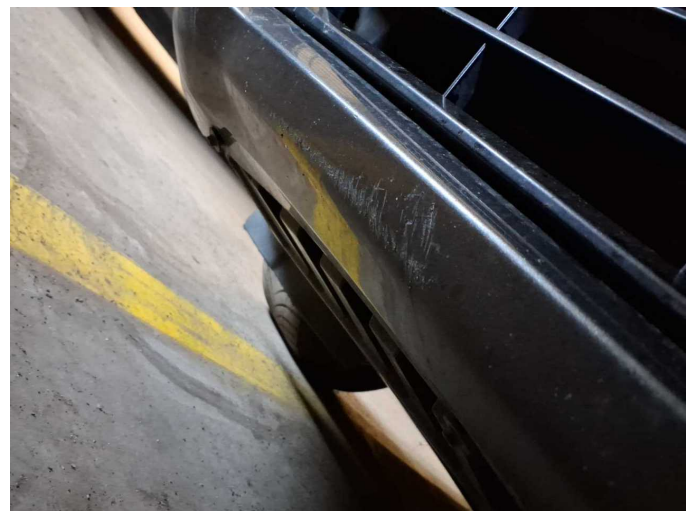
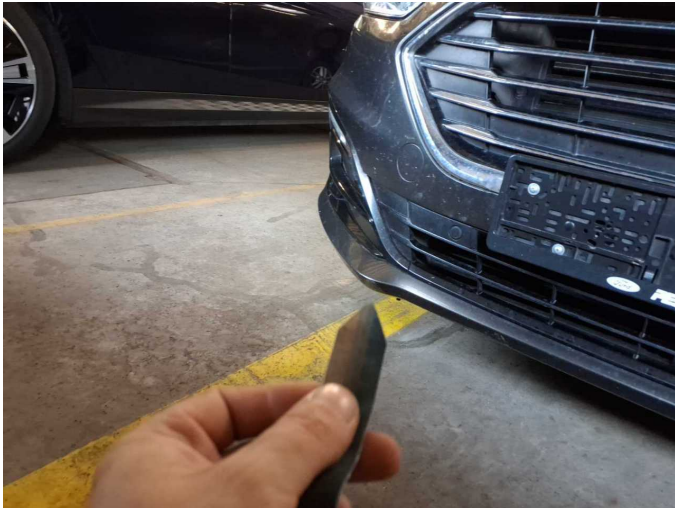
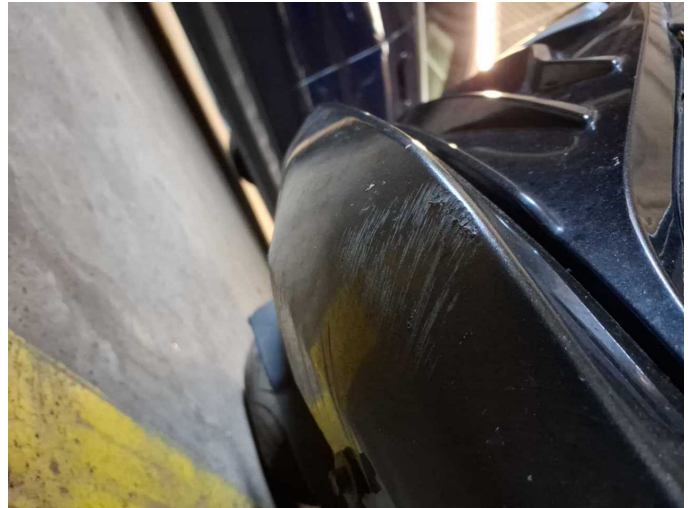
Damage 6: Front bumper: Spoiler - Scratched - Smart repair

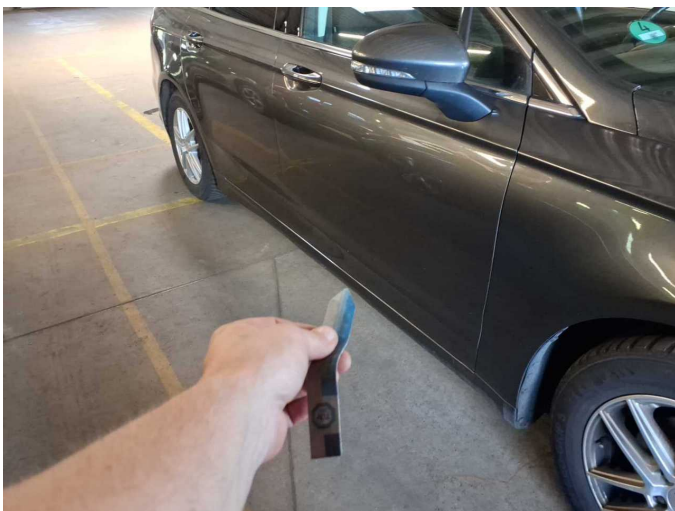
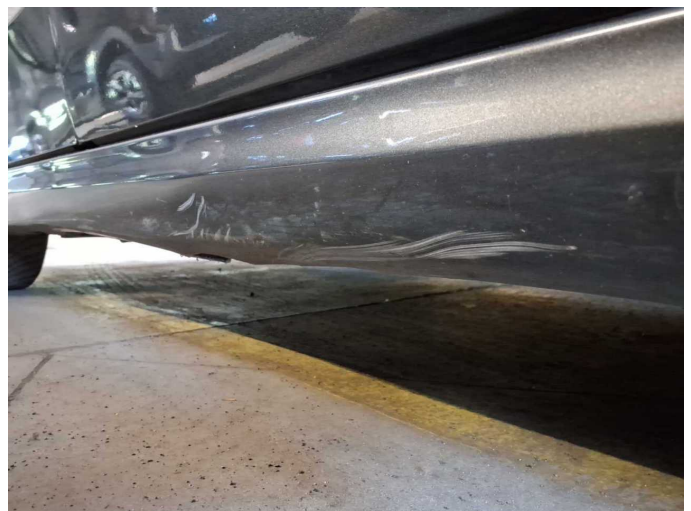
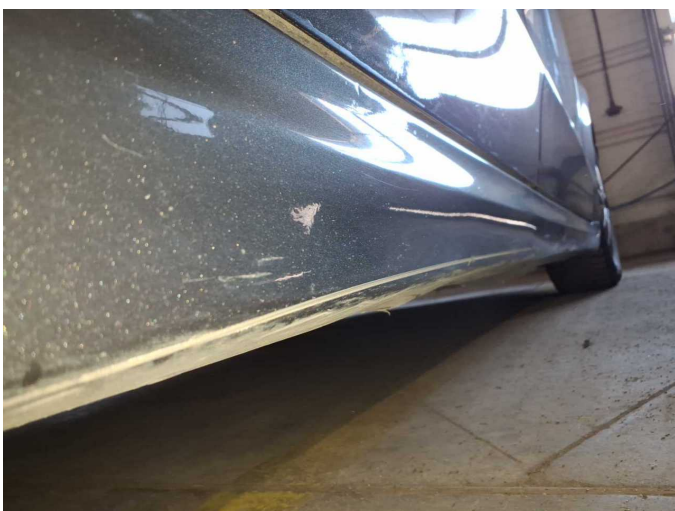
Damage 7: Sill - right side: Trim - Scratched - Paint

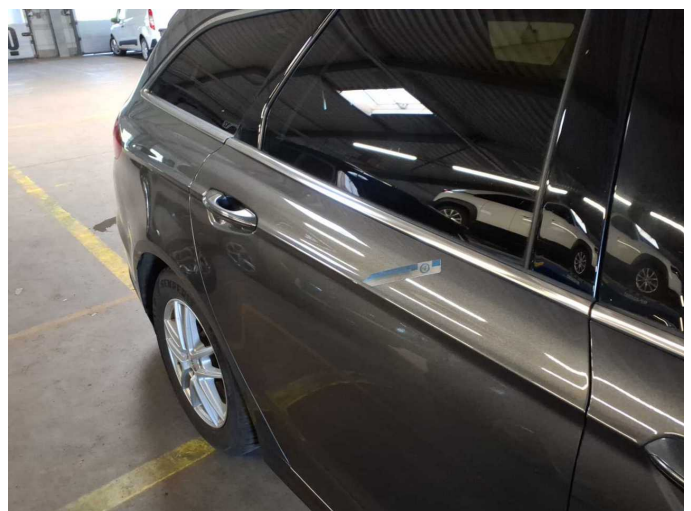
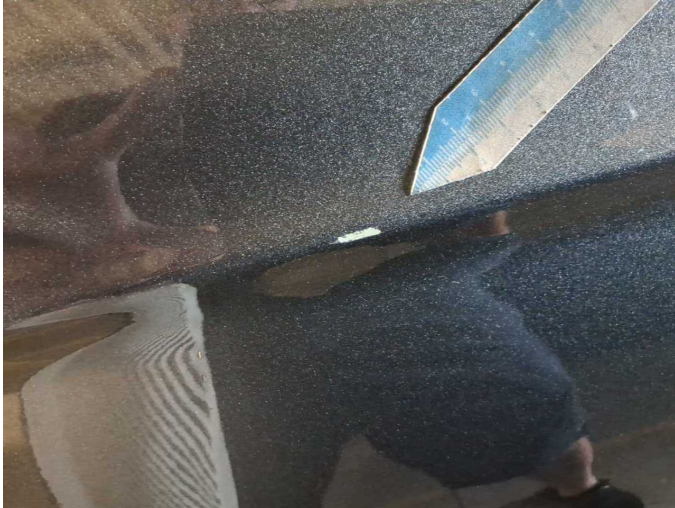
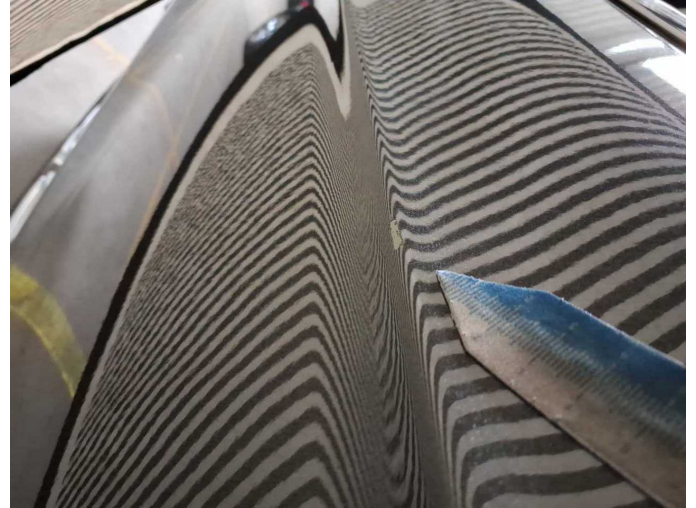
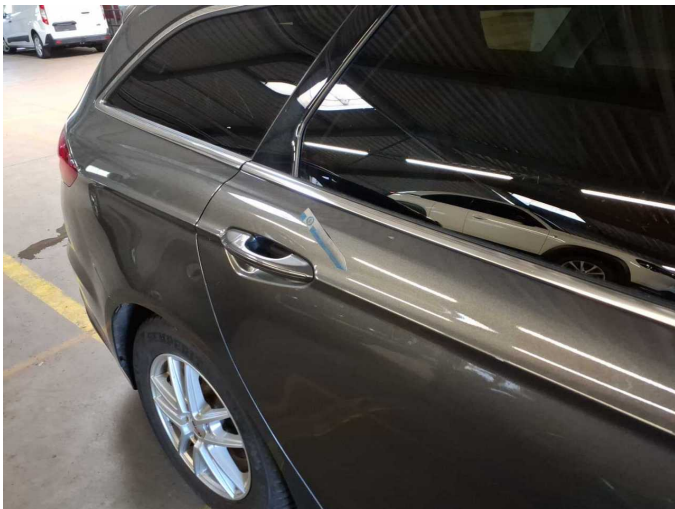
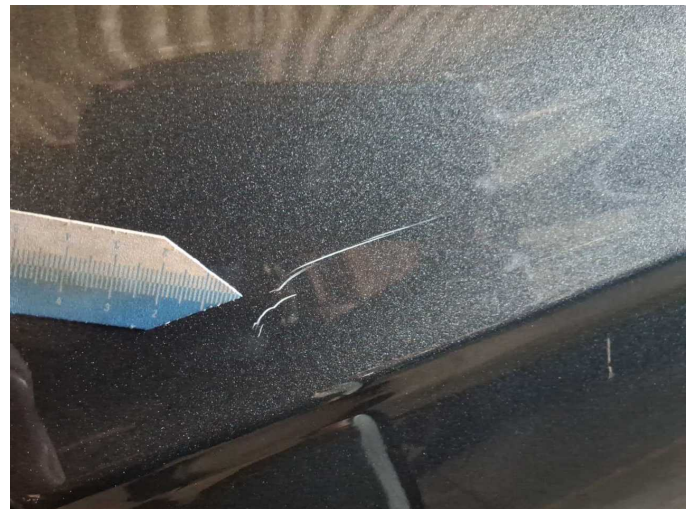
Damage 8: Door - rear right side: Door - Scratched - Paint

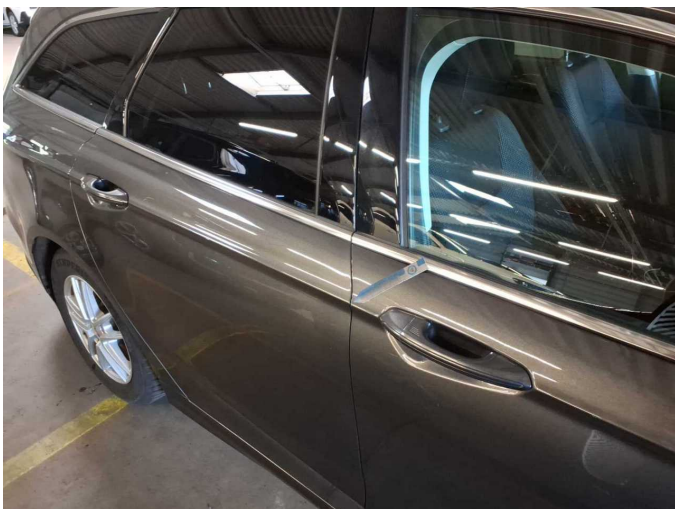
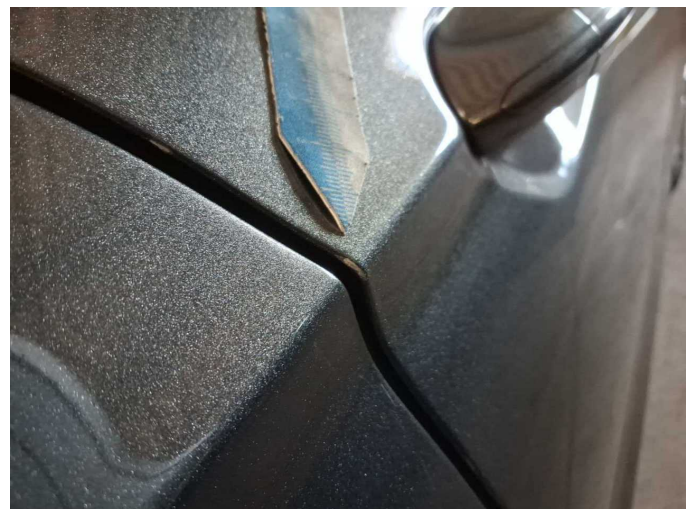
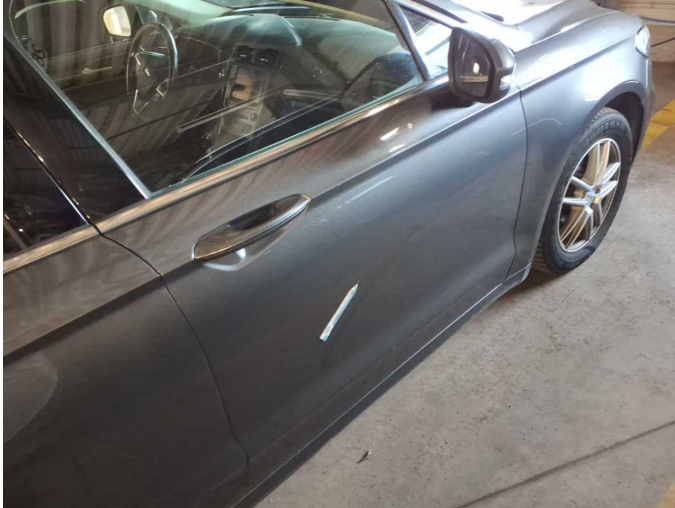
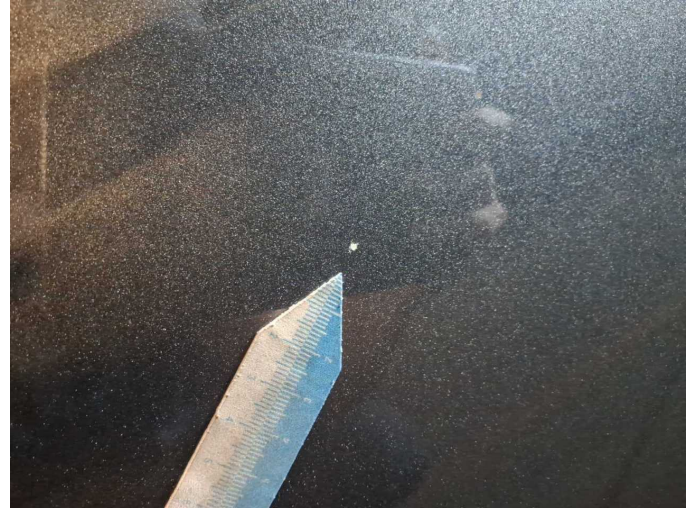
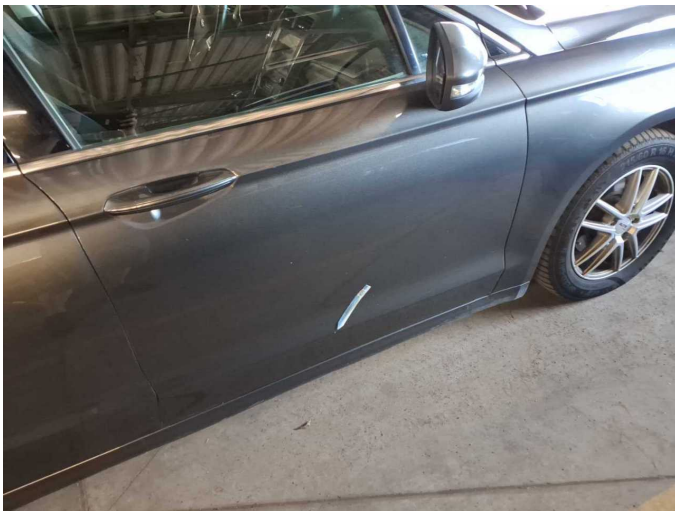
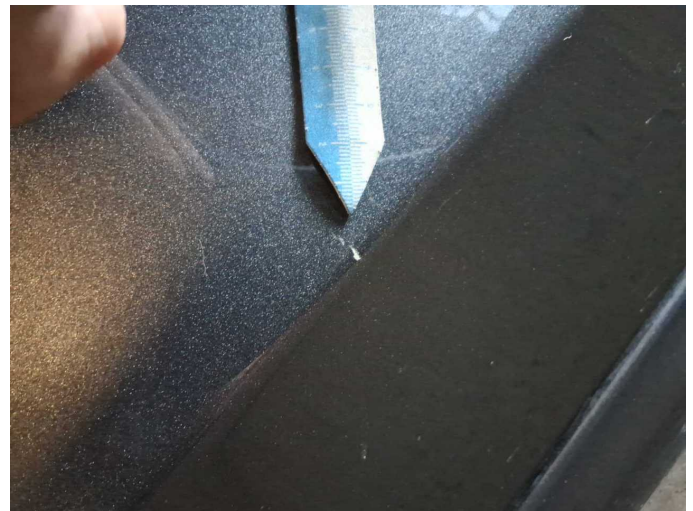
Damage 9: Door - front right side: Door - Scratch(es) - Paint

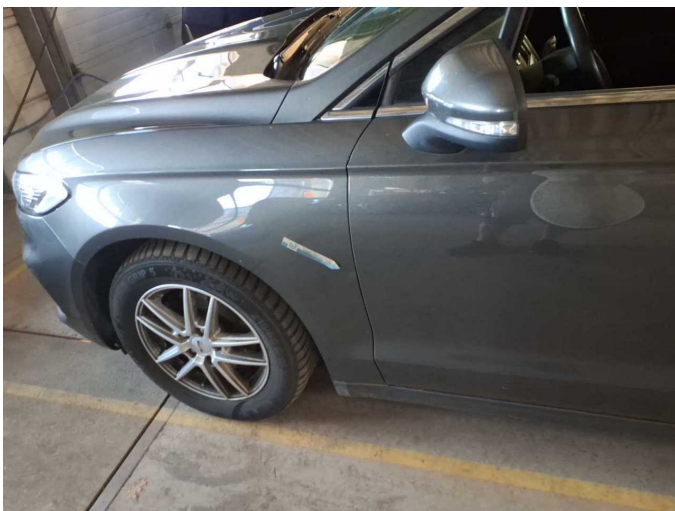
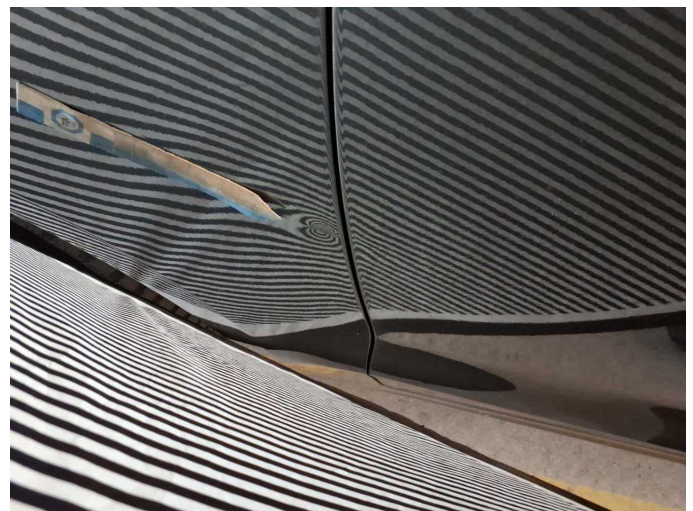
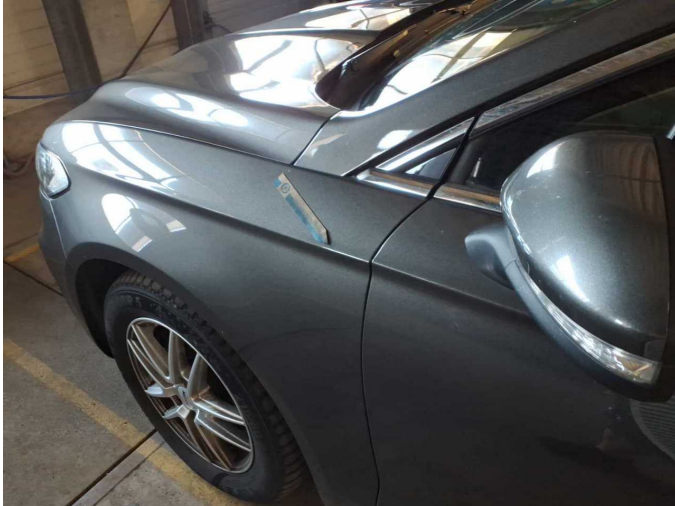
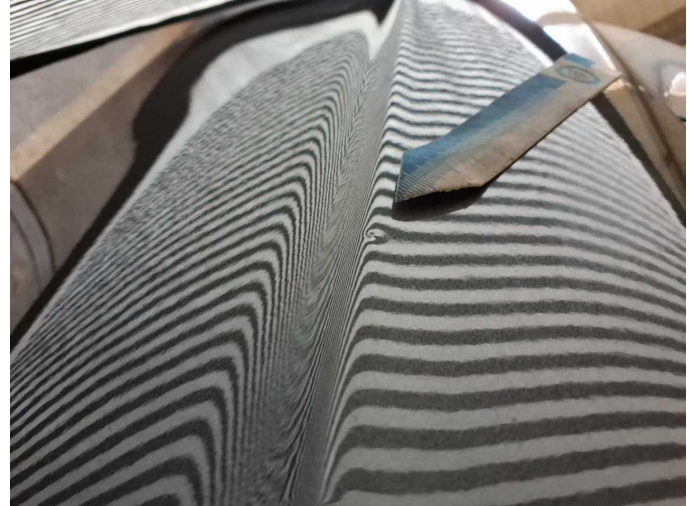
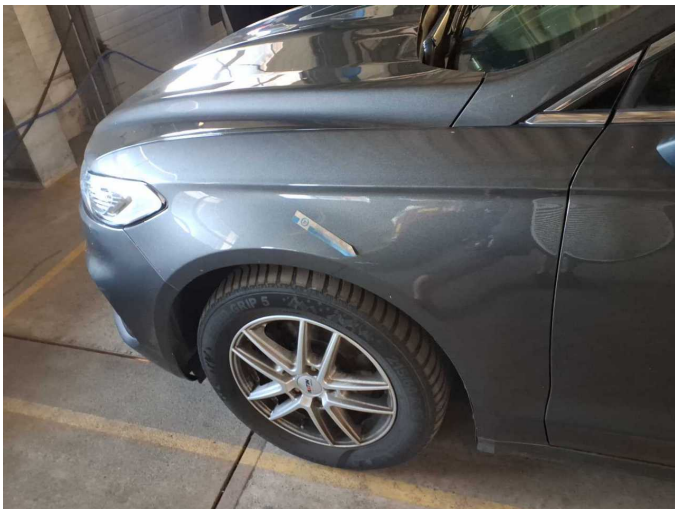
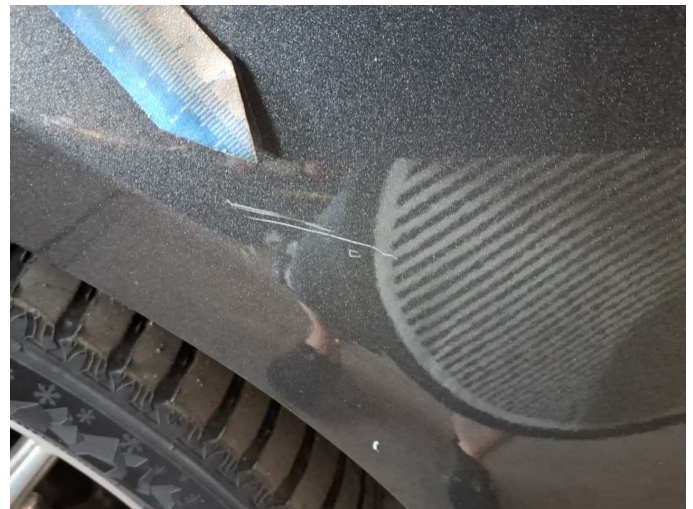
Damage 10: Mudguard - left side: Mudguard - left side - Dent / paintcoat damage - Repair and paint

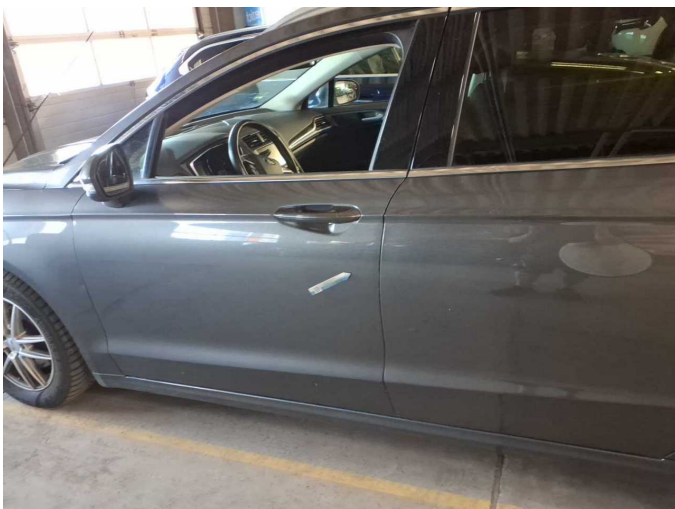
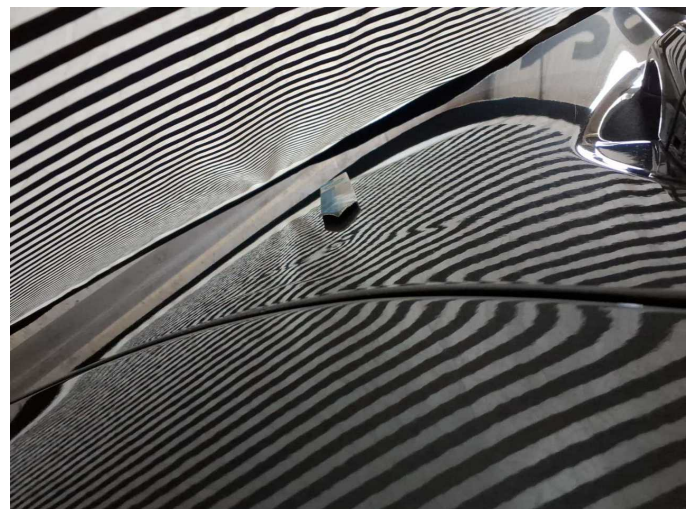
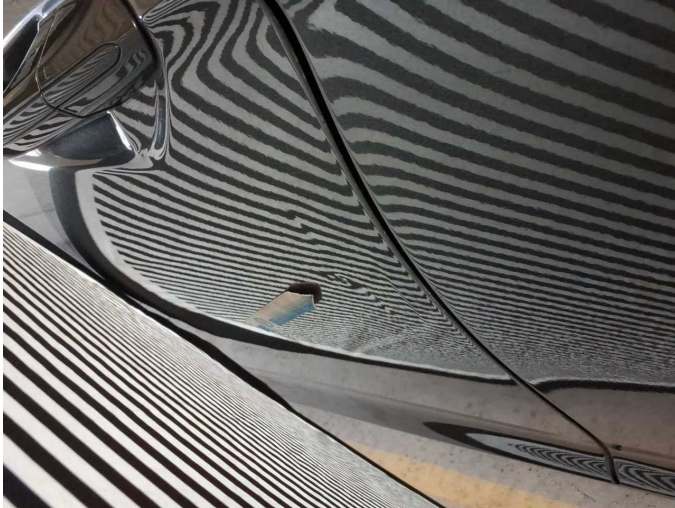
Damage 11: Door - front left side: Door - Deformed - Repair and paint

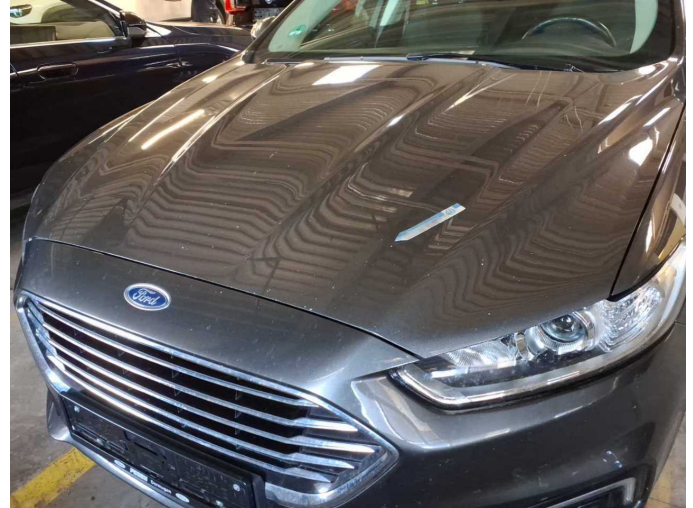
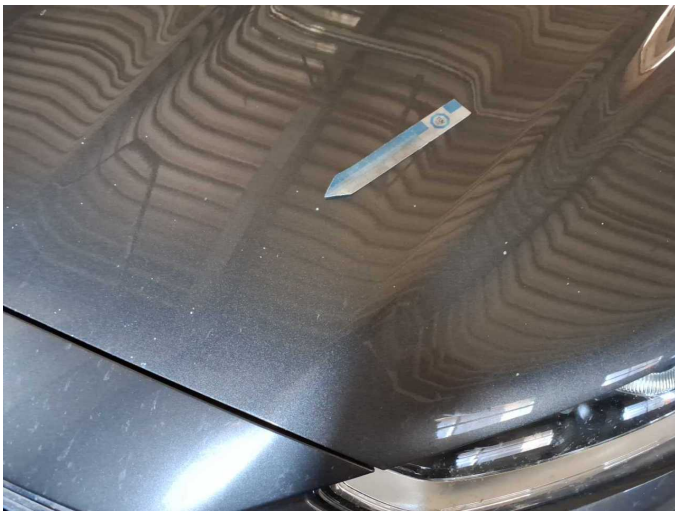
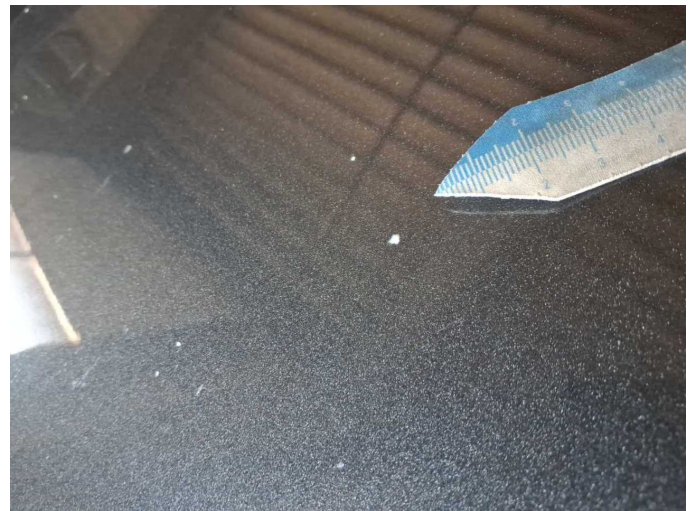
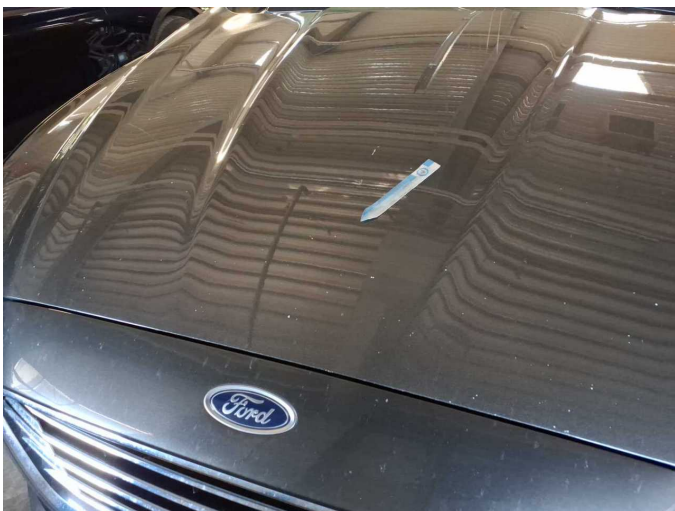
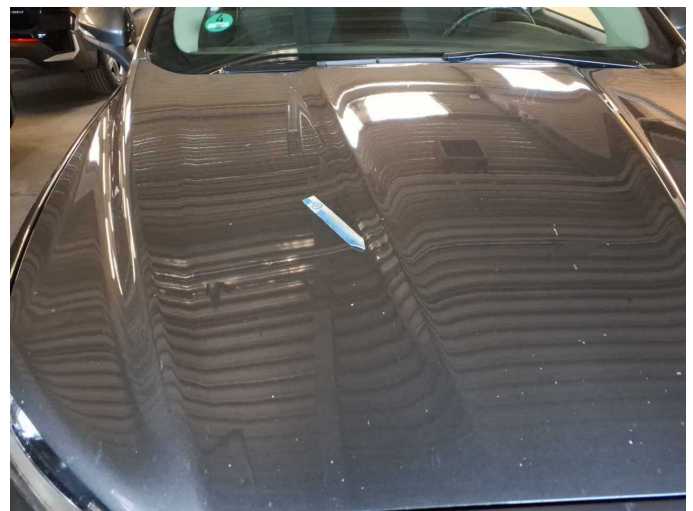
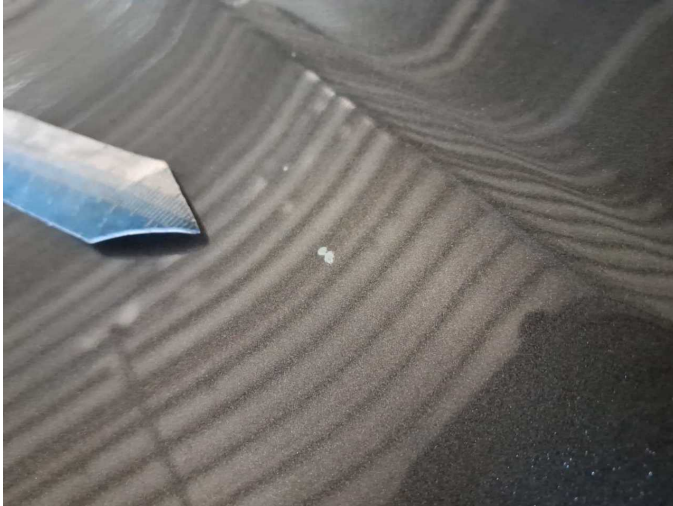
Damage 12: Bonnet: Bonnet (Sandstrahleffekt) - Stone chips - Paint

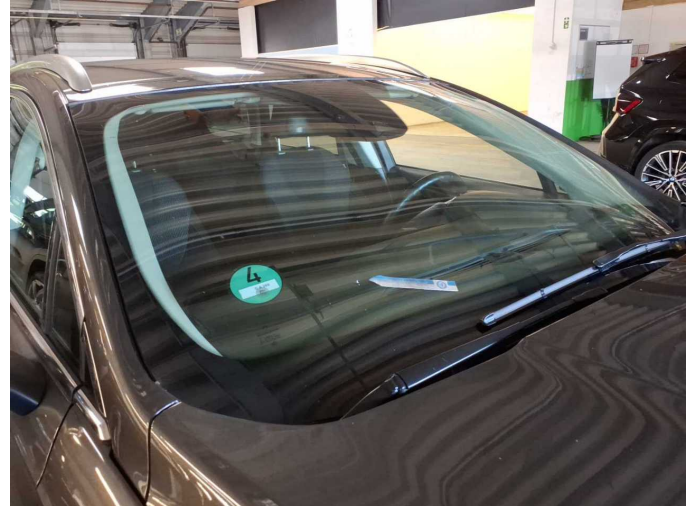
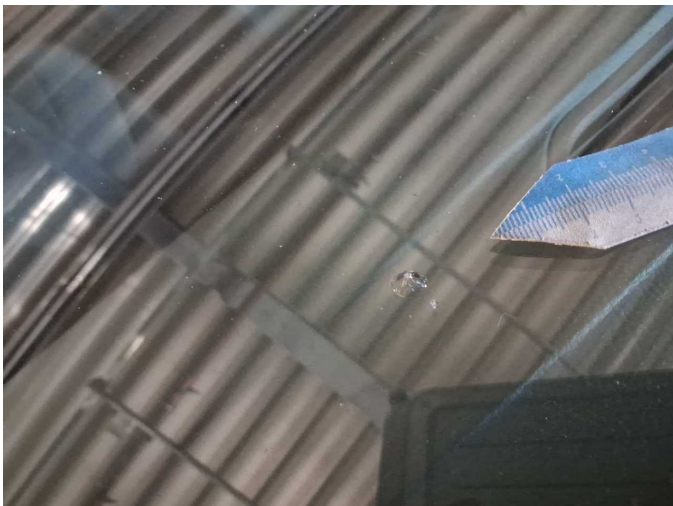
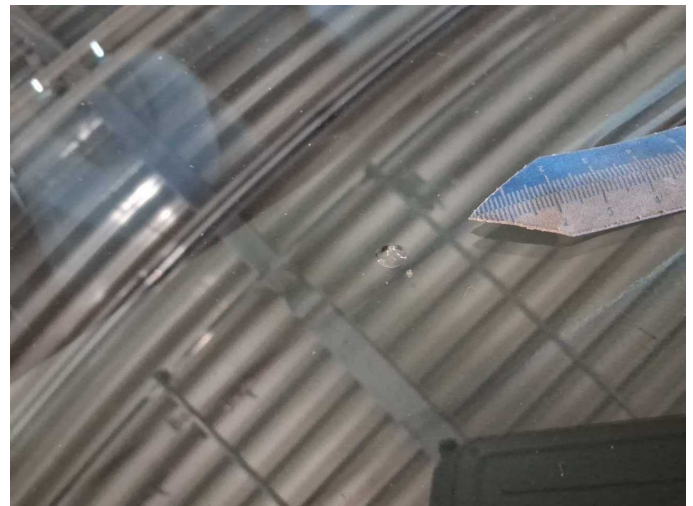
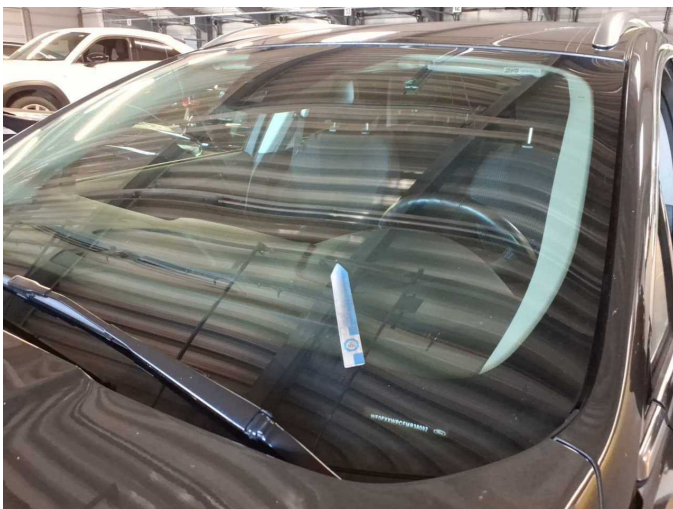
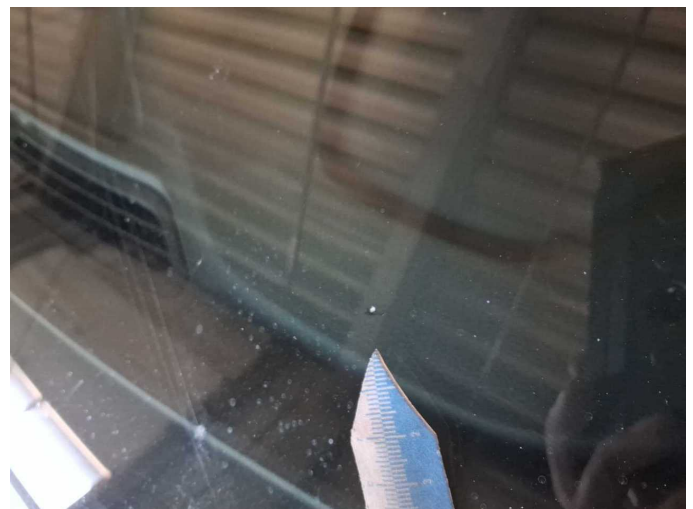
Damage 13: Vehicle glazing: Windscreen (Kein Staubschutz) - Stone chips - repair according to calculation

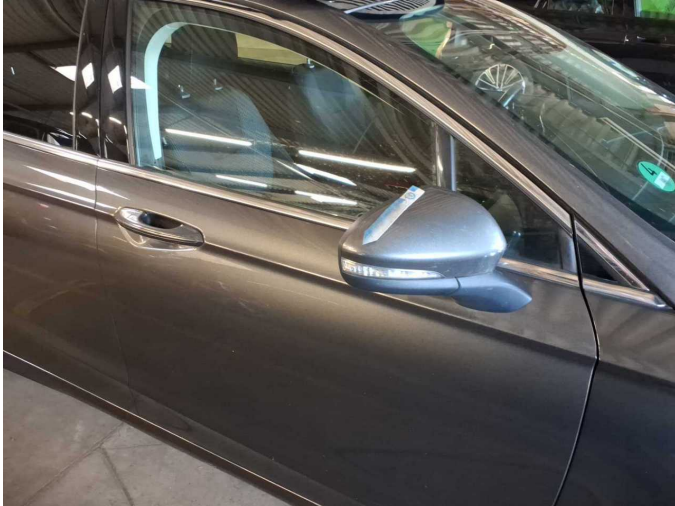
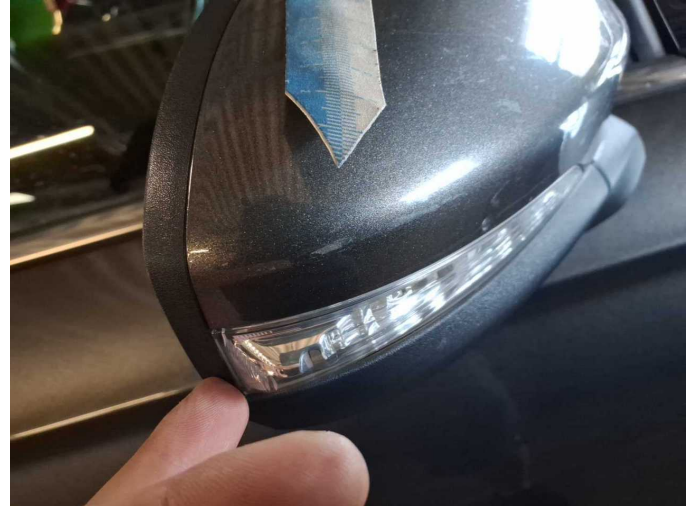
Wear and tear 3: Wing mirror - right side: Cap - Scratch(es) - No deduction

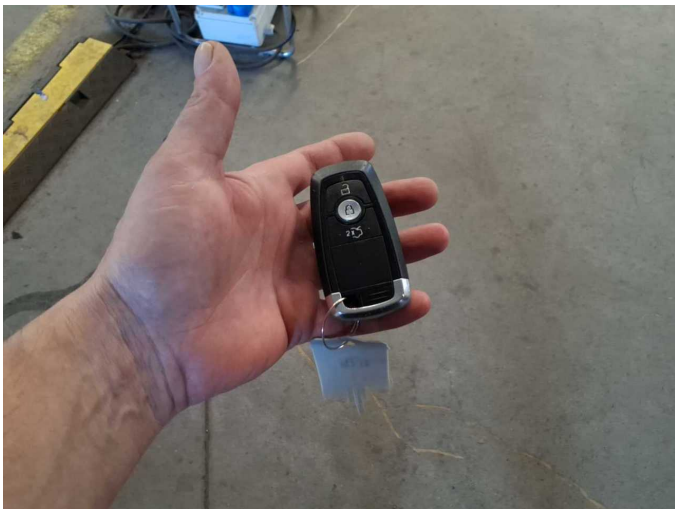
Missing part 2: Equipment: Vehicle key with remote control - Missing - Replace

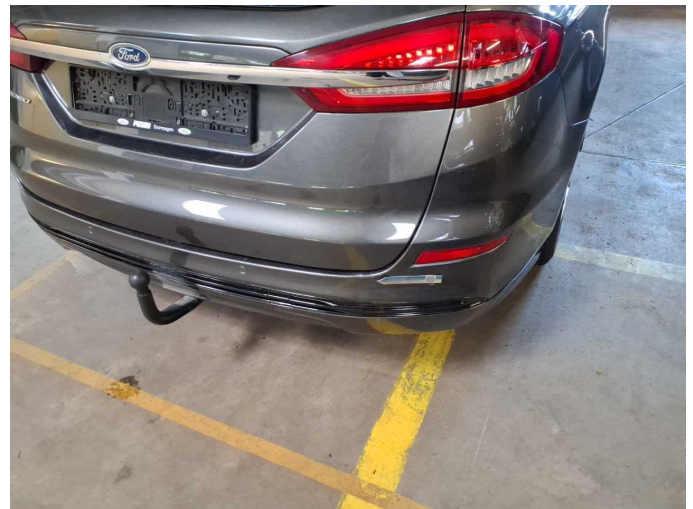
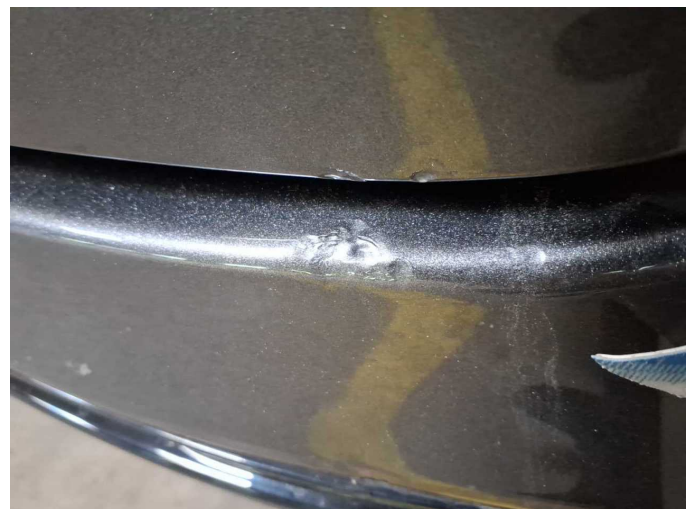
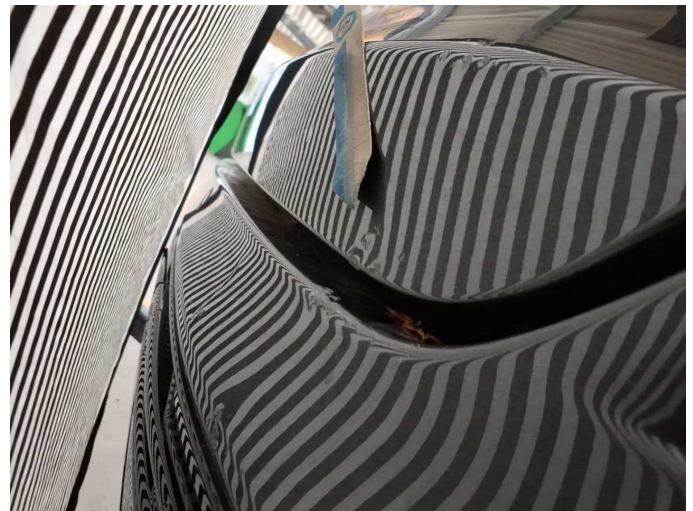
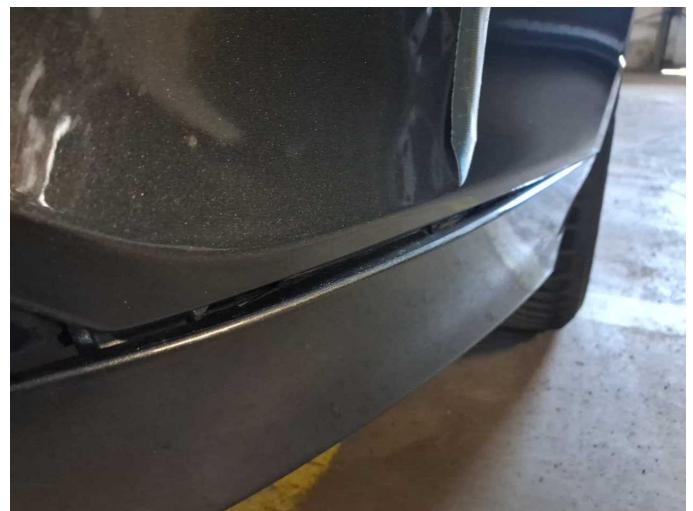
No.	Previous damage	Extent of damage (Net)
1	Rear, Provided by user / customer, from 3 Aug 2025	4.497,01 €

Accident 1: Rear
