Expertise

Protocol number: 46217594  
Order No. / Reference: 26554354  
Inspection date: 26 Jun 2026

Manufacturer: Skoda  
VIN: TMBLJ9NS6N8025907

Model: Kodiaq 2.0 TDI 4x4 DSG Style

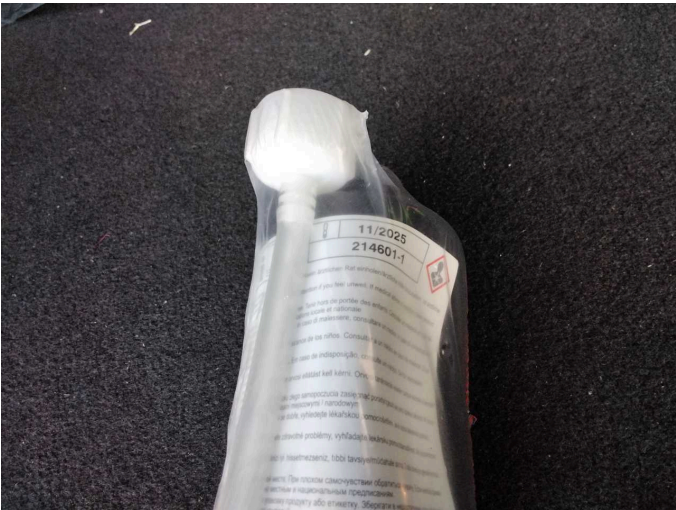
| No. | Component group | Description |
|---|---|---|
| 1 | Equipment | Tirefit filler - Expired - Replace |

Damage 1: Equipment: Tirefit filler - Expired - Replace

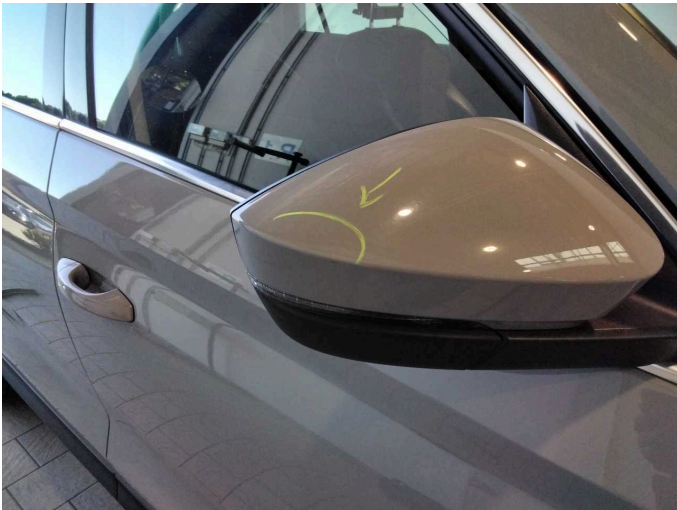
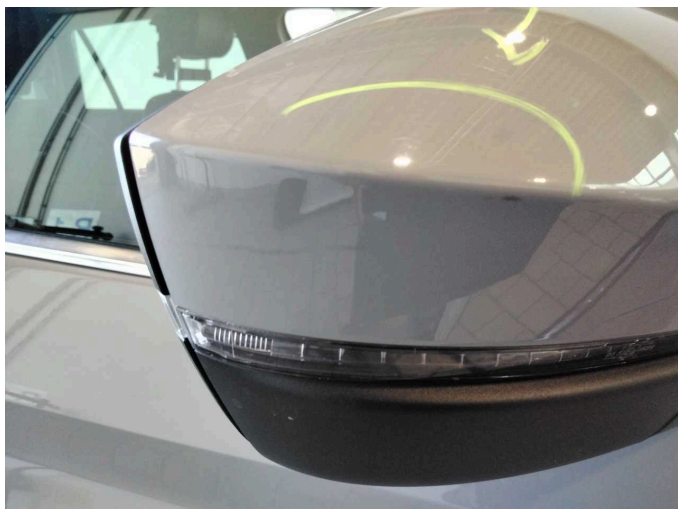
| No. | Component group | Description |
|---|---|---|
| 2 | Wing mirror - right side | Cap - Scratch(es) - Smart repair |

Damage 2: Wing mirror - right side: Cap - Scratch(es) - Smart repair

**Damage 2:** Wing mirror - right side: Cap - Scratch(es) - Smart repair

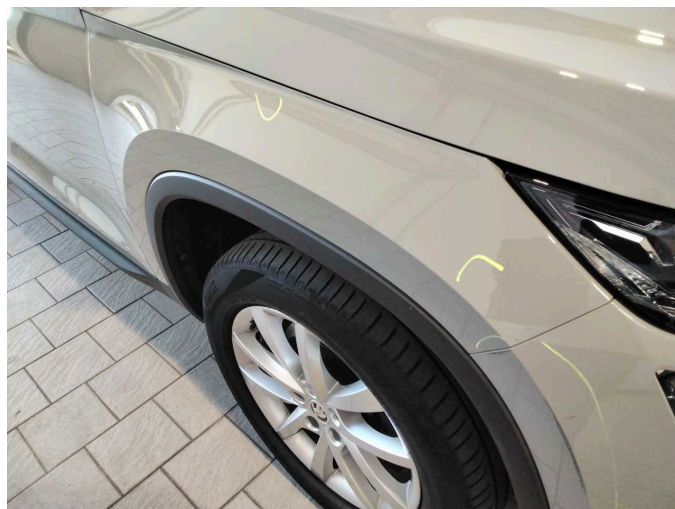
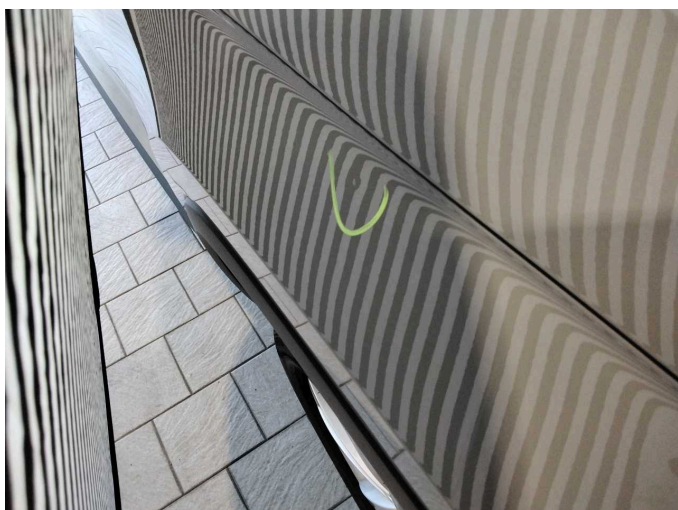
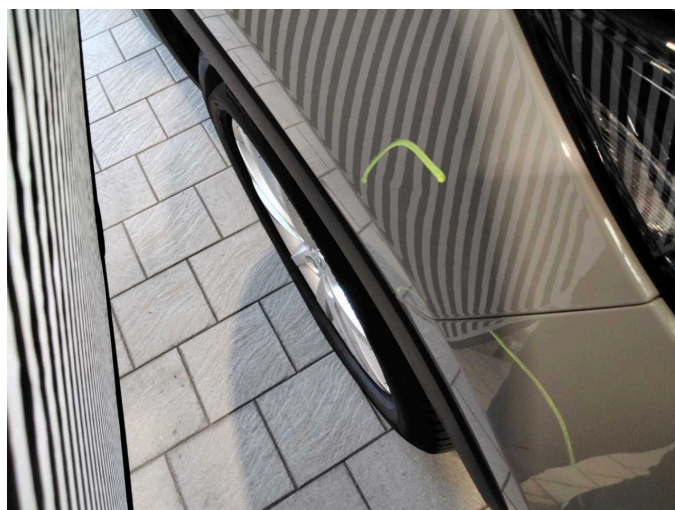
| No. | Component group | Description |
|---|---|---|
| 3 | Mudguard - right side | Mudguard - right side - dent(s) - Smooth repair work |

**Damage 3:** Mudguard - right side: Mudguard - right side - dent(s) - Smooth repair work

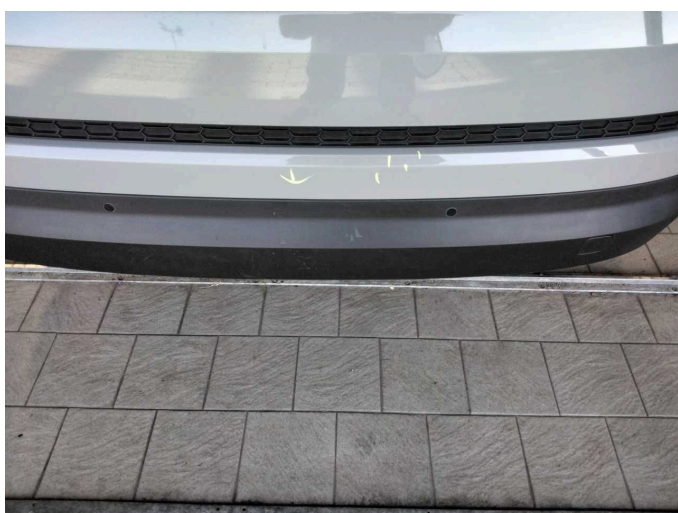
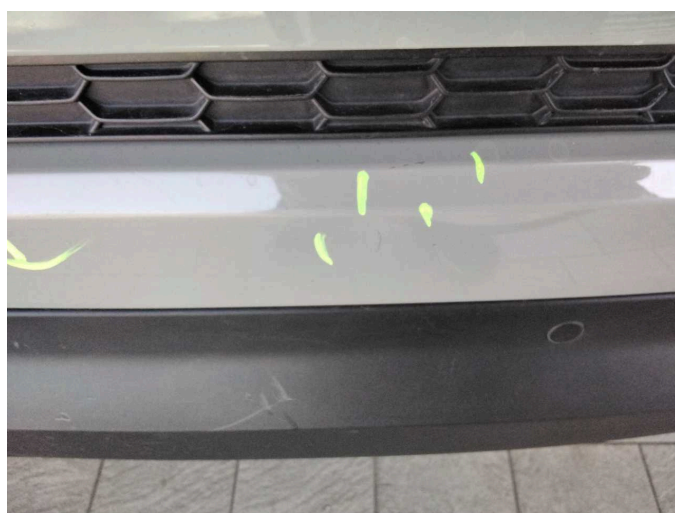
| No. | Component group | Description |
|---|---|---|
| 4 | Rear bumper | Rear bumper - Scratch(es) - Smart repair |

**Damage 4:** Rear bumper: Rear bumper - Scratch(es) - Smart repair

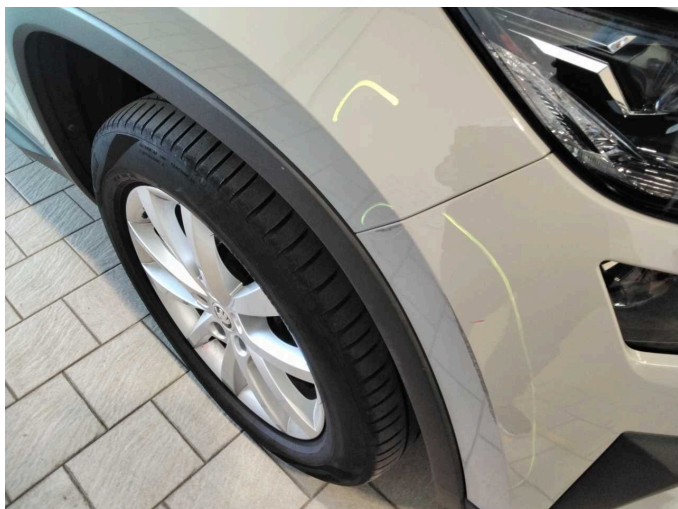
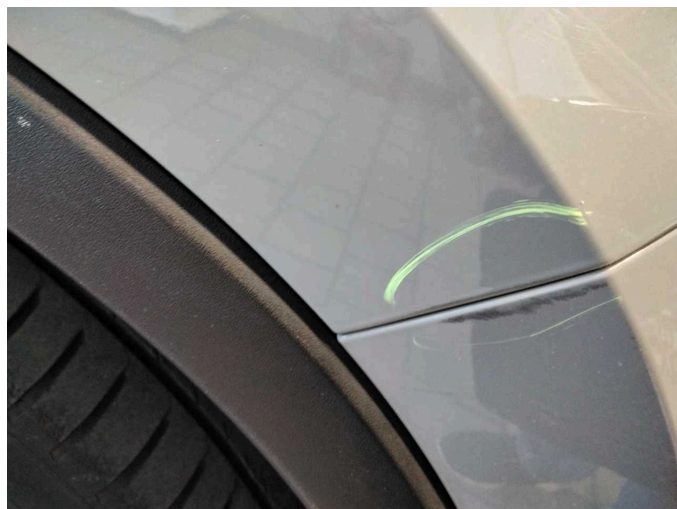
| No. | Component group | Description |
|---|---|---|
| 5 | Mudguard - right side | Mudguard - right side - Scratch(es) - Smart repair |

**Damage 5:** Mudguard - right side: Mudguard - right side - Scratch(es) - Smart repair

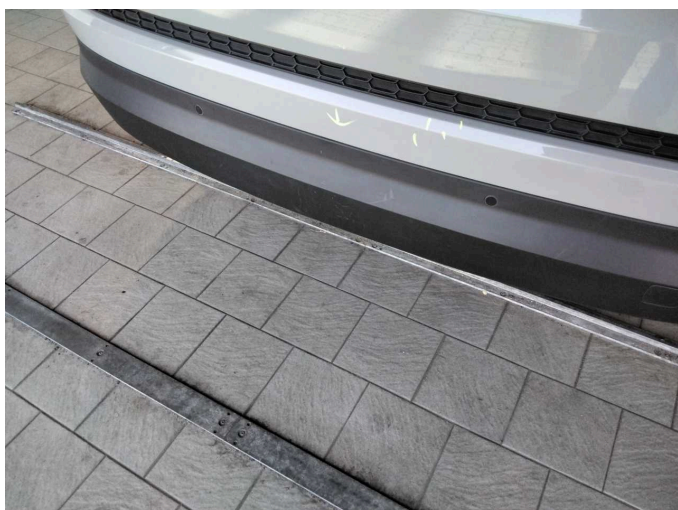
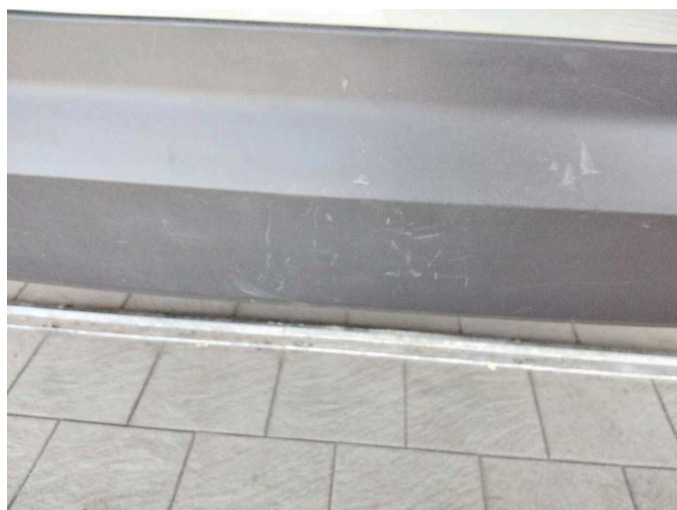
| No. | Component group | Description |
|---|---|---|
| 6 | Rear bumper | Spoiler - Scratch(es) - Replace |

**Damage 6:** Rear bumper: Spoiler - Scratch(es) - Replace

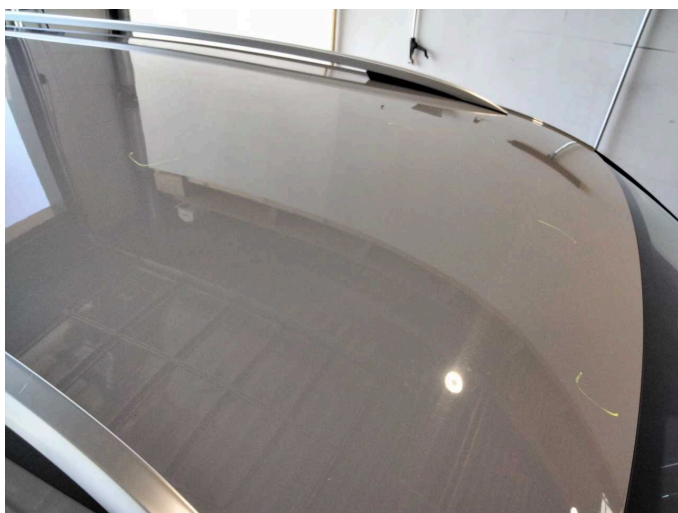
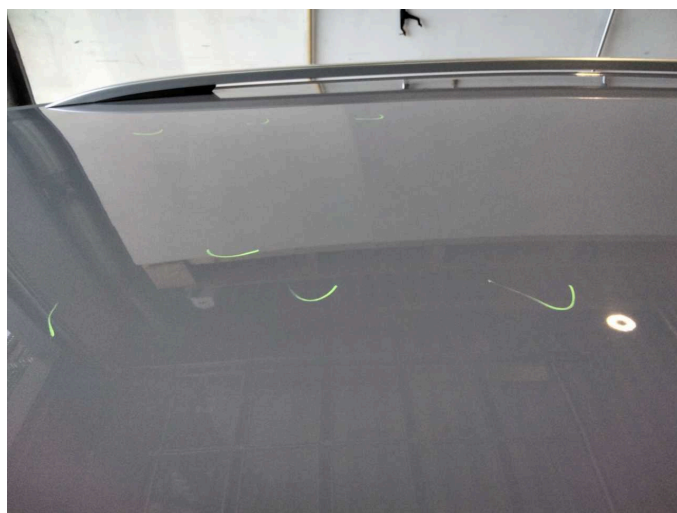
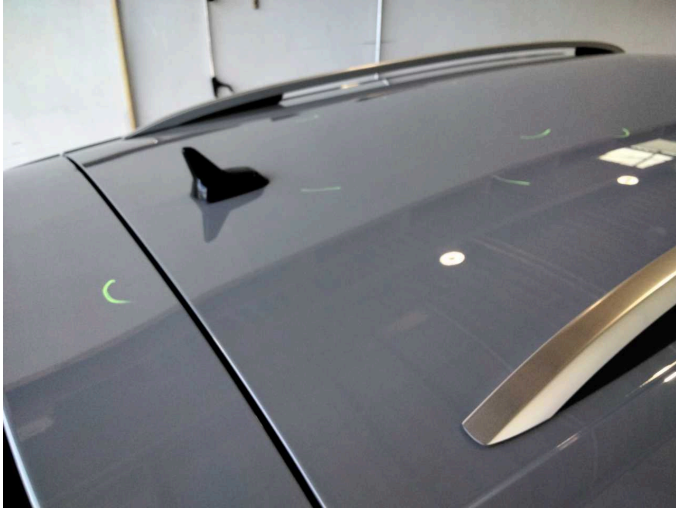
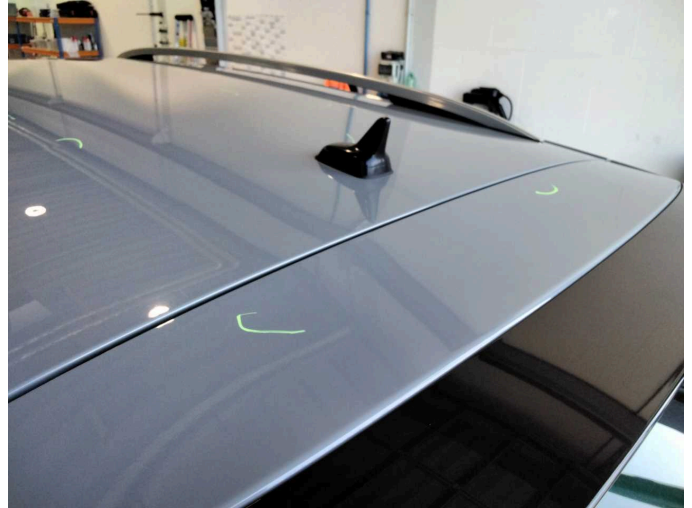
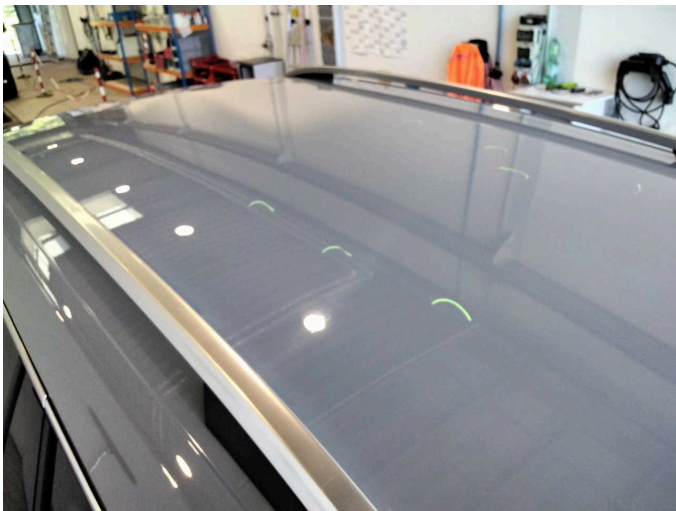
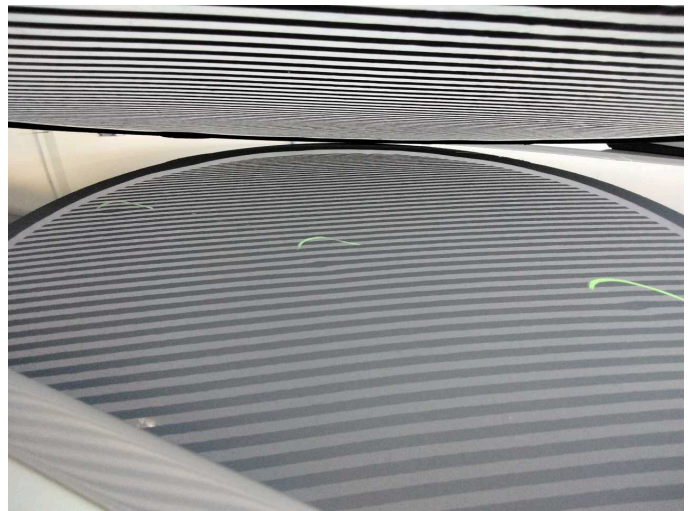
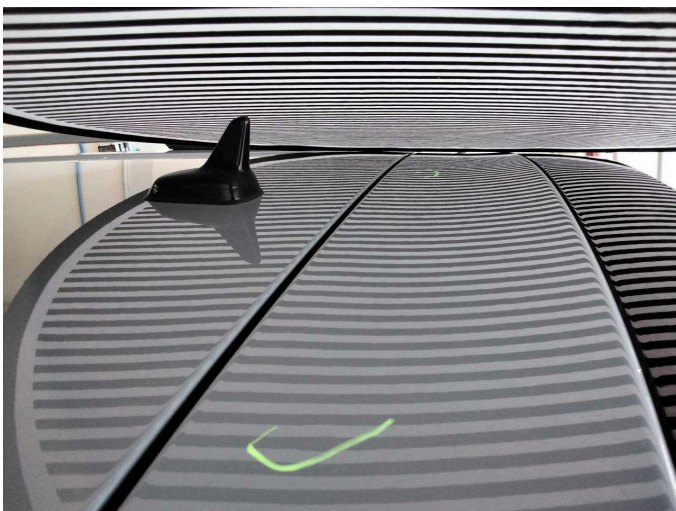
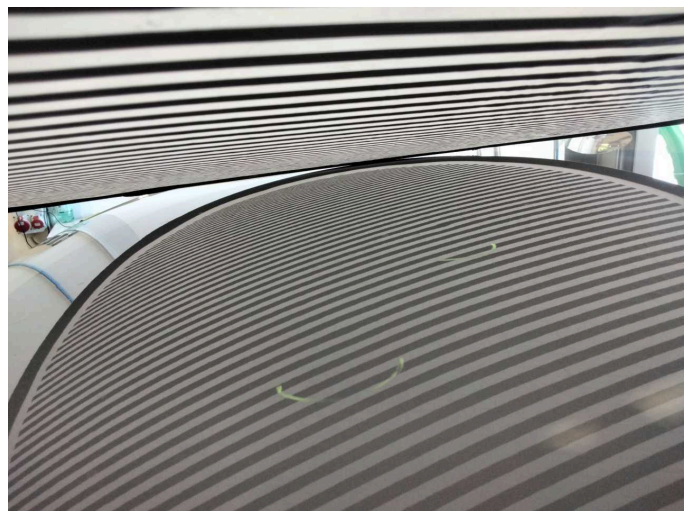
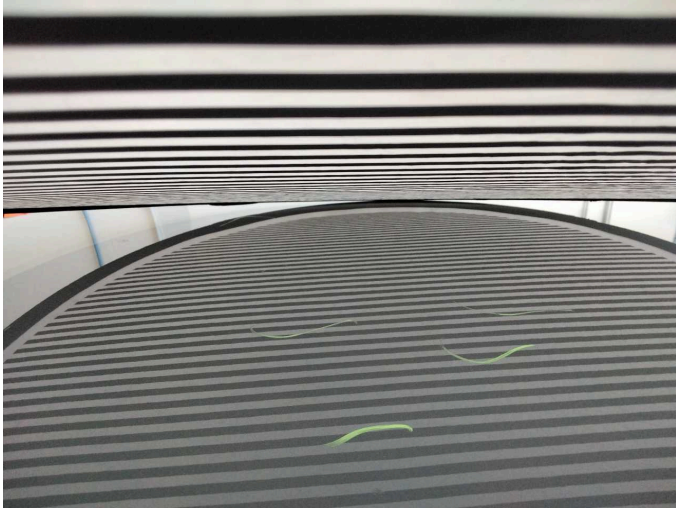
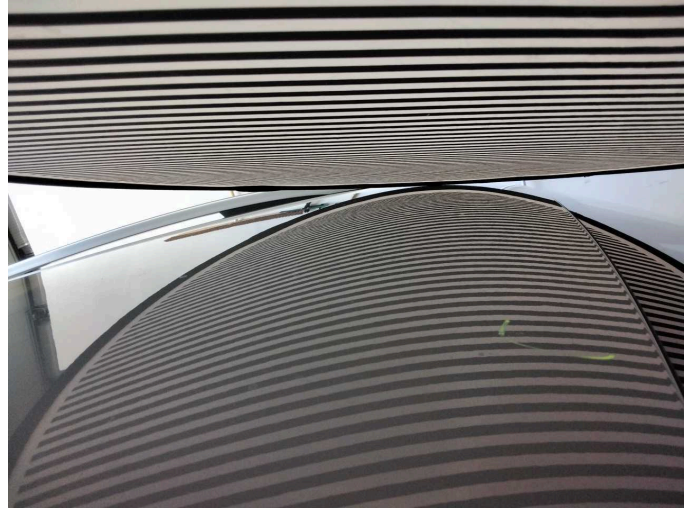
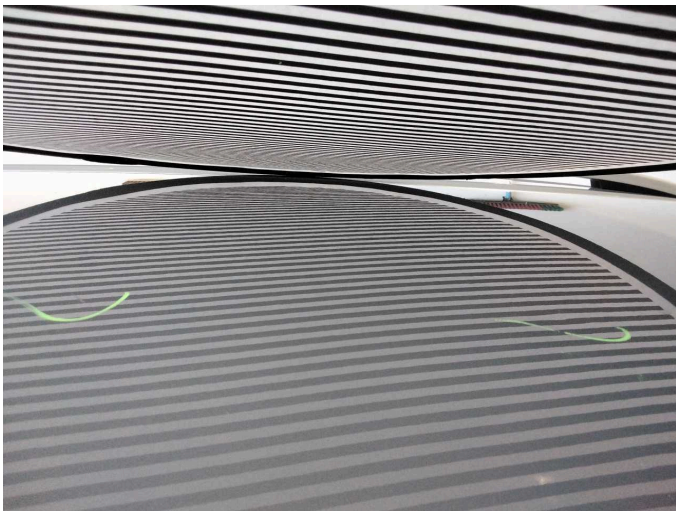
| No. | Component group | Description |
|---|---|---|
| 7 | Roof | Roof - Damage by hail - Smooth repair work |

**Damage 7:** Roof: Roof - Damage by hail - Smooth repair work

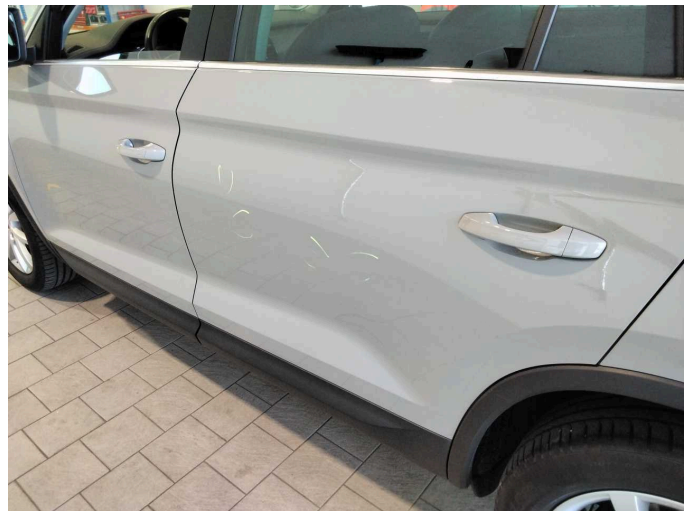
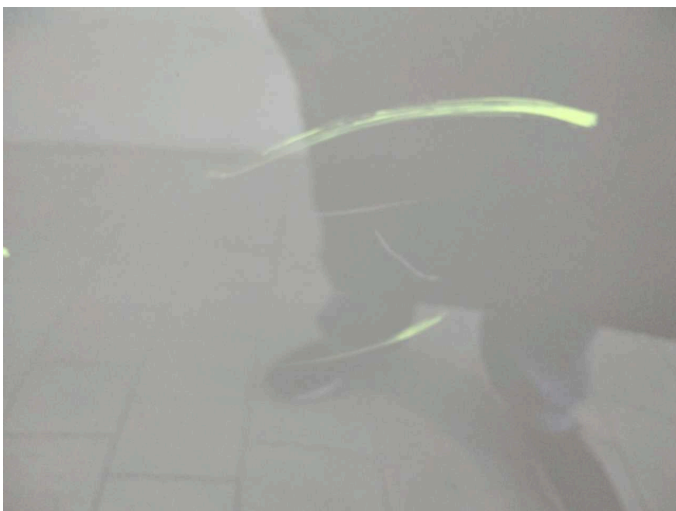
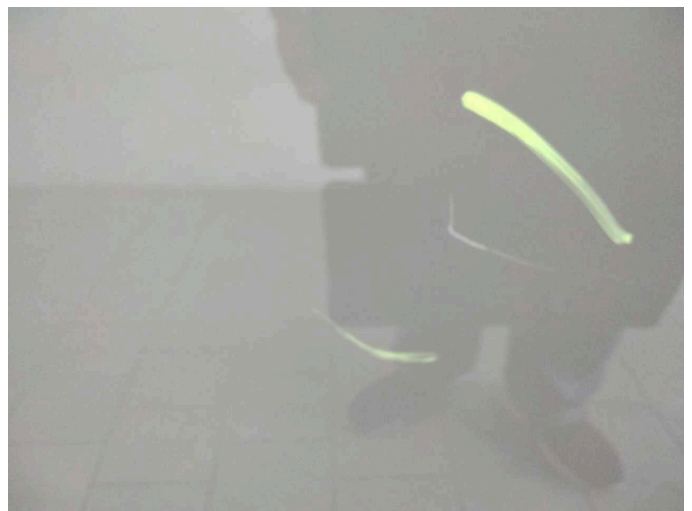
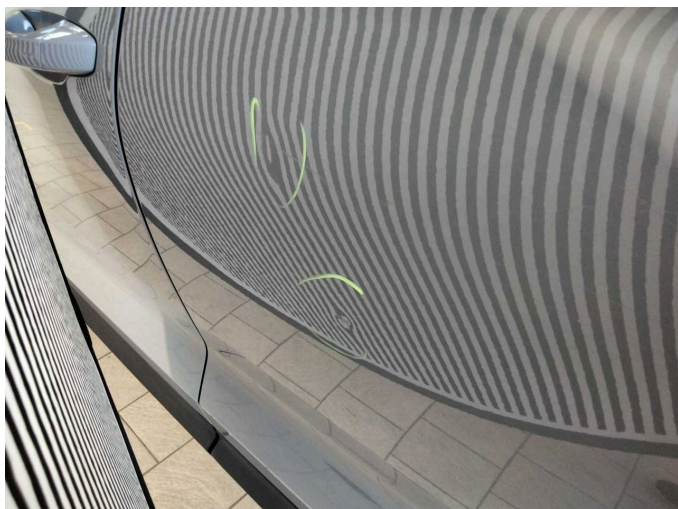
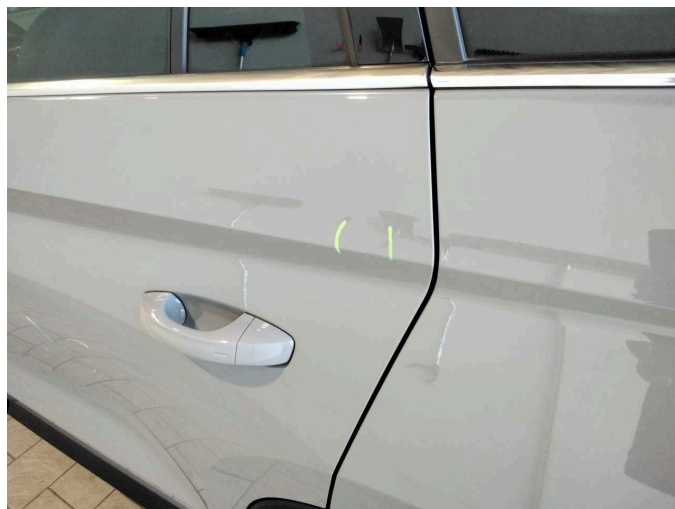
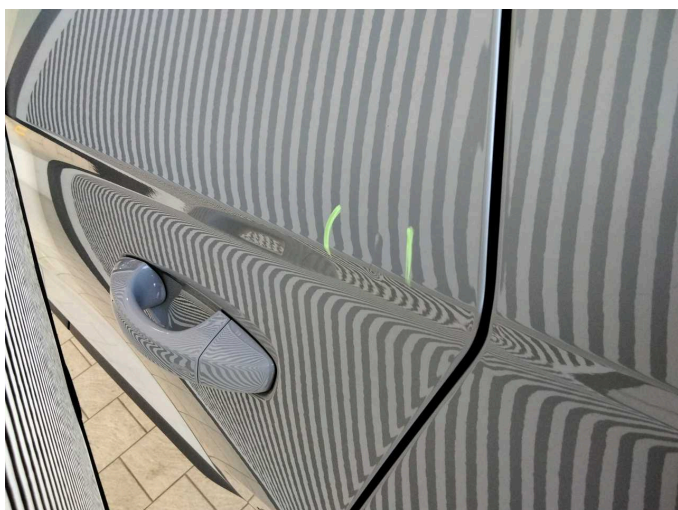
| No. | Component group | Description |
|---|---|---|
| 8 | Door - rear left side | Door - Dent / paintcoat damage - Repair and paint |

**Damage 8:** Door - rear left side: Door - Dent / paintcoat damage - Repair and paint

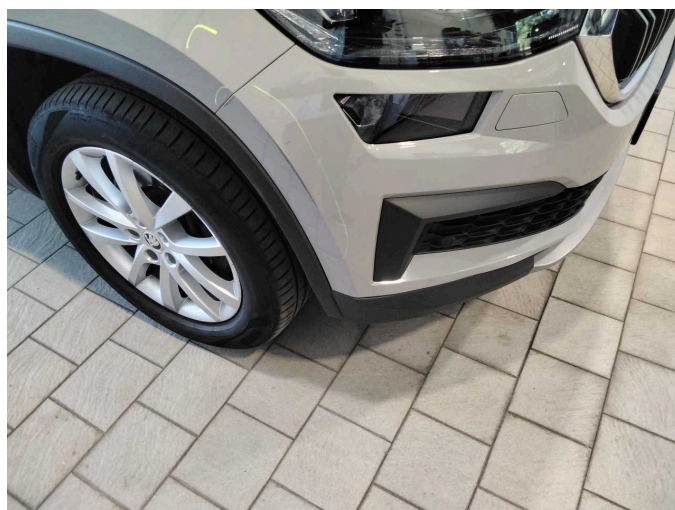
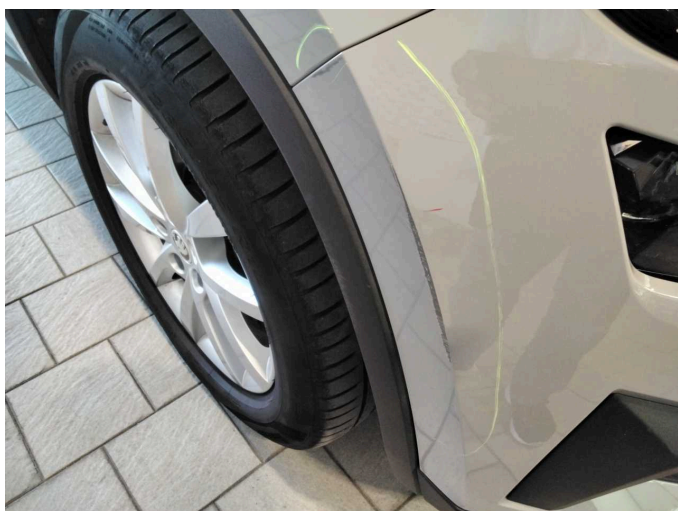
| No. | Component group | Description |
|---|---|---|
| 9 | Front bumper | Front bumper - Scratch(es) - Paint |

**Damage 9:** Front bumper: Front bumper - Scratch(es) - Paint

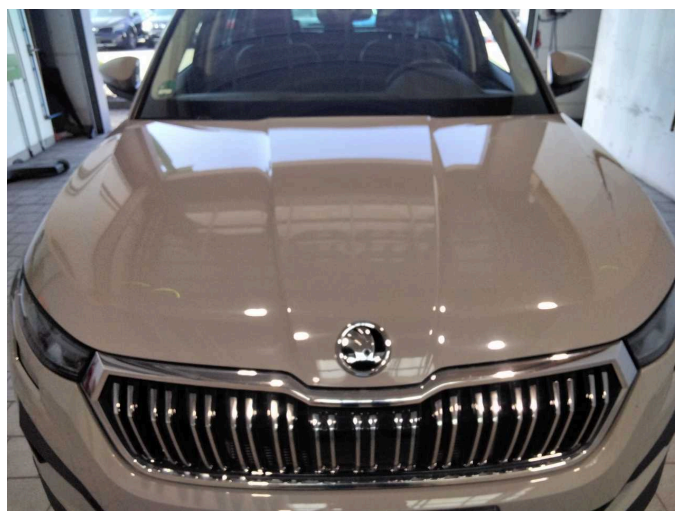
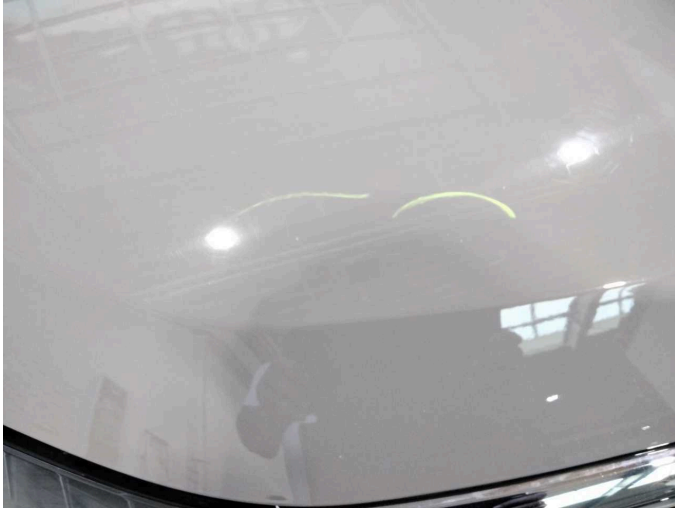
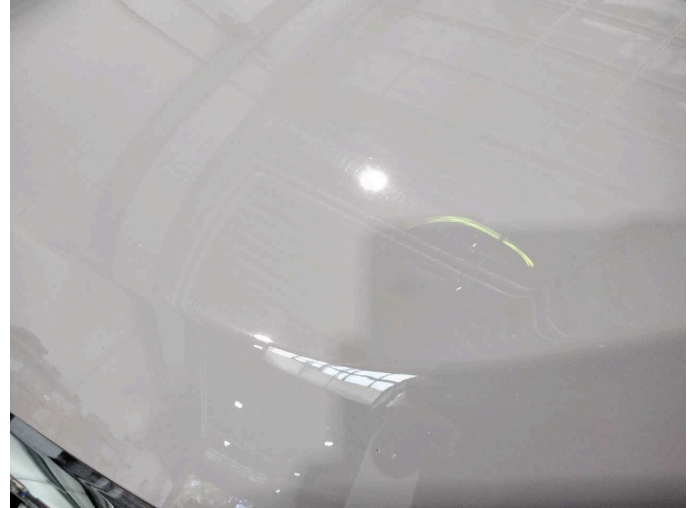
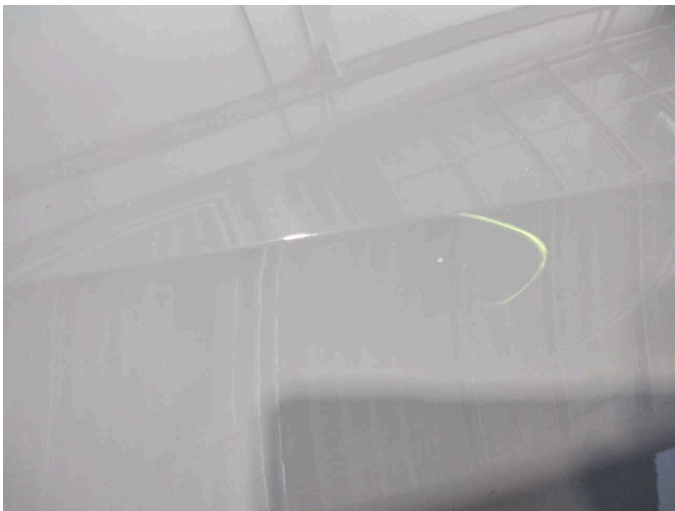
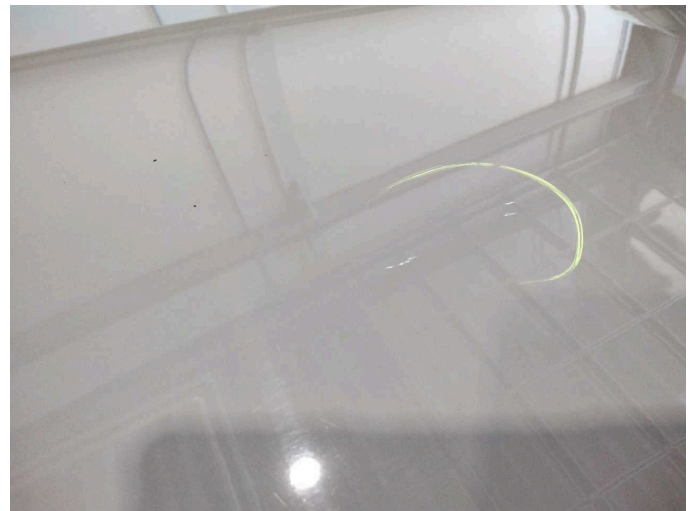
| No. | Component group | Description |
|---|---|---|
| 10 | Bonnet | Bonnet - Stone chips - Paint |

**Damage 10:** Bonnet: Bonnet - Stone chips - Paint

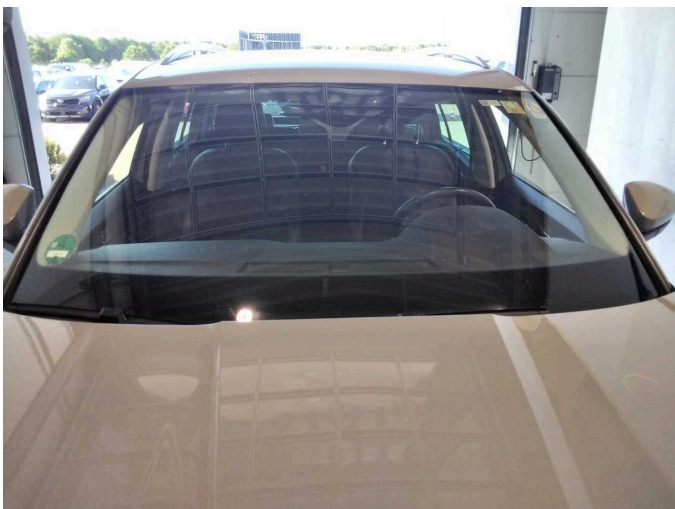
| No. | Component group | Description |
|---|---|---|
| 1 | Vehicle glazing | Windscreen - Stone chips - No deduction |

**Wear and tear 1:** Vehicle glazing: Windscreen - Stone chips - No deduction
