Expertise

Protocol number: 46516138  
Order No. / Reference: 26547066  
Inspection date: 9 Jul 2026

Manufacturer: Peugeot

Model: 208 Elektromotor 136 GT

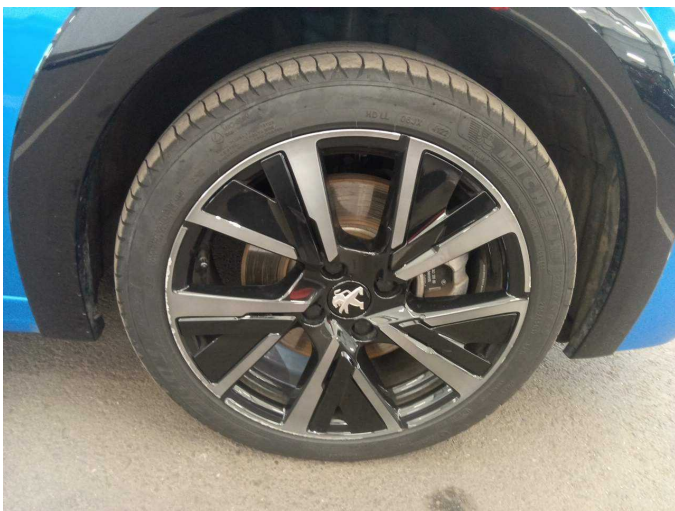
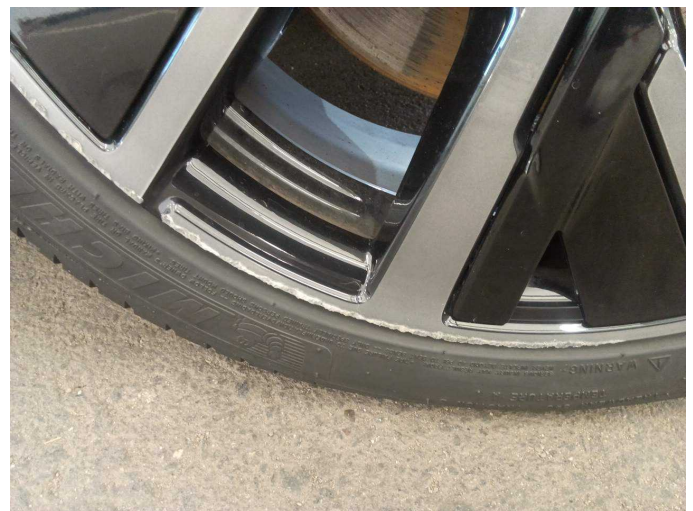
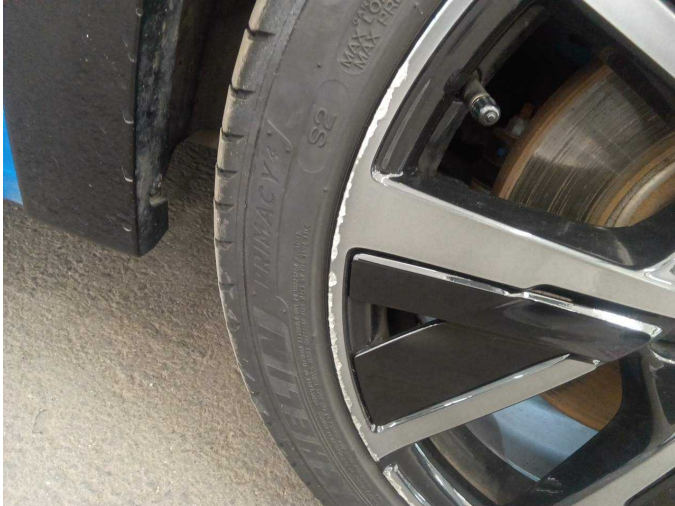
| No. | Component group | Description |
|---|---|---|
| 1 | Wheel / tyres | Alloy rim - front right side (Mit Materialabtrag inkl. Felgeneinsätze) - Scratch(es) - Replace |

**Damage 1:** Wheel / tyres: Alloy rim - front right side (Mit Materialabtrag inkl. Felgeneinsätze) - Scratch(es) - Replace

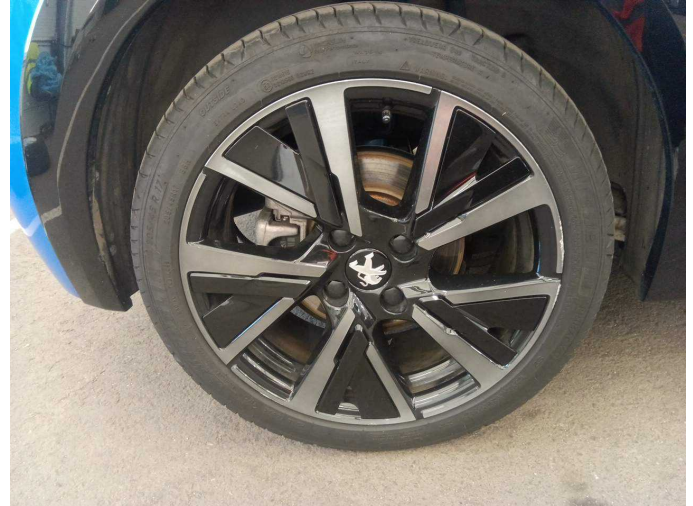
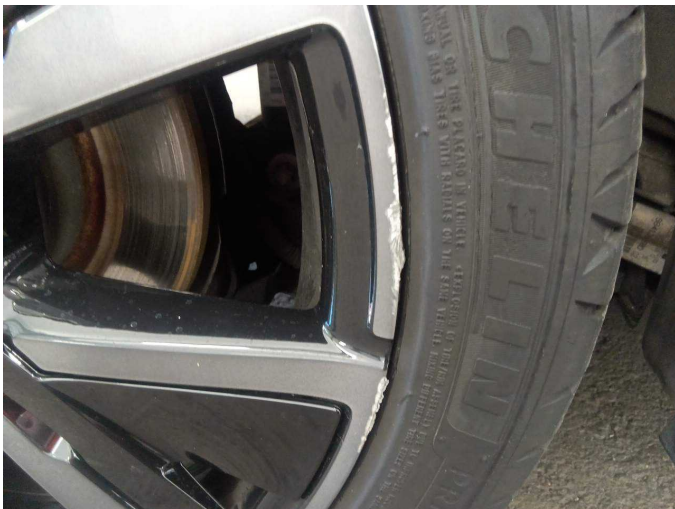
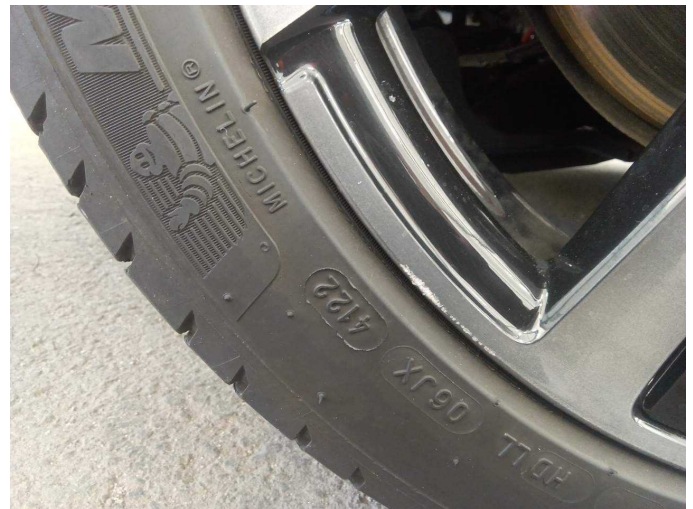
| No. | Component group | Description |
|---|---|---|
| 2 | Wheel / tyres | Alloy rim - rear right side (Mit Materialabtrag, ink. Felgeneinsätze) - Scratch(es) - Replace |

**Damage 2:** Wheel / tyres: Alloy rim - rear right side (Mit Materialabtrag, inkl. Felgeneinsätze) - Scratch(es) - Replace

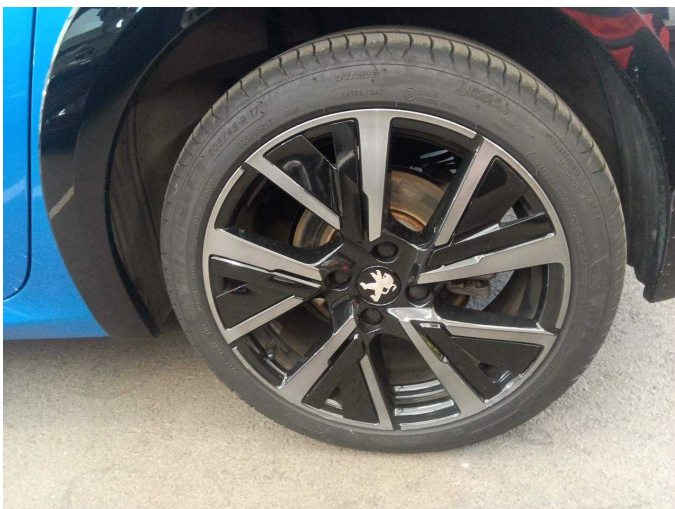
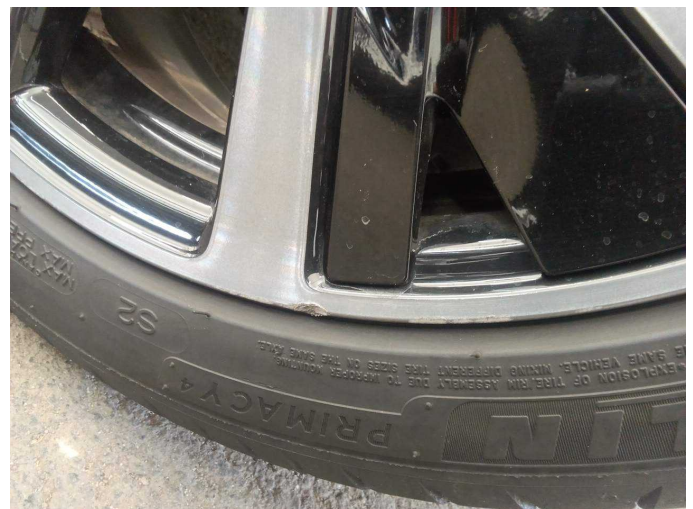
| No. | Component group | Description |
|---|---|---|
| 3 | Wheel / tyres | Alloy rim - rear left side - Scratch(es) - Replace |

**Damage 3:** Wheel / tyres: Alloy rim - rear left side - Scratch(es) - Replace

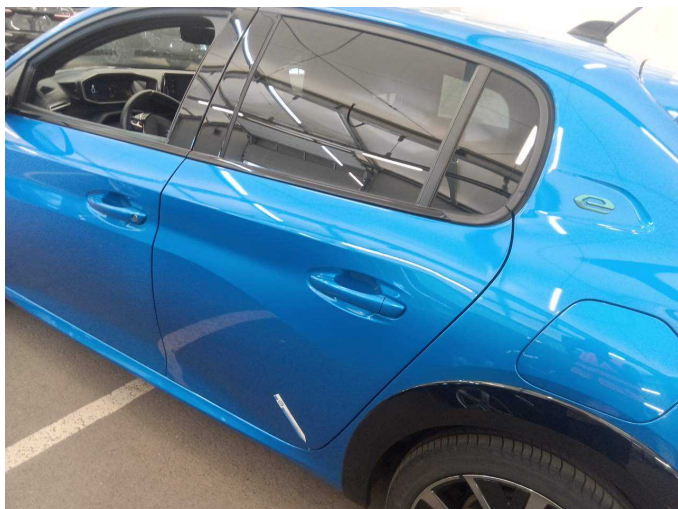
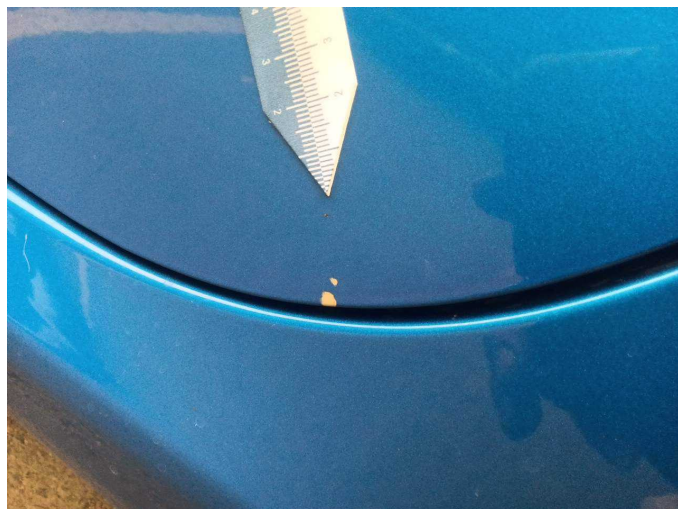
| No. | Component group | Description |
|---|---|---|
| 4 | Door - rear left side | Door - Scratch(es) - Paint |

**Damage 4:** Door - rear left side: Door - Scratch(es) - Paint

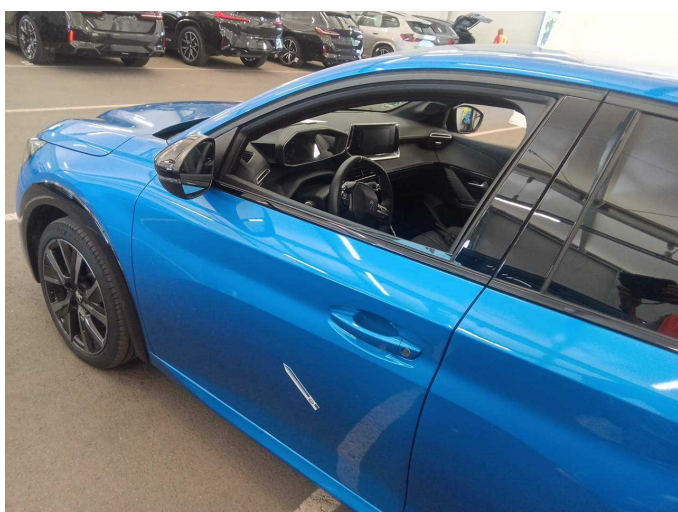
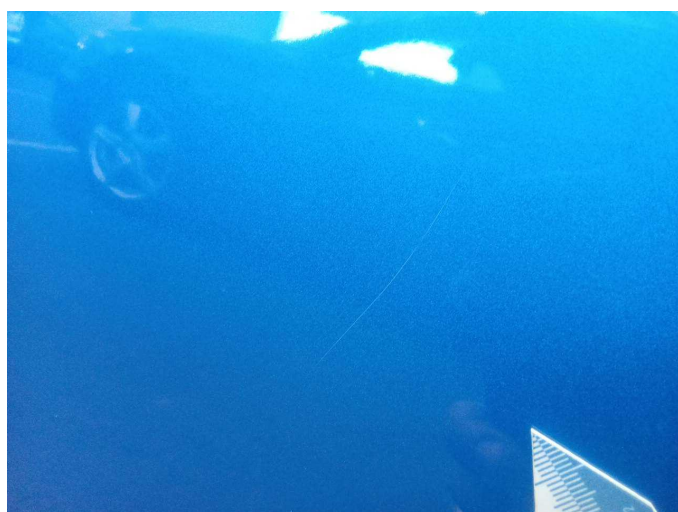
| No. | Component group | Description |
|---|---|---|
| 5 | Door - front left side | Door - Scratch(es) - Paint |

**Damage 5:** Door - front left side: Door - Scratch(es) - Paint

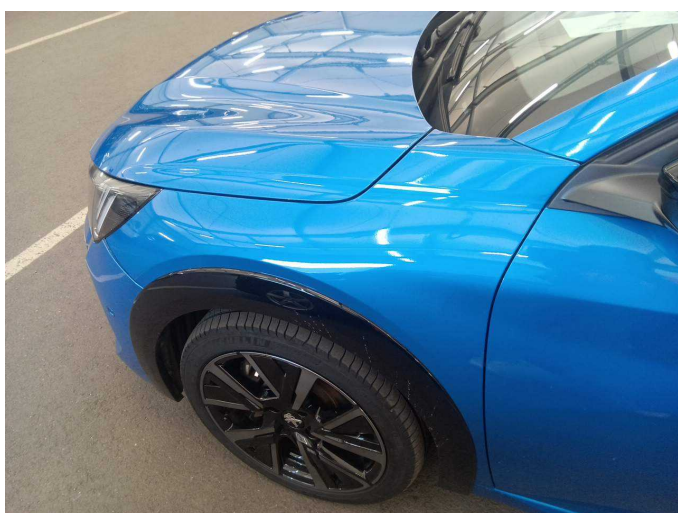
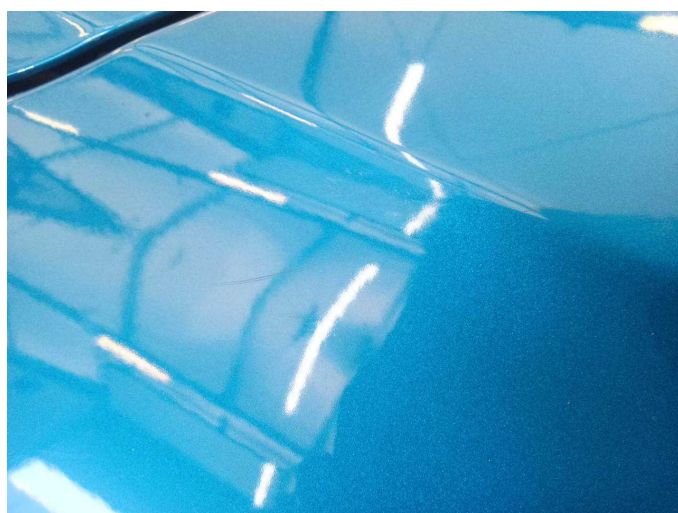
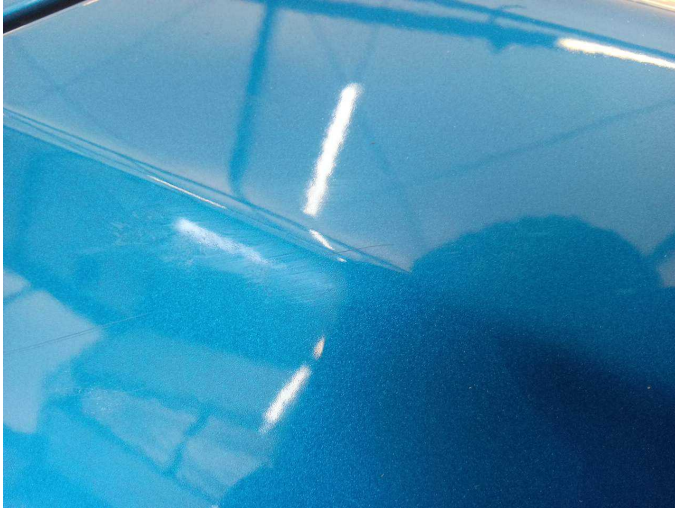
| No. | Component group | Description |
|---|---|---|
| 6 | Mudguard - left side | Mudguard - left side - Scratch(es) - Paint |

**Damage 6:** Mudguard - left side: Mudguard - left side - Scratch(es) - Paint

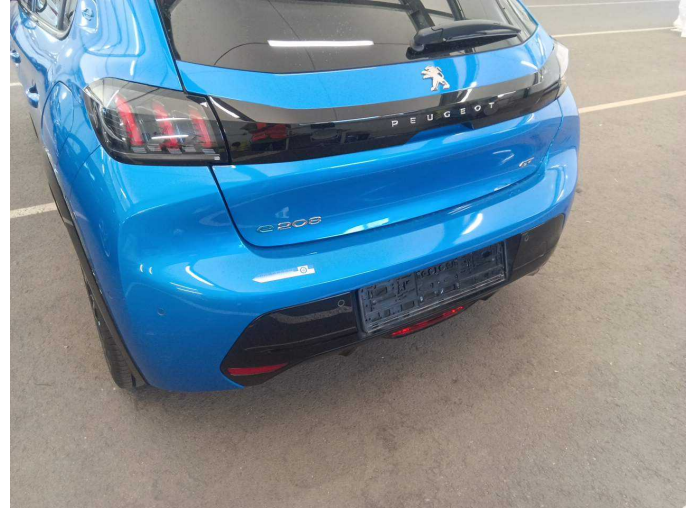
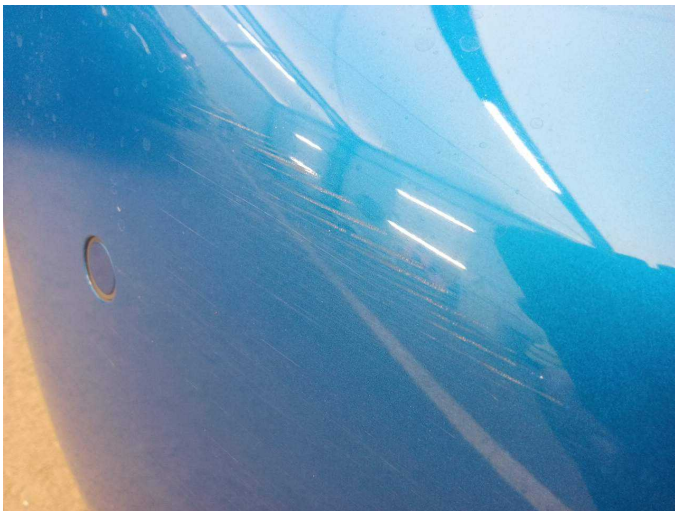
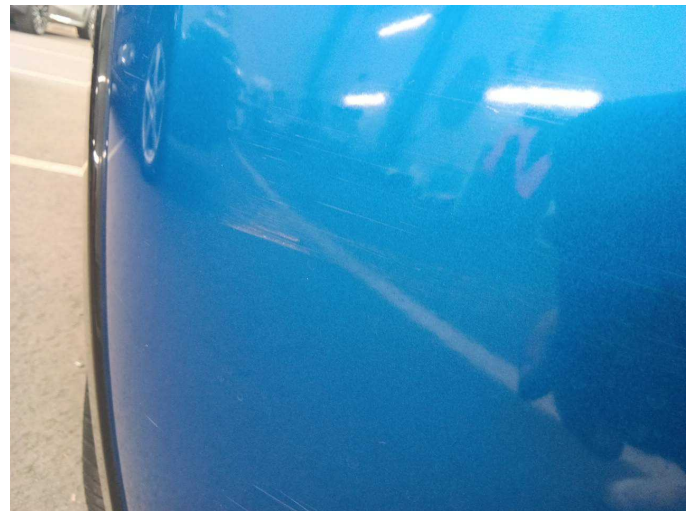
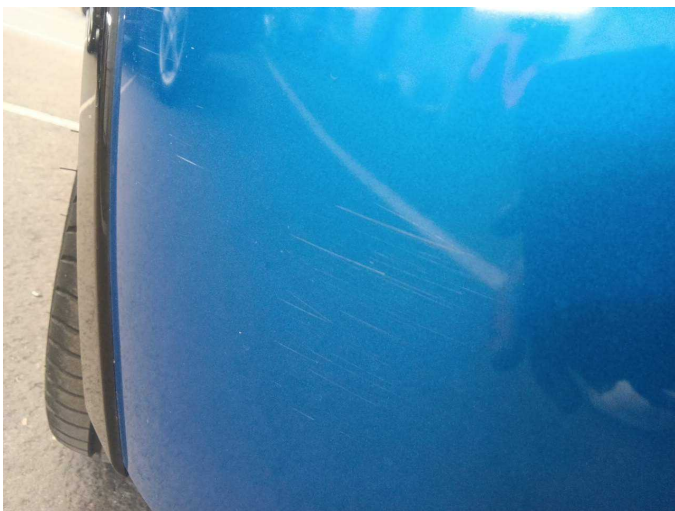
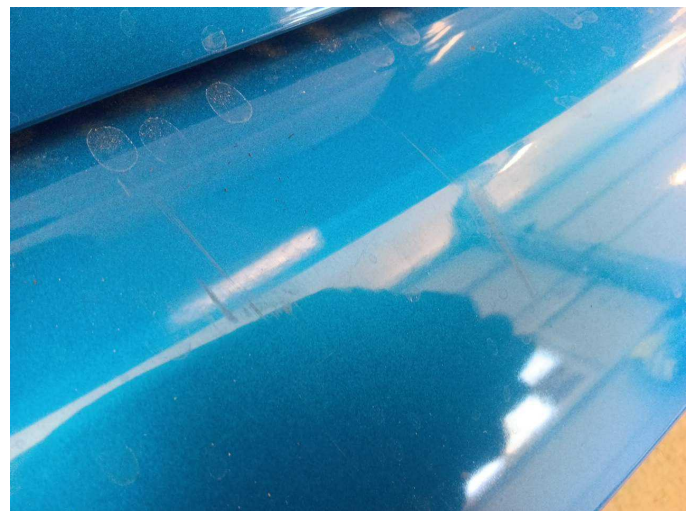
| No. | Component group | Description |
|---|---|---|
| 7 | Rear bumper | Rear bumper - Scratch(es) - Paint |

**Damage 7:** Rear bumper: Rear bumper - Scratch(es) - Paint
