## Expertise

Protocol number: 45790461  
Order No. / Reference: 26412629  
Inspection date: 29 May 2026

Manufacturer: Opel

Model: Mokka-e Elegance

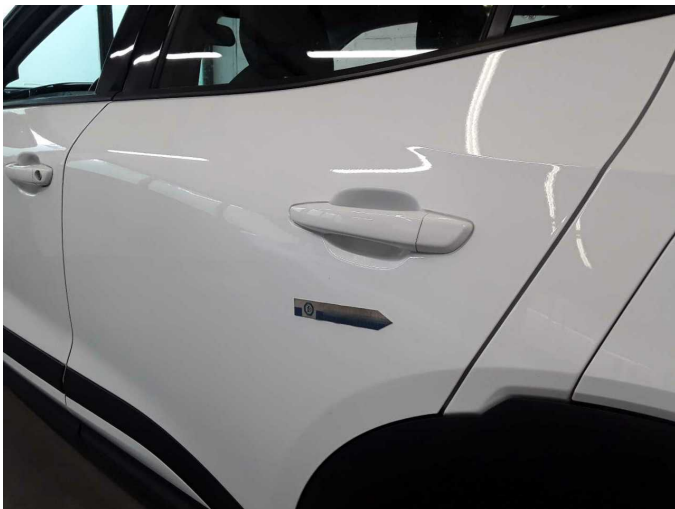
Damage 1: Door - rear left side: Door - dent(s) - Smooth repair work

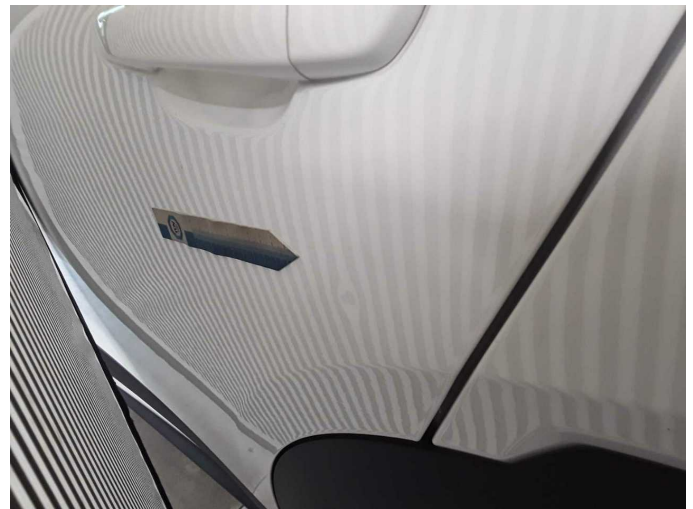
Damage 1: Door - rear left side: Door - dent(s) - Smooth repair work

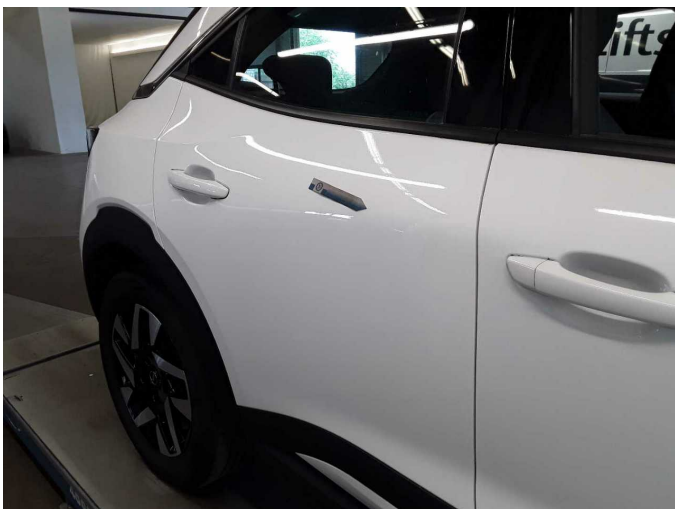
Damage 2: Door - rear right side: Door - dent(s) - Smooth repair work

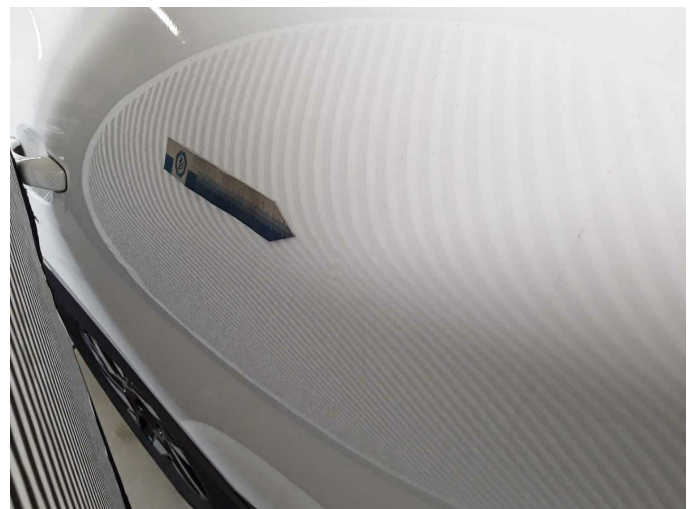
Damage 2: Door - rear right side: Door - dent(s) - Smooth repair work

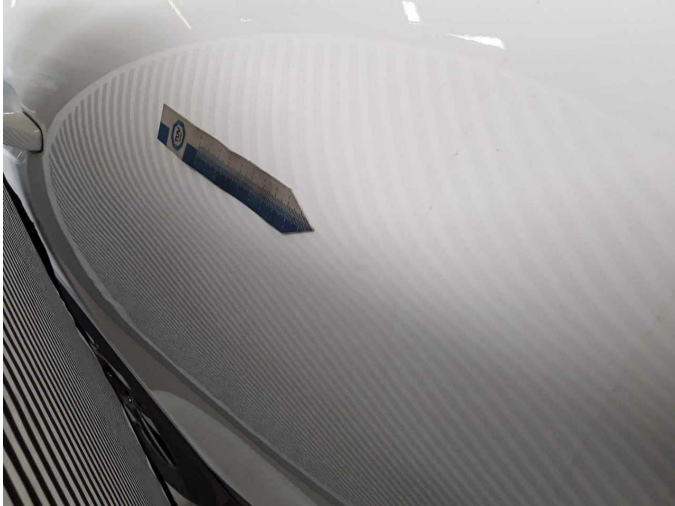
**Damage 2:** Door - rear right side: Door - dent(s) - Smooth repair work

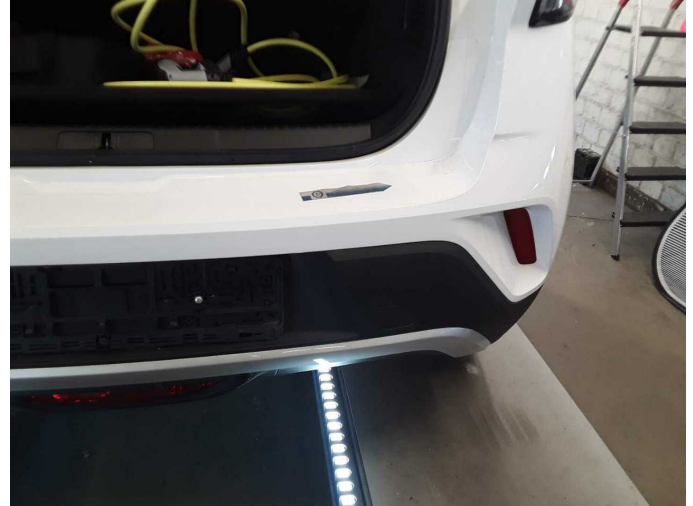
**Damage 3:** Rear bumper: Rear bumper - Scratch(es) - Smart repair

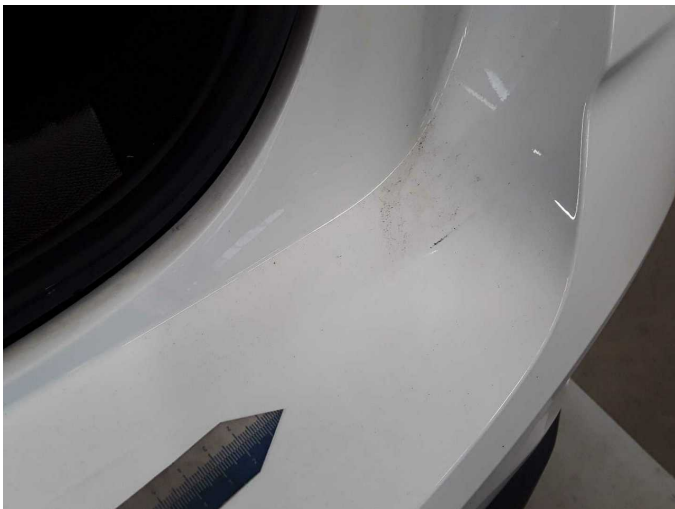
**Damage 3:** Rear bumper: Rear bumper - Scratch(es) - Smart repair

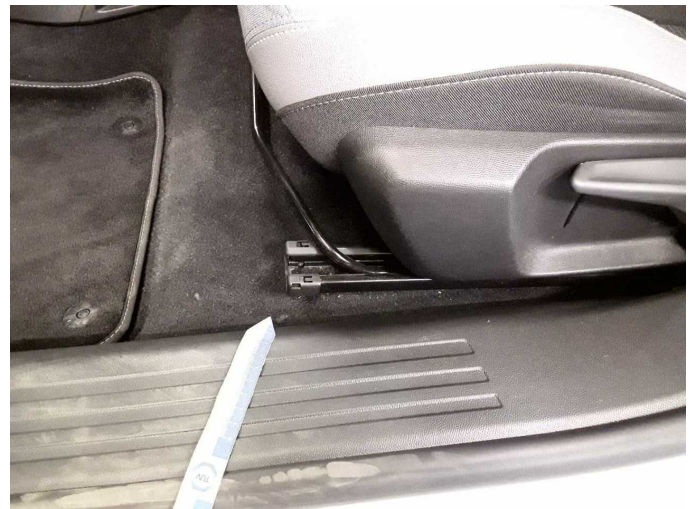
**Damage 4:** Trim / covers: Carpet - front left side - Burn hole (cigarettes) - Smart repair

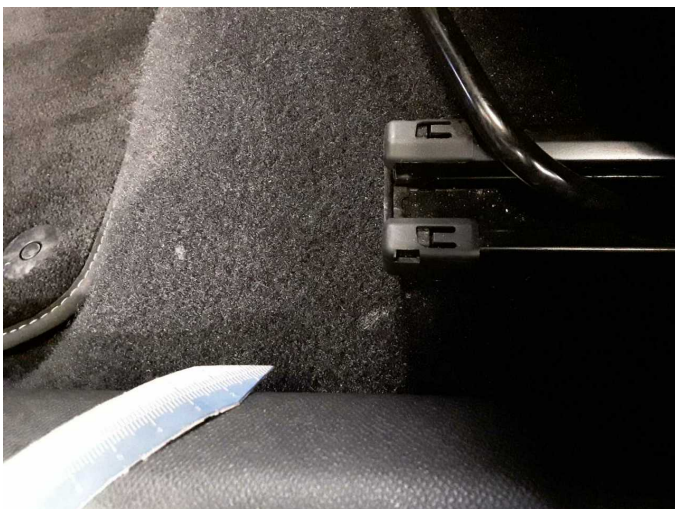
**Damage 4:** Trim / covers: Carpet - front left side - Burn hole (cigarettes) - Smart repair

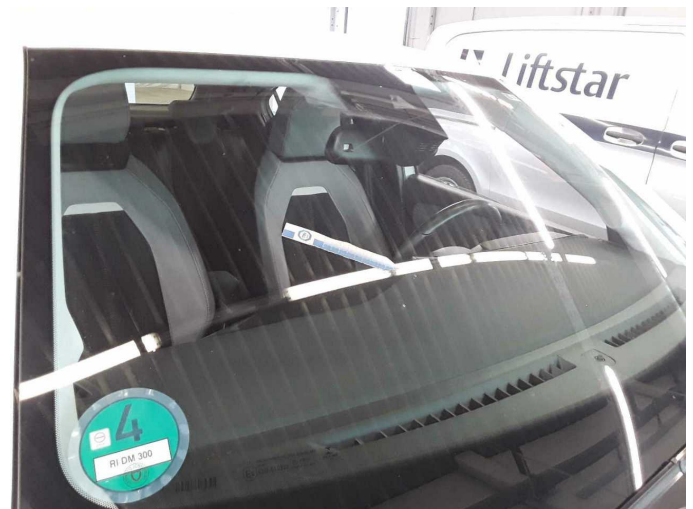
**Wear and tear 1:** Vehicle glazing: Windscreen - Stone chips - No deduction

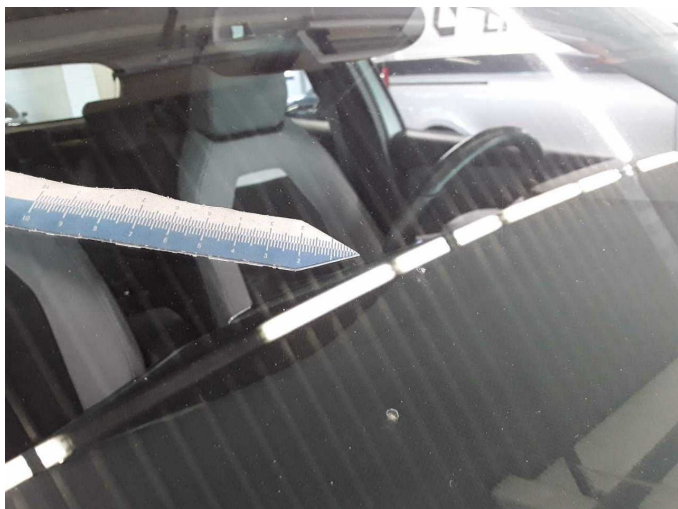
**Wear and tear 1:** Vehicle glazing: Windscreen - Stone chips - No deduction

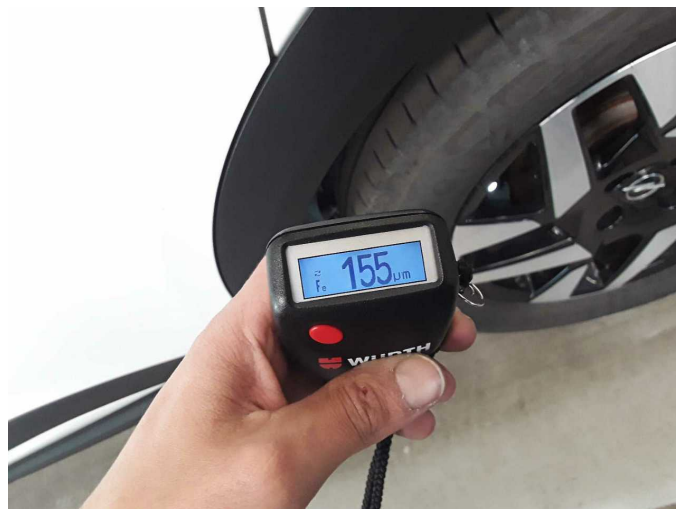
No.	Repainting
1	Side panel - rear left side, Professionally carried out, Invoice of repair done Non-existent

Side panel - rear left side	155 µm
-----------------------------	--------

**Repainting 1:** Side panel - rear left side

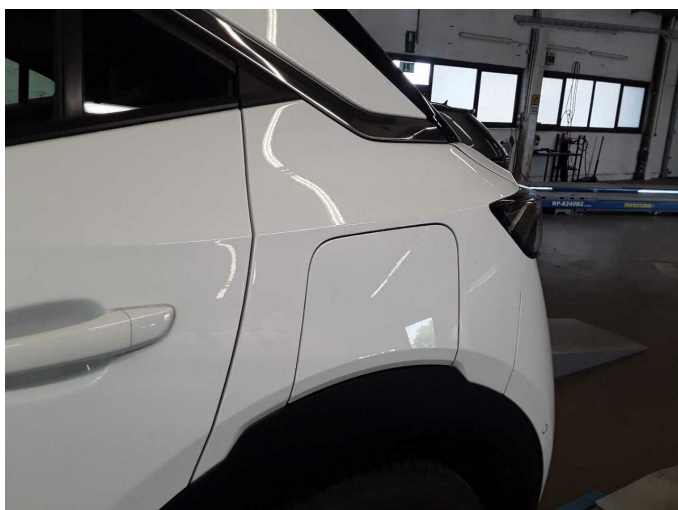
**Repainting 1:** Side panel - rear left side
