Protocol number: 45779104
Order No. / Reference: 26472021
Inspection date: 3 Jun 2026

Manufacturer: Peugeot

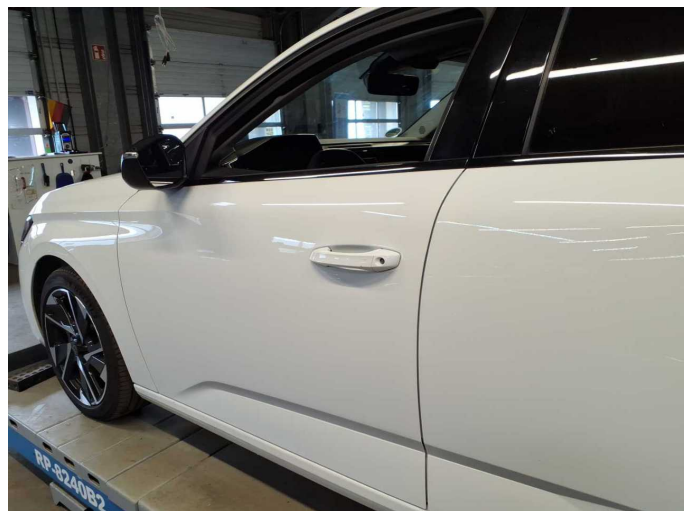
Damage 2: Door - front left side: Door handle - outside - Scratch(es) - Smart repair

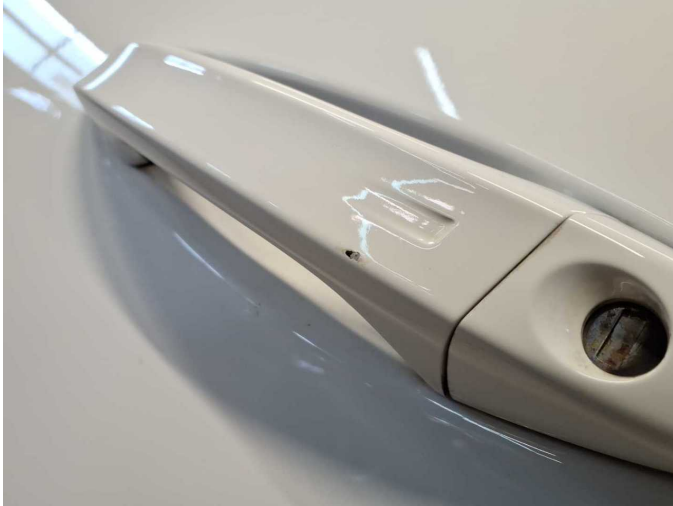
Damage 2: Door - front left side: Door handle - outside - Scratch(es) - Smart repair

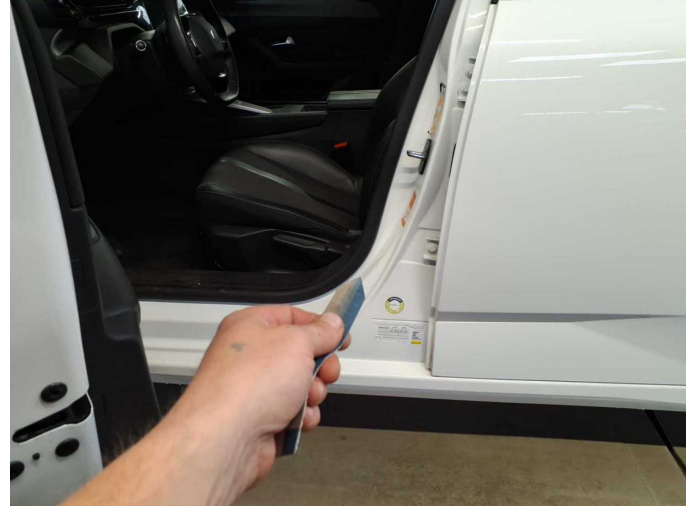
Damage 3: Body: B-pillar - left side - dent(s) - Smooth repair work

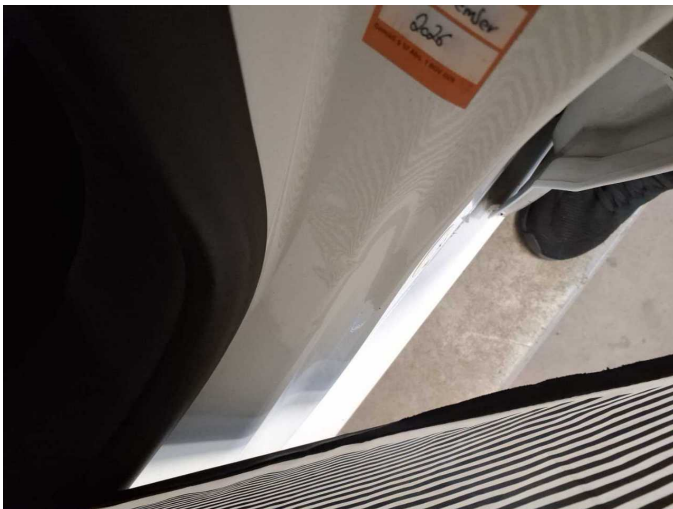
Damage 3: Body: B-pillar - left side - dent(s) - Smooth repair work

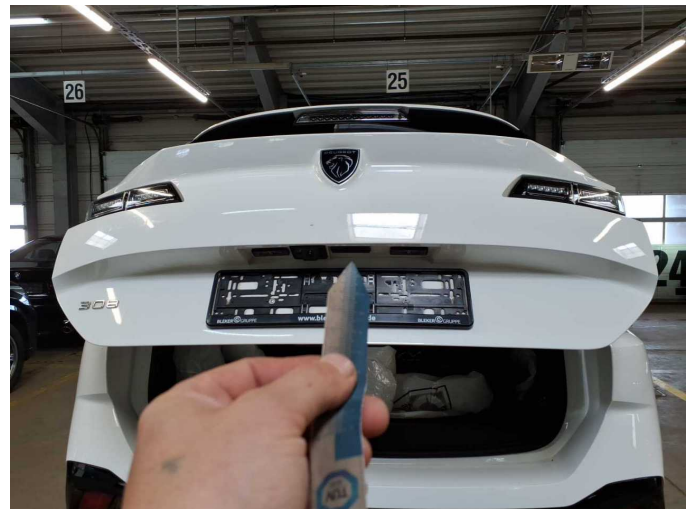
Damage 4: Boot lid / rear door: Boot lid (Betätigungsknopf) - Broken / torn - Replace

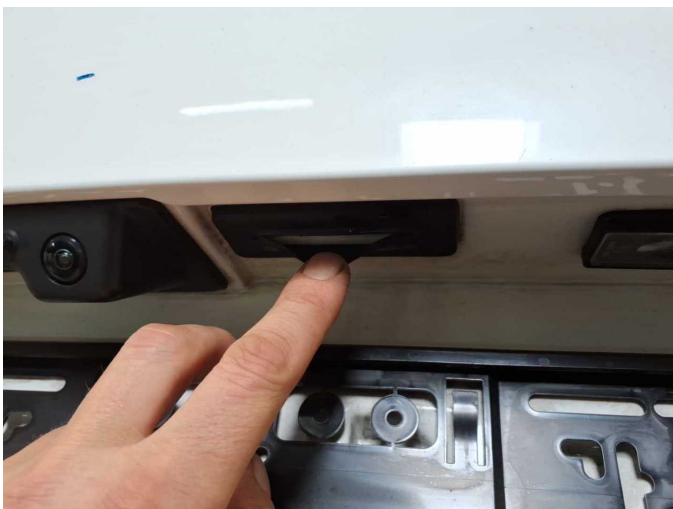
Damage 4: Boot lid / rear door: Boot lid (Betätigungsknopf) - Broken / torn - Replace

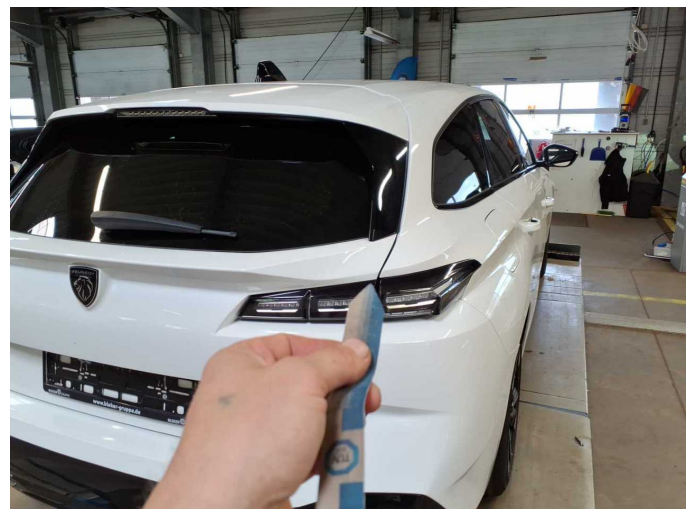
Damage 5: Boot lid / rear door: Boot lid - Malposition - Set / adjust

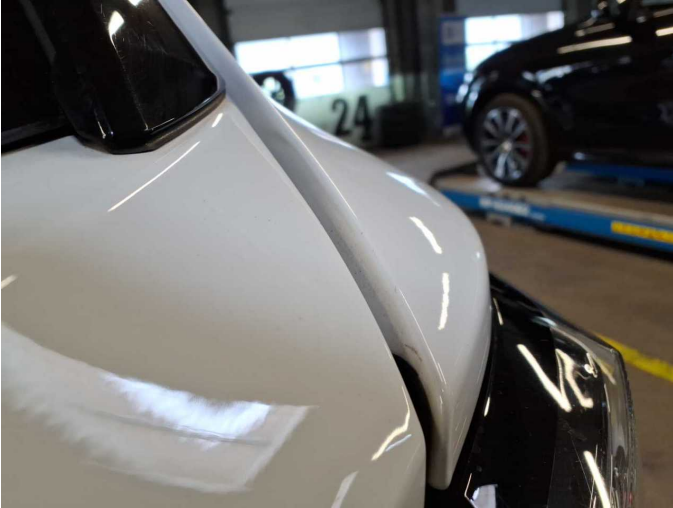
Damage 5: Boot lid / rear door: Boot lid - Malposition - Set / adjust

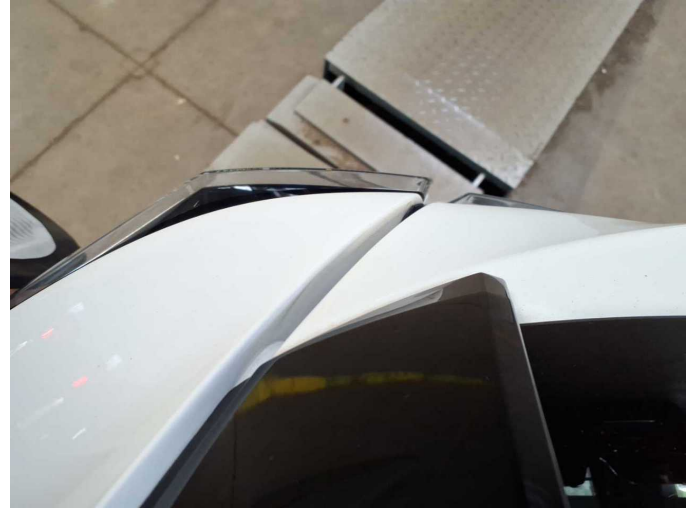
Damage 5: Boot lid / rear door: Boot lid - Malposition - Set / adjust

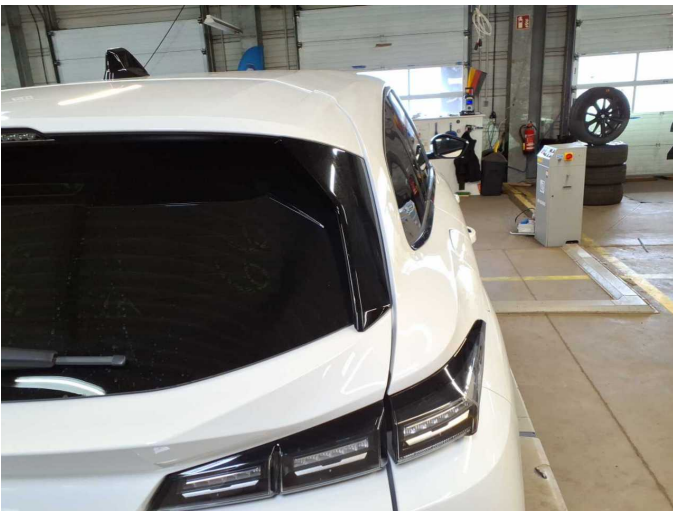
Damage 5: Boot lid / rear door: Boot lid - Malposition - Set / adjust

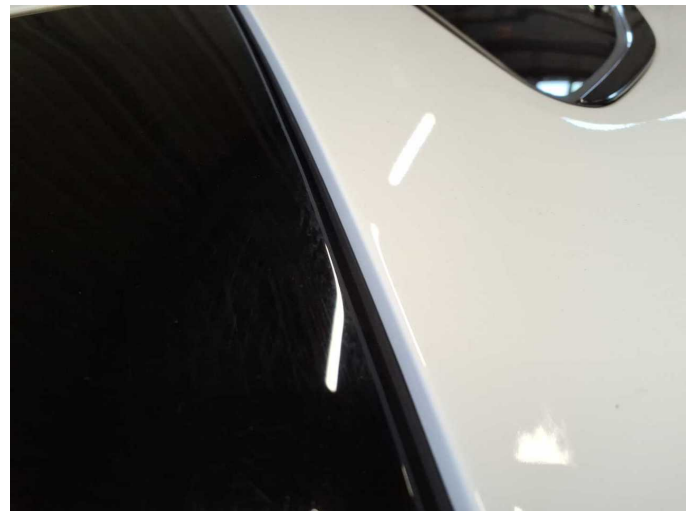
Damage 5: Boot lid / rear door: Boot lid - Malposition - Set / adjust

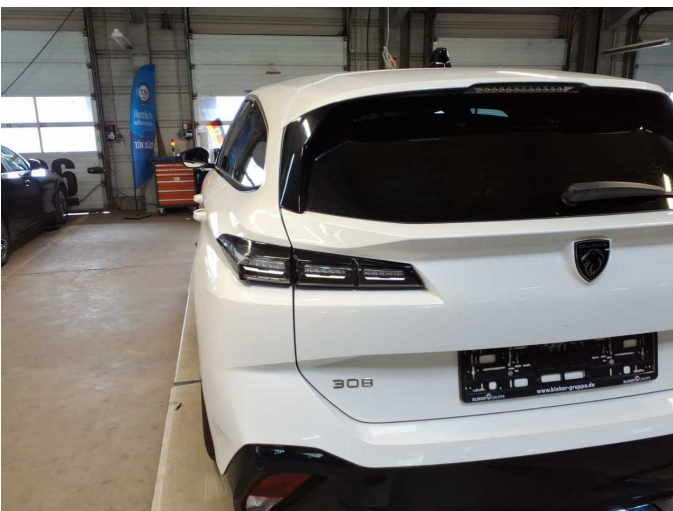
Damage 5: Boot lid / rear door: Boot lid - Malposition - Set / adjust

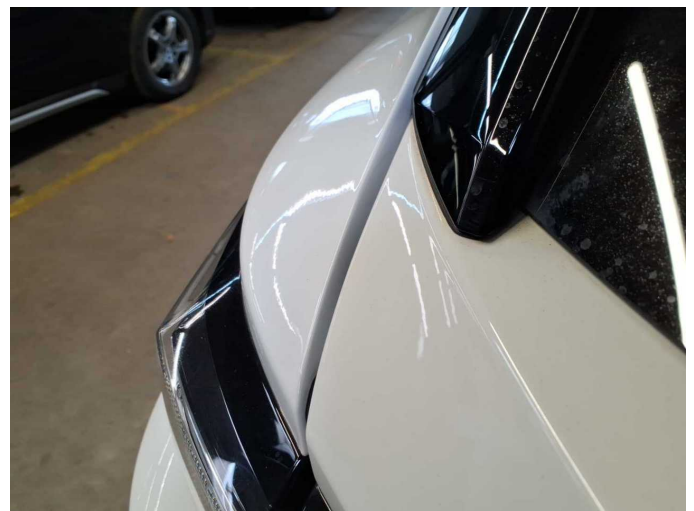
Damage 5: Boot lid / rear door: Boot lid - Malposition - Set / adjust

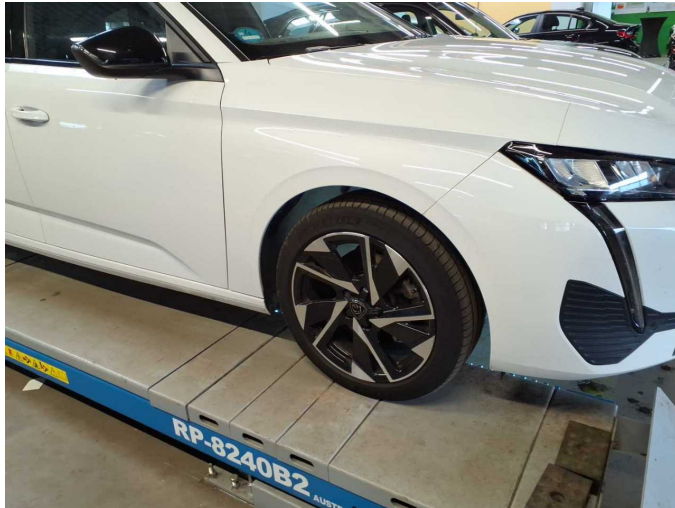
Damage 6: Wheel / tyres: Tyre - front right side (Flanke) - Damaged - Replace

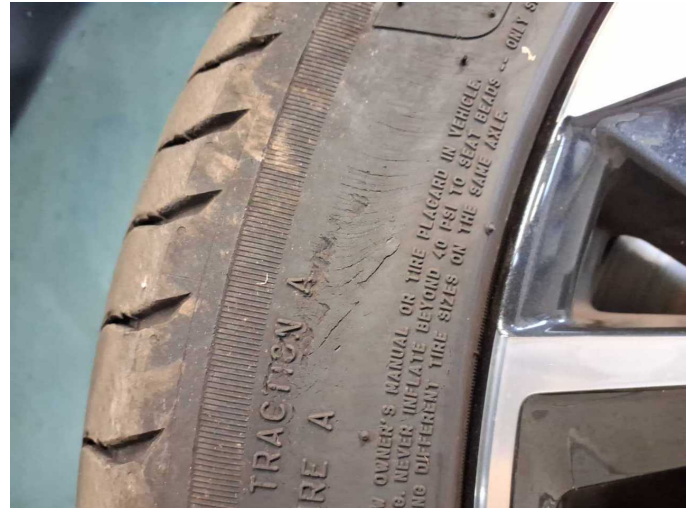
Damage 6: Wheel / tyres: Tyre - front right side (Flanke) - Damaged - Replace

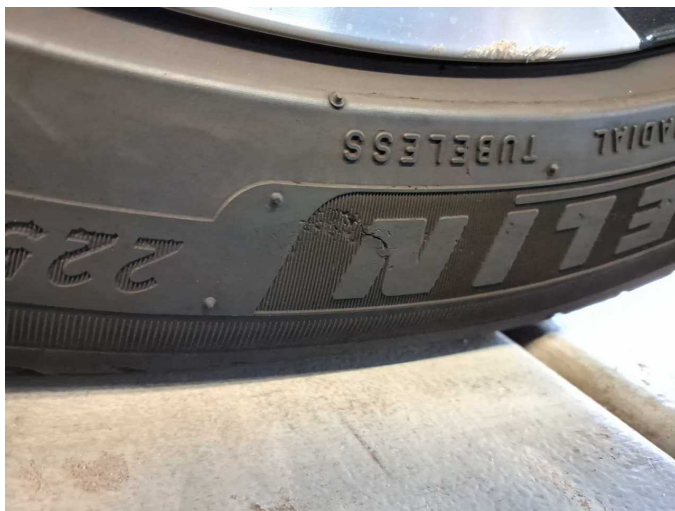
Damage 6: Wheel / tyres: Tyre - front right side (Flanke) - Damaged - Replace

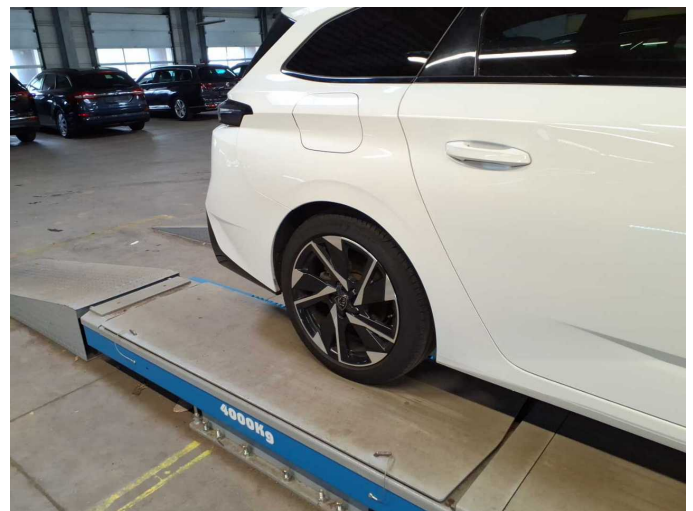
Damage 7: Wheel / tyres: Tyre - rear right side (Flanke) - Damaged - Replace

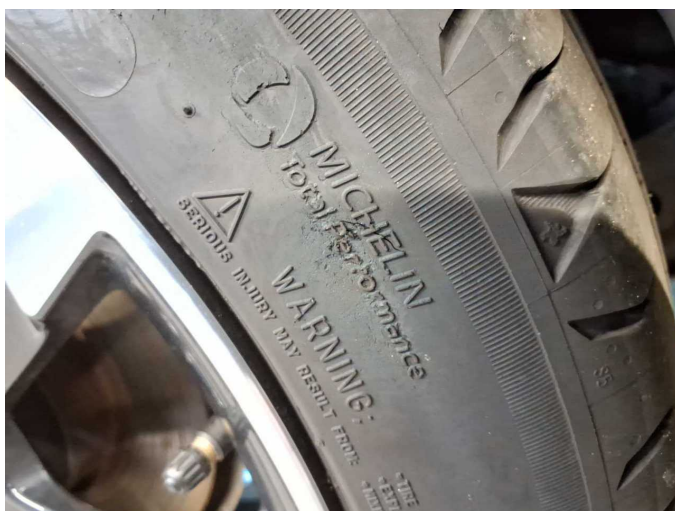
Damage 7: Wheel / tyres: Tyre - rear right side (Flanke) - Damaged - Replace

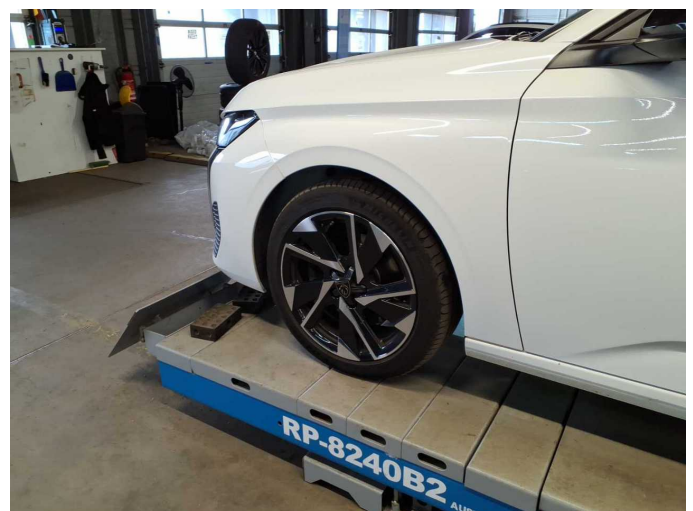
Damage 8: Wheel / tyres: Tyre - front left side (Flanke) - Damaged - Replace

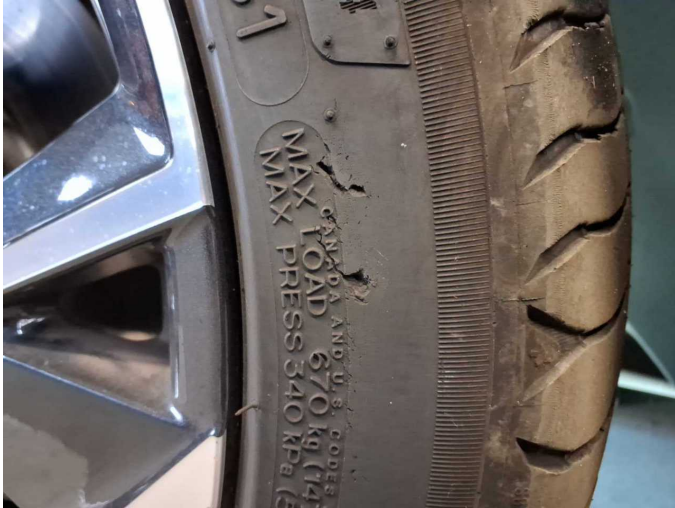
Damage 8: Wheel / tyres: Tyre - front left side (Flanke) - Damaged - Replace

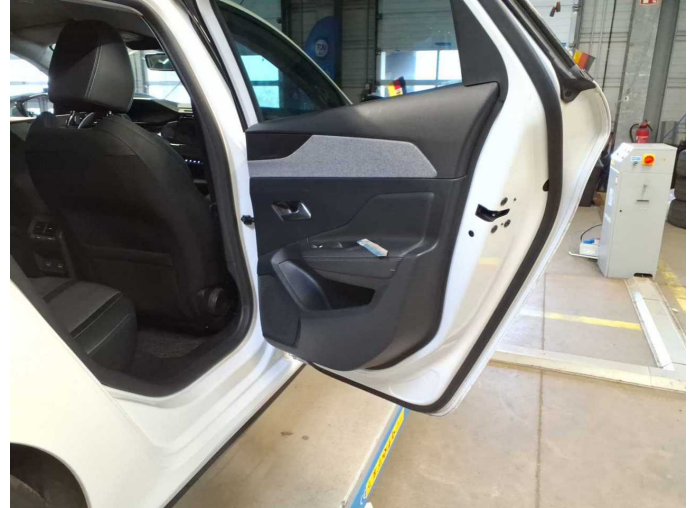
Damage 9: Trim / covers: Door trim - rear right side - Broken / torn - Smart repair

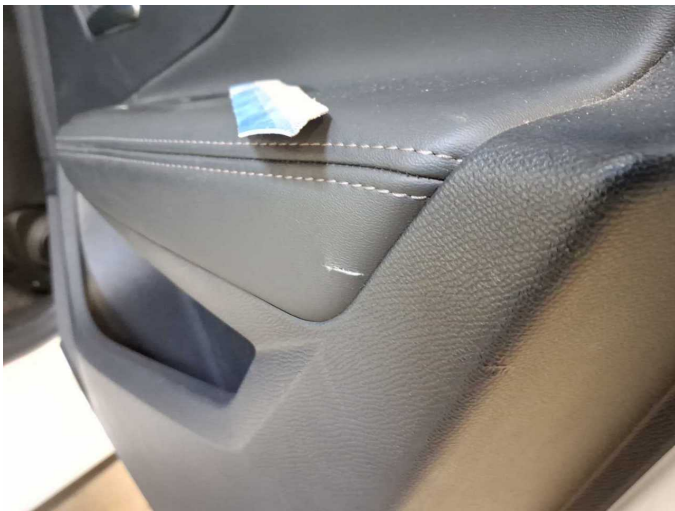
Damage 9: Trim / covers: Door trim - rear right side - Broken / torn - Smart repair

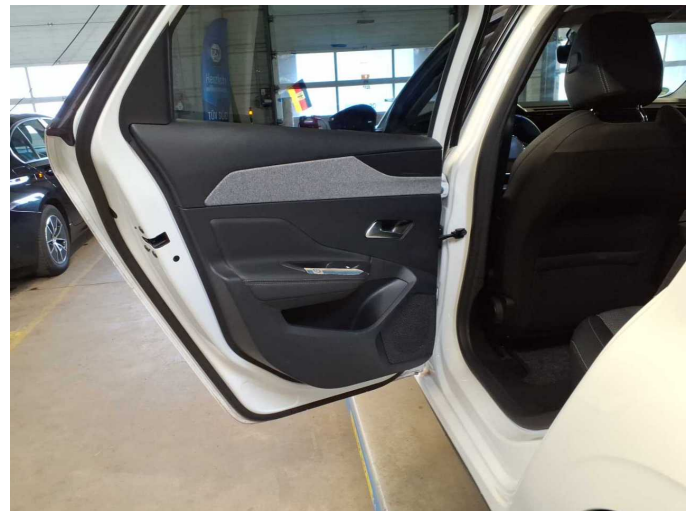
Damage 10: Trim / covers: Door trim - rear left side - Broken / torn - Smart repair

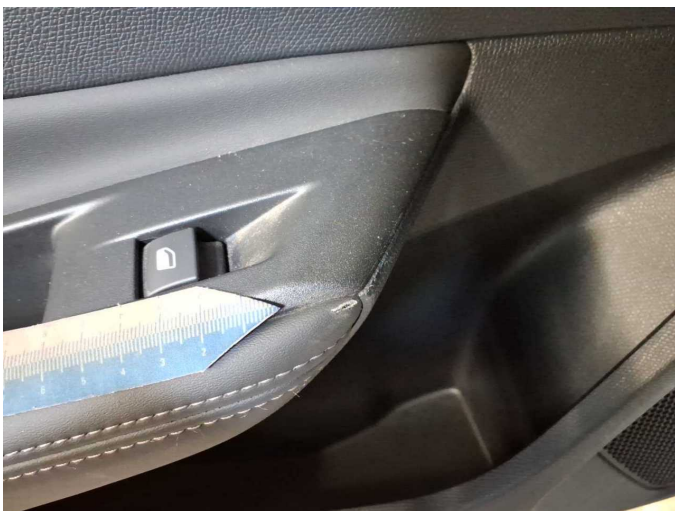
Damage 10: Trim / covers: Door trim - rear left side - Broken / torn - Smart repair

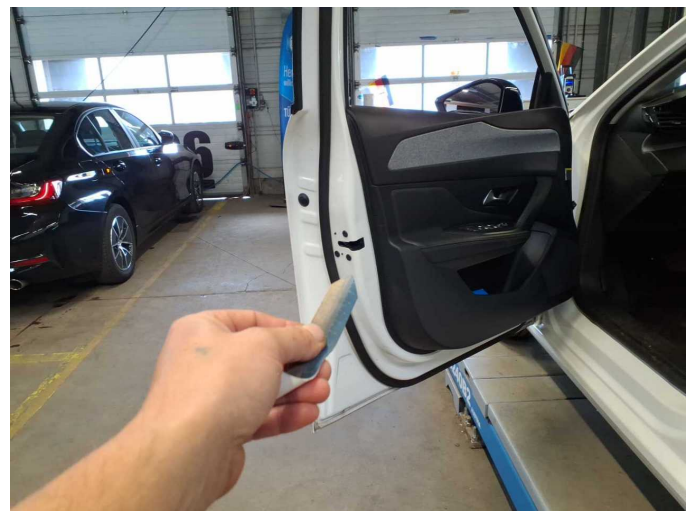
Damage 11: Door - front left side: Door (Innen) - dent(s) - Smooth repair work

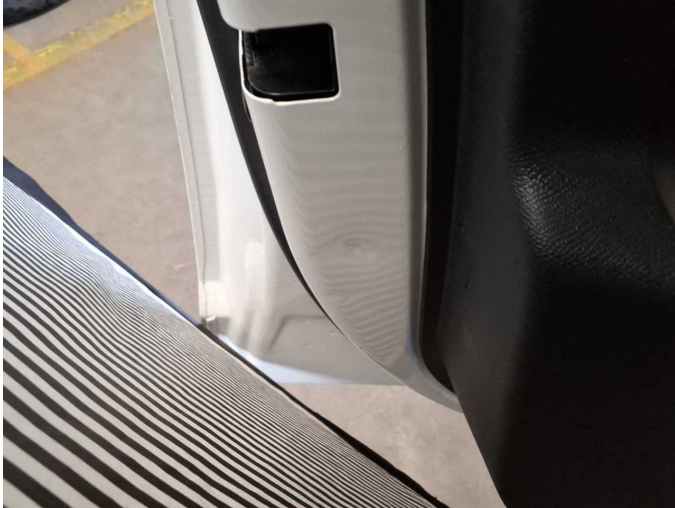
Damage 11: Door - front left side: Door (Innen) - dent(s) - Smooth repair work

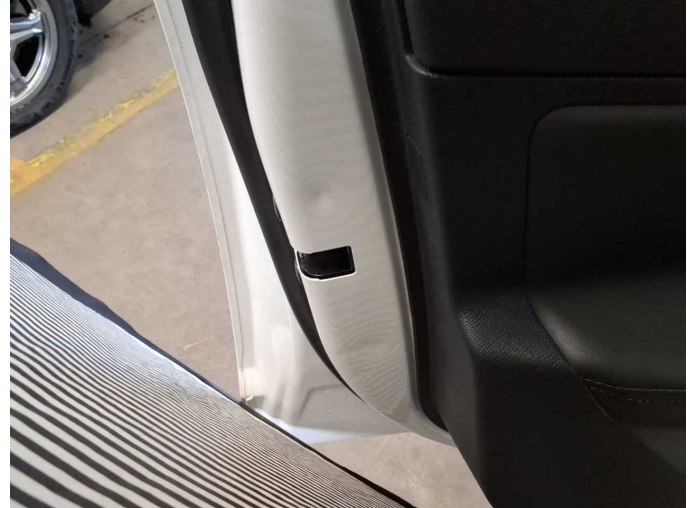
Damage 11: Door - front left side: Door (Innen) - dent(s) - Smooth repair work

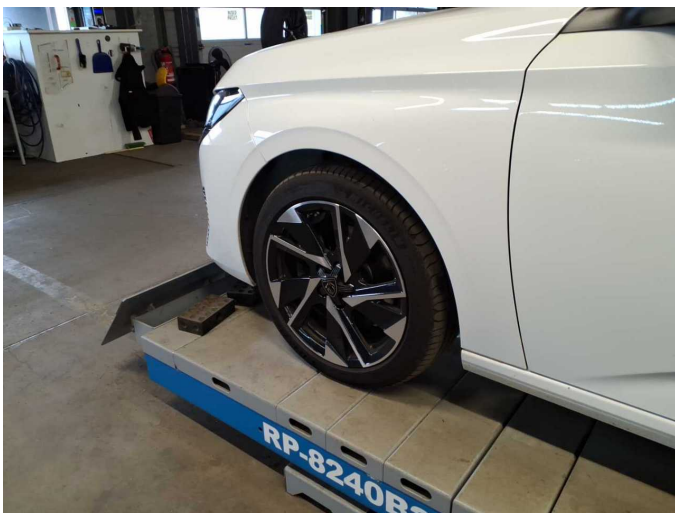
Damage 12: Wheel / tyres: Alloy rim - front left side - Scratch(es) - Loss in value

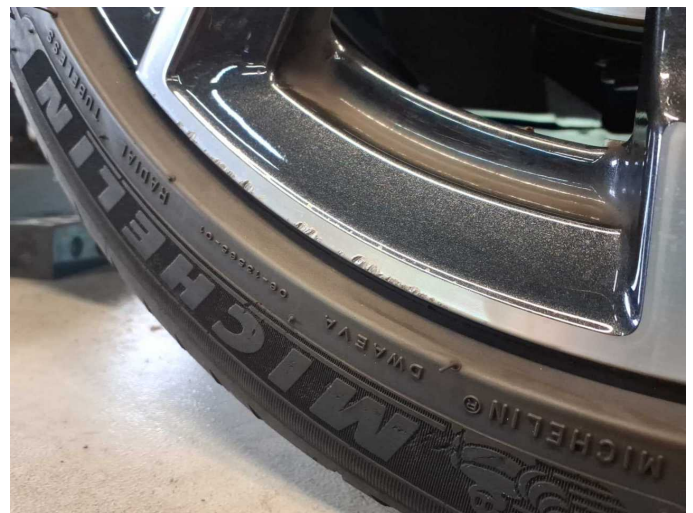
Damage 12: Wheel / tyres: Alloy rim - front left side - Scratch(es) - Loss in value

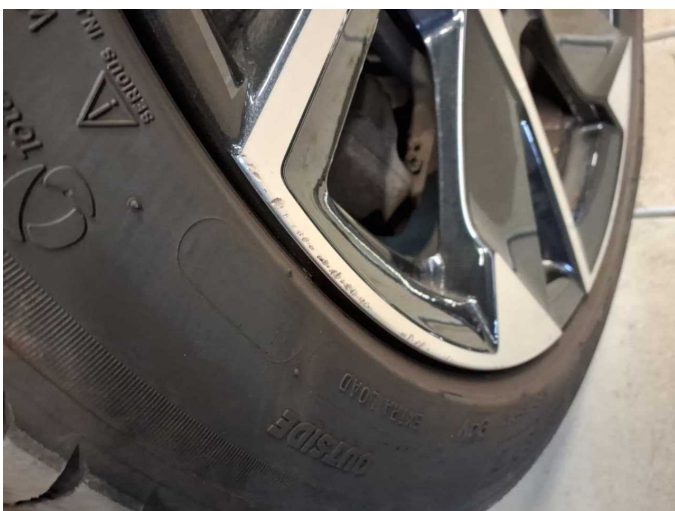
Damage 12: Wheel / tyres: Alloy rim - front left side - Scratch(es) - Loss in value

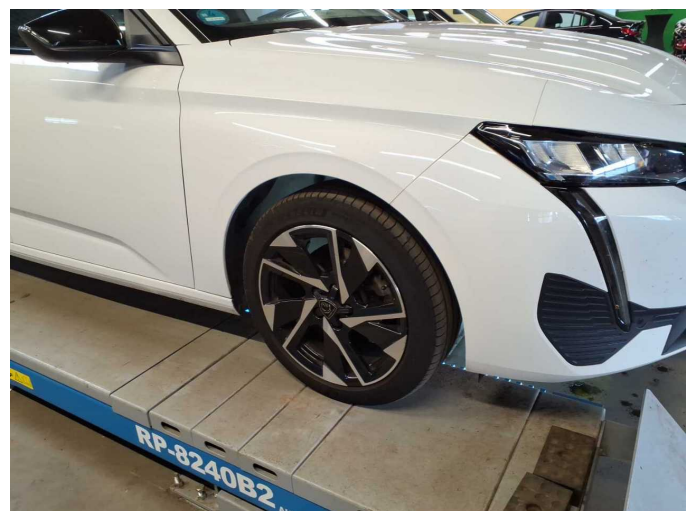
Damage 13: Wheel / tyres: Alloy rim - front right side - Scratch(es) - Loss in value

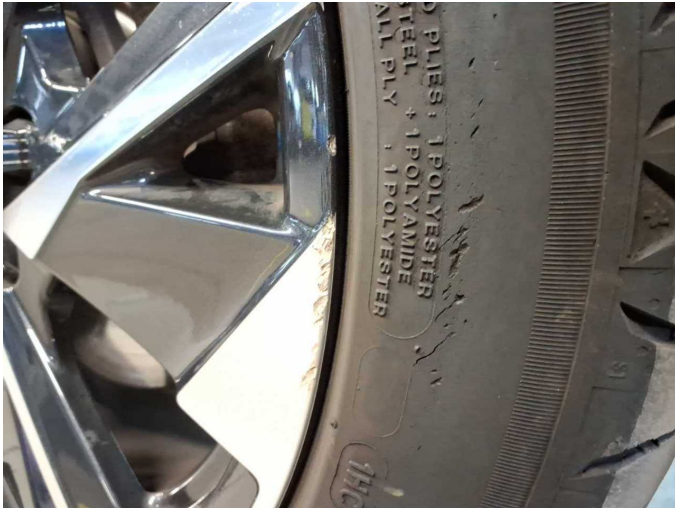
Damage 13: Wheel / tyres: Alloy rim - front right side - Scratch(es) - Loss in value

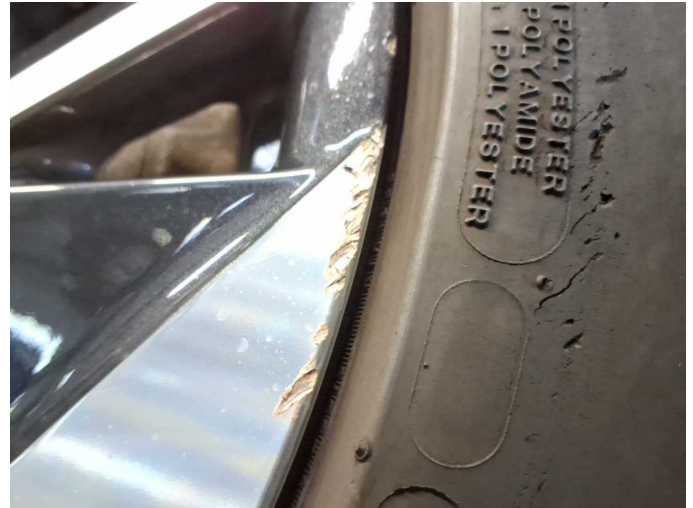
Damage 13: Wheel / tyres: Alloy rim - front right side - Scratch(es) - Loss in value

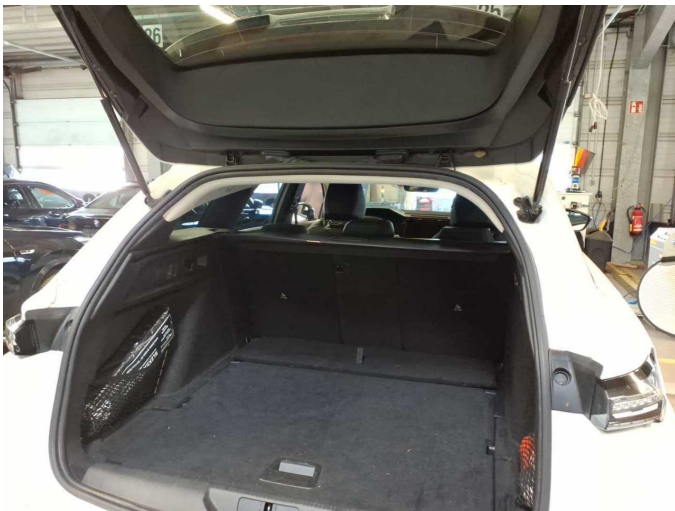
Damage 14: Interior: Boot cover / roller cover - Damaged - Replace

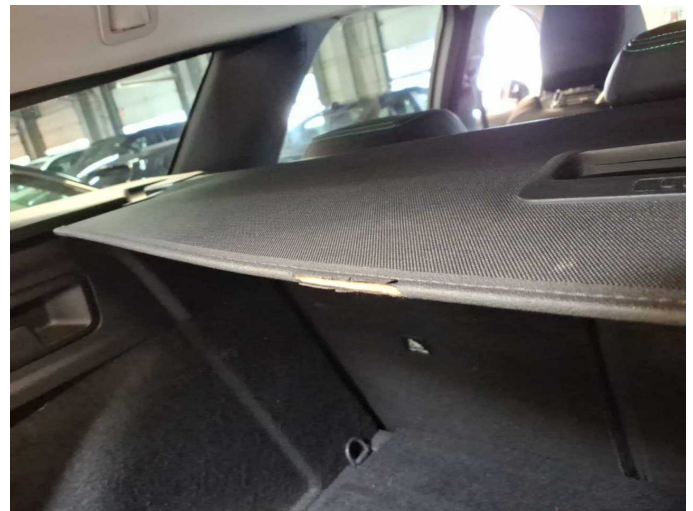
Damage 14: Interior: Boot cover / roller cover - Damaged - Replace

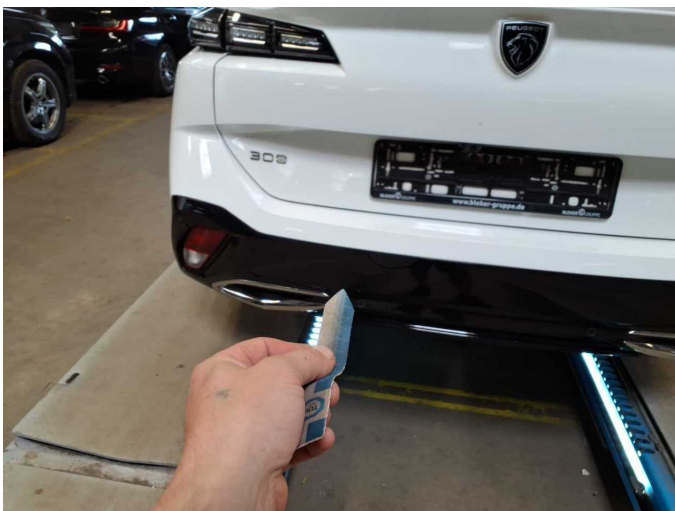
Damage 15: Rear bumper: Spoiler - Scratched - Replace

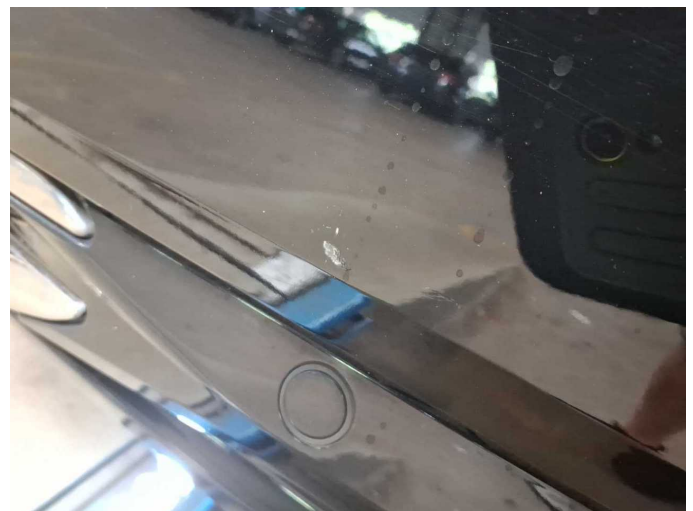
Damage 15: Rear bumper: Spoiler - Scratched - Replace

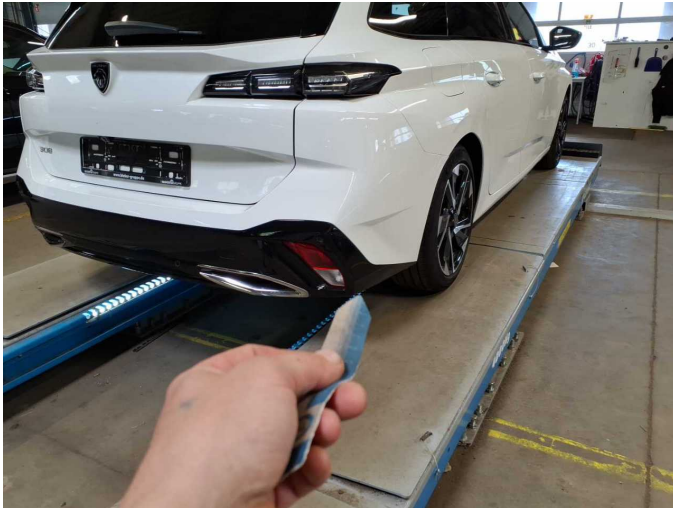
Damage 15: Rear bumper: Spoiler - Scratched - Replace

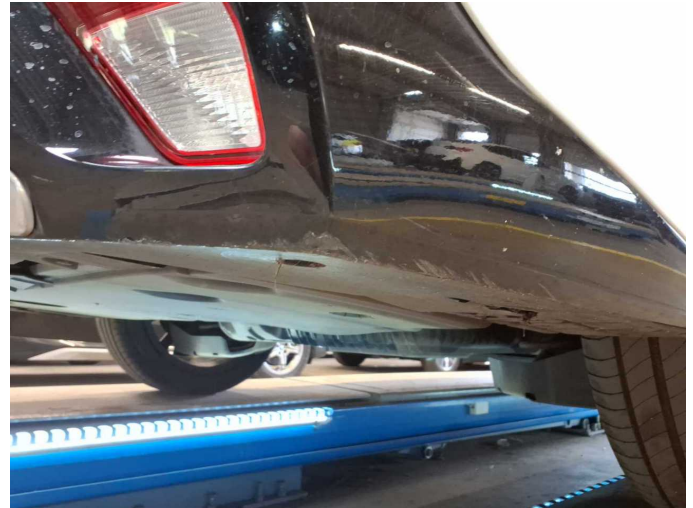
Damage 15: Rear bumper: Spoiler - Scratched - Replace

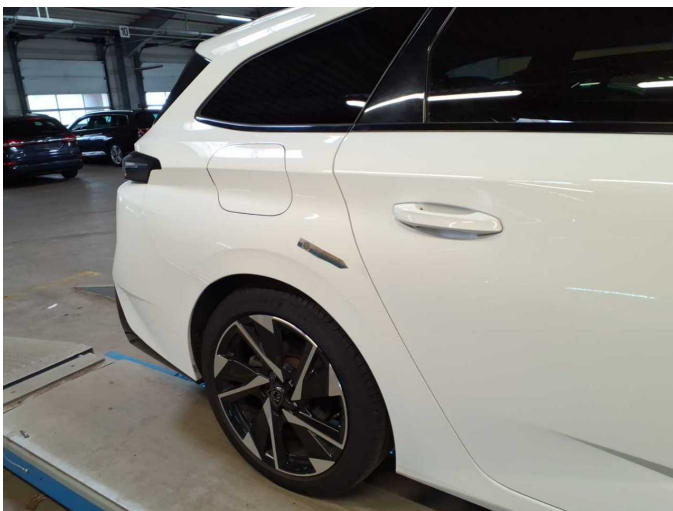
Damage 16: Side panel - rear right side: Side panel - Dent / paintcoat damage - Repair and paint

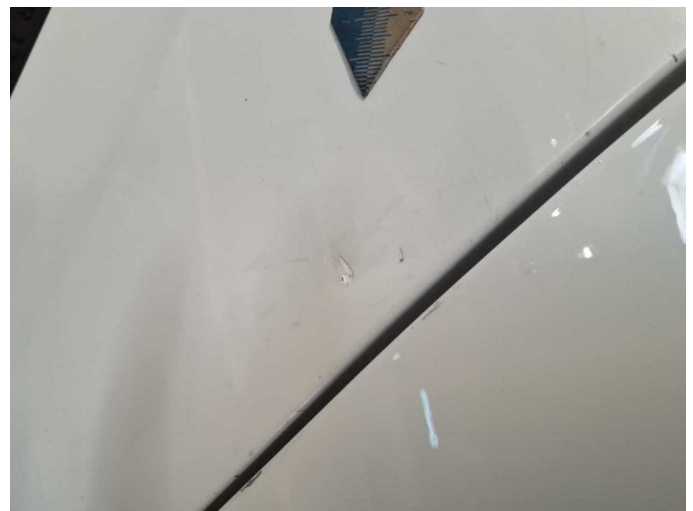
Damage 16: Side panel - rear right side: Side panel - Dent / paintcoat damage - Repair and paint

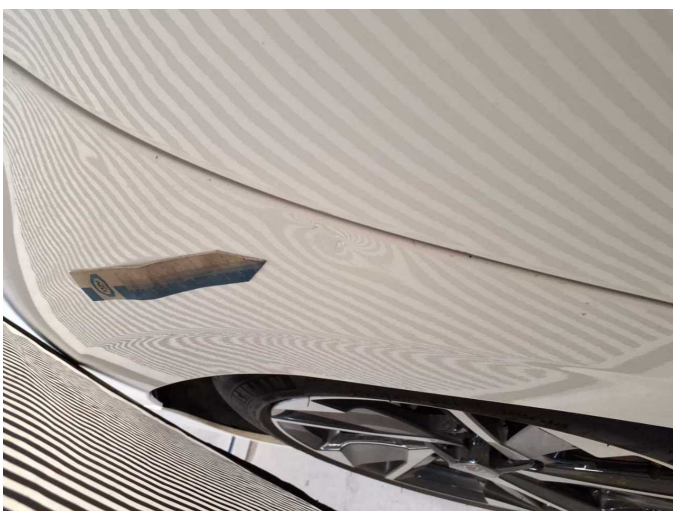
Damage 16: Side panel - rear right side: Side panel - Dent / paintcoat damage - Repair and paint

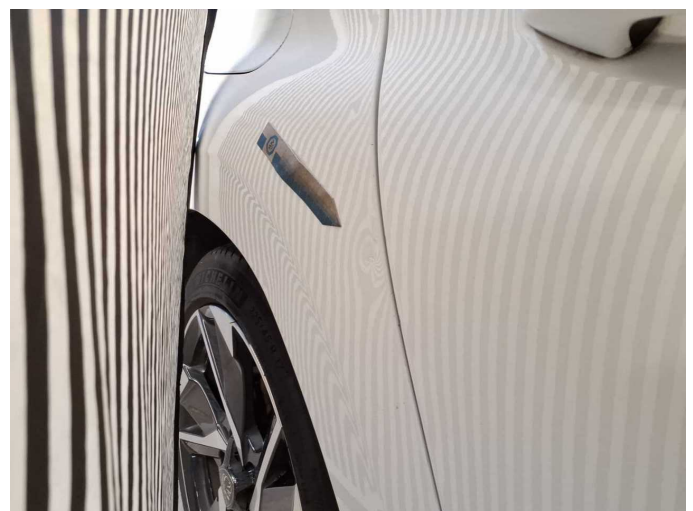
Damage 16: Side panel - rear right side: Side panel - Dent / paintcoat damage - Repair and paint

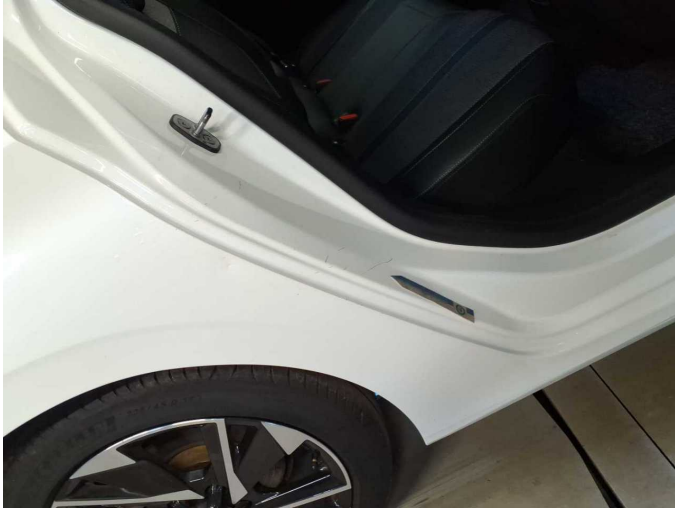
Damage 16: Side panel - rear right side: Side panel - Dent / paintcoat damage - Repair and paint

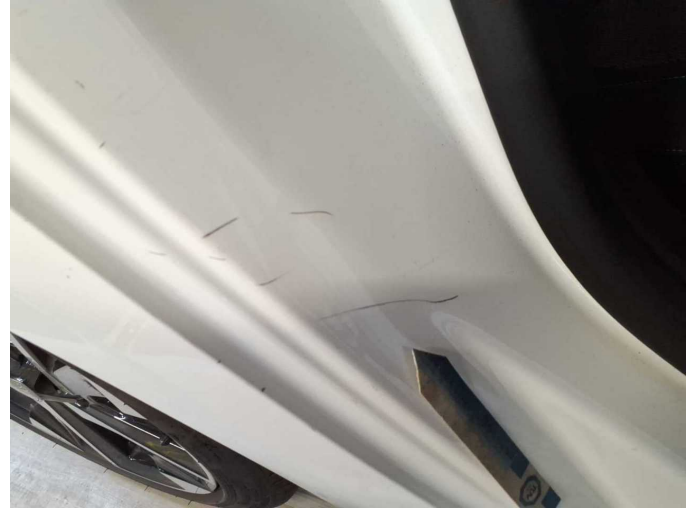
Damage 16: Side panel - rear right side: Side panel - Dent / paintcoat damage - Repair and paint

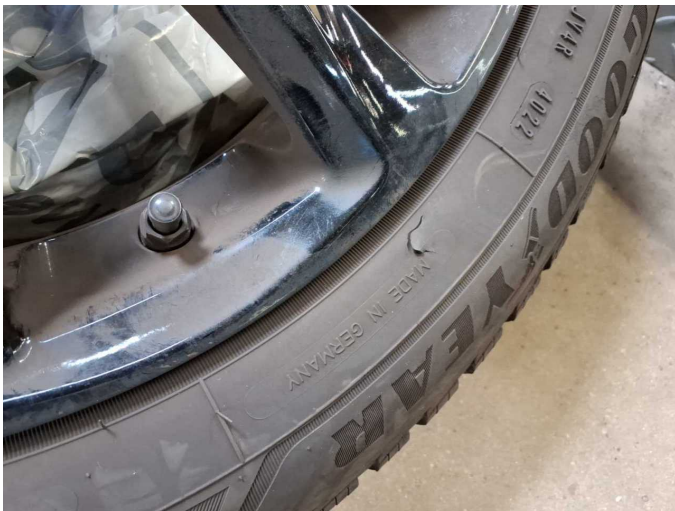
Wear and tear 3: 2nd wheel set: 1 tyre - Damaged - No deduction

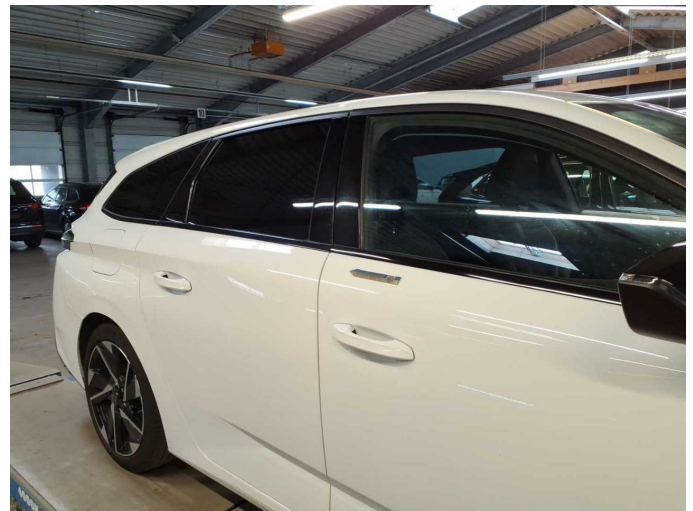
Wear and tear 5: Door - front right side: Door - dent(s) - No deduction

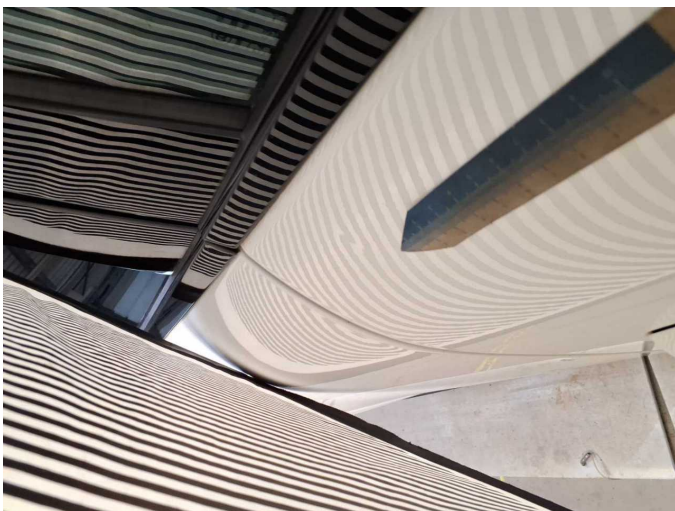
Wear and tear 5: Door - front right side: Door - dent(s) - No deduction
