## Expertise

Protocol number: 46344900  
Order No. / Reference: 26472716  
Inspection date: 6 Jul 2026

Manufacturer: Peugeot

Model: 508 SW Plug-In Hybrid 225 e-EAT8 GT

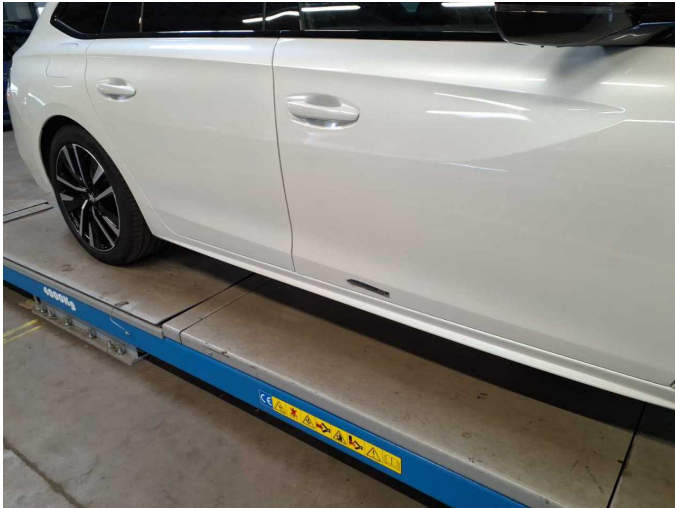
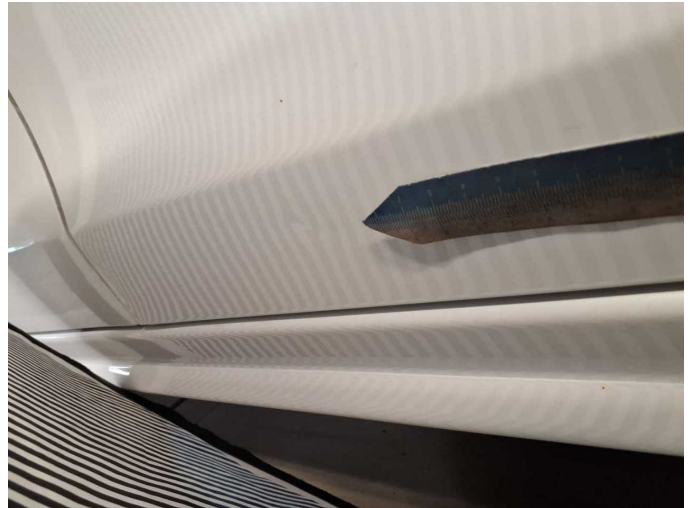
**Damage 2:** Door - front right side: Door - dent(s) - Smooth repair work

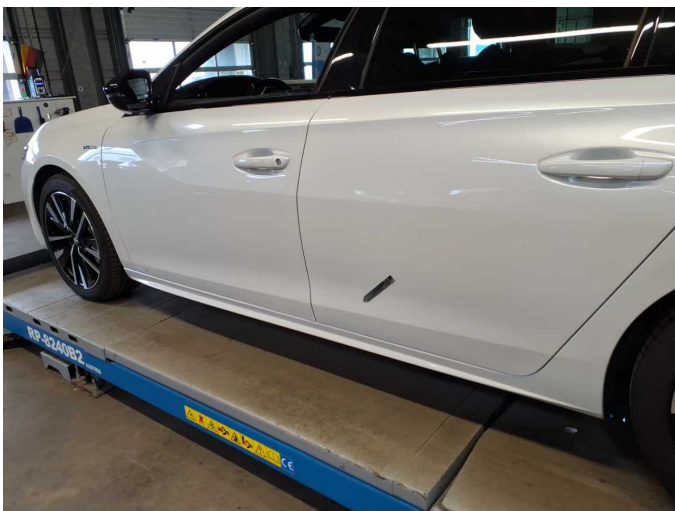
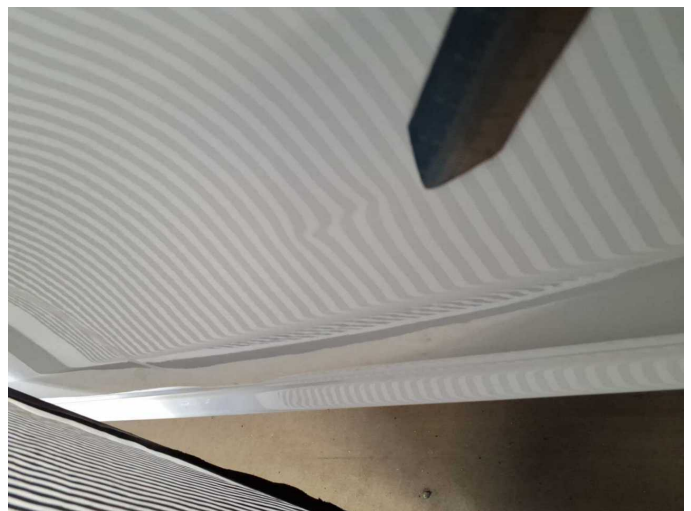
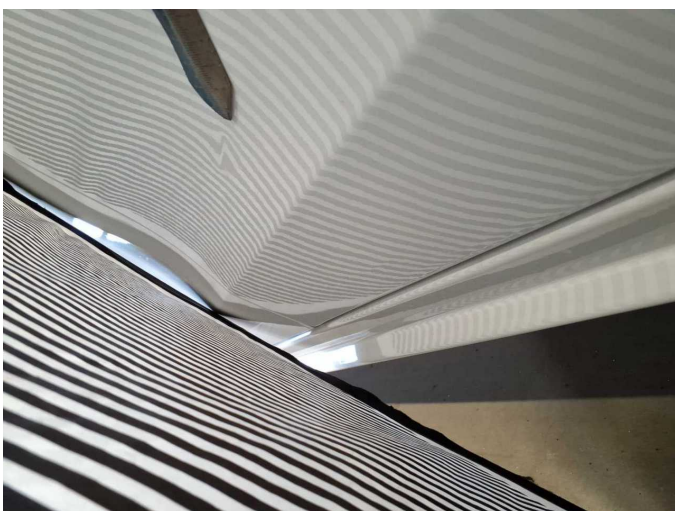
**Damage 3:** Door - rear left side: Door - dent(s) - Smooth repair work

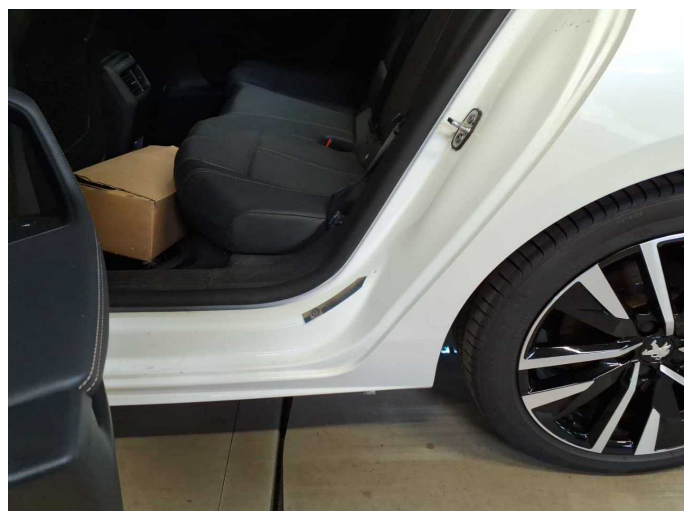
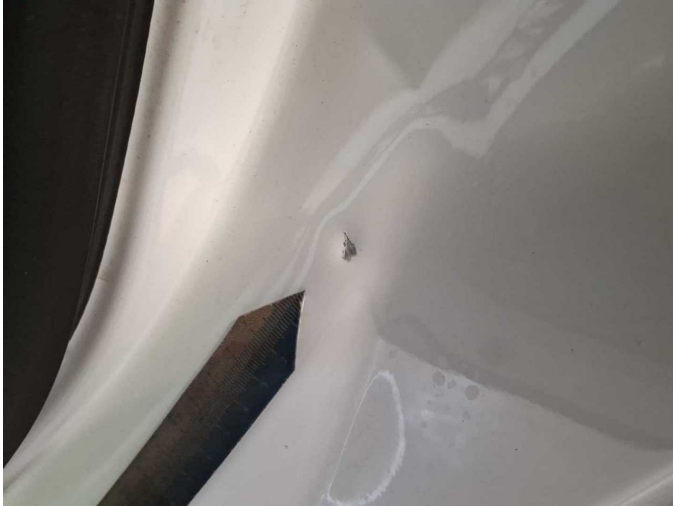
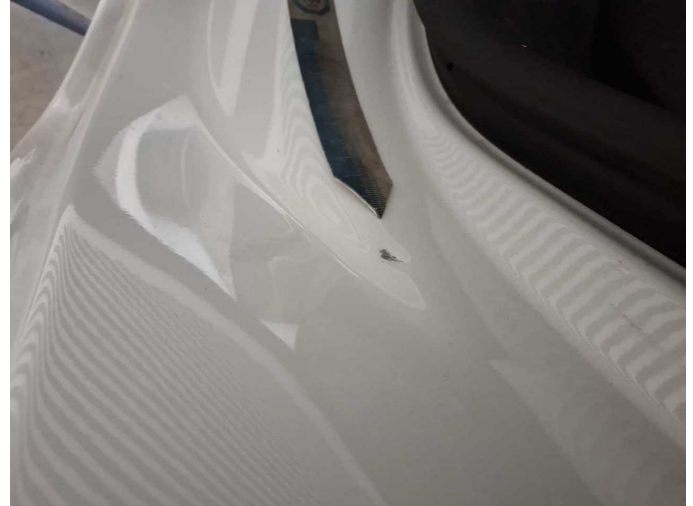
**Damage 4:** Side panel - rear left side: Sill - Dent / paintcoat damage - Smart repair

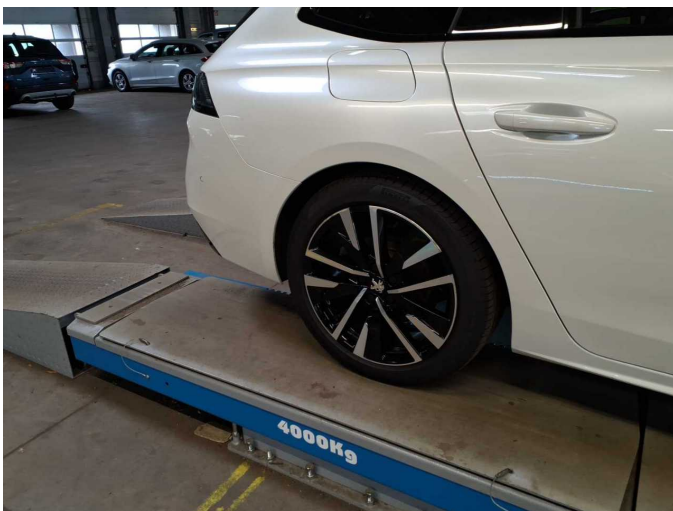
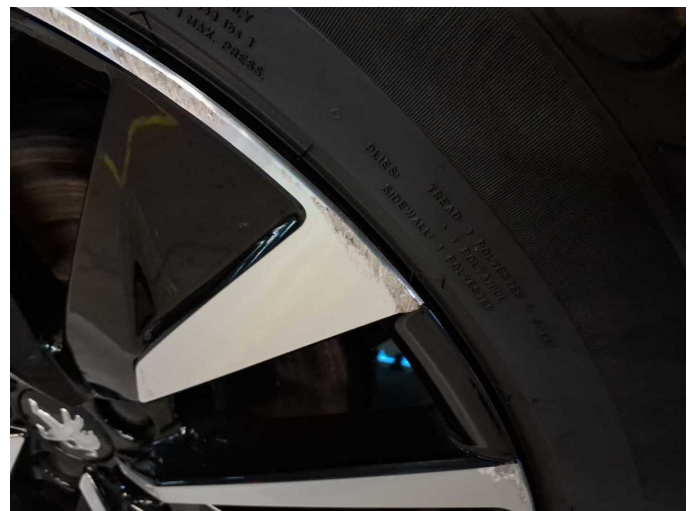
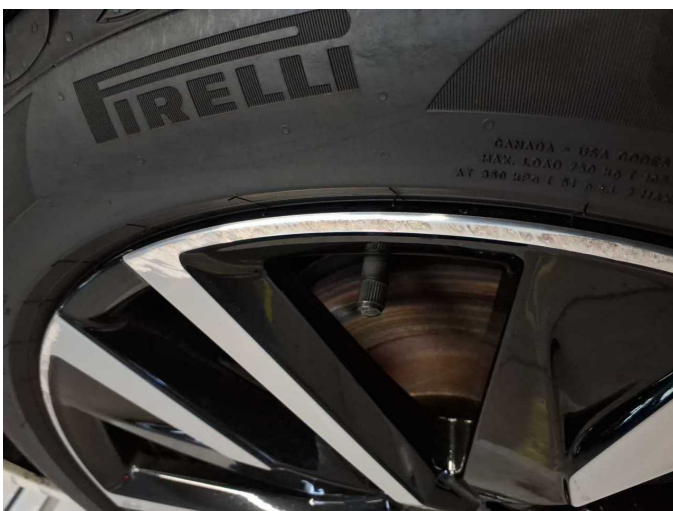
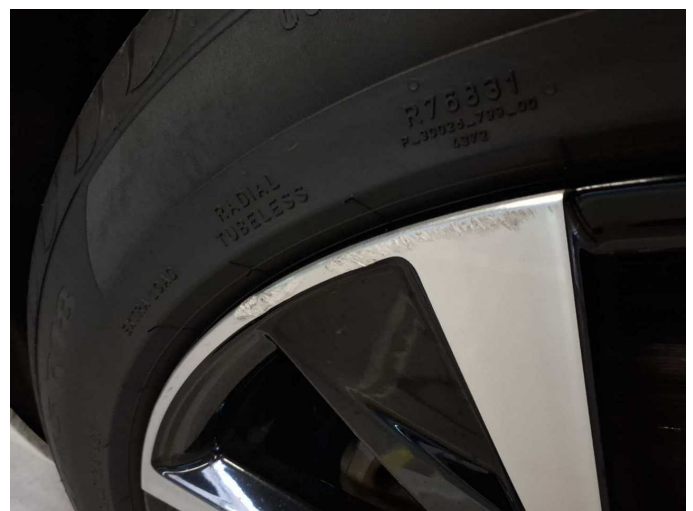
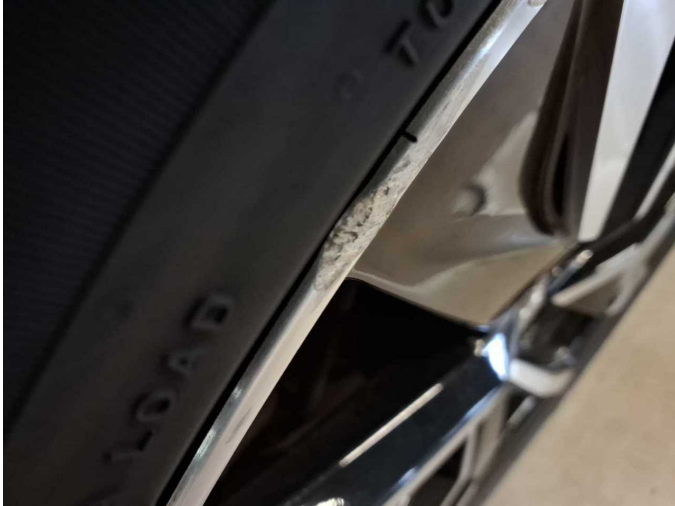
**Damage 5:** Wheel / tyres: Alloy rim - rear right side (Materialabtrag) - Scratched - Replace

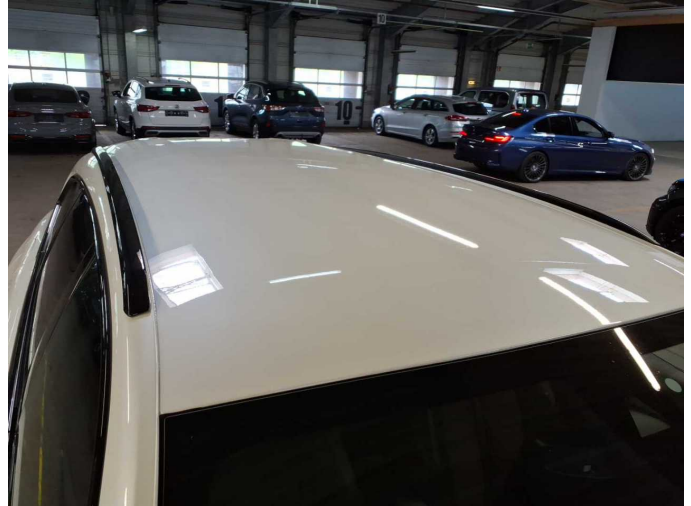
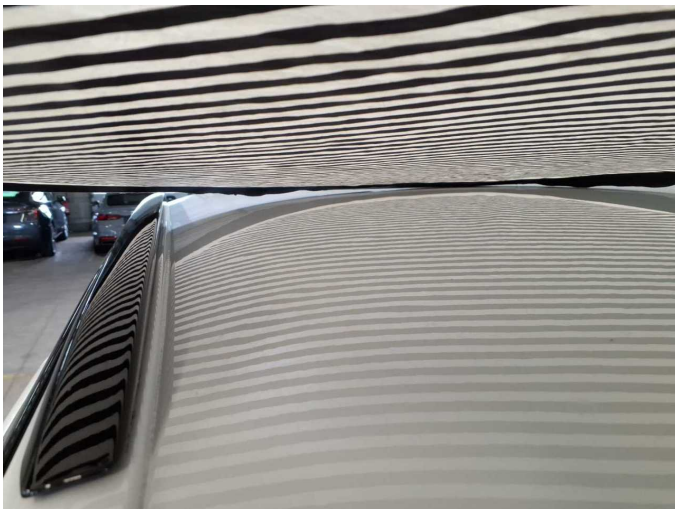
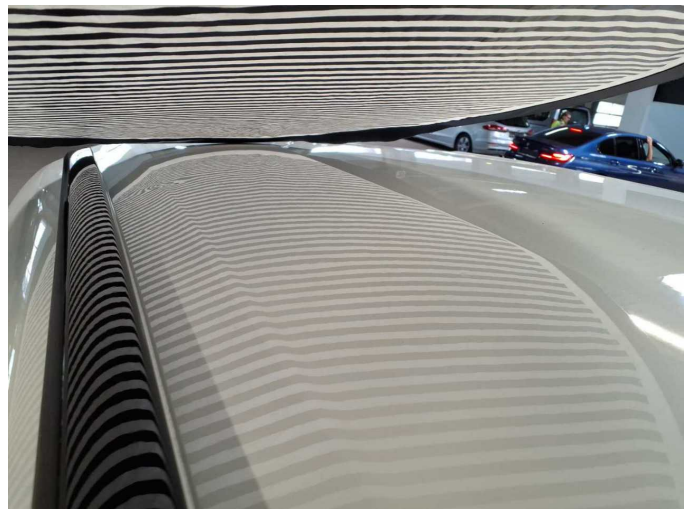
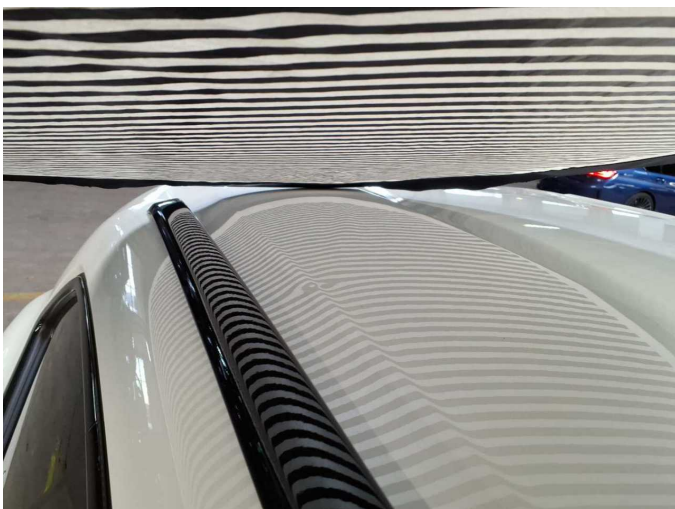
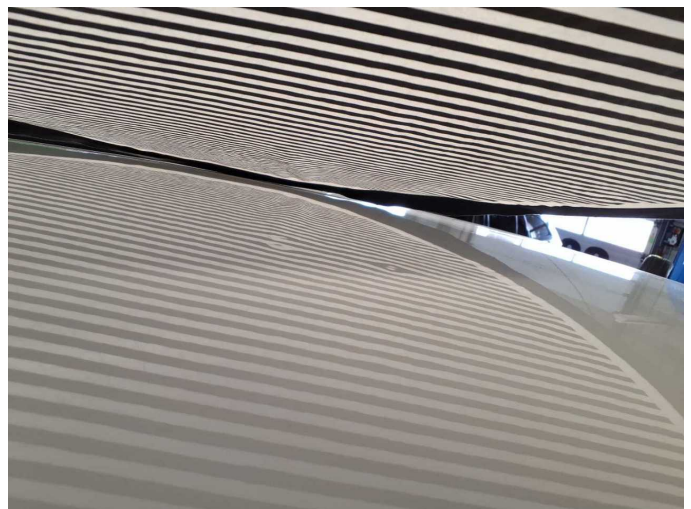
**Damage 6:** Roof: Roof - Damage by hail - Smooth repair work

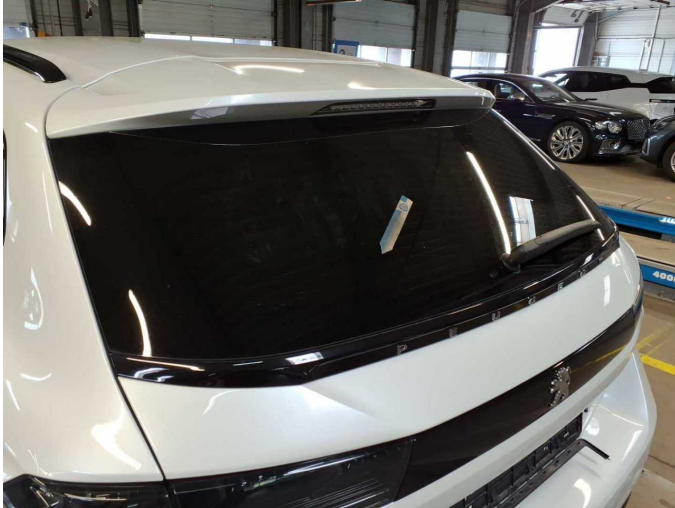
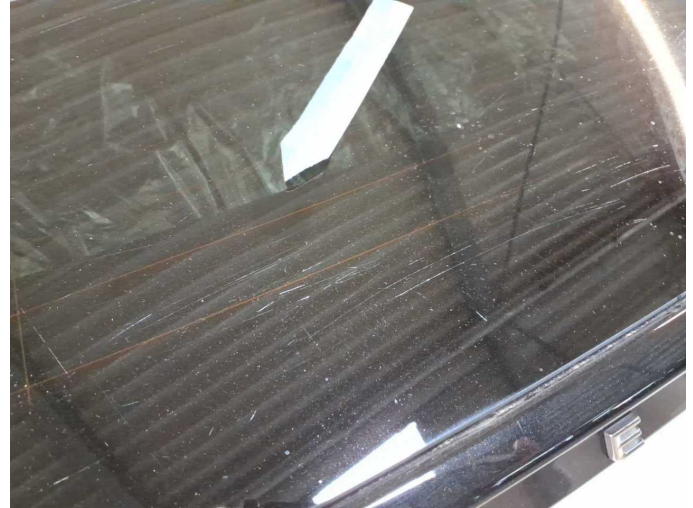
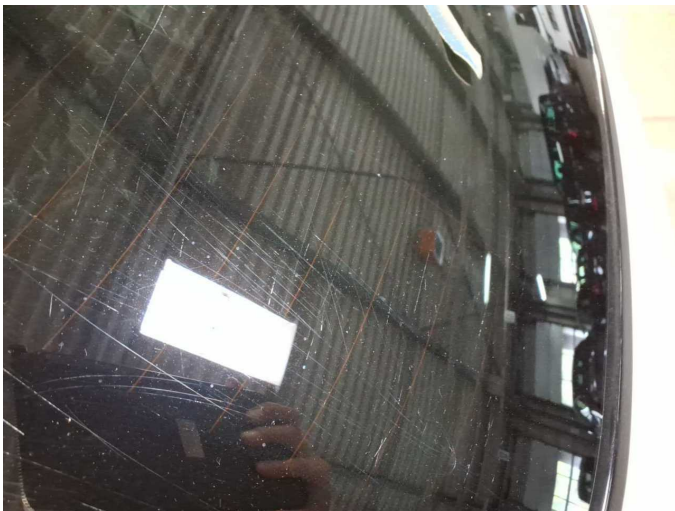
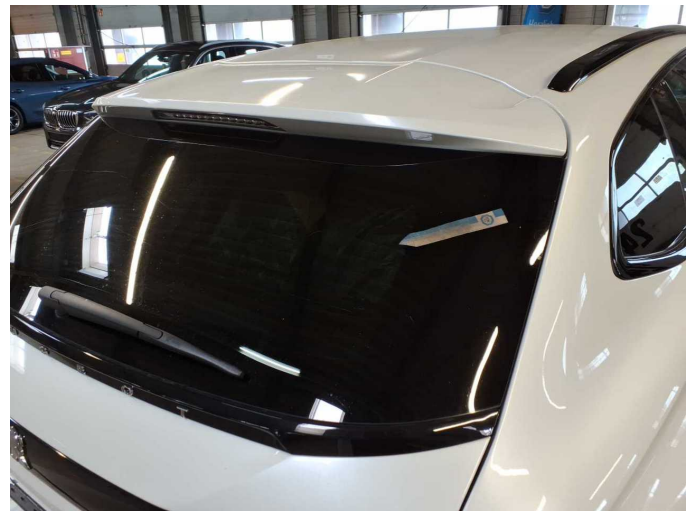
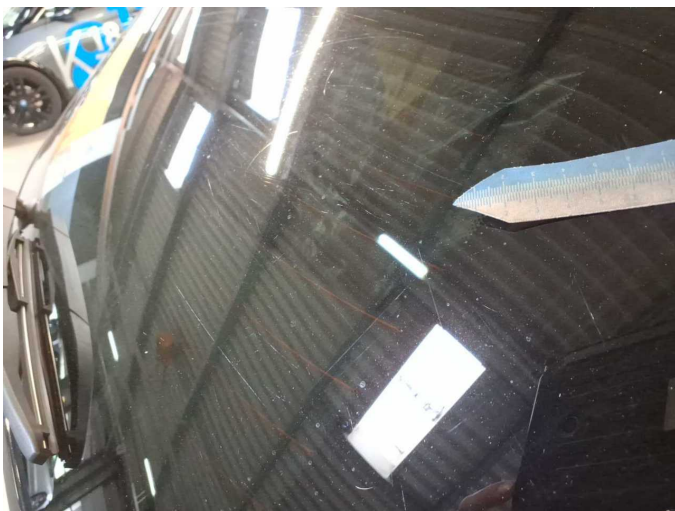
**Damage 7:** Vehicle glazing: Rear window - Scratched - Replace

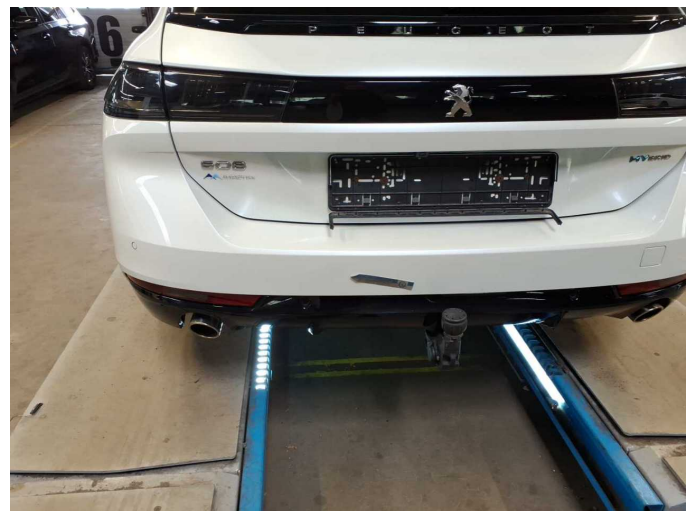
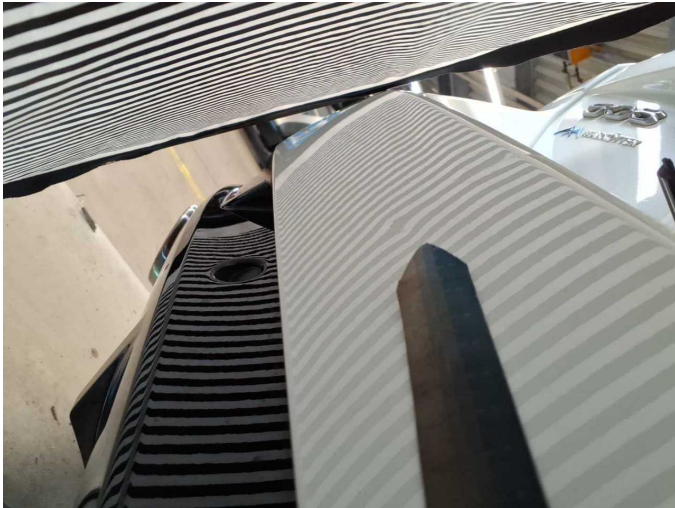
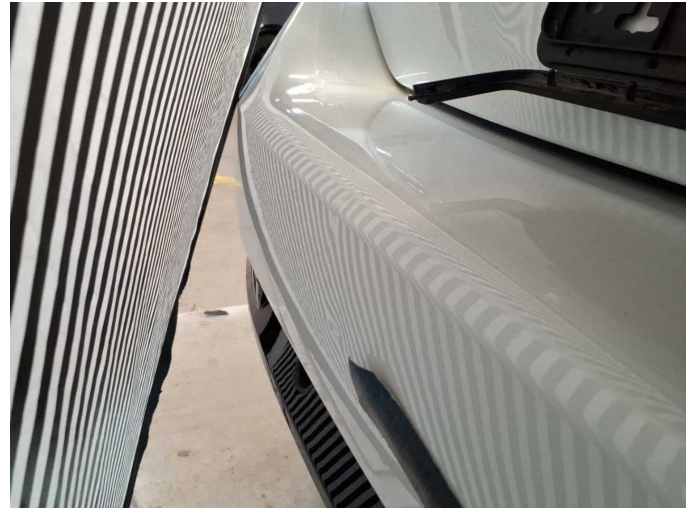
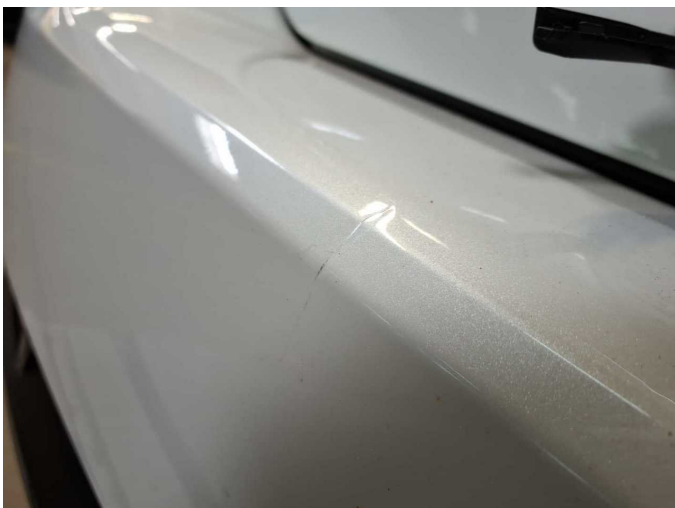
**Damage 8:** Rear bumper: Rear bumper - Deformed - Repair and paint

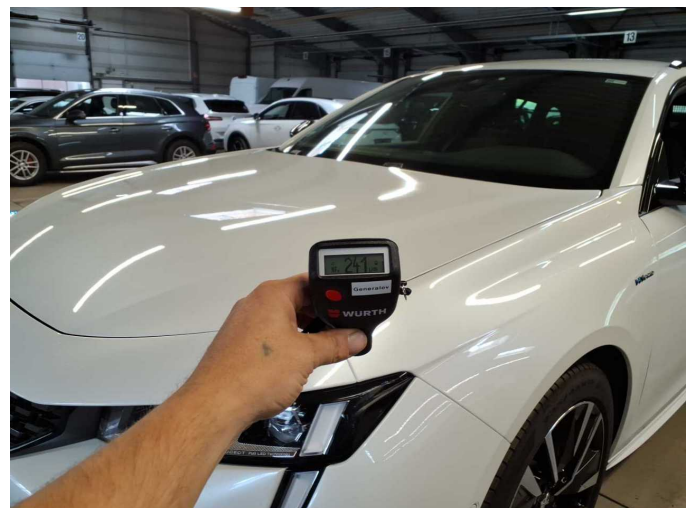
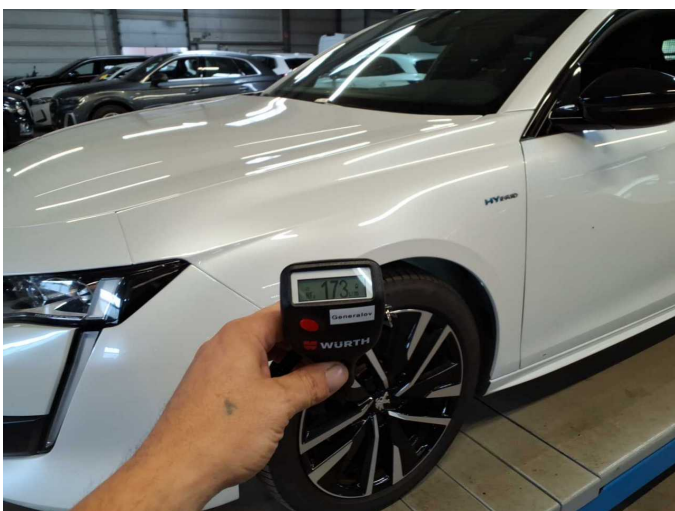
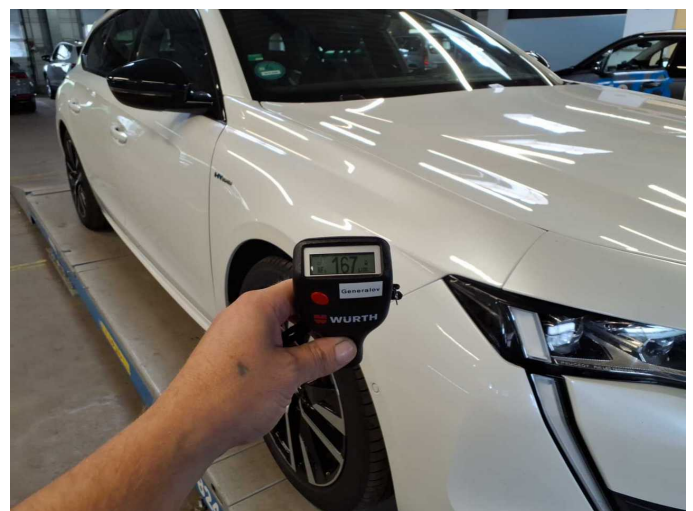
No.	Repainting
1	Mudguard - left side, Mudguard - right side, Bonnet, Professionally carried out, Invoice of repair done Non-existent

Mudguard - left side	173 µm	Mudguard - right side	167 µm
Bonnet	241 µm

**Repainting 1:** Mudguard - left side, Mudguard - right side, Bonnet
