Expertise

Protocol number: 46334963  
Order No. / Reference: 26512142  
Inspection date: 22 Jun 2026

Manufacturer: Opel

Model: Astra Sports Tourer 1.5 D Business Elegance

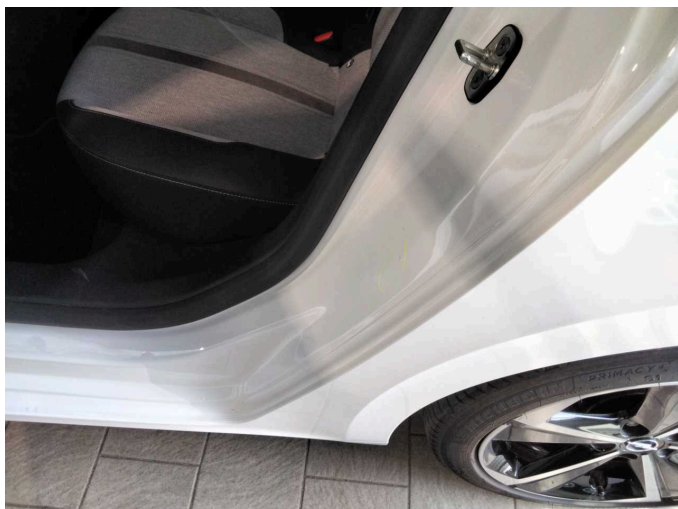
| No. | Component group | Description |
|---|---|---|
| 1 | Body | C-pillar - left side - Dent / paintcoat damage - Smart repair |

**Damage 1:** Body: C-pillar - left side - Dent / paintcoat damage - Smart repair

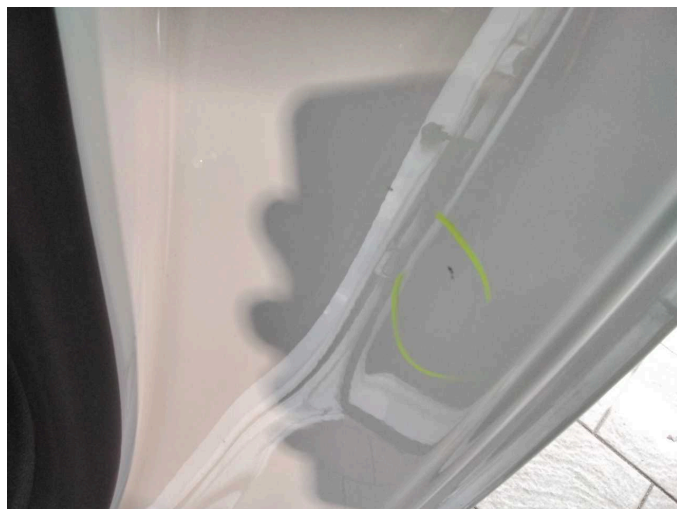
**Damage 1:** Body: C-pillar - left side - Dent / paintcoat damage - Smart repair

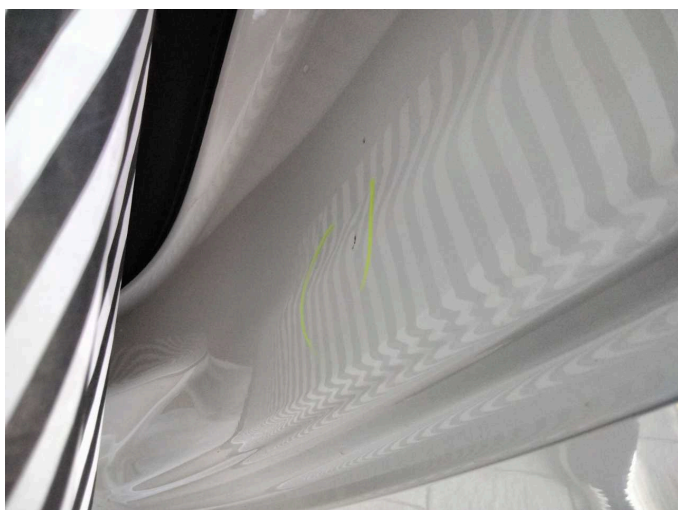
**Damage 1:** Body: C-pillar - left side - Dent / paintcoat damage - Smart repair

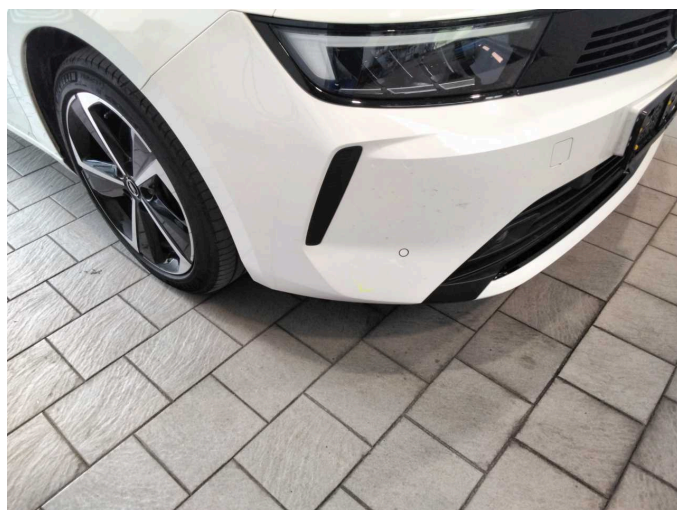
| No. | Component group | Description |
|---|---|---|
| 2 | Front bumper | Front bumper - Scratch(es) - Smart repair |

**Damage 2:** Front bumper: Front bumper - Scratch(es) - Smart repair

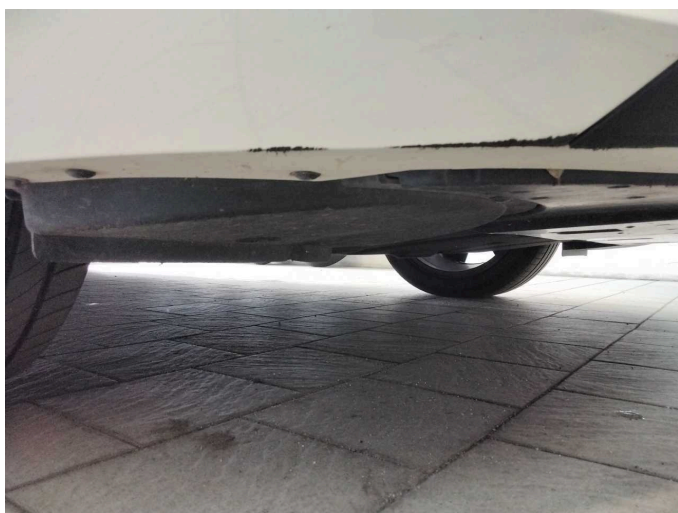
**Damage 2:** Front bumper: Front bumper - Scratch(es) - Smart repair

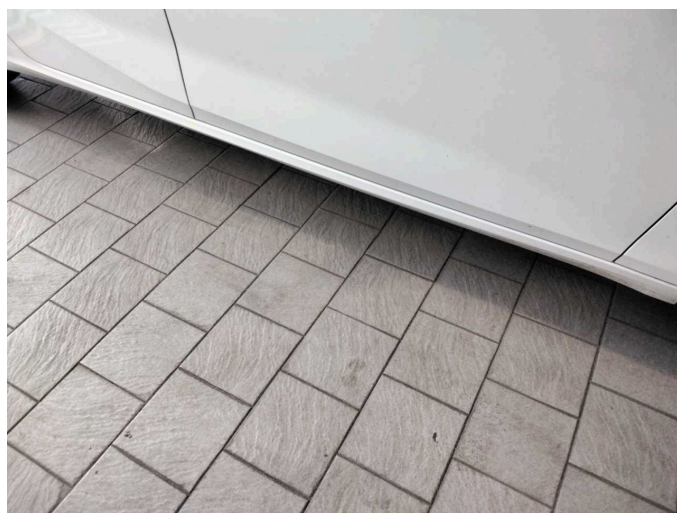
| No. | Component group | Description |
|---|---|---|
| 3 | Sill - right side | Sill - dent(s) - Smart repair |

**Damage 3:** Sill - right side: Sill - dent(s) - Smart repair

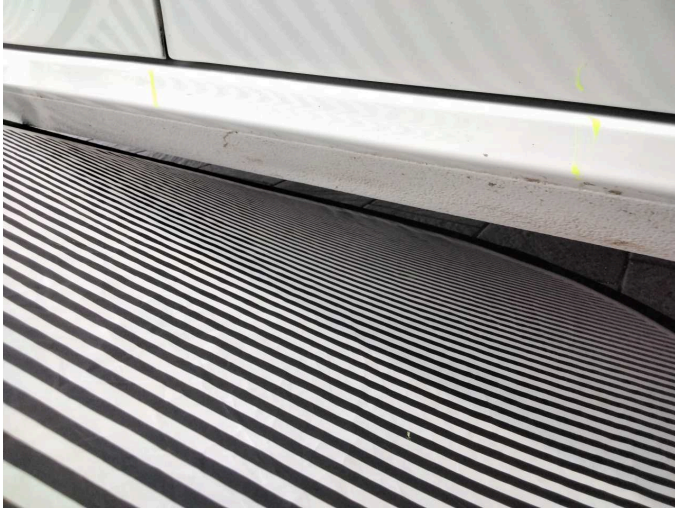
**Damage 3:** Sill - right side: Sill - dent(s) - Smart repair

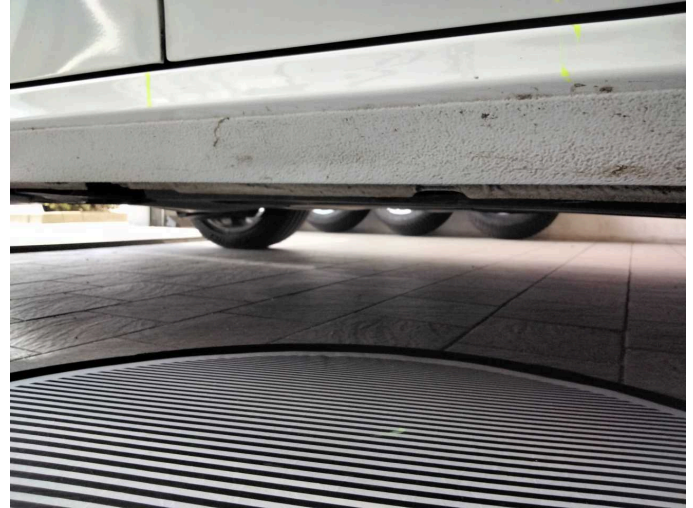
**Damage 3:** Sill - right side: Sill - dent(s) - Smart repair

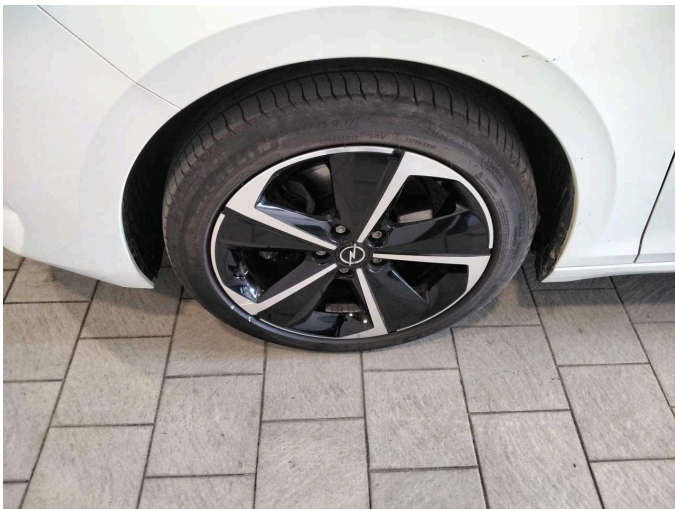
| No. | Component group | Description |
|---|---|---|
| 4 | Wheel / tyres | Alloy rim - front left side - Scratch(es) - Loss in value |

**Damage 4:** Wheel / tyres: Alloy rim - front left side - Scratch(es) - Loss in value

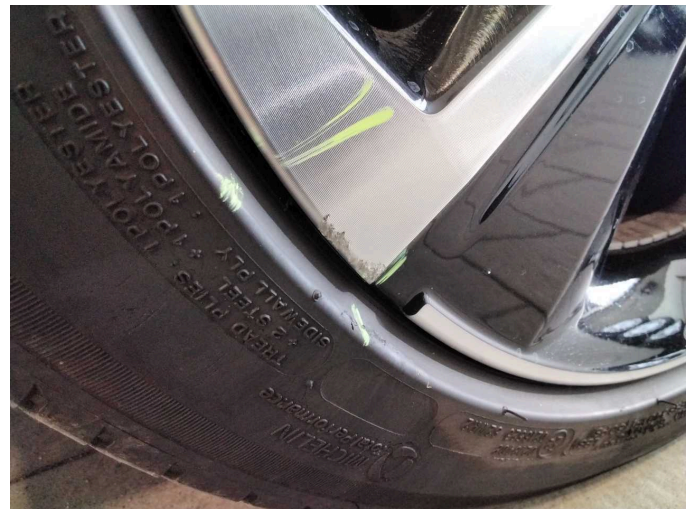
**Damage 4:** Wheel / tyres: Alloy rim - front left side - Scratch(es) - Loss in value

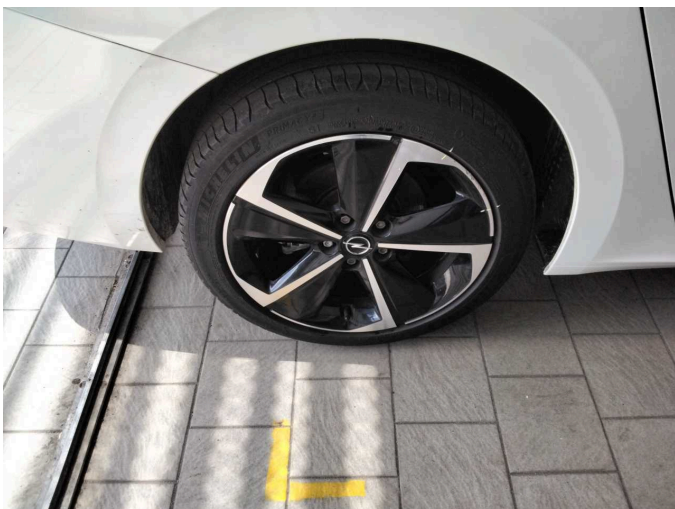
| No. | Component group | Description |
|---|---|---|
| 5 | Wheel / tyres | Alloy rim - rear right side - Scratched - Replace |

**Damage 5:** Wheel / tyres: Alloy rim - rear right side - Scratched - Replace

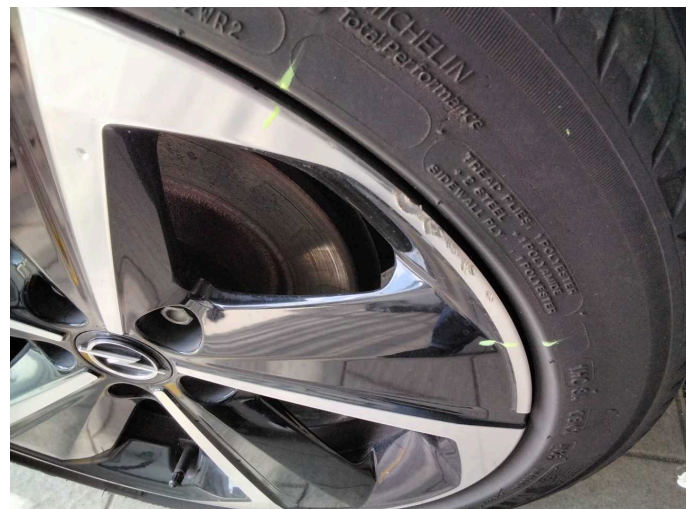
**Damage 5:** Wheel / tyres: Alloy rim - rear right side - Scratched - Replace

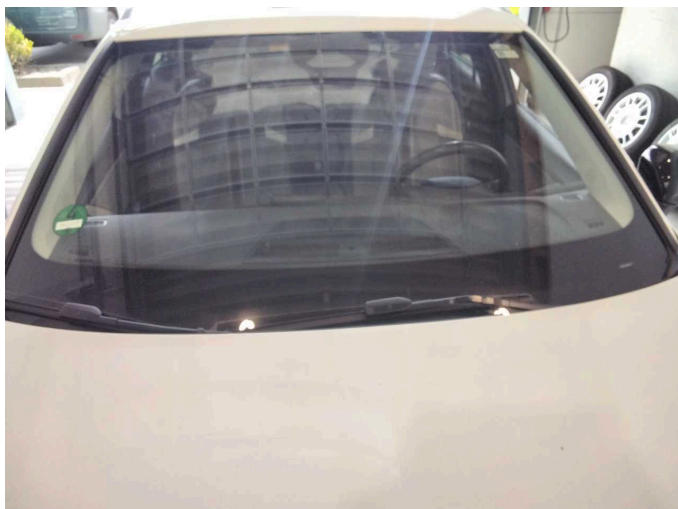
| No. | Component group | Description |
|---|---|---|
| 1 | Vehicle glazing | Windscreen - Stone chips - No deduction |

**Wear and tear 1:** Vehicle glazing: Windscreen - Stone chips - No deduction

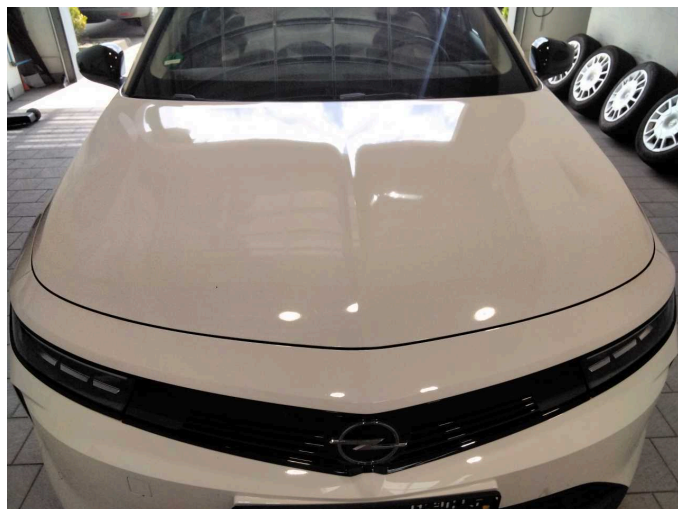
| No. | Component group | Description |
|---|---|---|
| 2 | Bonnet | Bonnet - Stone chips - No deduction |

**Wear and tear 2:** Bonnet: Bonnet - Stone chips - No deduction

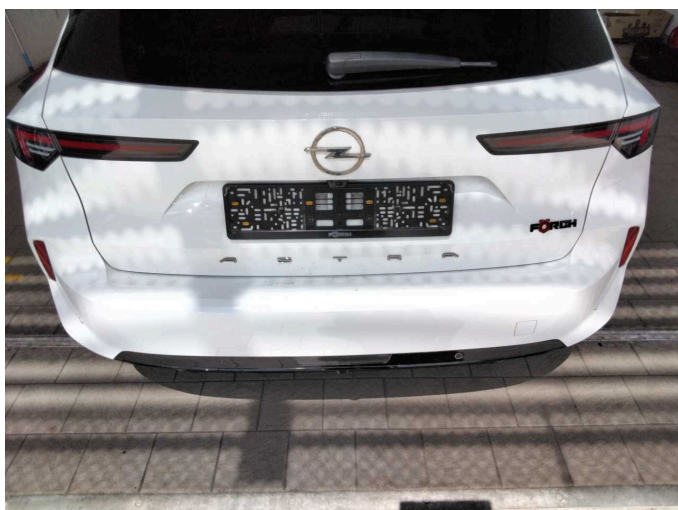
| No. | Component group | Description |
|---|---|---|
| 3 | Rear bumper | Rear bumper - Scratch(es) - No deduction |

**Wear and tear 3:** Rear bumper: Rear bumper - Scratch(es) - No deduction
