Expertise

Protocol number: 46694232  
Order No. / Reference: 26702518-1  
Inspection date: 21 Jul 2026

Manufacturer: Ford

Model: Focus Turnier 1.5 EcoBlue Start-Stopp-System  
COOL&CONNECT

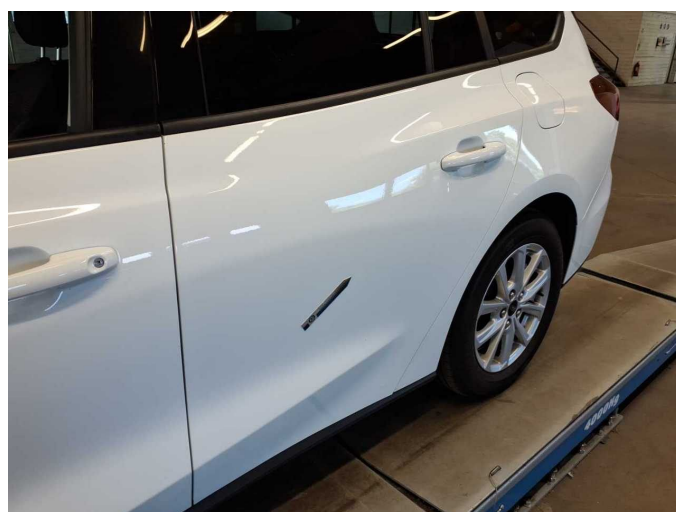
| No. | Component group | Description |
|---|---|---|
| 1 | Door - rear left side | Door - dent(s) - Smooth repair work |

**Damage 1:** Door - rear left side: Door - dent(s) - Smooth repair work

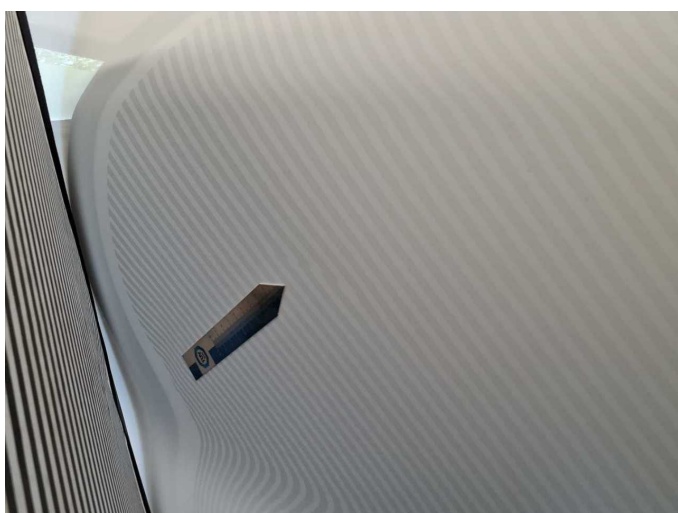
**Damage 1:** Door - rear left side: Door - dent(s) - Smooth repair work

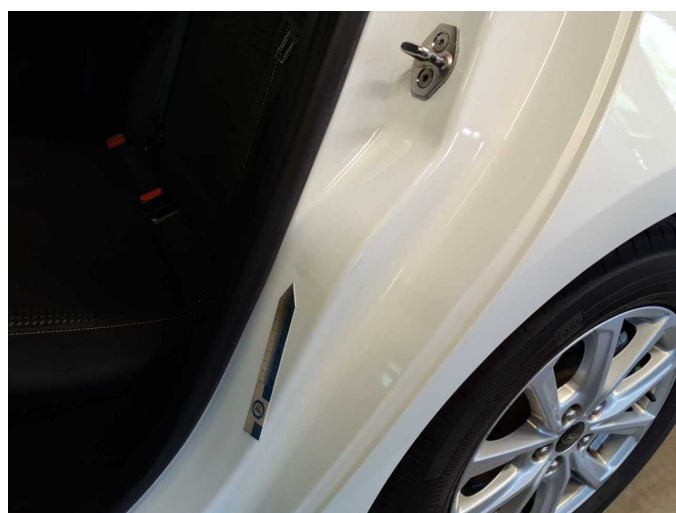
| No. | Component group | Description |
|---|---|---|
| 2 | Side panel - rear left side | Sill - dent(s) - Smart repair |

**Damage 2:** Side panel - rear left side: Sill - dent(s) - Smart repair

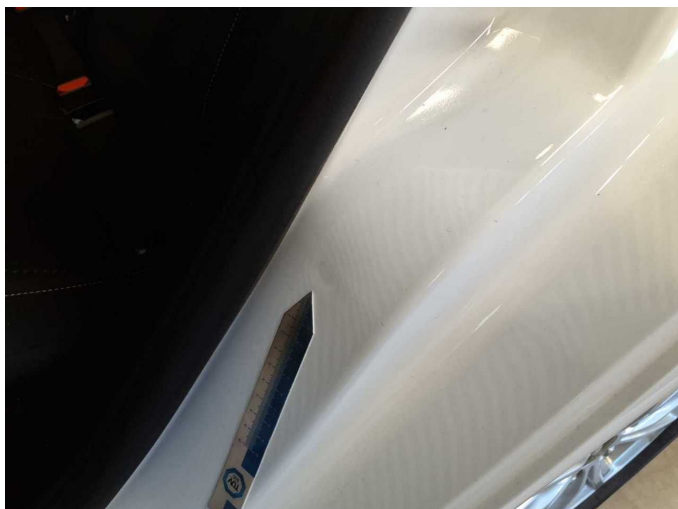
**Damage 2:** Side panel - rear left side: Sill - dent(s) - Smart repair

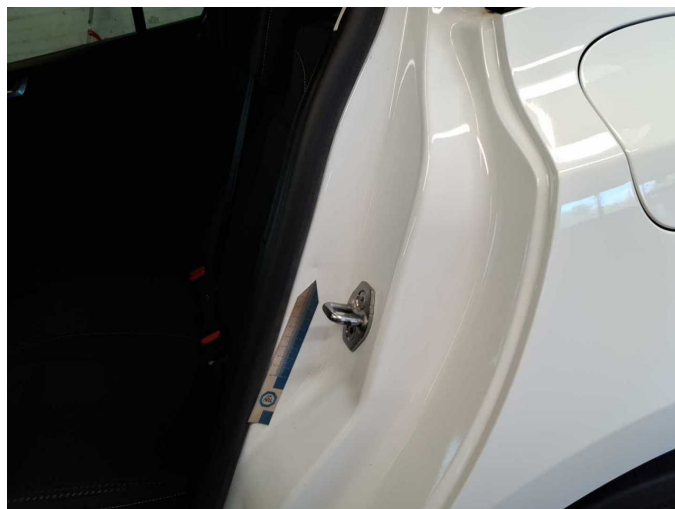
**Damage 2:** Side panel - rear left side: Sill - dent(s) - Smart repair

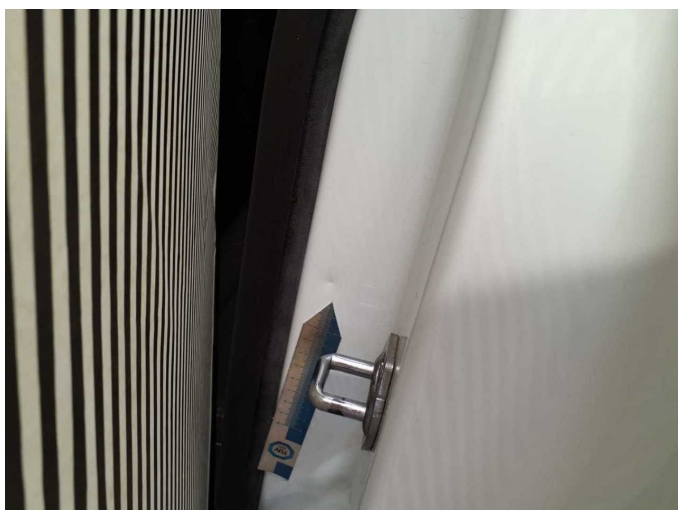
**Damage 2:** Side panel - rear left side: Sill - dent(s) - Smart repair

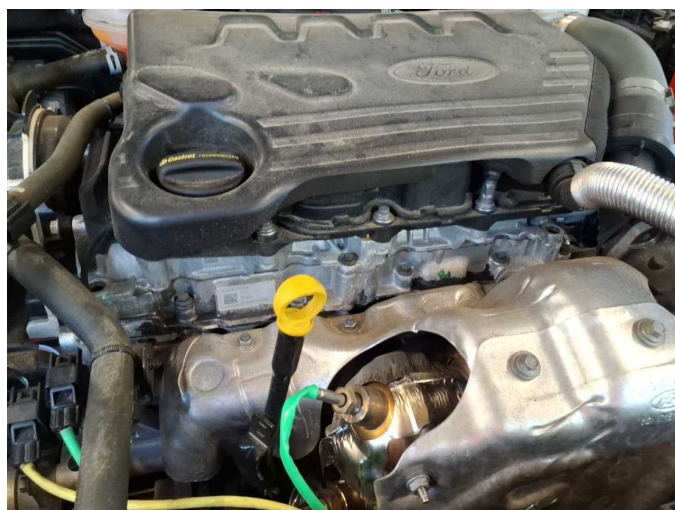
| No. | Component group | Description |
|---|---|---|
| 3 | Engine | Engine - Leaking - Perform diagnosis |

**Damage 3:** Engine: Engine - Leaking - Perform diagnosis

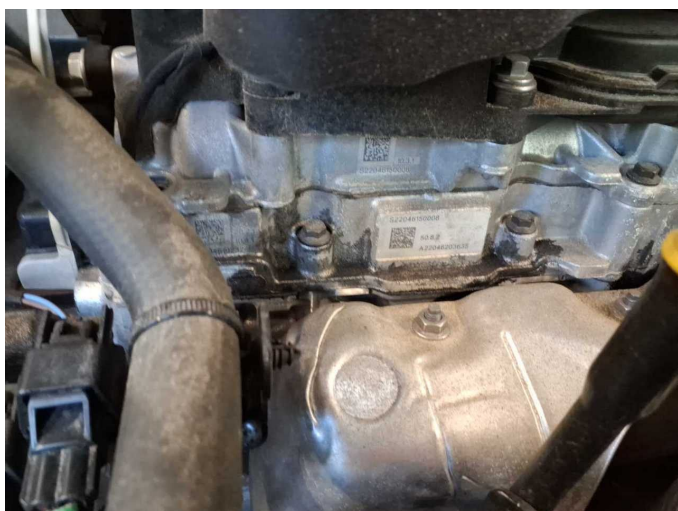
**Damage 3:** Engine: Engine - Leaking - Perform diagnosis

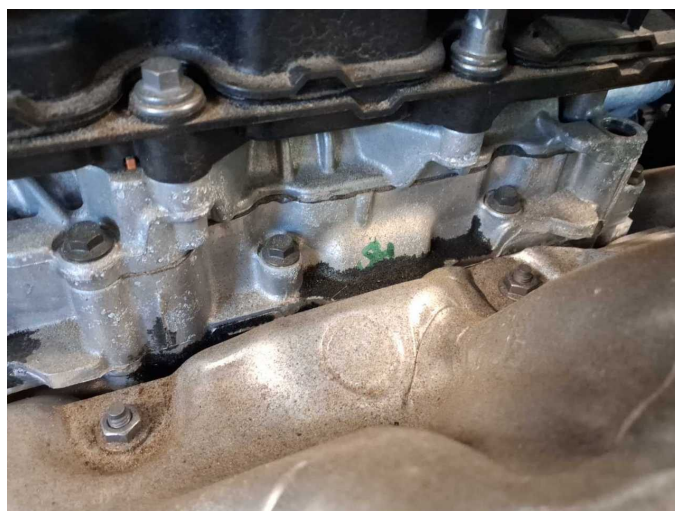
**Damage 3:** Engine: Engine - Leaking - Perform diagnosis

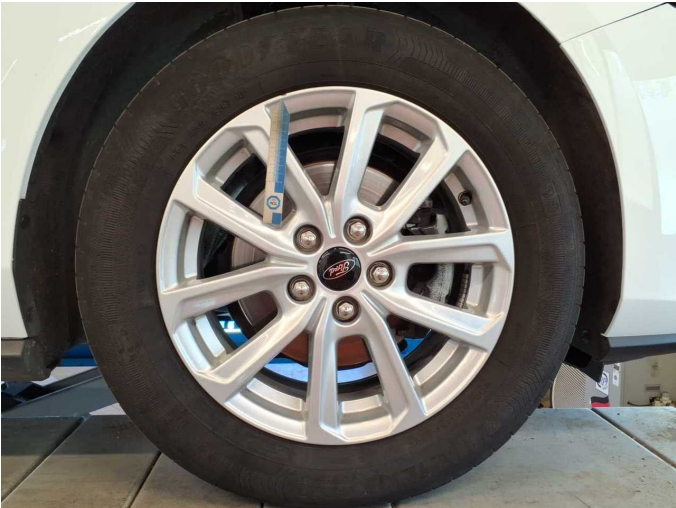
| No. | Component group | Description |
|---|---|---|
| 4 | Wheel / tyres | Alloy rim - front right side - Scratch(es) - Loss in value |

**Damage 4:** Wheel / tyres: Alloy rim - front right side - Scratch(es) - Loss in value

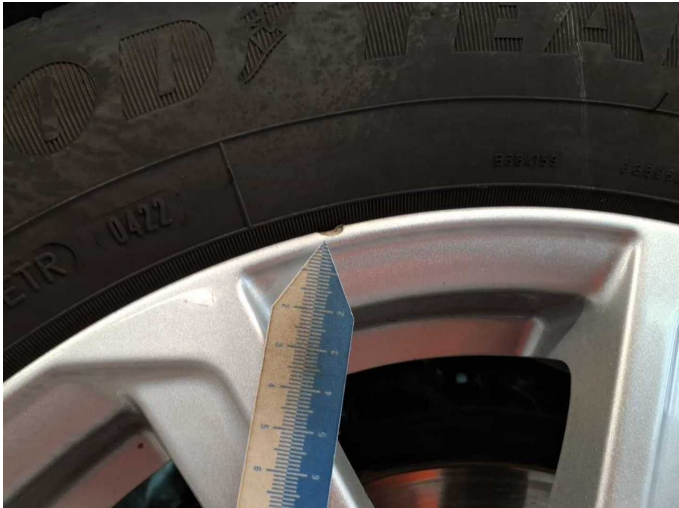
**Damage 4:** Wheel / tyres: Alloy rim - front right side - Scratch(es) - Loss in value

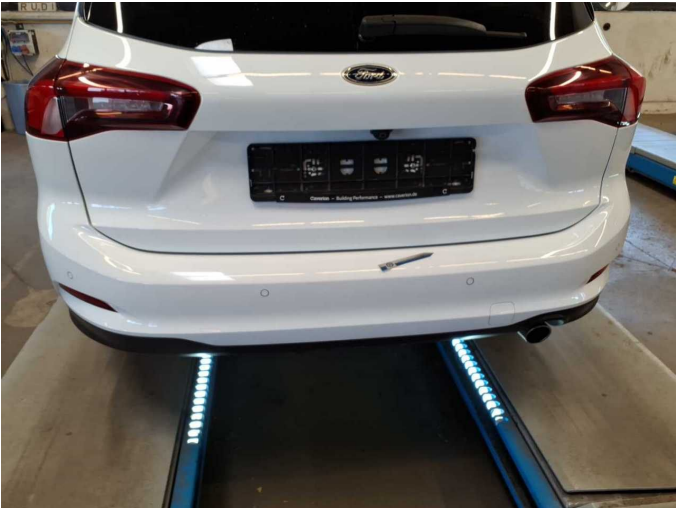
| No. | Component group | Description |
|---|---|---|
| 2 | Rear bumper | Rear bumper - Scratch(es) - No deduction |

**Wear and tear 2:** Rear bumper: Rear bumper - Scratch(es) - No deduction

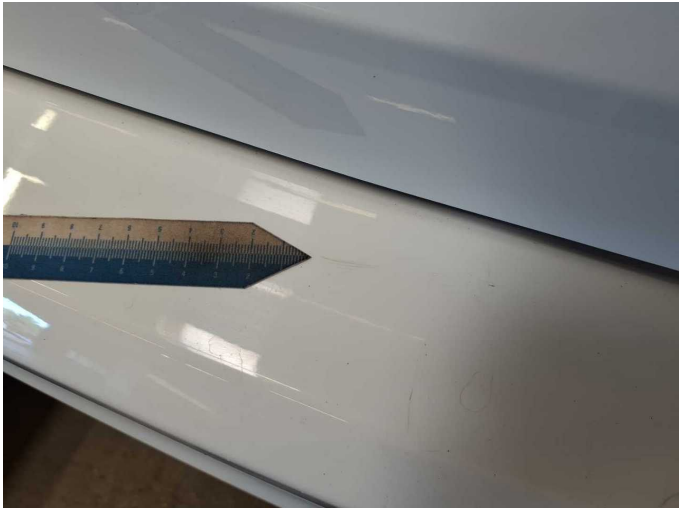
**Wear and tear 2:** Rear bumper: Rear bumper - Scratch(es) - No deduction
