Expertise

Protocol number: 46137900
Order No. / Reference: 26438096
Inspection date: 24 Jun 2026

Model: e-Spacetourer XL (75 kWh) Feel

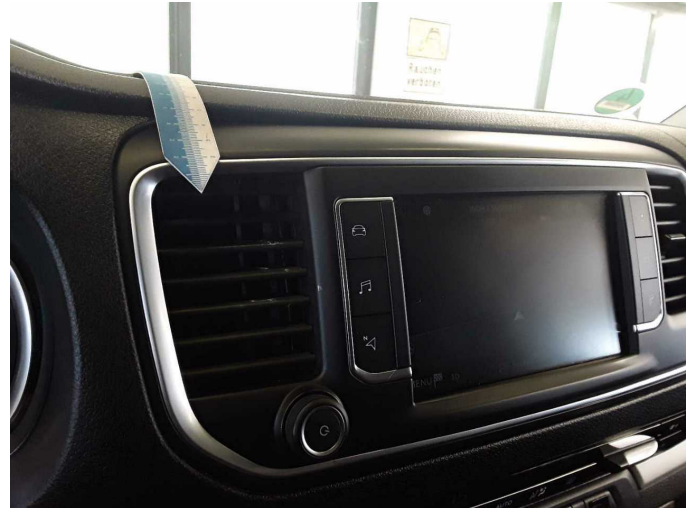
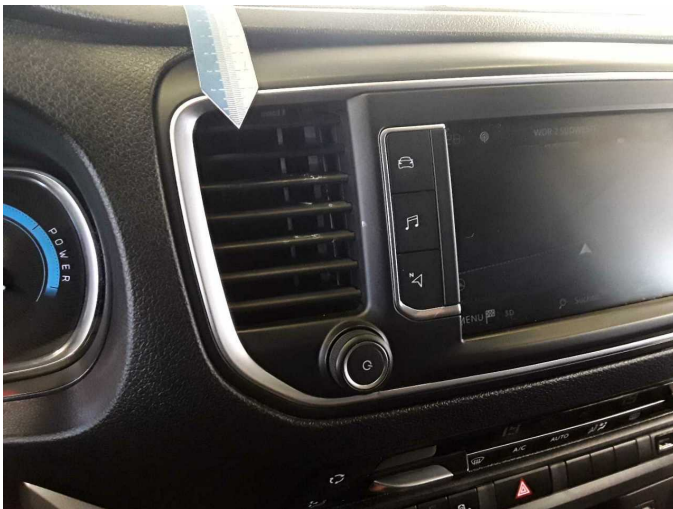
Damage 3: Instrument panel: Air nozzle - centre - Damaged - Replace

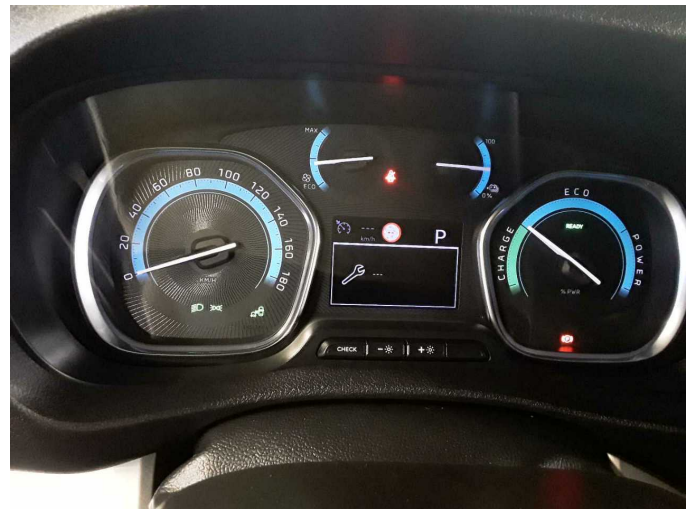
Damage 4: Misc.: Inspection / maintenance - Due - Perform

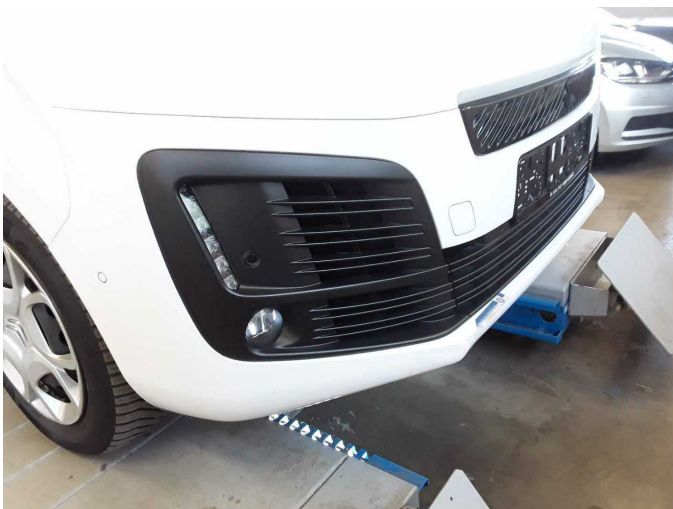
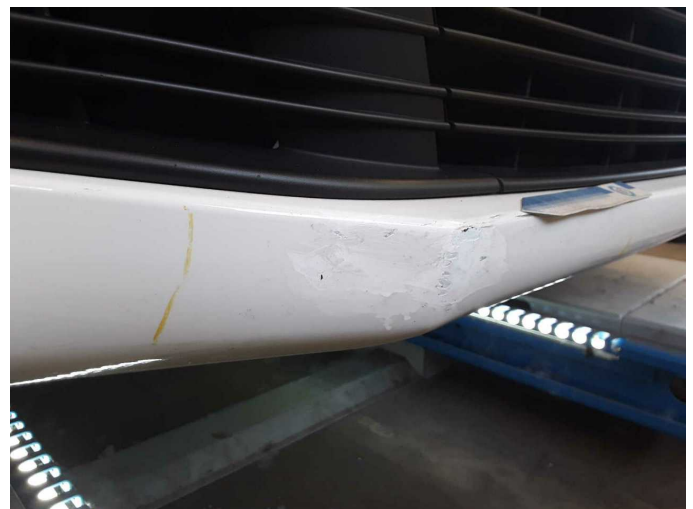
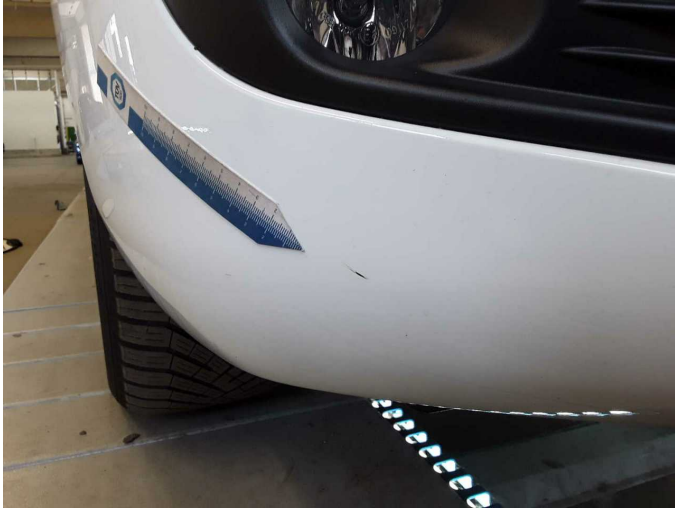
Damage 5: Front bumper: Front bumper - Scratched - Paint

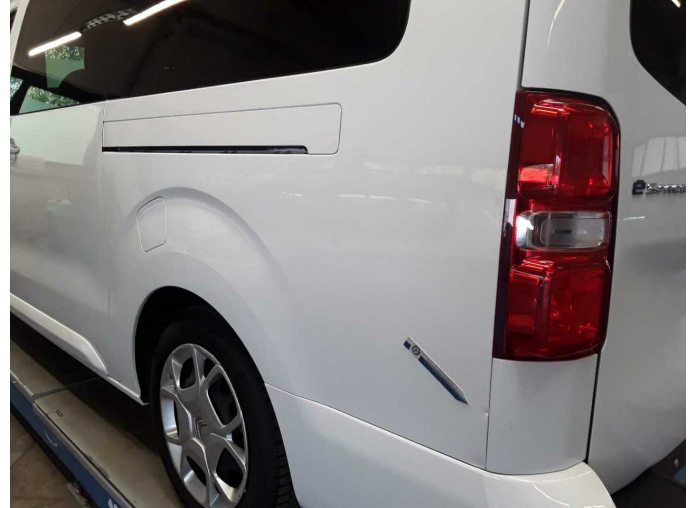
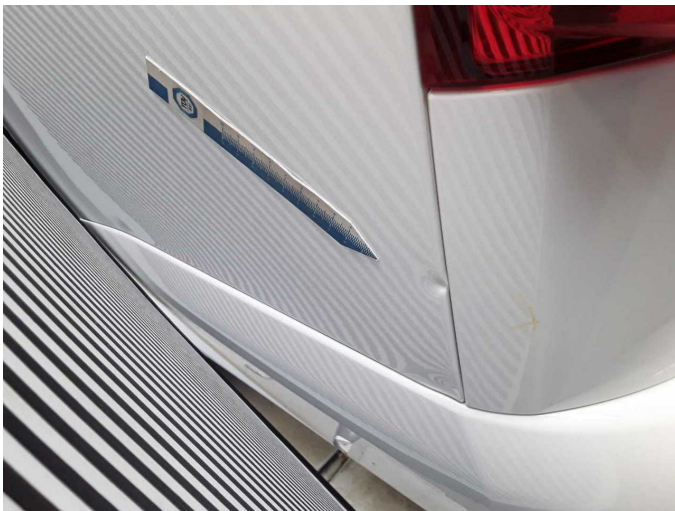
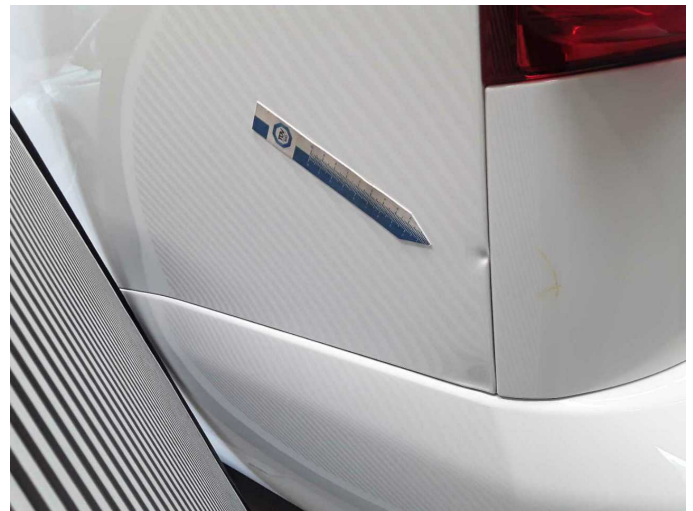
No.	Previous damage	Extent of damage (Net)
1	Rear, Side - left, Provided by user / customer	2.194,45 €

Damage 6: Side panel - rear left side: Side panel - Deformed - Repair and paint

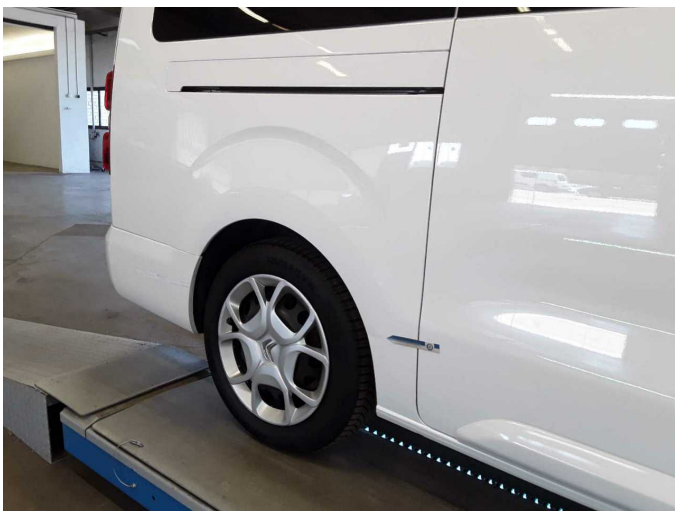
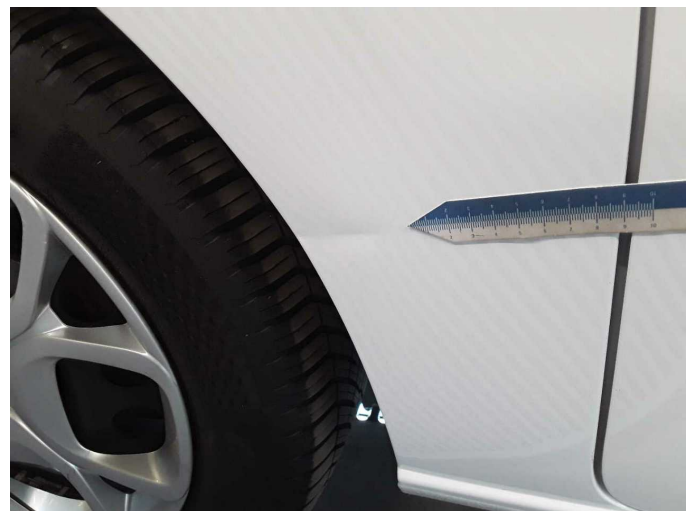
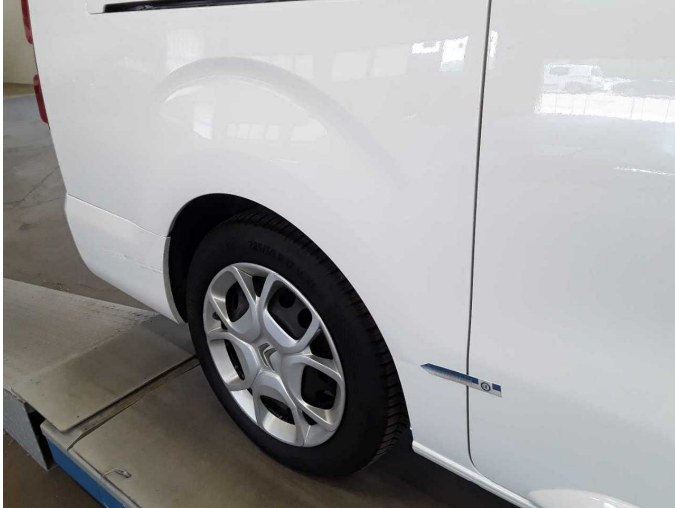
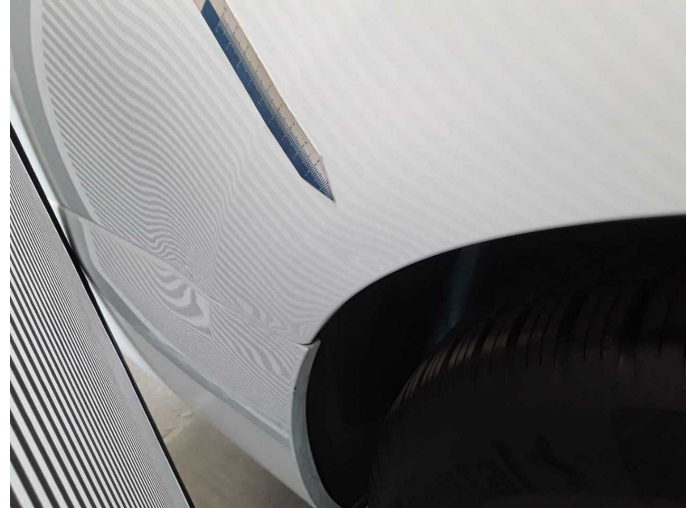
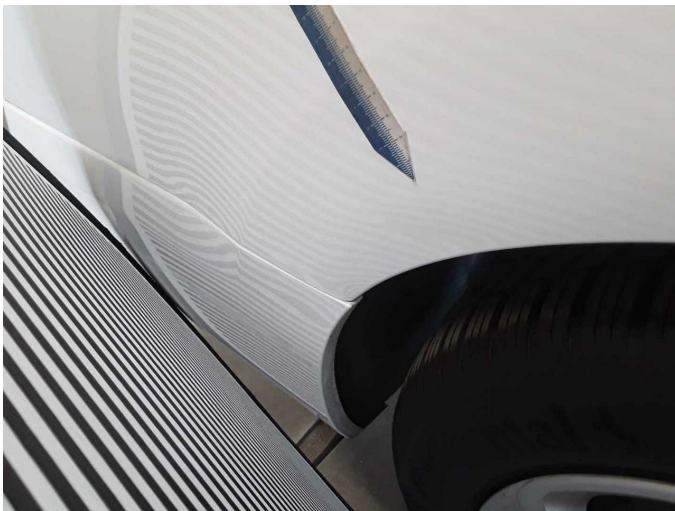
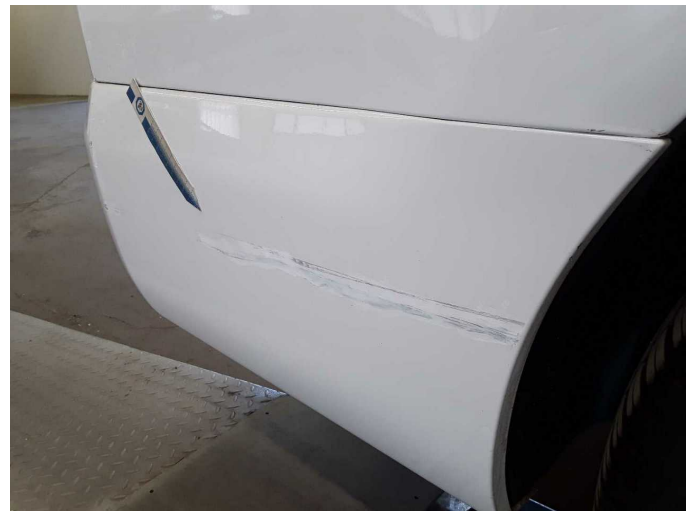
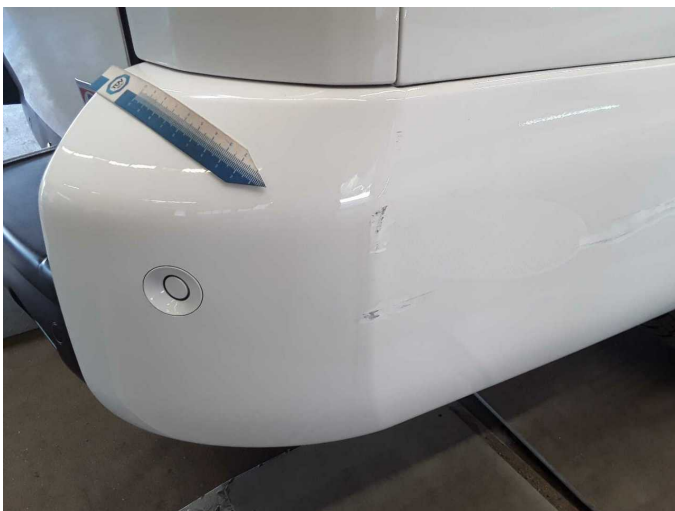
1 Side right

Accident 1: Side right
