Expertise

Protocol number: 45539062
Order No. / Reference: 26351906
Inspection date: 12 May 2026

Model: Focus Turnier 2.0 EcoBlue Start-Stopp-System Aut.
COOL&CONNECT

VIN: WF0PXXGCHPMA53490

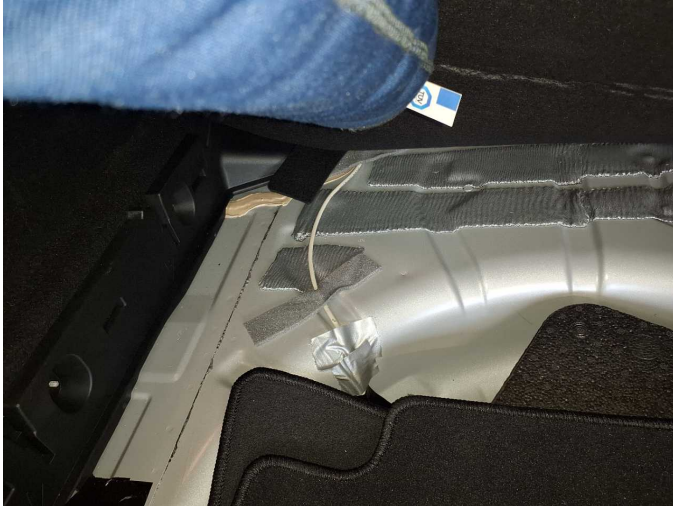
Damage 1: Electrical system: Cable strand (Kabelführung von Frontbereich in Laderaum) - Differs from the original configuration - Un-/install

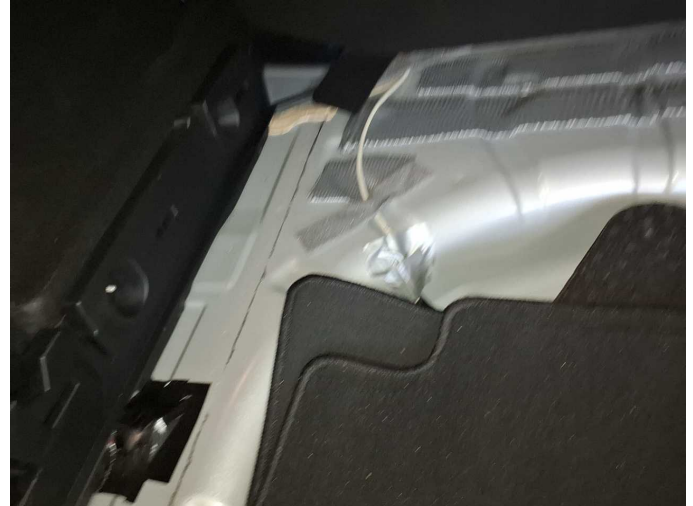
Damage 1: Electrical system: Cable strand (Kabelführung von Frontbereich in Laderaum) - Differs from the original configuration - Un-/install

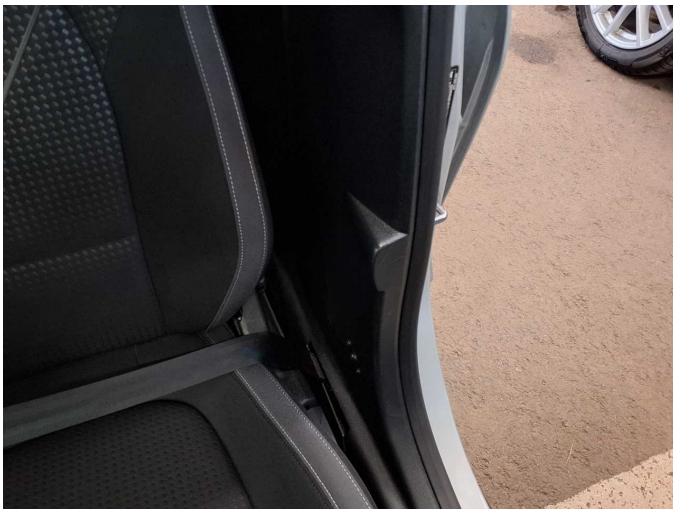
Damage 2: Trim / covers: B-pillar - trim - interior, left side (Fehlbohrungen) - Differs from the original configuration - Replace

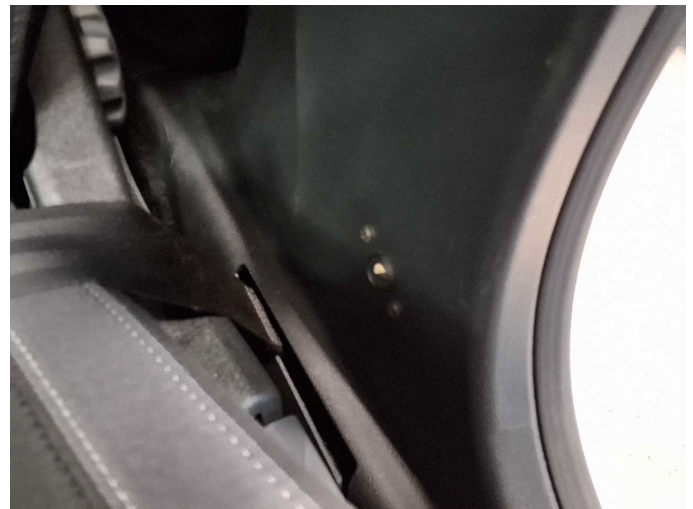
Damage 2: Trim / covers: B-pillar - trim - interior, left side (Fehlbohrungen) - Differs from the original configuration - Replace

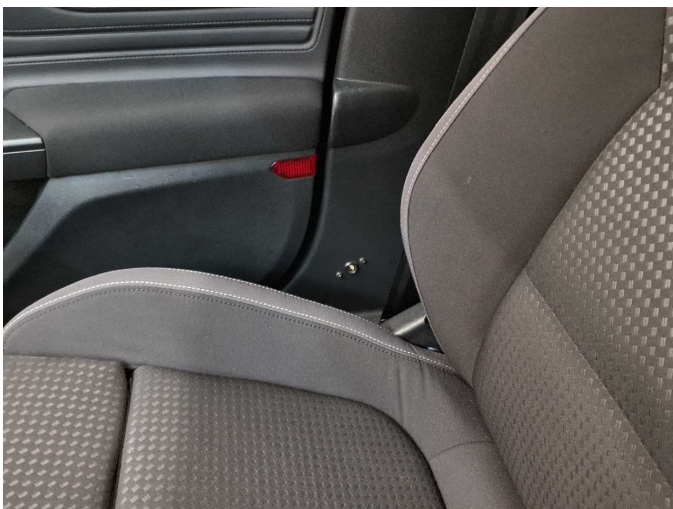
Damage 3: Trim / covers: B-pillar - trim - interior, right side (Fehlbohrungen) - Differs from the original configuration - Replace

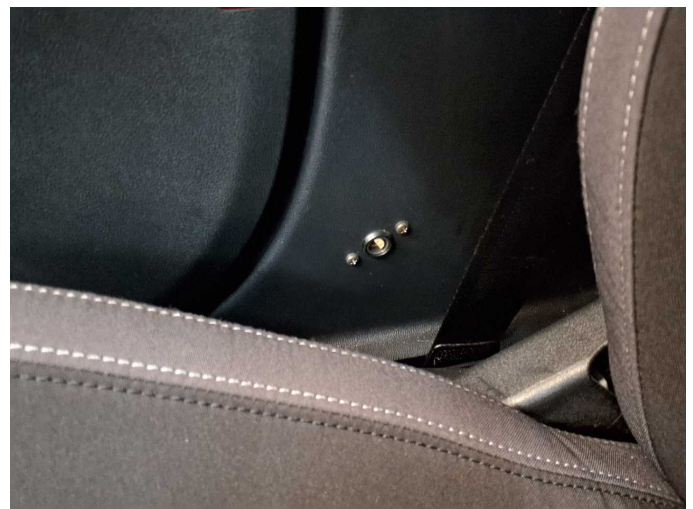
Damage 3: Trim / covers: B-pillar - trim - interior, right side (Fehlbohrungen) - Differs from the original configuration - Replace

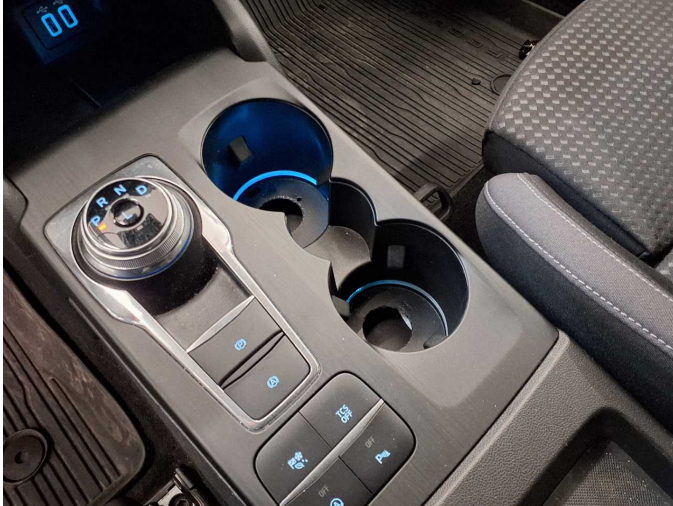
Damage 4: Instrument panel: Centre console - front (Getränkehalter, Fehlbohrungen) - Differs from the original configuration - Replace

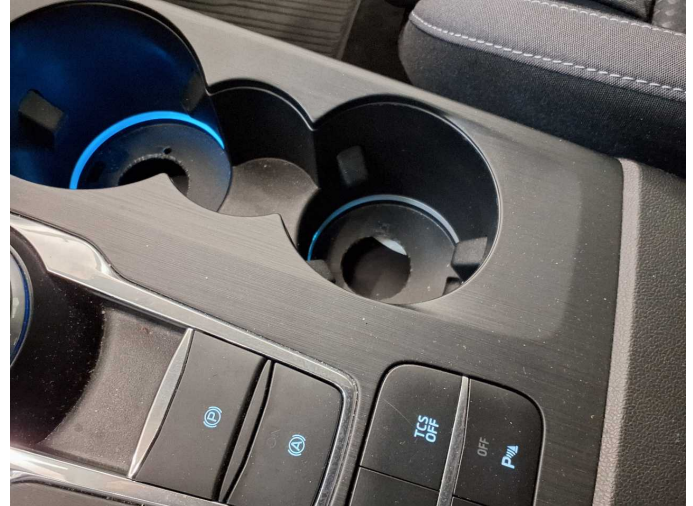
Damage 4: Instrument panel: Centre console - front (Getränkehalter, Fehlbohrungen) - Differs from the original configuration - Replace

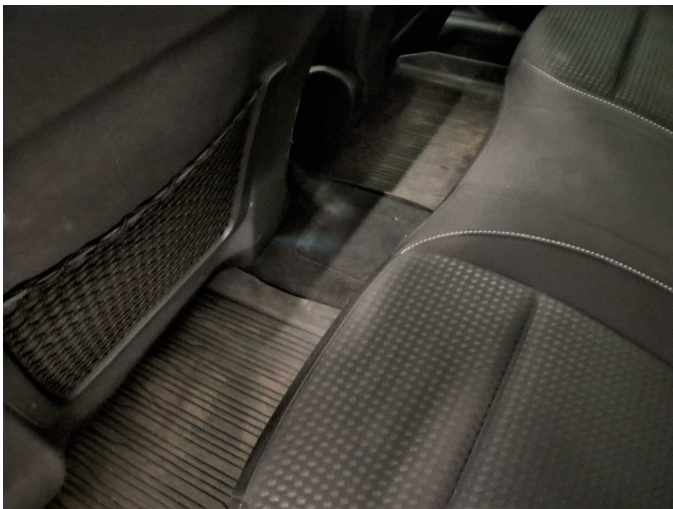
Damage 5: Trim / covers: Carpet - Differs from the original configuration - Loss in value

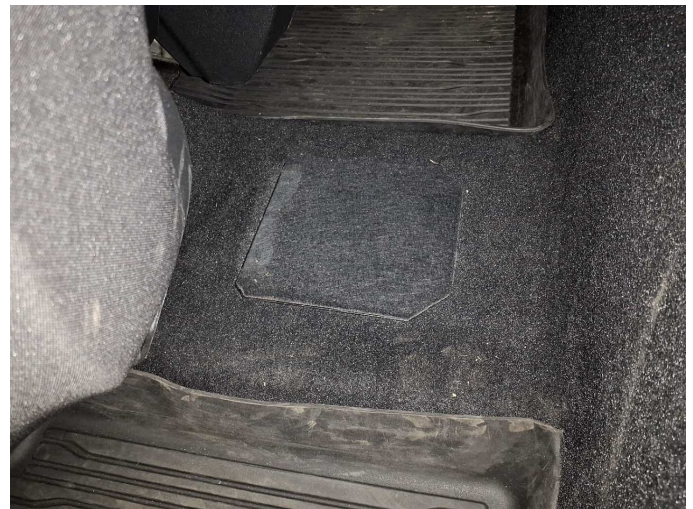
Damage 5: Trim / covers: Carpet - Differs from the original configuration - Loss in value

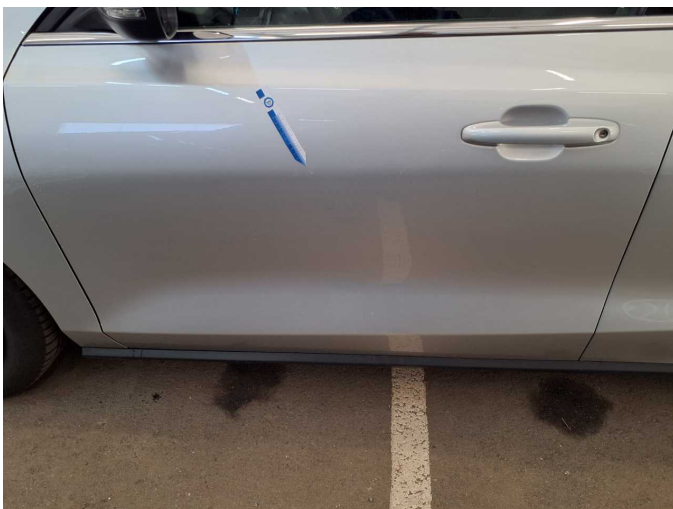
Damage 6: Door - front left side: Door - Scratch(es) - Paint

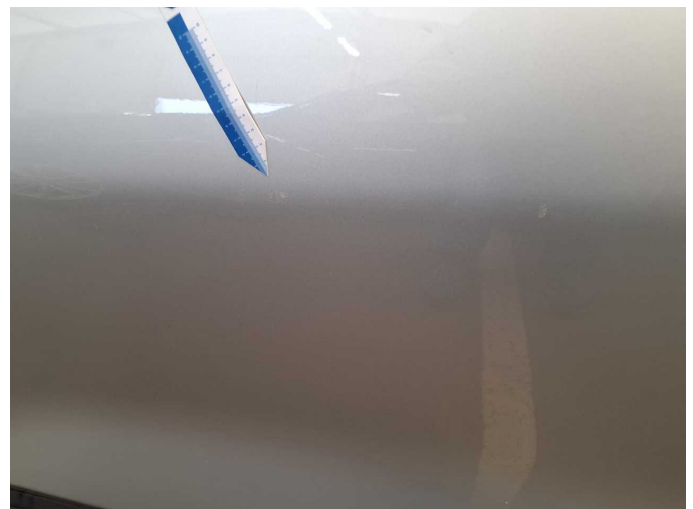
Damage 6: Door - front left side: Door - Scratch(es) - Paint

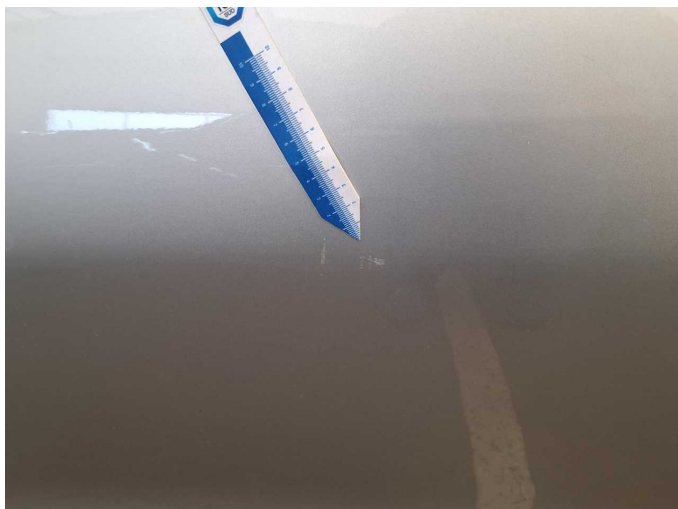
Damage 6: Door - front left side: Door - Scratch(es) - Paint
