Expertise

Protocol number: 46299685  
Order No. / Reference: 26622671  
Inspection date: 3 Jul 2026

Manufacturer: Ford

Model: Transit Custom 320 L2H1 LKW VA Aut. Trend

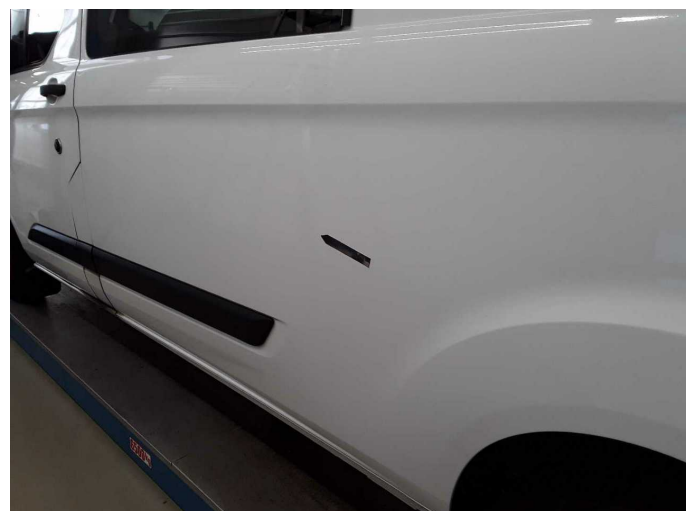
| No. | Component group | Description |
|---|---|---|
| 1 | Side panel - rear left side | Side panel - dent(s) - Smart repair |

**Damage 1:** Side panel - rear left side: Side panel - dent(s) - Smart repair

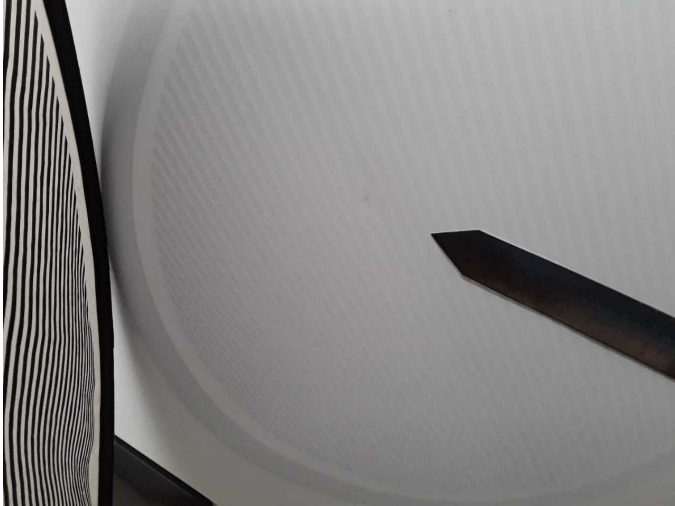
**Damage 1:** Side panel - rear left side: Side panel - dent(s) - Smart repair

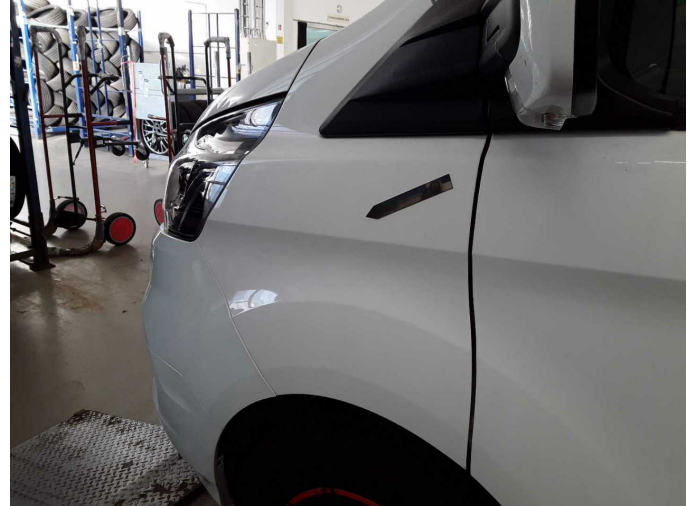
| No. | Component group | Description |
|---|---|---|
| 2 | Mudguard - left side | Mudguard - left side - dent(s) - Smart repair |

**Damage 2:** Mudguard - left side: Mudguard - left side - dent(s) - Smart repair

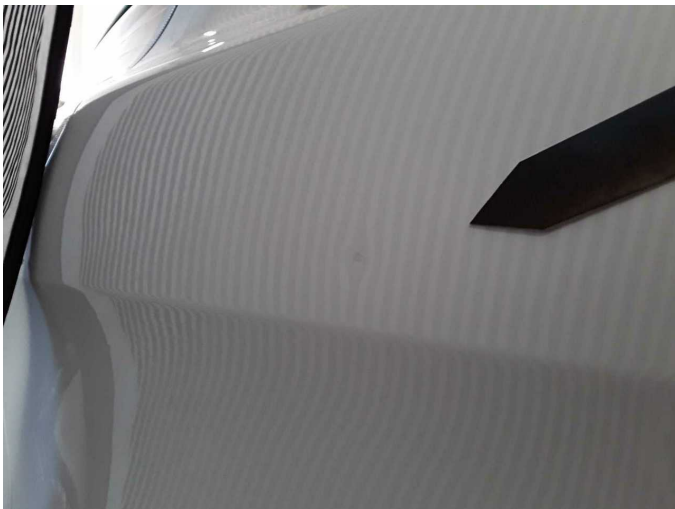
**Damage 2:** Mudguard - left side: Mudguard - left side - dent(s) - Smart repair
