Expertise

Protocol number: 46347368
Order No. / Reference: 26043063
Inspection date: 30 Jun 2026

Manufacturer: Mercedes-Benz

Model: Vito 116 CDI Tourer Lang Aut. PRO

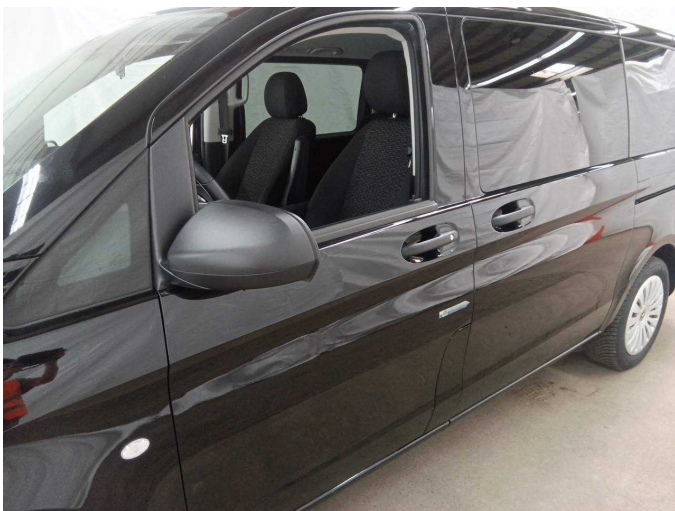
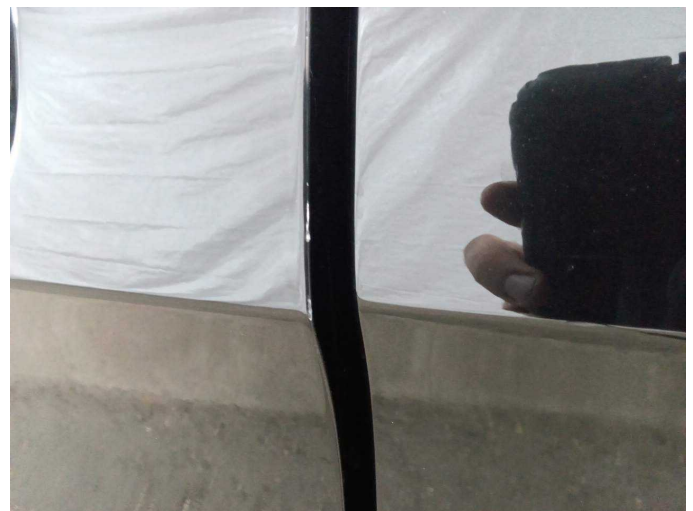
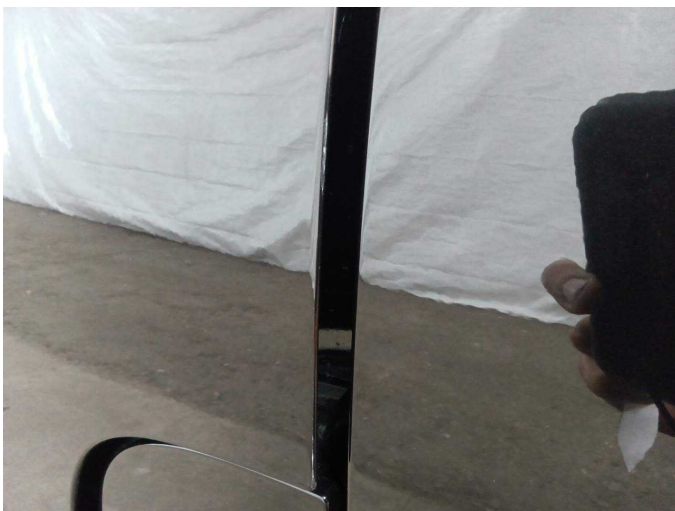
Damage 1: Door - front left side: Door edge - Scratch(es) - Smart repair

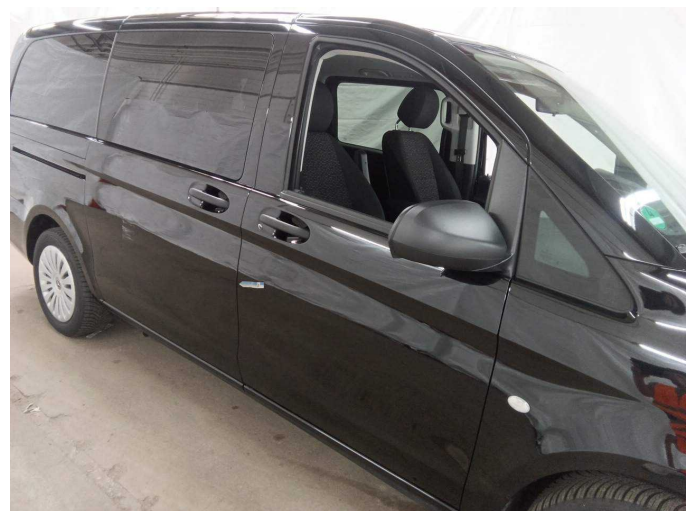
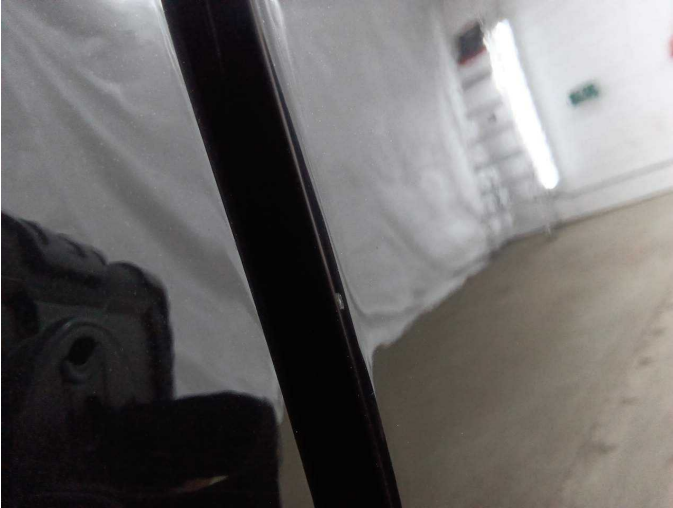
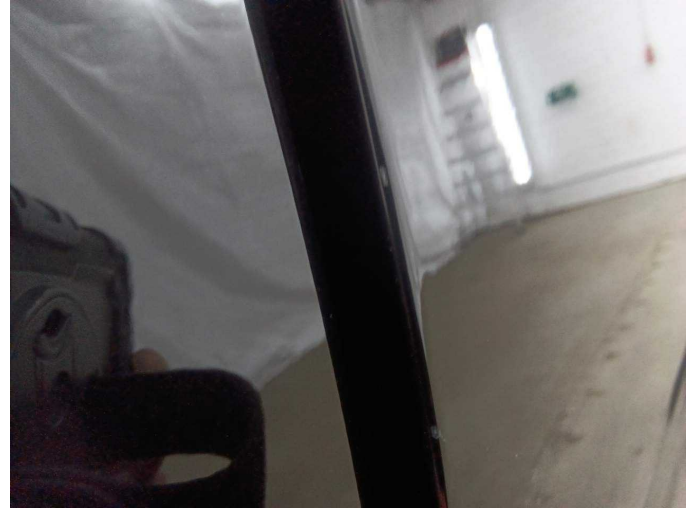
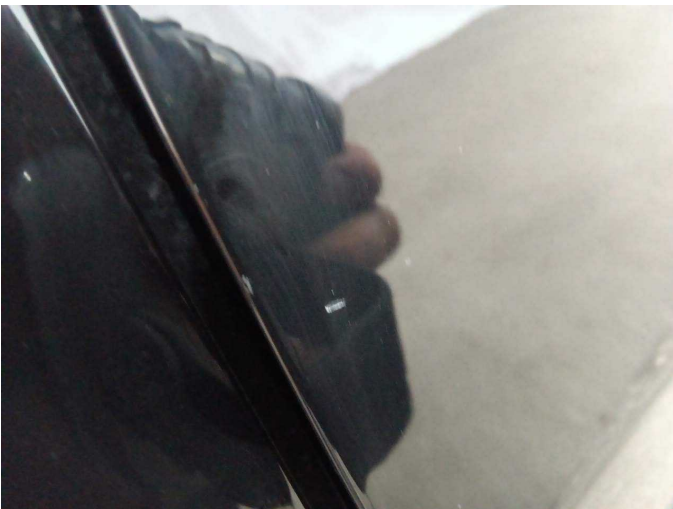
Damage 2: Door - front right side: Door edge - Scratch(es) - Smart repair

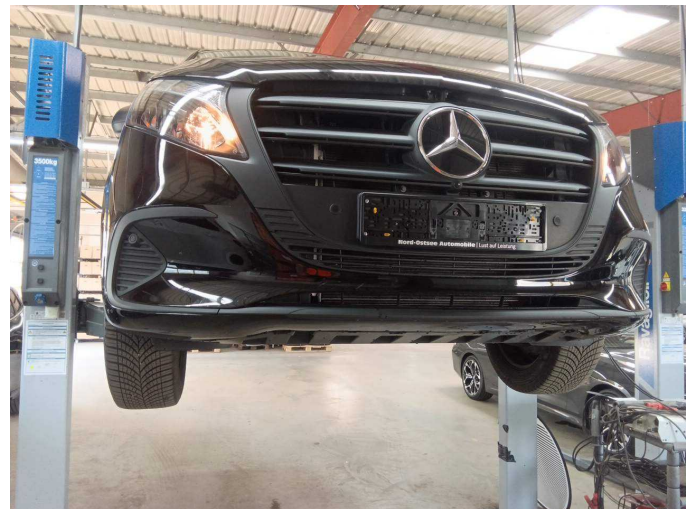
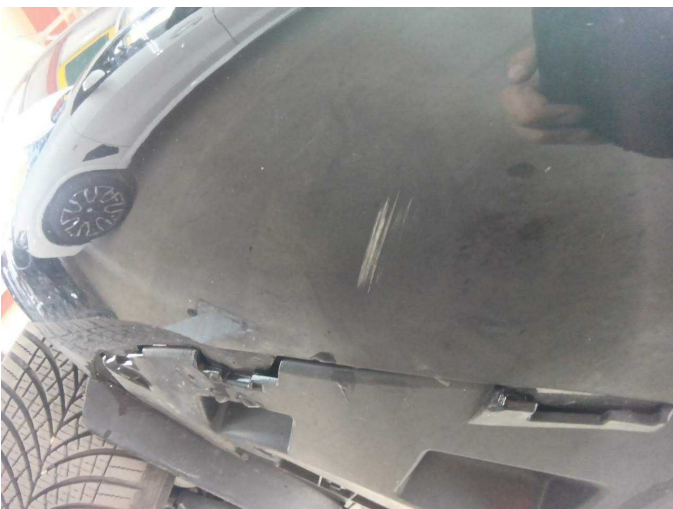
Damage 3: Front bumper: Front bumper - Scratch(es) - Smart repair

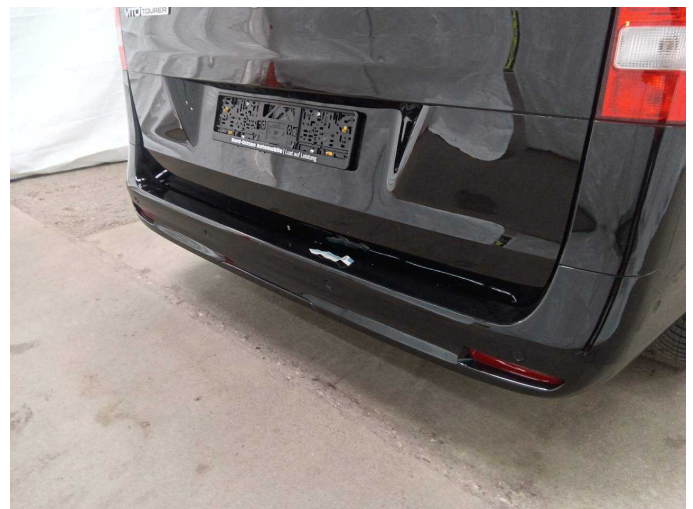
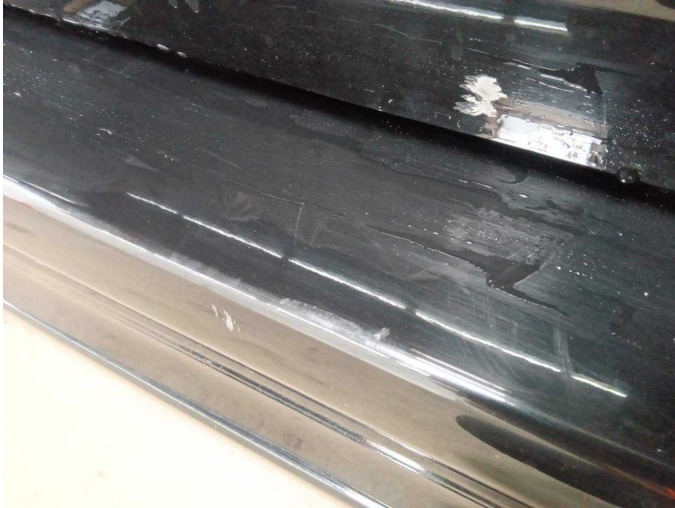
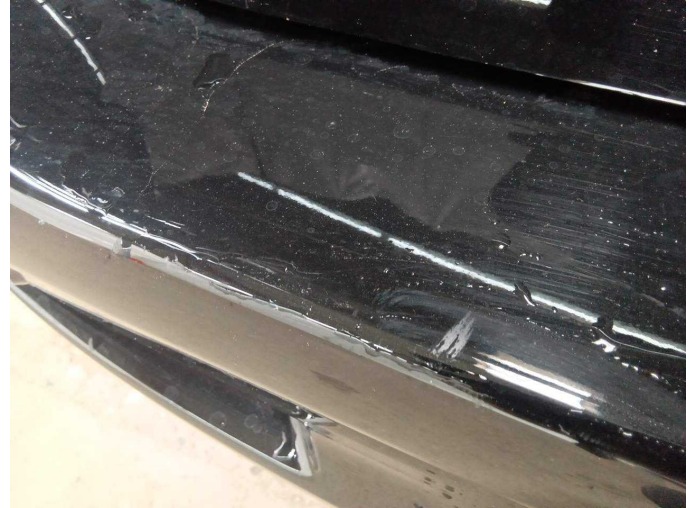
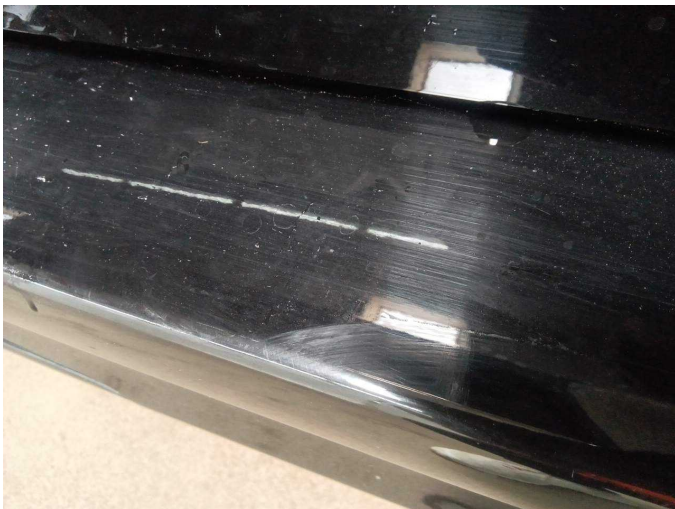
Damage 4: Rear bumper: Rear bumper - Scratch(es) - Paint

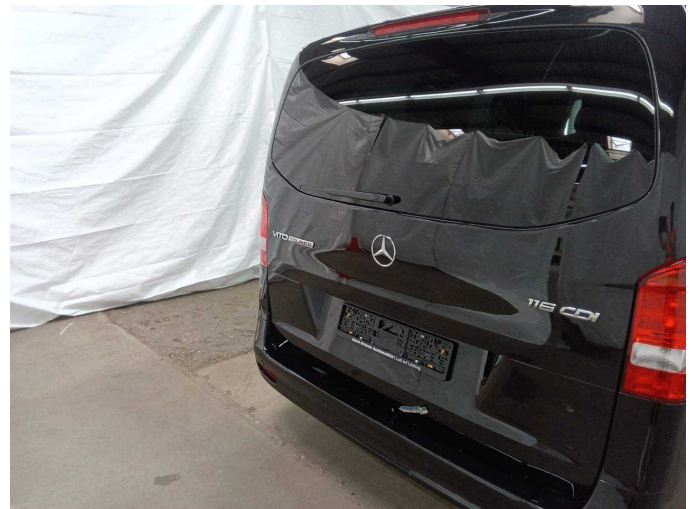
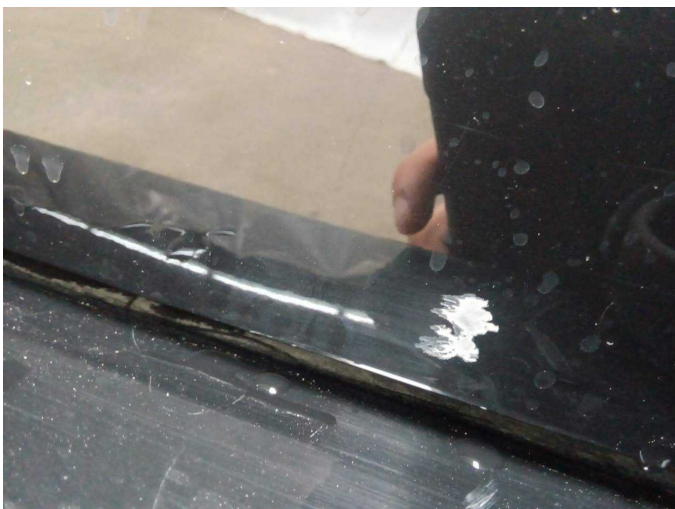
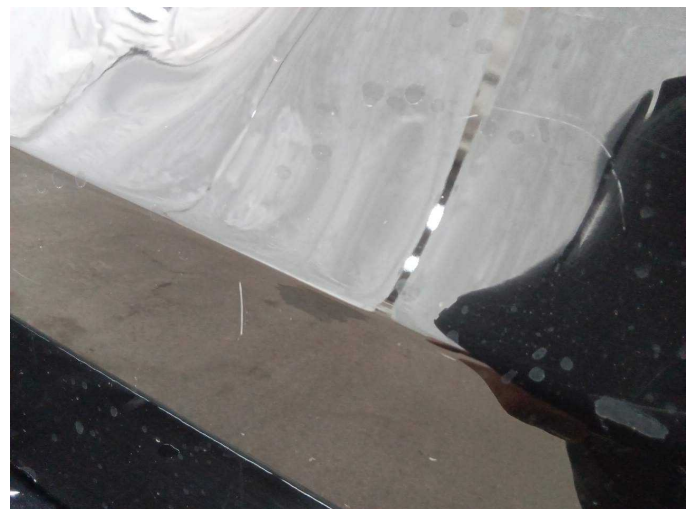
Damage 5: Boot lid / rear door: Boot lid - Scratch(es) - Paint

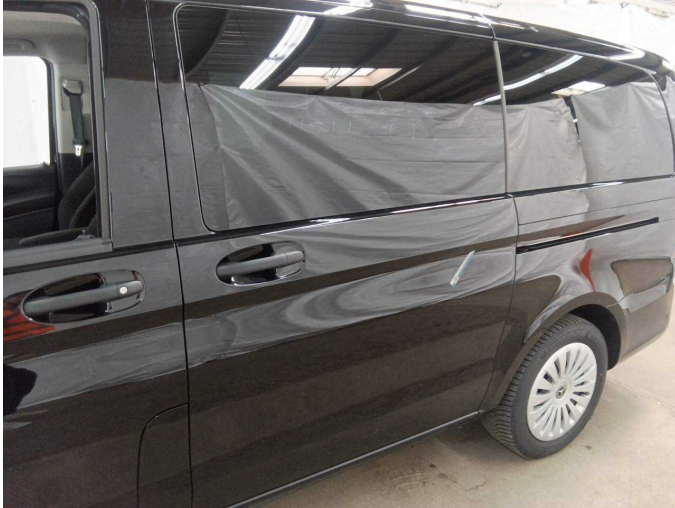
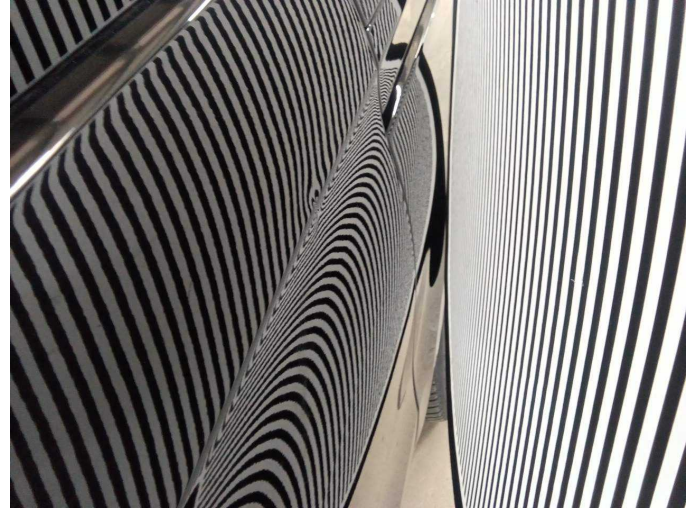
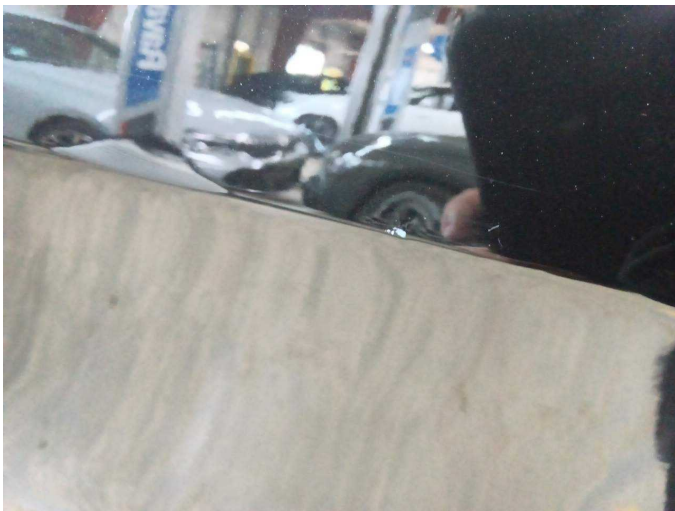
Damage 6: Sliding door - left side: Sliding door - Dent / paintcoat damage - Repair and paint

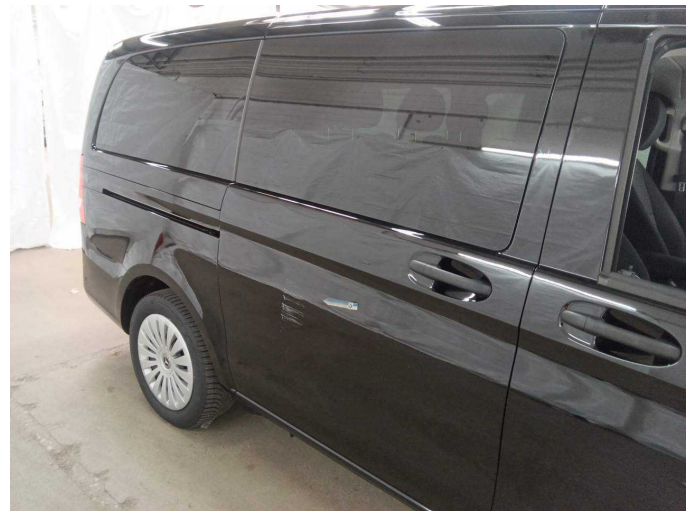
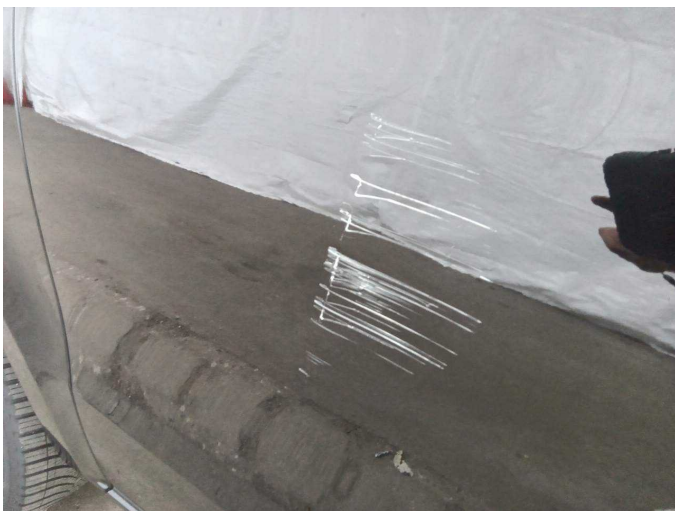
Damage 7: Sliding door, right: Sliding door - Scratched - Repair and paint

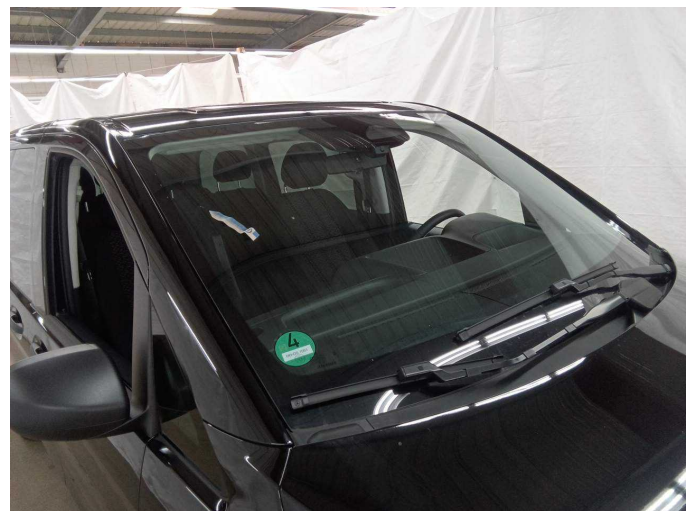
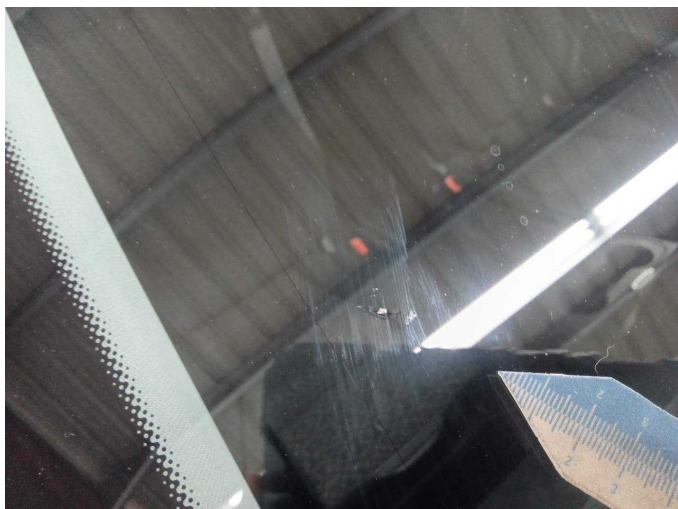
Damage 8: Vehicle glazing: Windscreen - Broken / torn - Replace
