## Expertise

Protocol number: 45947043  
Order No. / Reference: 26457222  
Inspection date: 15 Jun 2026

Model: 317 CDI Sprinter Standard HA 9G-TRONIC

VIN: W1V9076331P402270

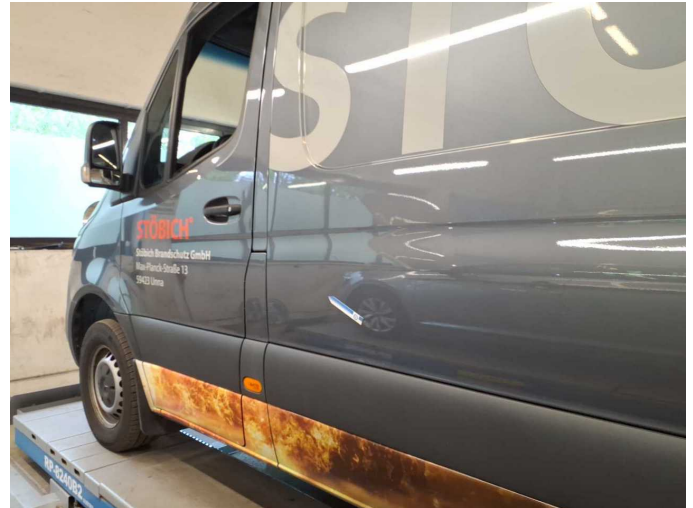
No.	Component group	Description
1	Misc.	Inspection / maintenance - No evidence - No deduction
2	Braking system	Brake fluid - No evidence - No deduction
3	Side panel - rear left side	Side panel - dent(s) - Smooth repair work
4	Body	B-pillar - right side - Scratch(es) - Smart repair
5	Body	Body - Glued / labelled - De-glue / neutralise
6	Rear of vehicle	Foot plate - Broken / torn - Replace
7	Bonnet	Bonnet - Stone chips - Paint
8	Sliding door, right	Sliding door - Scratch(es) - Paint

Damage 3: Side panel - rear left side: Side panel - dent(s) - Smooth repair work

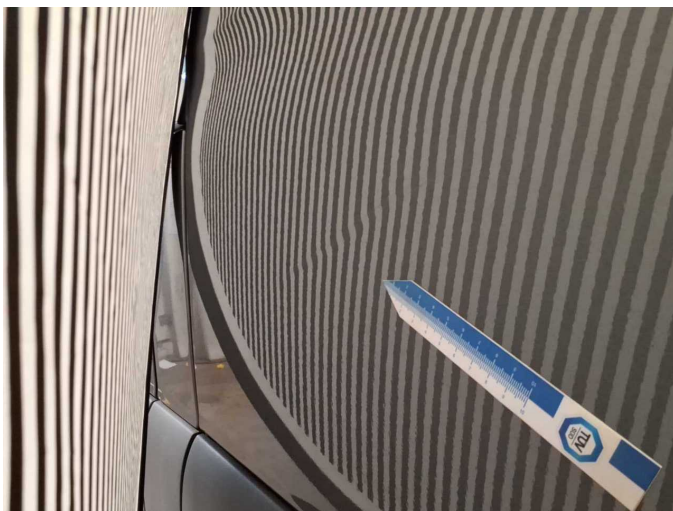
Damage 3: Side panel - rear left side: Side panel - dent(s) - Smooth repair work

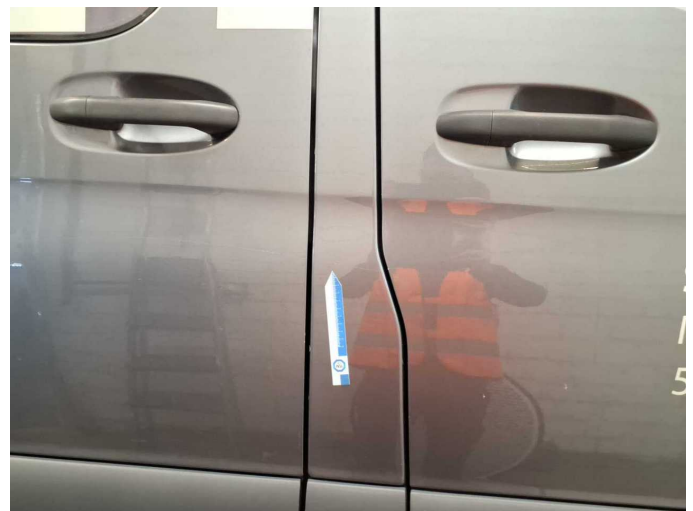
Damage 4: Body: B-pillar - right side - Scratch(es) - Smart repair

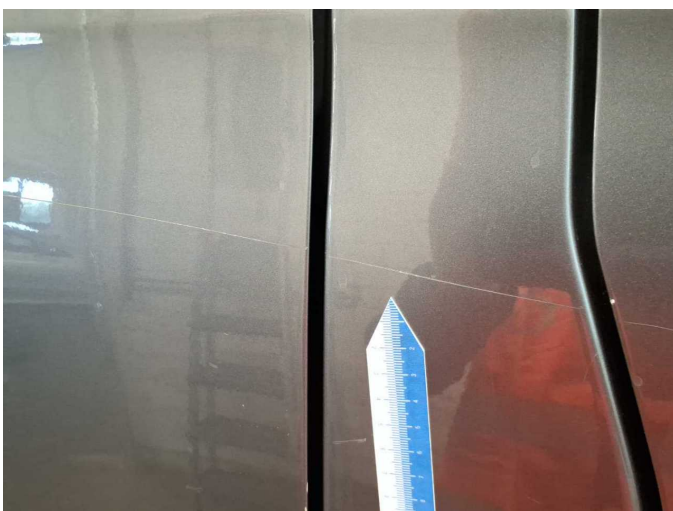
Damage 4: Body: B-pillar - right side - Scratch(es) - Smart repair

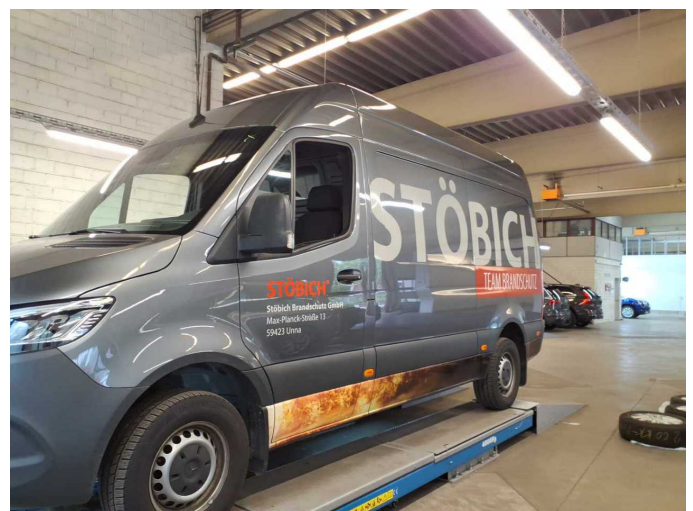
Damage 5: Body: Body - Glued / labelled - De-glug / neutralise

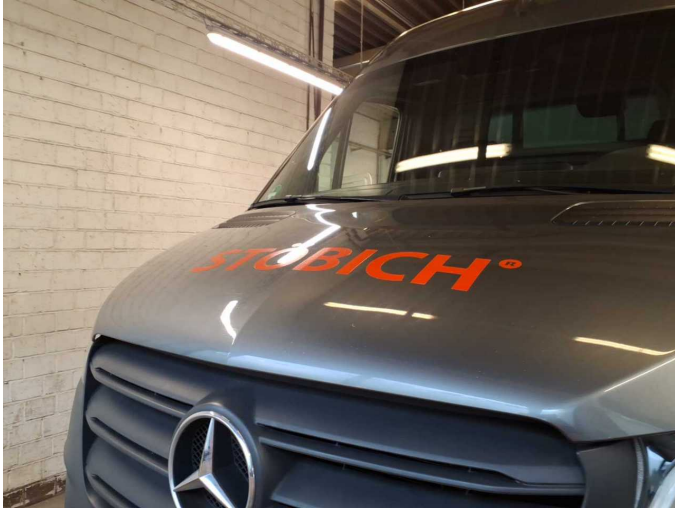
**Damage 5:** Body: Body - Glued / labelled - De-glude / neutralise

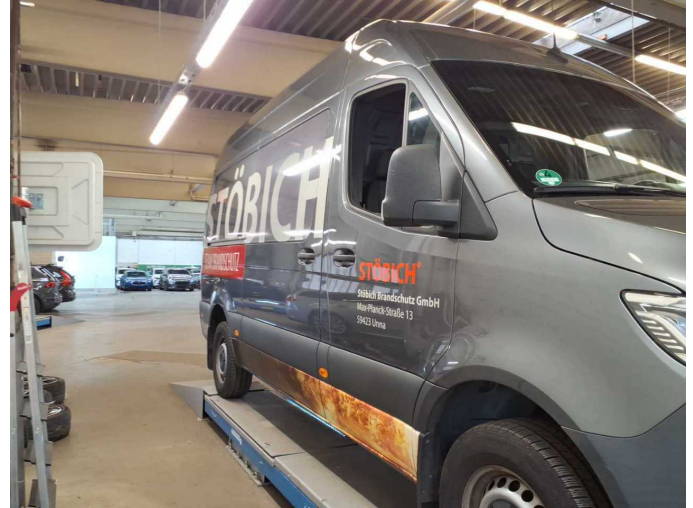
**Damage 5:** Body: Body - Glued / labelled - De-glude / neutralise

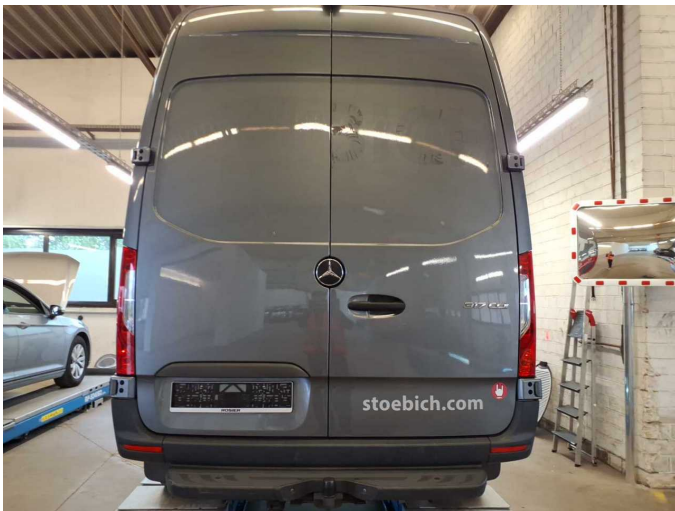
**Damage 5:** Body: Body - Glued / labelled - De-glude / neutralise

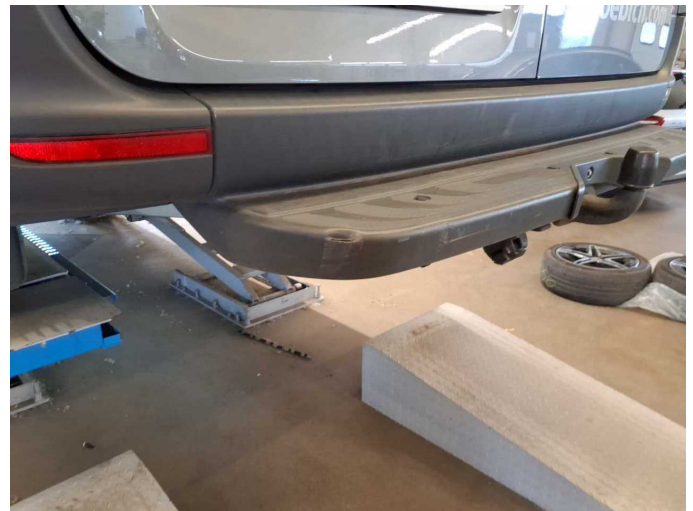
**Damage 6:** Rear of vehicle: Foot plate - Broken / torn - Replace

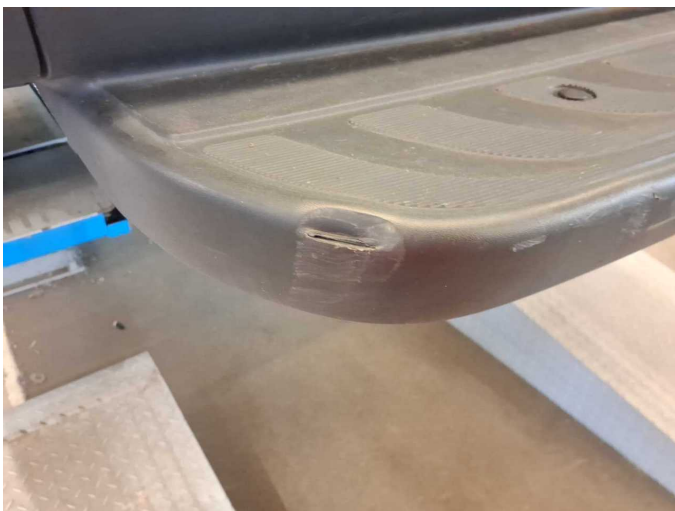
**Damage 6:** Rear of vehicle: Foot plate - Broken / torn - Replace

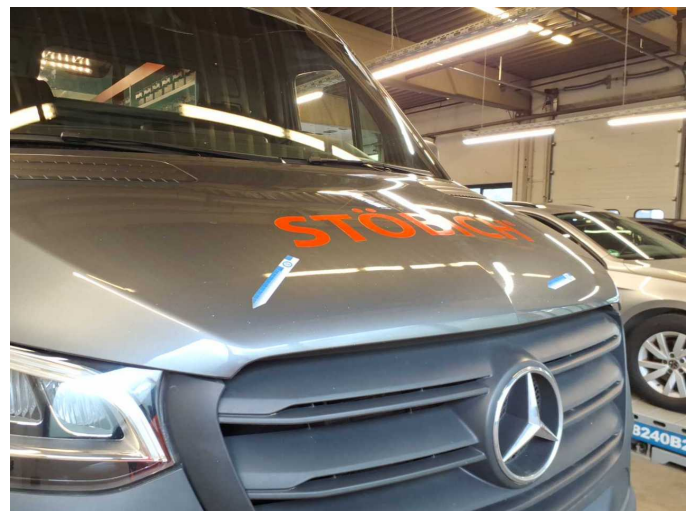
**Damage 7:** Bonnet: Bonnet - Stone chips - Paint

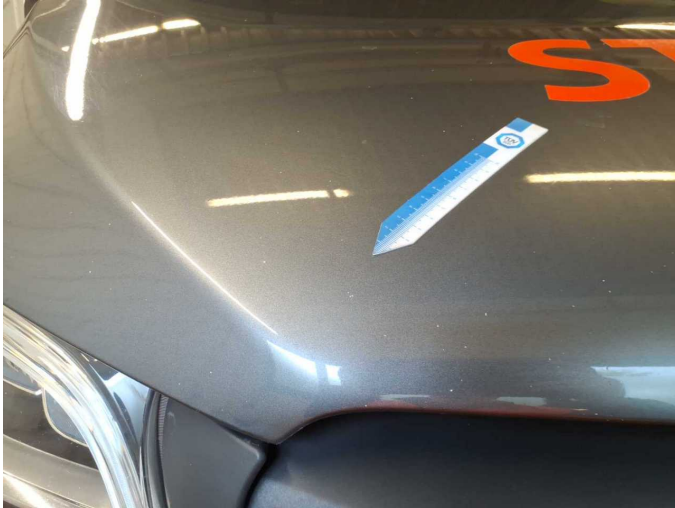
**Damage 7:** Bonnet: Bonnet - Stone chips - Paint

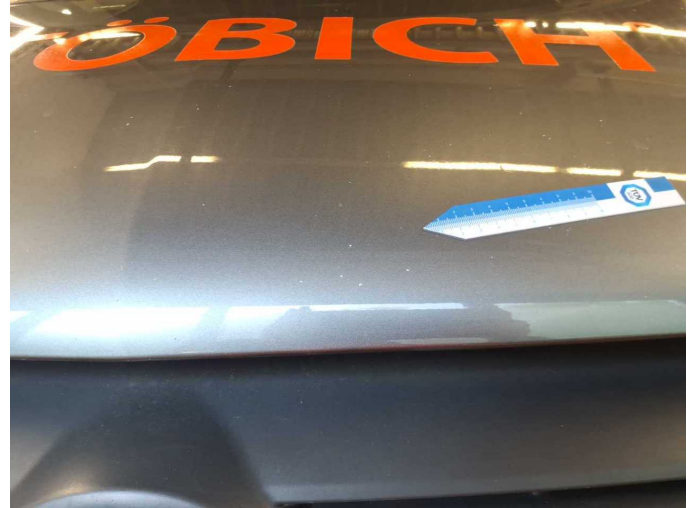
**Damage 7:** Bonnet: Bonnet - Stone chips - Paint

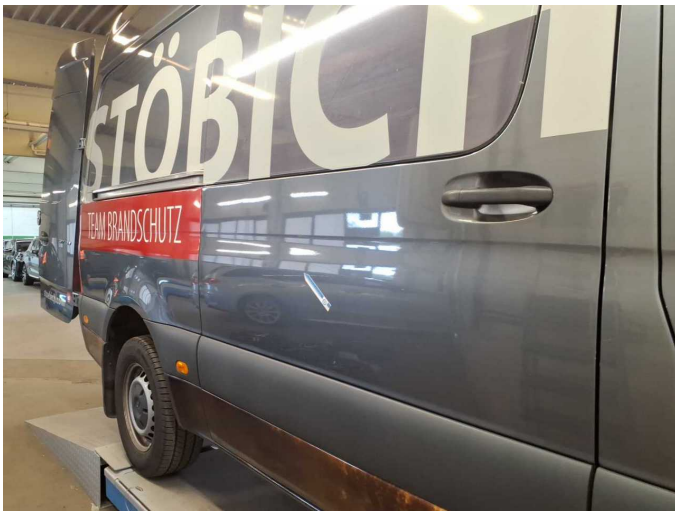
**Damage 8:** Sliding door, right: Sliding door - Scratch(es) - Paint

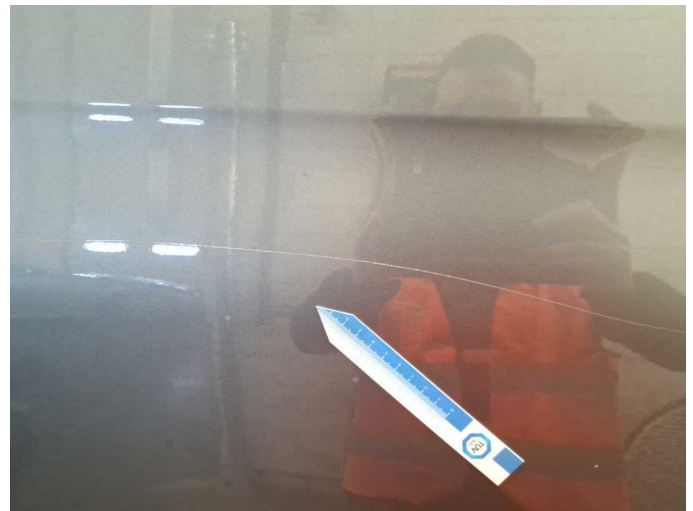
**Damage 8:** Sliding door, right: Sliding door - Scratch(es) - Paint

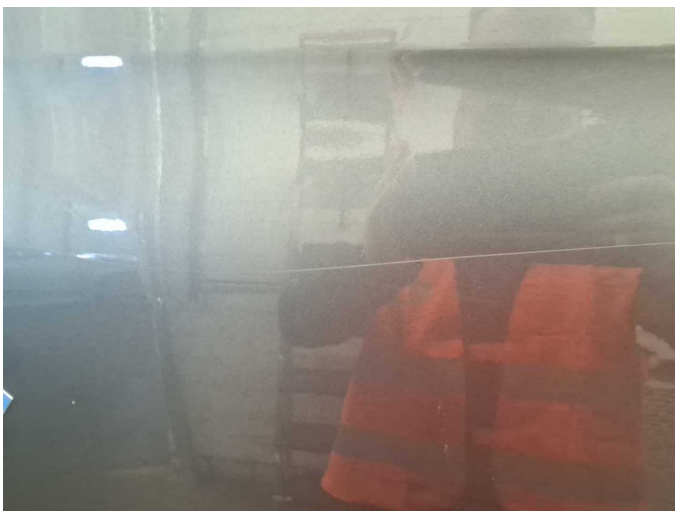
**Damage 8:** Sliding door, right: Sliding door - Scratch(es) - Paint

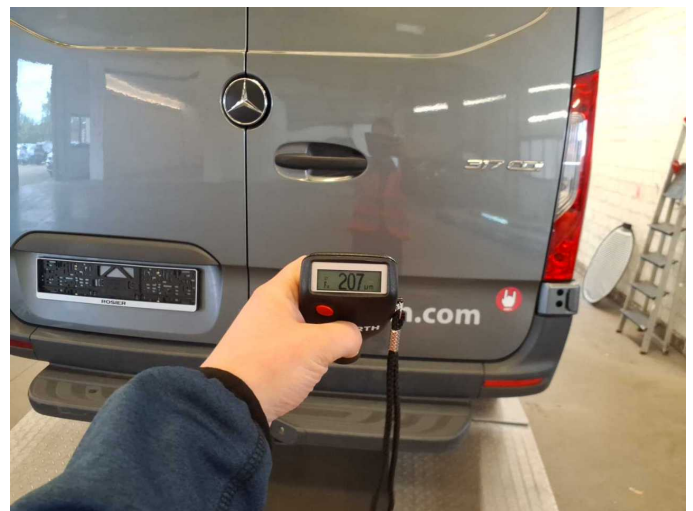
**Repainting 1:** Boot lid / rear door

1 Boot lid / rear door, Professionally carried out, Invoice of repair done Non-existent

Boot lid / rear door 207 µm |
