Expertise

Protocol number: 46225453
Order No. / Reference: 26484675
Inspection date: 29 Jun 2026

Model: Transit Connect 250 L2 Trend

VIN: WF0SXXWPGSNJ44633

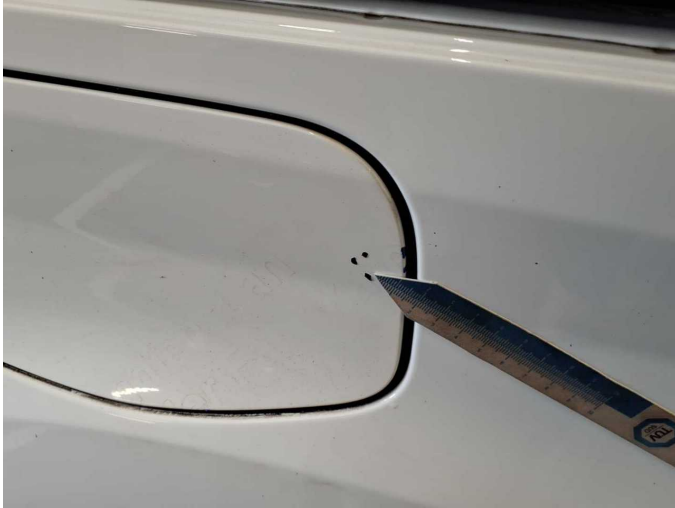
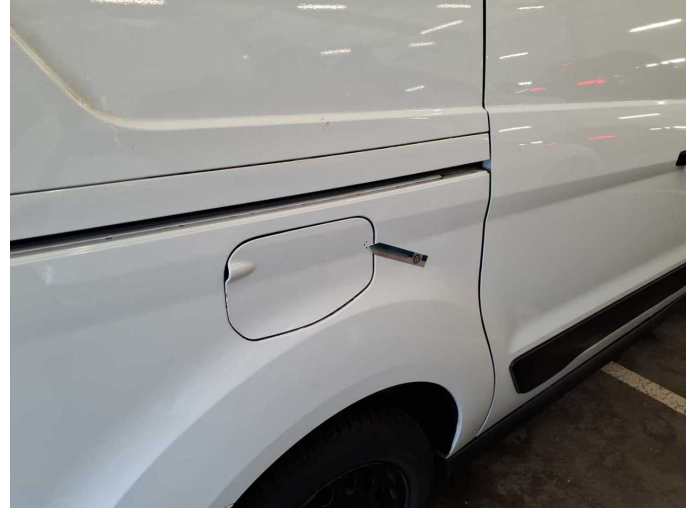
Damage 1: Fuel system: Tank cap - Scratch(es) - Smart repair

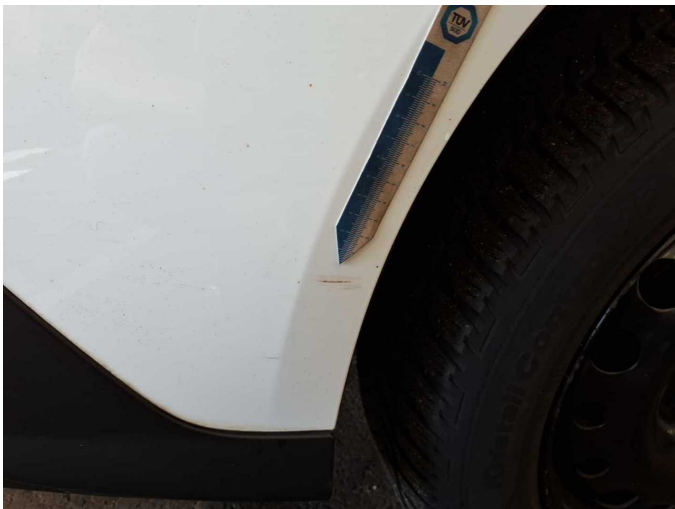
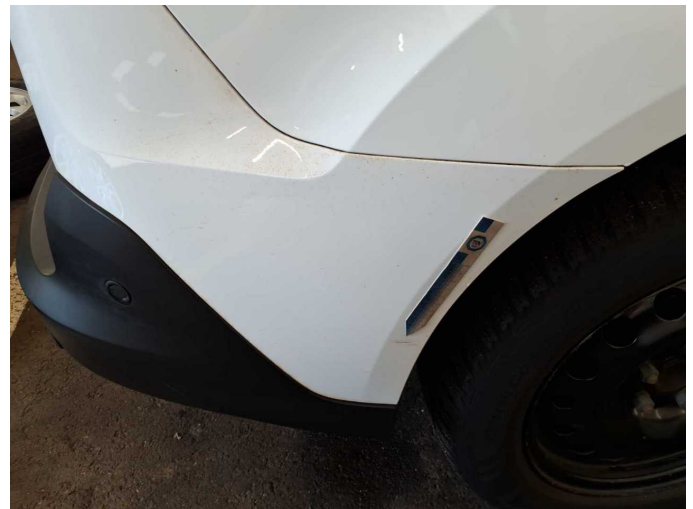
Damage 2: Rear bumper: Rear bumper - Scratch(es) - Smart repair

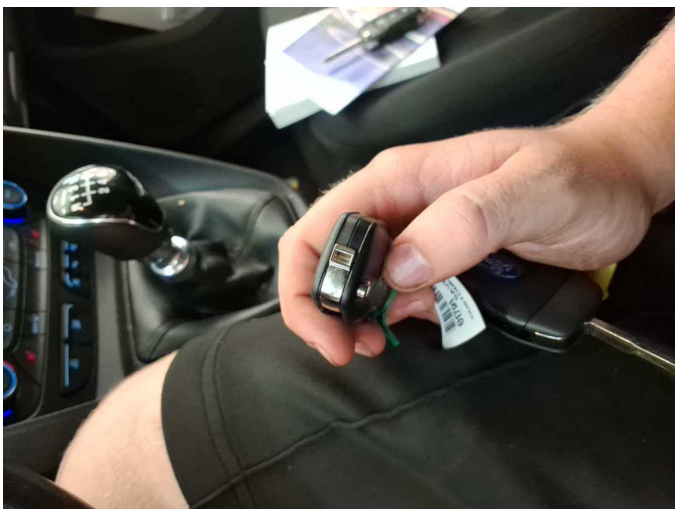
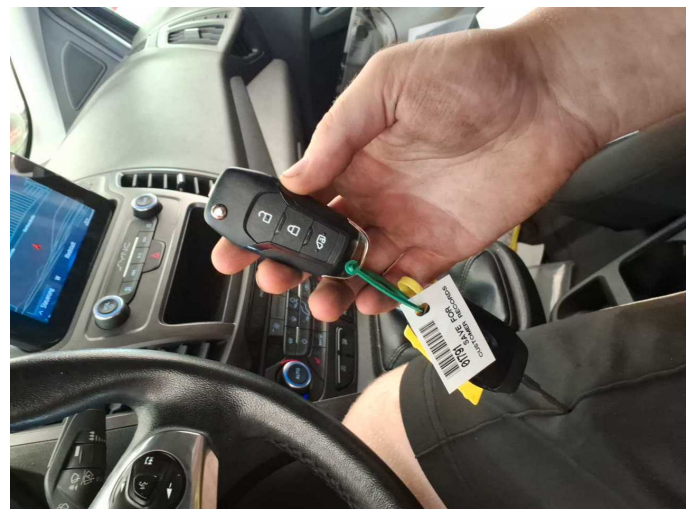
Damage 3: Equipment: Vehicle key - Damaged - Replace

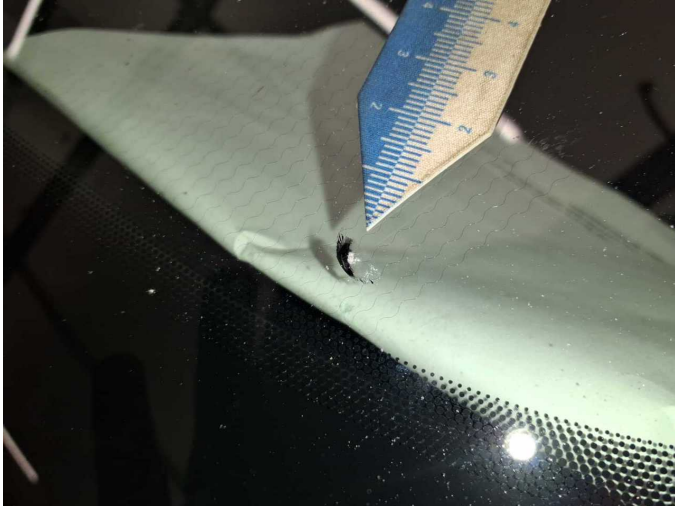
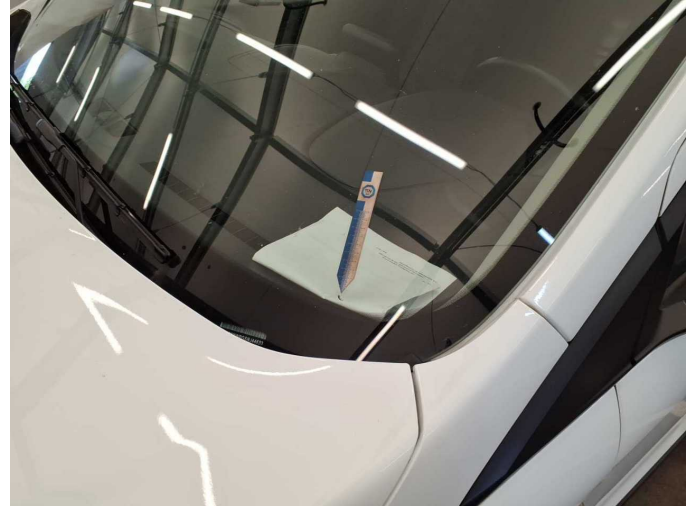
Damage 4: Vehicle glazing: Windscreen - Broken / torn - Replace

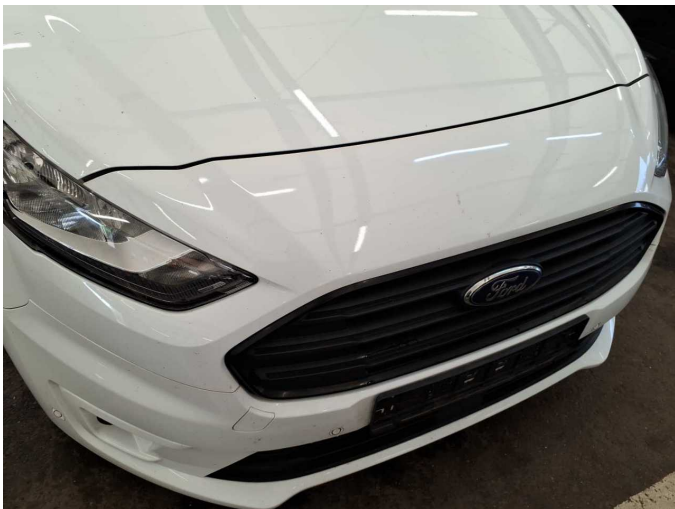
Wear and tear 1: Front bumper: Front bumper - Stone chips - No deduction

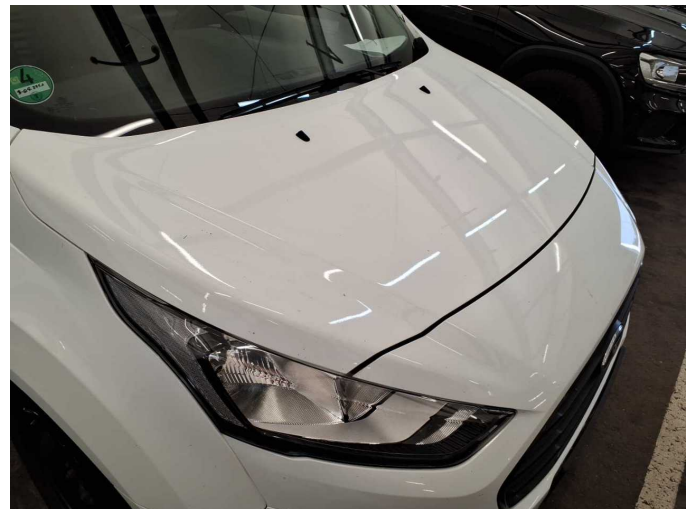
Wear and tear 2: Front bumper: Front bumper - Stone chips - No deduction

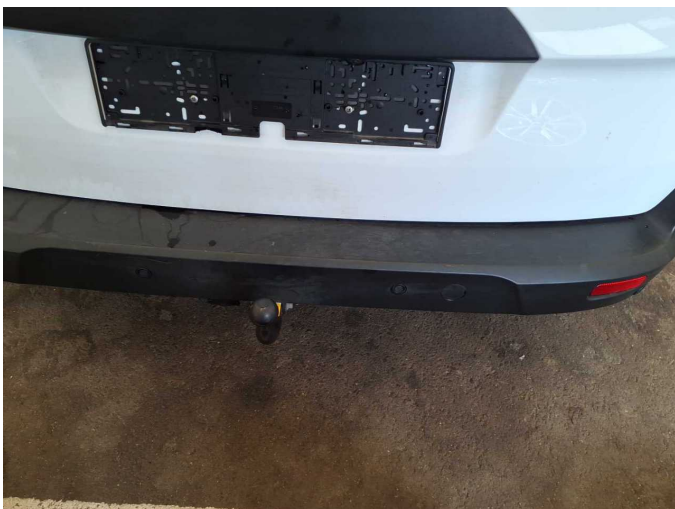
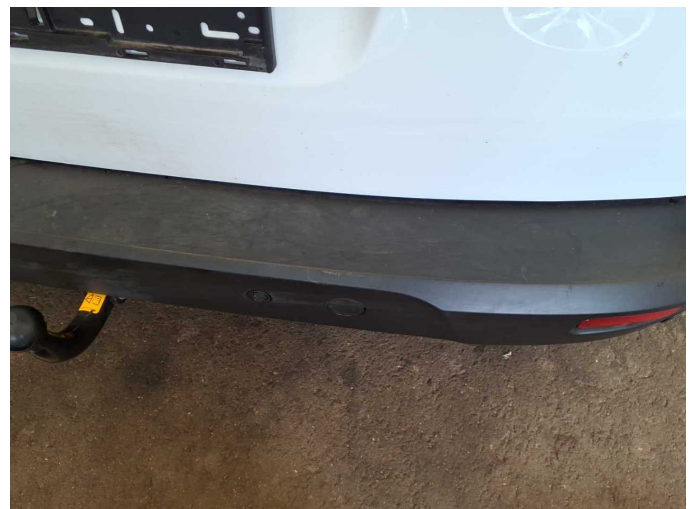
Wear and tear 4: Rear bumper: Rear bumper (unpainted) - Scratch(es) - No deduction

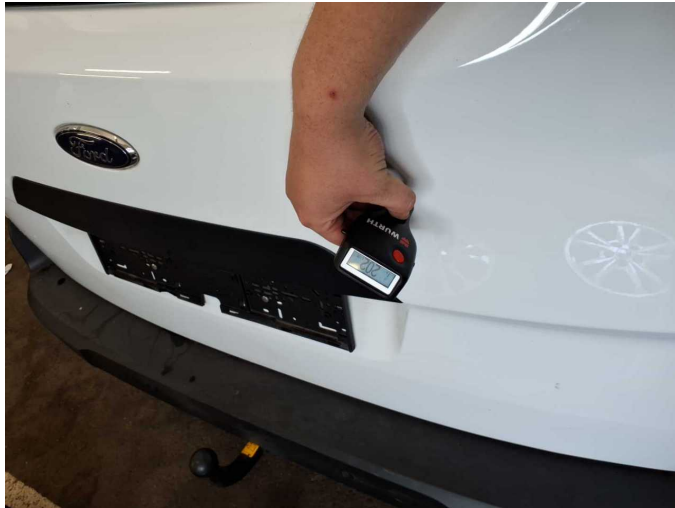
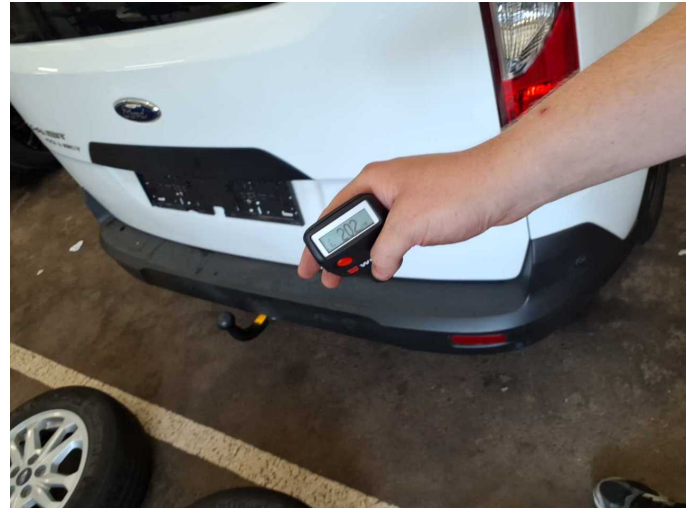
Boot lid / rear door	202 µm	Side panel - rear right side	150 µm
----------------------	--------	------------------------------	--------

Repainting 1: Boot lid / rear door

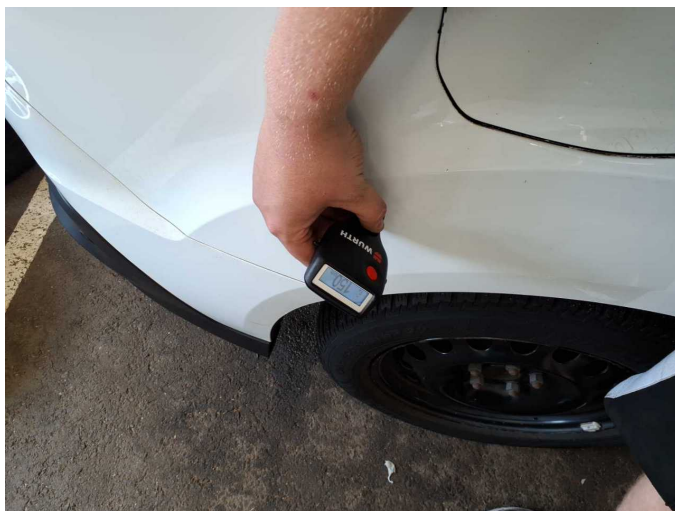
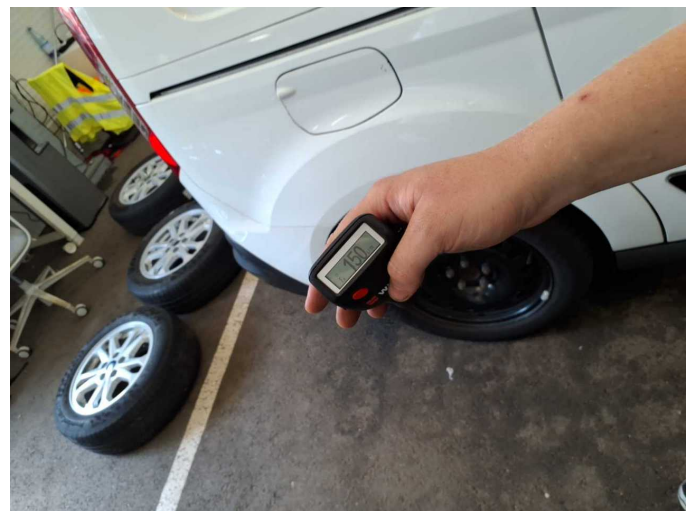
Repainting 2: Side panel - rear right side
