Expertise

Protocol number: 46673051  
Order No. / Reference: 26687745  
Inspection date: 23 Jul 2026

| Manufacturer: Opel | Model: Astra 1.5 D Start/Stop Sports Tourer Automatik Edition |

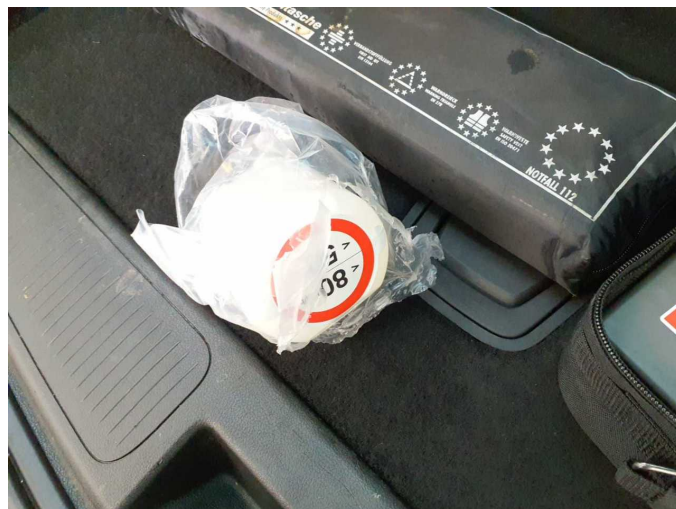
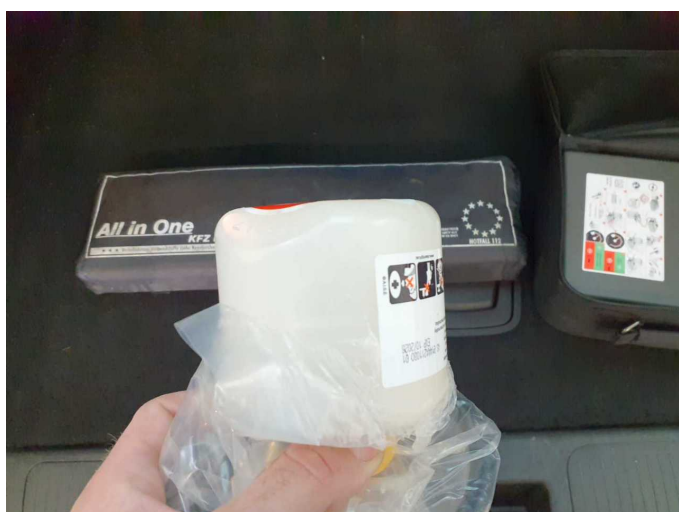
| No. | Component group | Description |
|---|---|---|
| 1 | Equipment | Tirefit filler - Empty - Replace |

**Damage 1:** Equipment: Tirefit filler - Empty - Replace

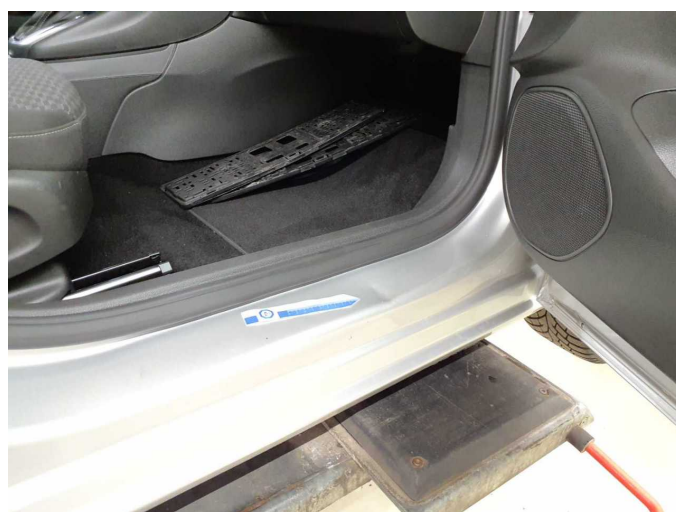
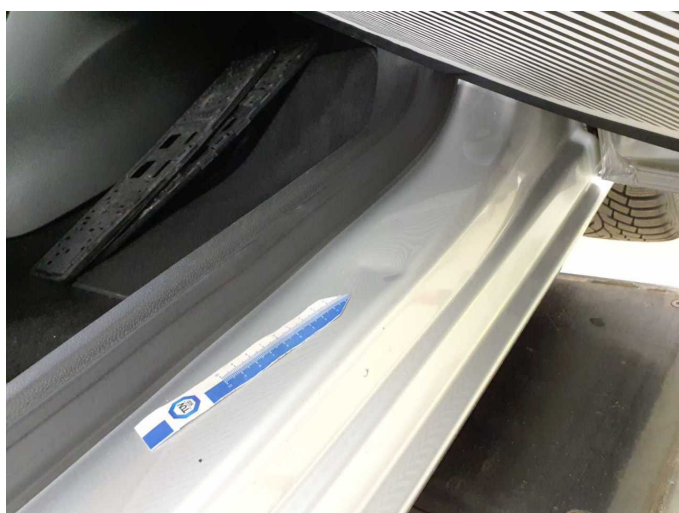
| No. | Component group | Description |
|---|---|---|
| 2 | Sill - right side | Sill - dent(s) - Smart repair |

**Damage 2:** Sill - right side: Sill - dent(s) - Smart repair

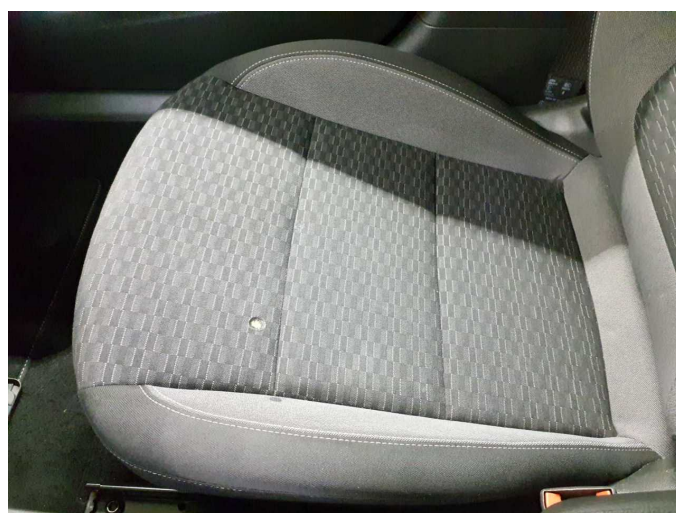
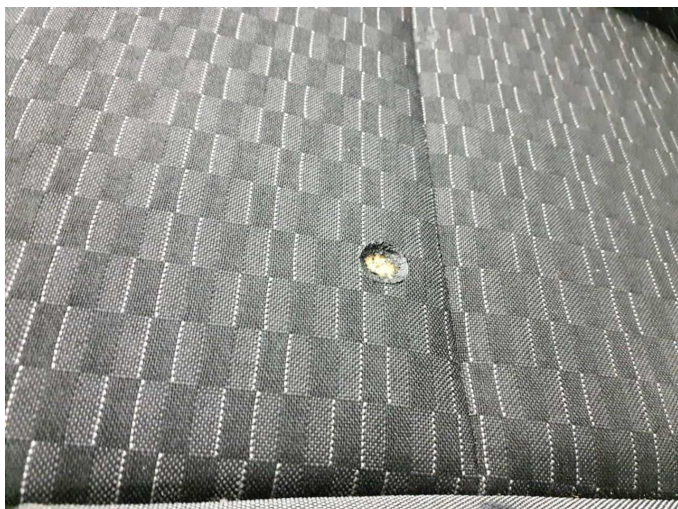
| No. | Component group | Description |
|---|---|---|
| 3 | Seat - front | Seat cover - right side - Burn hole (cigarettes) - Smart repair |

**Damage 3:** Seat - front: Seat cover - right side - Burn hole (cigarettes) - Smart repair

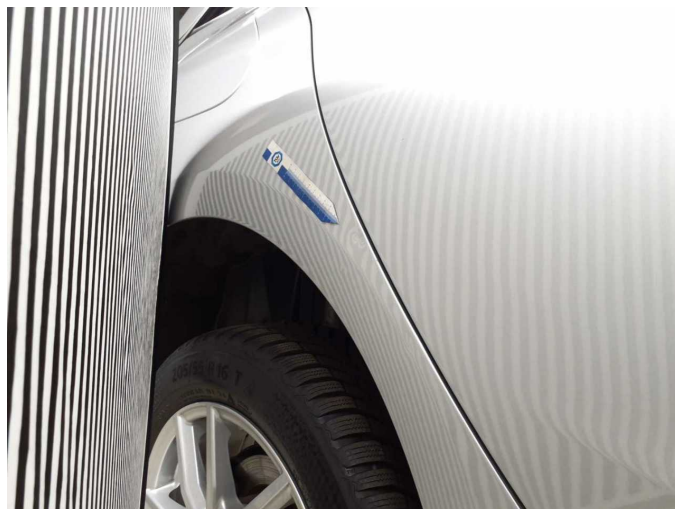
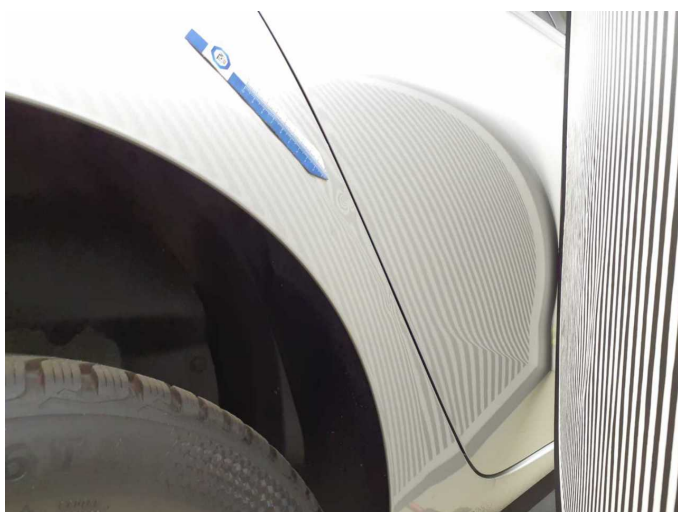
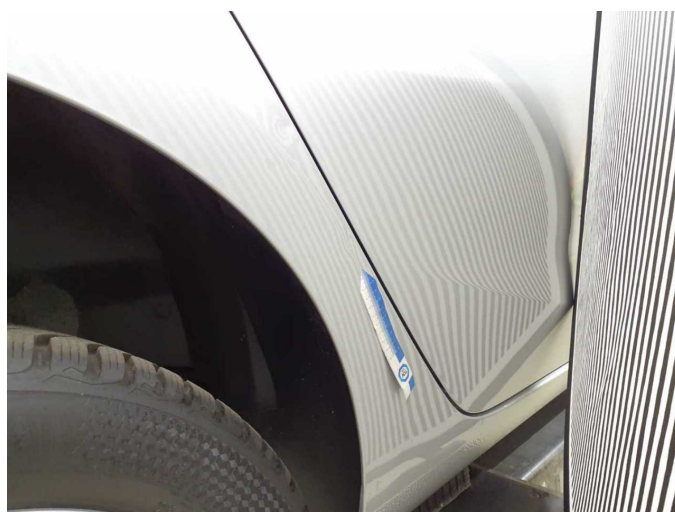
| No. | Component group | Description |
|---|---|---|
| 4 | Side panel - rear right side | Side panel - dent(s) - Smart repair |

**Damage 4:** Side panel - rear right side: Side panel - dent(s) - Smart repair

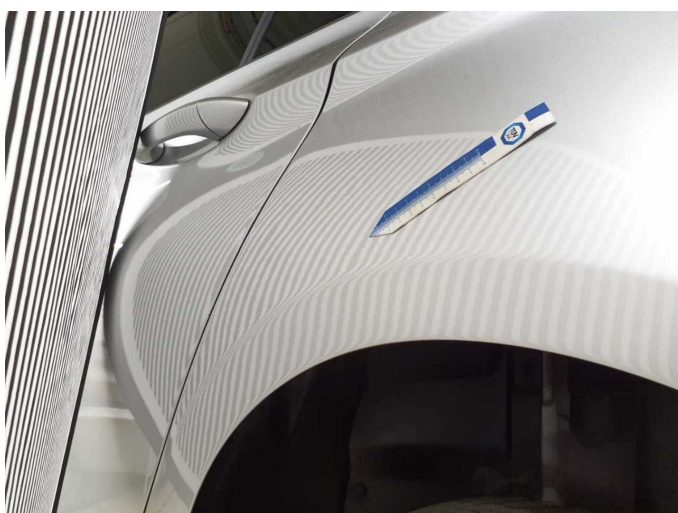
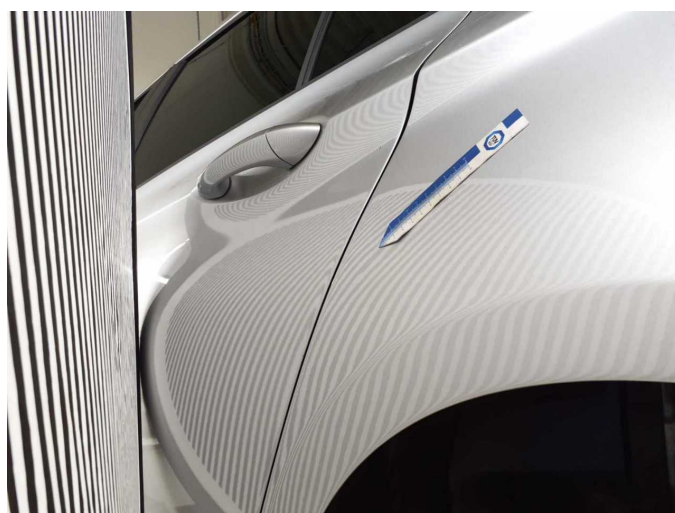
| No. | Component group | Description |
|---|---|---|
| 3 | Side panel - rear left side | Side panel - dent(s) - No deduction |

**Wear and tear 3:** Side panel - rear left side: Side panel - dent(s) - No deduction

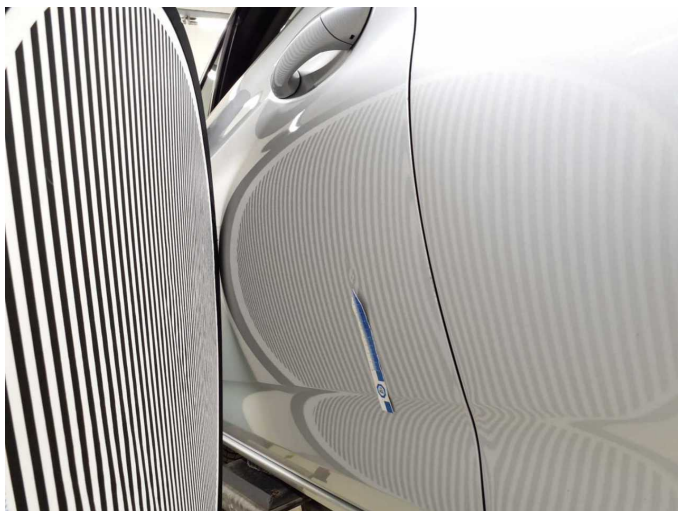
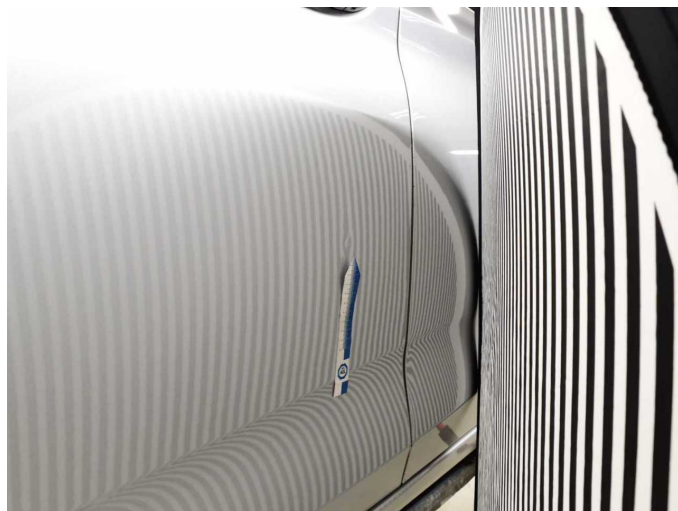
| No. | Component group | Description |
|---|---|---|
| 4 | Door - front left side | Door - dent(s) - No deduction |

**Wear and tear 4:** Door - front left side: Door - dent(s) - No deduction

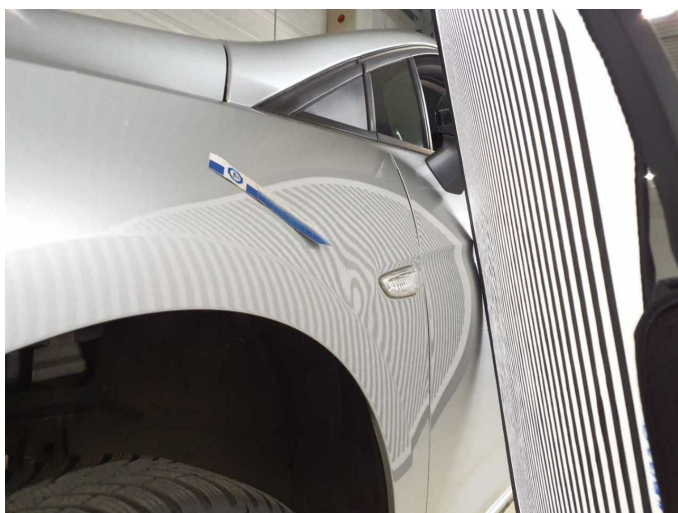
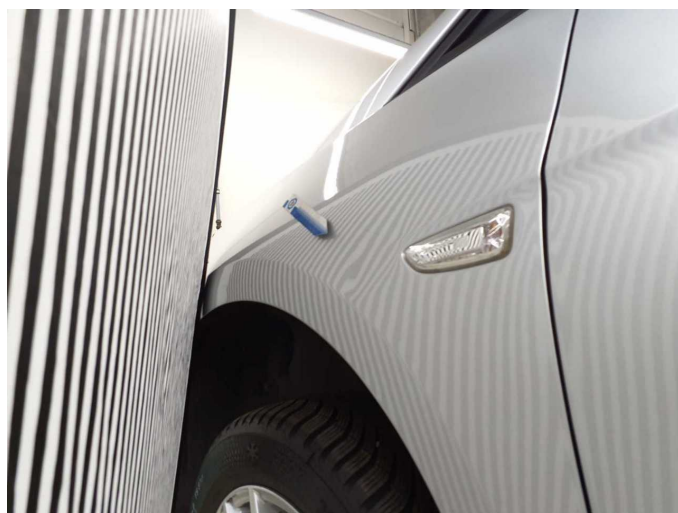
| No. | Component group | Description |
|---|---|---|
| 5 | Mudguard - left side | Mudguard - left side - dent(s) - No deduction |

**Wear and tear 5:** Mudguard - left side: Mudguard - left side - dent(s) - No deduction

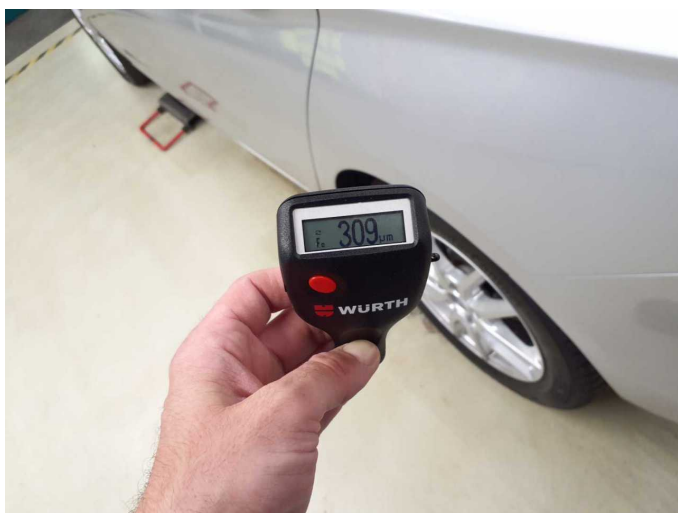
| 1 | Side panel - rear left side |

| Side panel - rear left side | 309 µm |

**Side panel - rear left side:** 309 µm
