Expertise

Protocol number: 46363941  
Order No. / Reference: 26642381  
Inspection date: 3 Jul 2026

Manufacturer: Ford

Model: Kuga 1.5 EcoBlue Aut. TITANIUM X

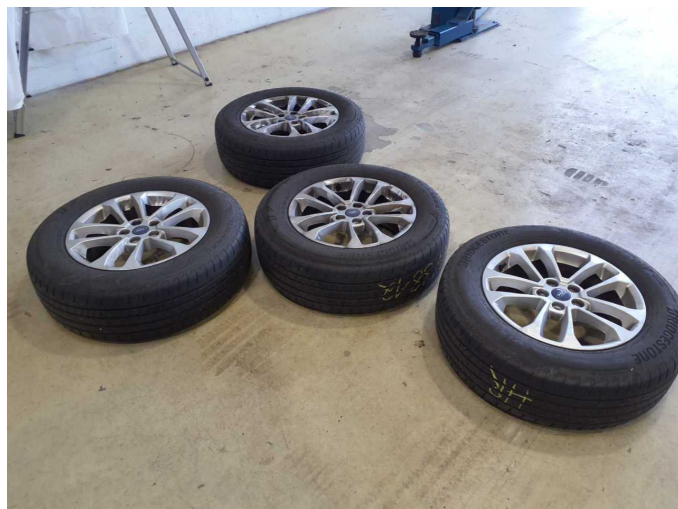
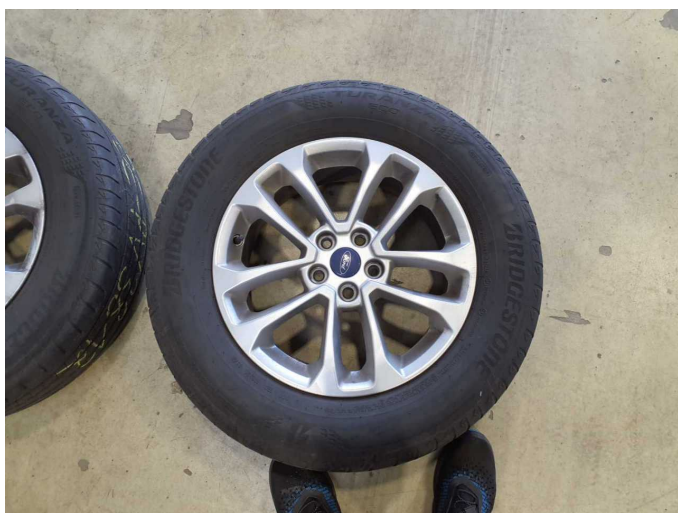
Figure 14: Additional tyres

| Tyres | | | | |
|---|---|---|---|---|
| 1) | 225/65 R17 102V | Summer tyres on Light alloy | Bridgestone | 2mm / 2mm |
| 2) | 225/65 R17 102V | Summer tyres on Light alloy | Bridgestone | 3mm / 3mm |

| No. | Component group | Description |
|---|---|---|
| 2 | 2nd wheel set | 2 tyres (Über 2mm) - No deduction |

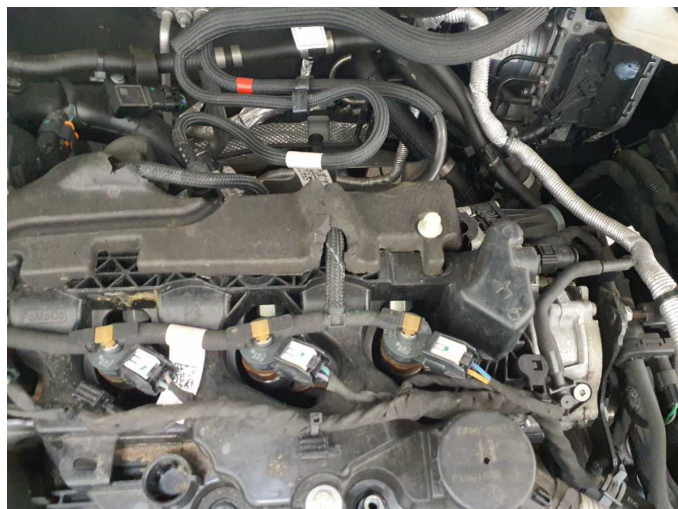
| No. | Component group | Description |
|---|---|---|
| 1 | Engine | Engine cover - Broken / torn - Replace |

**Damage 1:** Engine: Engine cover - Broken / torn - Replace

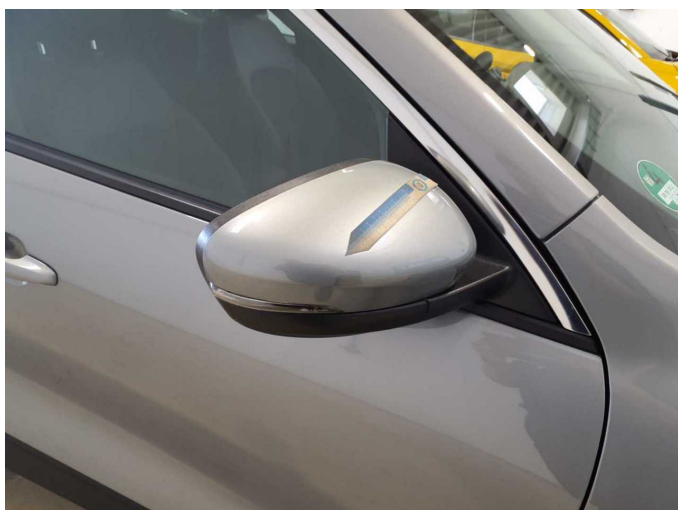
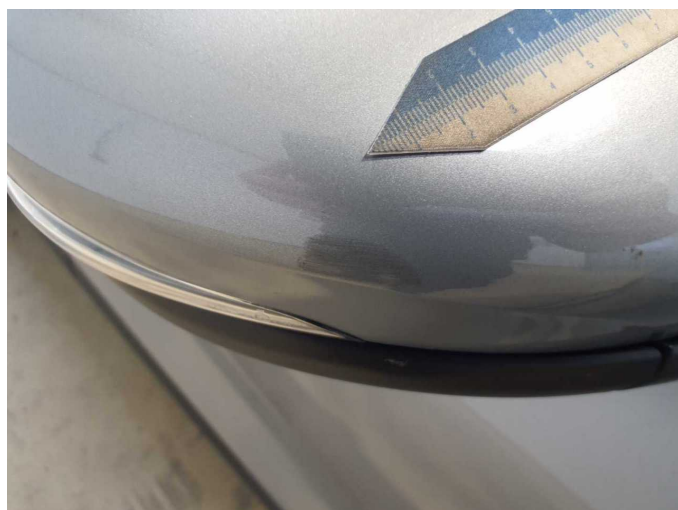
| No. | Component group | Description |
|---|---|---|
| 2 | Wing mirror - right side | Cap - Scratch(es) - Smart repair |

**Damage 2:** Wing mirror - right side: Cap - Scratch(es) - Smart repair

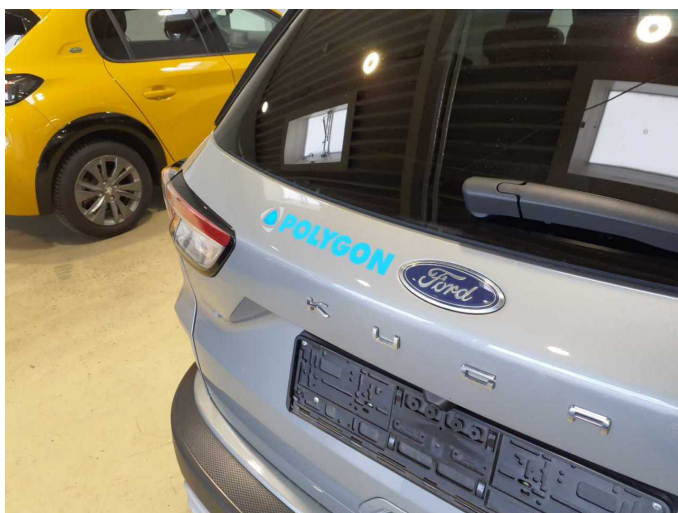
| No. | Component group | Description |
|---|---|---|
| 3 | Boot lid / rear door | Boot lid - Glued / labelled - De-glue / neutralise |

**Damage 3:** Boot lid / rear door: Boot lid - Glued / labelled - De-glue / neutralise

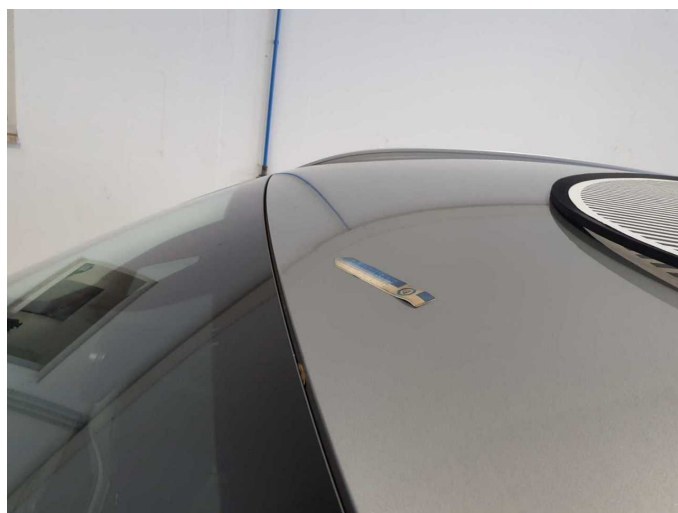
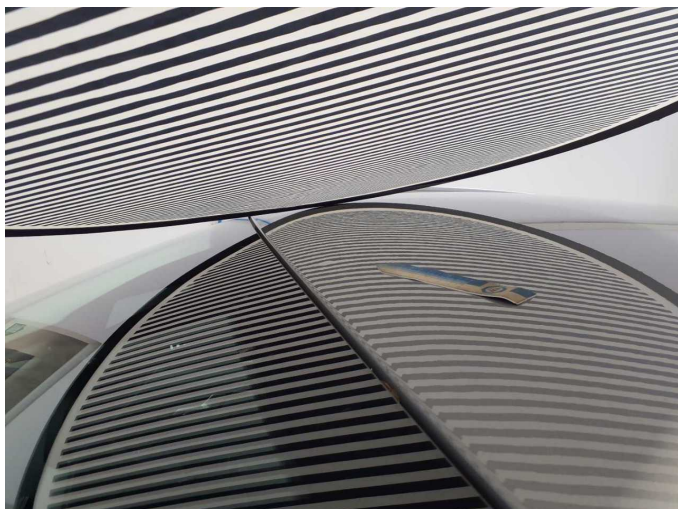
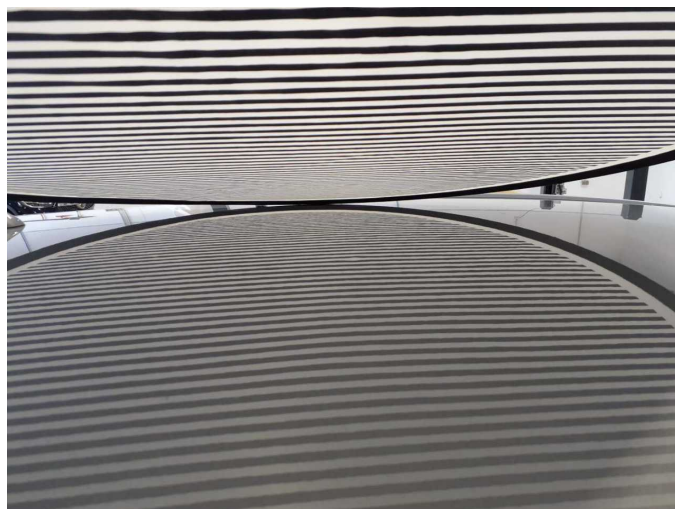
| No. | Component group | Description |
|---|---|---|
| 4 | Roof | Roof - dent(s) - Smooth repair work |

**Damage 4:** Roof: Roof - dent(s) - Smooth repair work

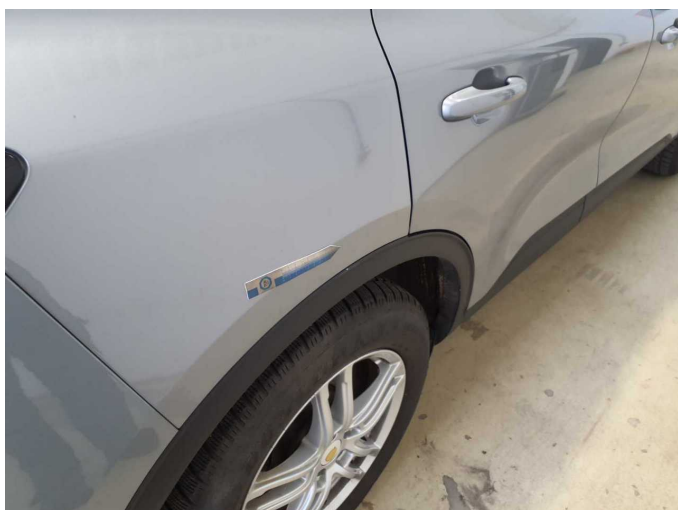
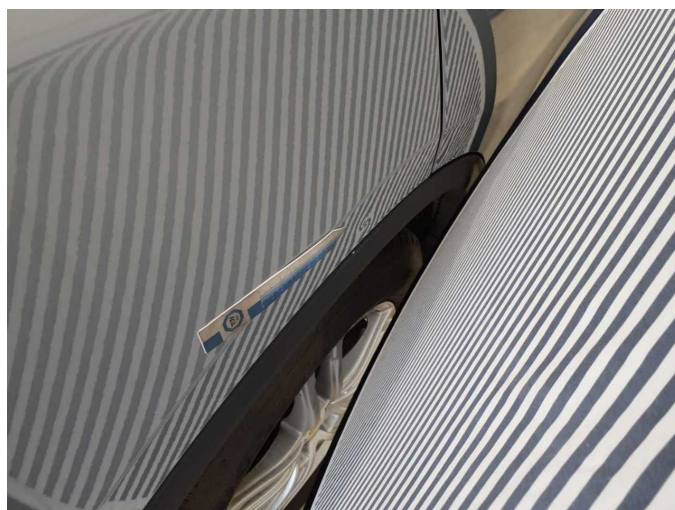
| No. | Component group | Description |
|---|---|---|
| 5 | Side panel - rear right side | Side panel - Dent / paintcoat damage - Smart repair |

**Damage 5:** Side panel - rear right side: Side panel - Dent / paintcoat damage - Smart repair

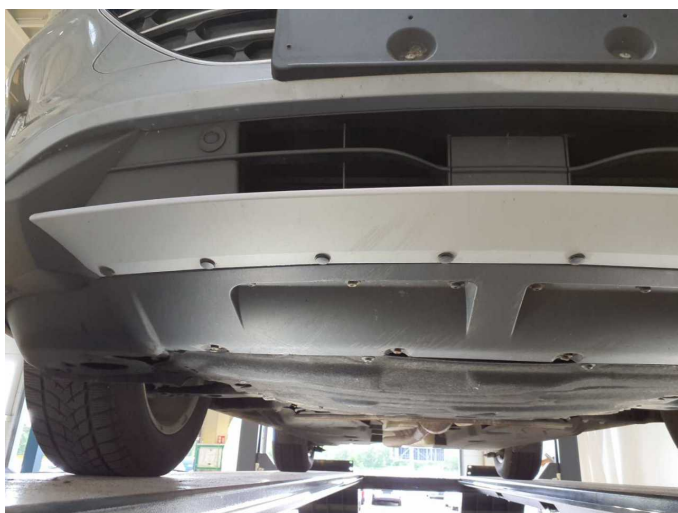
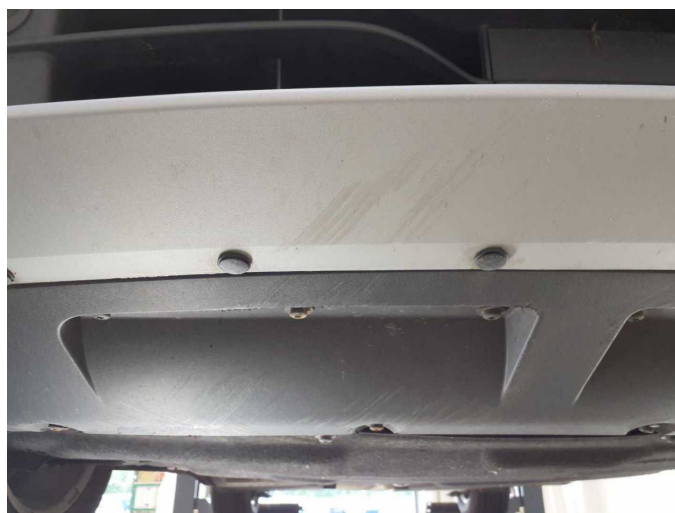
| No. | Component group | Description |
|---|---|---|
| 6 | Front bumper | Spoiler - Scratch(es) - Replace |

**Damage 6:** Front bumper: Spoiler - Scratch(es) - Replace

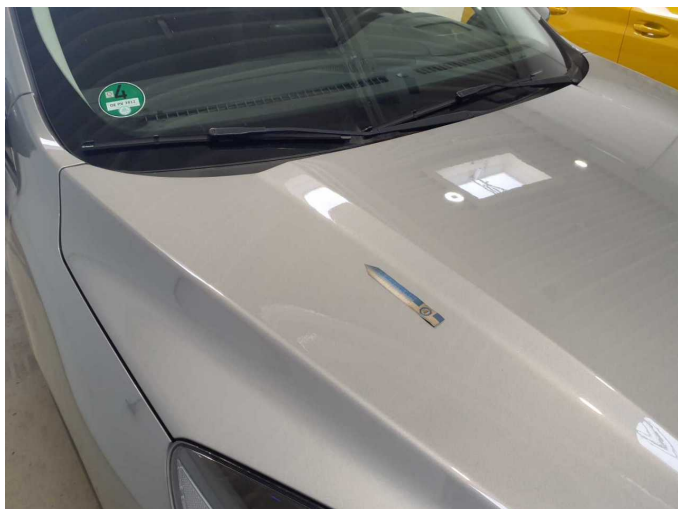
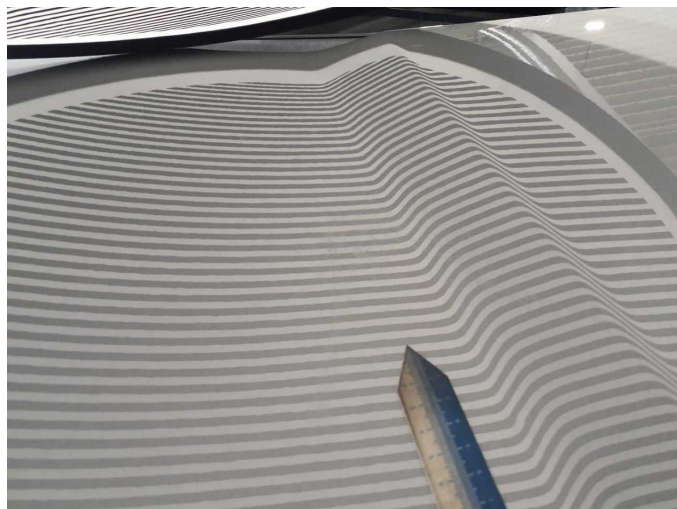
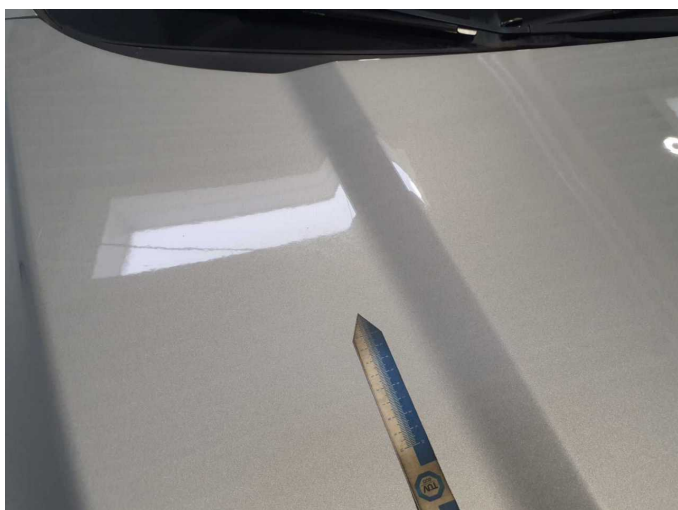
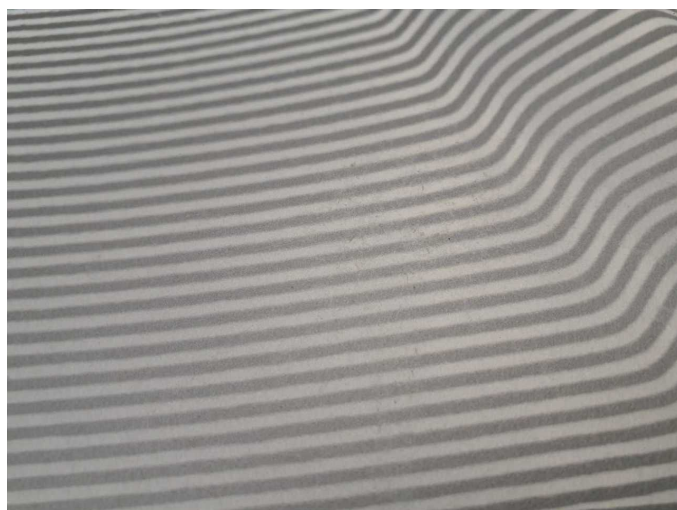
| No. | Component group | Description |
|---|---|---|
| 7 | Bonnet | Bonnet (Anätzung) - Paint defect - Paint |

**Damage 7:** Bonnet: Bonnet (Anätzung) - Paint defect - Paint

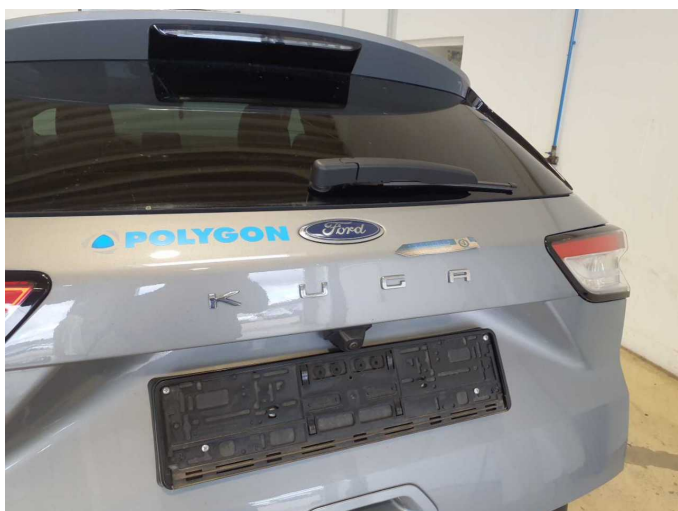
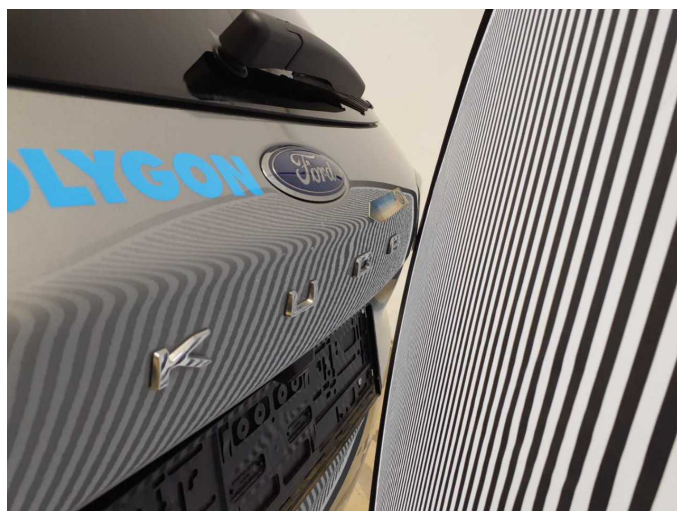
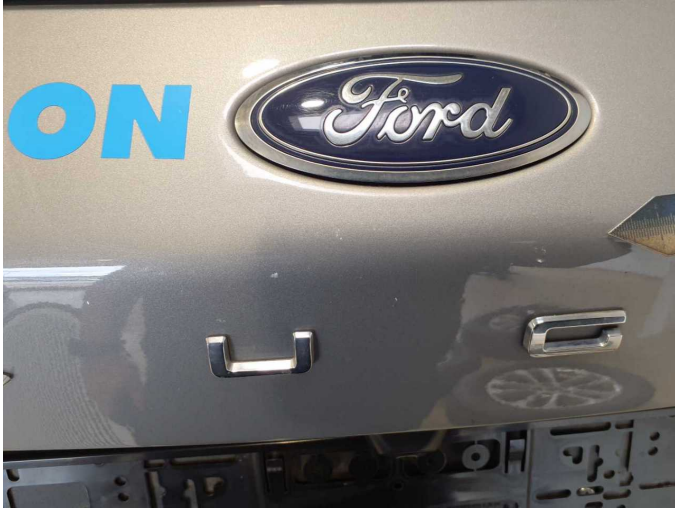
| No. | Component group | Description |
|---|---|---|
| 8 | Boot lid / rear door | Boot lid - Dent / paintcoat damage - Repair and paint |

**Damage 8:** Boot lid / rear door: Boot lid - Dent / paintcoat damage - Repair and paint

**Damage 8:** Boot lid / rear door: Boot lid - Dent / paintcoat damage -  
Repair and paint
