Expertise

Protocol number: 46695337  
Order No. / Reference: 26760069  
Inspection date: 21 Jul 2026

Manufacturer: Opel

Model: Insignia Sports Tourer 2.0 Diesel Business

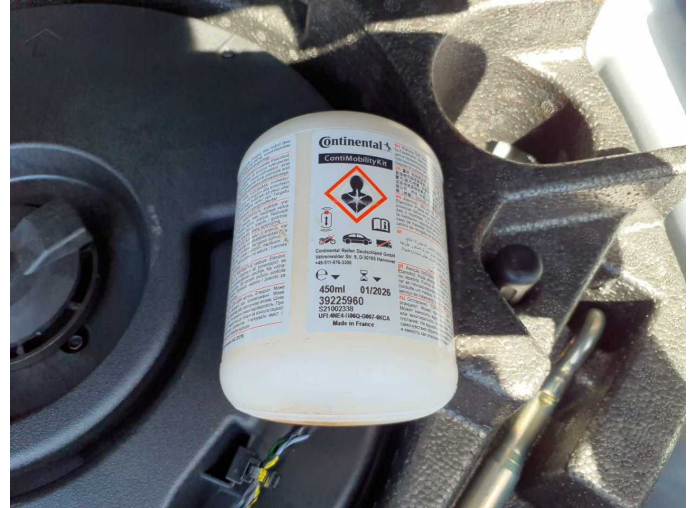
| No. | Component group | Description |
|---|---|---|
| 2 | Equipment | Tirefit filler - Expired - Replace |

**Damage 2:** Equipment: Tirefit filler - Expired - Replace

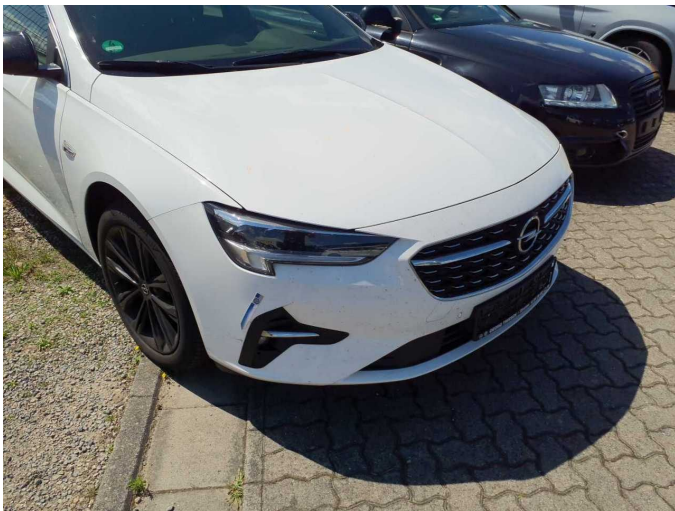
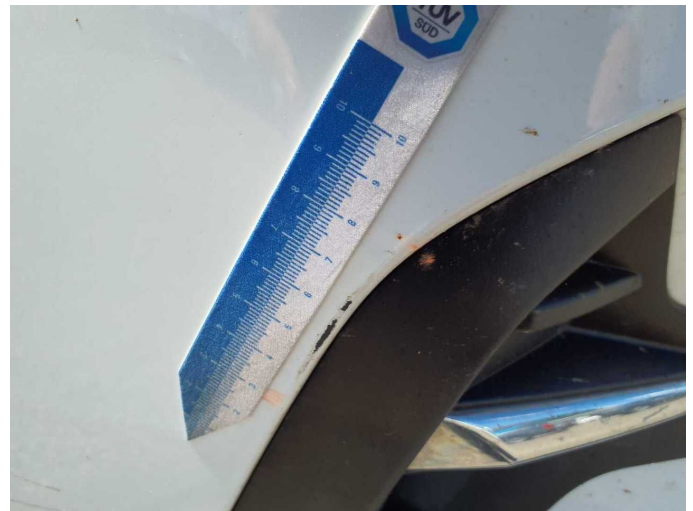
| No. | Component group | Description |
|---|---|---|
| 3 | Front bumper | Front bumper - Scratch(es) - Smart repair |

**Damage 3:** Front bumper: Front bumper - Scratch(es) - Smart repair

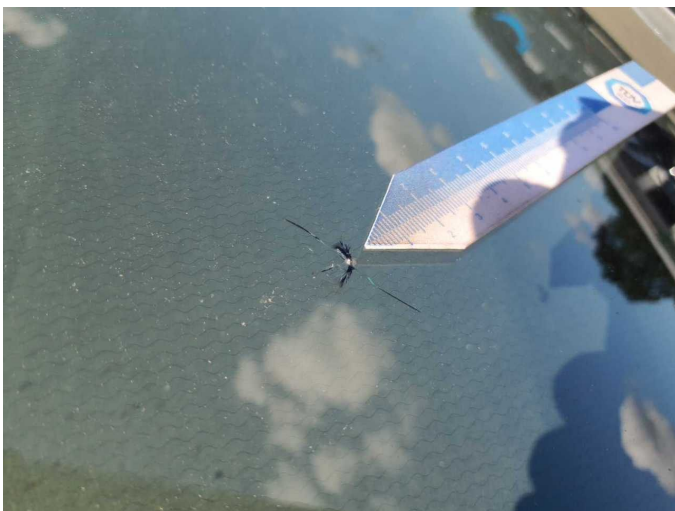
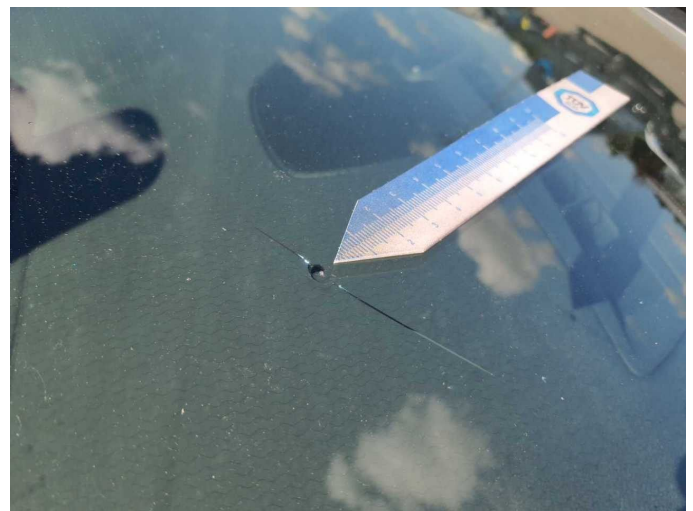
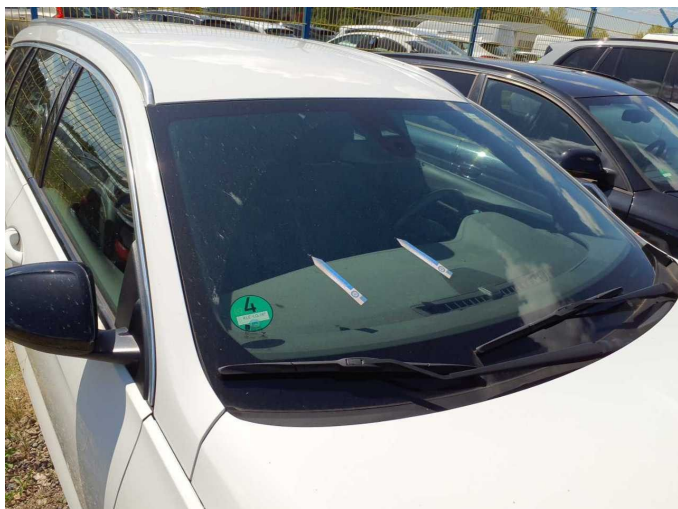
| No. | Component group | Description |
|---|---|---|
| 4 | Vehicle glazing | Windscreen - Broken / torn - Replace |

**Damage 4:** Vehicle glazing: Windscreen - Broken / torn - Replace
