Expertise

Protocol number: 46181937
Order No. / Reference: 26242175
Inspection date: 25 Jun 2026

Model: Tiguan Allspace 2.0 TDI SCR Comfortline

VIN: WVGZZZ5NZLM160478

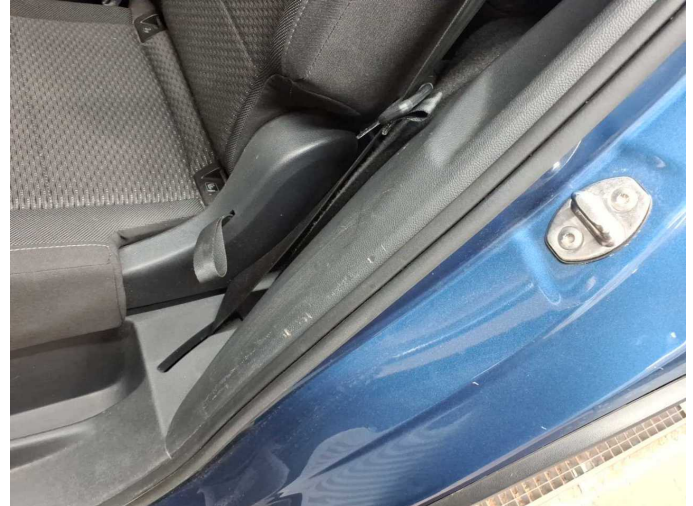
Damage 1: Side panel - rear left side: Interior trim - Scratch(es) - Loss in value

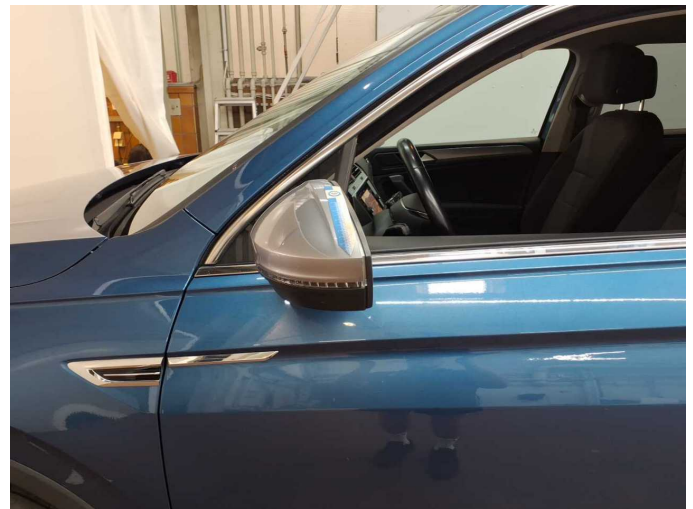
Damage 2: Wing mirror - left side: Cap - Scratch(es) - Smart repair

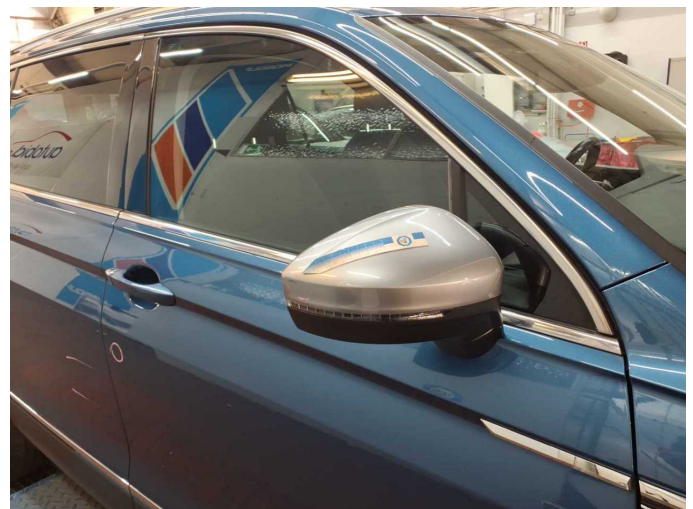
Damage 3: Wing mirror - right side: Cap - Scratch(es) - Smart repair

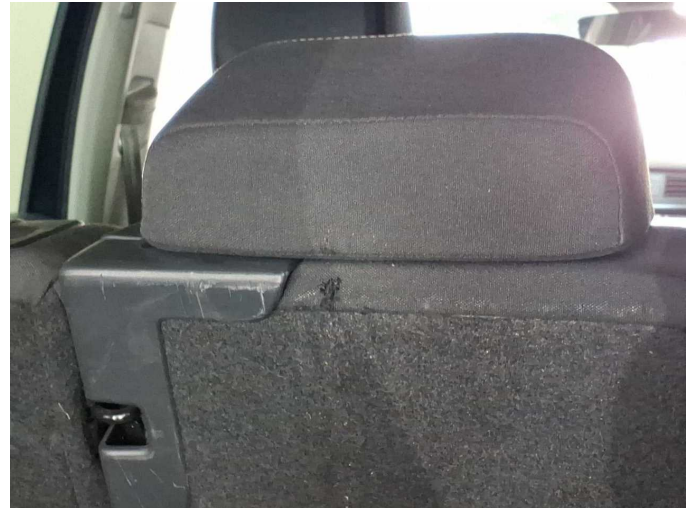
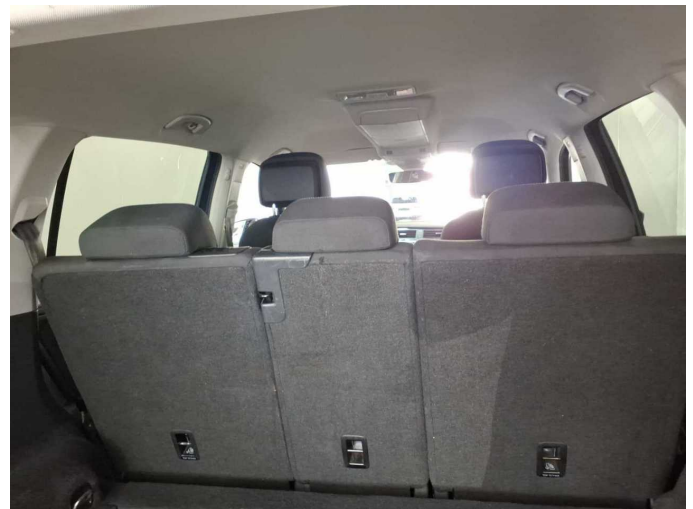
Damage 4: Seat - rear: Back seat - Holes - Smart repair

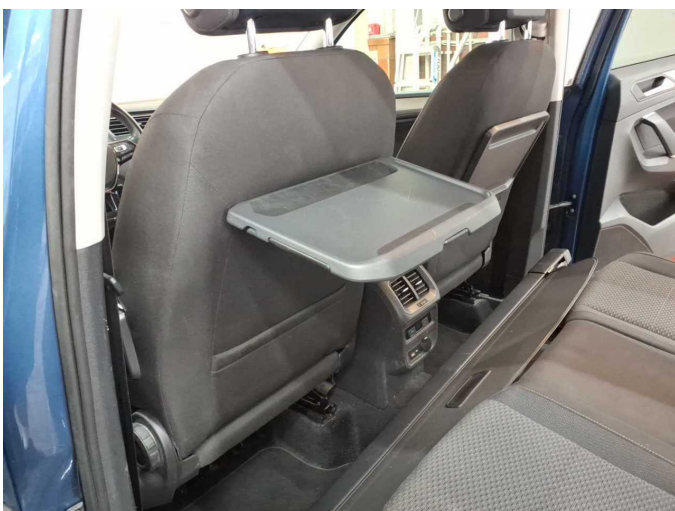
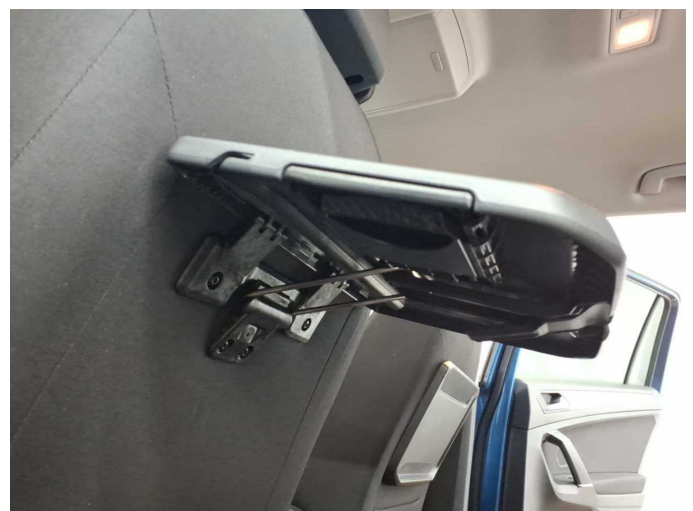
Damage 5: Equipment: Table support - Non-operational - Replace

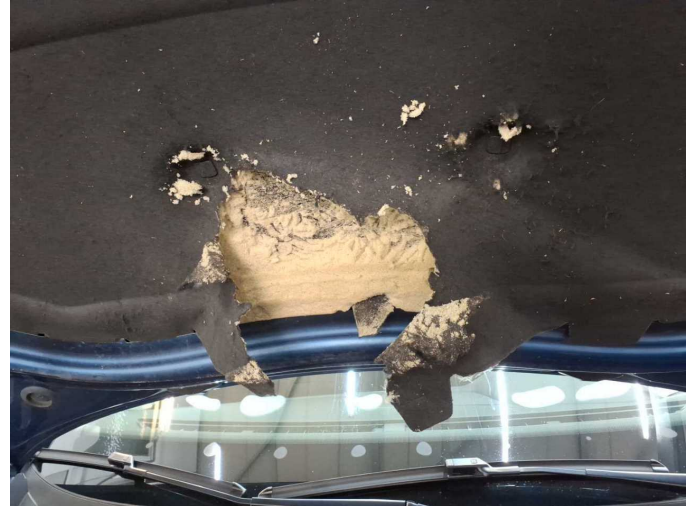
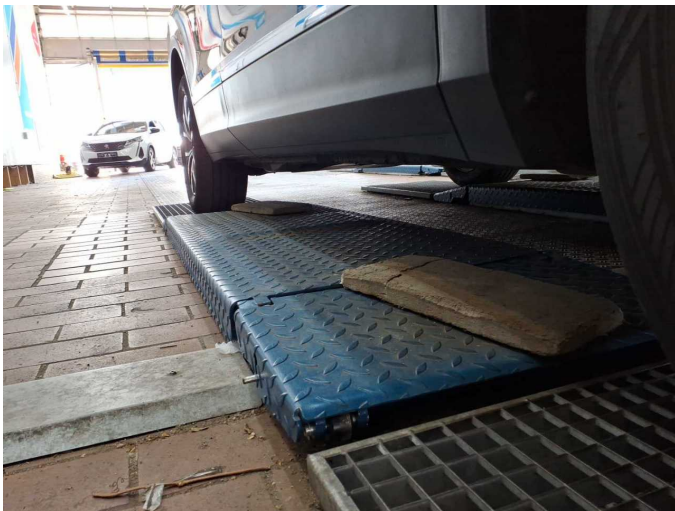
Marder Spuren sind im Motorraum, weitere Schäden sind möglich.

Damage 6: Bonnet: Insulation lining - Damage caused by marten / rodent
- Replace

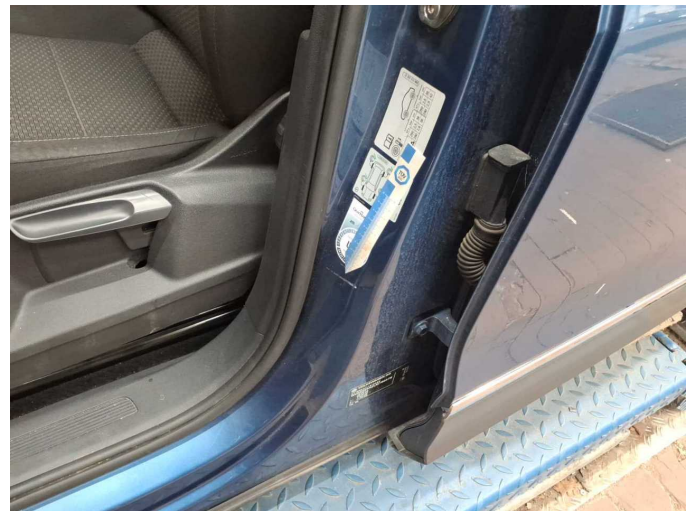
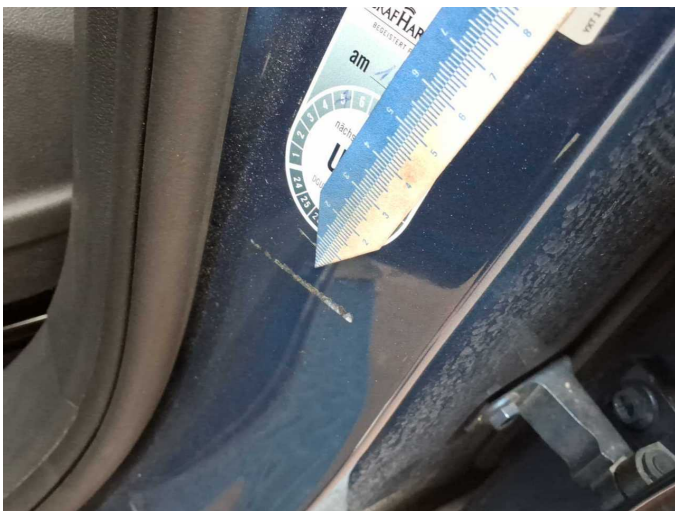
Damage 7: Sill - left side: Sill - Scratch(es) - Smart repair

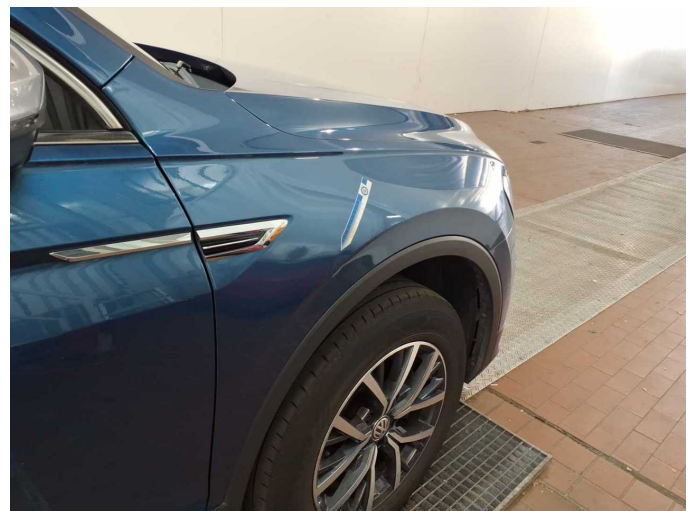
Damage 8: Mudguard - right side: Mudguard - right side - dent(s) - Smart repair

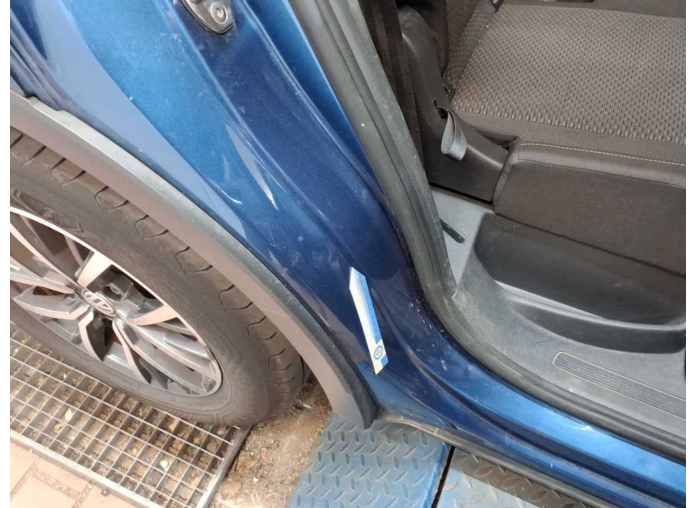
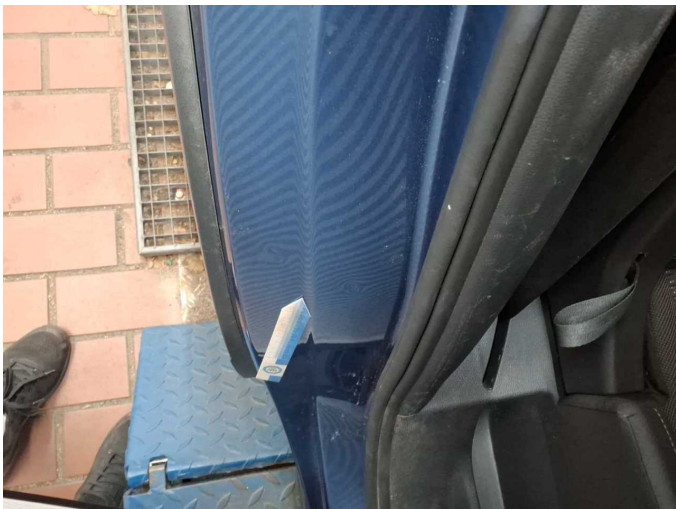
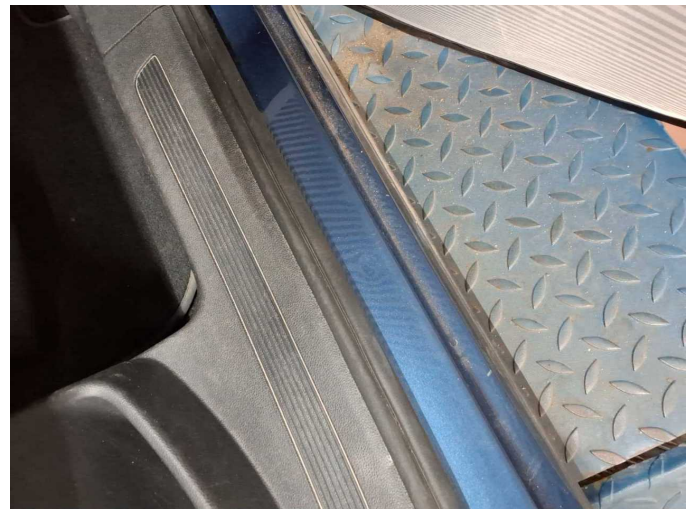
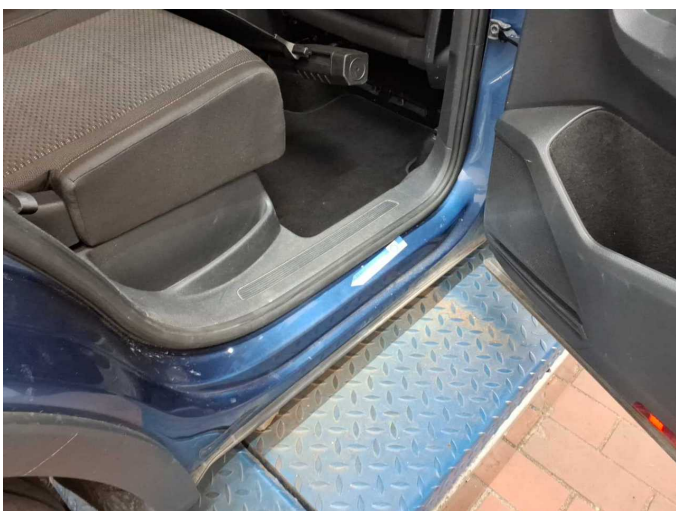
Damage 9: Side panel - rear right side: Sill - dent(s) - Smart repair

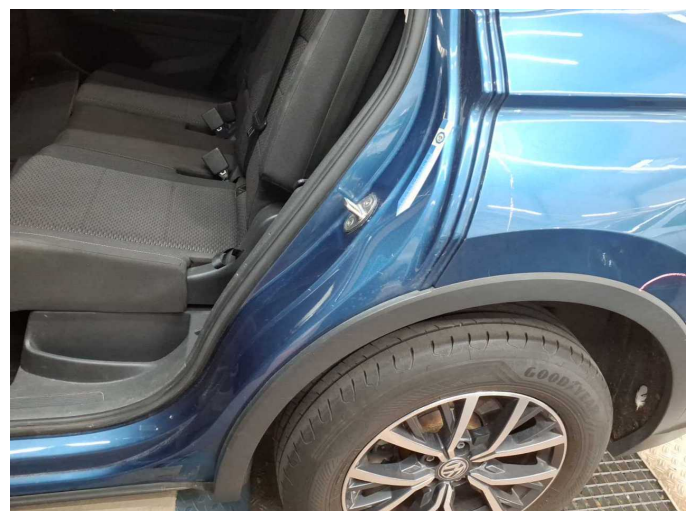
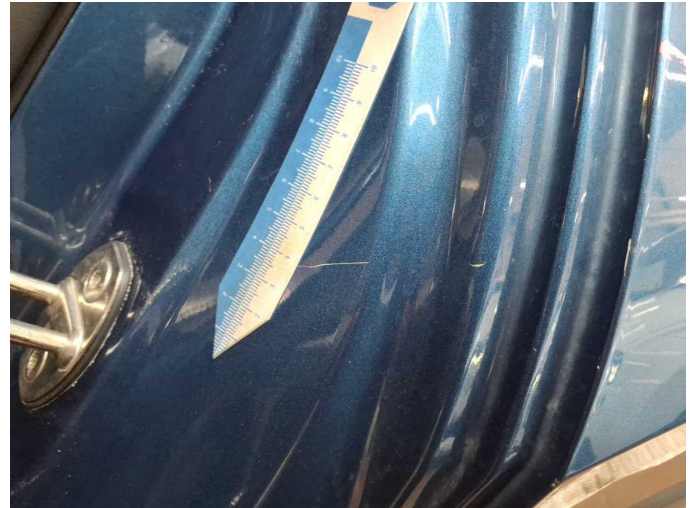
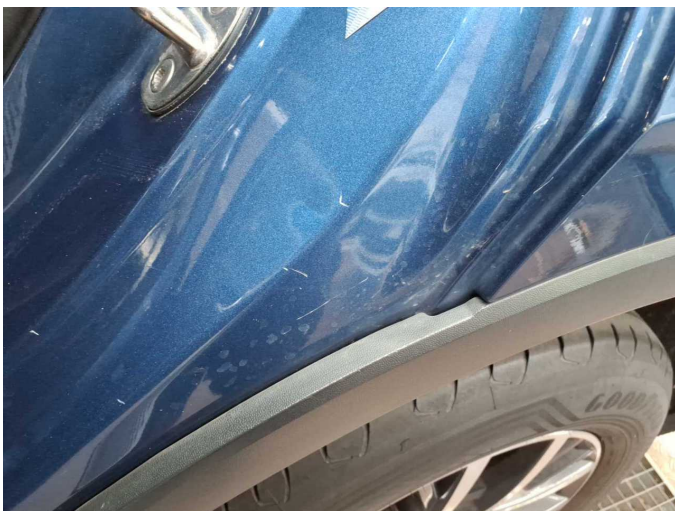
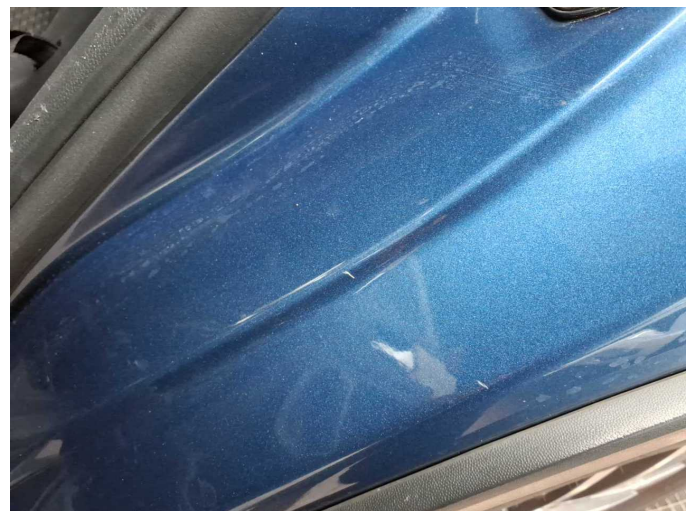
Damage 10: Side panel - rear left side: Sill - Dent / paintcoat damage - Smart repair

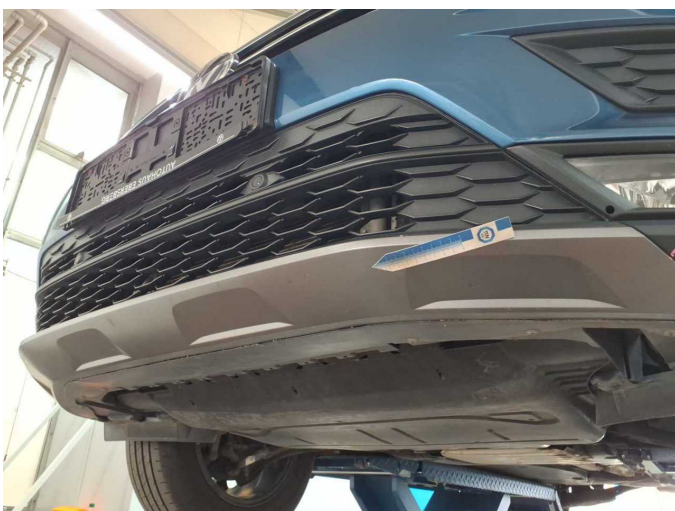
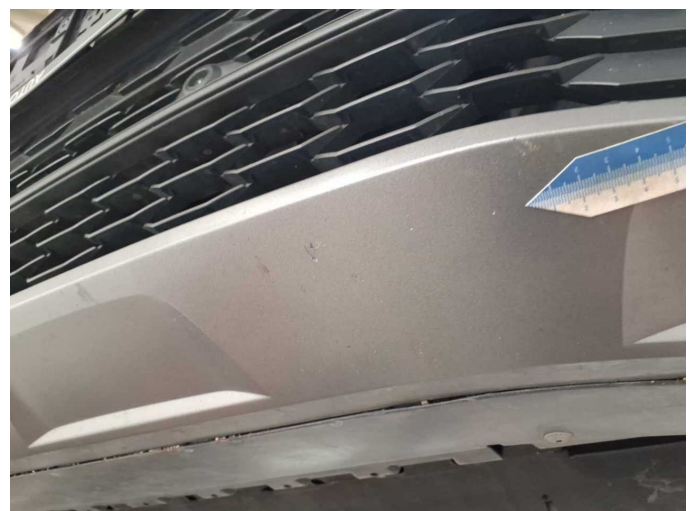
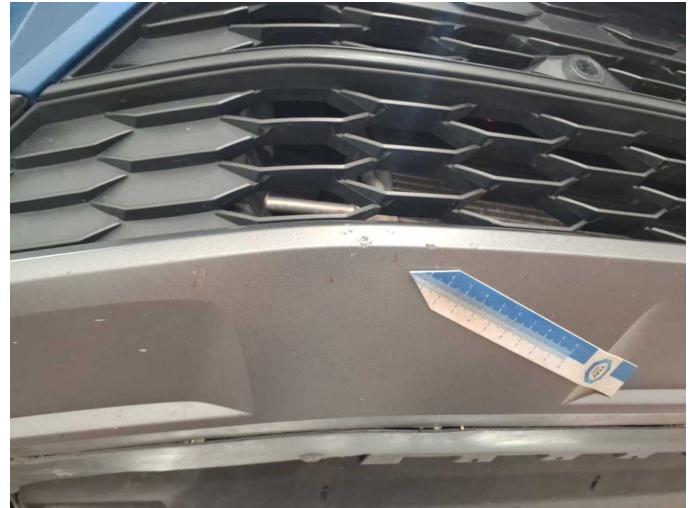
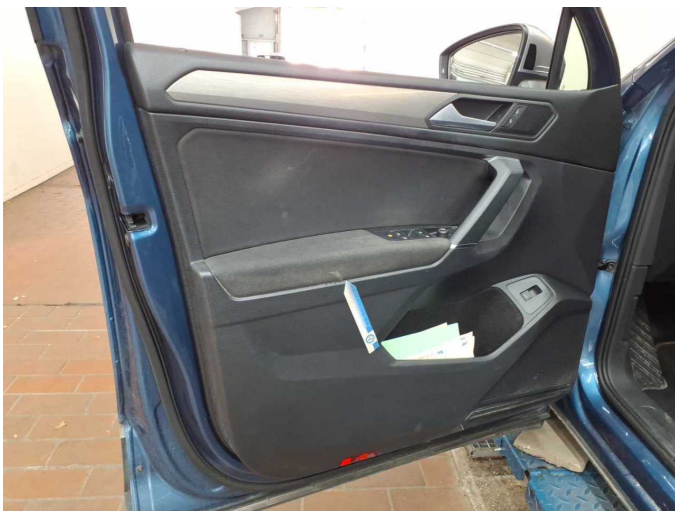
Damage 11: Front bumper: Spoiler - Scratch(es) - Paint

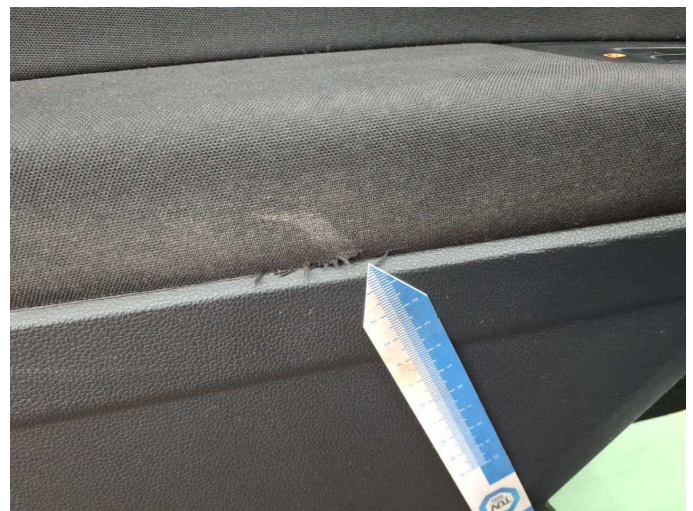
Damage 12: Trim / covers: Door trim - front right side - Broken / torn - Replace

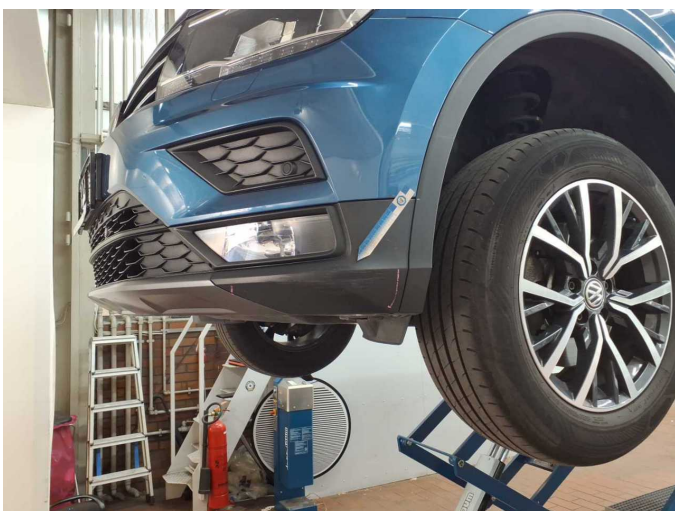
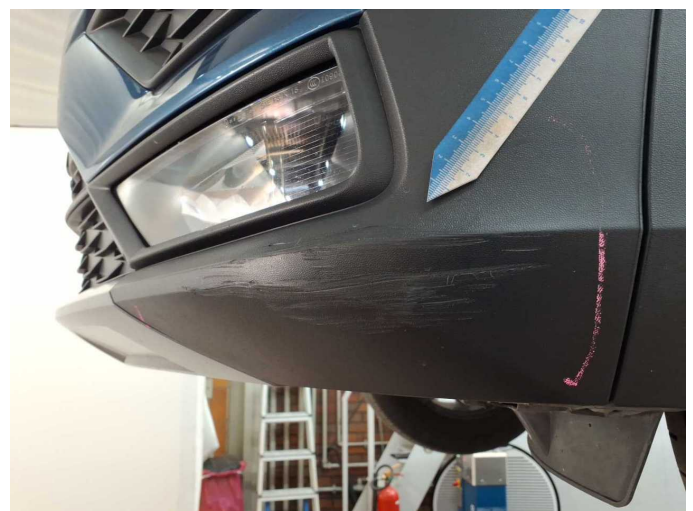
Damage 13: Front bumper: Spoiler (Links) - Scratched - Replace

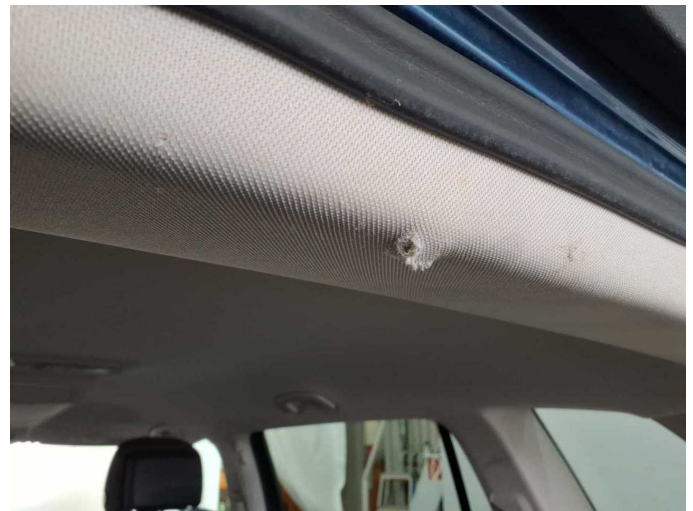
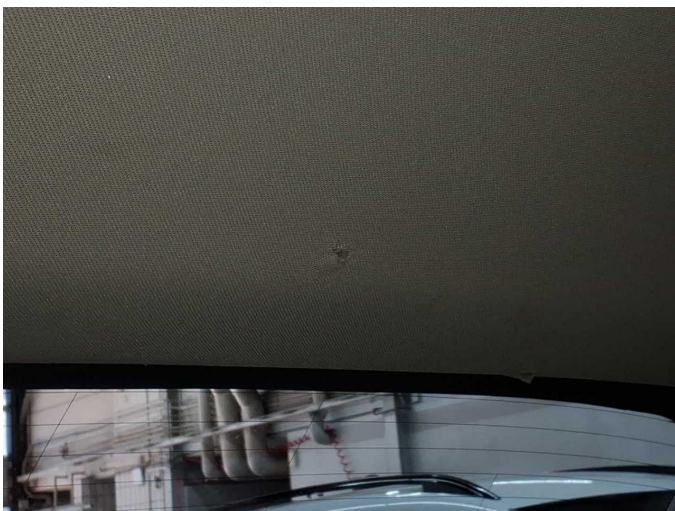
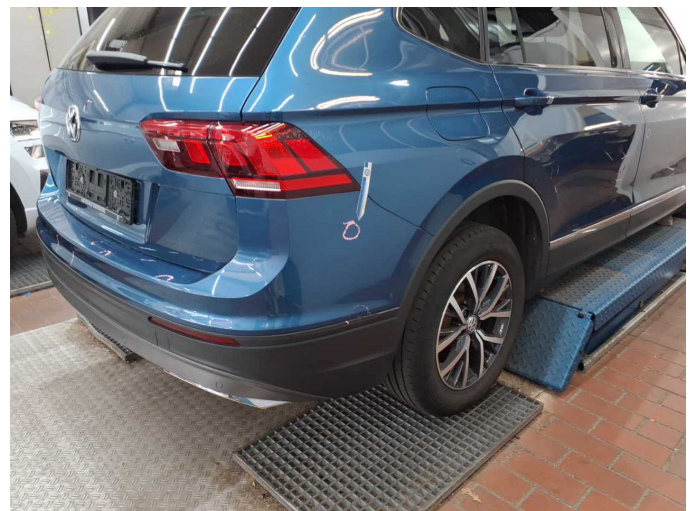
Damage 15: Trim / covers: Roof lining - Broken / torn - Replace

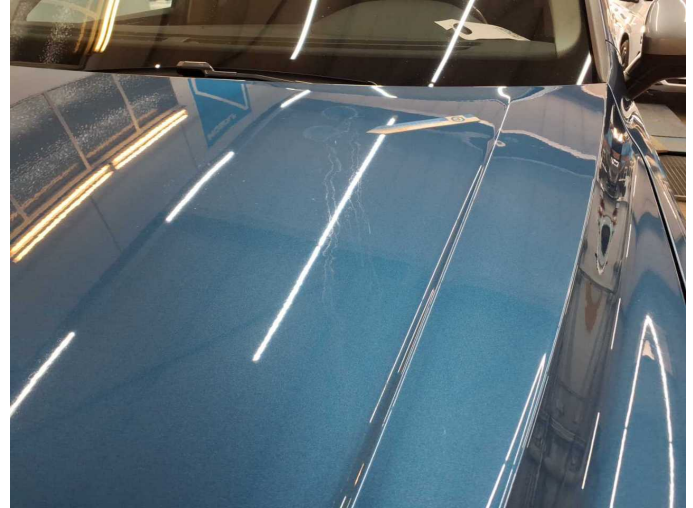
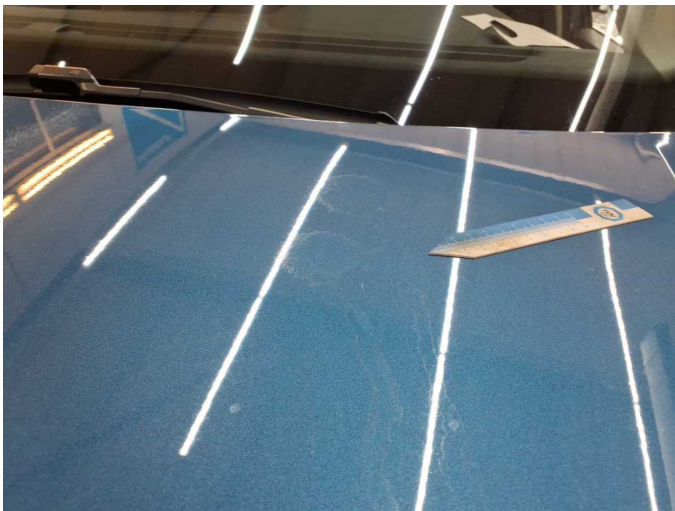
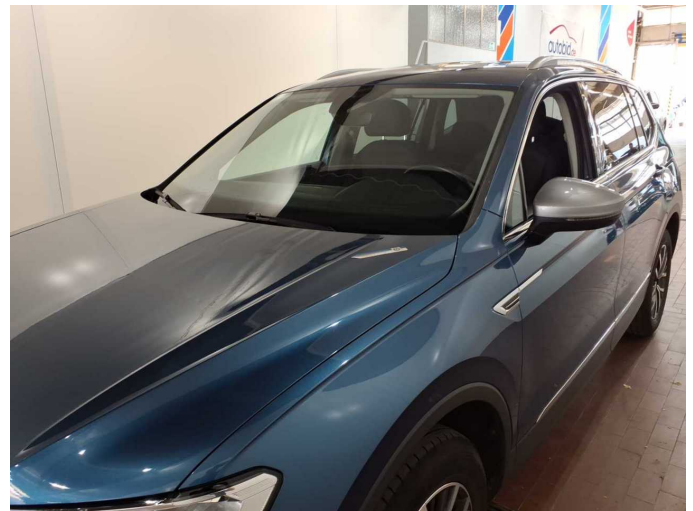
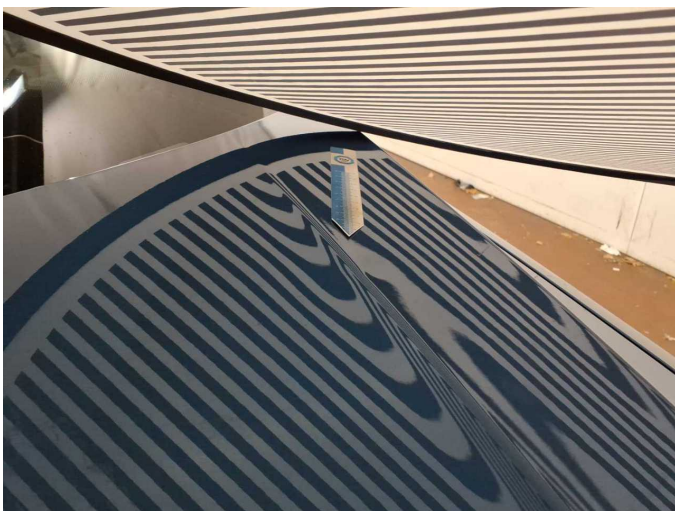
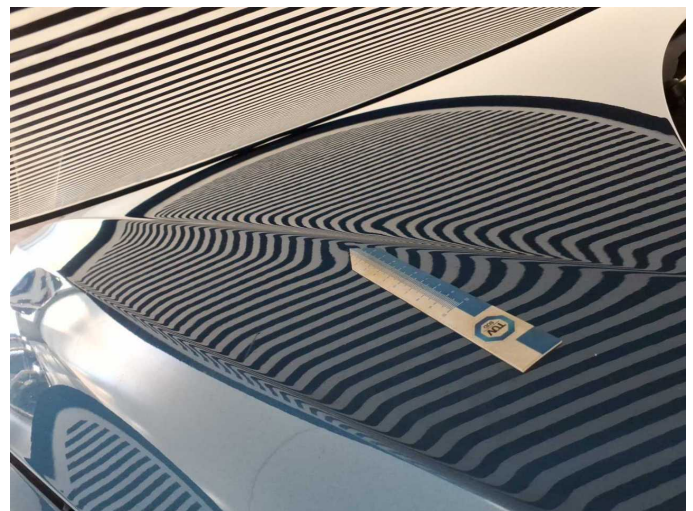
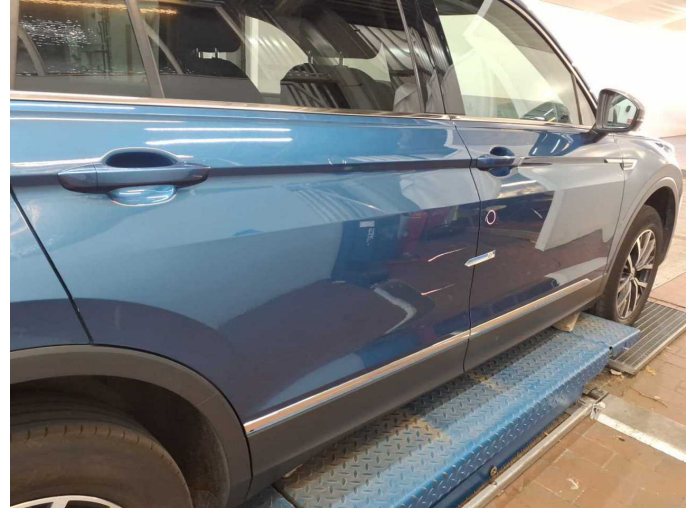
Damage 17: Bonnet: Bonnet (Verätzungen / mit Delle) - Paint defect - Repair and paint

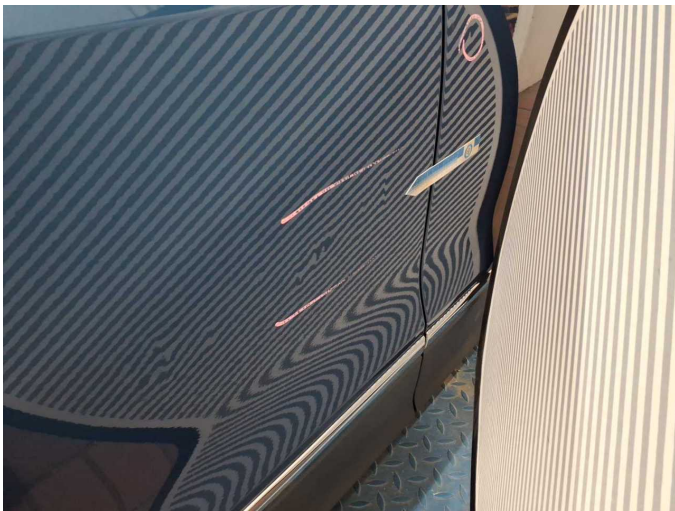
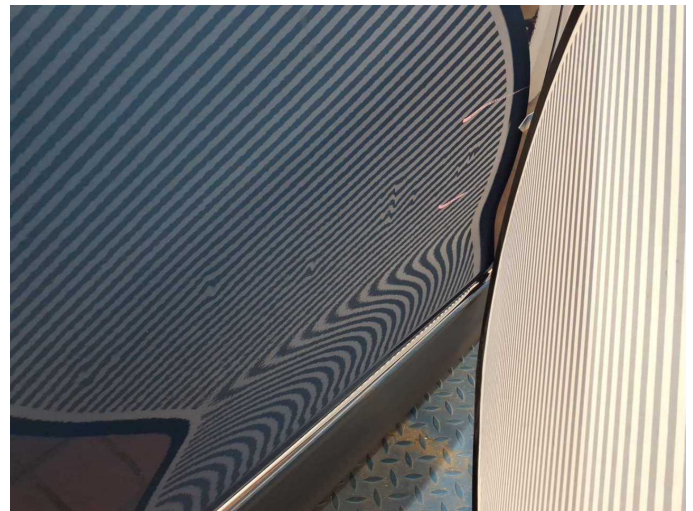
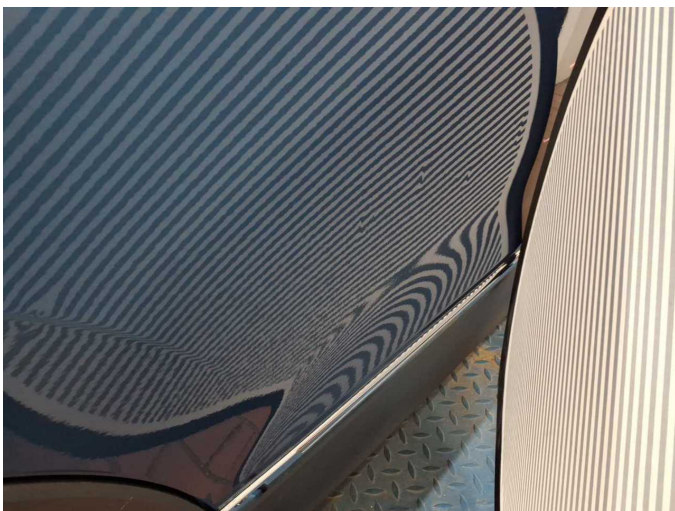
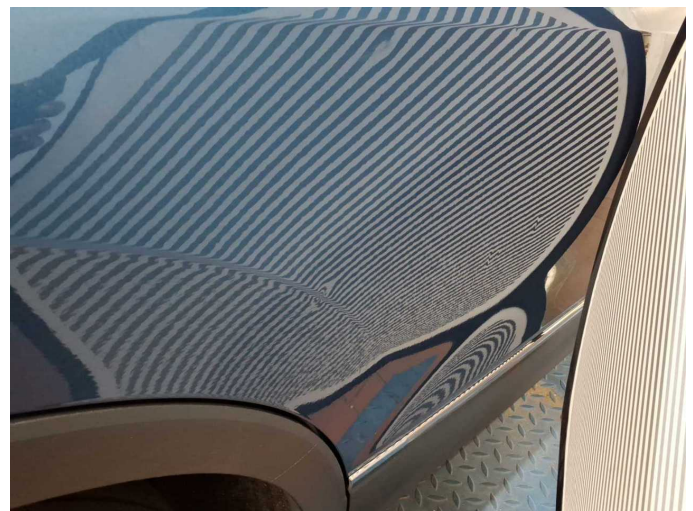
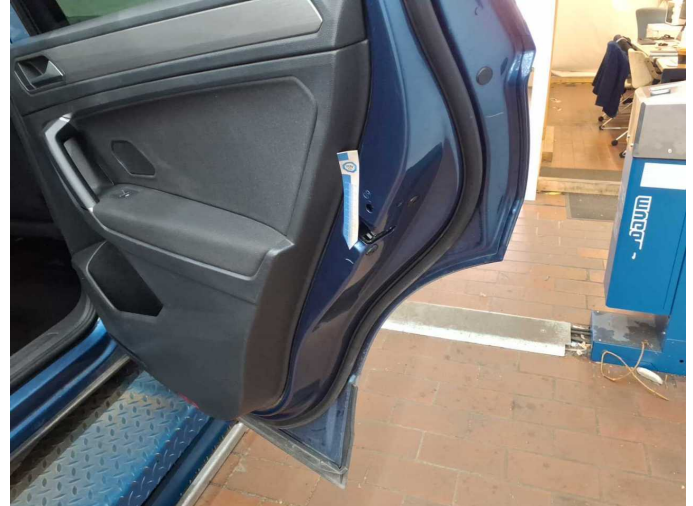
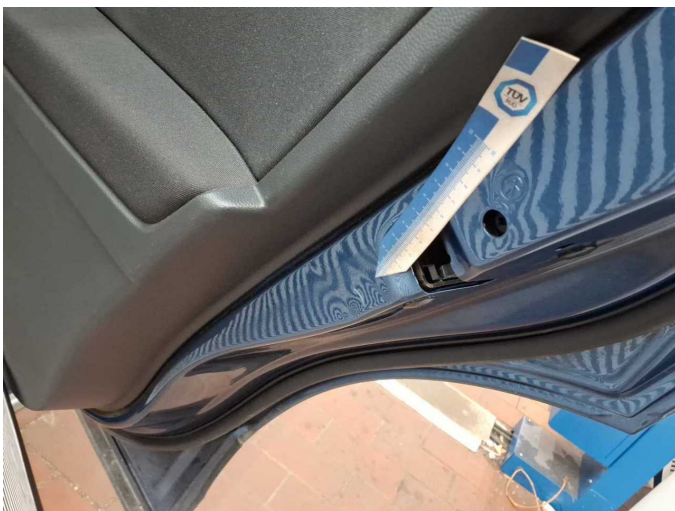
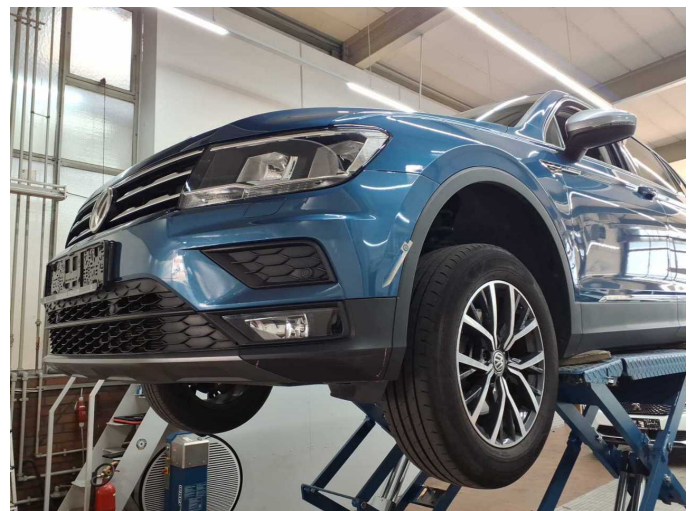
Damage 18: Door - rear right side: Door - dent(s) - Repair and paint

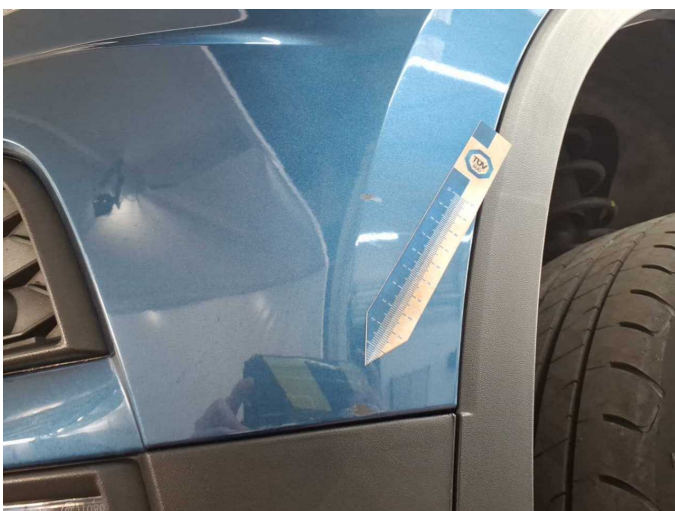
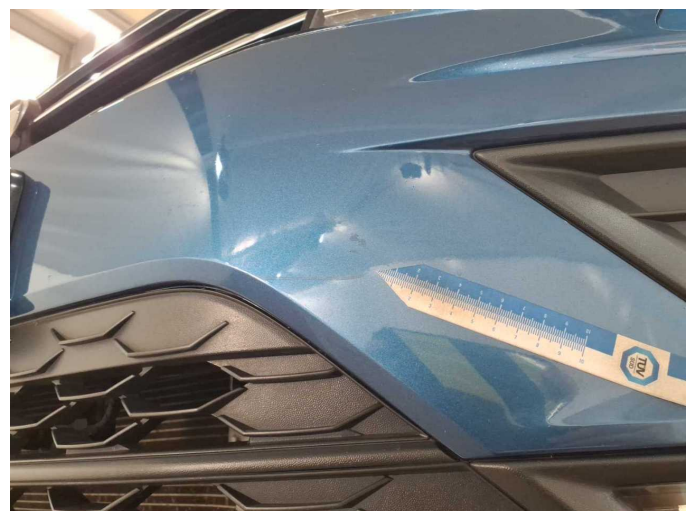
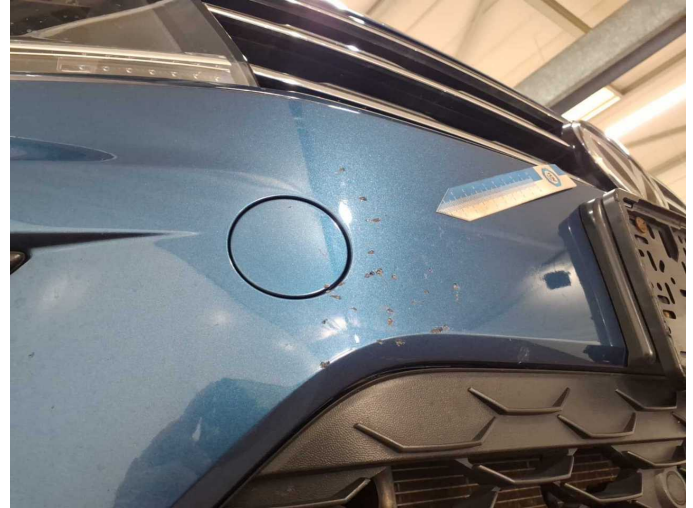
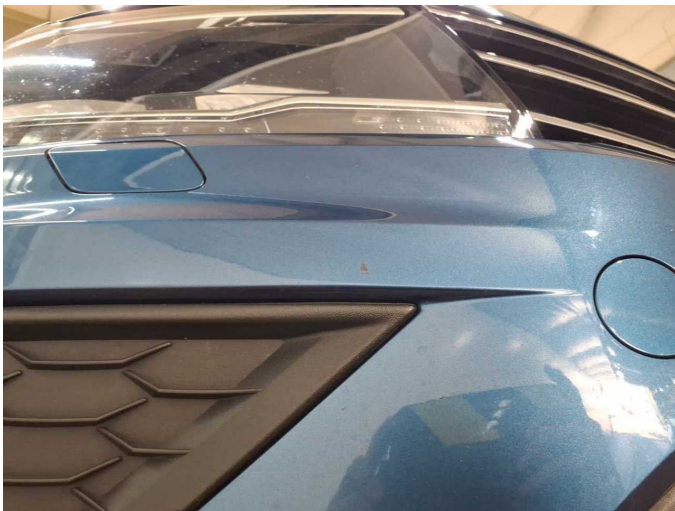
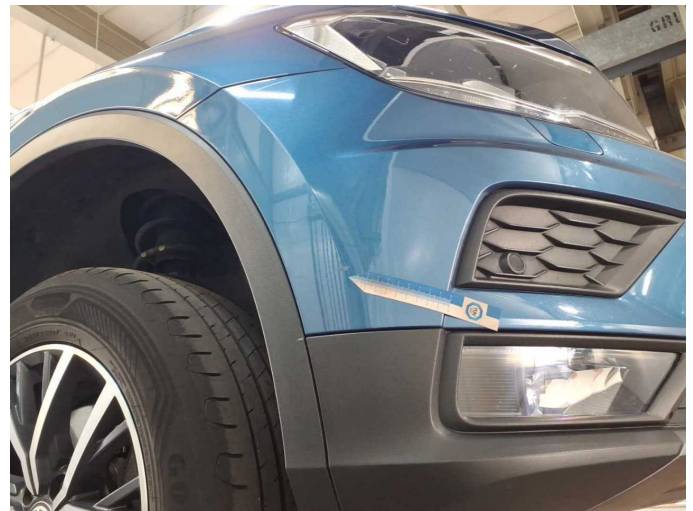
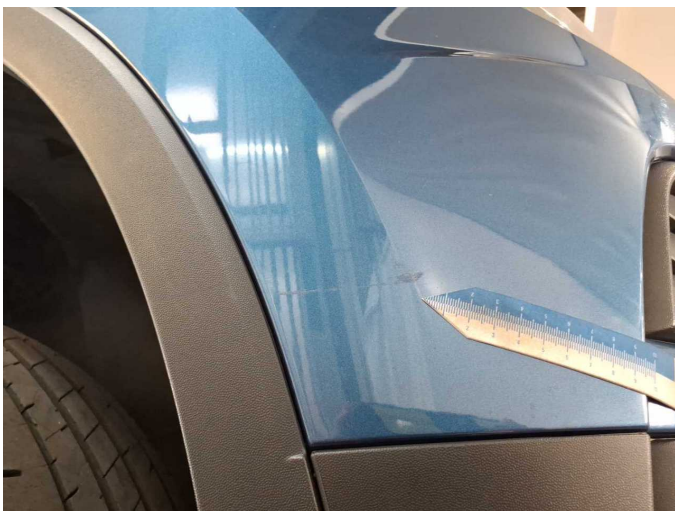
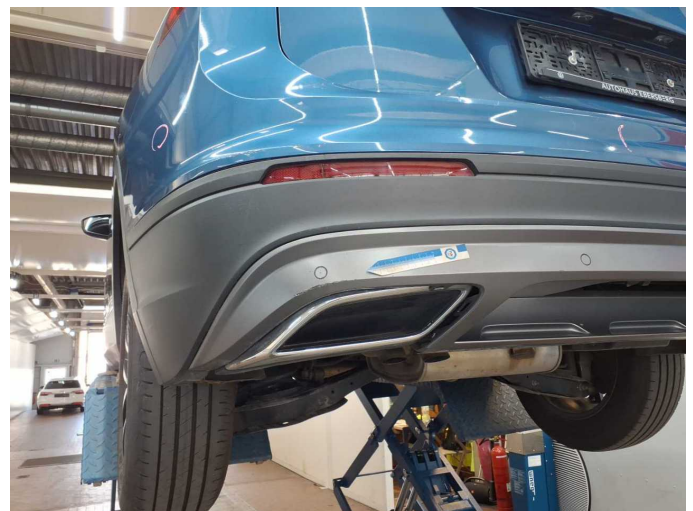
Damage 19: Front bumper: Front bumper - Scratch(es) - Paint

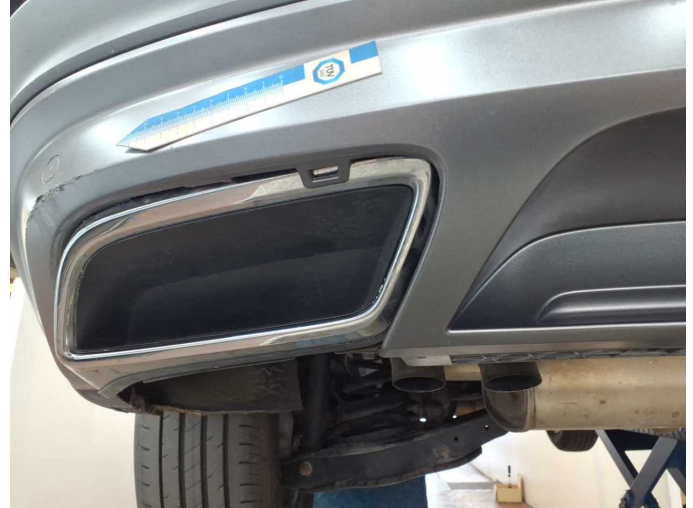
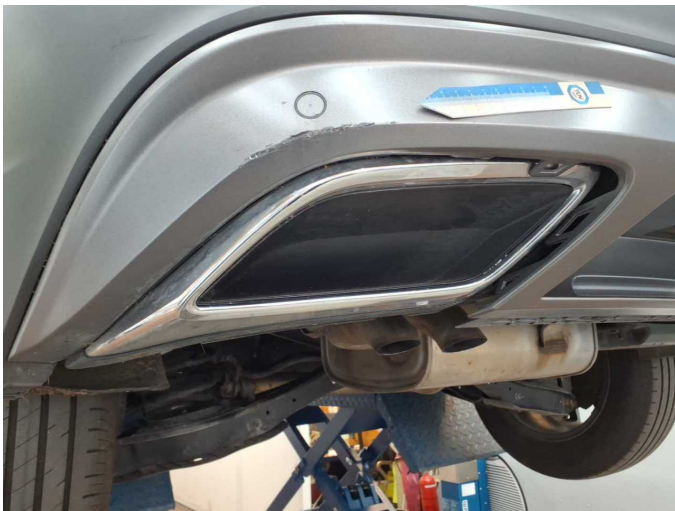
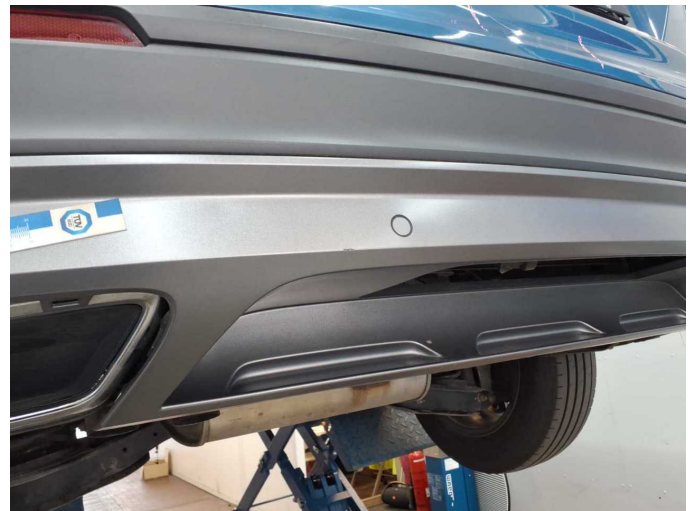
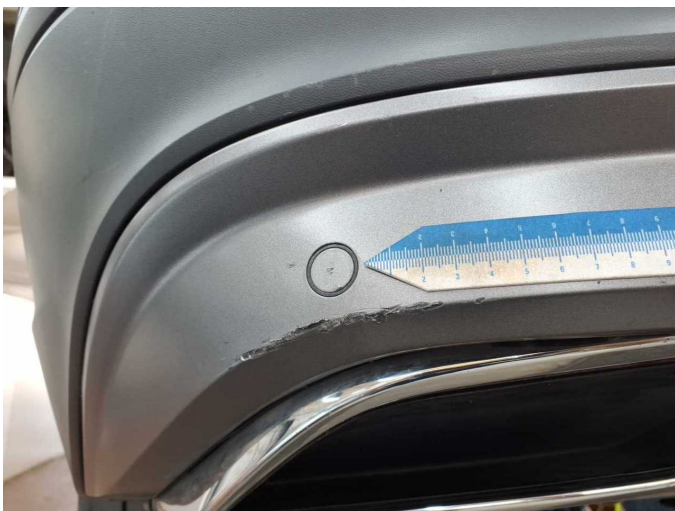
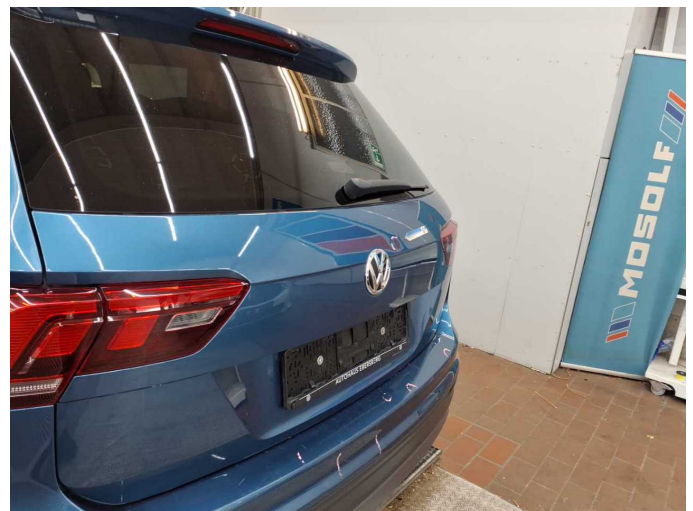
Damage 20: Rear bumper: Spoiler (Mit Blende lose) - Scratched - Paint

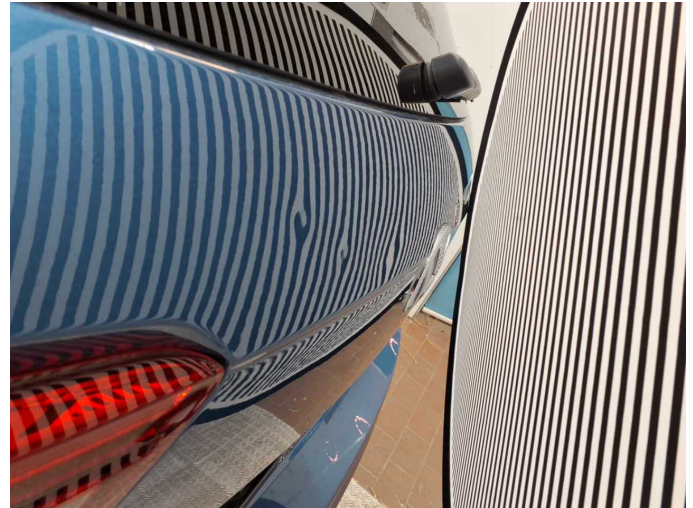
Damage 21: Boot lid / rear door: Boot lid - dent(s) - Repair and paint

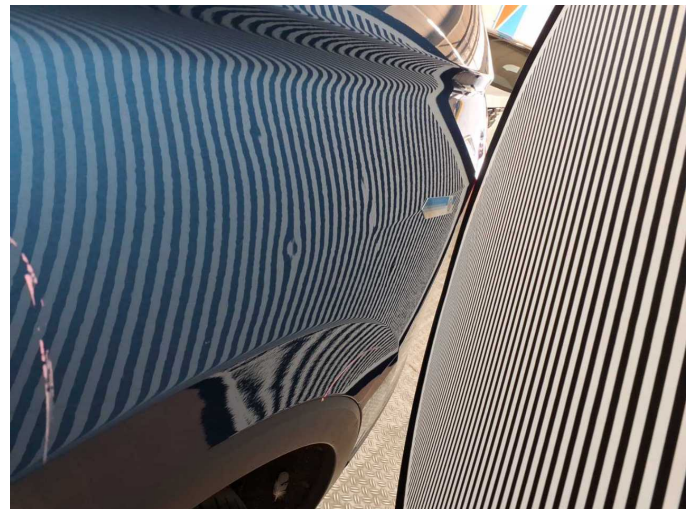
Wear and tear 8: Side panel - rear left side: Side panel - dent(s) - Repair and paint
