Expertise

Protocol number: 46433733  
Order No. / Reference: 26652040  
Inspection date: 7 Jul 2026

Manufacturer: Opel

Model: Movano 2.2 BlueHDi 140 L2H2 VA Autm.

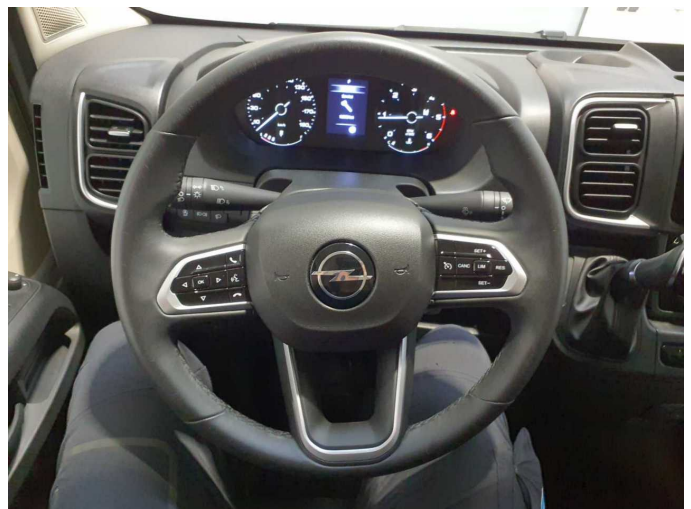
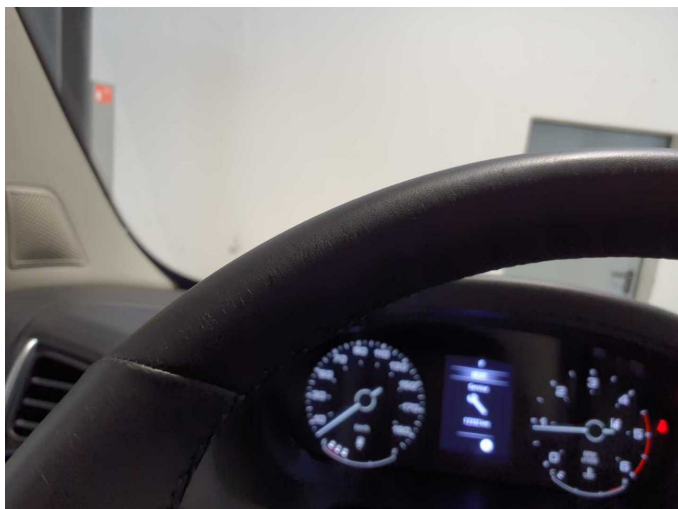
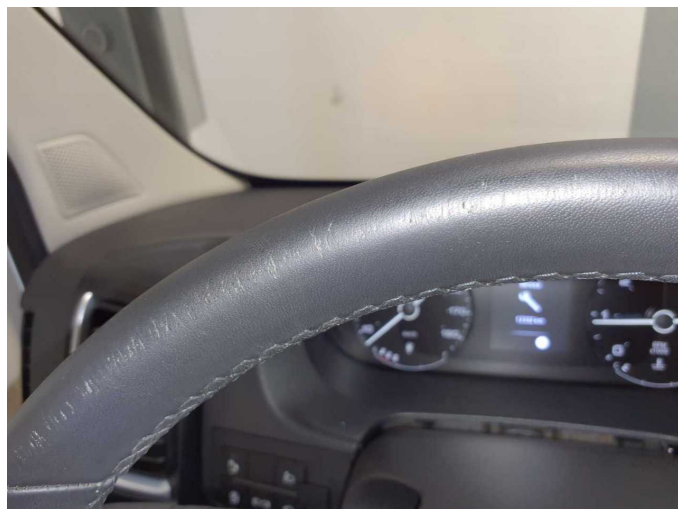
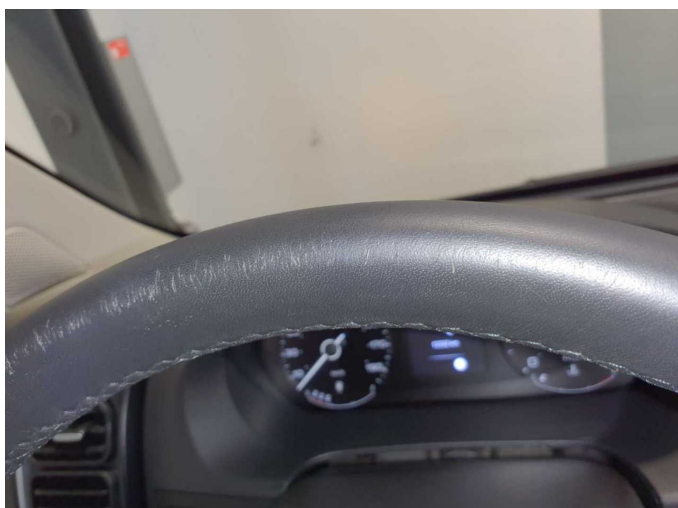
| No. | Component group | Description |
|---|---|---|
| 1 | Steering system | Steering wheel sheath - Scratch(es) - Loss in value |

**Damage 1:** Steering system: Steering wheel sheath - Scratch(es) - Loss in value

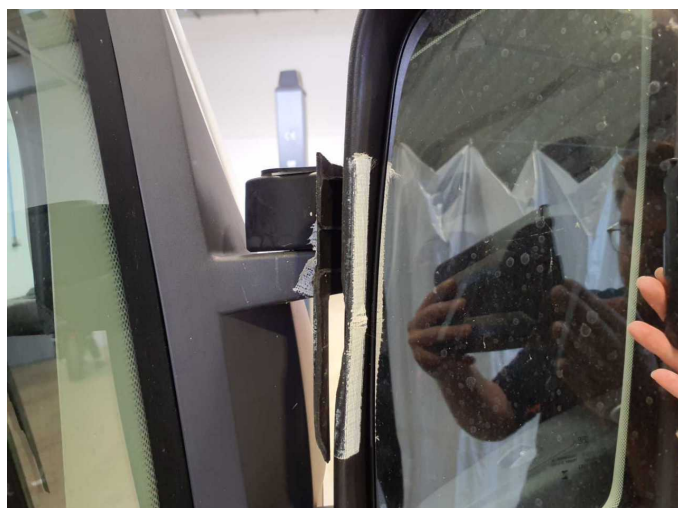
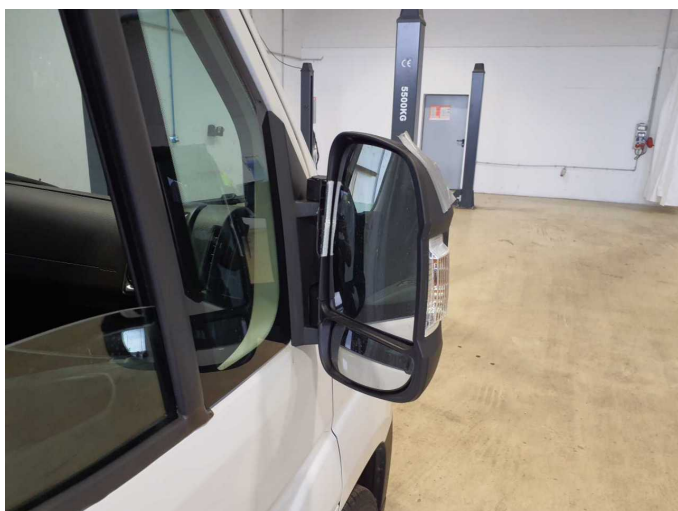
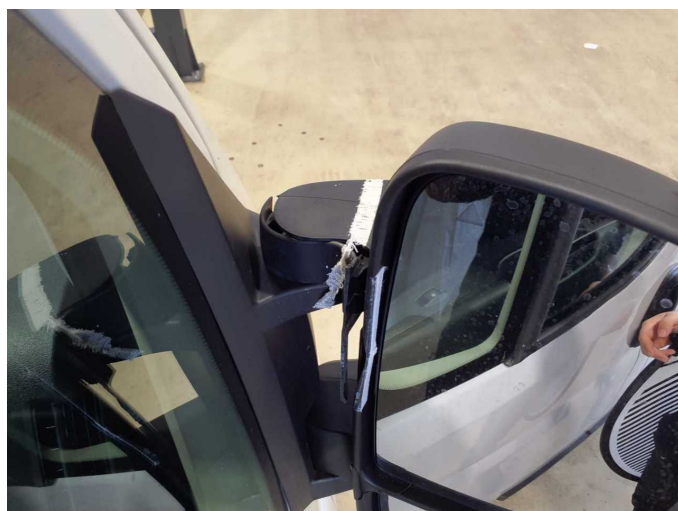
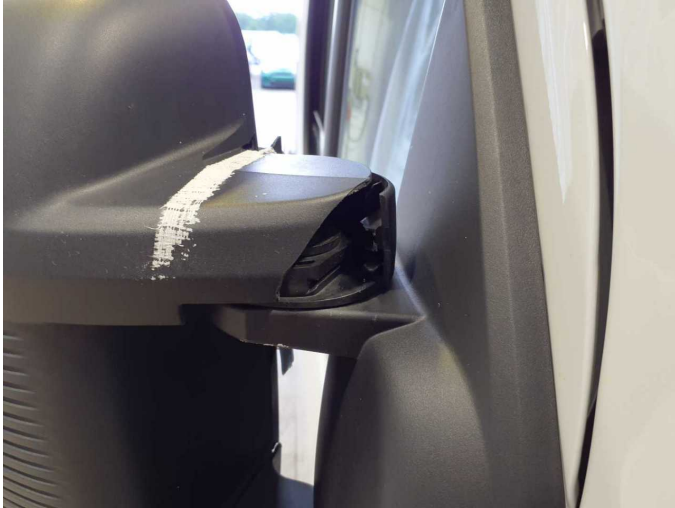
| No. | Component group | Description |
|---|---|---|
| 3 | Wing mirror - right side | Mirror housing - Broken / torn - Replace |

**Damage 3:** Wing mirror - right side: Mirror housing - Broken / torn - Replace

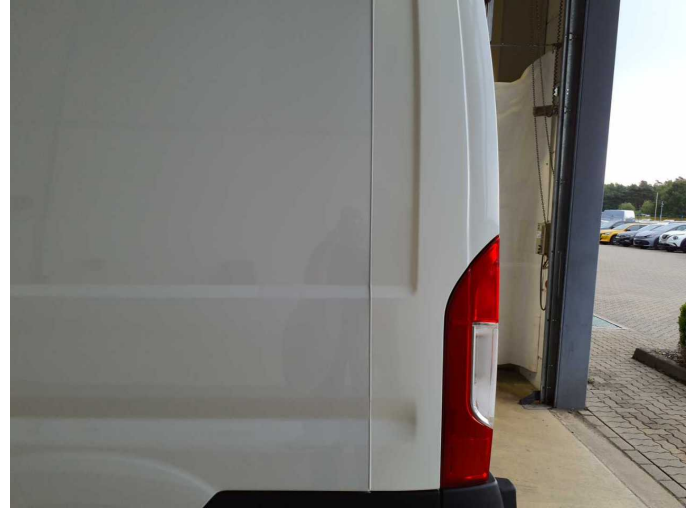
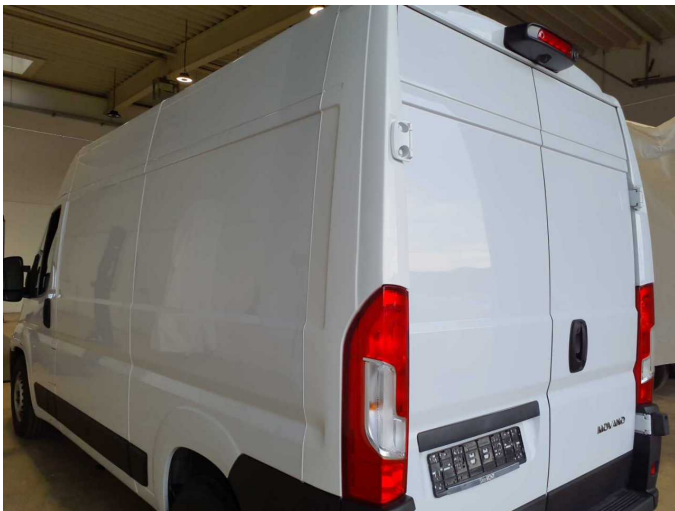
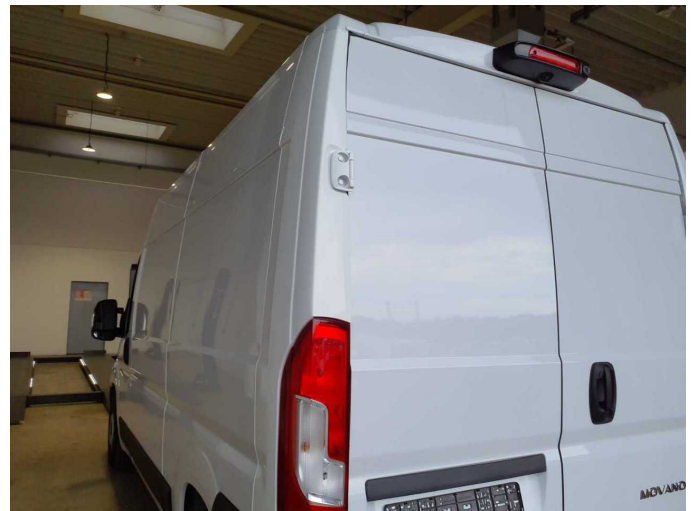
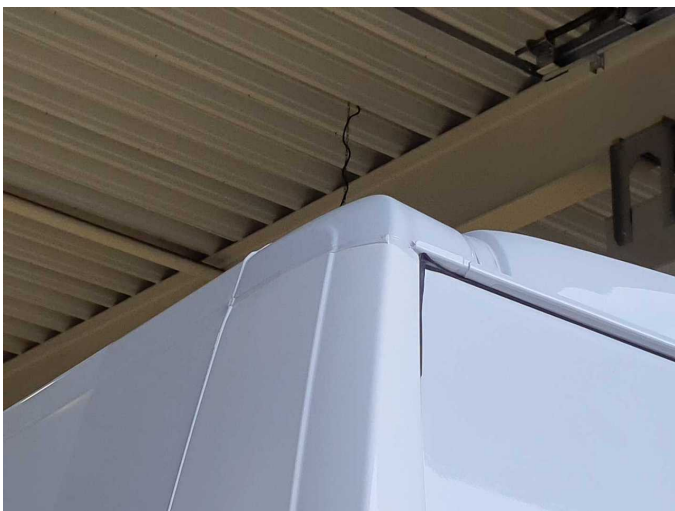
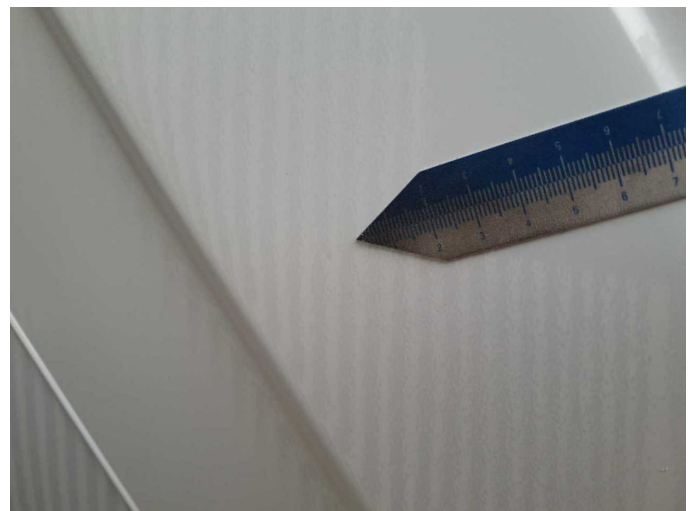
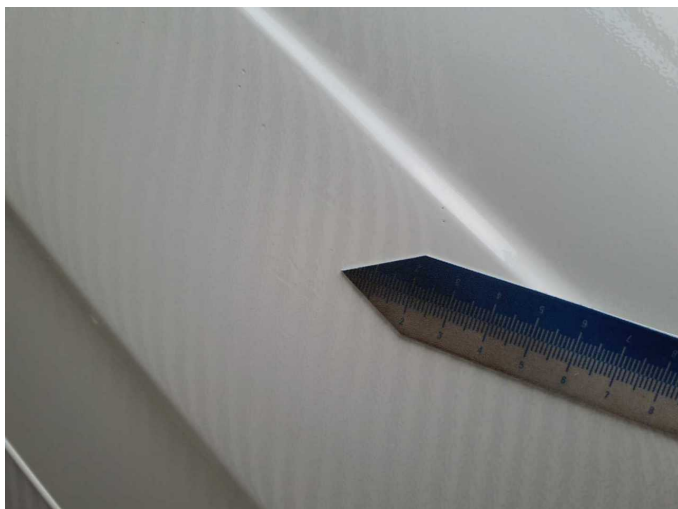
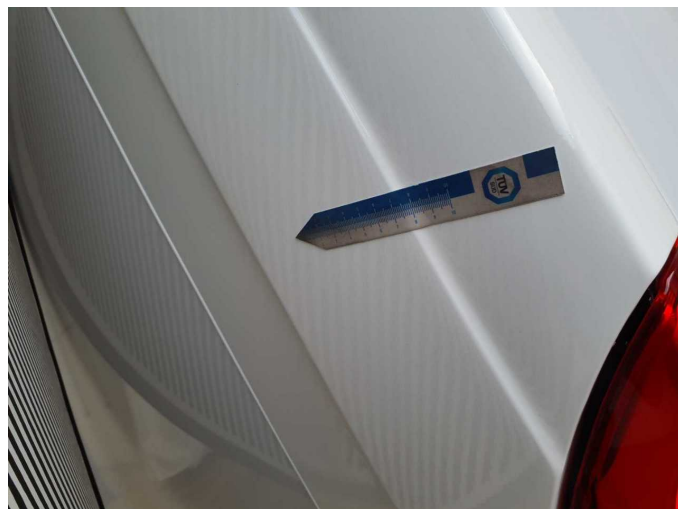
| No. | Component group | Description |
|---|---|---|
| 4 | Side panel - rear left side | Side panel (Heckecke, falscher Lackton und Spachtelmasse eingefallen) - Unprofessionally repaired - Repair and paint |

| No. | Previous damage | Extent of damage (Net) |
|---|---|---|
| 1 | Side - left, not professionally repaired | |

**Damage 4:** Side panel - rear left side: Side panel (Heckecke, falscher Lackton und Spachtelmasse eingefallen) - Unprofessionally repaired - Repair and paint

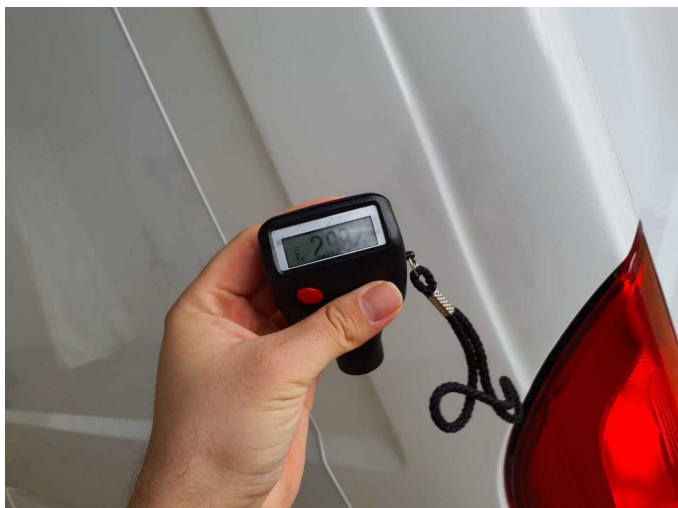
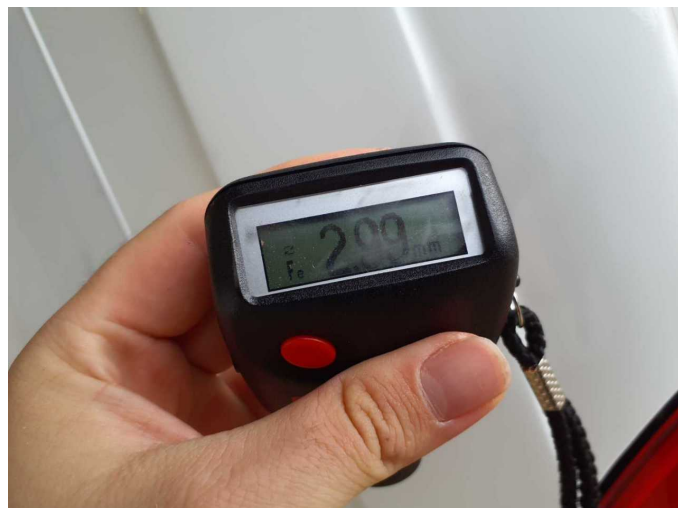
| No. | Repainting |
|---|---|
| 1 | Side panel - rear left side, Unprofessionally carried out |

| Side panel - rear left side | 2,990<br>µm |

**Repainting 1:** Side panel - rear left side
