Expertise

Protocol number: 46251092
Order No. / Reference: 26594245
Inspection date: 29 Jun 2026

Manufacturer: Volkswagen

Model: ID.4 Performance Upgrade Pro Business

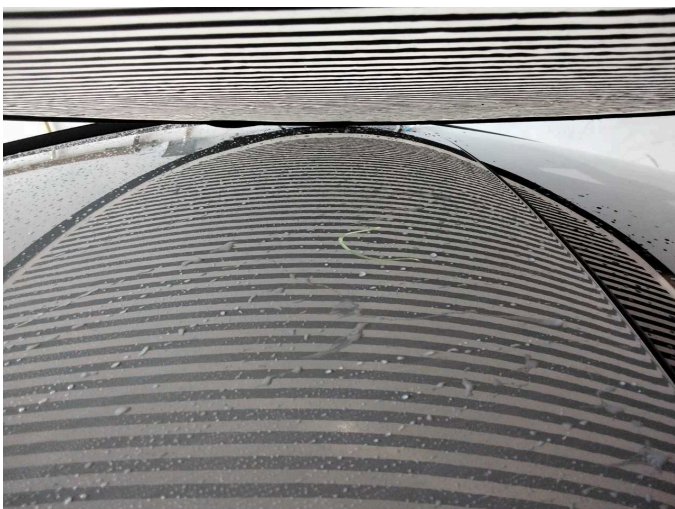
Wear and tear 4: Roof: Roof - dent(s) - No deduction

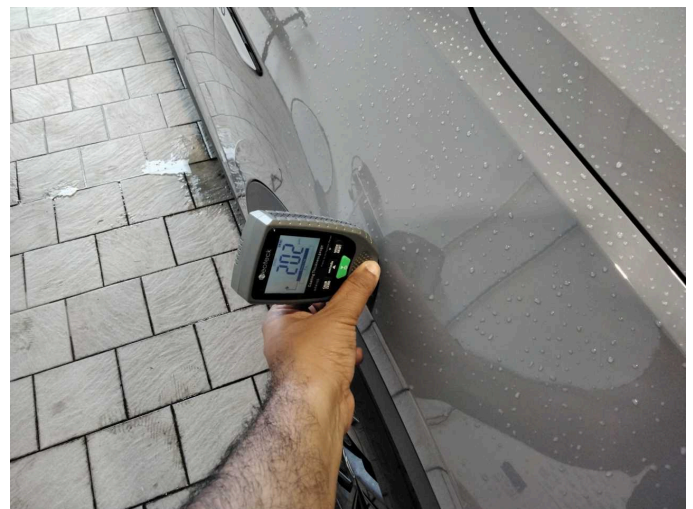
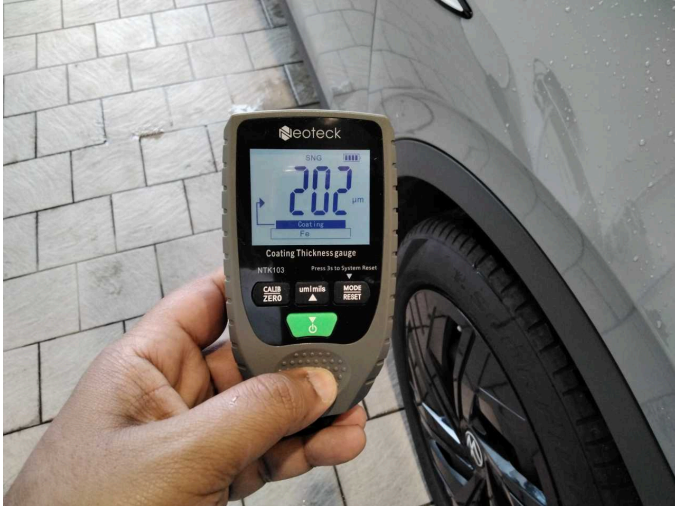
Mudguard - right side: 202 µm

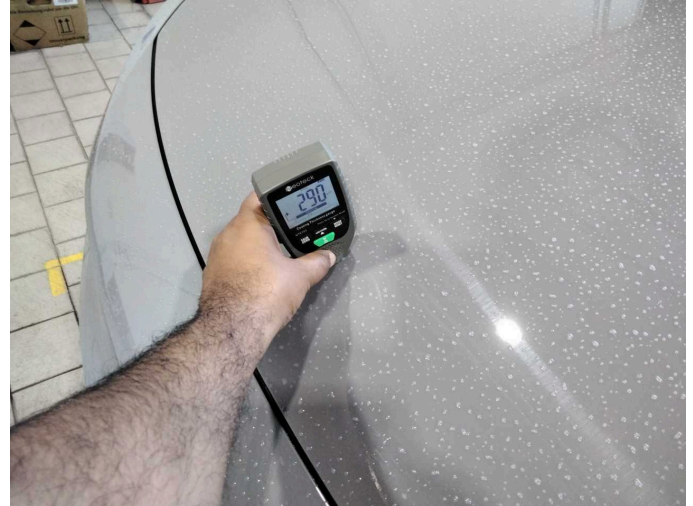
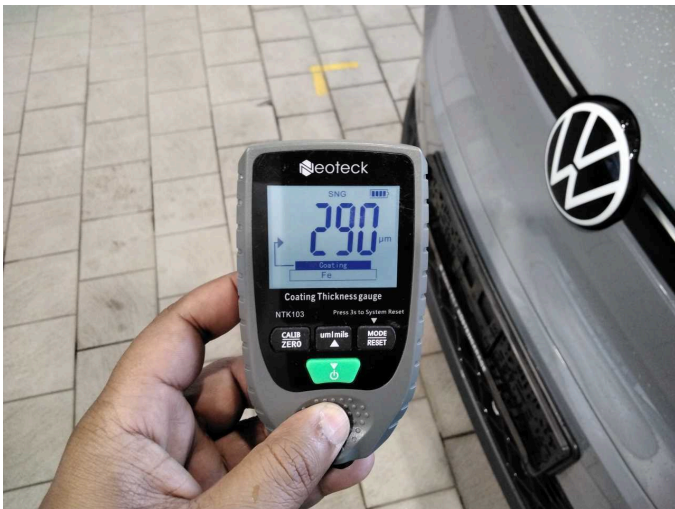
Bonnet: 290 µm
